BOLLMAN HOUSE Historic Structure Report

**1530 North Ogden Drive
Los Angeles, California**

Final Report

August 25, 2015
WJE No. 2015.1764

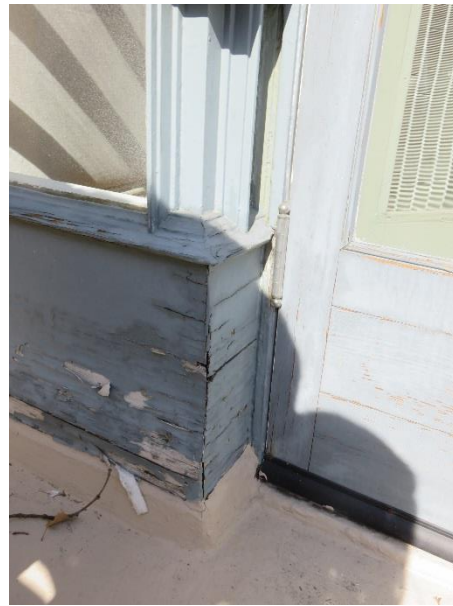
- Typically the windows and doors are in good condition.
- Areas of peeling/delaminated paint and some wood deterioration were observed, mostly on the second floor windows and doors (Figure 64 and Figure 65).
- Two lights were cracked on the second floor west door sidelights (Figure 66).
- Signs of water intrusion were noted on the sill at the hallway door on the second floor. It appears the door sill flashing has been replaced to correct this issue, but a gap is visible between the wood floorboards and stainless steel sill flashing (Figure 67).

FIGURE 65. Peeling paint and deteriorated wood at the west balcony doors.

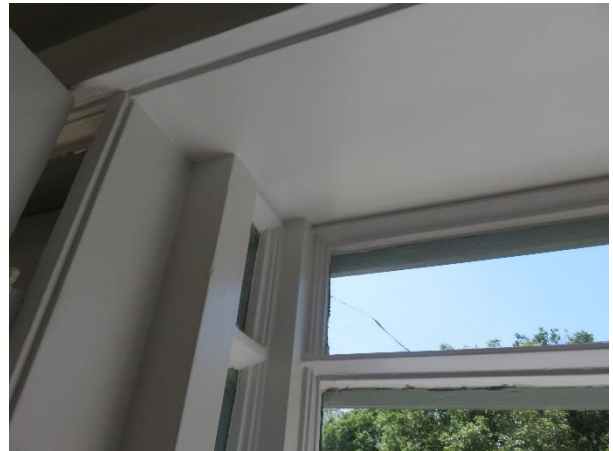
FIGURE 66. Cracked glass on the west balcony doors.

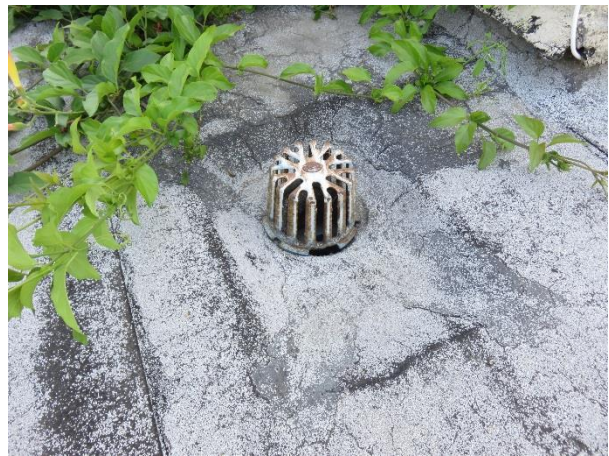
- The first floor roof had several blisters and areas of visible delamination (
- **FIGURE 68**).
- The flashing at the stucco to roof transition was deteriorated and bent, and the asphalt on the flashing is cracked and deteriorated. The drainage condition in this area is unknown (Figure 69).
- The membrane around the drain depression was cracked and deteriorated throughout (Figure 70).

FIGURE 70. Deteriorated membrane around the roof drain.

Repairs should be implemented to address roof membrane blistering, deterioration at roof drain locations, and flashing at roof transitions to stucco walls at the first floor roof. While the drainage conditions in these areas are unknown, further investigation to develop a repair program which addresses signs of deterioration and possible areas of water infiltration should be considered. Repairs should include improved detailing of the roof membrane at perimeter drain areas where the roofing was observed to be cracked and deteriorated throughout.

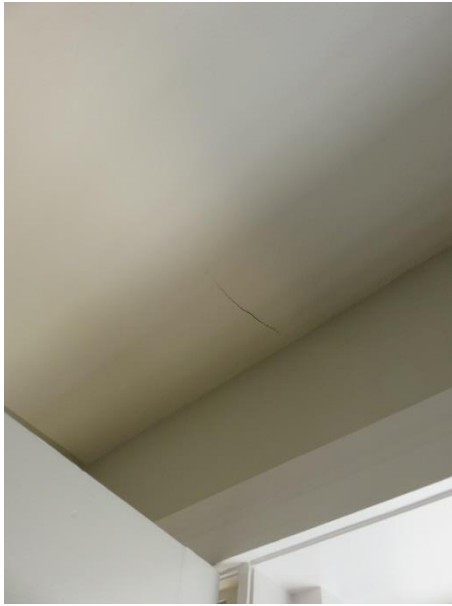
- The finishes, which include plaster walls and ceilings, paint coatings, wood trim, and wood flooring, are typically in fair to good condition.
- One area of cracked plaster was noted at the northwest bedroom ceiling (Figure 104). The crack noted is above the west door, which appears to be slightly racked, but remains operational.

FIGURE 104. Cracked plaster above the west door in the northwest bedroom.

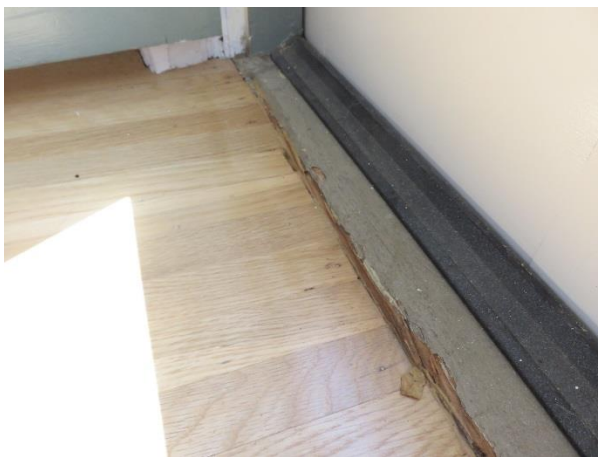
- Interior wood doors are generally in good condition.
- As described in the exterior condition assessment, there are some areas of wood decay at the second floor doors and windows, particularly in the northwest bedroom, where the interior of the wood sill was checked and split along the edge (Figure 105).

FIGURE 105. Cracked wood sill on the west door of the northwest bedroom.

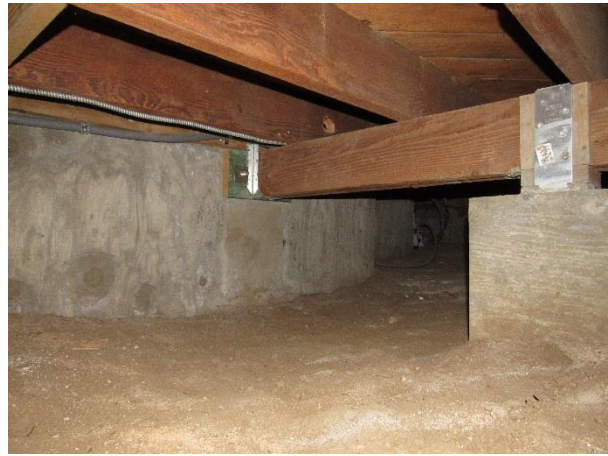
FIGURE 107. Typical wood framing, with wood beam framed into thickened concrete footing foundation (chimney location).

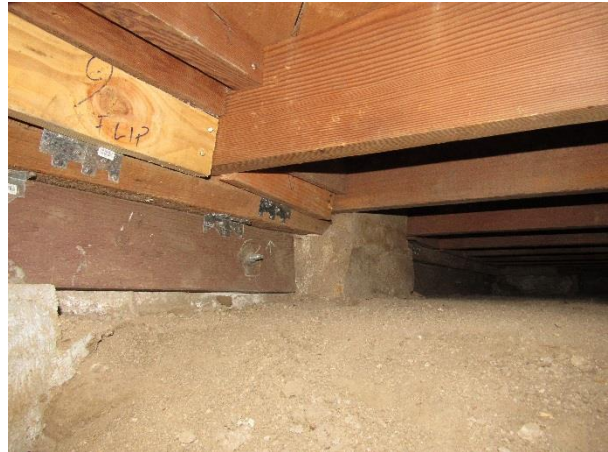
FIGURE 108. Strengthening measures at southeast crawlspace, including new plate bolted to foundation with new blocking and connections between joists and foundation and sill plate.

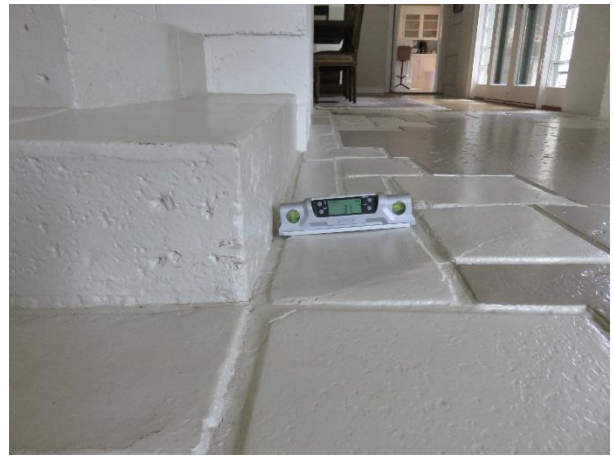
FIGURE 110. Uneven surface and bowing of the concrete entry slab.

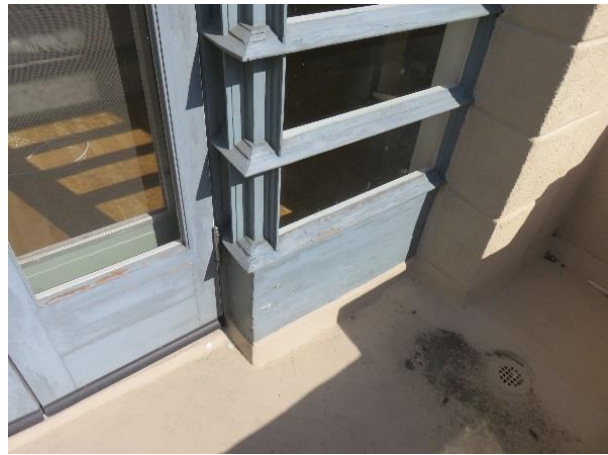
FIGURE 119. Peeling paint and wood deterioration at original west balcony doors.

- Consideration should also be given to addressing water infiltration, which appears to be occurring sill of the hallway door on the second floor. It appears the door sill flashing has been replaced in the past, possibly to correct this issue; however, a gap remains between the wood floorboards and stainless steel sill flashing. A repair should be developed to address this condition and ensure that this and other door sill locations are protected against water infiltration.

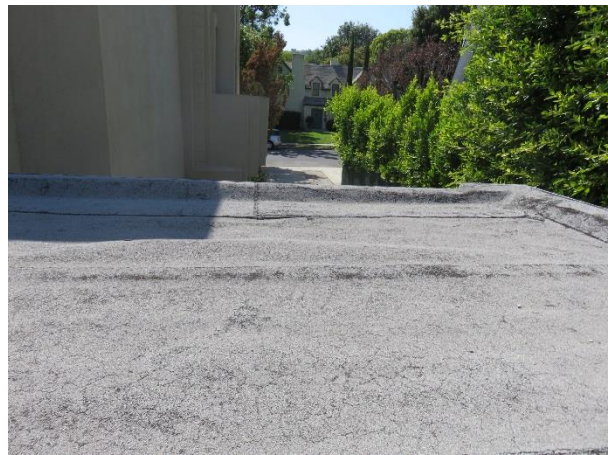
FIGURE 120. Area where the roof membrane is blistered and not bonded to the substrate.

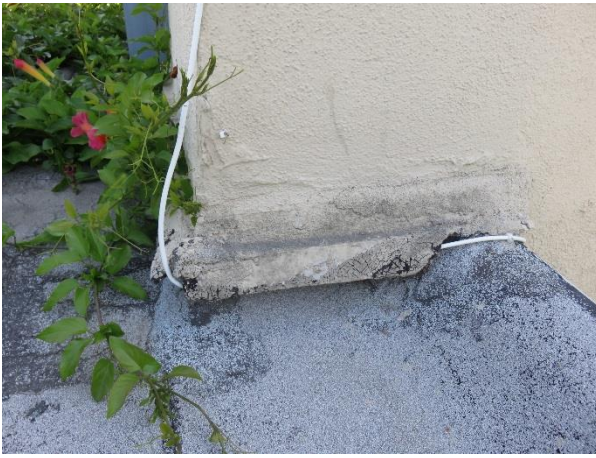
FIGURE 121. Deteriorated flashing at the roof to stucco-clad wall transition.

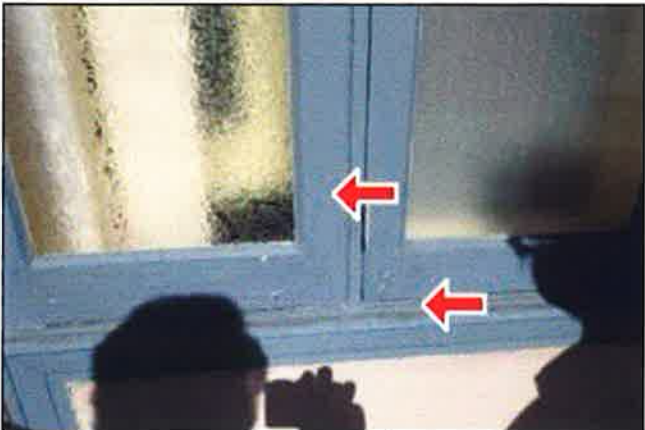
1.2 Picture 1

- Moisture stains, peeling paint noted at front elevation windows - have it checked by a qualified termite inspector and painting contractor.

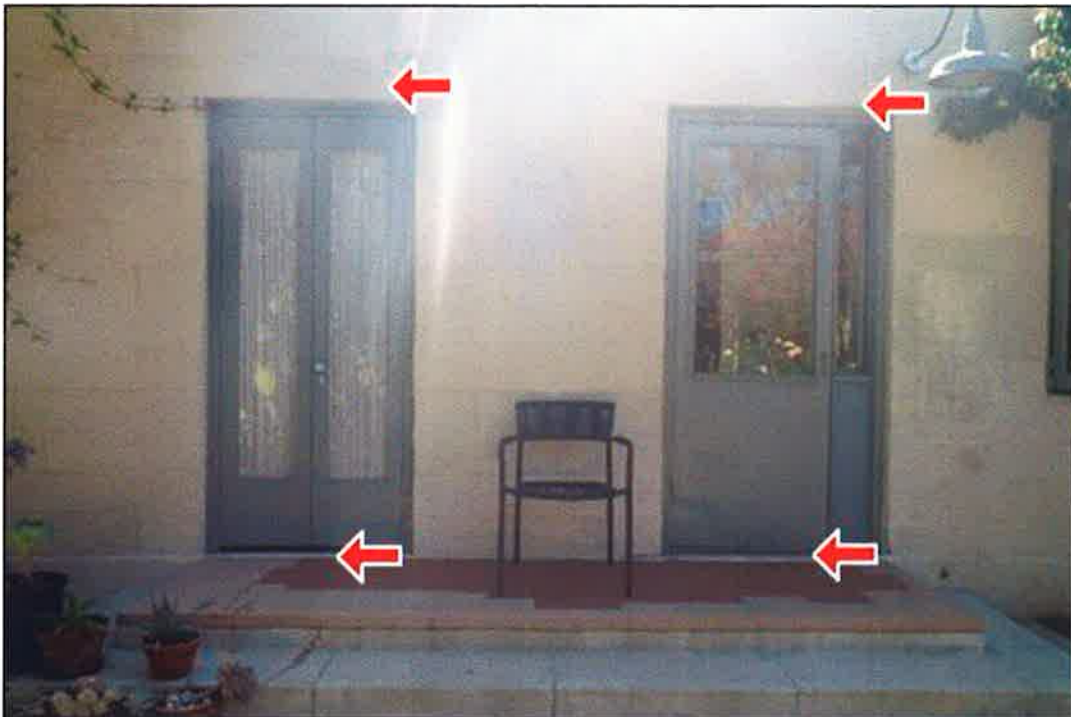
1.3 Picture 1

- Recommend to install awnings at exterior doors to prevent water seepage/ damage. (Picture 1). Some water stains noted at Lower Bathroom door - possible seepage from door. Have it checked. Recommend to install proper threshold at exterior doors to prevent water seepage(Picture 2)
- Exterior doors open over step - a trip hazard; door is hinged on the exterior with loose pin hinges(recommend to replace with pick proof type hinges) - a security concern.
- Missing proper landing at rear right side door noted(Picture 3)(Picture 4)

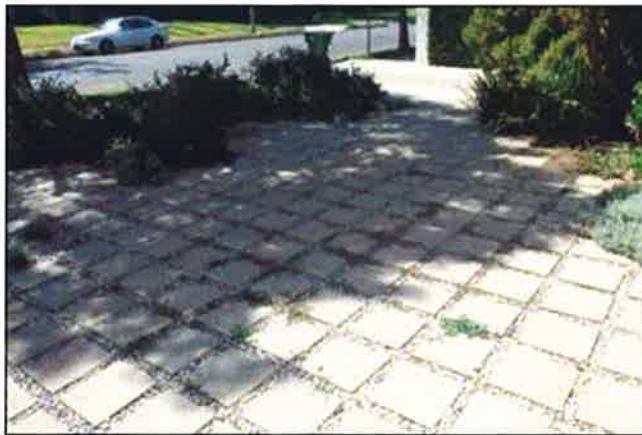
2.1 Picture 1

- Some cracks noted at driveway. Not fully visible at the time.
- Uneven areas noted at front walks(Picture 1) - use caution.

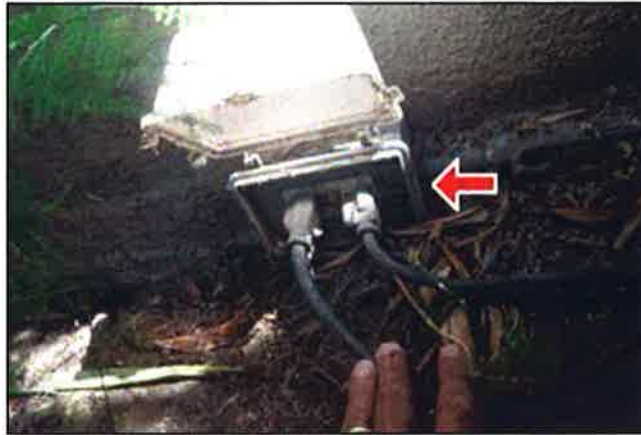
4.5 Picture 1

- Recommend to have GFCI outlets in all "wet" locations as a safety upgrade, and to test them periodically.
- Electric outlet for garden lights installed to low at the ground at rear yard(Picture 1) - have it checked/ upgrade

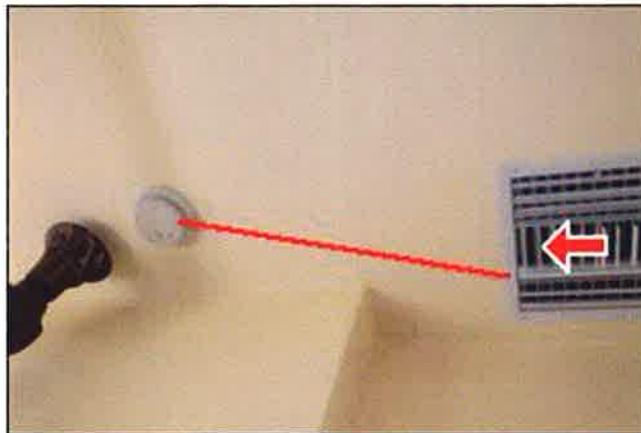
4.6 Picture 1

- Recommend to have operational smoke detectors in bedrooms and hallways and to test them periodically.
- Recommend to install carbon monoxide detectors per City/Manufacturers requirements and test them periodically.
- Smoke detectors were installed too close to air grill - recommend to relocate minimum 3' away. (Picture 1)

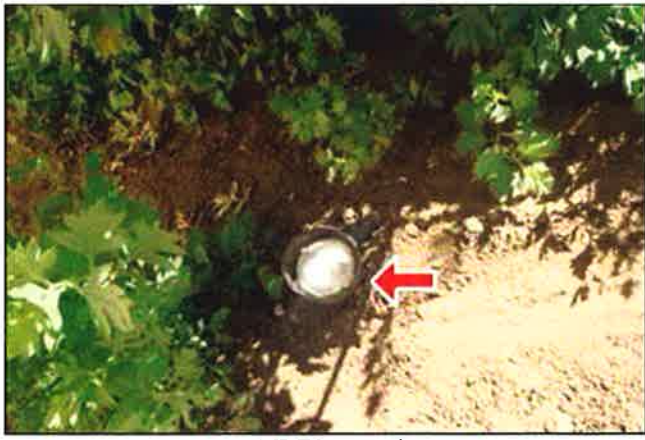
4.7 Picture 1

- Phone/ cable, low voltage systems... not part of this inspection.
- Garden lights/ transformers, timers not part of this inspection. Check with the seller. Missing/ damaged garden lights noted(Picture 1, 2)

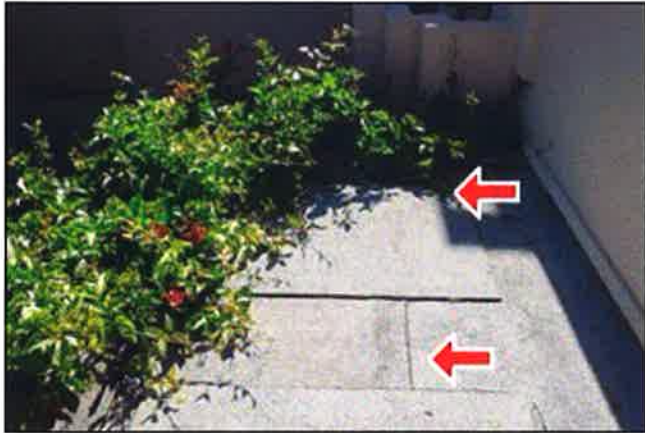
7.0 Picture 1

- Tree limbs that are in contact with roof or hanging near roof should be trimmed away. Recommend to trim away and inspect the roof. (Picture 1)
- Worn, damaged roof cover noted at lower roof. (Picture 1-5)
- **Recommend further/ complete evaluation/ maintenance by a qualified roofer.**
- Upper roof; newer vinyl roof cover noted - check the warranties.(Picture 6)

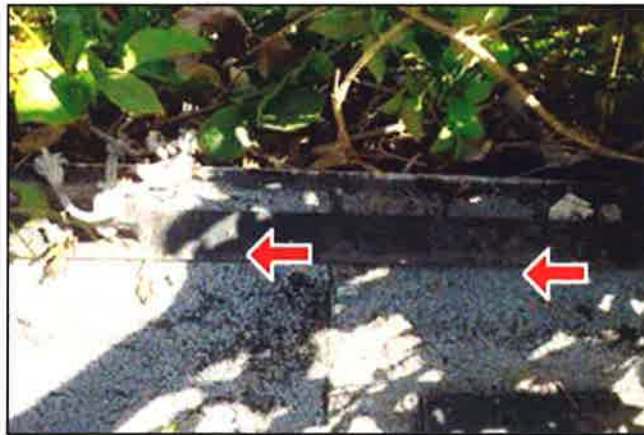
7.1 Picture 1

- Missing coping metal at lower roof parapet walls noted.(Picture 1). Recommend to install to prevent leaks/seepage.
