ARCADY APARTMENTS (HCM #1124)
2615-2627 West Wilshire Boulevard
CHC-2017-2795-MAEX

RECOMMENDATION REPORT

CASE NO.: CHC-2017-2795-MAEX

PROJECT: 2615-2627 West Wilshire Boulevard; 622-630 South Rampart Boulevard
Arcady Apartments, Historic-Cultural Monument (HCM) #1124

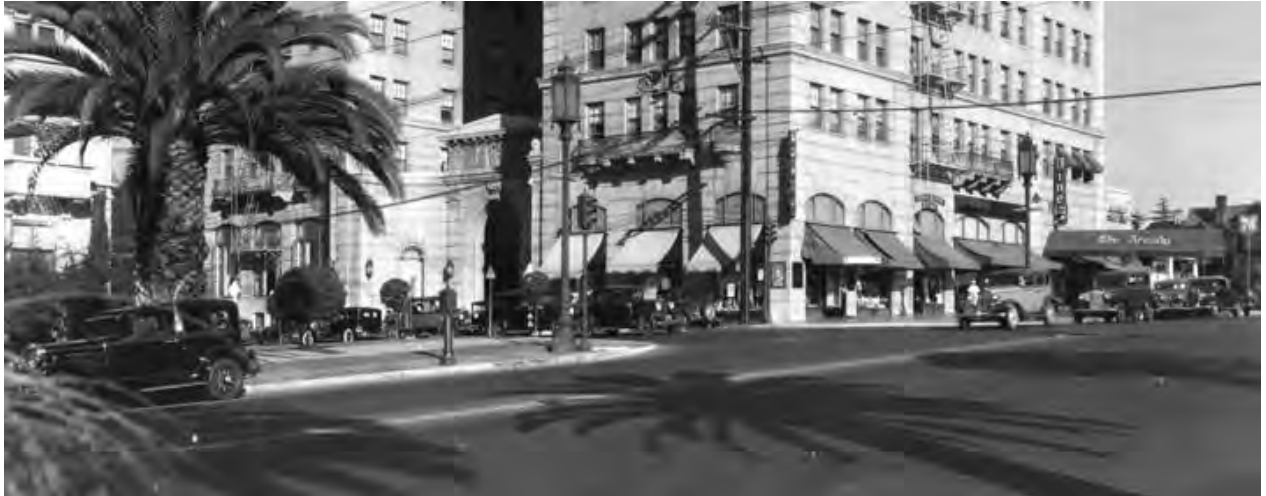
Initial arched entry was located between the two primary wings. It was damaged by earthquake in 1971 and removed.

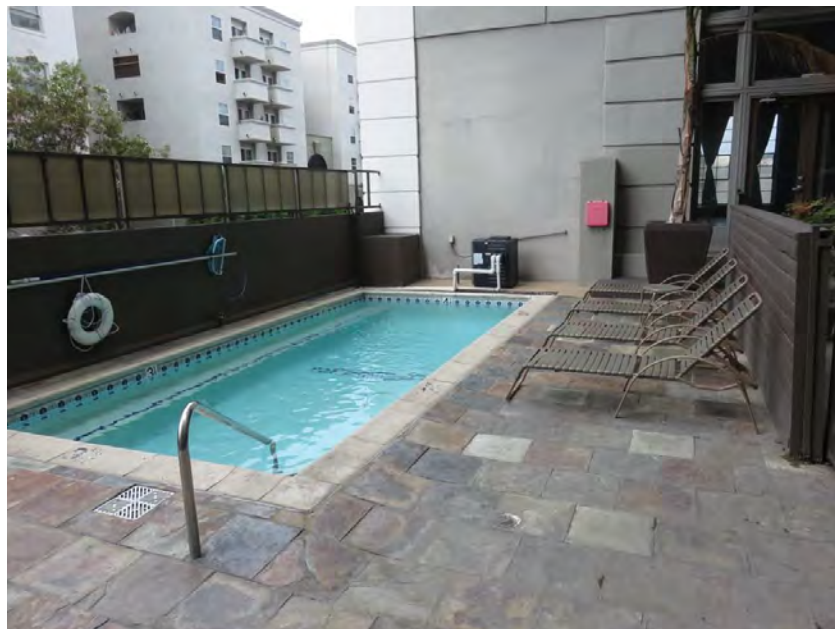
Pool and surrounding deck installed in 1982. The pool is located in the exact position of the original arched entry portal which is visible in the historic photo. This alteration fundamentally changed the function of this area from an entrance and courtyard, to what is effectively now a private deck between the two flanking wings of the building, with no relationship to the street.

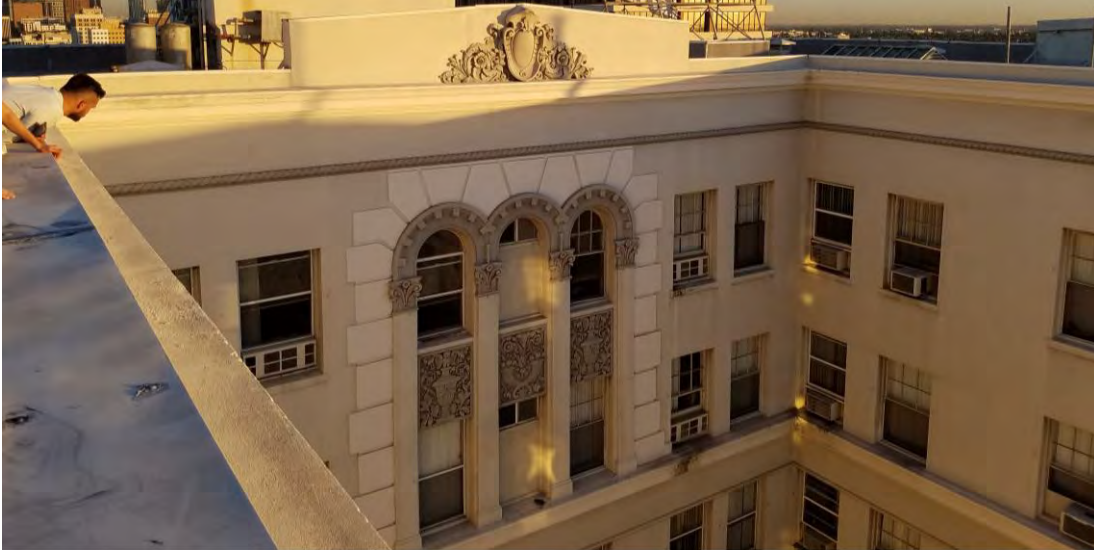
Upper façade ornamentation and cornice details. The window openings are evenly spaced. Window air conditioning units have a minor impact on the integrity of the appearance of these primary elevations, although there is no real alternative without major intervention to the interior.

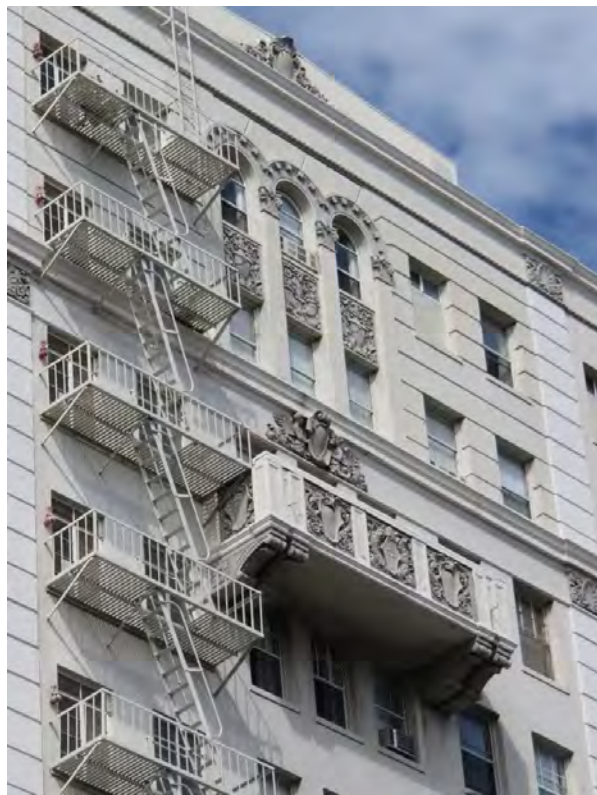
Upper façade ornamentation and balconies, typical on the primary elevations. All of these components need periodic inspection for cracks and any weakening of the attachments.

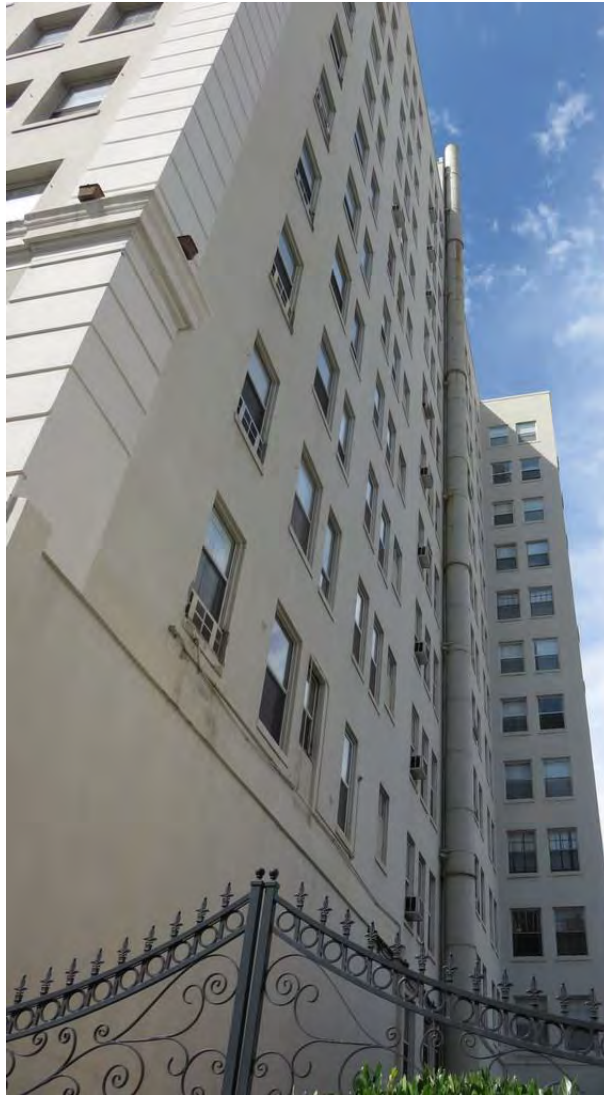
The rear elevation (east) is not ornamental or intended to be in prominent view. The walls are plain and only noted for the evenly spaced window openings. Window air conditioning units are less of a concern on these elevations in terms of impact on the architectural integrity of the building.

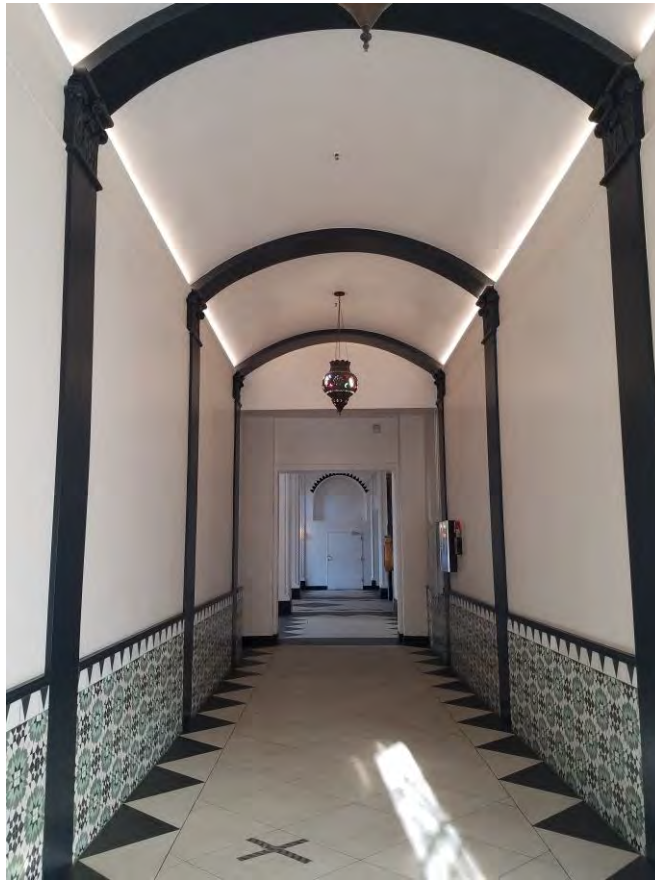
Main Entrance from Wilshire Boulevard, corridor leading to main lobby. This area was recently repainted to convey a “Moorish” character of the grand lobby. The original NeoClassic architectural features remain intact. The tile wainscot was added in 2016 as part of the upgrade.

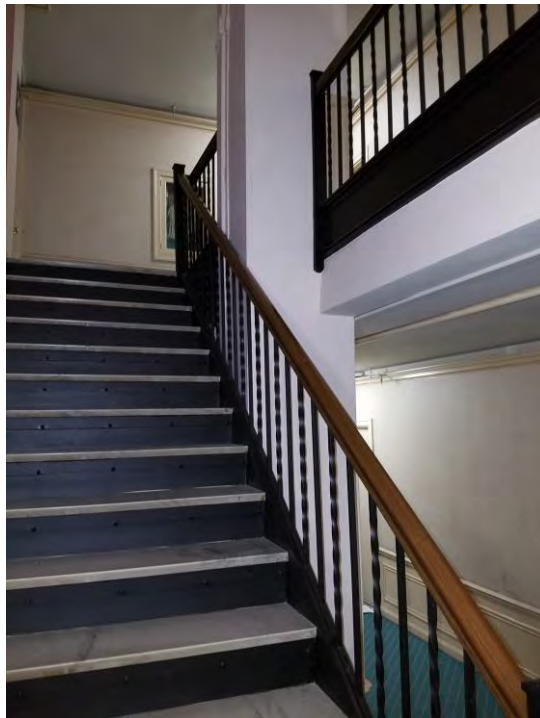
Stairway 2 accesses the upper stories. The marble stair treads and balustrade with wood bannister are original and should be retained. The railing does not meet current code requirements. A variance may be required to avoid future modifications of the railing, or the potential to enclose the stairwell, which would have a major impact on the character of the corridors, and the interior in general.

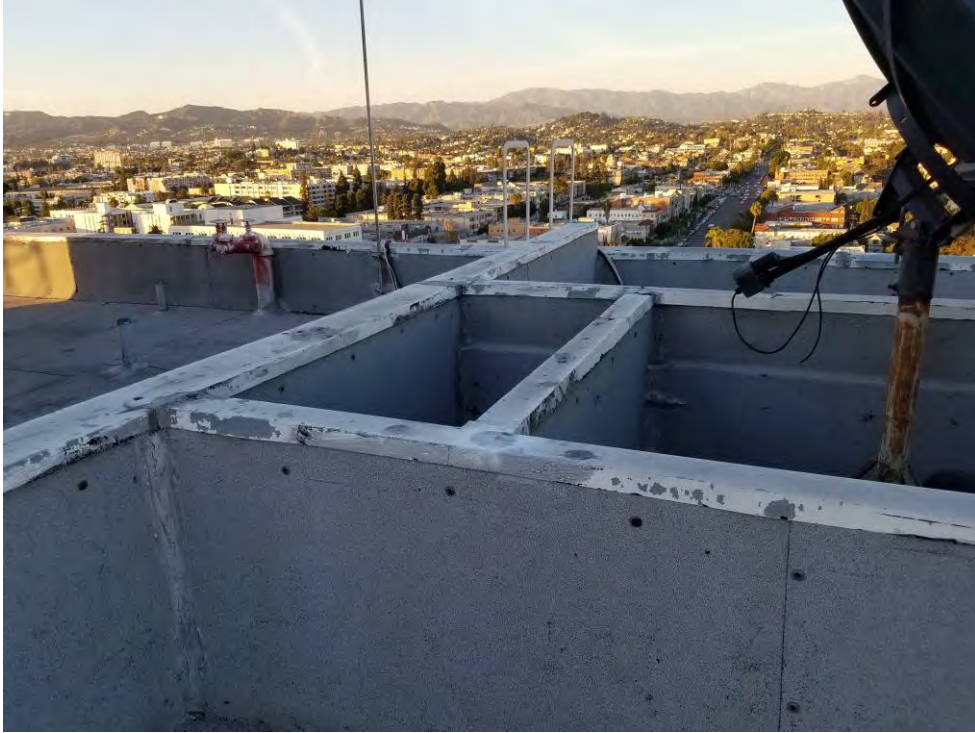
The rooftop will need maintenance. The sheathing will need to be replaced on a cyclical basis, and flashing painted.

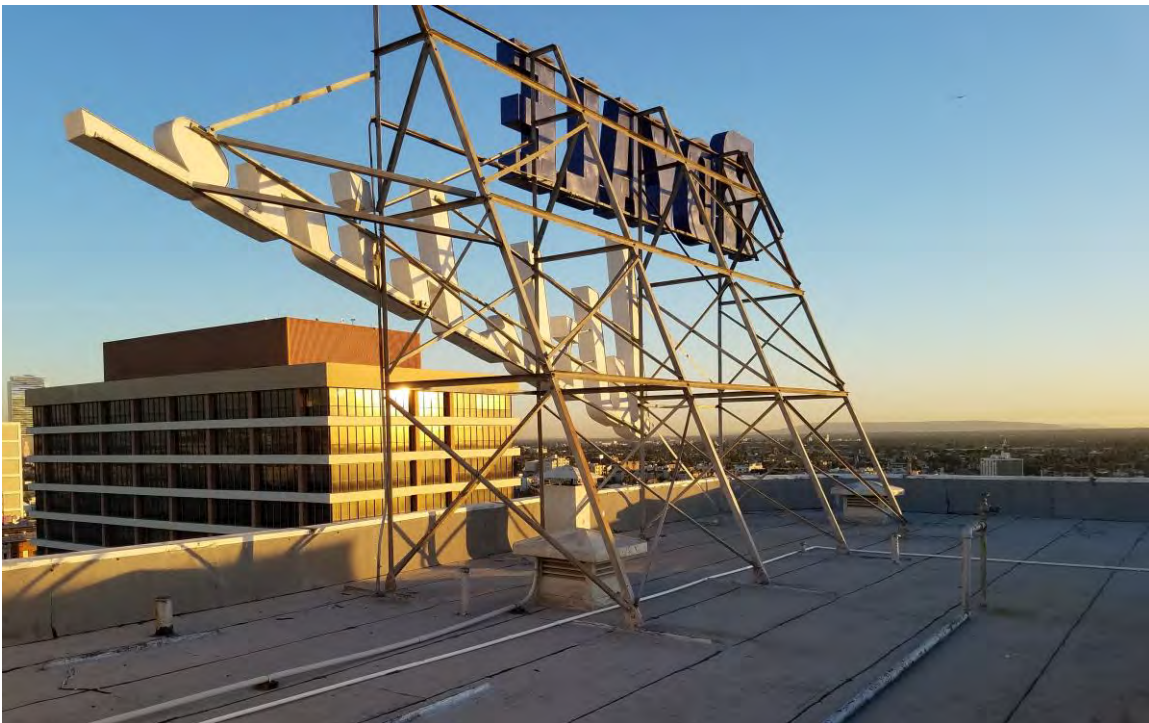
The framework of the sign is an original feature, although the actual sign and language has changed. The frame has been recently stabilized and painted (2016).

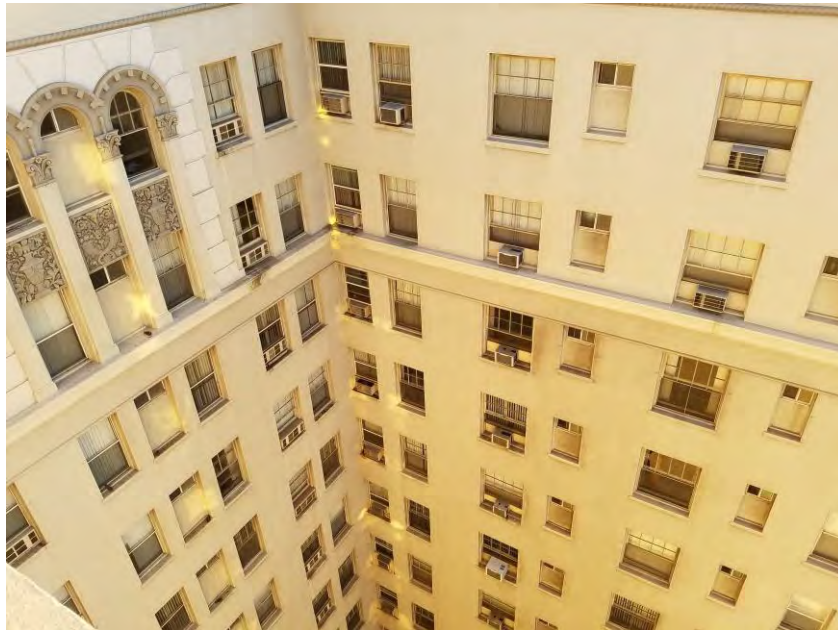
Projecting air conditioning units with the original sash open, as well as the infilled windows for the showers, have a cumulative visual impact.

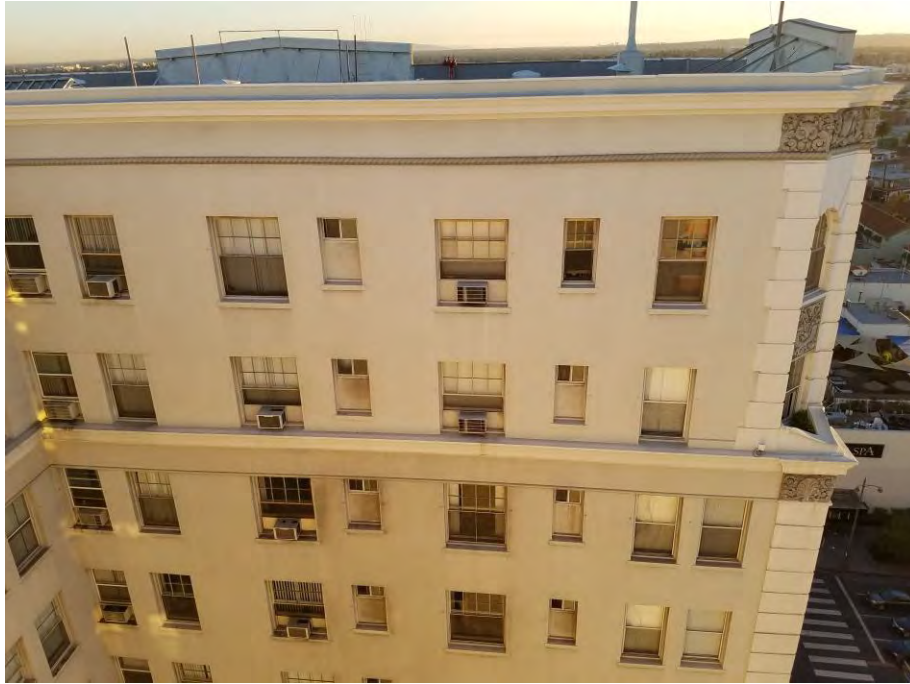
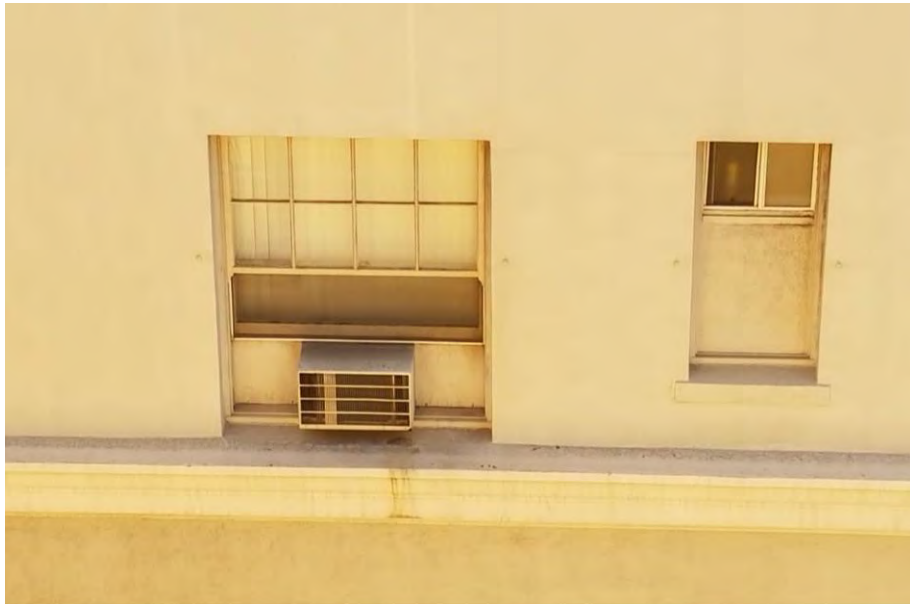
As noted, due to the concrete structural framing and walls of the building, there is no realistic option to install a central air conditioning system that would allow the air units to be removed from the window openings. New AC units of a flatter profile that would fit across the base of the window opening may present an option that would be less impactful to the character of the facades, especially the primary elevations and internal courtyard walls.
