104-112 NORTH AVENUE 56; 5567-5577 NORTH FIGUEROA STREET
Highland Park Masonic Temple, HCM #282
Contributor to the Highland Park-Garvanza HPOZ
CHC-2018-1406-MAEX

Agenda packet includes:

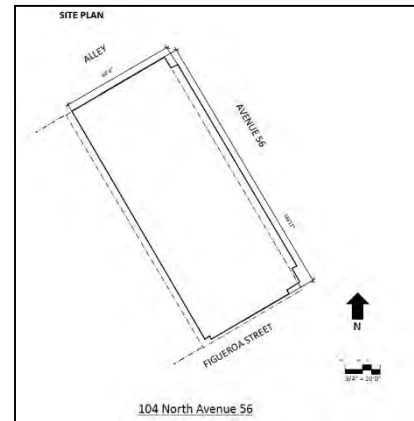
Site Plan of subject property (2018)

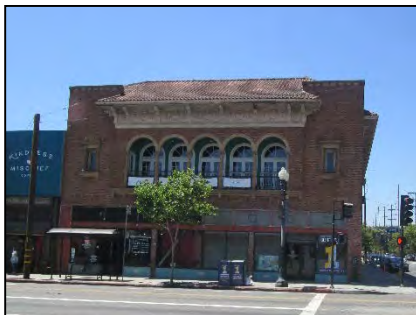
Primary, south elevation along North Figueroa St., view north

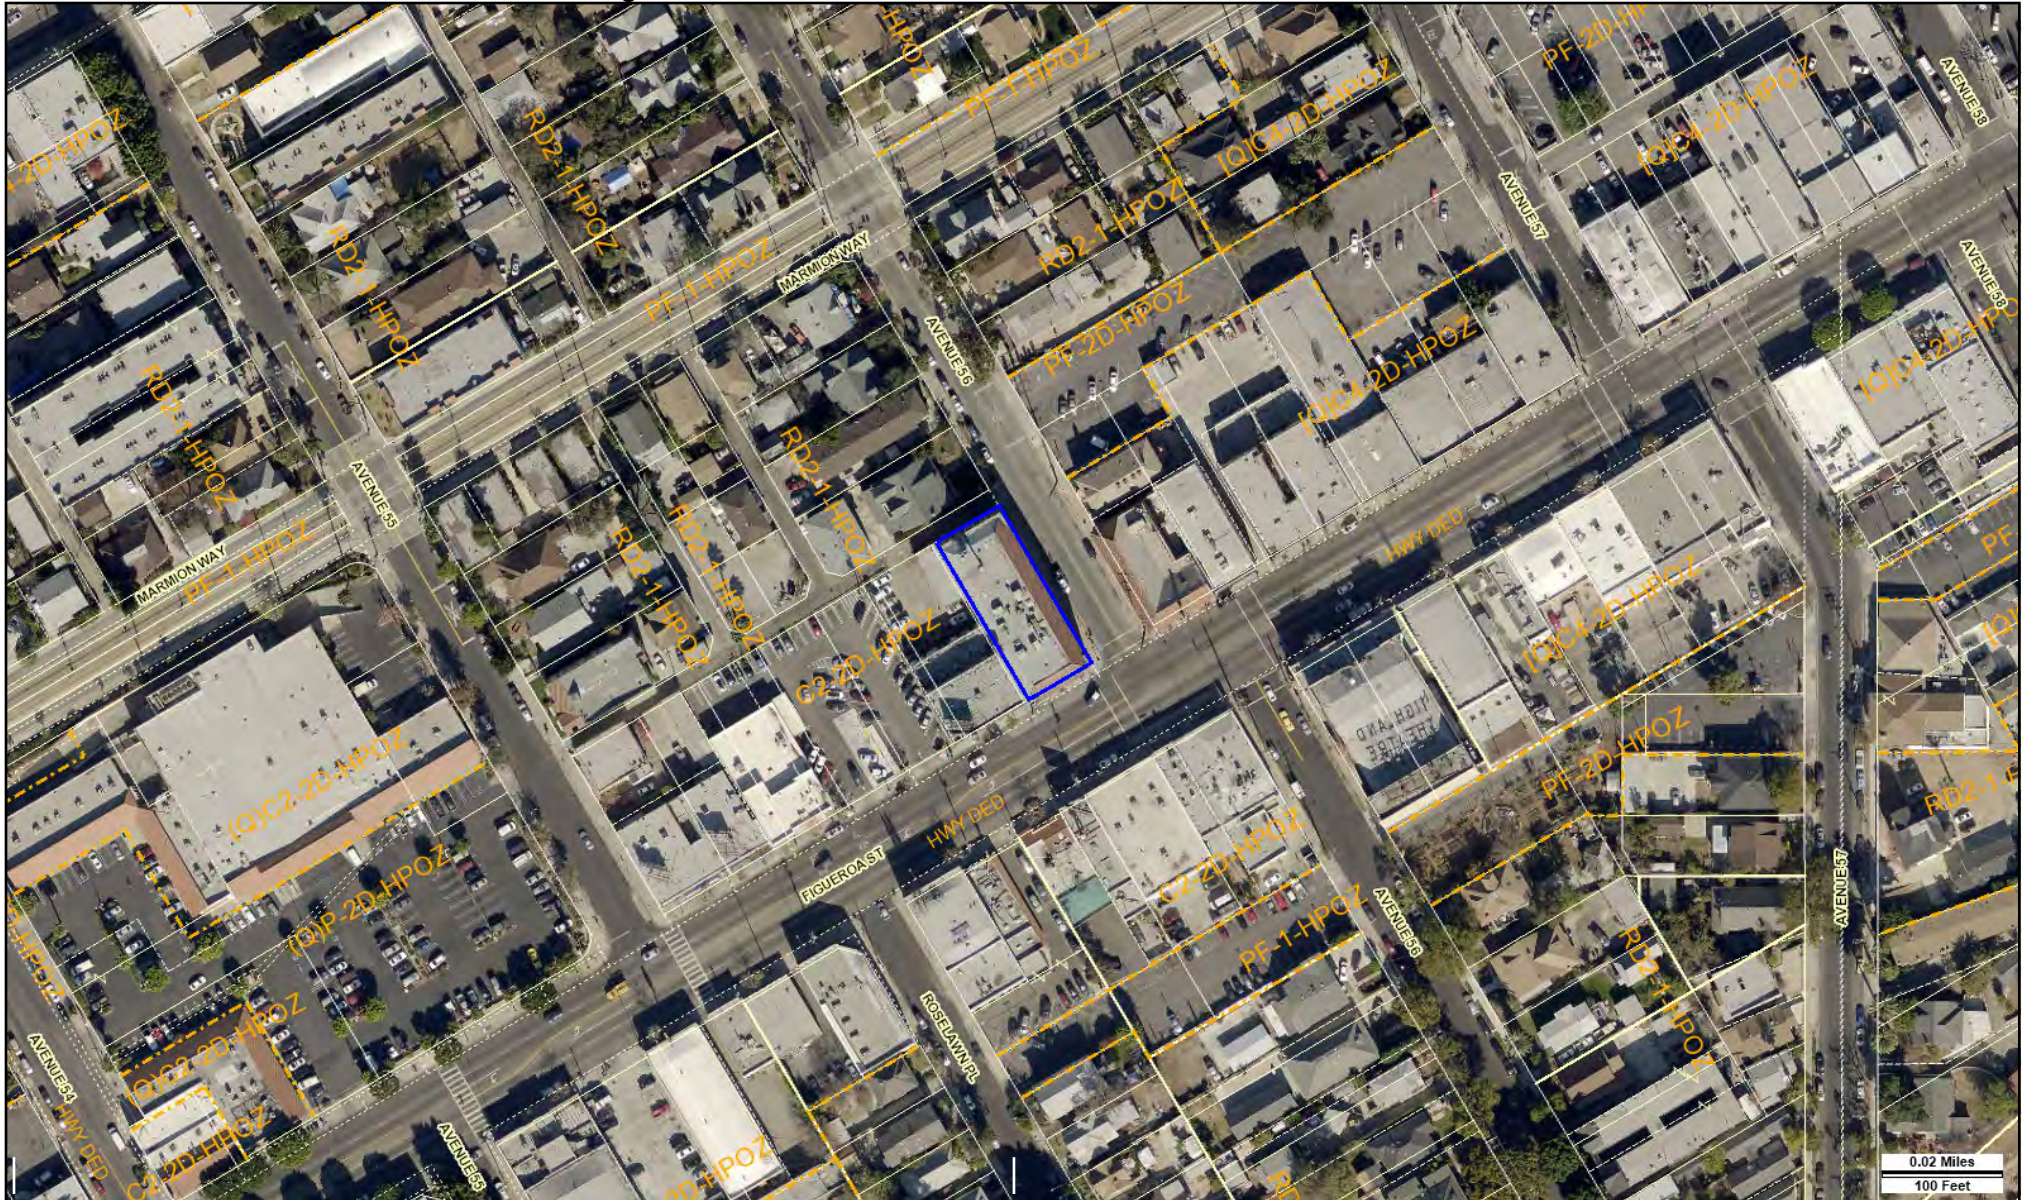
Address: 104 N AVENUE 56

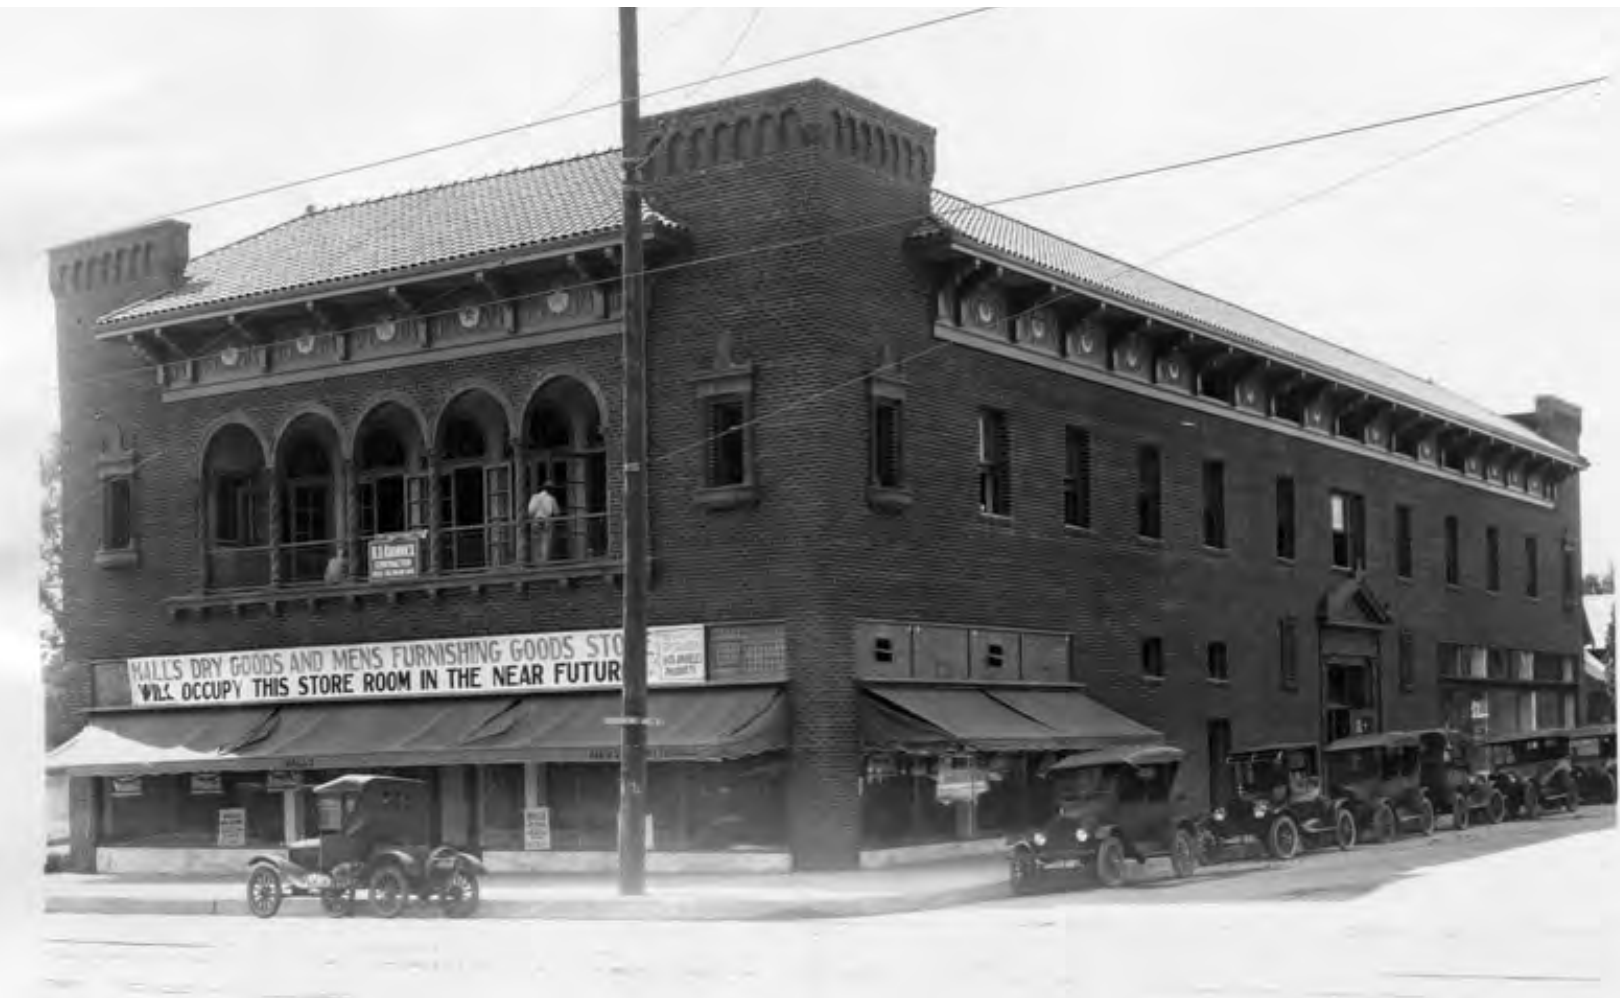
2. Developmental History

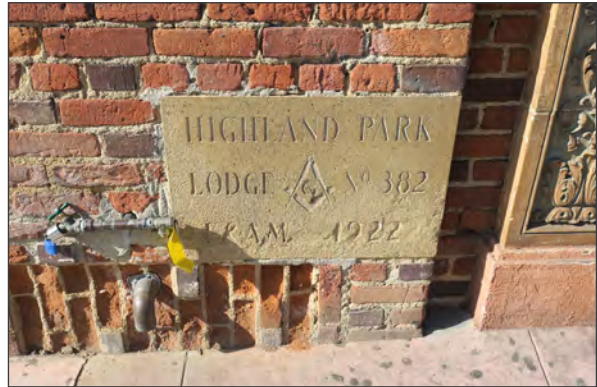
Cornerstone on northeast elevation (ARG, 2018)

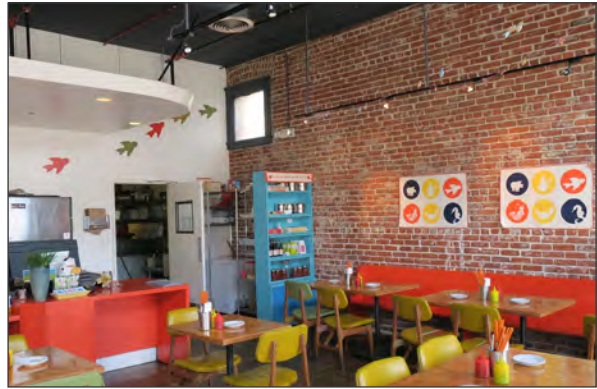
Interior of retail unit at 110 North Avenue 56, currently occupied by Good Girl Dinette (ARG, 2018)

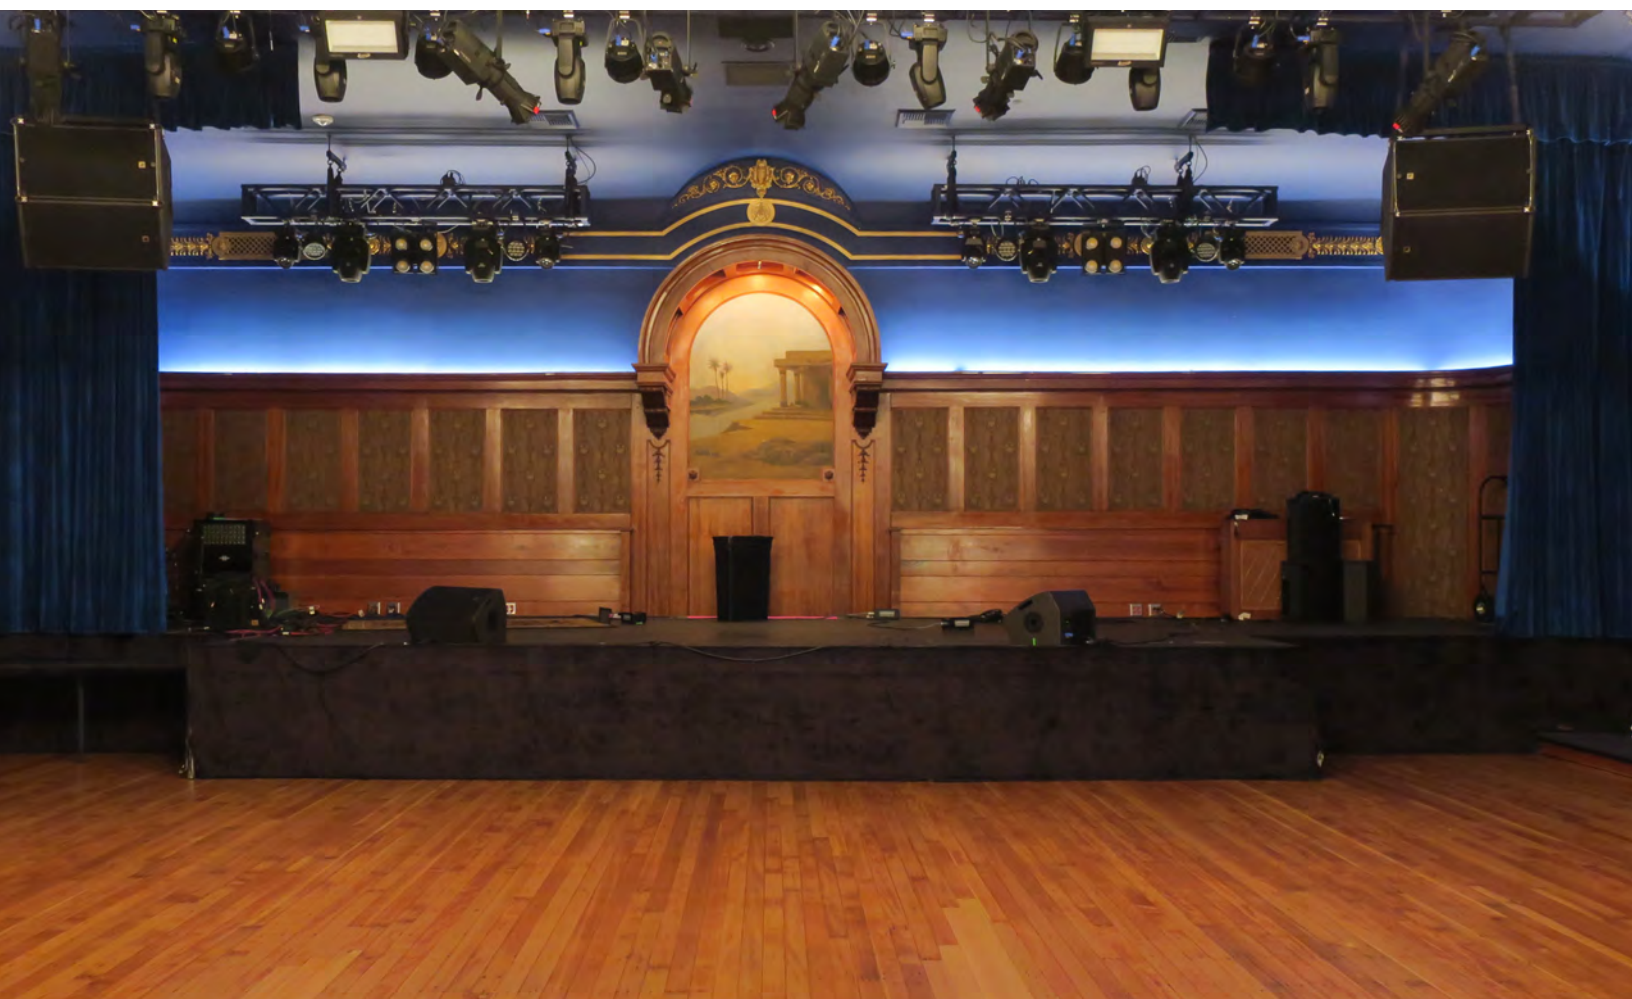
5. Existing Conditions

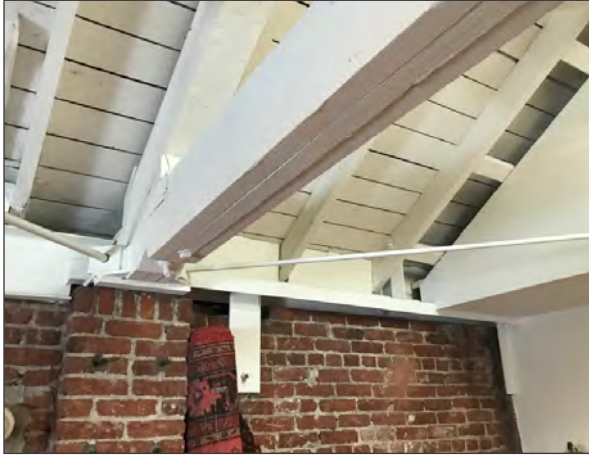
Wood bowstring truss and framing at third story interior (ARG, 2018)

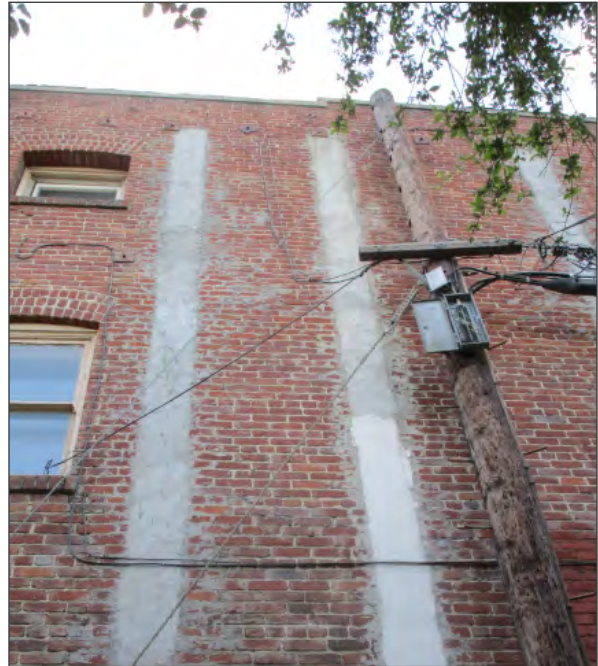
Seismic wall anchors and braced framing at exterior URM wall, northwest elevation (ARG, 2018)

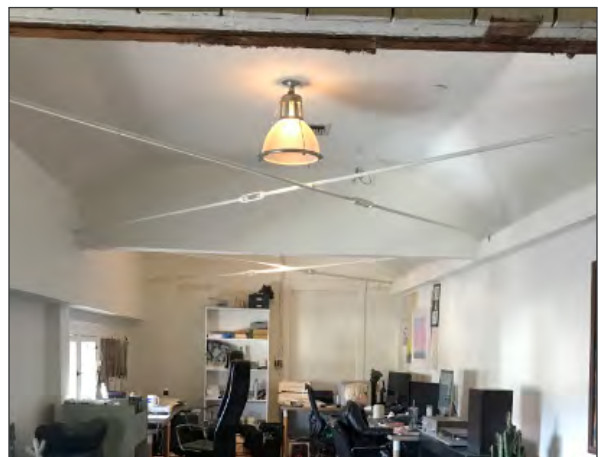
Tie rods at third floor interior (ARG, 2018)

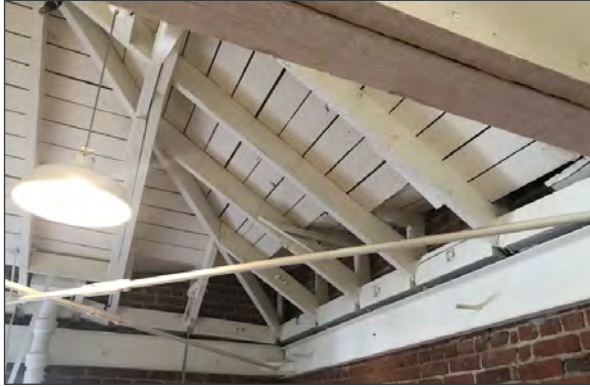
Wood joist roof framing and board sheathing (trusses not shown) (ARG, 2018)

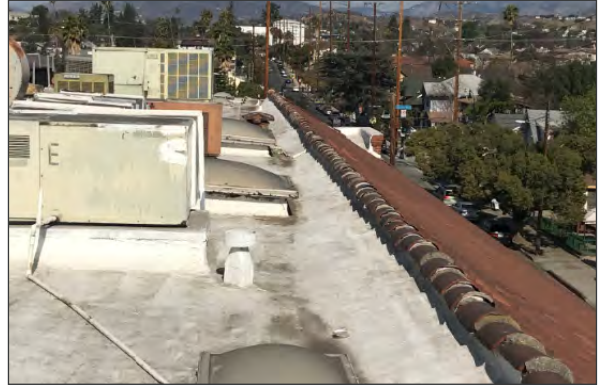
Membrane roof, view northwest. Note skylights and rooftop HVAC units (ARG, 2018)

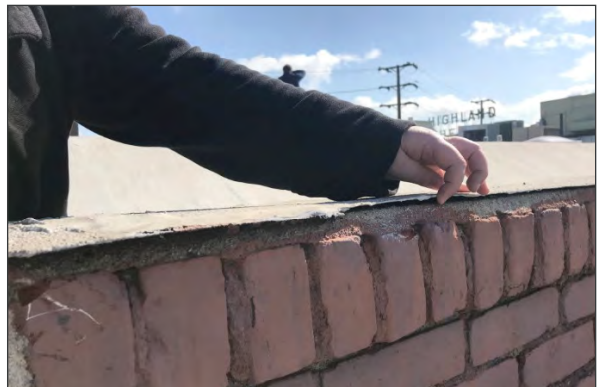
Brick parapet wall. Note loose membrane at top of wall, with no turn down or coping/ flashing. Also note general deterioration of brick masonry (ARG, 2018)

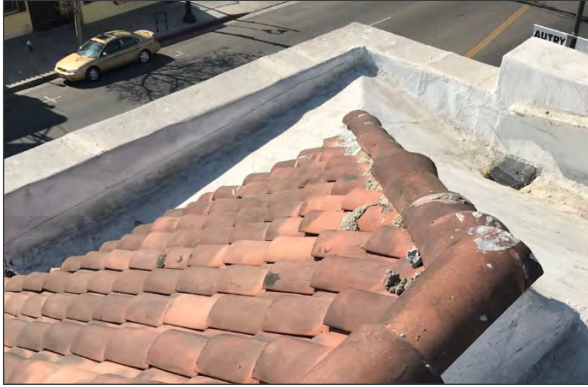
Tile roof at east corner of building (ARG, 2018)

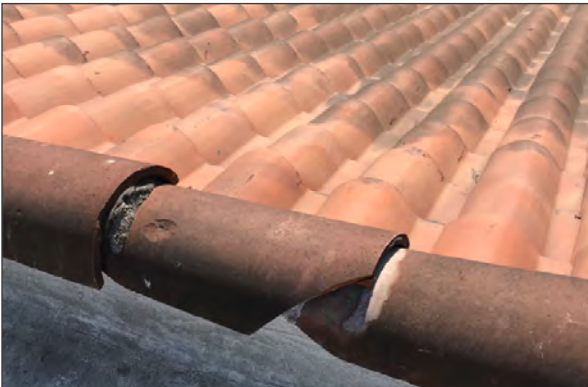
Chipped and broken ridge coping tile along northeast elevation (ARG, 2018)

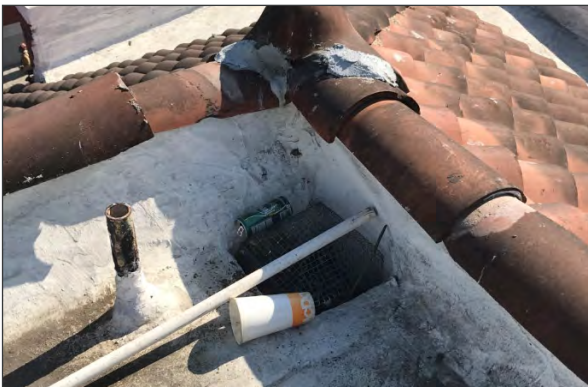
Area drain at east corner of membrane roof. Note trash/debris and loose screen (ARG, 2018)

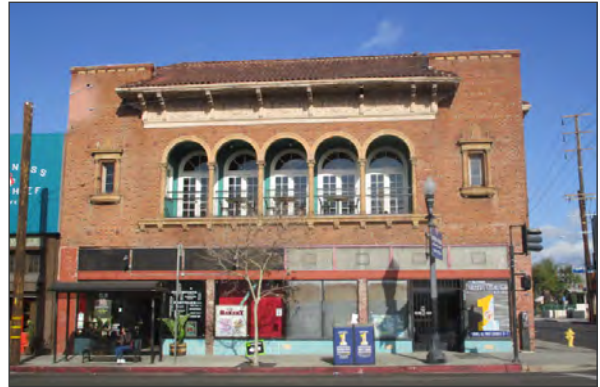
Brick exterior walls on primary (southeast) elevation (ARG, 2018)

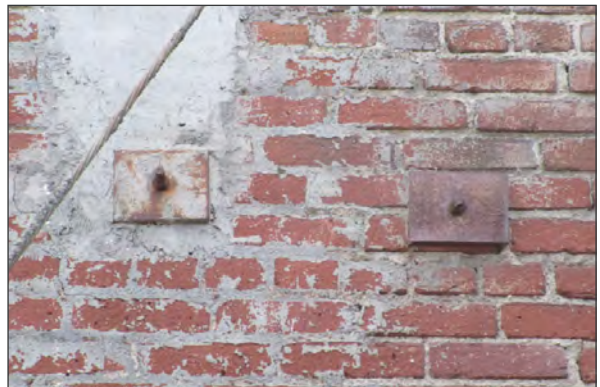
Detail of seismic plates and anchors at second floor level, northwest elevation. Note surface corrosion (ARG, 2018)

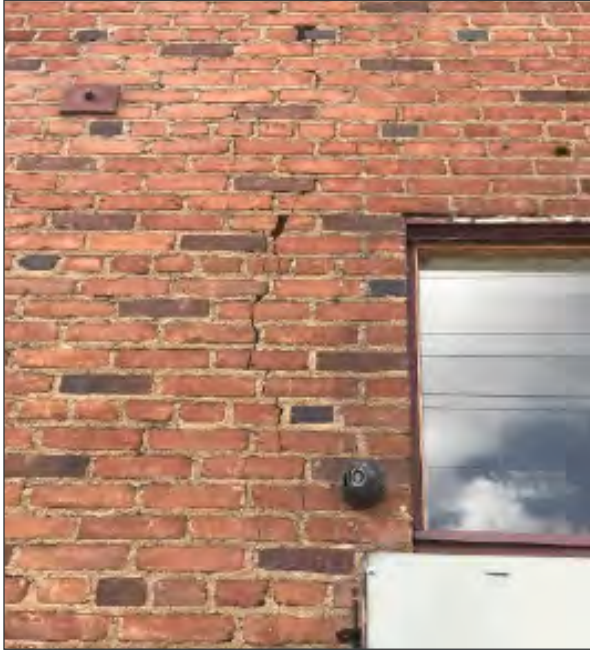
Crack at brick masonry, northeast elevation (ARG, 2018)

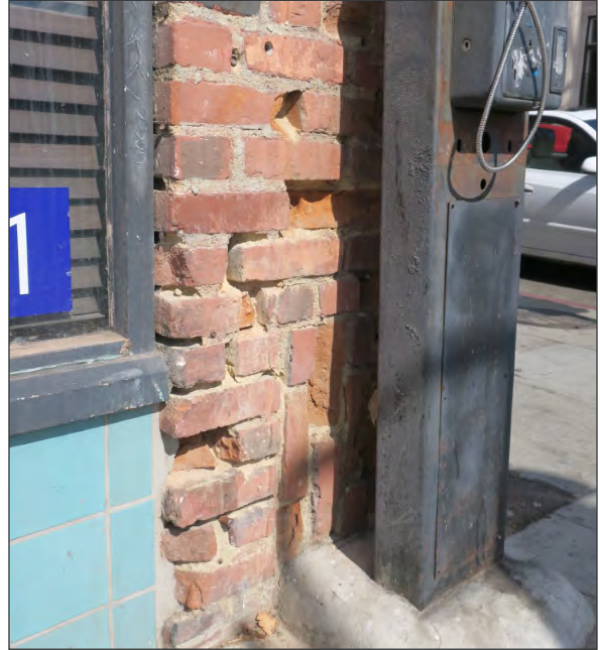
Deteriorated and missing brick at southeast corner (ARG, 2018)

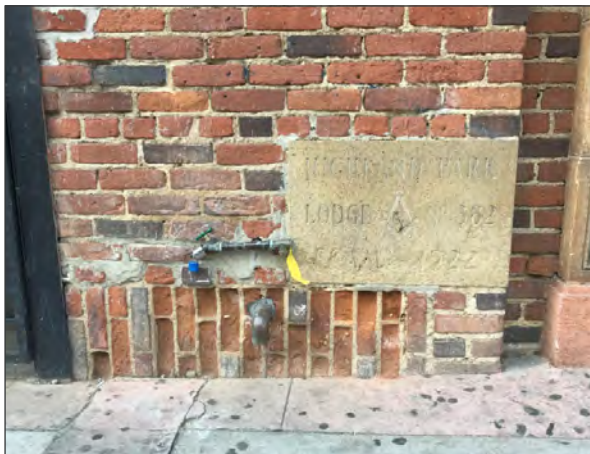
Eroded/deteriorated brick at base of building wall, northeast elevation (ARG, 2018)

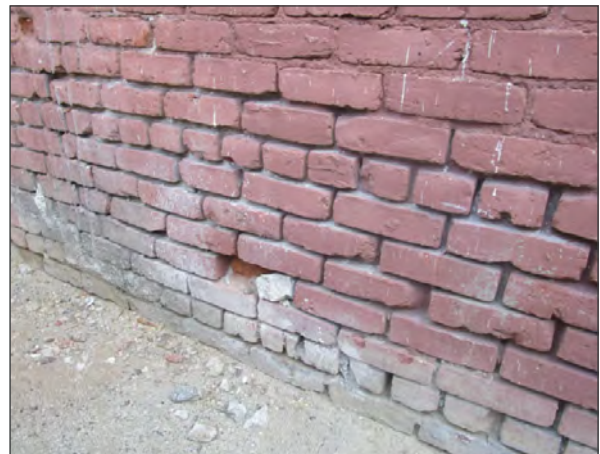
Deteriorated brick and open mortar joints at base of wall, southwest elevation (ARG, 2018)

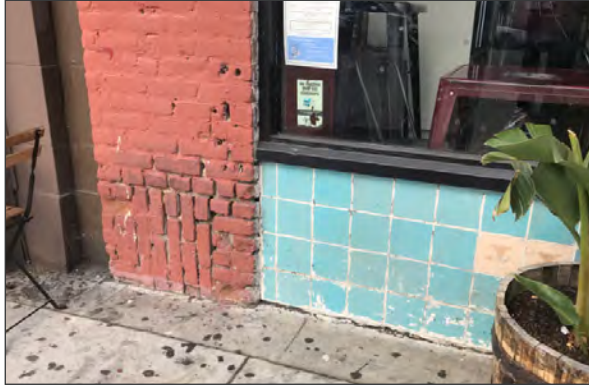
Open mortar joints at base of wall, northeast elevation (ARG, 2018)

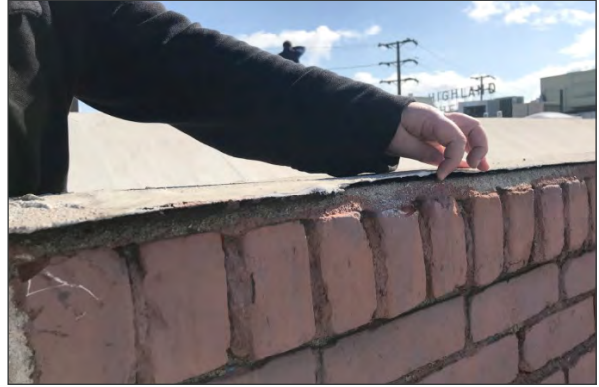
Deteriorated mortar joints at top of parapet wall (ARG, 2018)

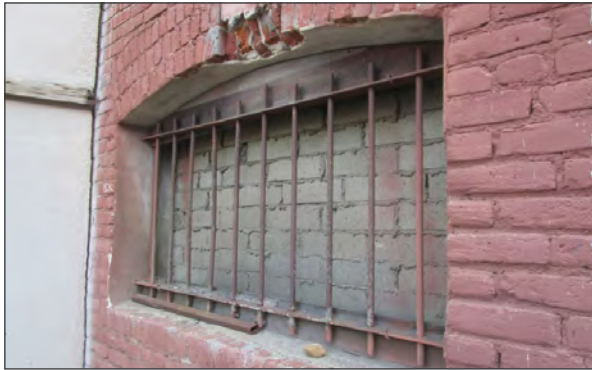
Damaged brick at window opening, southwest elevation (ARG, 2018)

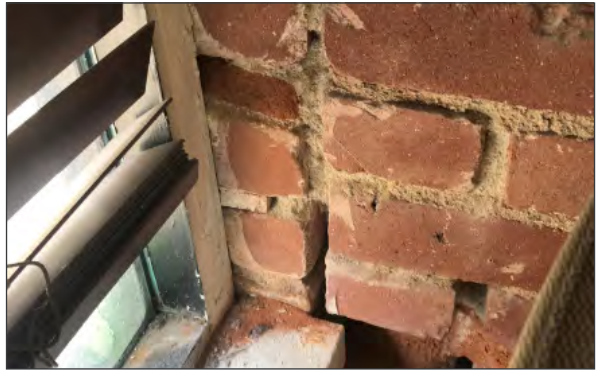
Deteriorated brick and mortar at interior side of brick wall, southeast building corner (ARG, 2018)

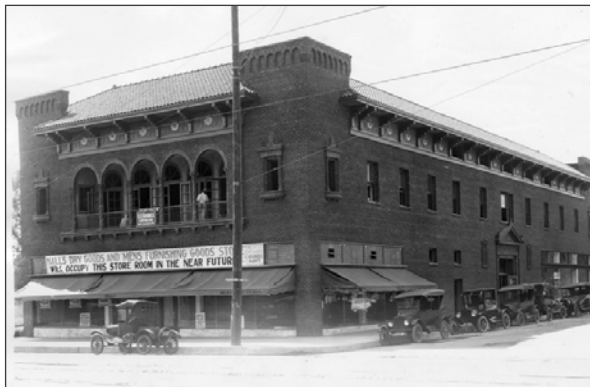
Historic photo, c. 1920s. Note taller parapets at corners (Los Angeles Public Library)

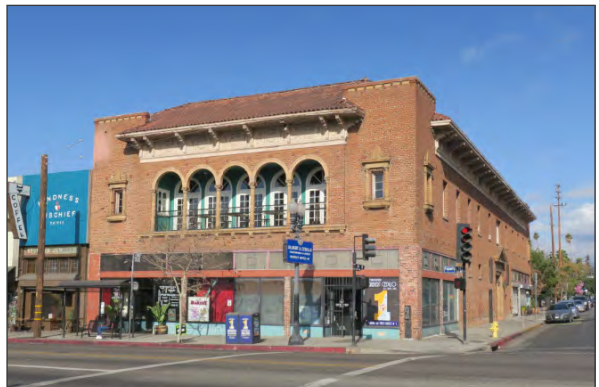
Current view of building. Note shortened parapets (ARG, 2018)

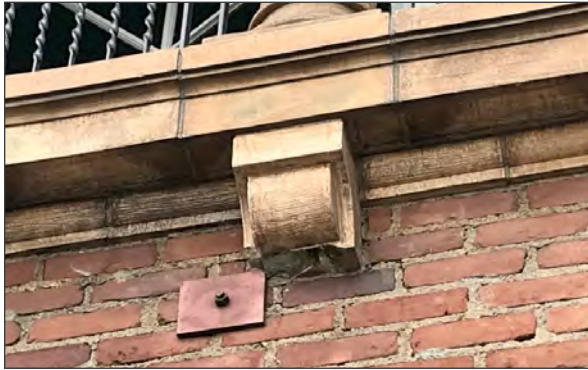
Spall damage at terra cotta unit, southeast elevation. Damage may have occurred during installation of adjacent seismic plate/tie rod (ARG, 2018)

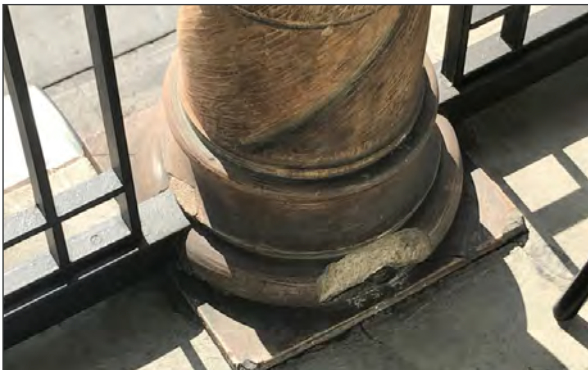
Large spall at balcony side of terra cotta column, and previous patch at railing connection (ARG, 2018)

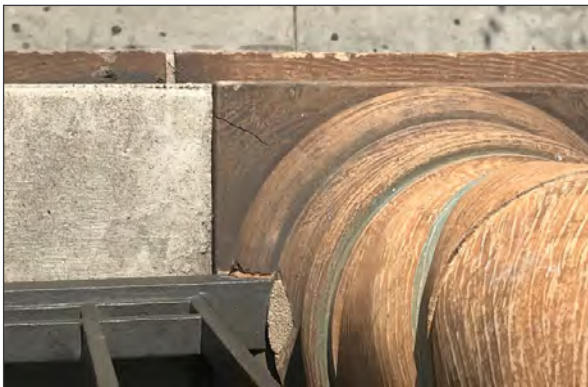
Crack at base of terra cotta column (ARG, 2018)

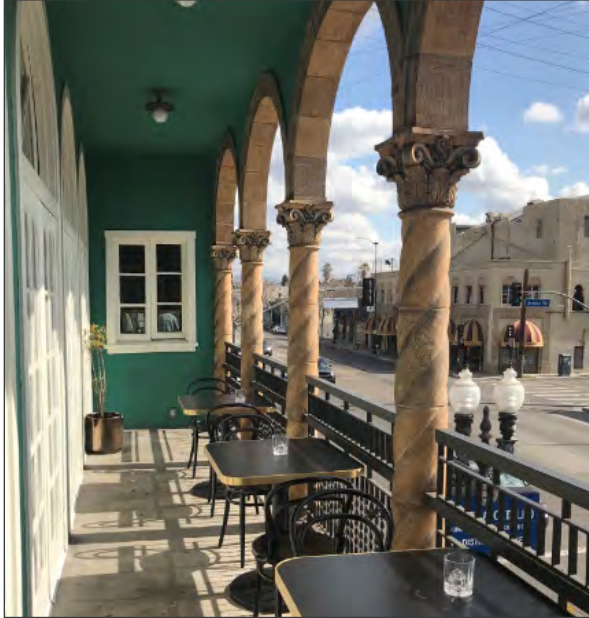
View of second floor balcony with terra cotta columns and arches (ARG, 2018)

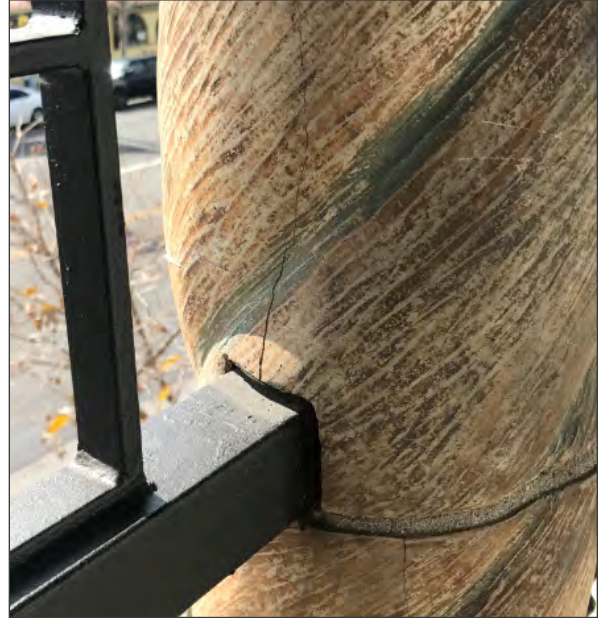
Detail of railing connection at terra cotta column. Note vertical crack at column (ARG, 2018)

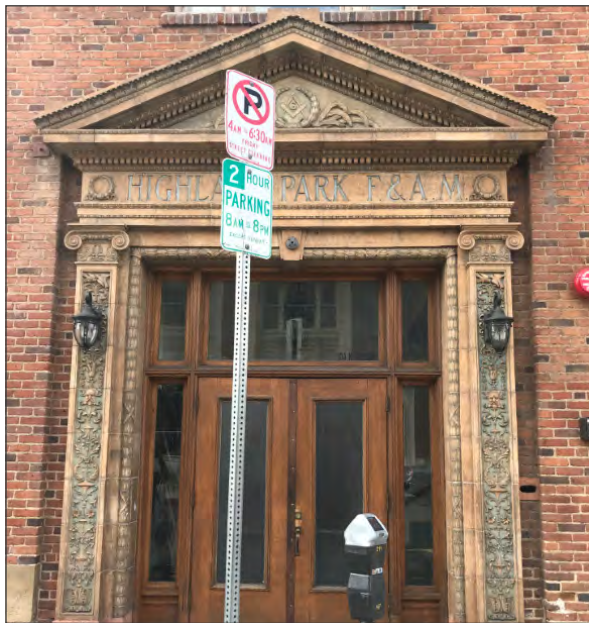
Terra cotta surround and pediment at main entrance, northeast elevation (ARG, 2018)

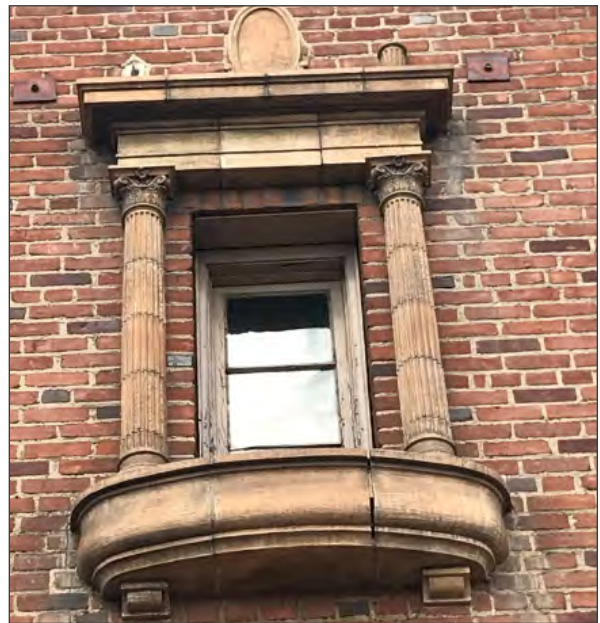
Typical terra cotta window surround at building corner, found on both street elevations (ARG, 2018)

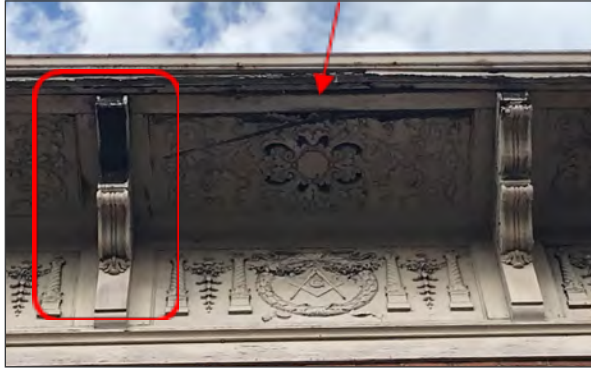
Missing wood bracket and heavily deteriorated/loose wood trim, southeast elevation cornice (ARG, 2018)

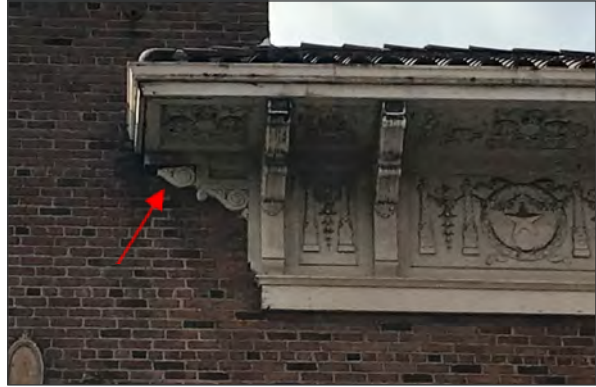
Deteriorated cornice at northeast elevation; also note loose bracket at wall (ARG, 2018)

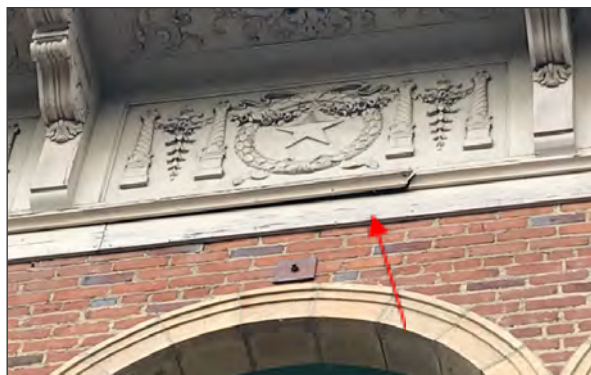
Loose trim at southeast elevation frieze panel (ARG, 2018)

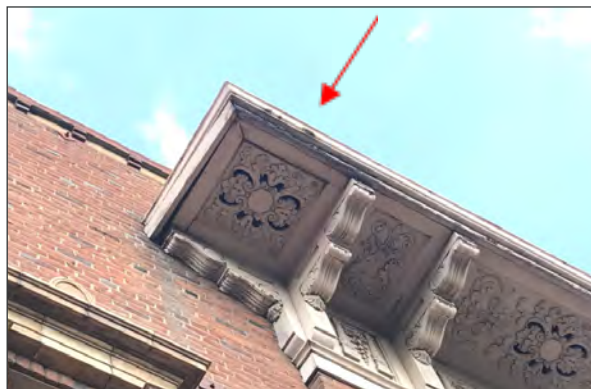
Deteriorated and loose trim at end of cornice, southeast elevation. Also note vents at cornice soffit (ARG, 2018)

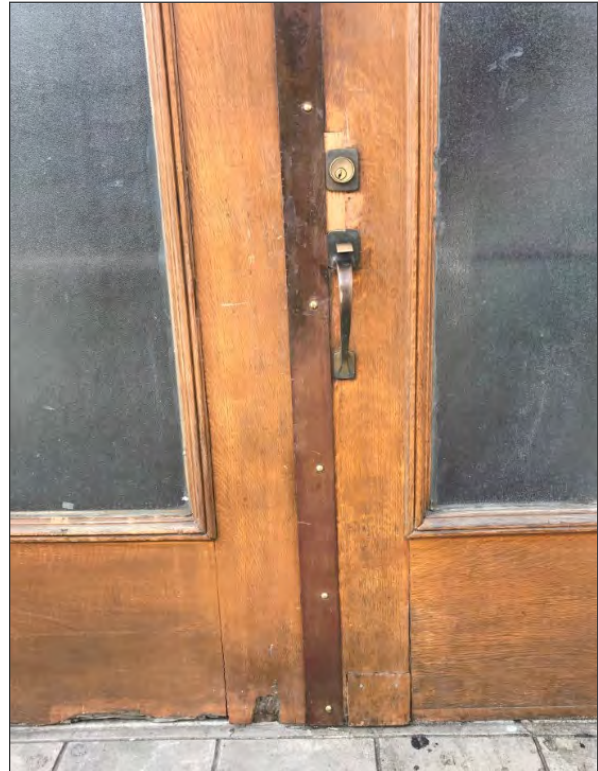
Damage and previous repairs at wood doors, northeast elevation (ARG, 2018)

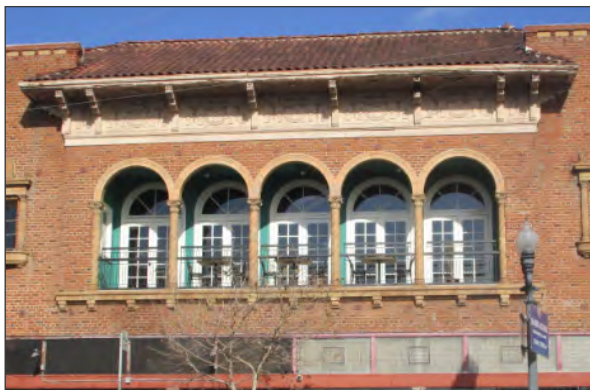
Balcony doors at southeast elevation (ARG, 2018)

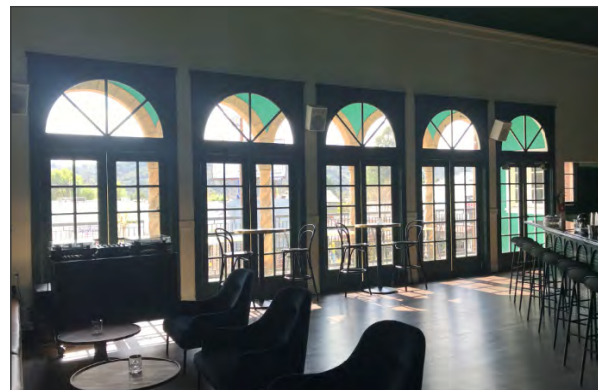
Interior view of balcony doors and transoms (ARG, 2018)

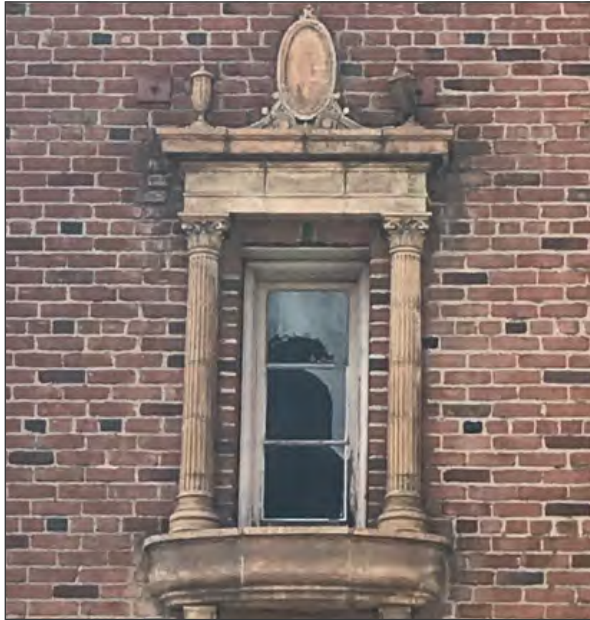
Original three-light wood casement window in terra cotta surround, southeast elevation (ARG, 2018)

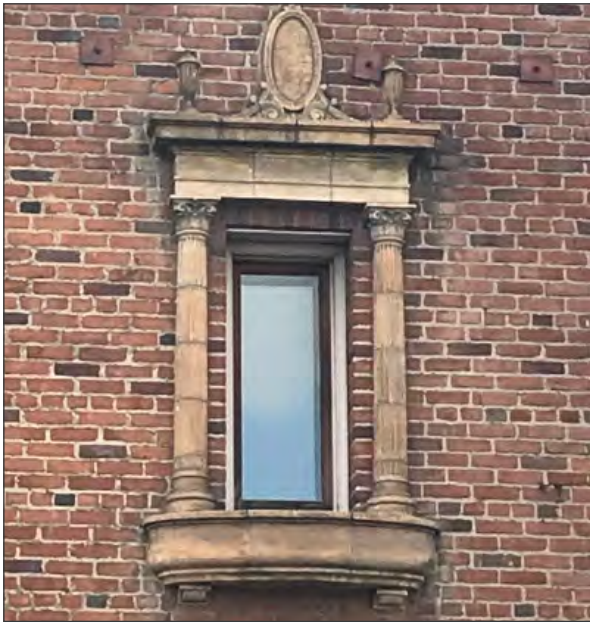
Replacement window in terra cotta surround, northeast elevation (ARG, 2018)

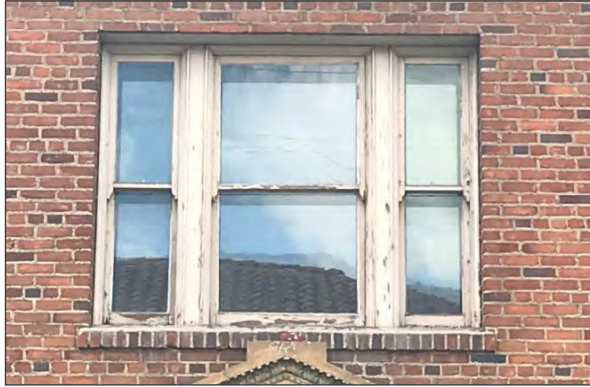
Original wood double-hung windows over primary entrance, northeast elevation (ARG, 2018)

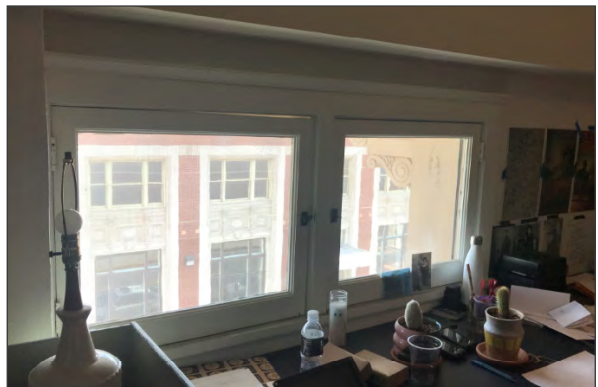
Interior view of paired wood casement windows (ARG, 2018)

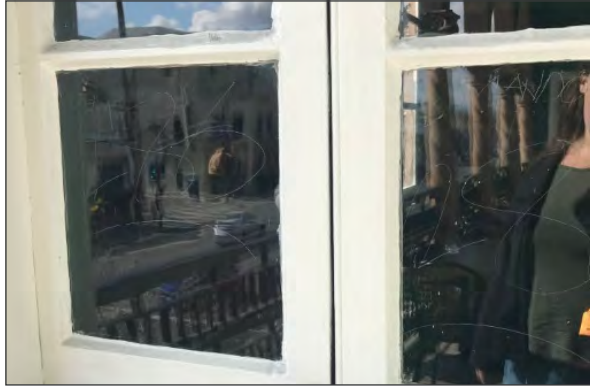
Paired wood casement window at west end of second floor balcony; note scratched glass pane (ARG, 2018)

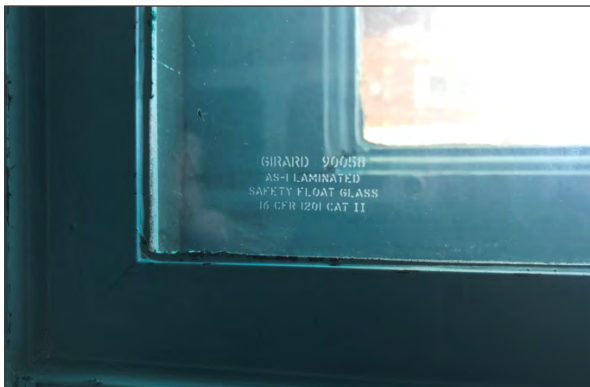
Detail of interior pane: Girard 90058 AS-1 Laminated Safety Float Glass (ARG, 2018)

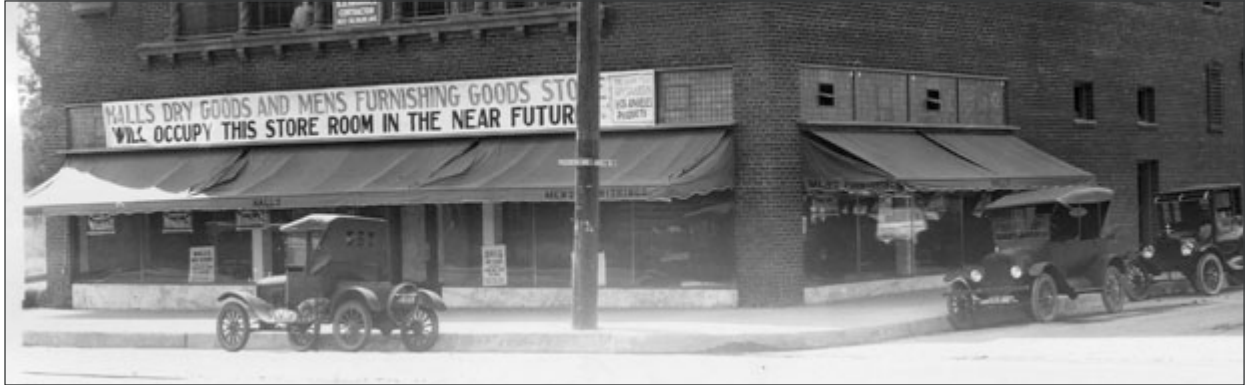
Historic photo, ca. 1920s; note storefronts, awnings, and bulkhead (possibly white marble). The storefront originally contained one central entrance (Los Angeles Public Library)

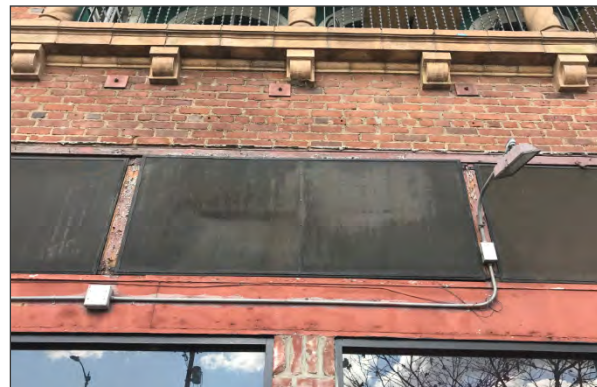
Portion of transoms at southeast elevation covered with painted plywood (ARG, 2018)

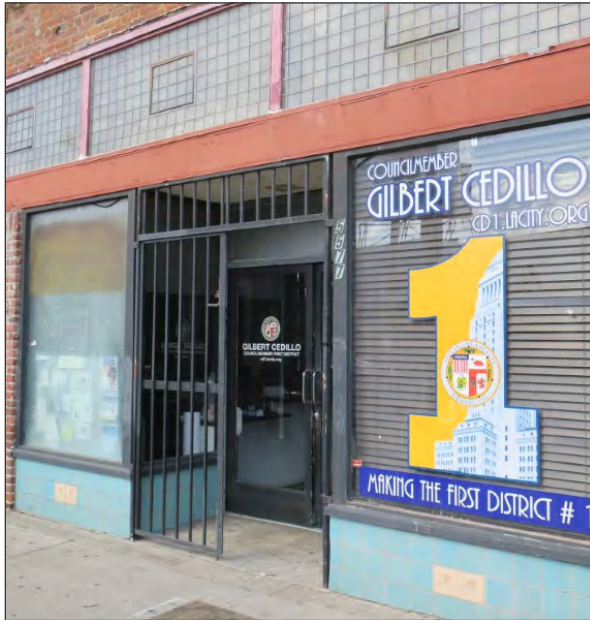
Entrance to 5577 North Figueroa Street; note aluminum storefront framing, gates and ceramic tile (ARG, 2018)

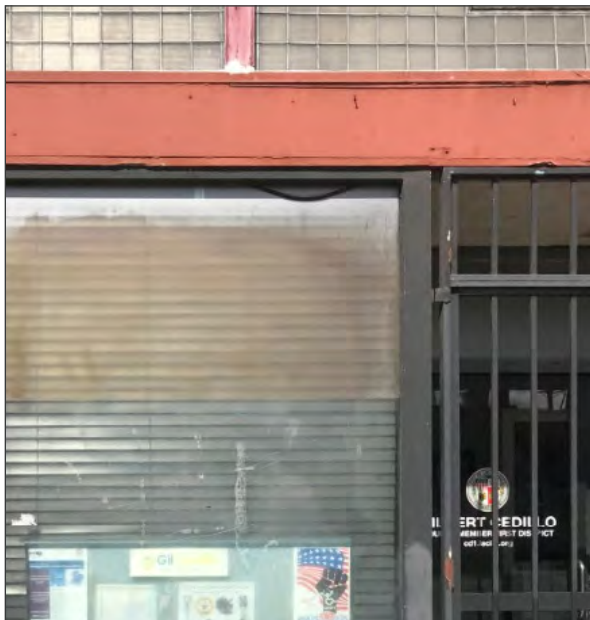
Detail of storefront, 5577 North Figueroa Street; note loose gaskets and deterioration (ARG, 2018)

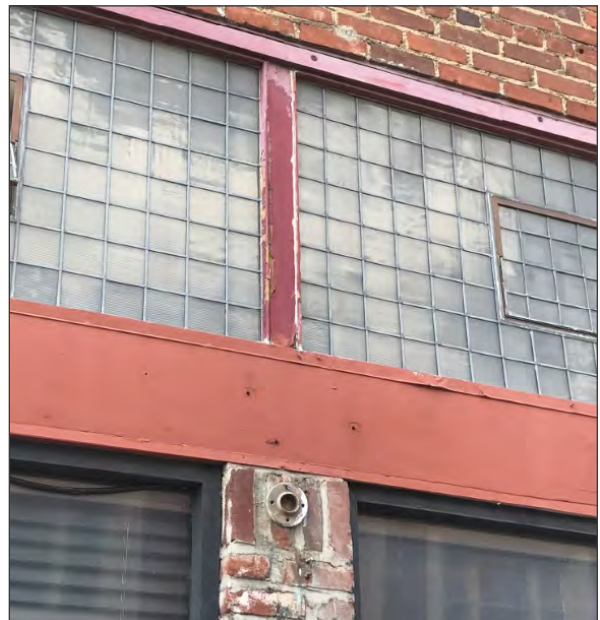
Detail view of transom and storefront framing, northeast elevation (ARG, 2018)

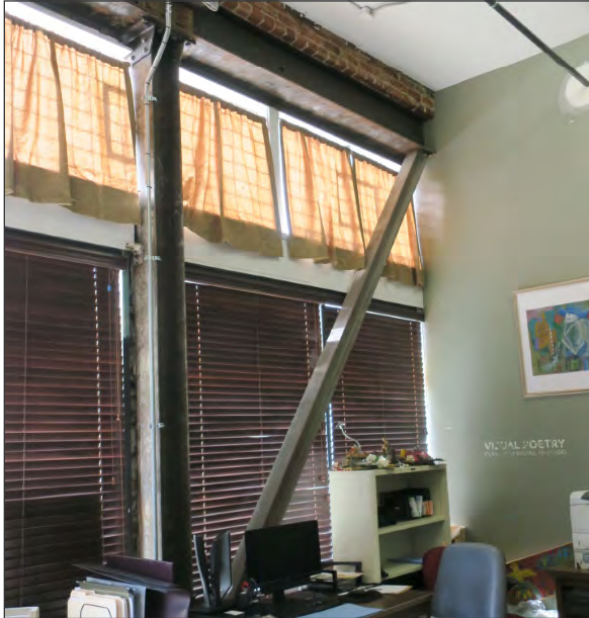
Interior of storefront, 5577 North Figueroa Street; note steel bracing installed during seismic retrofit (ARG, 2018)

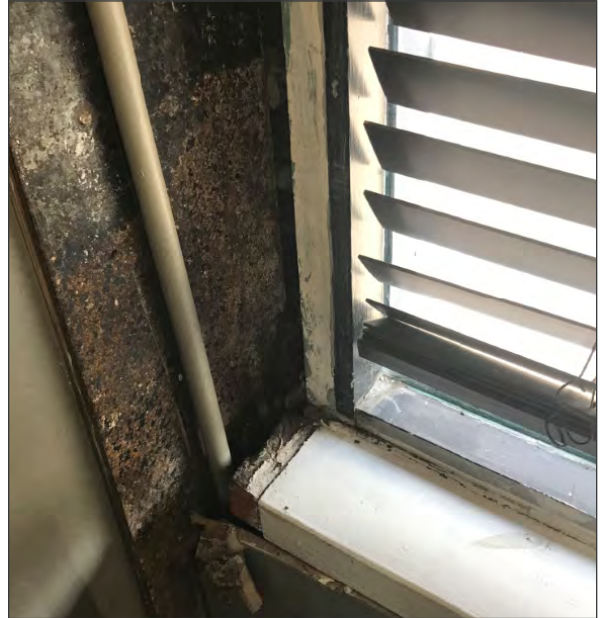
Corrosion at steel storefront frame, northeast elevation (ARG, 2018)

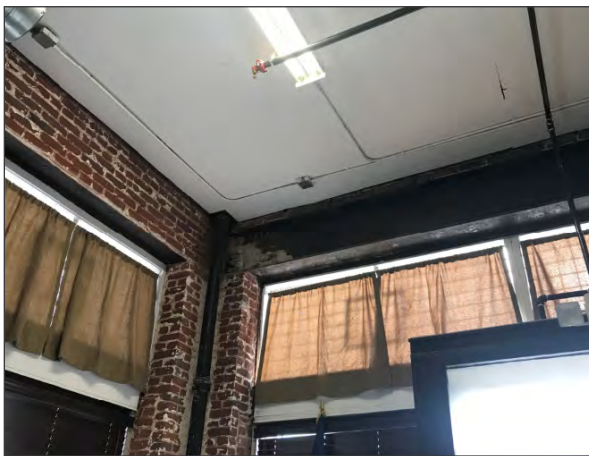
Interior view of storefront transoms, 5577 North Figueroa Street (ARG, 2018)

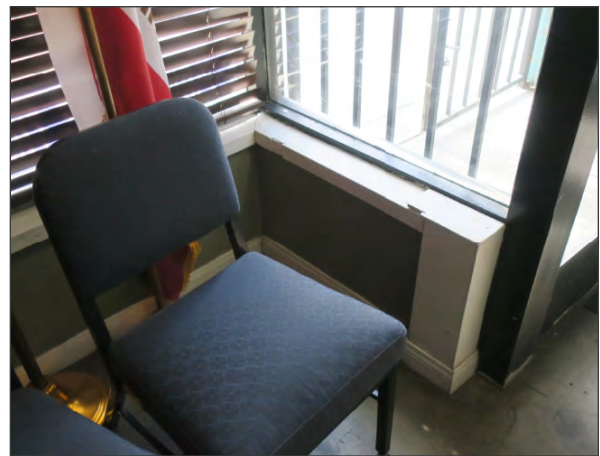
Interior view of storefront bulkhead/entry, 5577 North Figueroa Street (ARG, 2018)

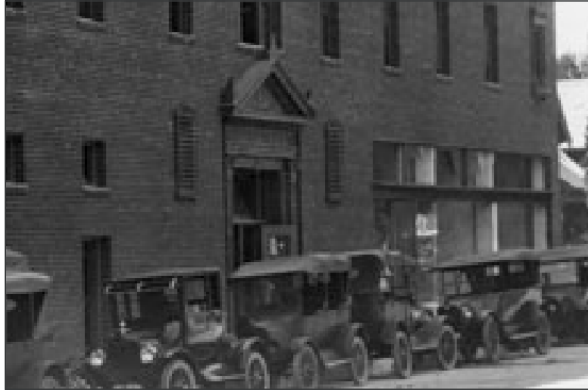
Historic view of storefronts at west end of northeast elevation, ca. 1920s (Los Angeles Public Library)

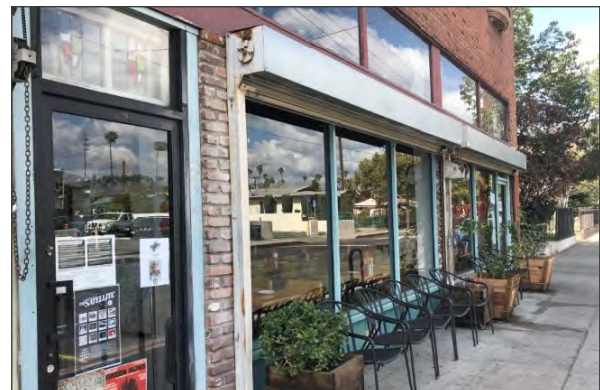
Detail view of storefronts (ARG, 2018)

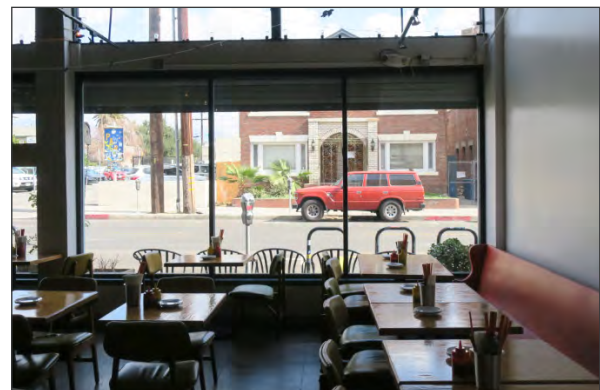
Interior view of storefronts from inside restaurant at 110 North Avenue 56 (ARG, 2018)

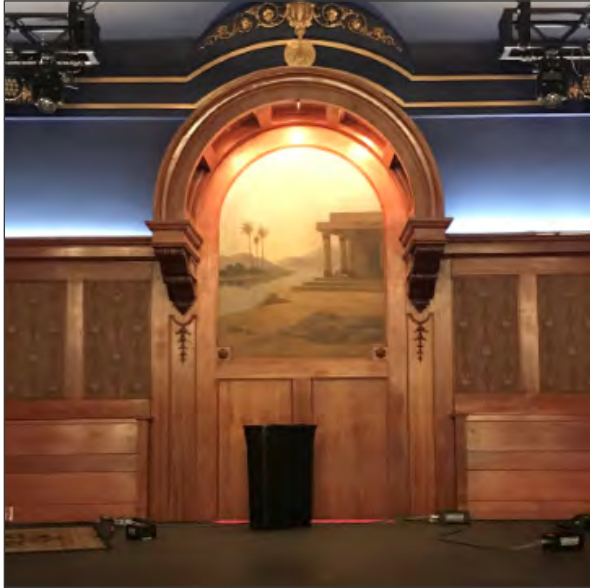
Arched top mural at northwest wall, over stage (focal point of room) (ARG, 2018)
