104-112 NORTH AVENUE 56; 5567-5577 NORTH FIGUEROA STREET
Highland Park Masonic Temple, HCM #282
Contributor to the Highland Park-Garvanza HPOZ
CHC-2018-1406-MAEX

Agenda packet includes:

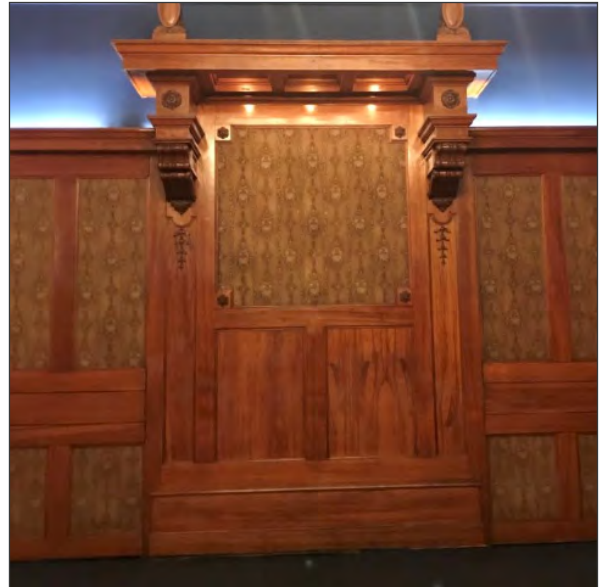
Mural missing at southwest wall (ARG, 2018)

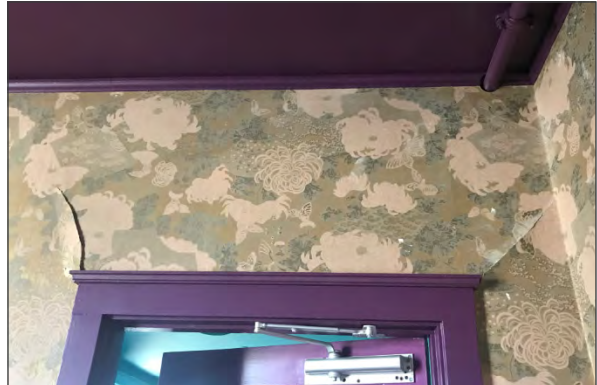
Northwest parlor, damage to wallpaper over entrance (ARG, 2018)

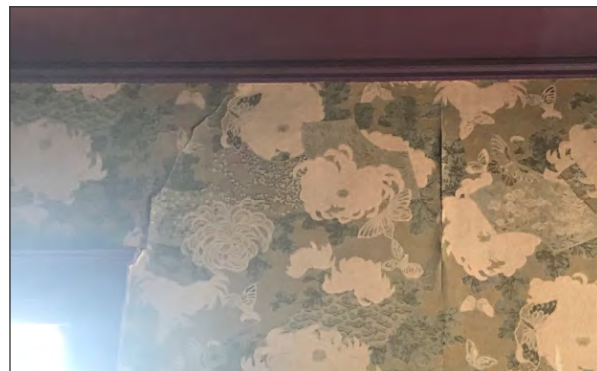
Southeast parlor, damage to wallpaper at northeast wall (ARG, 2018)

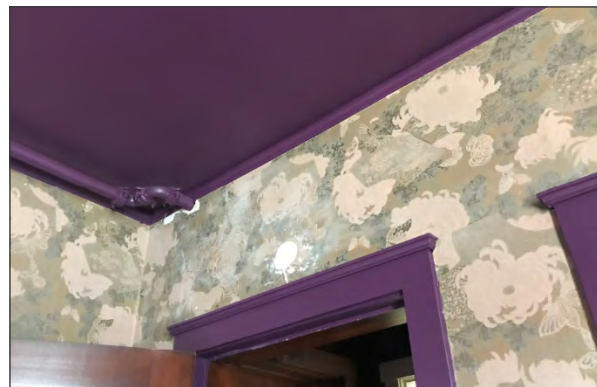
Southeast parlor, damage to wallpaper over entrance; note plaster patches (ARG, 2018)

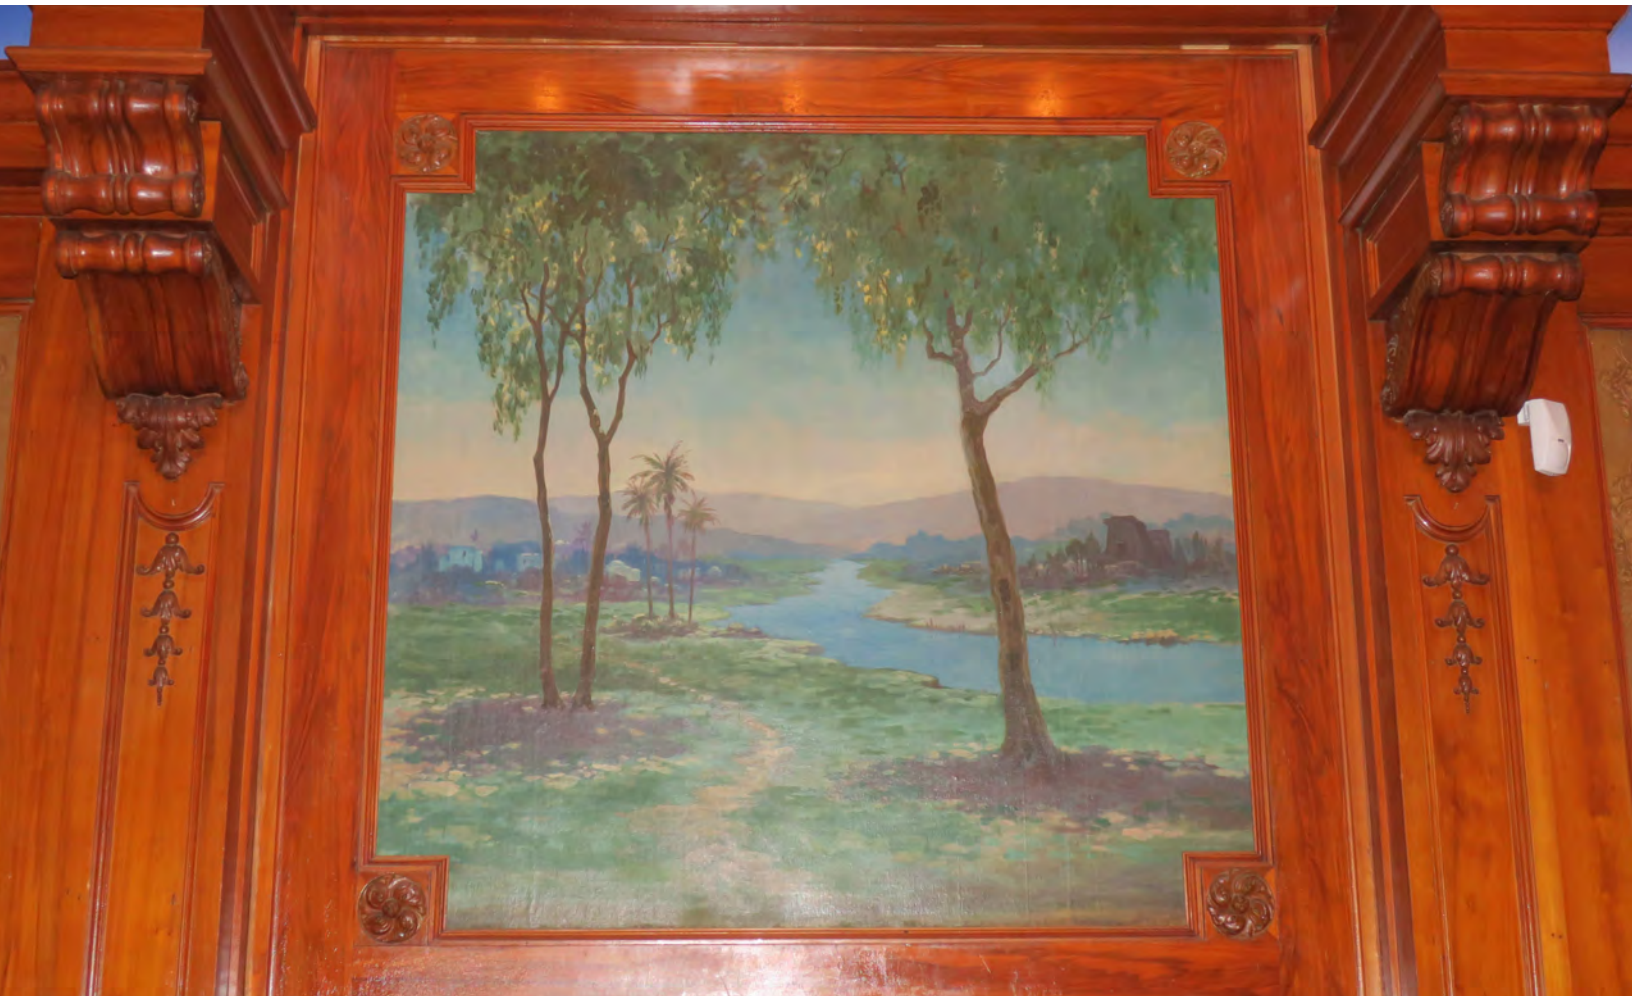
7. Treatment and Work Recommendations

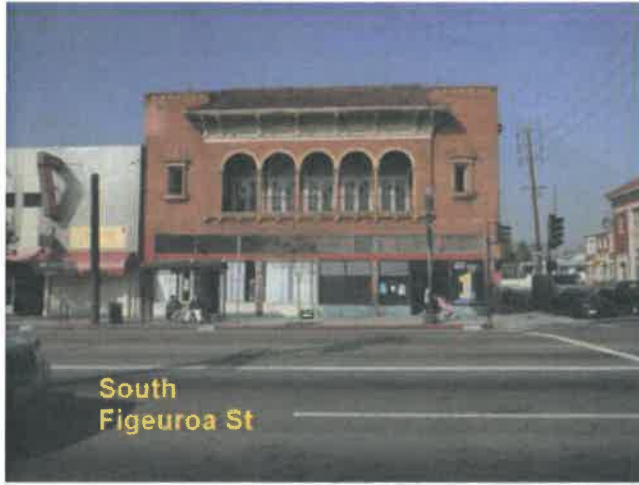
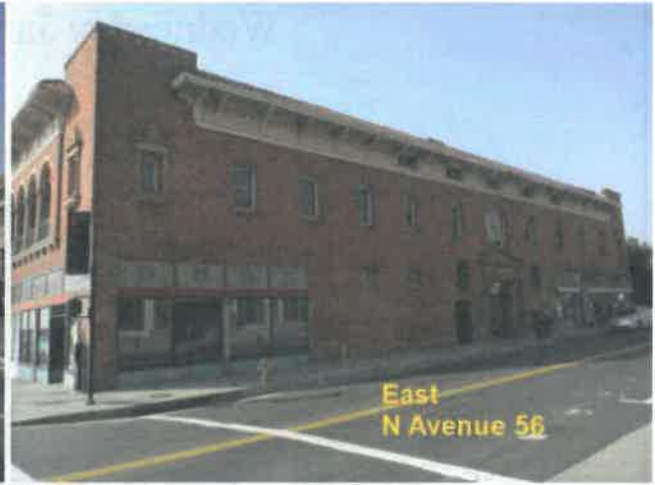
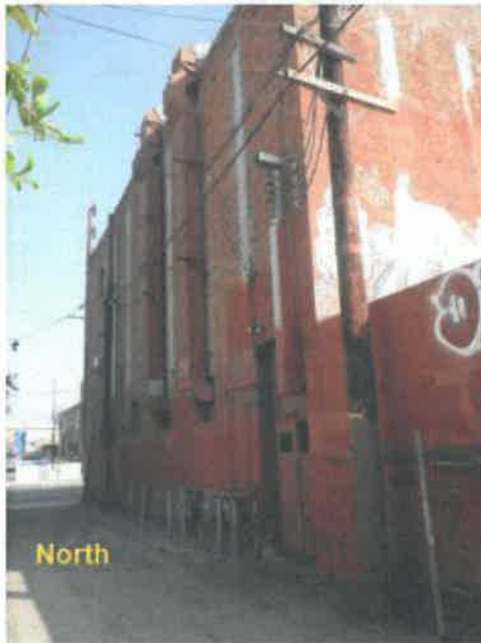
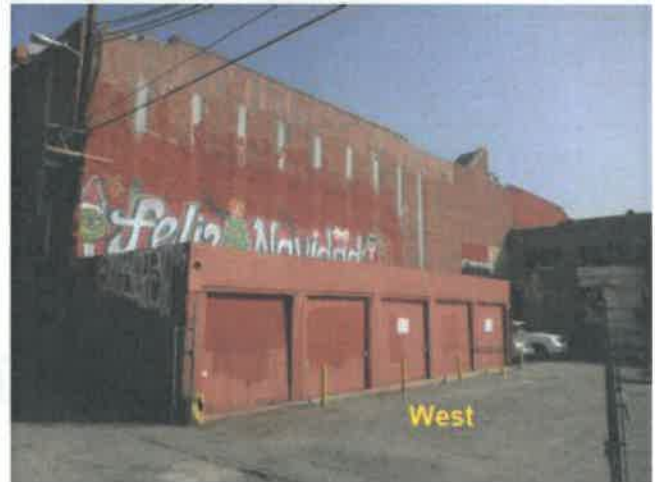
CLIENT NAME: Hugh Horne
CLIENT ADDRESS: 104 N Avenue 56, Highland Park, CA 90042
INSPECTION DATE: Wednesday January 21, 2015, 12:30 PM
TOTAL FEE: \$1540
INSPECTOR: Jerry Corum, David Hamilton, Gregg Forscher

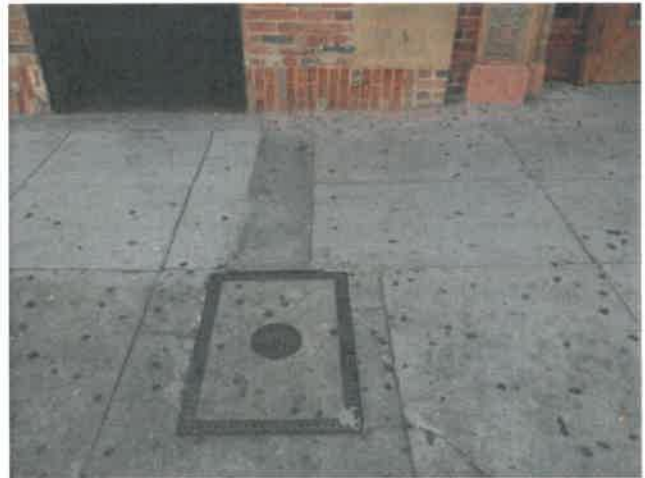
The main water line shut off was not located. It is advised to check with the current owner to determine where the shut off valve is located. As this line is underground from the street to the building and not visible, the material it is made of is not known.

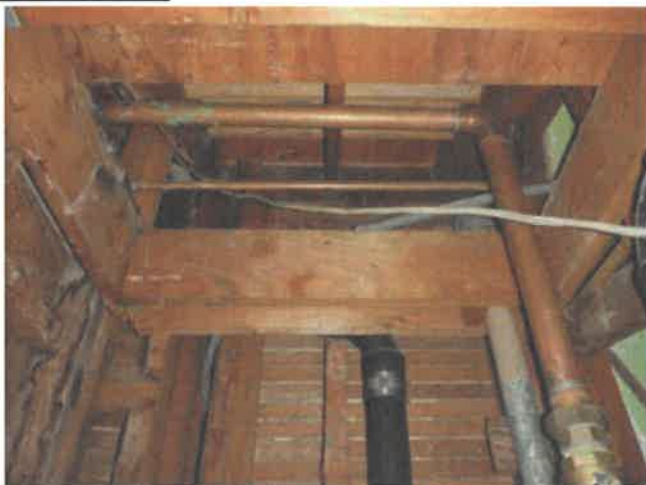
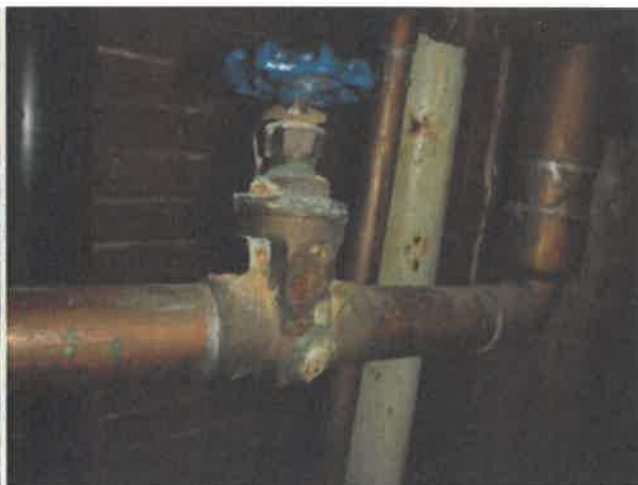
Needs Attention: There is rust and corrosion on the valves in the piping near the Banquet area, and they may need to be replaced soon.

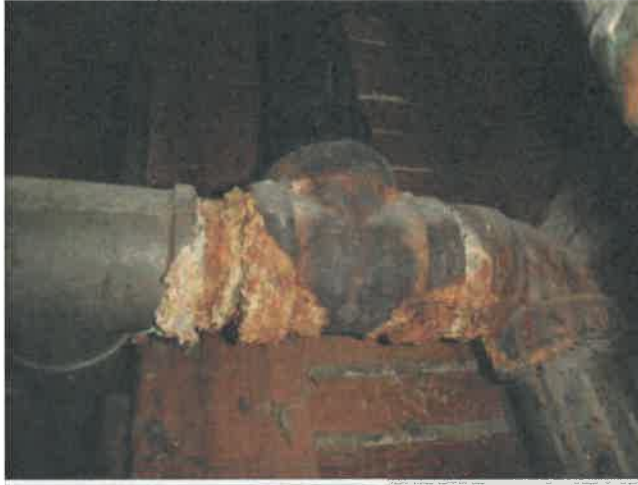
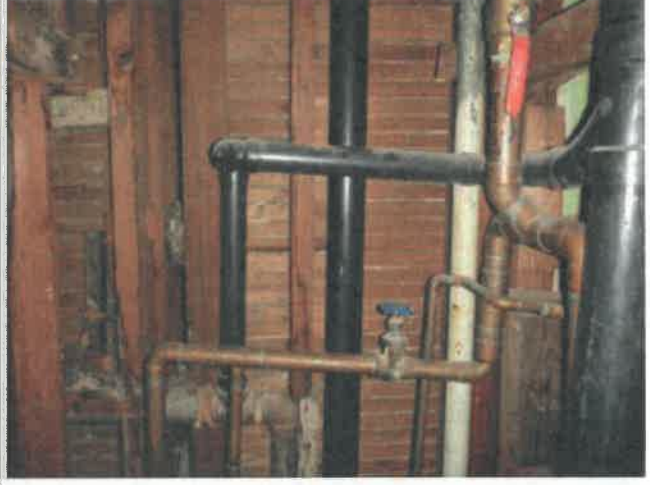
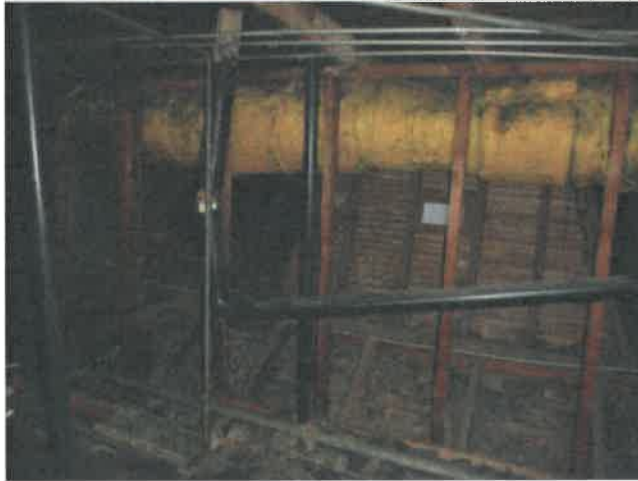
Needs Attention: There are areas on the visible waste lines with rust blisters where the material is failing and may seep or leak at any time, such as noted in the Banquet room area. These sections of pipe have failed and are ready for replacement at this time. **The waste system should be fully evaluated by a plumbing specialist and repaired / replaced as needed.**

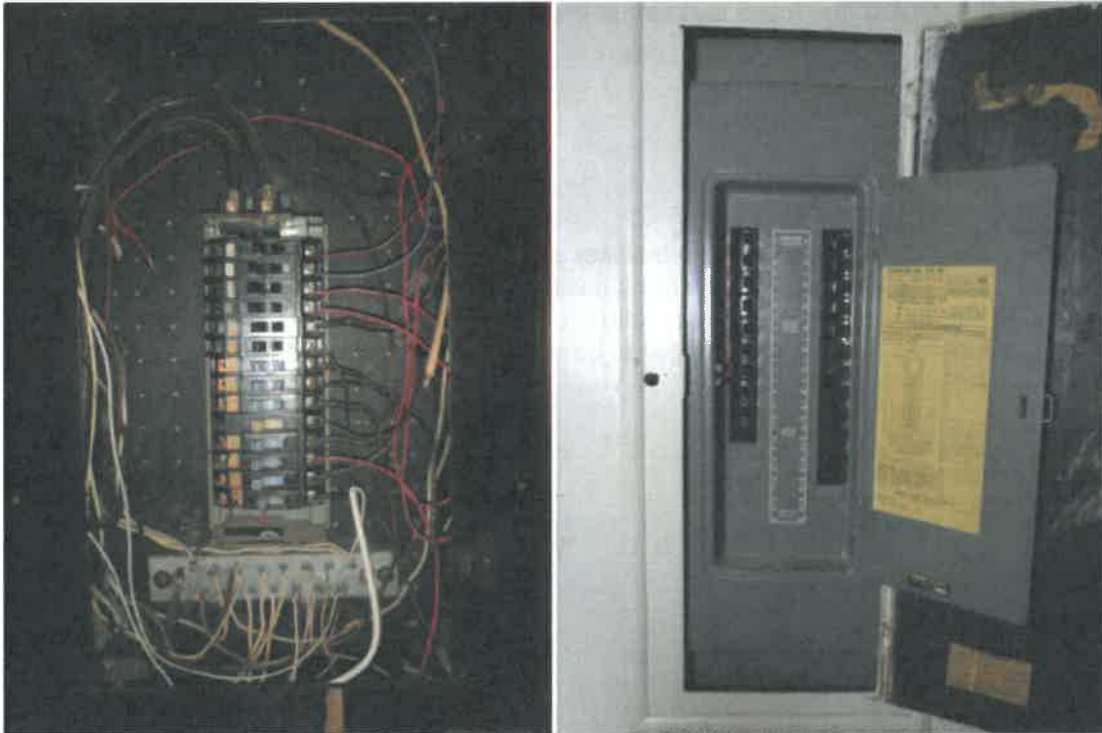
Needs Attention: Some panel and circuit breaker are an older system, such as in the Lodge stage area, and at the back stairway near the kitchen. These are past their expected useful service life span. As with all older systems they will be more prone to failure due to its age and design. An electrician may recommend replacement if called upon to do repairs to the system.

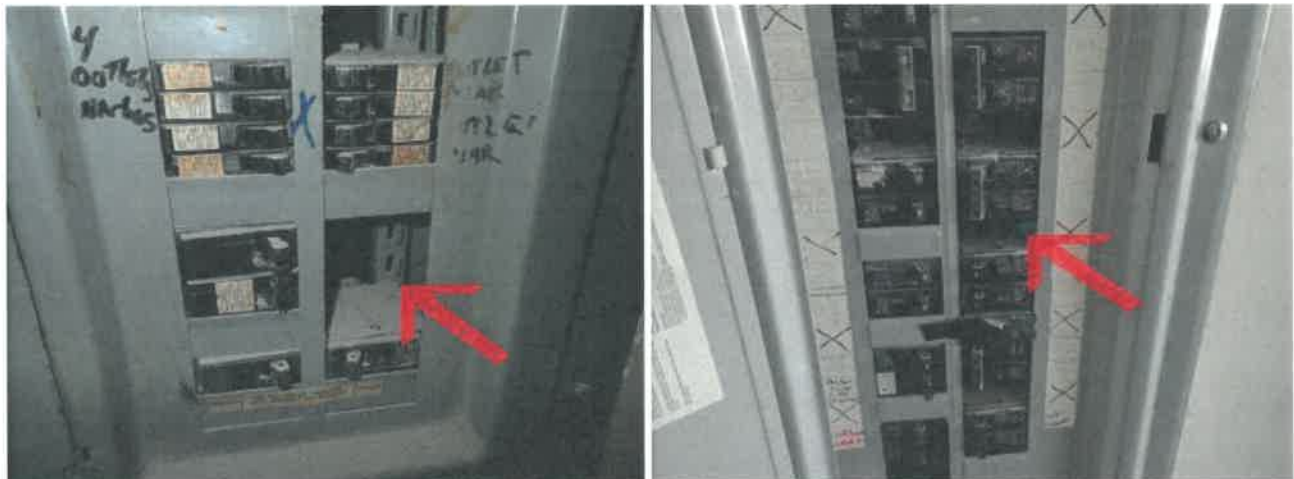
There are knock-outs missing at many of the panels leaving open spaces in the cover and there are exposed live electrical parts as a result. This is inexpensive to correct but should be repaired to make the panel safer.

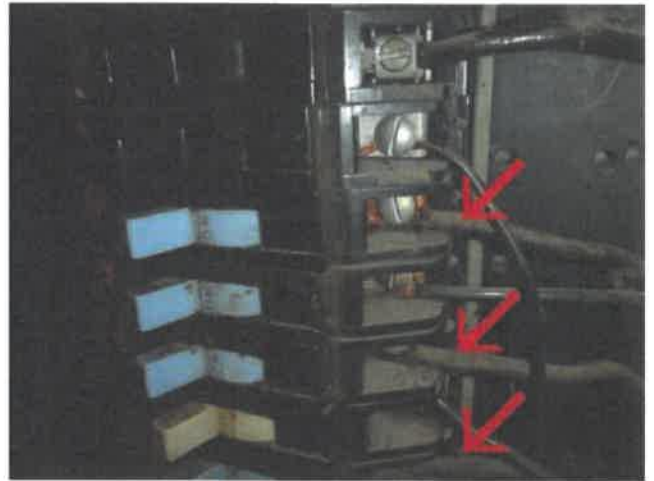
There is damage conduit and exposed wiring, as found in the south end of the attic above the office areas.

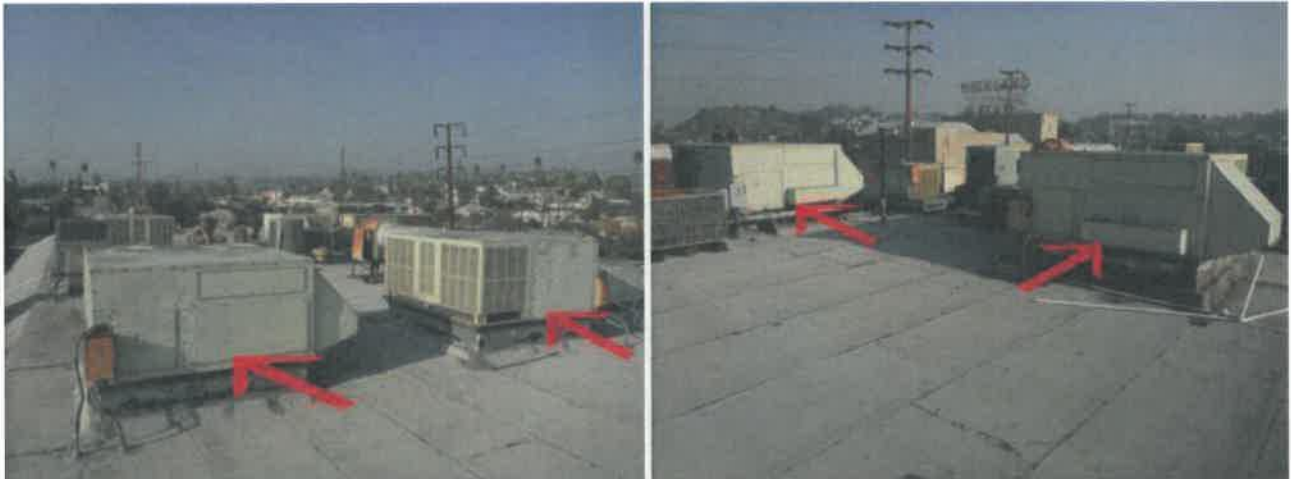
There are four large package units which appear to serve the Banquet room, and Lodge. The systems are a heat pump - an all electric system that uses refrigerant to produce heating and cooling.

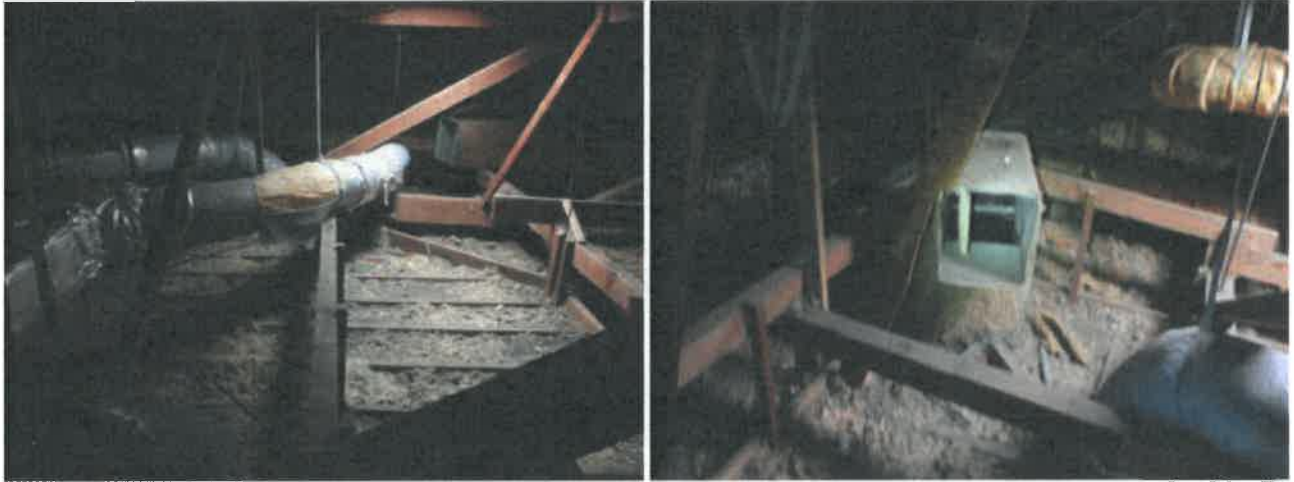
There are damaged areas of duct insulation inside the attic. There are abandoned ducts inside the attic.

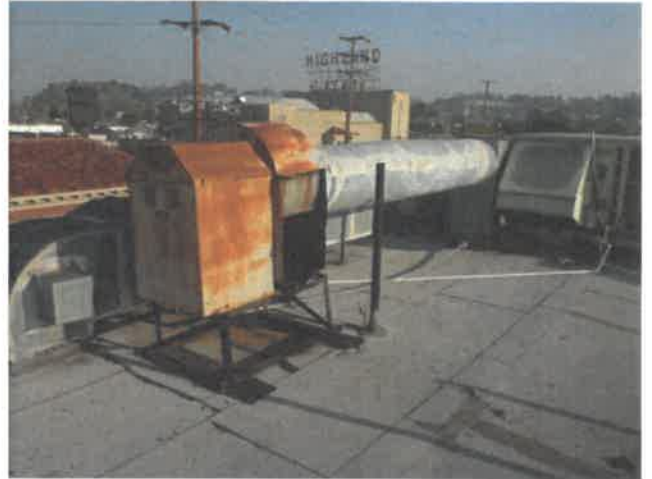
The ventilation equipment at the south end was operating. This system is much older and has deteriorated. This system appears to serve the Bakery but this was not confirmed.

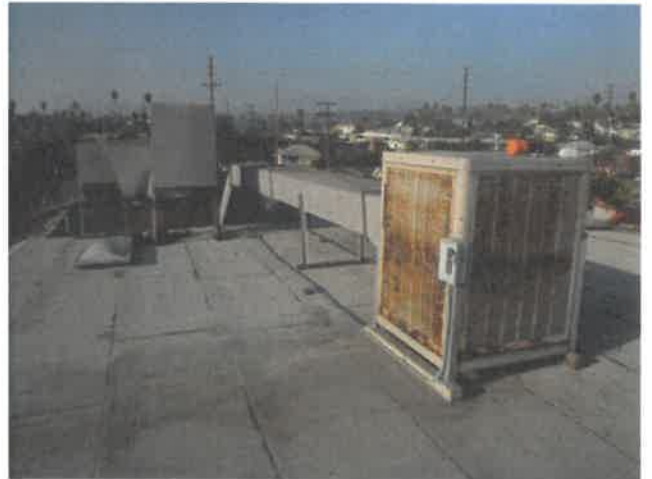
HEATING AND COOLING COMMENTS:

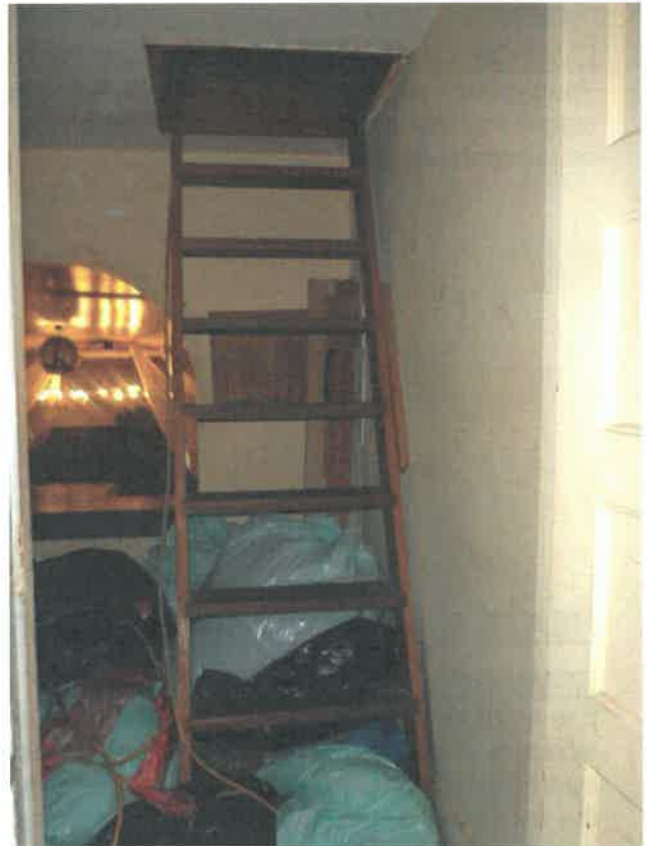
The attic access is located in the choir loft.

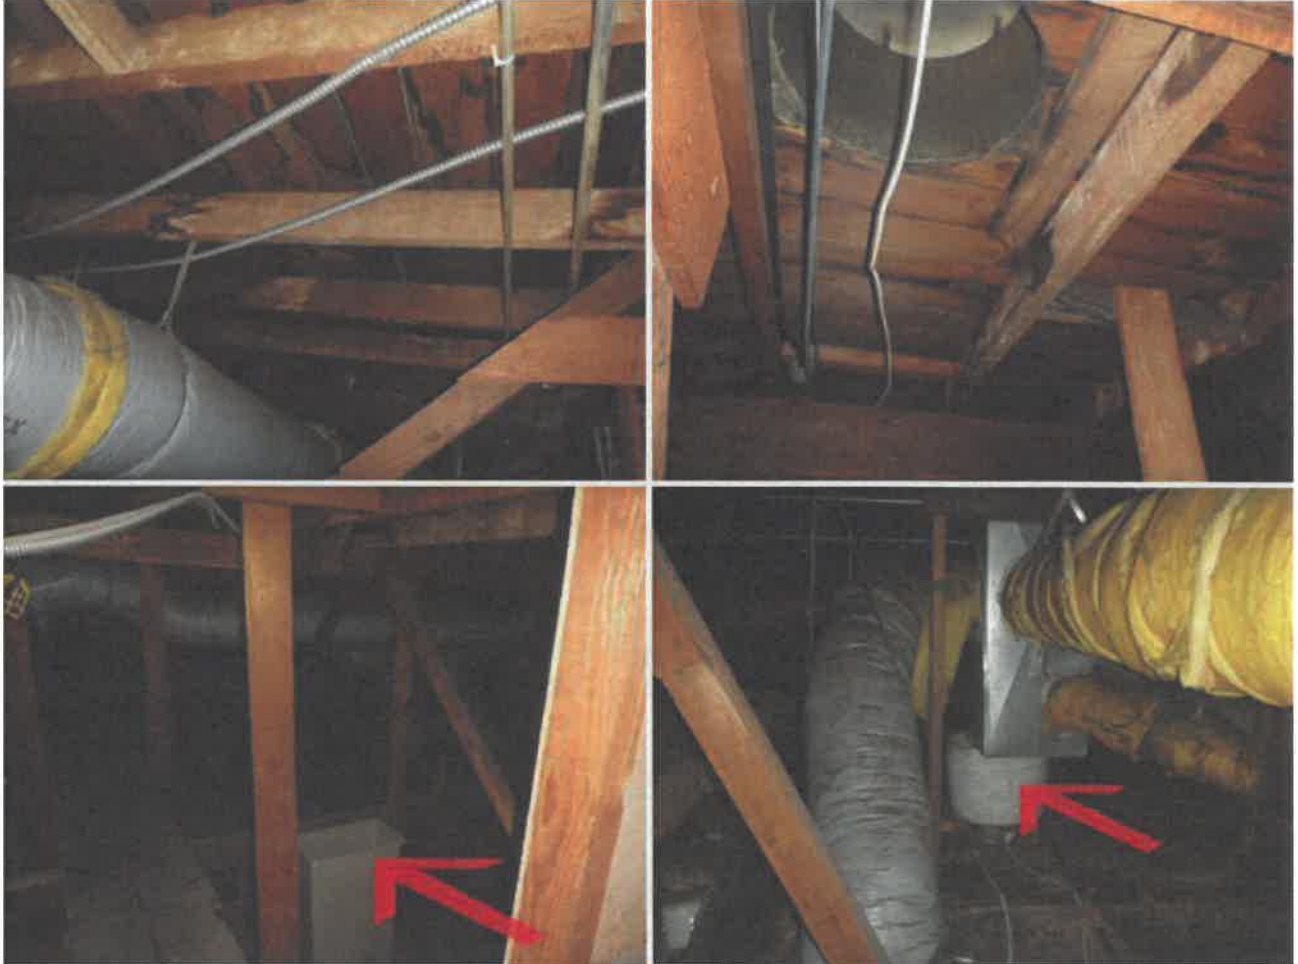
Needs Attention: There are areas of stains on the framing lumber - it is unknown if this is from a current or past roof leak

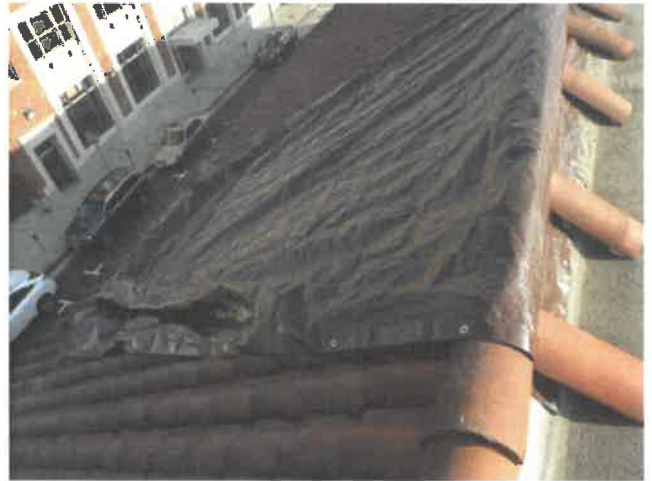
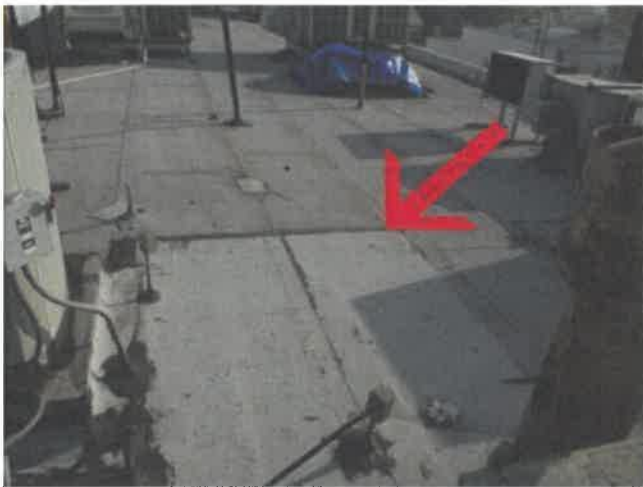
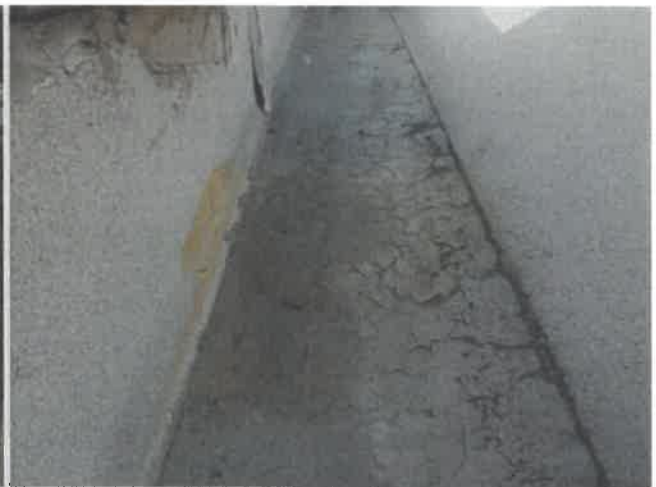
On the low sloped / flat roof, there are areas of patching near the center of the roof.

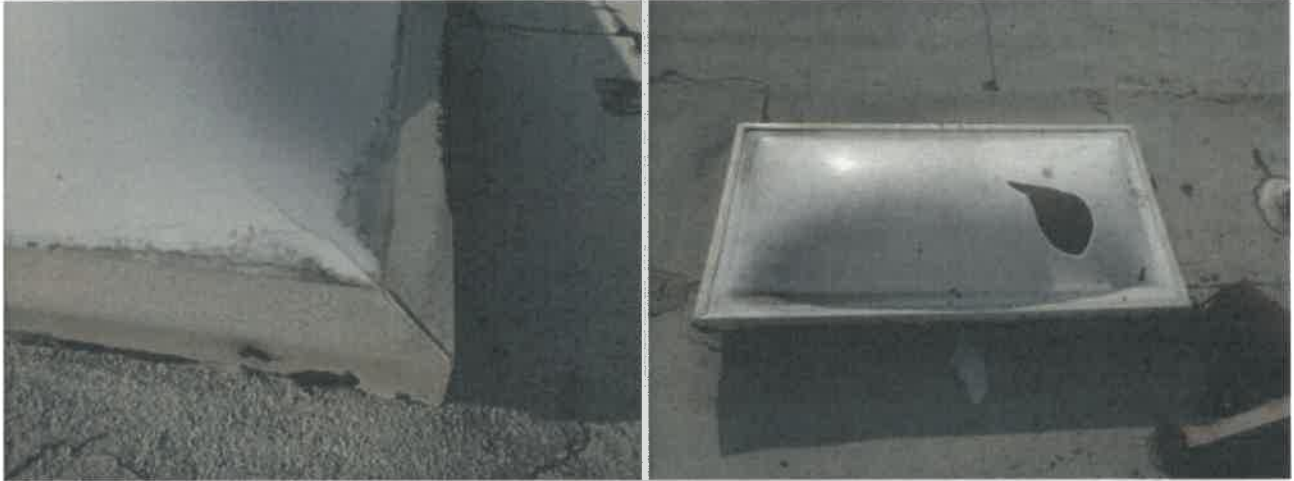
Not Acceptable: There are skylight lens which are cracked and damaged. There is a tarp over one of the skylights.

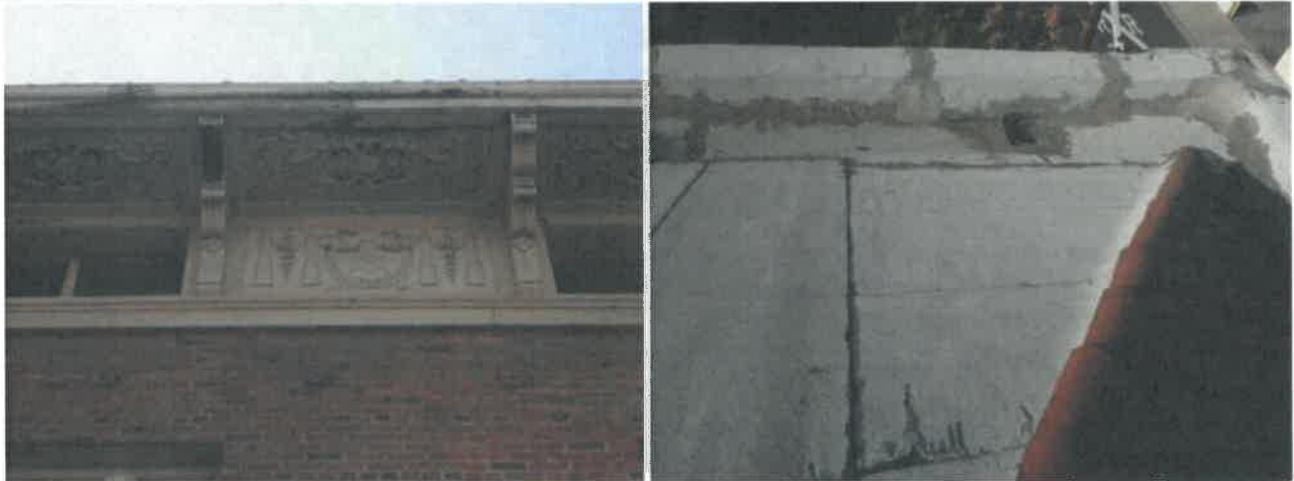
Needs Attention: There are rusty areas in the gutter system, and staining in the trim near the gutters.

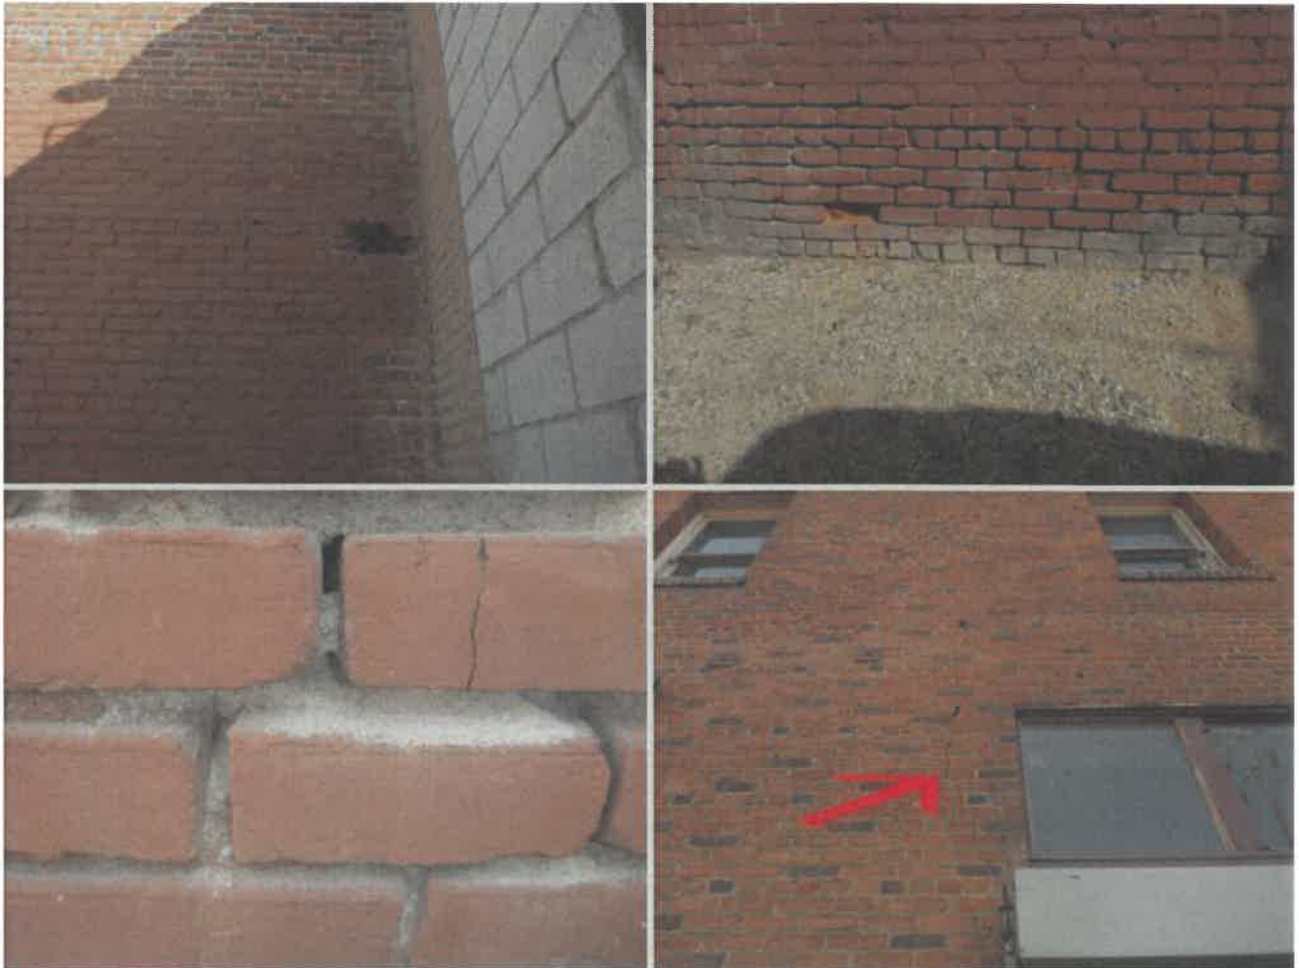
Needs Attention: There are open holes in the brick wall at the west side.

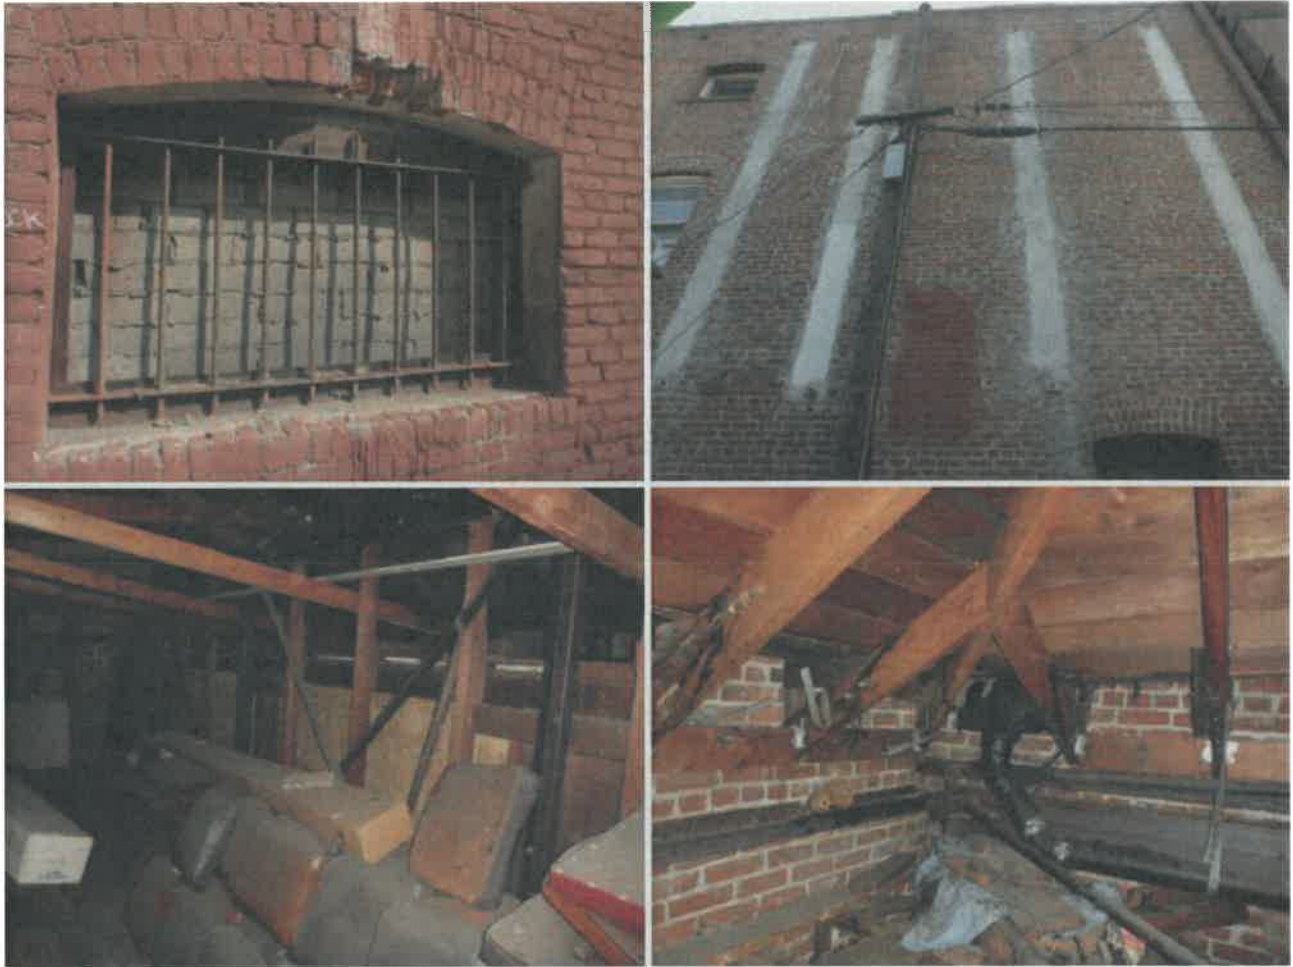
This is a brick or partially brick structure. It is unknown if this was reinforced at the time of construction, or may require retrofitting designed to reduce the damage to the structure in the event of movement (such as due to a seismic disturbance). It appears modifications have been made in the past to add some reinforcing at the floor and roof level. It is advised to get the history on this work including plans and permits.

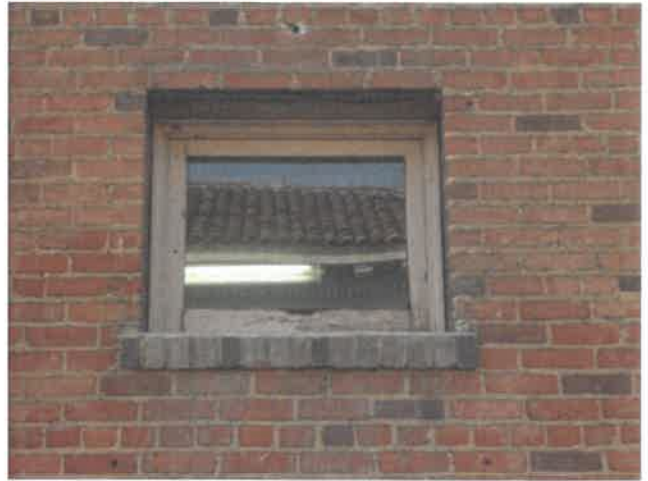
EXTERIOR DOOR SURFACES:

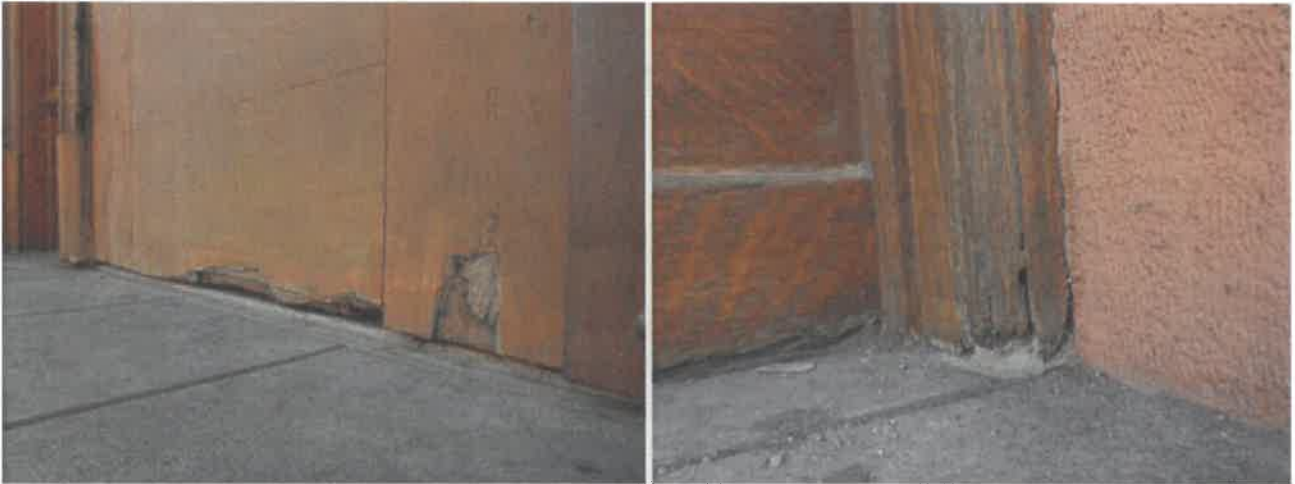
Needs Attention: There are areas of deterioration to the exterior of the doors, such as the 104 N entry. There are areas of damage to the roof access door.

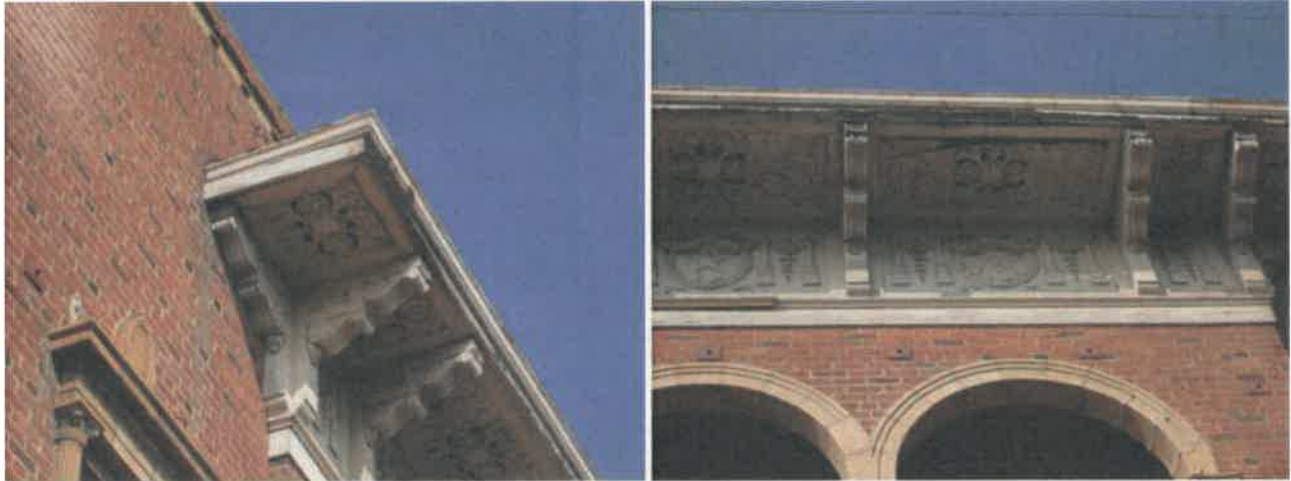
Needs Attention: The trim has areas of damage and needs repair/restoration.

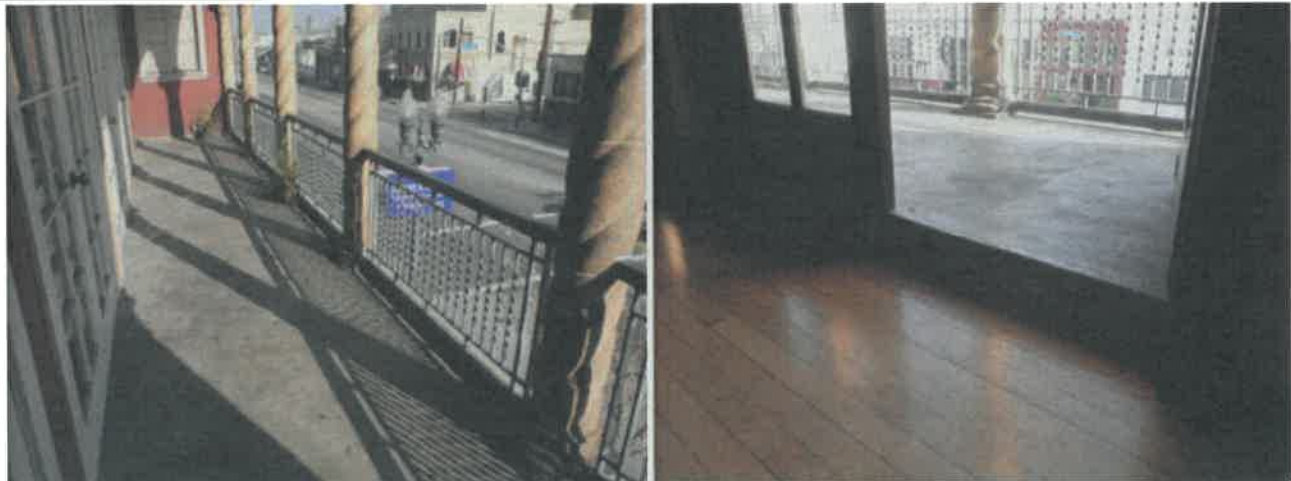
Needs Attention: There are areas of cracked concrete on the deck.

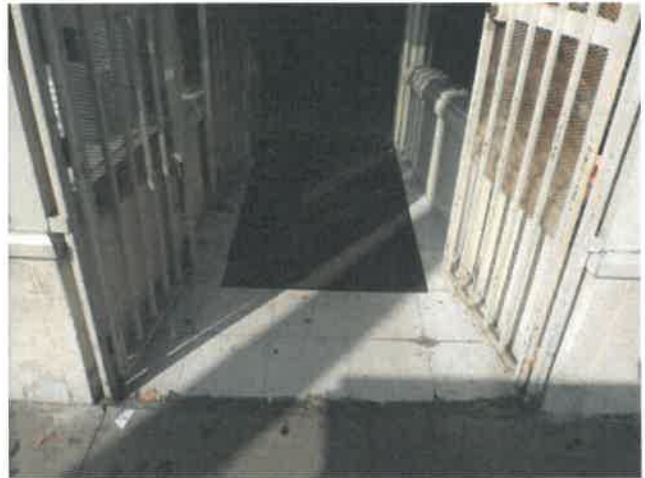
There are cracked and damaged tiles in areas, such as the entry to the Bakery.

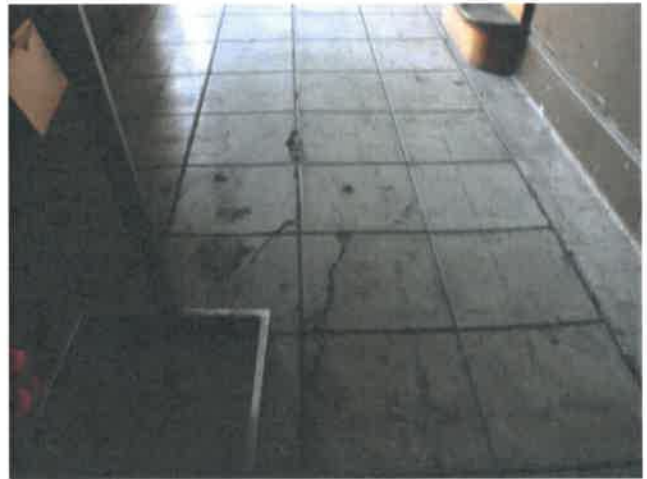
Needs Attention: There is some cracking and damage to the floor at the entry area of #104.

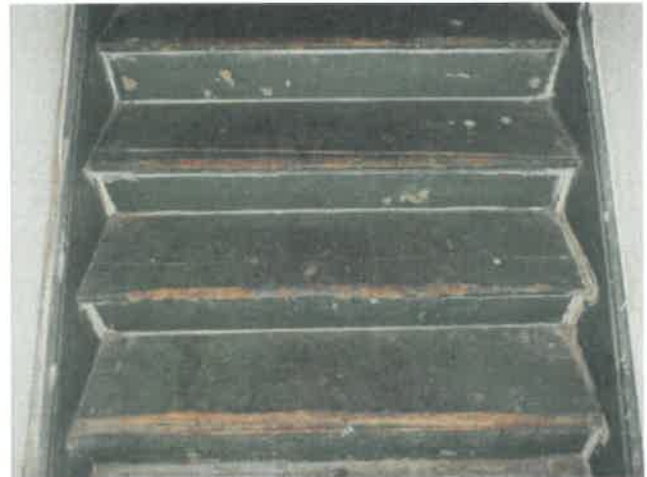
OVERVIEW OF UNIT COMPONENTS:

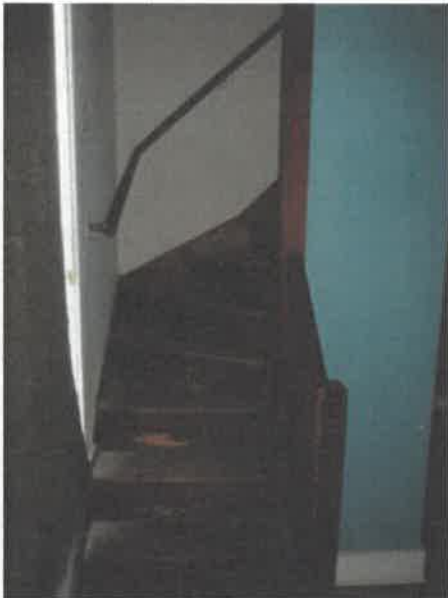
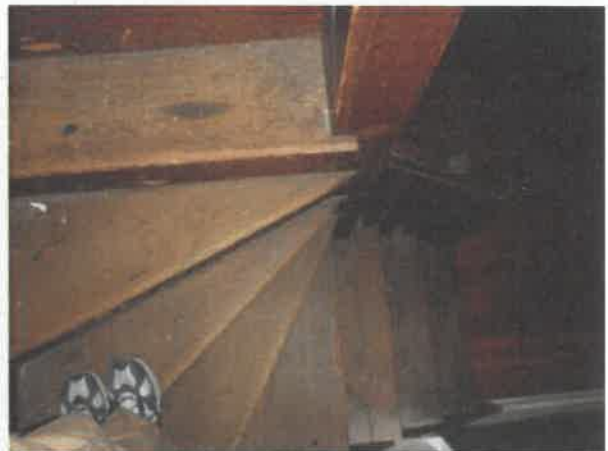
Needs Attention: For the winding or circular stair, current requirements are for the step surface at 12 inches from the inside to be at least 9 inches wide for foot support, this has less than this and may be a trip hazard at the northwest.

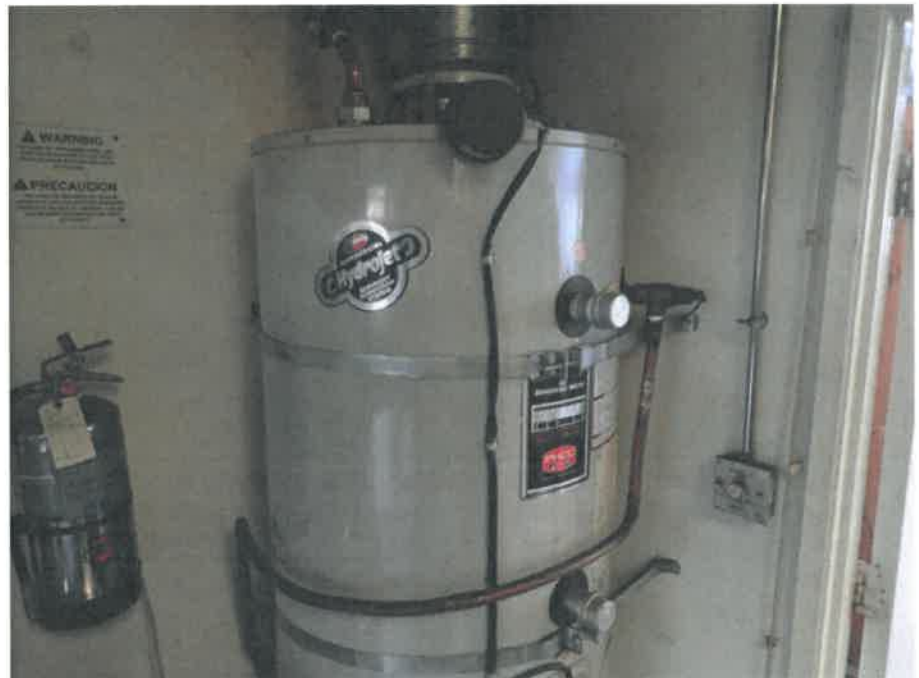
Not Acceptable: The vent is in contact with combustible materials.

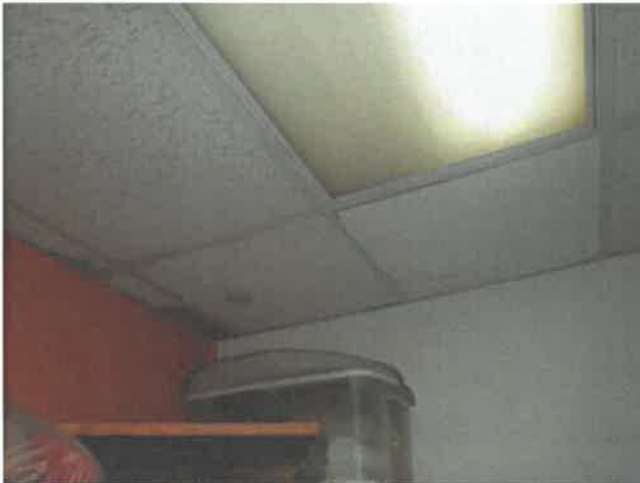
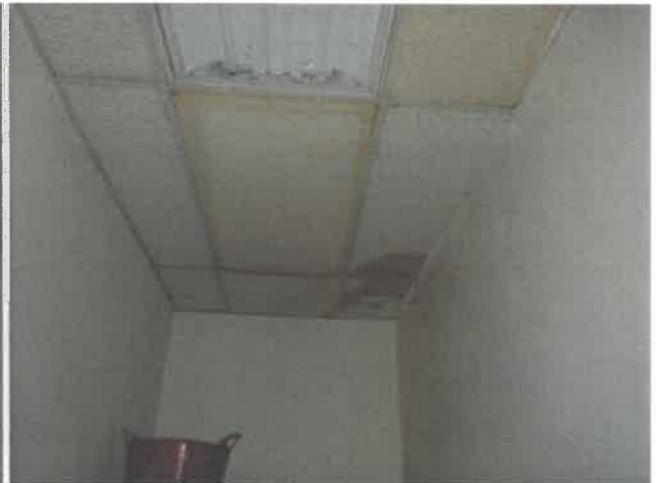
Needs Attention: There are moisture stains on the ceiling tiles in the back storage rooms/office area.

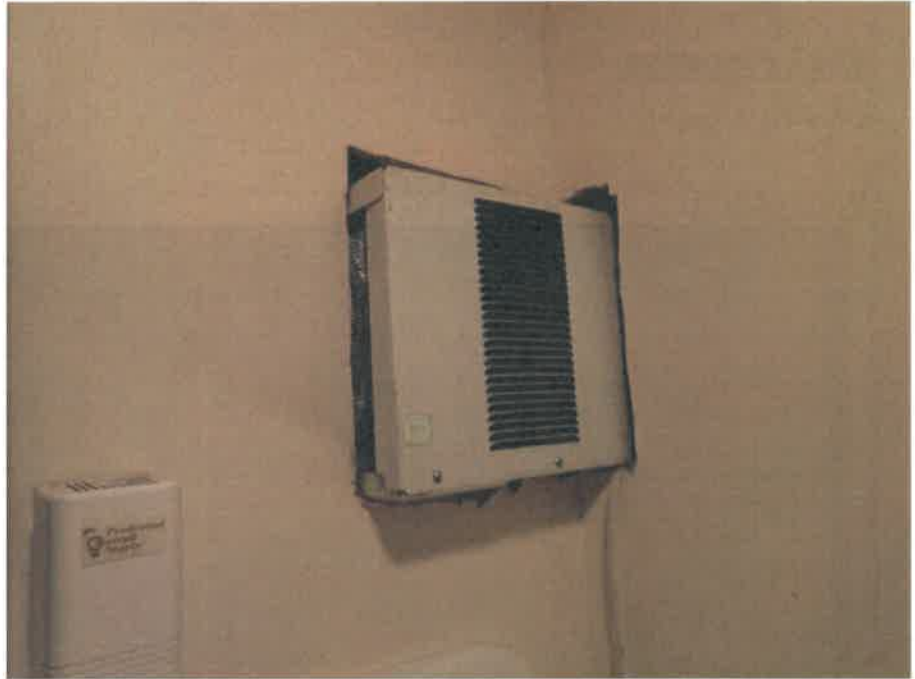
SINK: The faucet hoses are old and appear rusty.

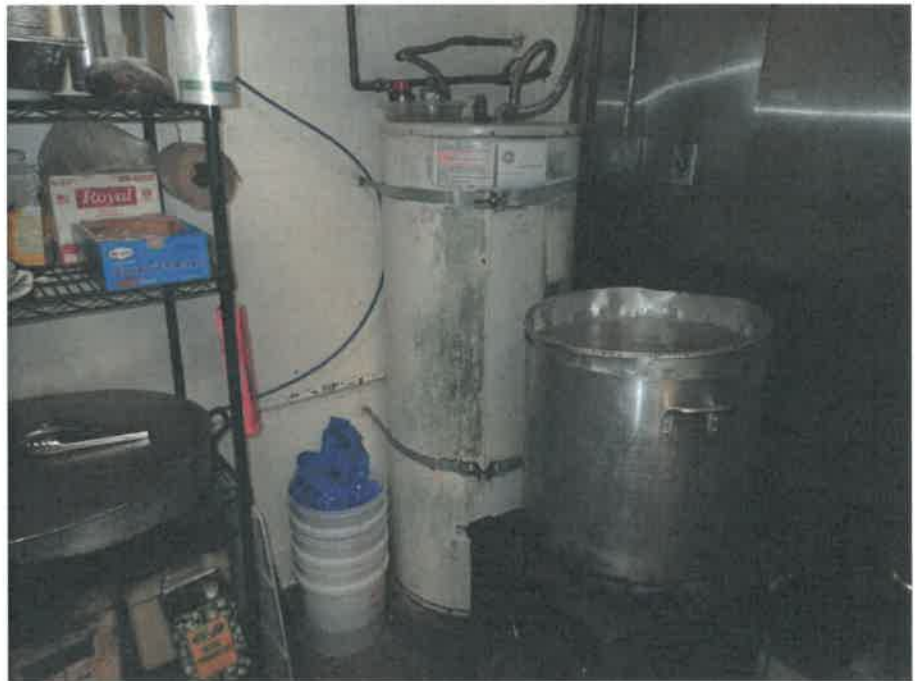
104 N Ave 56 - Lodge.
