104-112 NORTH AVENUE 56; 5567-5577 NORTH FIGUEROA STREET
Highland Park Masonic Temple, HCM #282
Contributor to the Highland Park-Garvanza HPOZ
CHC-2018-1406-MAEX

Agenda packet includes:

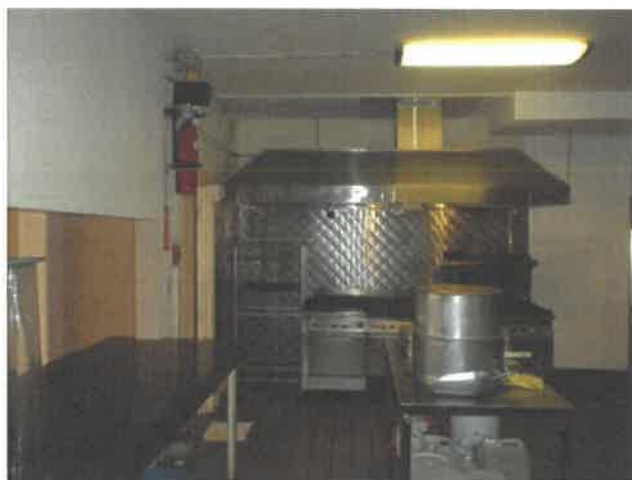
NOTE: The kitchen equipment is not evaluated as part of this report.

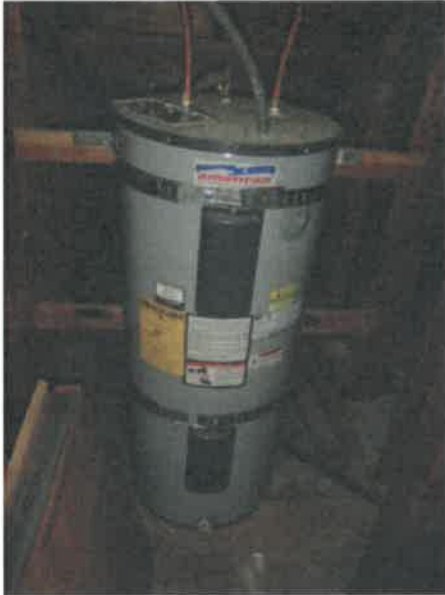
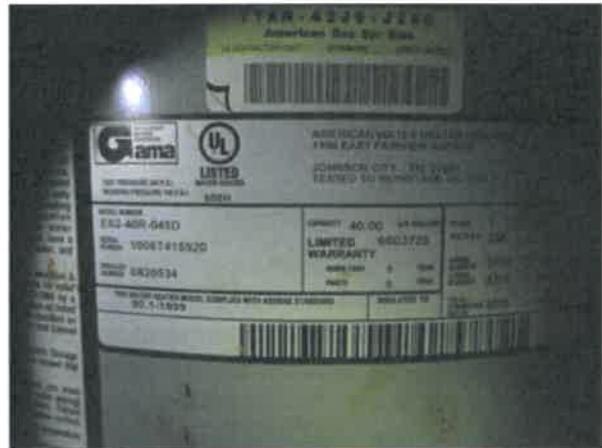
The water heater is located in a closet below the stairs.
It is electrically heated.
30 gallons.
The age of the water heater is about 7 years old.

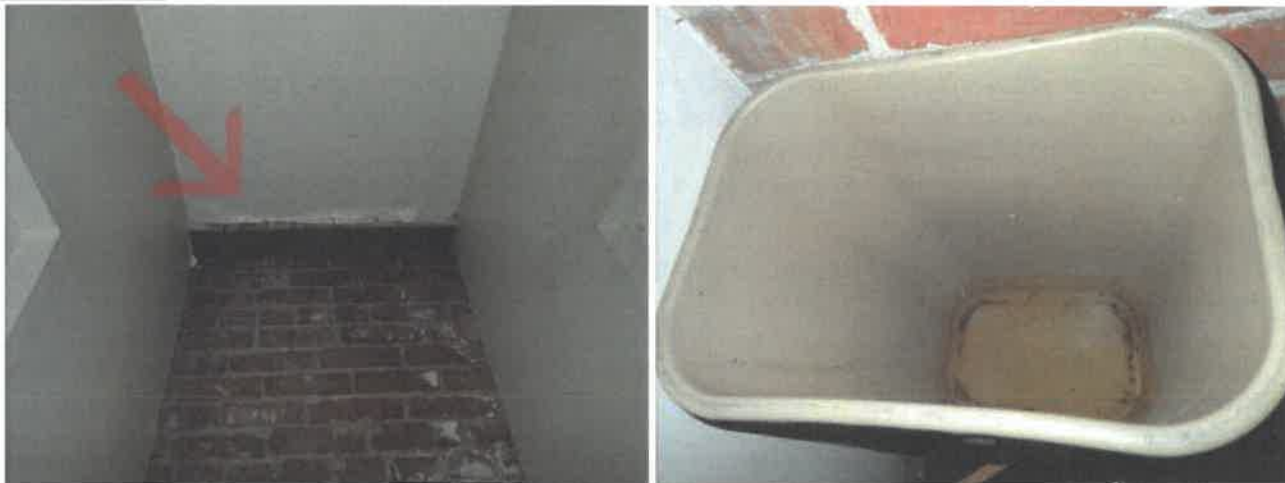
Not Acceptable: There is rough patching and potential moisture damage on the ceiling. There are bolts sticking out of the wall in the office/storage area and the floor slopes significantly and has some damage and wear. This room also has some cracking and potential moisture damage where the wall meets the ceiling.

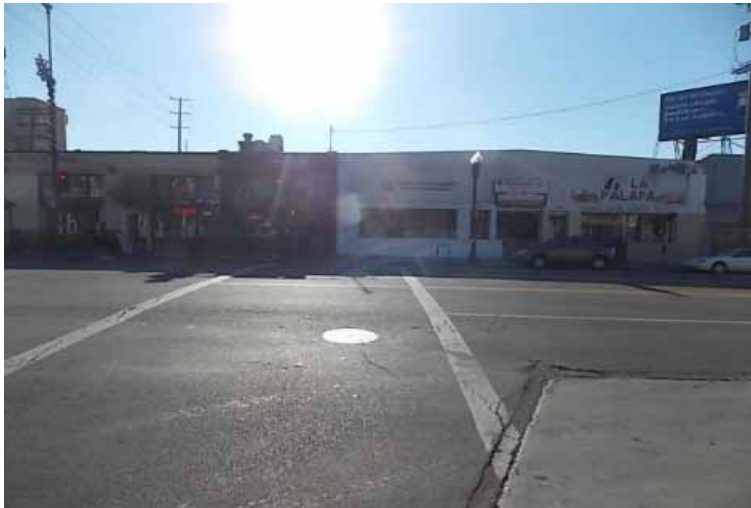
Retail Office Building
Property Condition Assessment
December 30, 2015

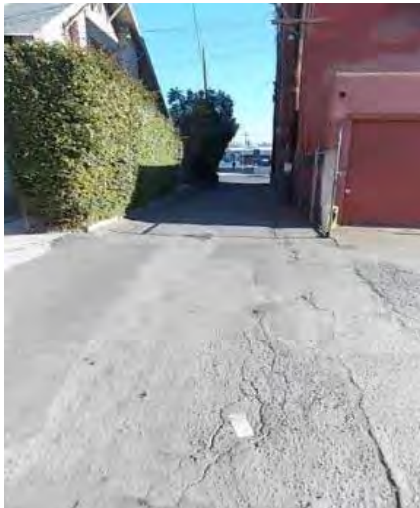
Retail Office Building
Property Condition Assessment
December 30, 2015

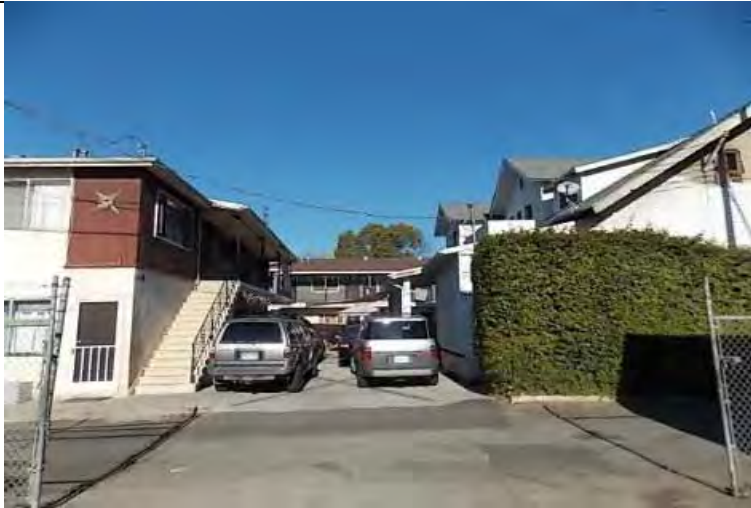
View of residential across alley.

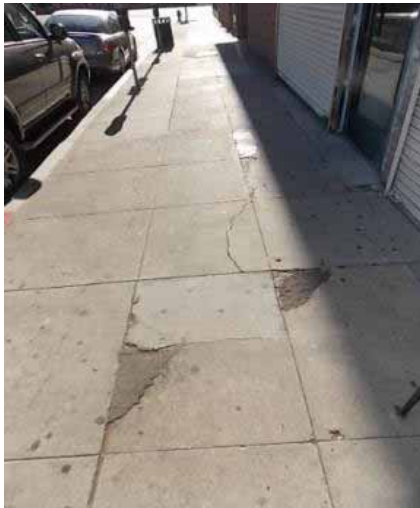
View of damaged north sidewalk.

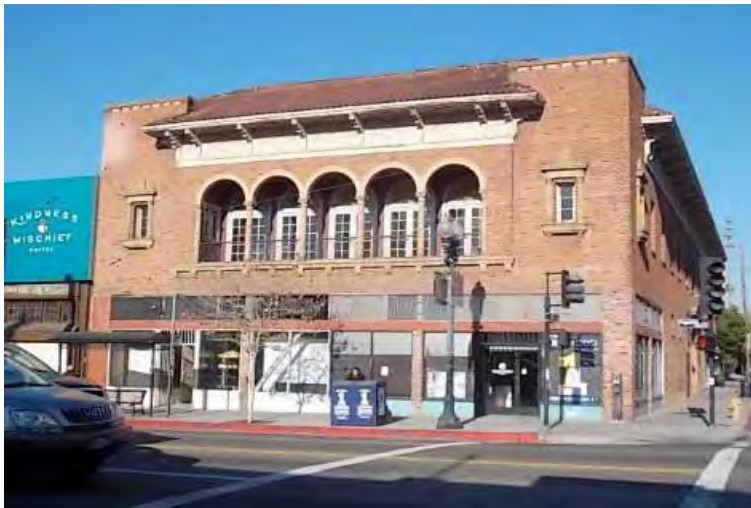
Retail Office Building
Property Condition Assessment
December 30, 2015

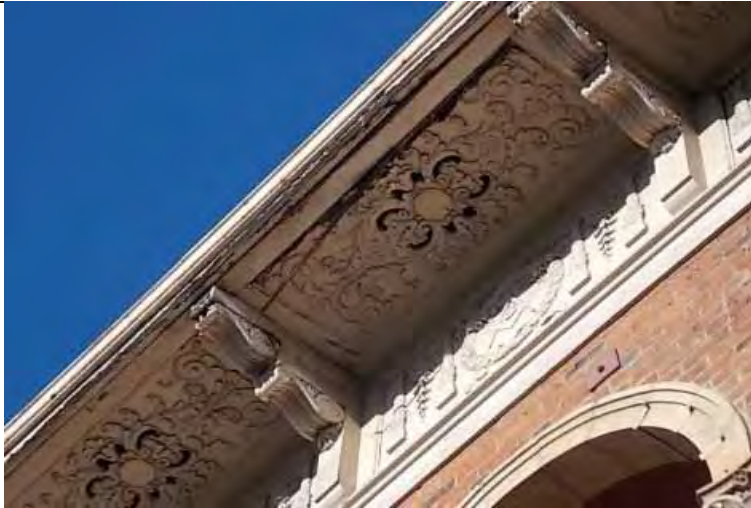
View of damaged soffit at east side of building.

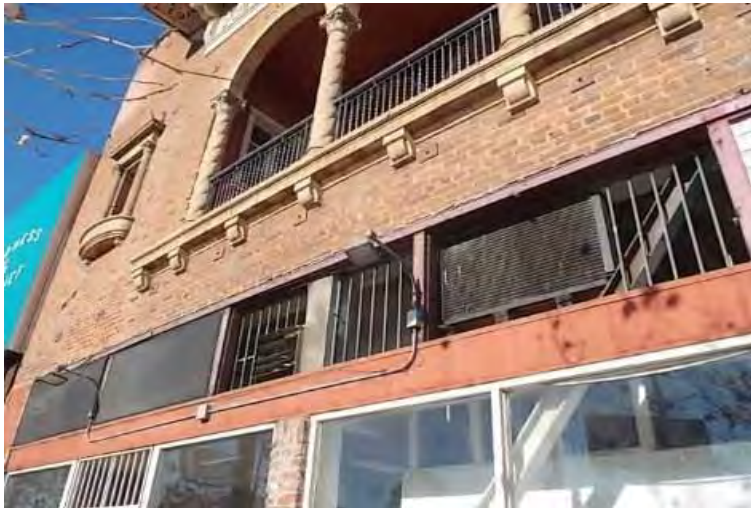
View of missing window panes leading into the bakery.

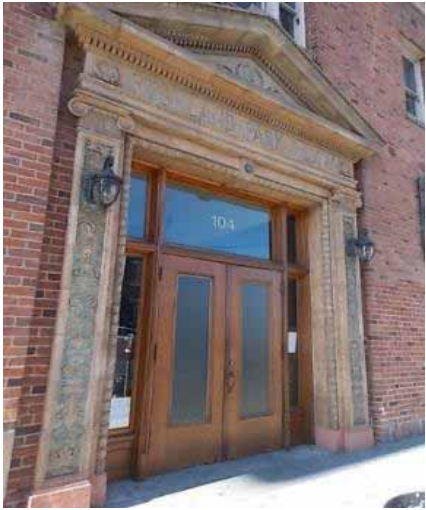
View of the main entrance to access the upper floors

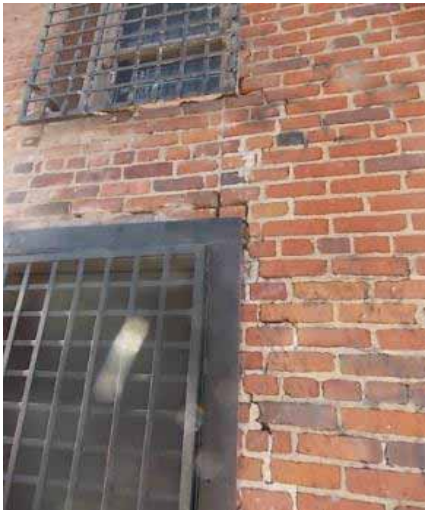
Retail Office Building
Property Condition Assessment
December 30, 2015

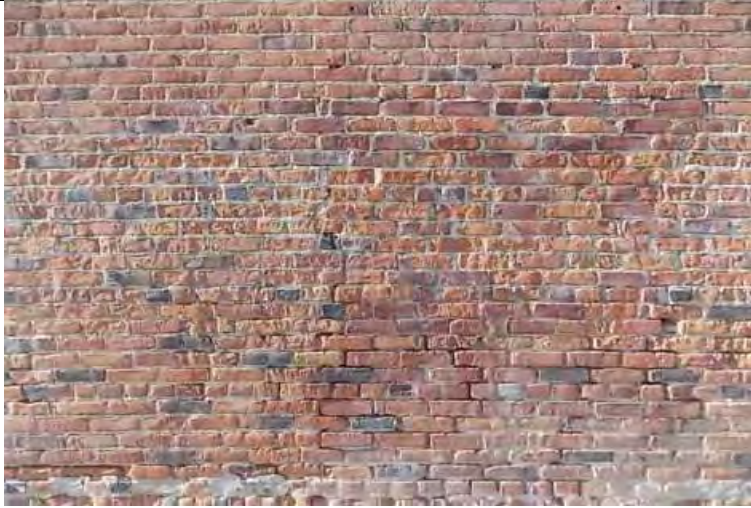
Close view of brick surface damage

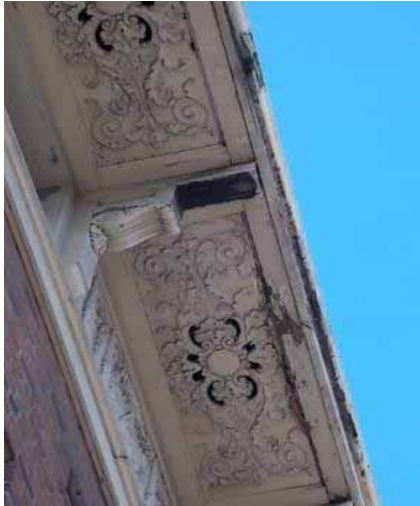
Soffit damage at north soffit

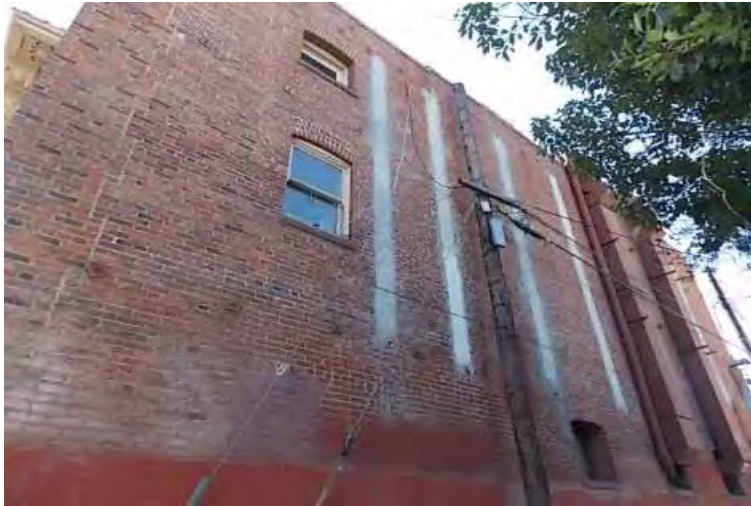
Retail Office Building
Property Condition Assessment
December 30, 2015

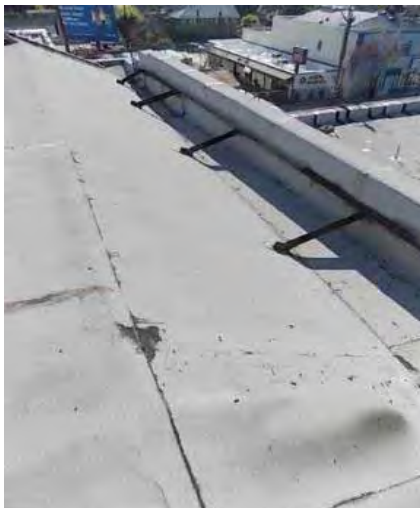
View of parapet wall and support

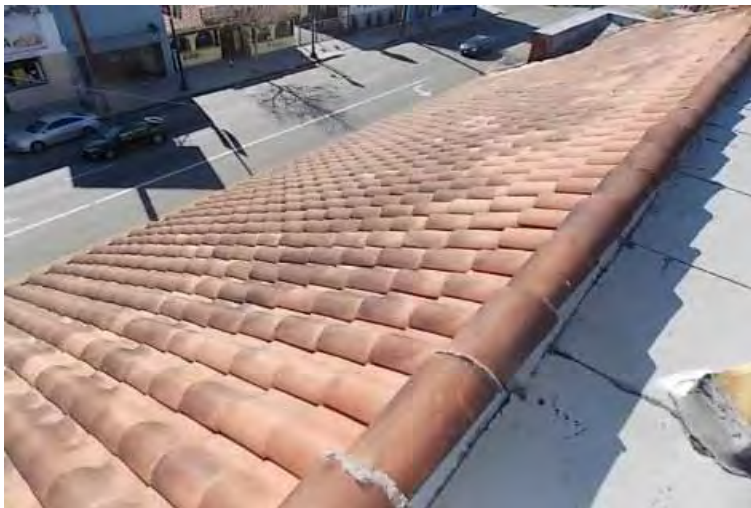
View of roof tiles - Fair condition

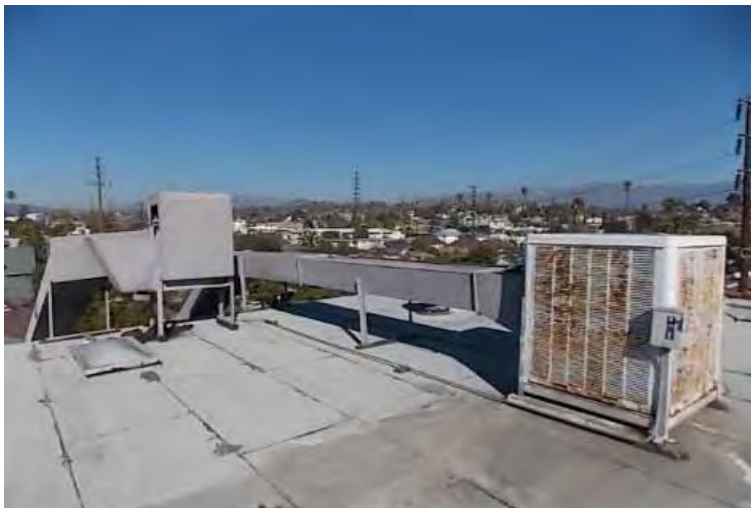
Retail Office Building
Property Condition Assessment
December 30, 2015

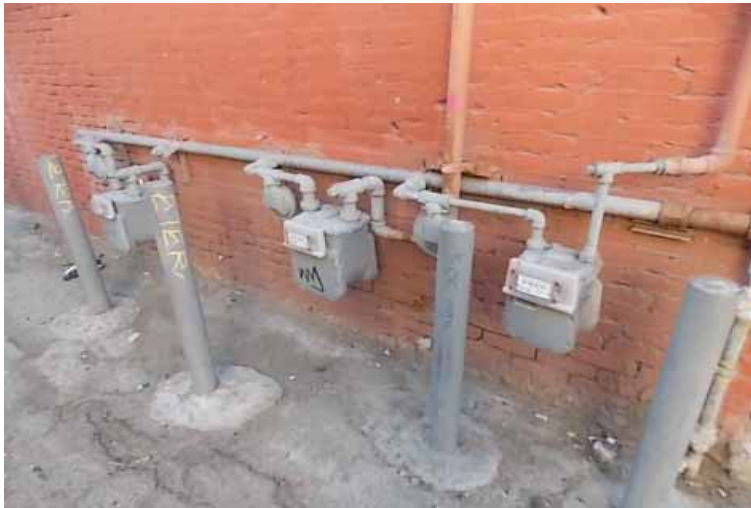
View of gas meters behind building

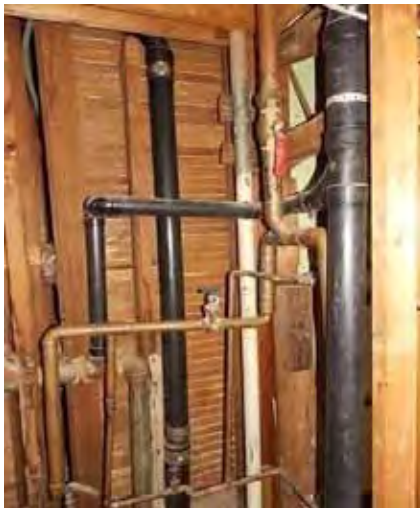
Retail Office Building
Property Condition Assessment
December 30, 2015

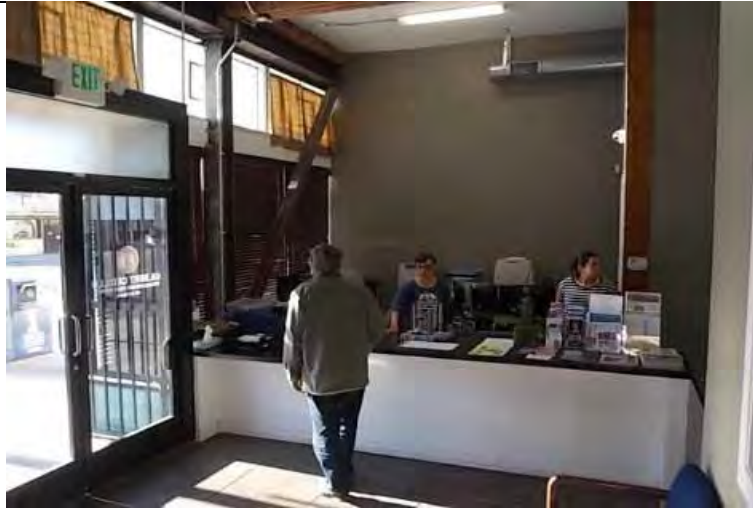
View of 1st floor Councilman's office - Good condition

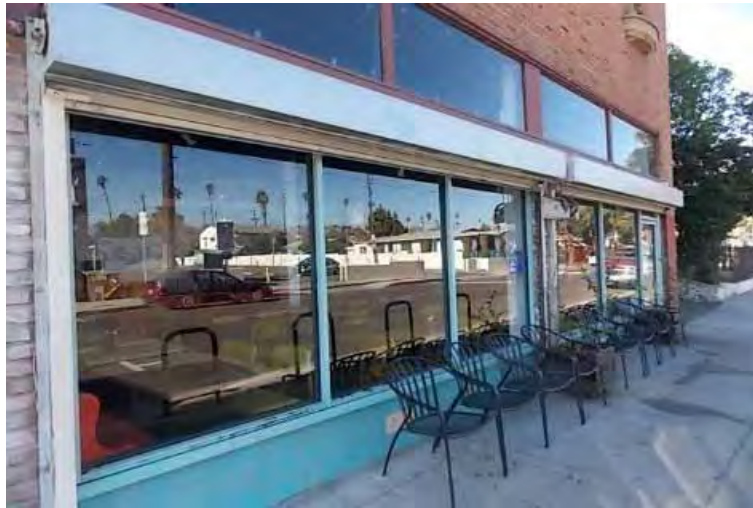
View of restaurant storefront

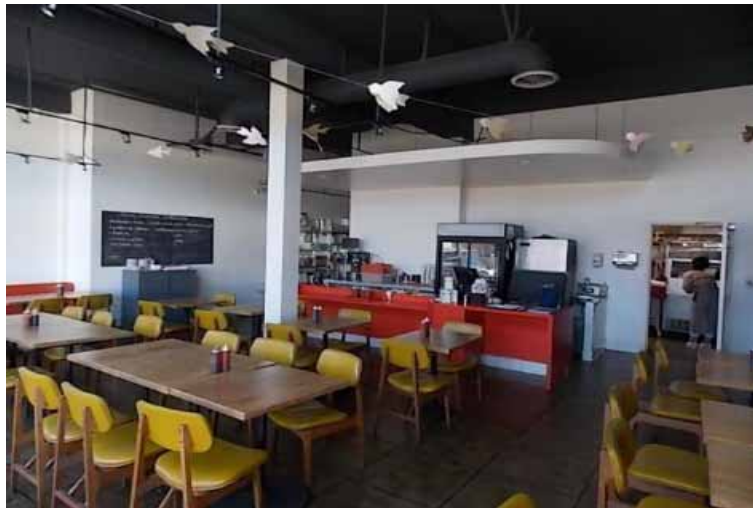
Retail Office Building
Property Condition Assessment
December 30, 2015

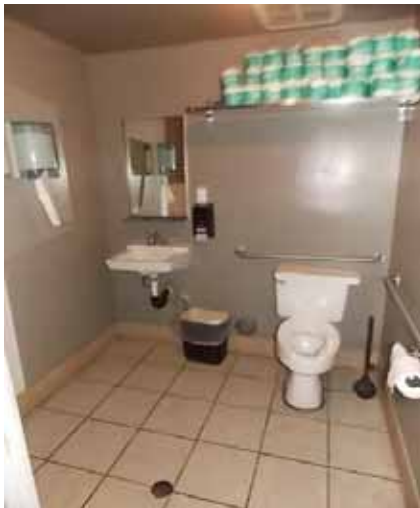
Retail Office Building
Property Condition Assessment
December 30, 2015

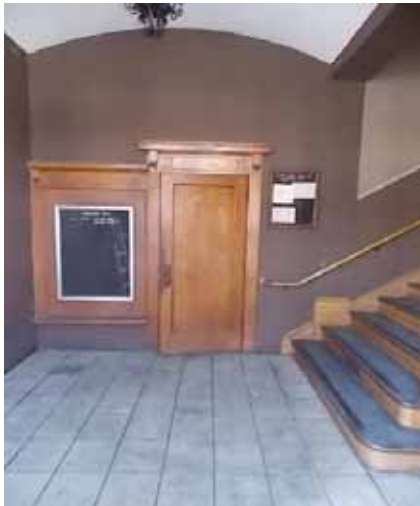
View of 1st floor entry into building.

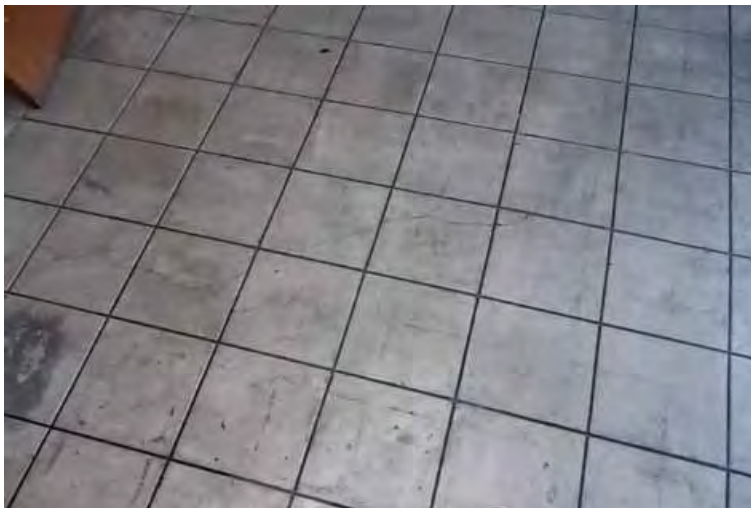
View of cracked floor tiles

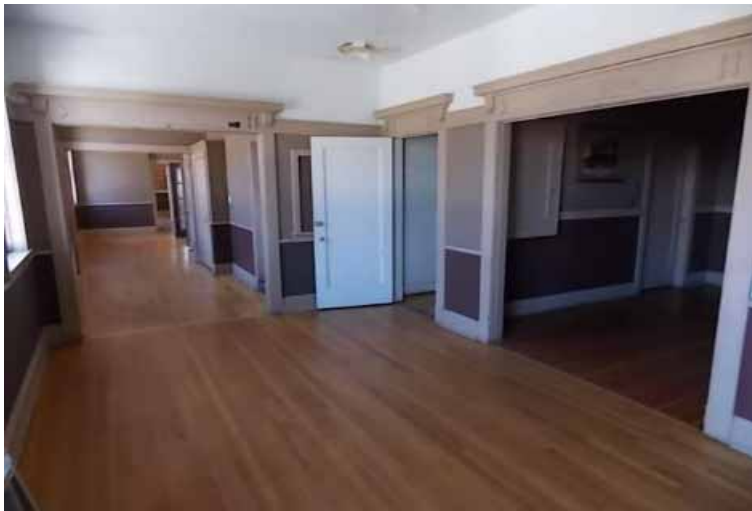
View of 2nd floor landing

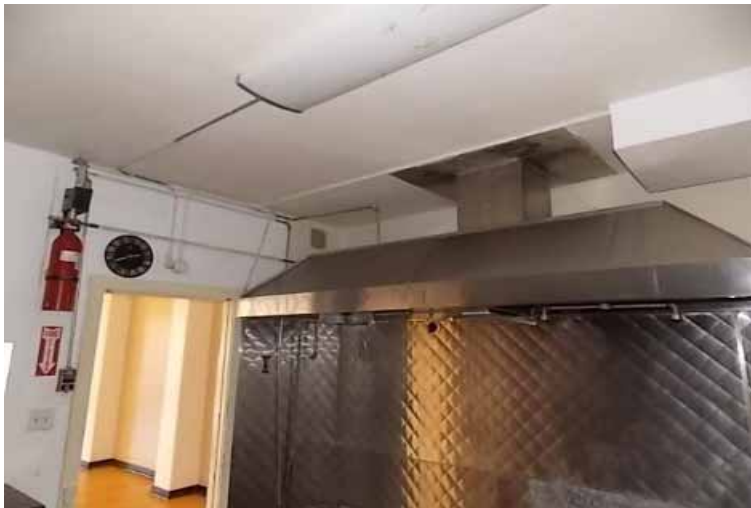
Retail Office Building
Property Condition Assessment
December 30, 2015

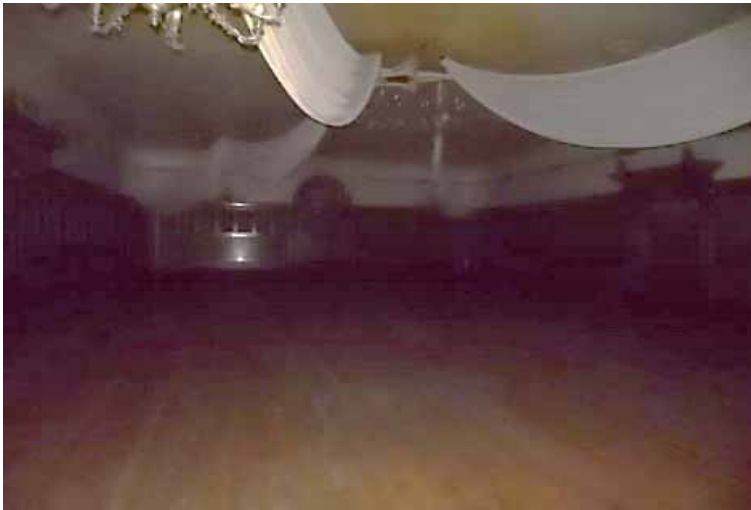
View of meeting hall - No lighting provided

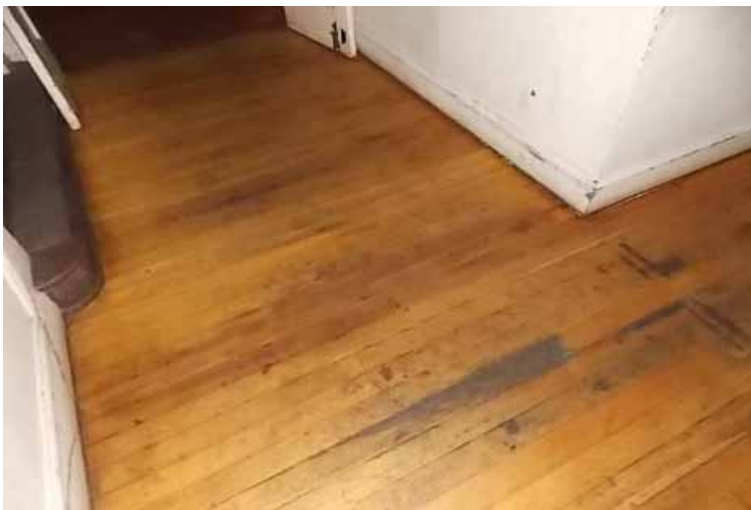
Retail Office Building
Property Condition Assessment
December 30, 2015

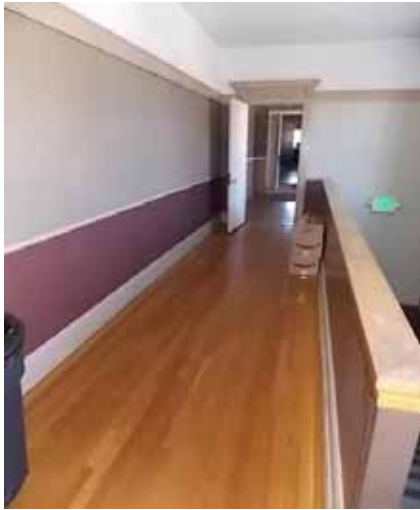
Retail Office Building
Property Condition Assessment
December 30, 2015

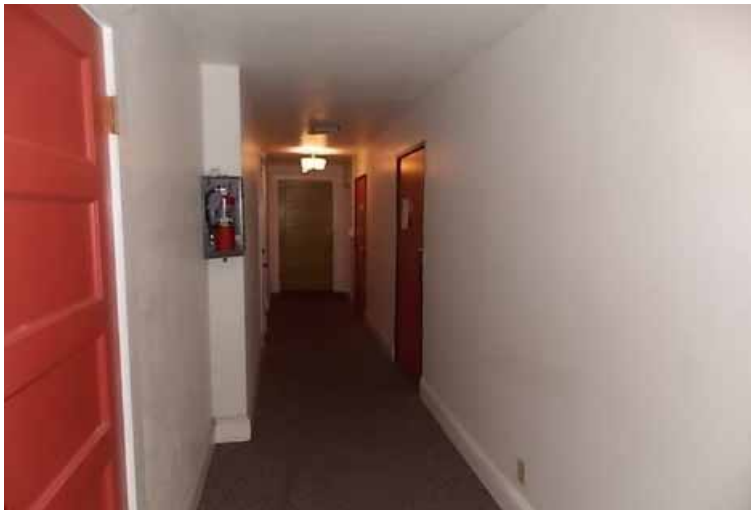
Retail Office Building
Property Condition Assessment
December 30, 2015

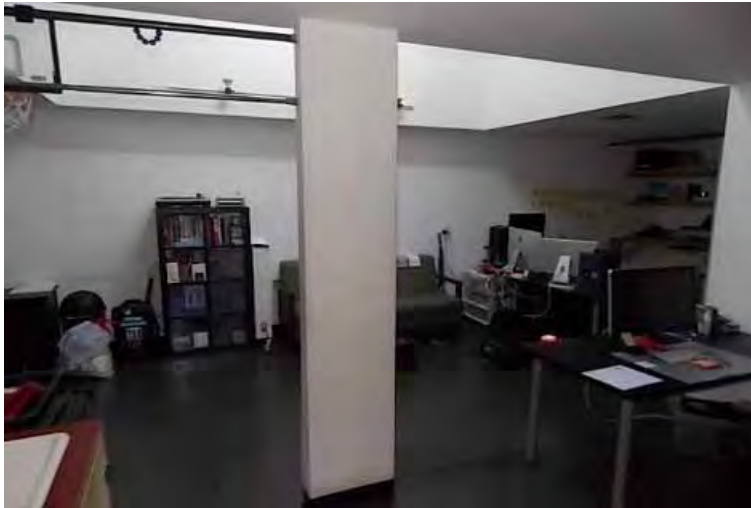
View of 3B office - 3A & 3C were not accessible

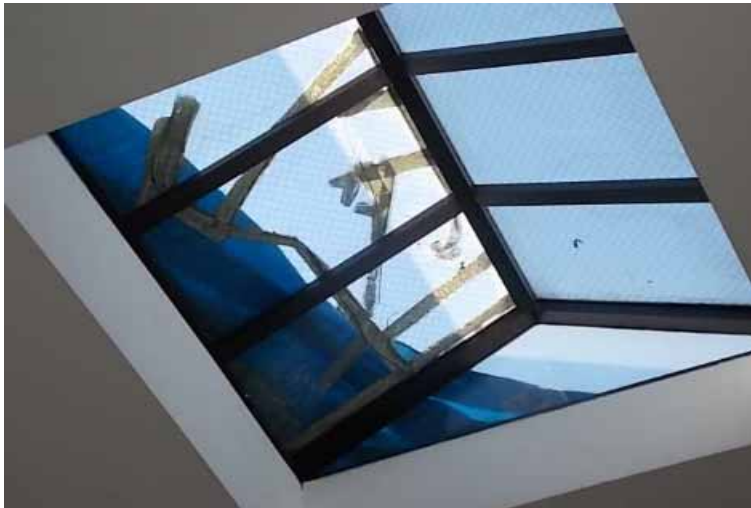
Retail Office Building
Property Condition Assessment
December 30, 2015

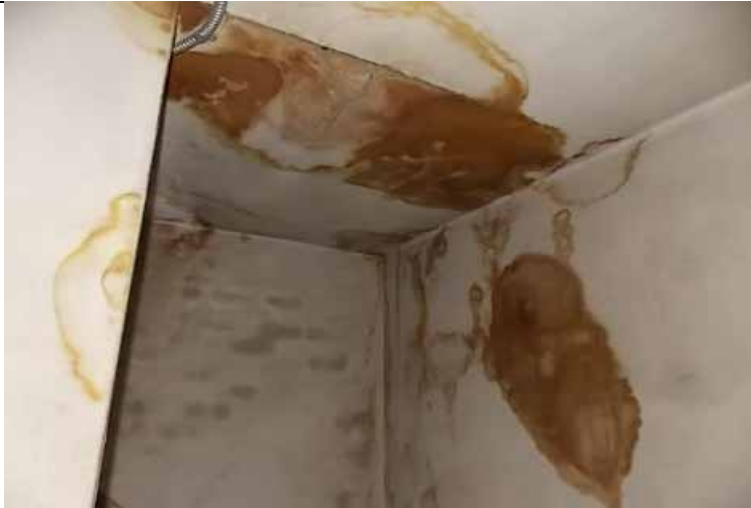
View of wall & ceiling damage in stairwell leading up to the roof

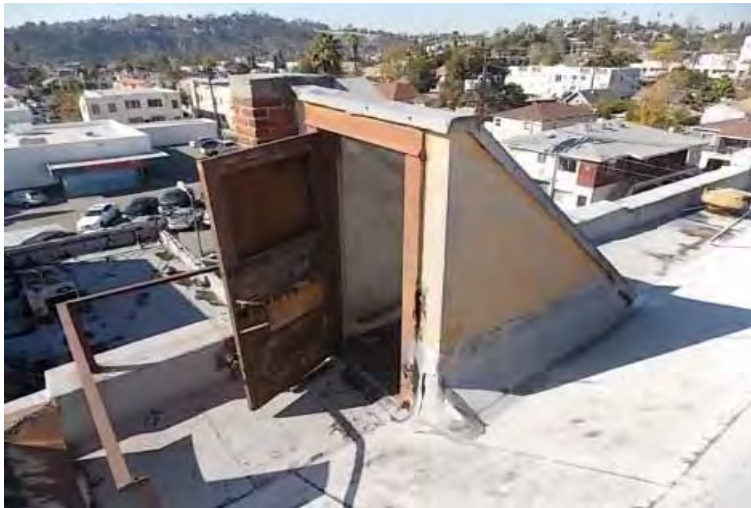
View of damaged roof access

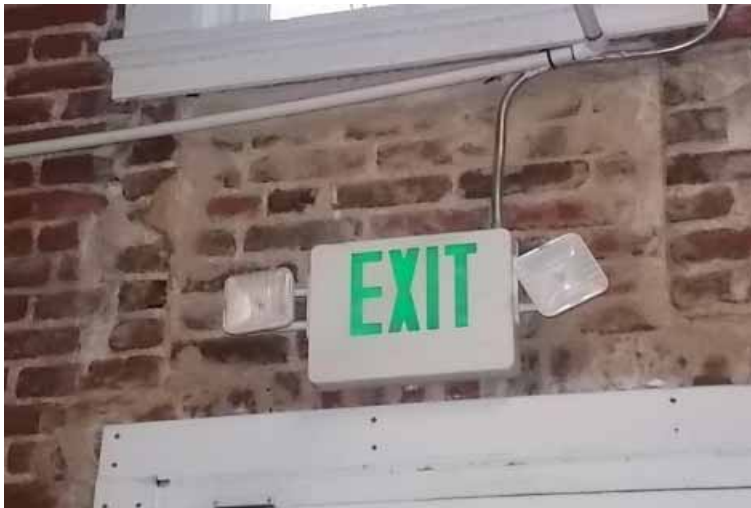
Retail Office Building
Property Condition Assessment
December 30, 2015

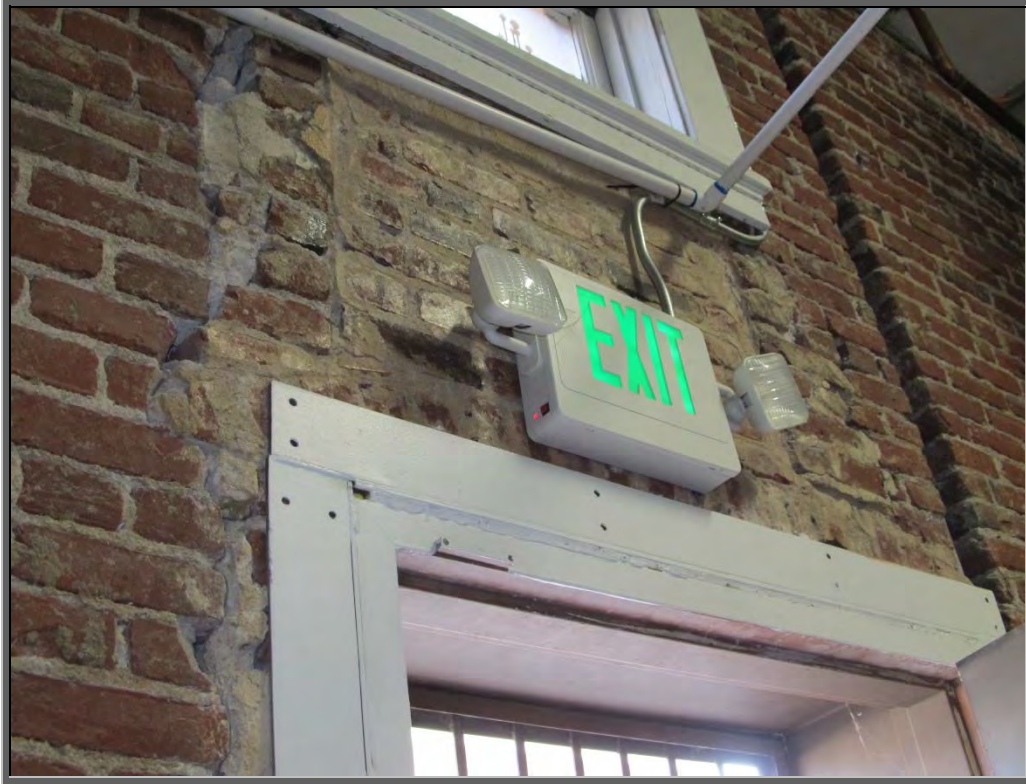
Photo 15: Deterioration of URM wall.

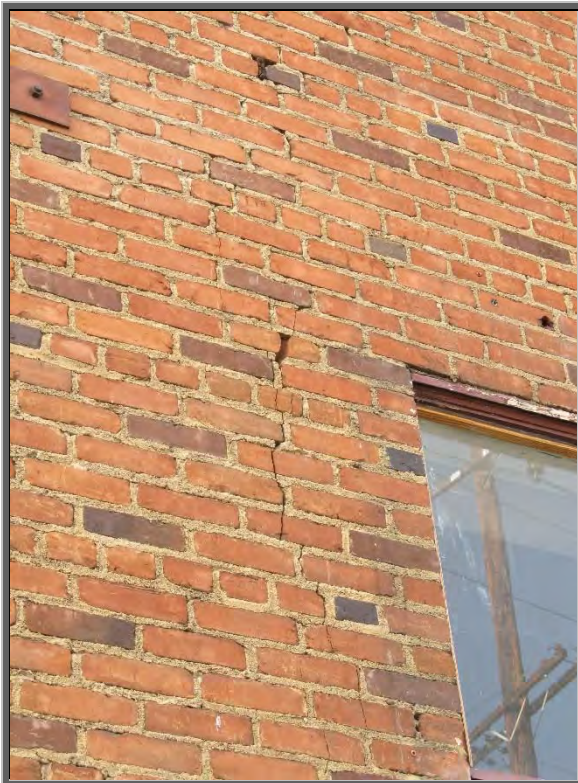
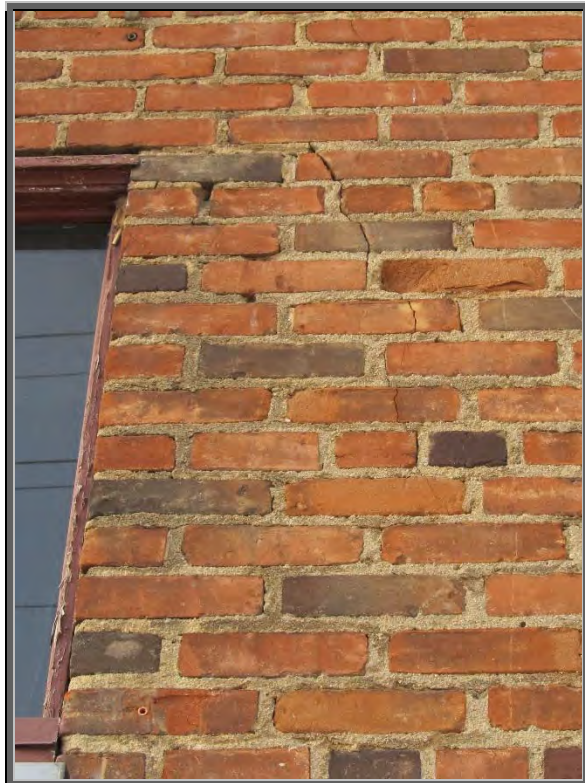
Photos 16A & B: Cracks in URM walls.

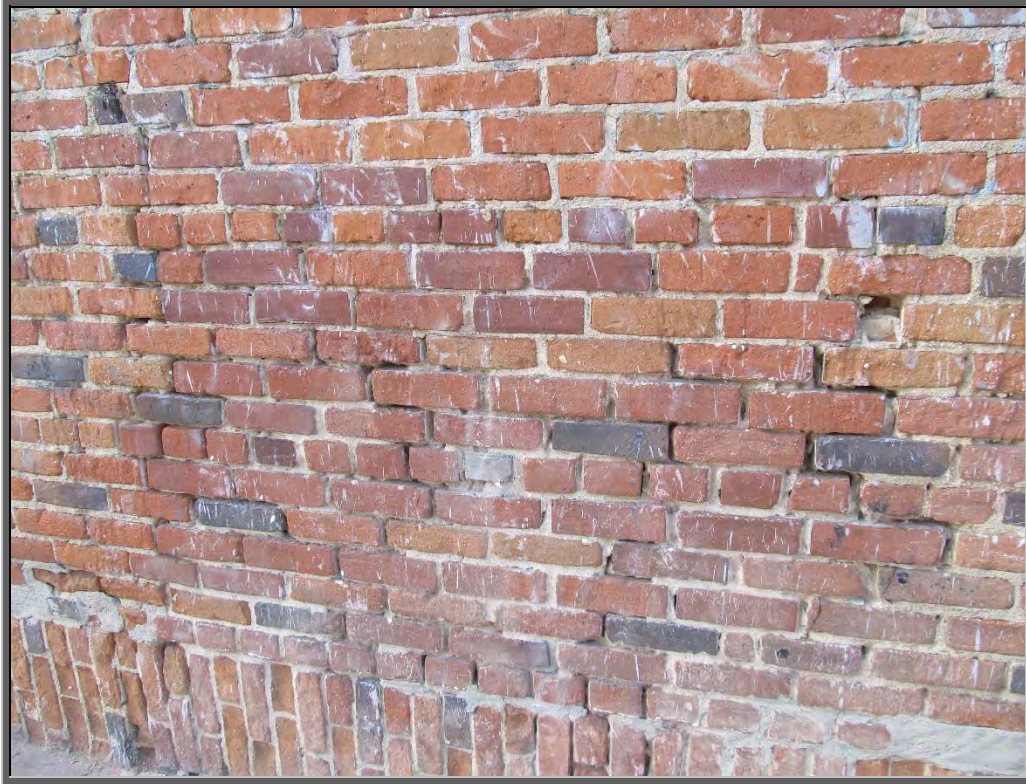
Photo 17: URM wall with deteriorating grout.

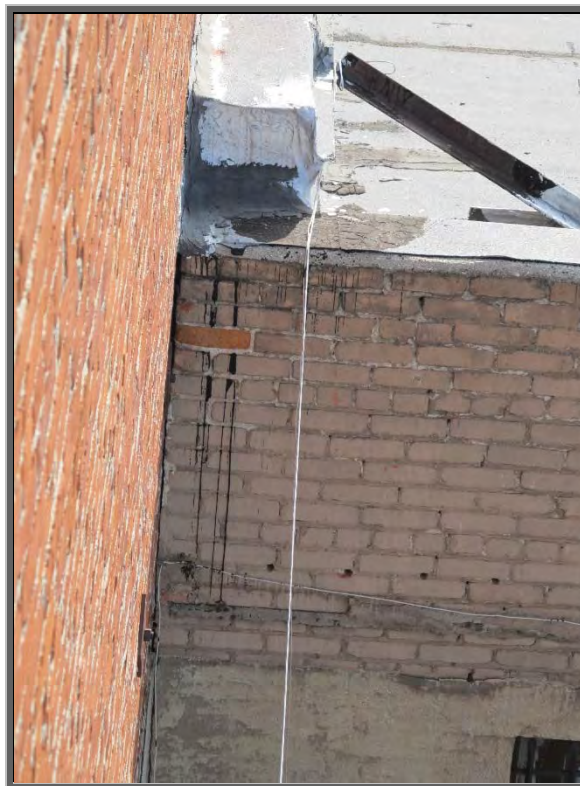
Photo 18: Minimal seismic separation to adjacent building.

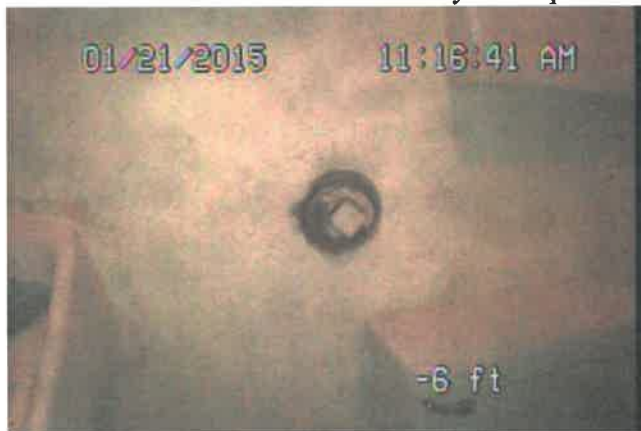
FINDINGS: The main sewer line is made of vitrified clay pipe. The line exits the front of the building to the left of the gated door and runs straight out toward the middle of the street dropping down about a foot a few feet before the public sewer connection at the middle of the street. The red chip in the photograph below illustrates the approximate location where the clay pipe begins.

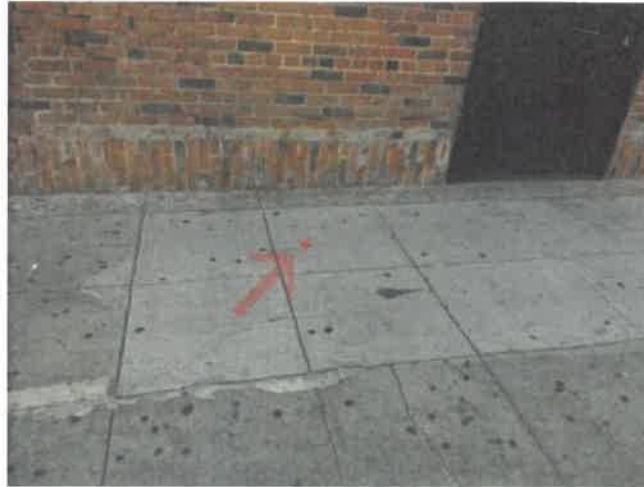
Needs Attention: Where the pipe drops down near the middle of the street there is a section that is sloped incorrectly backward causing a short section of pipe to hold about one inch or so of water. There is no break here that can be seen. Instead it looks to be a past repair that was not done well. Ideally the line would have a downward slope. The minimum slope requirement for a main sewer line is one quarter on an inch per foot of pipe run. Either end of this section can also be seen to be offset at the joints. That being said, there is no evidence to support that this section is causing blockage issues in the line so an expensive repair recommendation is not really justified at this time.

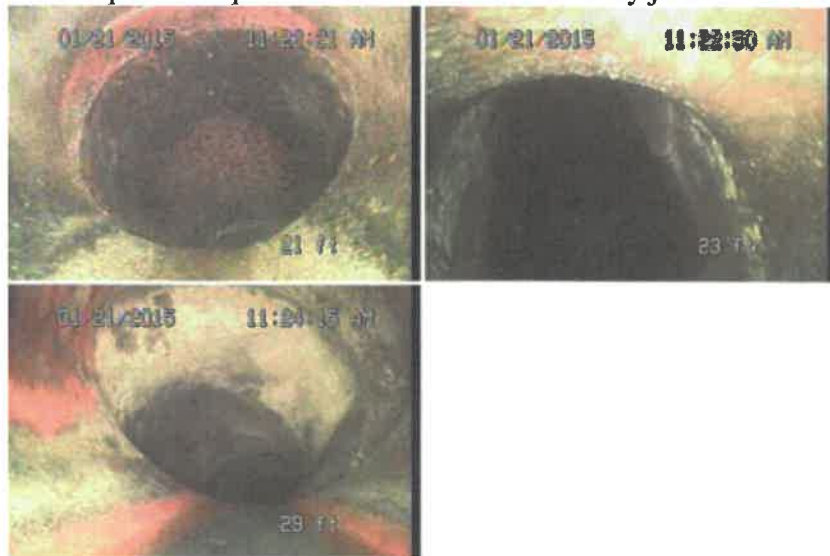
The bigger concern here is an older section of cast iron piping under the concrete floor of the building before the drain exits the structure. Cast iron pipe was typically expected to have an average service life of approximately 70 to 80 years. This pipe should be upgraded/rehabilitated before failures prevent the system from operating and is being recommended at this time

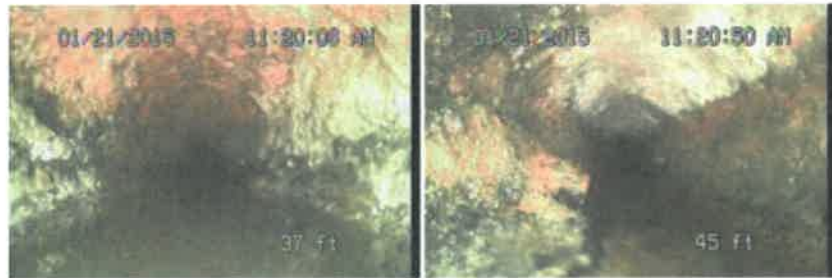
Most of what was seen under the building today has already been upgraded and the patches in the floor are further evidence that several of the drains have been replaced. Modern plastic and less deteriorated cast iron pipes were seen in these areas.
