**921 SOUTH BEACON STREET**  
Harbor View House, Historic-Cultural Monument (HCM) #252  
Contributor to the Vinegar Hill Historic Preservation Overlay Zone (HPOZ)  
CHC-2019-1291-MAEX

## RECOMMENDATION REPORT

CASE NO.: CHC-2019-1291-MAEX

## CHARACTER-DEFINING FEATURES & EXISTING CONDITIONS SURVEY

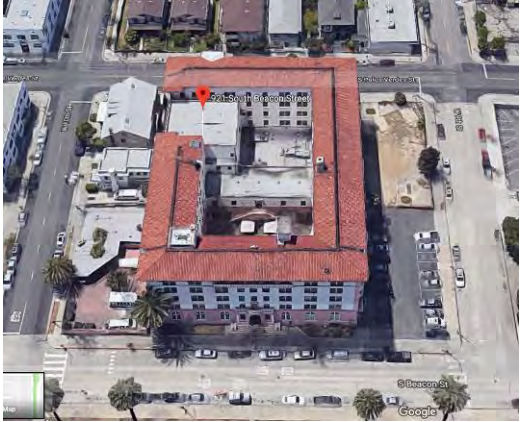
| EXTERIOR | | | | | | |
|---|---|---|---|---|---|---|
| Exterior | Site | Narrow setbacks on Beacon Street and Palos Verdes Street<br><br>Shallow planters with concrete curbs<br><br>Surface parking lot | Good | Primary | Cracked and broken concrete curbs at planter beds | |

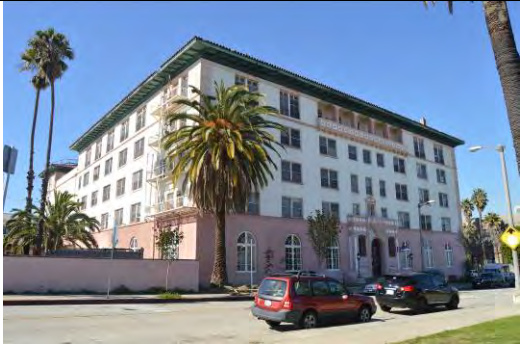
| EXTERIOR | | | | | | |
|---|---|---|---|---|---|---|
| Exterior | Massing | Simple massing<br><br>Rectangular plan around central courtyard<br><br>Five stories above raised basement | Good | Primary | Addition of exterior stair on west façade, elevator on west façade of inner court, and one-story kitchen addition on south façade. | |

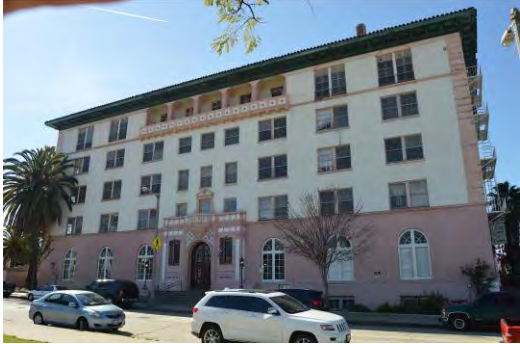
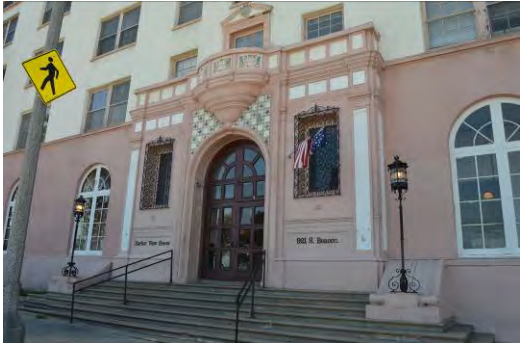
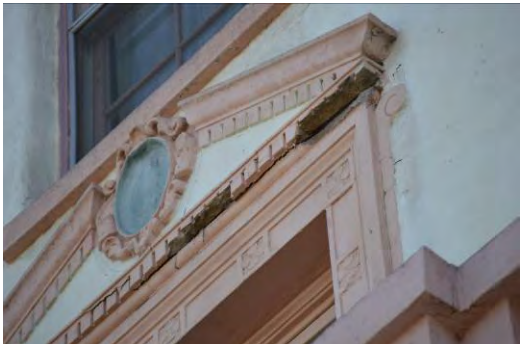
| EXTERIOR | | | | | | |
|---|---|---|---|---|---|---|
| Exterior | East (primary) Façade | <p>Symmetrical composition</p> <p>Smooth cement plaster veneer</p> <p>Classical articulation of base, shaft, and capital</p> <p>Molded water table</p> <p>Sill courses under second- and fifth-story windows</p> <p>Stacked cast stone quoins</p> <p>Broad cast concrete entrance steps with scrolled parasteds and decorative metal lanterns</p> <p>Cast stone entrance portal with paneled pilasters, frieze, and balcony parapet; dentil cornice; and corbelled balconette</p> <p>Entrance portal balconette window with pediment, architrave and scrolled surround</p> <p>Recessed wood entrance doors with glazed panels, round-arched transom light and cast stone archivolt</p> <p>Accent windows flanking entrance with decorative metal grilles</p> <p>Recessed, divided-light, wood sash casement windows with round-arched transom lights at first story</p> <p>Recessed, paired and single six-over-six double hung wood sash</p> | Fair | Primary | <p>Surface staining on plaster and cast stone surfaces</p> <p>Peeling paint</p> <p>Cracking and losses in cement plaster veneer</p> <p>Cracking and losses in decorative cast stone</p> <p>Over paint of decorative cast stone</p> <p>Cracks and losses in cast stone subsills, quoins, and sill courses</p> <p>Weathered and broken wood window assemblies, many windows non-operable, missing hardware, and exhibit termite damage</p> <p>Subsidence, cracks, and mortar losses at concrete entrance steps</p> | |

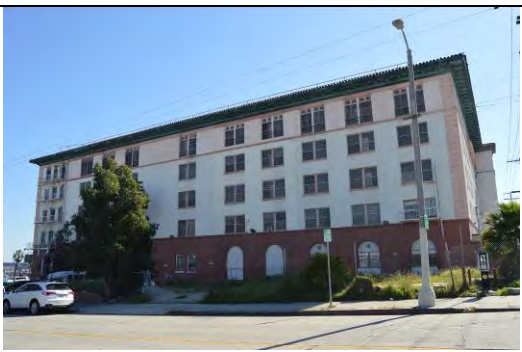
| EXTERIOR | | | | | | |
|---|---|---|---|---|---|---|
| Exterior | North Facade | <p>Asymmetrical composition</p> <p>Smooth cement plaster veneer</p> <p>Classical articulation of base, shaft, and capital</p> <p>Molded water table</p> <p>Sill courses under second- and fifth-story windows</p> <p>Stacked quoins</p> | Fair | Primary | <p>One vertical stack of windows has been infilled.</p> <p>Two round-arched openings at ground floor (location of former swimming pool) have been infilled; three round-arched openings have original wood sash windows with concrete bulkhead; however, the transom lights have been removed and infilled.</p> | |

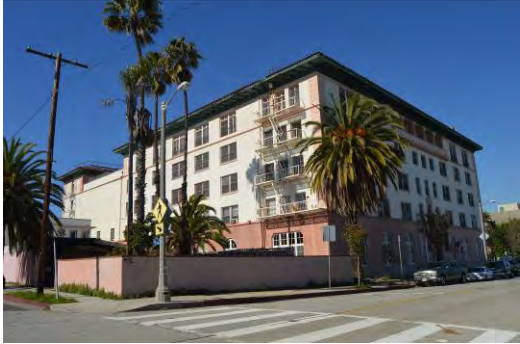
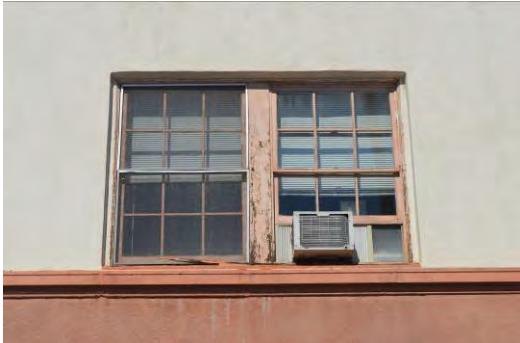
| EXTERIOR | | | | | | |
|---|---|---|---|---|---|---|
| Exterior | South Facade | <p>Asymmetrical composition</p> <p>Smooth cement plaster veneer</p> <p>Classical articulation of base, shaft, and capital</p> <p>Molded water table</p> <p>Sill courses under second- and fifth-story windows</p> <p>Stacked quoins</p> <p>Shouldered window at east end of ground floor with four-over-four wood sash double hung windows and divided transom lights</p> <p>Eight round-arched openings at ground floor</p> <p>Recessed, paired and single six-over-six double hung wood sash windows with projecting subsills at second, third and fourth stories</p> <p>Wood sash, divided-light French windows with transom lights and metal balconettes</p> <p>Two metal fire escapes</p> | Fair | Primary | <p>Some round-arched window openings at the ground floor have been partially or completely infilled</p> <p>Surface staining on plaster and cast stone surfaces</p> <p>Peeling paint</p> <p>Cracking and losses in cement plaster veneer</p> <p>Cracks and losses in cast stone subsills, quoins, and sill courses</p> <p>Weathered and broken wood window assemblies, many windows non-operable, missing hardware, and exhibit termite damage</p> | |

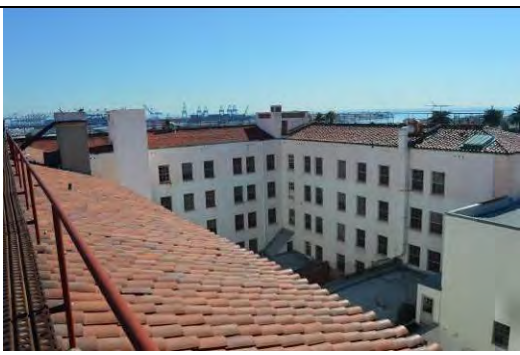
| EXTERIOR | | | | | | |
|---|---|---|---|---|---|---|
| Exterior | Roof | <p>Hipped roofs with clay barrel tile roofing</p> <p>Cement plaster clad concrete stair penthouse and chimney with red quarry tile panels, wood paneled door, and skylight</p> <p>Cement plaster clad concrete chimney with red quarry tile panels</p> <p>Metal eave soffit and cornice with brackets</p> | Fair | Primary | <p>Broken and missing clay tiles</p> <p>Cracked and missing cement plaster; exposed brick at penthouse parapet</p> <p>Penetrations and inappropriate repairs with sealant and mortar</p> <p>Cracked and missing quarry tile and missing mortar</p> <p>Appears metal skylights, scuppers, and cornice have been</p> | |

- Repair and retain decorative red quarry tile panels on the stair penthouse and chimneys.
- In the gymnasium, retain the wood basketball court floor, and carefully remove paint from the brick veneer below the suspended track and restore the glazed finish to match the original brick finish extant above suspended track.

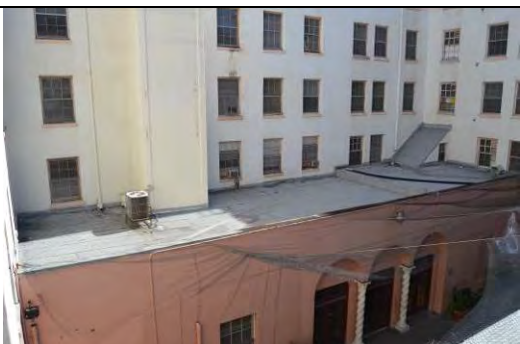
| EXTERIOR | | | | | | |
|---|---|---|---|---|---|---|
| Exterior | Roof | Flat roofs with parapets over lobby, former handball court, former locker room, and theater of inner court | Fair | Secondary | Some staining and pooling of water on flat roofs<br>Built up roofing with previous repairs and patching with mastic<br>Roof vents and penetrations<br>Added mechanical equipment<br>Broken rain leader pipe<br>Missing parapet roof tile coping | |

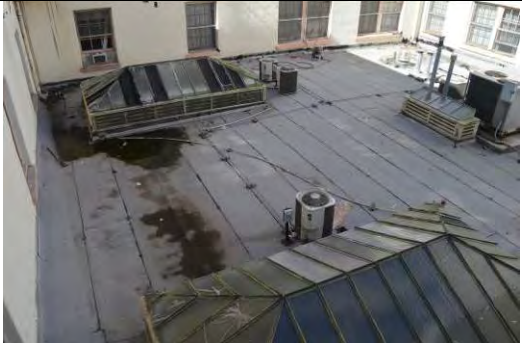
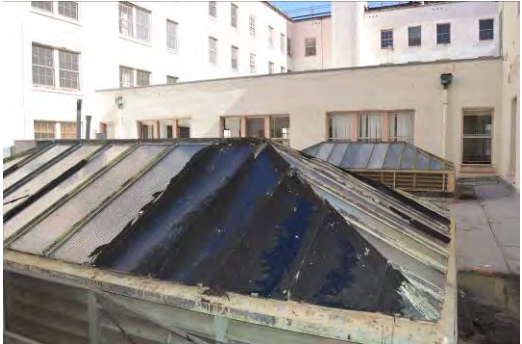
| EXTERIOR | | | | | | |
|---|---|---|---|---|---|---|
| Exterior | Roof | Skylights with hipped-shaped steel structure over raised louvered base<br>Wire glazing | Poor | Secondary | Broken and cracked glazing<br>Replacement panes<br>Non-original sealant and mastic<br>Surface staining and minor corrosion of steel structure | |

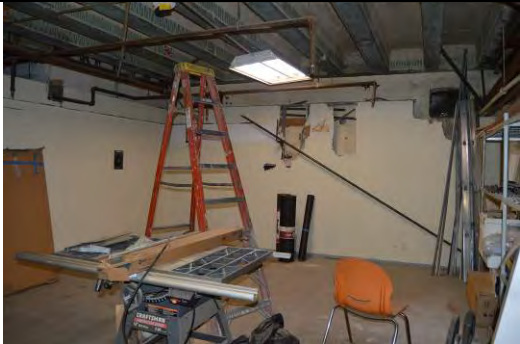
| INTERIOR | | | | | | |
|---|---|---|---|---|---|---|
| Basement | General | <p>Stamped concrete flooring</p> <p>Plaster walls</p> <p>Tile wainscot</p> <p>Stenciled concrete beamed ceiling</p> | Fair | Secondary | <p>The northeast portion of the basement was historically finished with materials similar to the first story.</p> <p>Tile wainscot has been painted over but appears intact.</p> | |

- Engage the services of a specialist to restore decorative paint and stencil work on ceilings in lobby, physical therapy room, and basement where damaged or missing. Investigate presence of other decorative beams hidden by suspended acoustical tile ceilings in the basement, and restore as appropriate.

- Investigate and document extent and condition of glazed ceramic tile in the basement. Retain original ceramic tile if intact, and determine scope of tile restoration in consultation with the Office of Historic Resources.

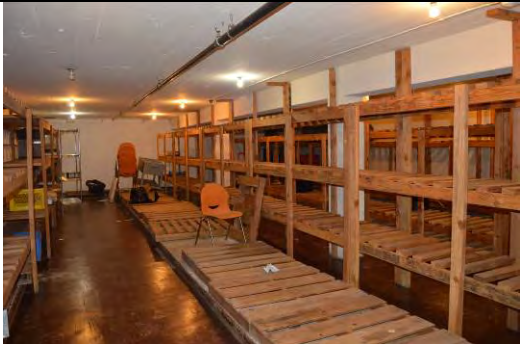
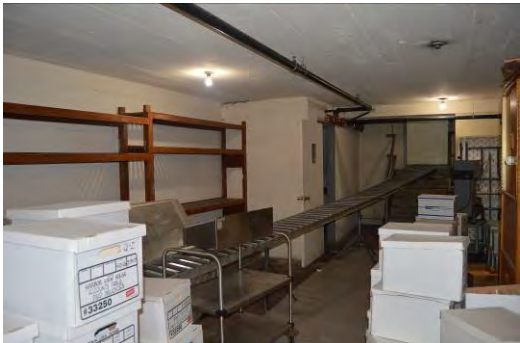
| INTERIOR | | | | | | |
|---|---|---|---|---|---|---|
| Basement | Dry Storage | Painted plaster walls<br>Board-formed concrete walls and ceilings | Good | Secondary | Concrete floors covered with resilient tile flooring | |

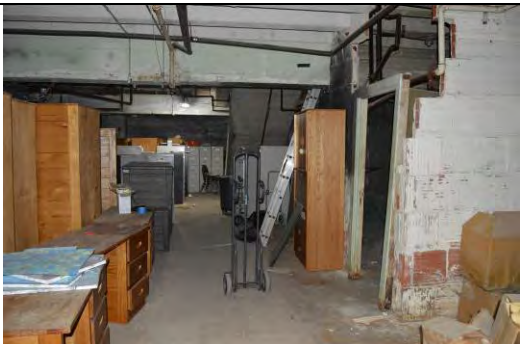
| INTERIOR | | | | | | |
|---|---|---|---|---|---|---|
| Basement | Storage | Stamped concrete flooring<br>Painted plaster walls<br>Board-formed concrete walls and ceilings<br>Hollow clay tile partitions | Fair | Secondary | Peeling paint<br>Water pooling at base of stair under courtyard<br>Corroded and exposed rebar and concrete losses in ceiling of stair under courtyard | |

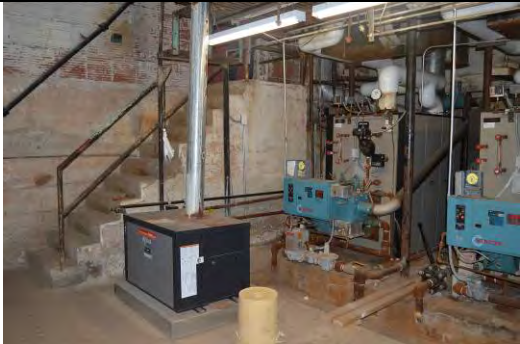
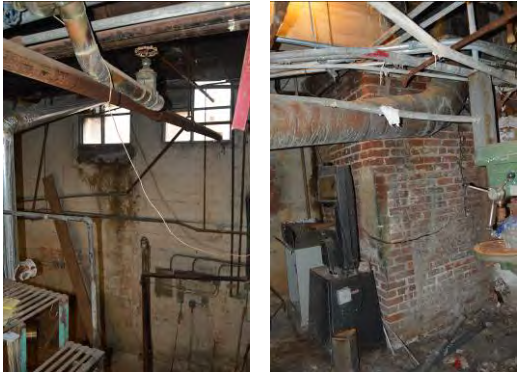
| INTERIOR | | | | | | |
|---|---|---|---|---|---|---|
| Basement | Mechanical Rooms | <p>Stamped concrete flooring</p> <p>Painted plaster walls</p> <p>Board-formed concrete walls and ceilings</p> <p>Hollow clay tile partitions</p> <p>Brick chimney</p> <p>Paneled wood doors</p> <p>Metal clad doors</p> | Fair | Secondary | <p>Water infiltration and rust staining at lightwell windows</p> <p>Rusting mechanical equipment</p> <p>Peeling paint</p> <p>Pooling water on floors</p> <p>Concrete and plaster losses from water infiltration</p> | |

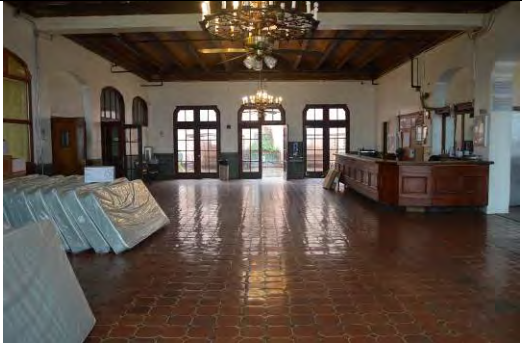
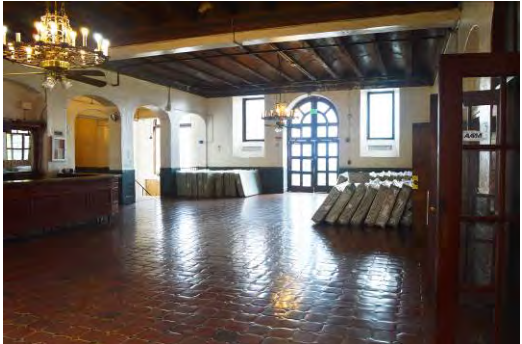
| INTERIOR | | | | | | |
|---|---|---|---|---|---|---|
| Ground Floor | Lobby | <p>Location, configuration, and spatial relationships</p> <p>Terra cotta and glazed ceramic tile flooring</p> <p>Textured plaster walls</p> <p>Ceramic tile wainscot</p> <p>Stenciled concrete beamed ceiling</p> <p>Wrought iron chandeliers</p> <p>Shouldered arches and arched openings with wood-framed glazing</p> <p>Divided-light glazed wood doors and transom lights</p> <p>Paneled wood doors</p> | Fair | Primary | <p>Surface soil and staining on tile flooring</p> <p>Missing, replacement, and broken ceramic tiles at wainscot</p> <p>Paint losses at ceiling</p> <p>Ceiling fans added to chandeliers</p> | |

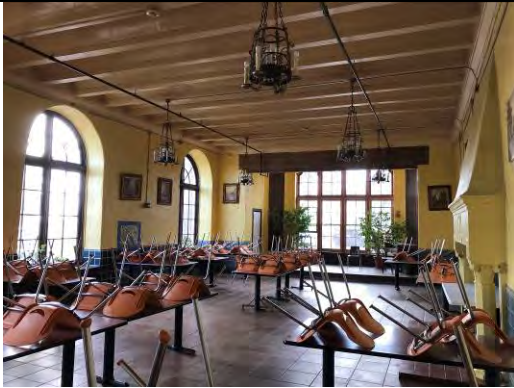
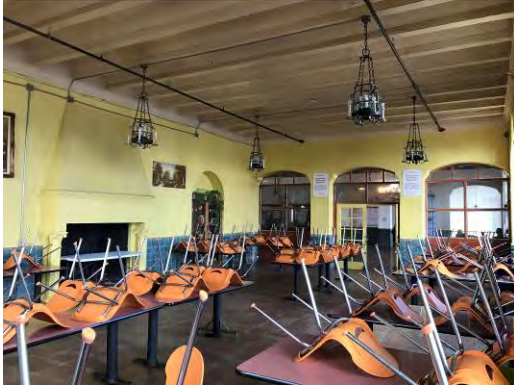
| INTERIOR | | | | | | |
|---|---|---|---|---|---|---|
| Ground Floor | Dining Room (former South Lounge) | <p>Location, configuration, and spatial relationships</p> <p>Stamped and stained concrete floor</p> <p>Textured plaster walls</p> <p>Ceramic tile wainscot</p> <p>Hooded fireplace with cast stone mantel and tiled hearth</p> <p>Concrete beamed ceiling</p> <p>Decorative wrought iron light fixtures</p> <p>Divided-light glazed wood doors in blind arch</p> <p>Built-in glazed wood cabinet in blind arch</p> <p>Raised alcove with stenciled beam and wood stage and wall panels</p> | Fair | Primary | <p>Shouldered arched openings from lobby have been infilled with divided-light windows</p> <p>Missing, replacement, and broken ceramic tiles at wainscot</p> <p>Surface wear and scuffs to concrete flooring</p> <p>Surface wear to wood windows seats and stage</p> <p>Exposed conduit and sprinkler piping attached to ceiling and walls</p> | |

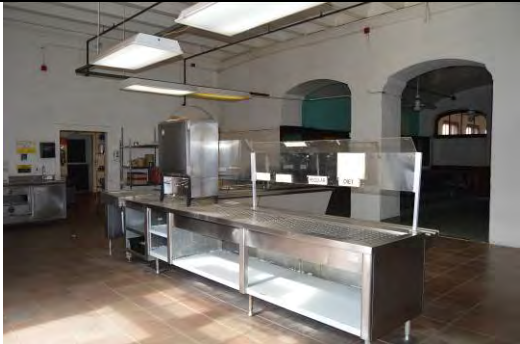
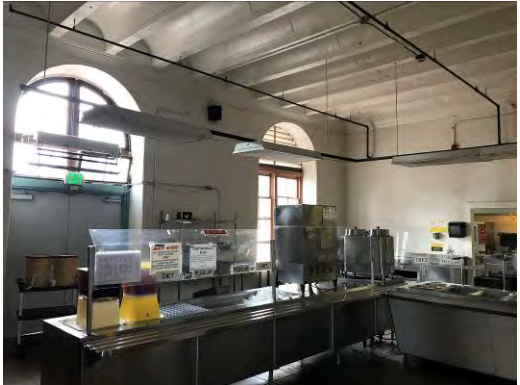
| INTERIOR | | | | | | |
|---|---|---|---|---|---|---|
| Ground Floor | Food Service (former Billiard Room) | Location, configuration, and spatial relationships<br>Stamped and stained concrete floor<br>Textured plaster walls<br>Wood paneling<br>Concrete beamed ceiling<br>Shouldered arches | Fair | Secondary | Surface wear and scuffs to concrete flooring<br>Exposed conduit and sprinkler piping attached to ceiling and walls | |

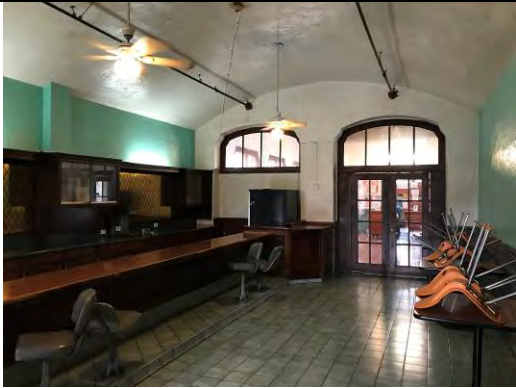
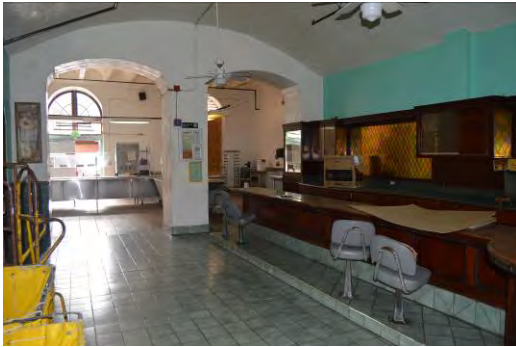
| INTERIOR | | | | | | |
|---|---|---|---|---|---|---|
| Ground Floor | Coffee Shop | <p>Location, configuration, and spatial relationships</p> <p>Plaster walls</p> <p>Ceramic tile wainscot</p> <p>Vaulted plaster ceiling</p> <p>Partially glazed paneled wood doors</p> <p>Wood lunch counter and remaining stools</p> <p>Wood back bar with diamond-paned glazing</p> | Fair | Primary | <p>Permit records indicate the Coffee Shop was installed in 1936, during the property's period of significance</p> <p>Exposed conduit and sprinkler piping attached to ceiling and walls</p> <p>Missing, replacement, and broken ceramic tiles at wainscot</p> <p>Non-original ceiling fans</p> | |

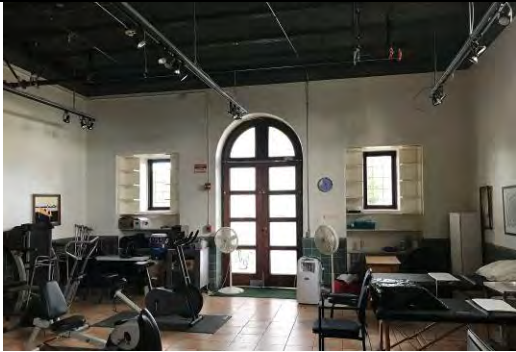
| INTERIOR | | | | | | |
|---|---|---|---|---|---|---|
| Ground Floor | Physical Therapy Room (former North Lounge) | Location<br>Textured plaster walls<br>Ceramic tile wainscot<br>Stenciled concrete beamed ceiling<br>Built-in shelving in window embrasures<br>Fireplace with decorative cast stone surround and mantel<br>Decorative wrought iron light fixtures | Fair | Primary | South and east walls are infill in order to convert space from a Lounge to the Physical Therapy room<br><br>Paint losses at ceiling<br><br>Exposed conduit and sprinkler piping attached to ceiling and walls<br><br>Missing, replacement, and broken ceramic tiles at wainscot<br><br>Non-original tile flooring | |

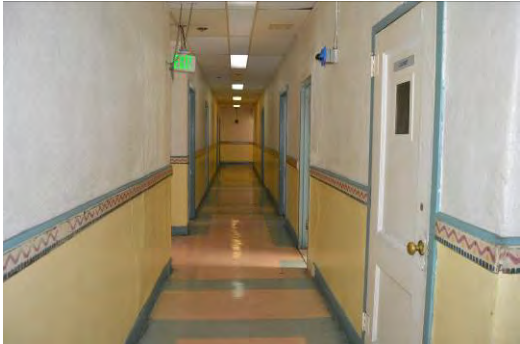
| INTERIOR | | | | | | |
|---|---|---|---|---|---|---|
| Ground Floor | Corridors | <p>Location, configuration, and spatial relationships</p> <p>Stained and stamped concrete flooring, where remaining</p> <p>Textured plaster walls</p> <p>Ceramic tile wainscot, where remaining</p> <p>Two-panel wood doors with metal hardware, where remaining</p> <p>Remaining interior divided-light wood sash windows of former swimming pool</p> | Fair | Primary | <p>Many portions of the corridors have been altered with resilient tile flooring, suspended ceilings, and added or replaced doors and hardware</p> <p>Corridor to east of Physical Therapy room is not original</p> | |

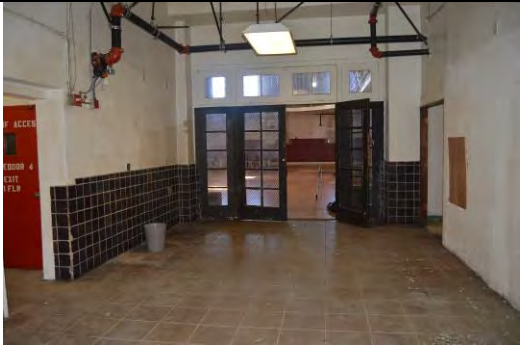
| INTERIOR | | | | | | |
|---|---|---|---|---|---|---|
| Ground Floor | Gymnasium Vestibule | Location, configuration, and spatial relationships<br>Stamped and stained concrete floor<br>Textured plaster walls and ceiling<br>Ceramic tile wainscot | Fair | Primary | Missing, replacement, and broken ceramic tiles at wainscot<br><br>Surface wear, damage, and staining to concrete flooring<br><br>Exposed conduit and sprinkler piping attached to ceiling and walls<br><br>Plaster patching and infilled walls | |

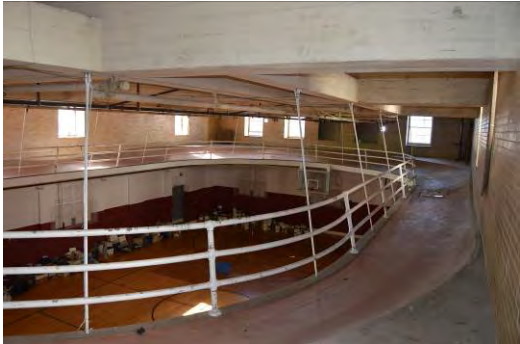
| INTERIOR | | | | | | |
|---|---|---|---|---|---|---|
| Ground Floor | Gymnasium | Location, configuration, and spatial relationships<br>Two-story volume<br>Maple flooring<br>Brick walls<br>Exposed concrete ceiling structure<br>Suspended wood running track with pipe metal guardrail<br>Divided-light, wood sash casement windows with round-arched transom lights<br>Divided-light, glazed wood doors with sidelights and transom lights<br>Wall-mounted drinking fountain in round-arched niche | Fair | Primary | Several windows have been infilled at the exterior, but the windows remain in place<br><br>Water damage to maple flooring; and previous repairs<br><br>Water damage to wood running track<br><br>Water infiltration from concrete ceiling | <br> |

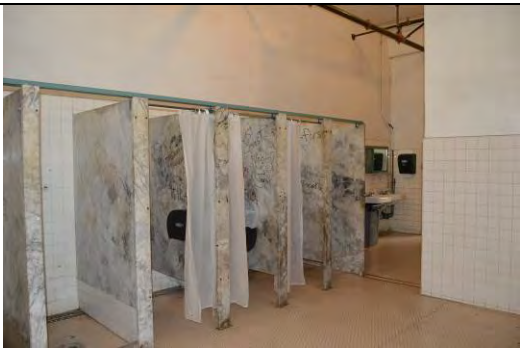
| INTERIOR | | | | | | |
|---|---|---|---|---|---|---|
| Ground Floor | Men's Restroom | Location, configuration, and spatial relationships<br>Smooth plaster walls and ceiling<br>Marble partitions<br>Ceramic hex tile flooring with mosaic meander border | Fair | Secondary | Non-original ceramic tile wainscot and fixtures<br>Surface stains and graffiti on marble<br>Cracks in tile floor | |

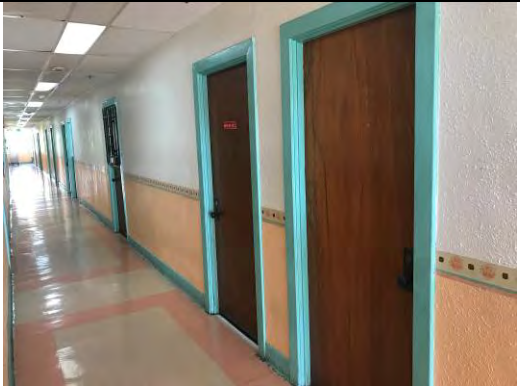
| INTERIOR | | | | | | |
|---|---|---|---|---|---|---|
| Second, Third, Fourth, and Fifth Floor | Typical Corridors | <p>Location, configuration, and spatial relationships</p> <p>Double loaded configuration</p> <p>Textured and smooth plaster walls</p> <p>Door openings with wood frame, jams, and trim</p> <p>Two-panel wood doors with metal hardware, where remaining; typically, at utility closets or for plumbing chase access</p> | Fair | Primary | <p>The corridors at the upper floors have been altered with resilient tile flooring, suspended ceilings, and added or replaced doors and hardware</p> <p>Door openings replaced with metal frames at fifth floor</p> <p>Wood door frames spilt at jams</p> <p>Water damage and peeling paint at plaster ceilings above suspended ceilings</p> | |

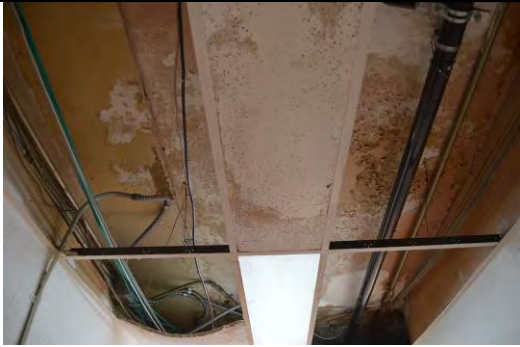
| INTERIOR | | | | | | |
|---|---|---|---|---|---|---|
| Second, Third, Fourth, and Fifth Floor | Typical Dwelling Units | Location, configuration, and spatial relationships<br>Single-occupancy rooms<br>Single-occupancy rooms with shared bathroom<br>Textured and smooth plaster walls and ceilings<br>Scored concrete flooring, where remaining<br>Wood and concrete baseboards<br>Radiators | Fair to poor | Secondary | Some rooms have been altered with the addition of resilient tile flooring and suspended ceilings<br>Peeling paint<br>Surface stains and graffiti on plaster walls<br>Water infiltration at windows and water damage to plaster<br>Termite damage to wood windows | |

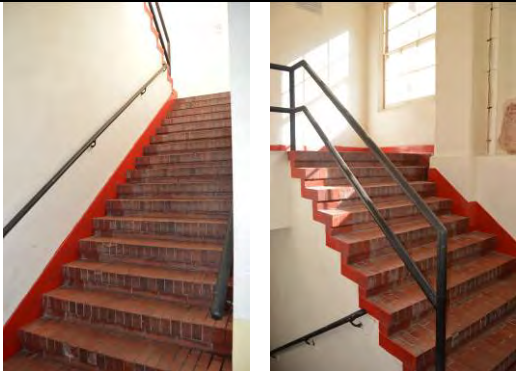
| INTERIOR | | | | | | |
|---|---|---|---|---|---|---|
| Circulation | Stairwell (northeast) | Stair from first floor to second floor<br>Location, configuration, and spatial relationship<br>Glazed brick treads and risers<br>Textured plaster walls<br>Metal pipe handrails<br>Poured concrete landing at second floor | Fair | Primary | Broken and chipped edges on brick treads<br>Surface soiling and staining | |

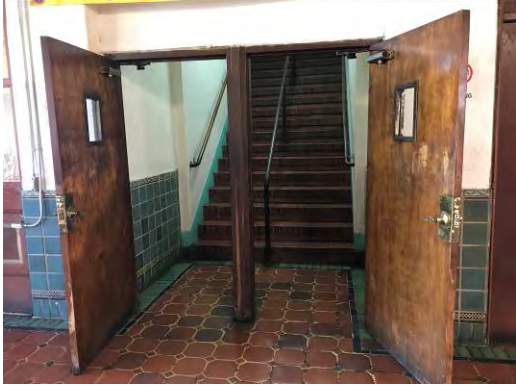
| INTERIOR | | | | | | |
|---|---|---|---|---|---|---|
| Circulation | Stairwell (southeast) | Stair from first floor to second floor<br>Location, configuration, and spatial relationship<br>Glazed brick treads and risers<br>Textured plaster walls<br>Metal pipe handrail<br>Wall mounted wood handrails | Fair | Primary | Surface soiling and staining<br>Non-original flush wood doors | |

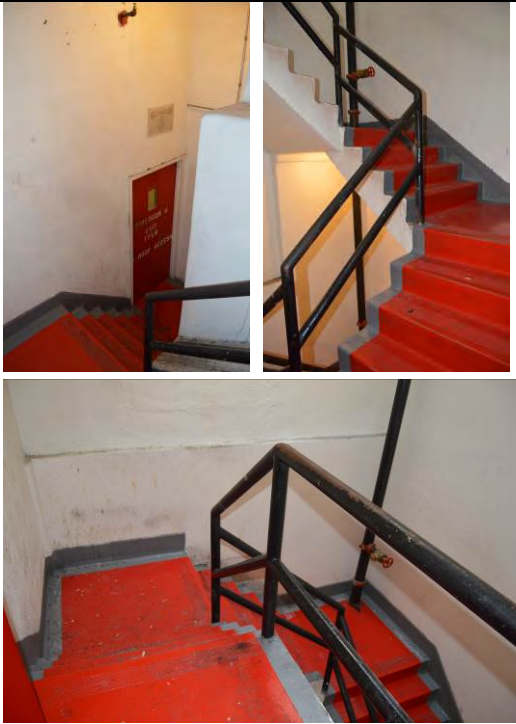
| INTERIOR | | | | | | |
|---|---|---|---|---|---|---|
| Circulation | Stairwell (south) | <p>Stair from first floor to fifth floor</p> <p>Location, configuration, and spatial relationship</p> <p>Poured concrete treads and risers</p> <p>Smooth plaster walls</p> <p>Metal pipe handrails</p> <p>Wire glass skylight</p> | Fair | Primary | Surface soiling and staining | |
