Protected Tree Report

December 5, 2016

**1045 S Olive St
Los Angeles, CA 90015**

**Evergreen Arborist Consultants, Inc.
Michael Green
Registered Consulting Arborist No.: 602
Certified Arborist No.: WE9464A
ISA Qualified Tree Risk Assessor
California Licensed Landscape Contractor
5670 Wilshire Blvd. Suite 1800
Los Angeles, CA 90036
310.913.5203**

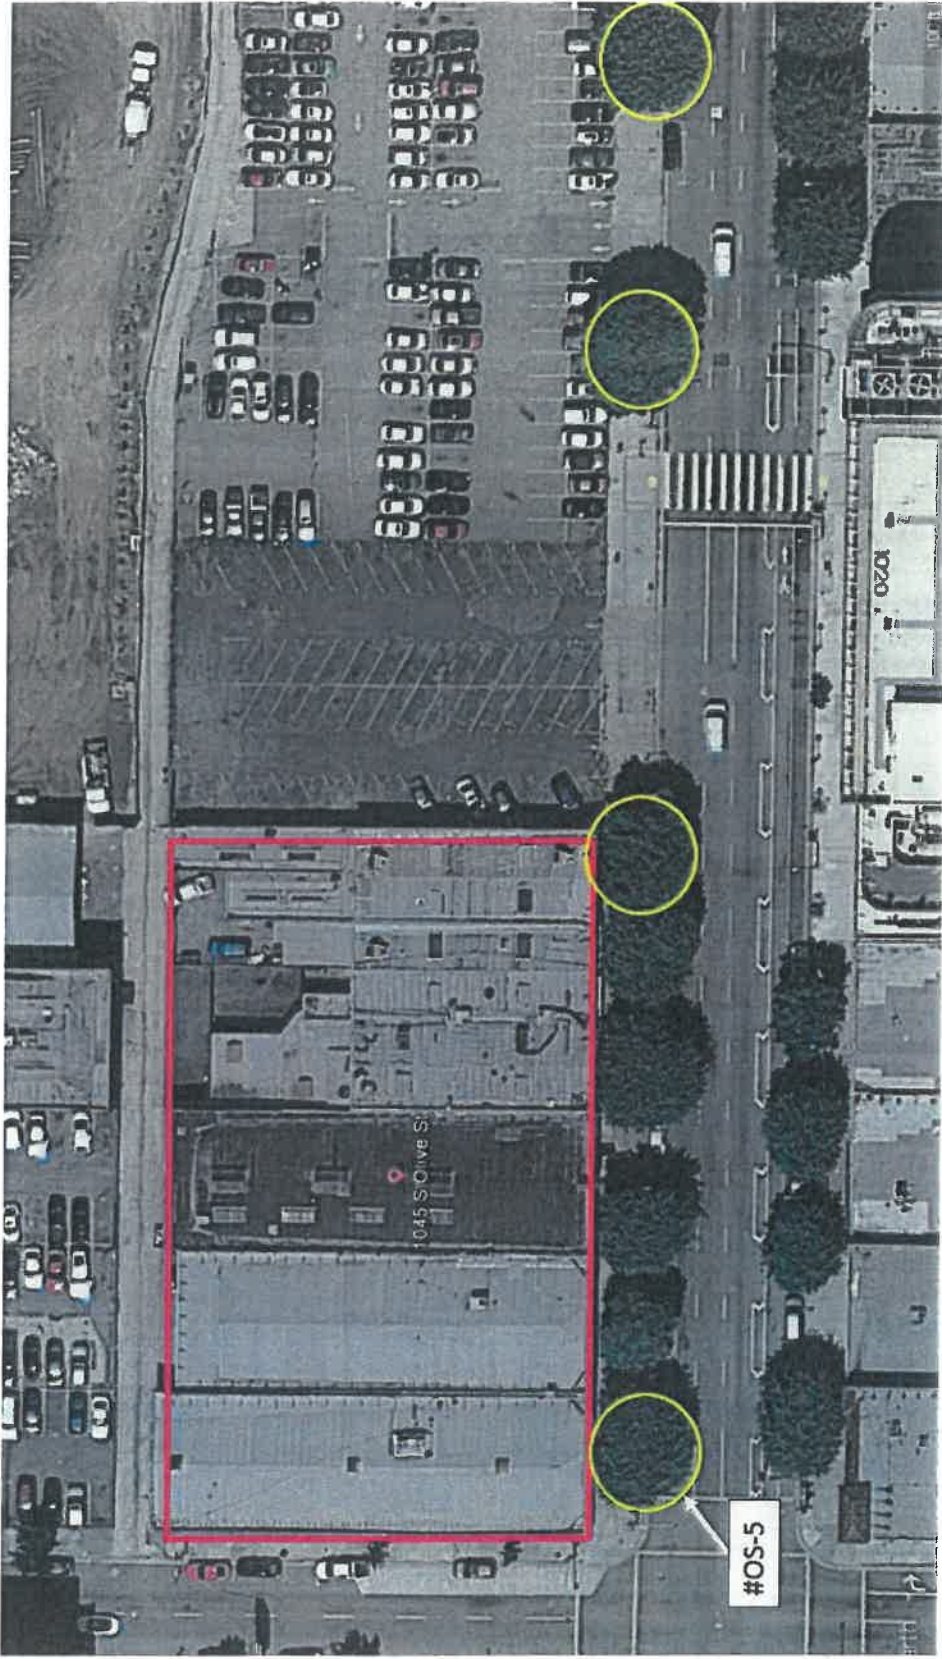
Figure 1. Google Earth Aerial April 23, 2014 depicting the four ficus trees (yellow circles) that existed prior to my site inspection on October 15, 2016 but were removed to allow for new construction. A very large ficus tree with destructive roots existed at the location of tree #OS-5, pink trumpet tree. The tree appears to have been removed to accommodate the construction of a renovated sidewalk. Approximate property boundary outlined in red.

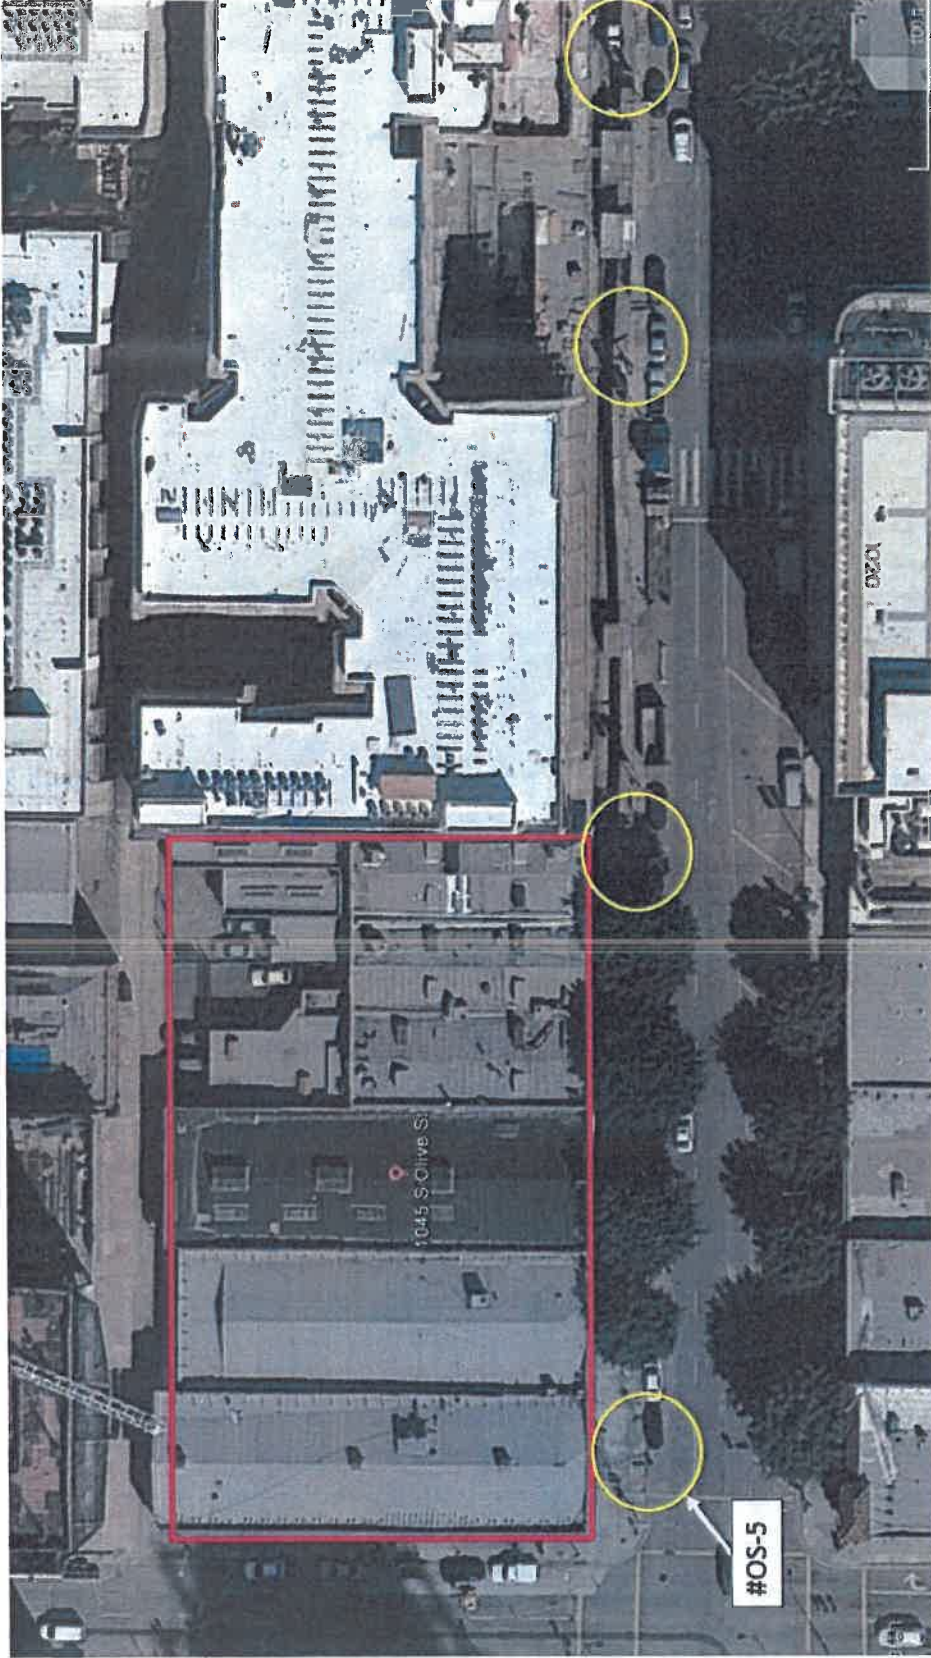
Figure 2. Google Earth Aerial February 2, 2016 depicting the location of the four prior existing ficus trees (yellow circles). A very large ficus tree with destructive roots existed at the location of tree #OS-5, pink trumpet tree. The tree appears to have been removed to accommodate the construction of a renovated sidewalk. Approximate property boundary outlined in red.

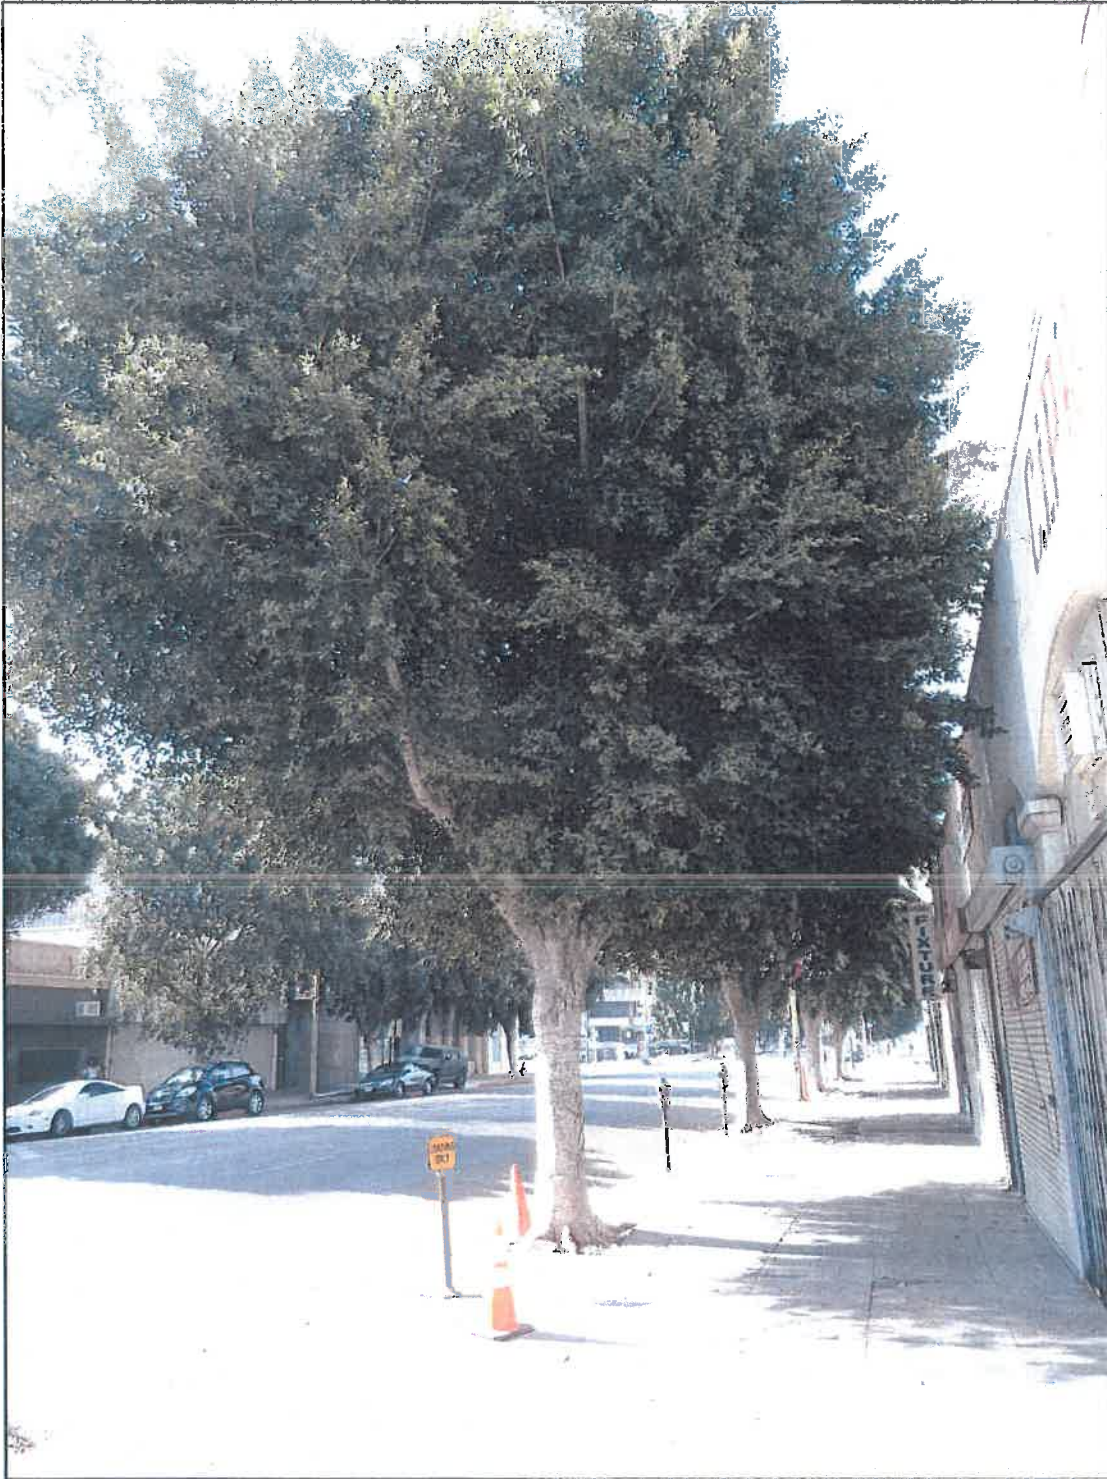
Tree no. OS-1

Applies to trees #OS-1 through #OS-5.

A total of four ficus trees, trees #OS-1 through OS-4, and one pink trumpet tree, #OS-5 are proposed for removal. The City of Los Angeles Tree Preservation Ordinance No. 177,404 calls for a protected street tree replacement of 1:1, I recommend five 24-inch box replacement mitigation pink trumpet trees or suitable species (see Attachment D- Landscape Plan).

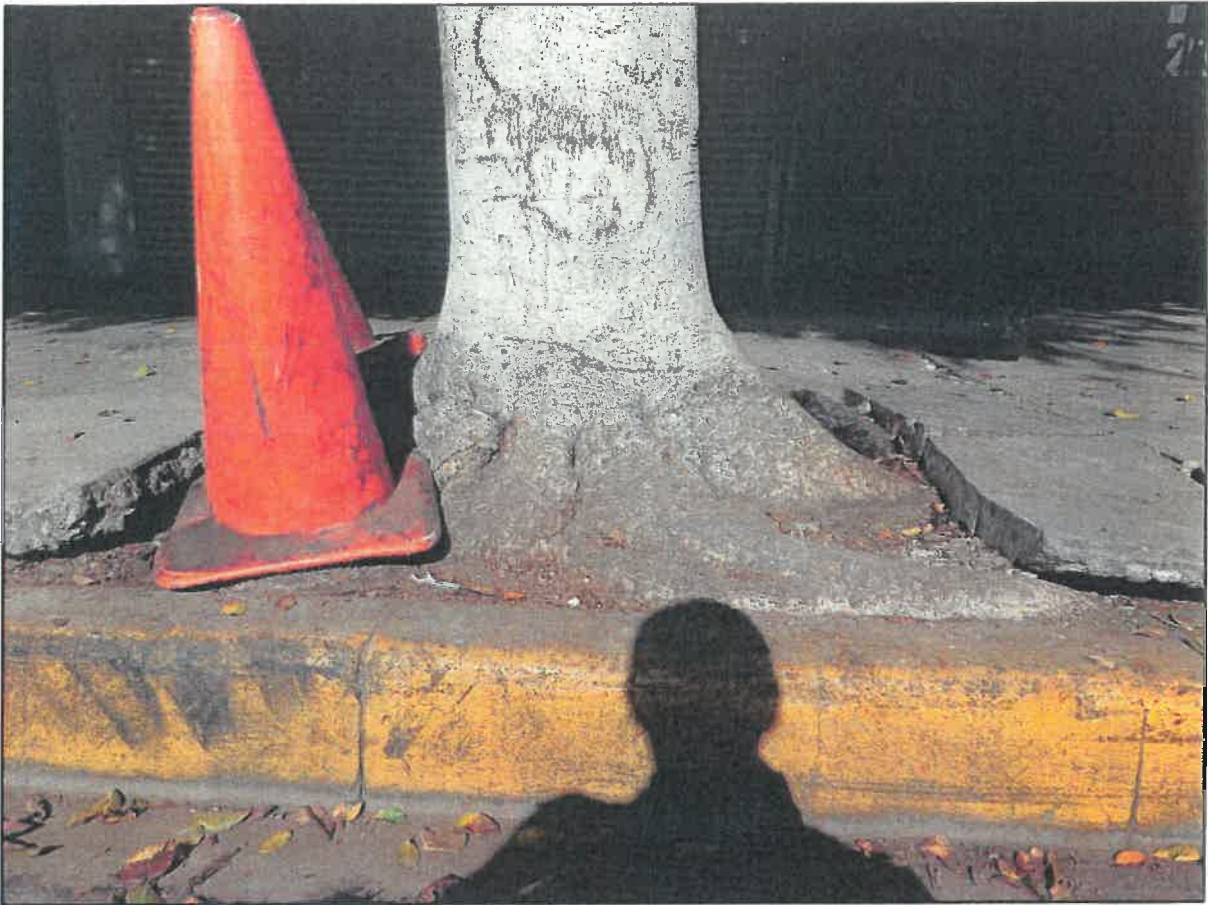
Extensive surface roots from ficus tree no. OS-1 that are causing destructive damage to surrounding sidewalk and city hardscape.

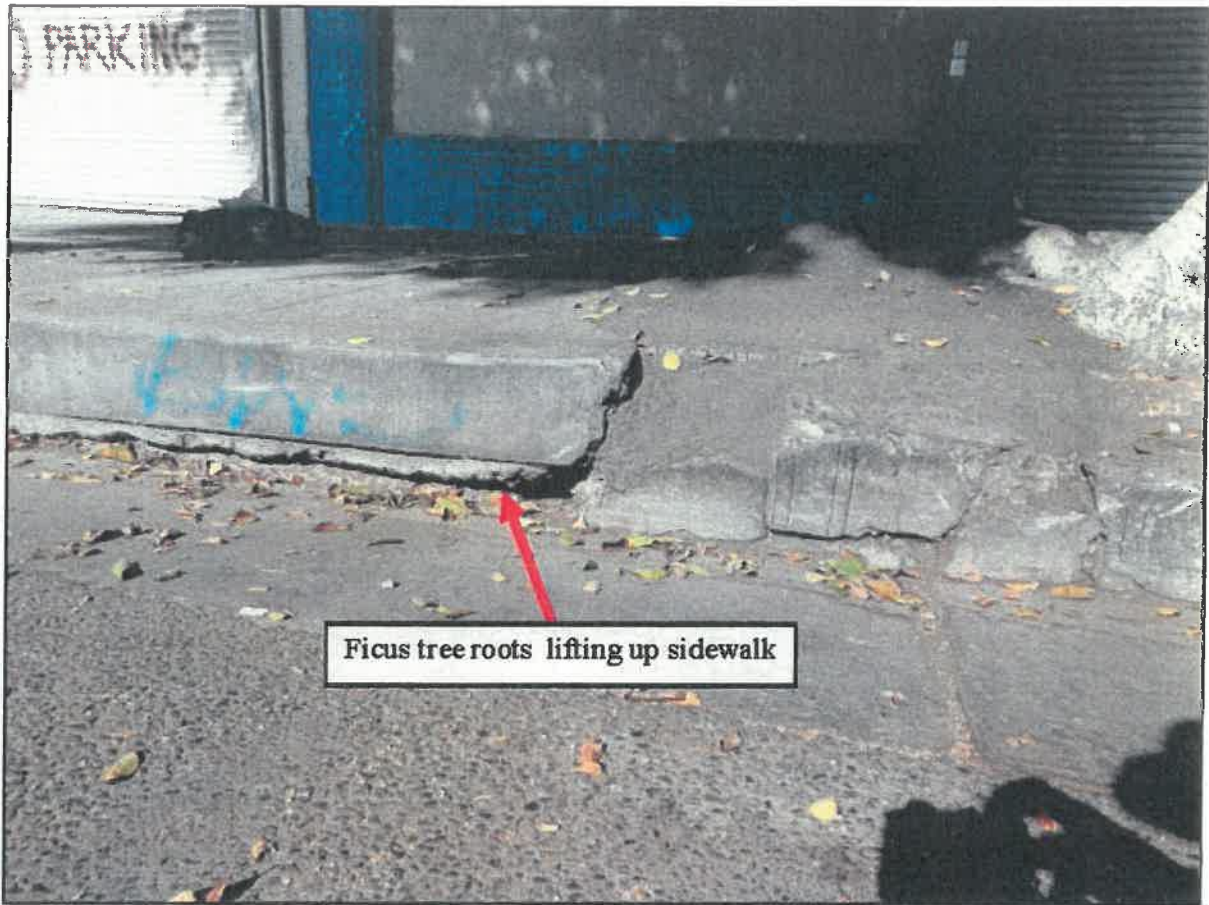
Extensive surface roots from ficus tree no. OS-2 that are causing destructive damage to surrounding sidewalk and city hardscape.

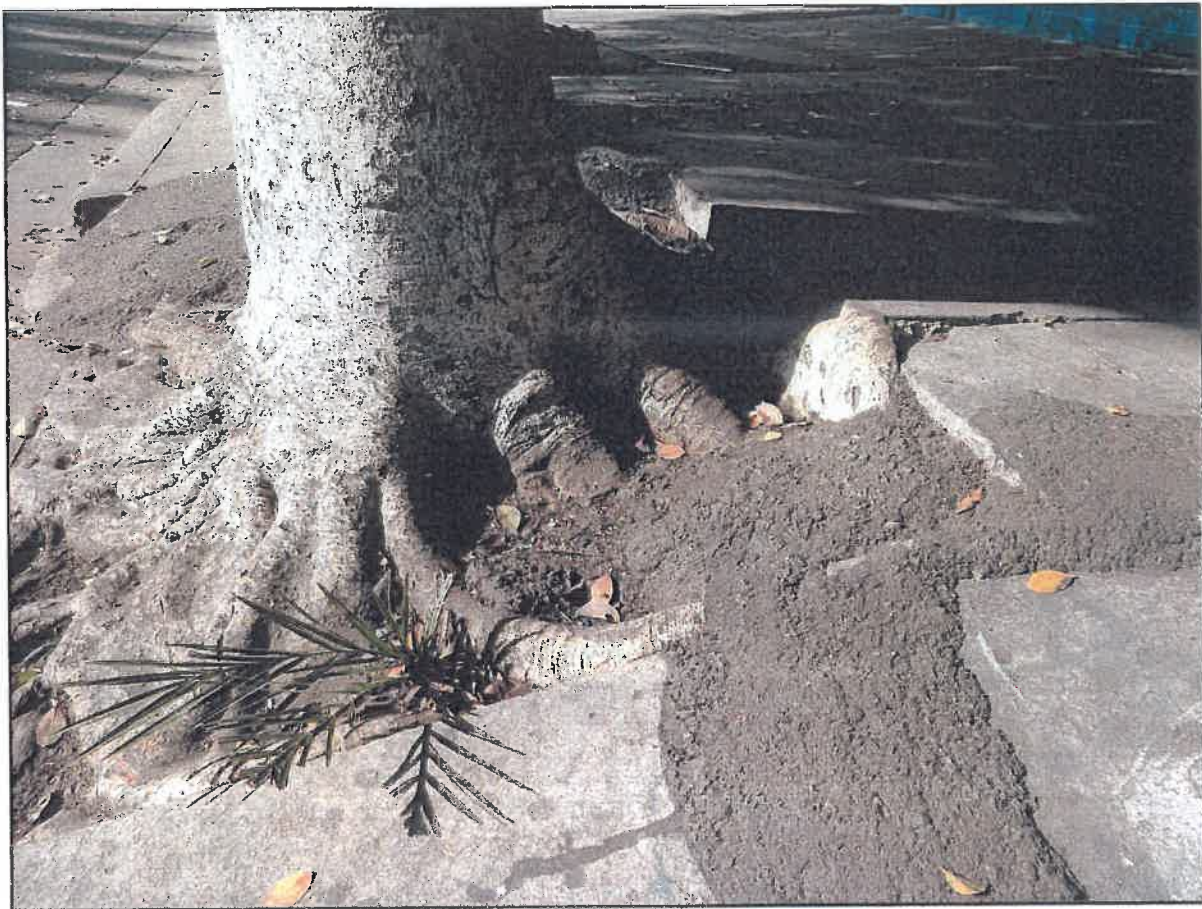
Extensive surface roots from ficus tree no. OS-2 that are causing destructive damage to surrounding sidewalk and city hardscape.

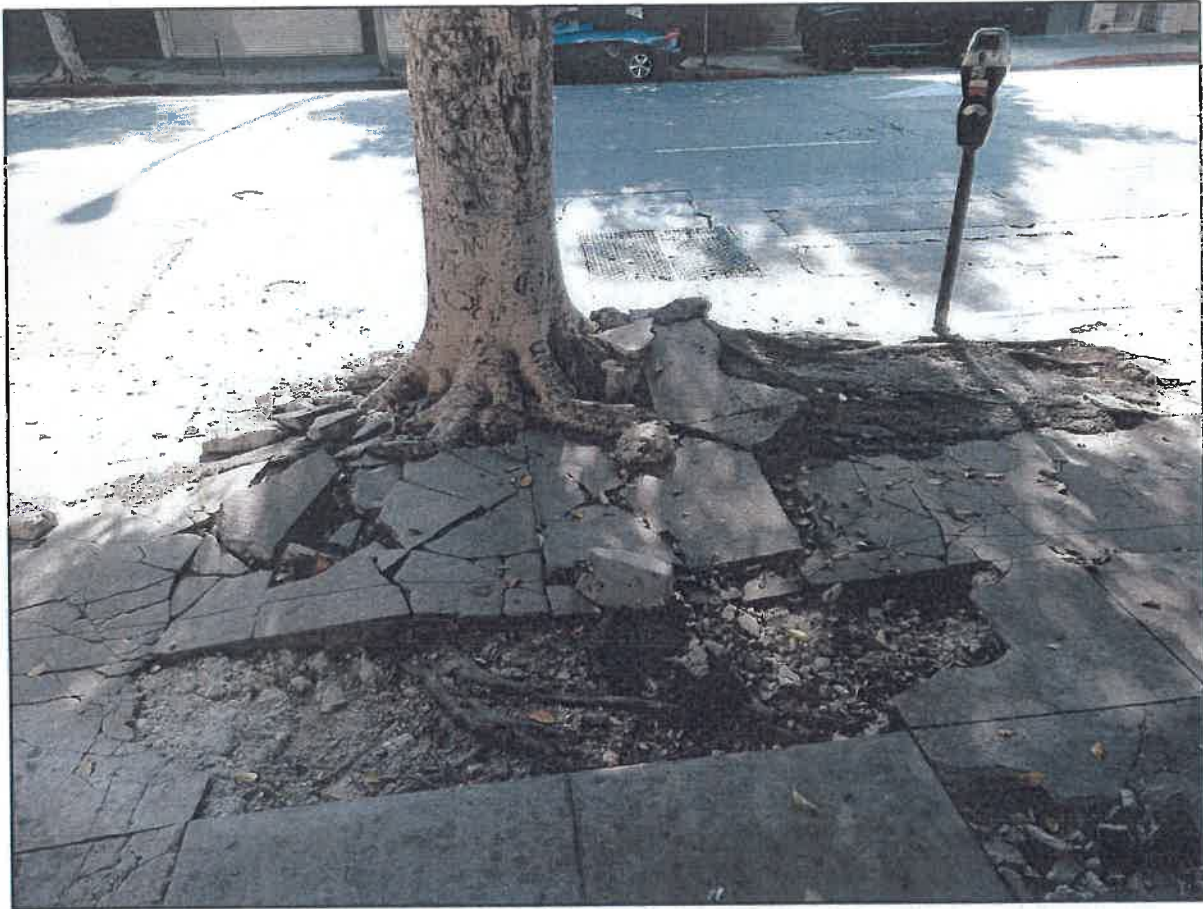
Extensive surface roots from ficus tree no. OS-3 that are causing destructive damage to surrounding sidewalk and city hardscape.

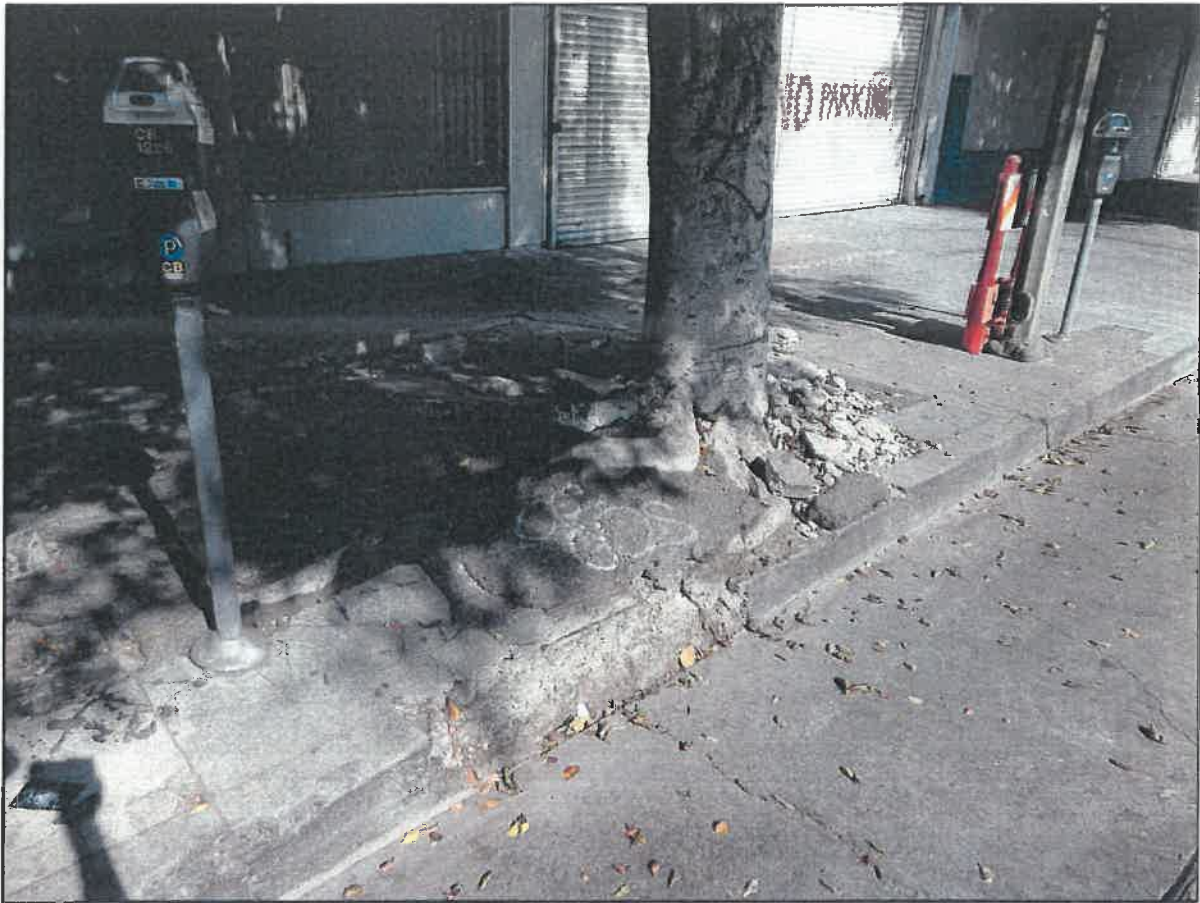
Extensive surface roots from ficus tree no. OS-3 that are causing destructive damage to surrounding sidewalk and city hardscape.

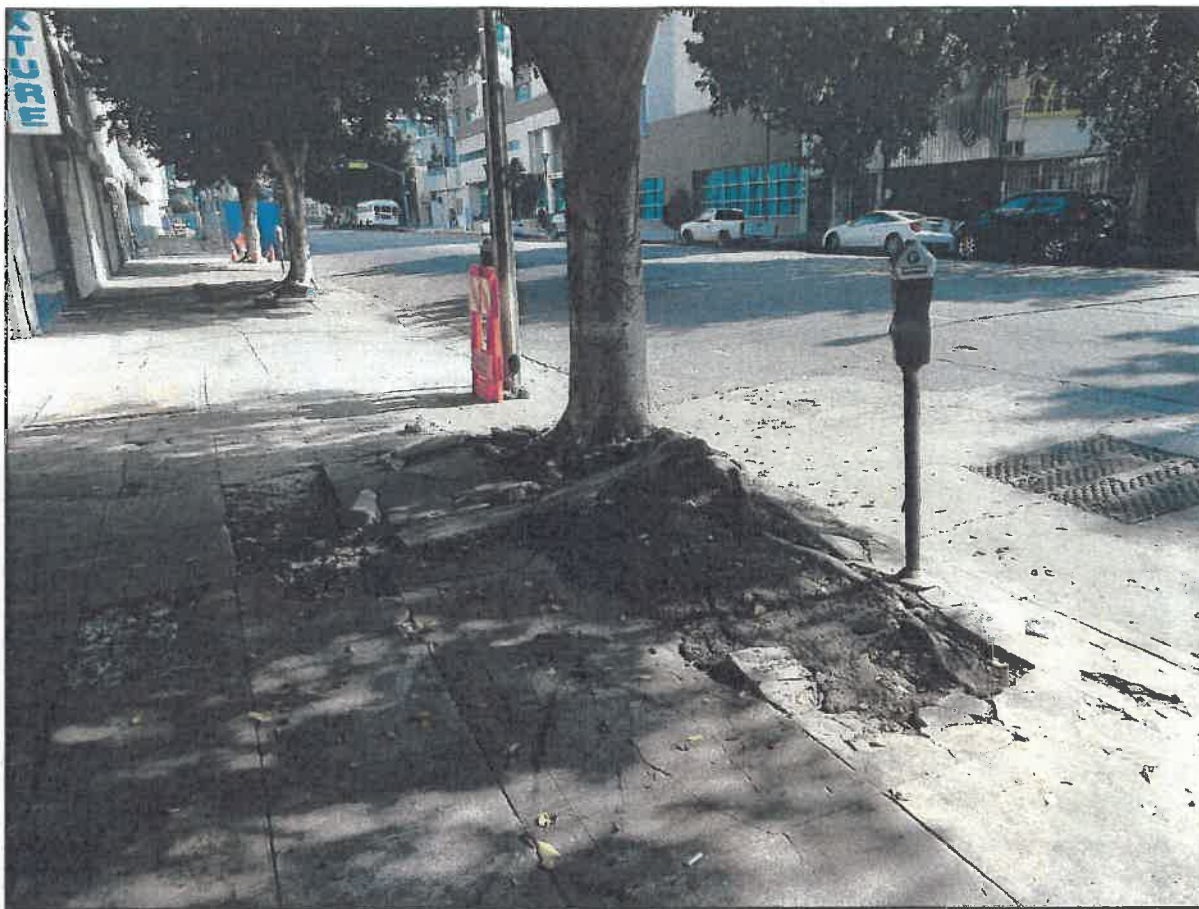
Extensive surface roots from ficus tree no. OS-3 that are causing destructive damage to surrounding sidewalk and city hardscape.

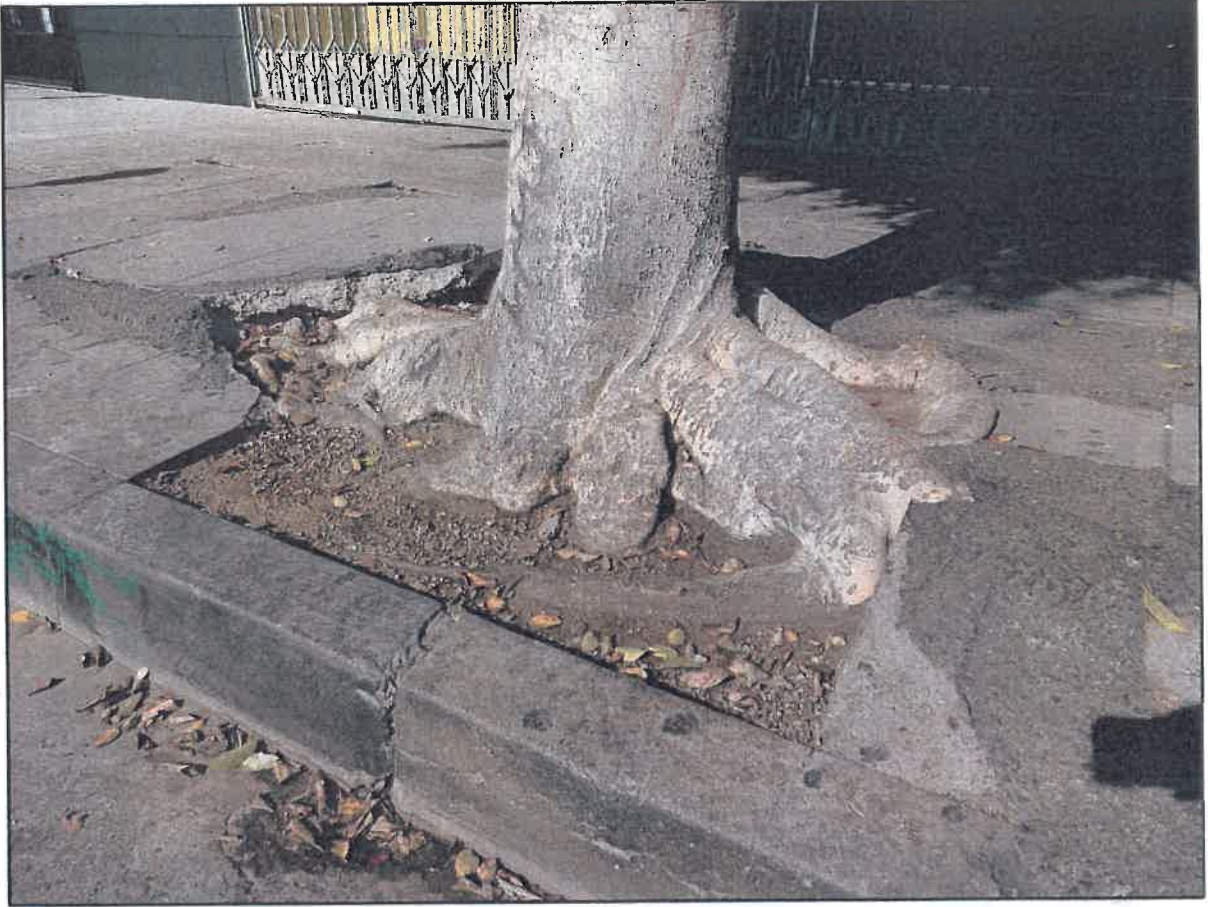
Extensive surface roots from ficus tree no. OS-4 that are causing destructive damage to surrounding sidewalk and city hardscape.

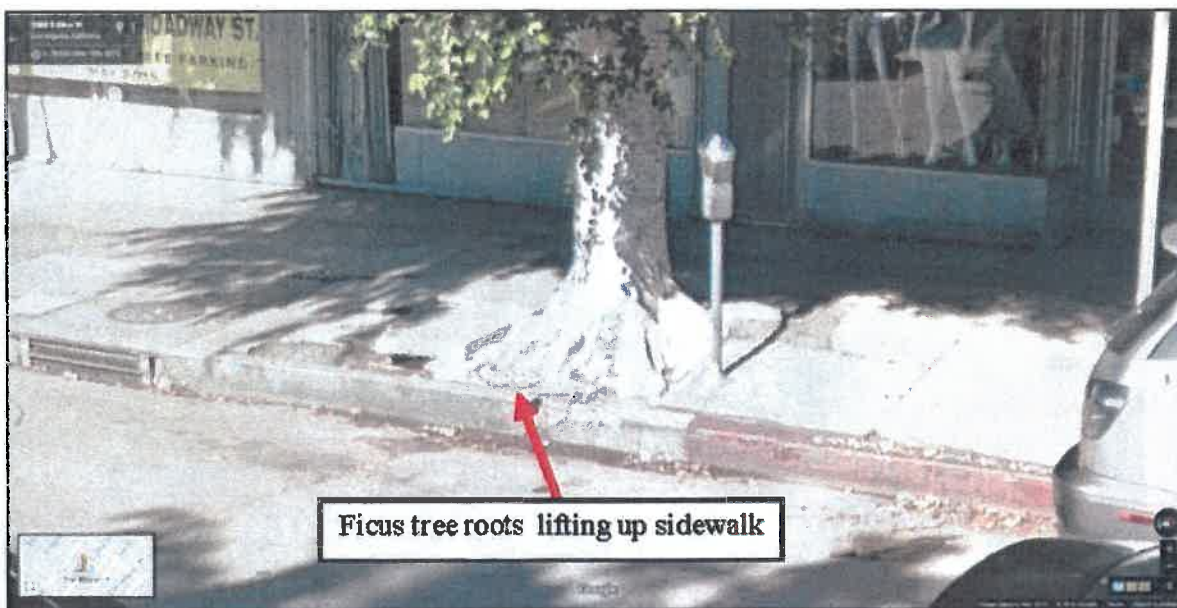
This photo, dated March 2015, depicts the ficus tree that existed prior to the planting of the current street tree no. OS-5 pink trumpet tree. The previously existing ficus tree had extensive surface roots that were causing damage to surrounding sidewalk and city hardscape.
