Protected Tree Report

December 5, 2016

1045 S Olive St
Los Angeles, CA 90015

Evergreen Arborist Consultants, Inc.
Michael Green
Registered Consulting Arborist No.: 602
Certified Arborist No.: WE9464A
ISA Qualified Tree Risk Assessor
California Licensed Landscape Contractor
5670 Wilshire Blvd. Suite 1800
Los Angeles, CA 90036
310.913.5203

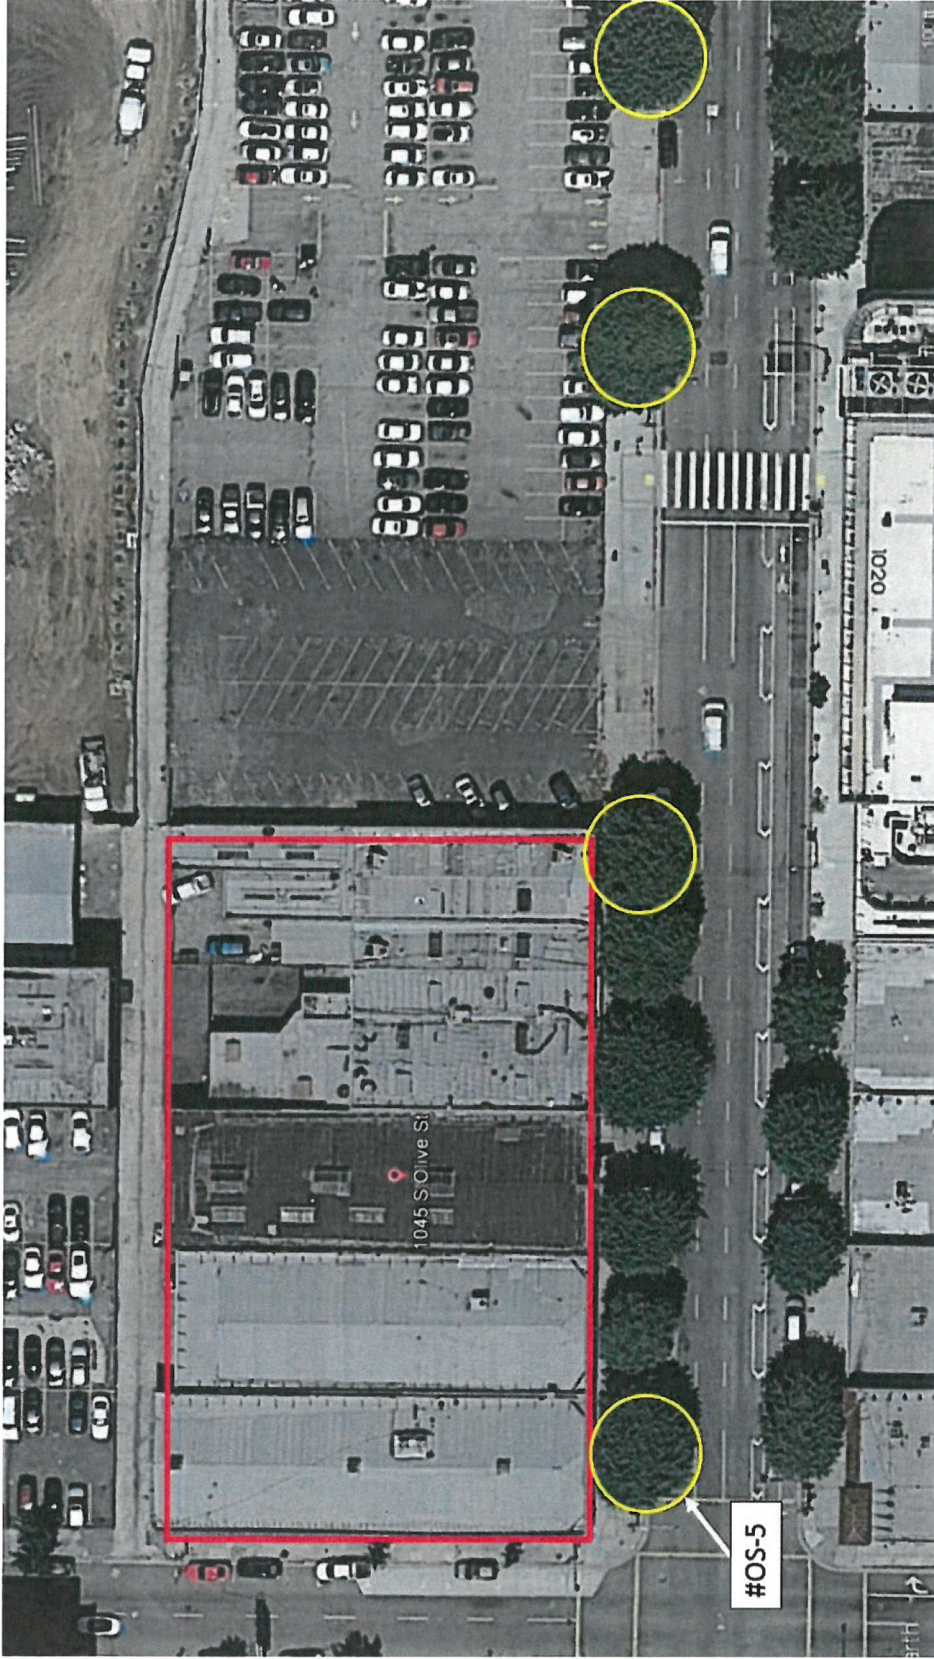
Figure 1. Google Earth Aerial April 23, 2014 depicting the four ficus trees (yellow circles) that existed prior to my site inspection on October 15, 2016 but were removed to allow for new construction. A very large ficus tree with destructive roots existed at the location of tree #OS-5, pink trumpet tree. The tree appears to have been removed to accommodate the construction of a renovated sidewalk. Approximate property boundary outlined in red.

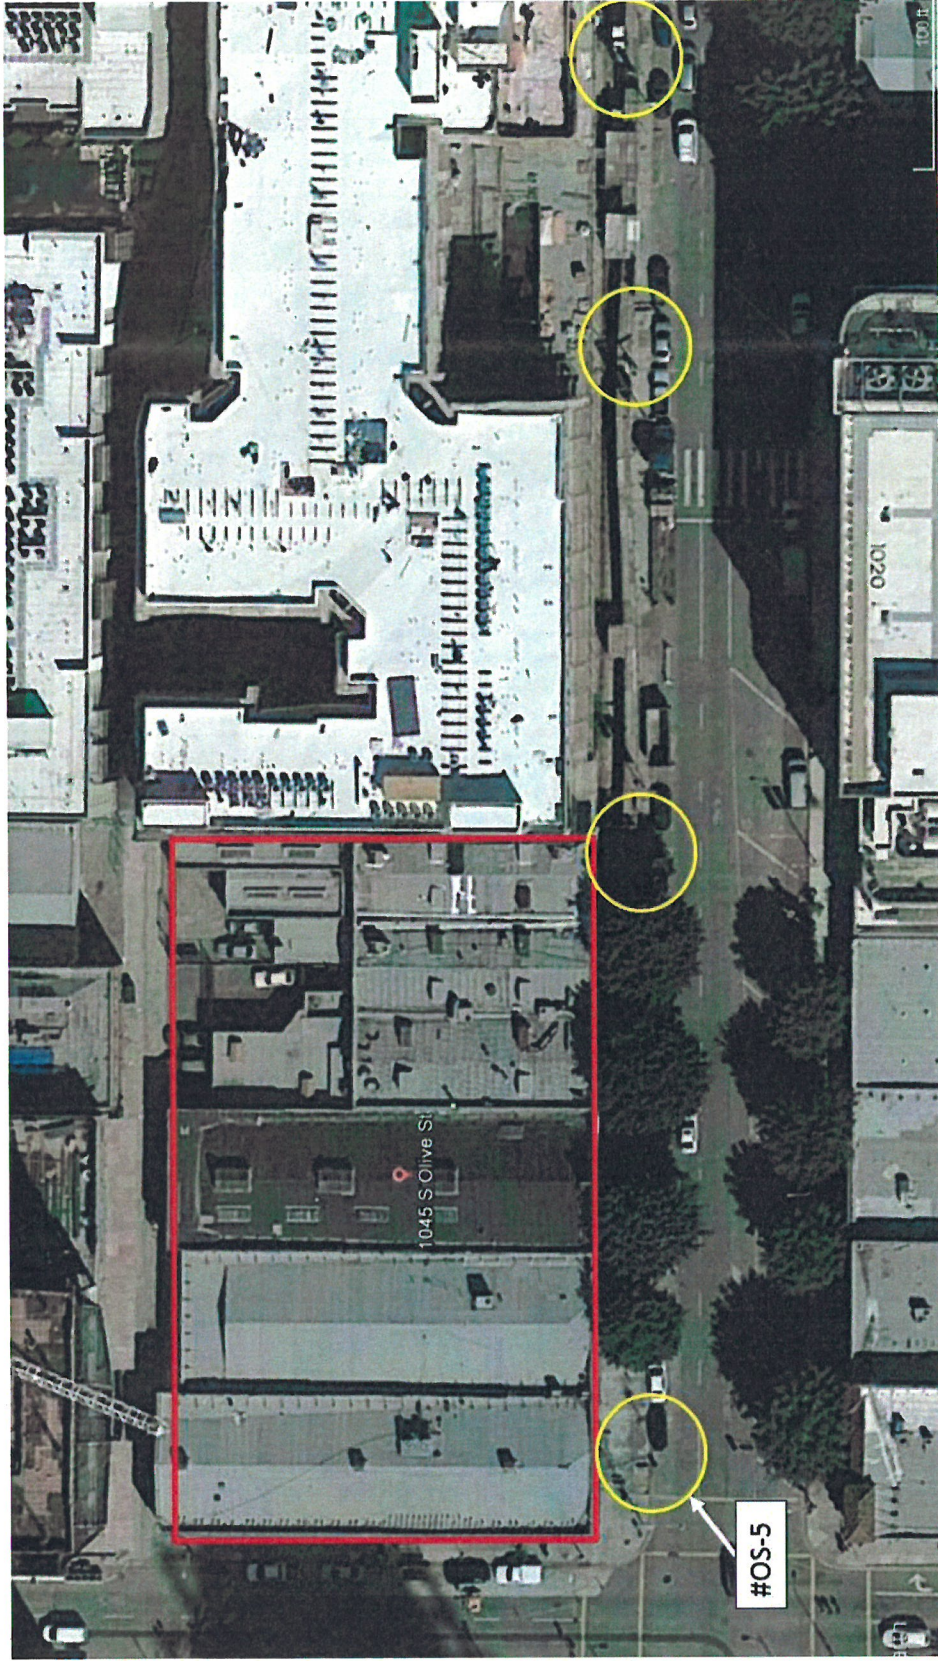
Figure 2. Google Earth Aerial February 2, 2016 depicting the location of the four prior existing ficus trees (yellow circles). A very large ficus tree with destructive roots existed at the location of tree #OS-5, pink trumpet tree. The tree appears to have been removed to accommodate the construction of a renovated sidewalk. Approximate property boundary outlined in red.

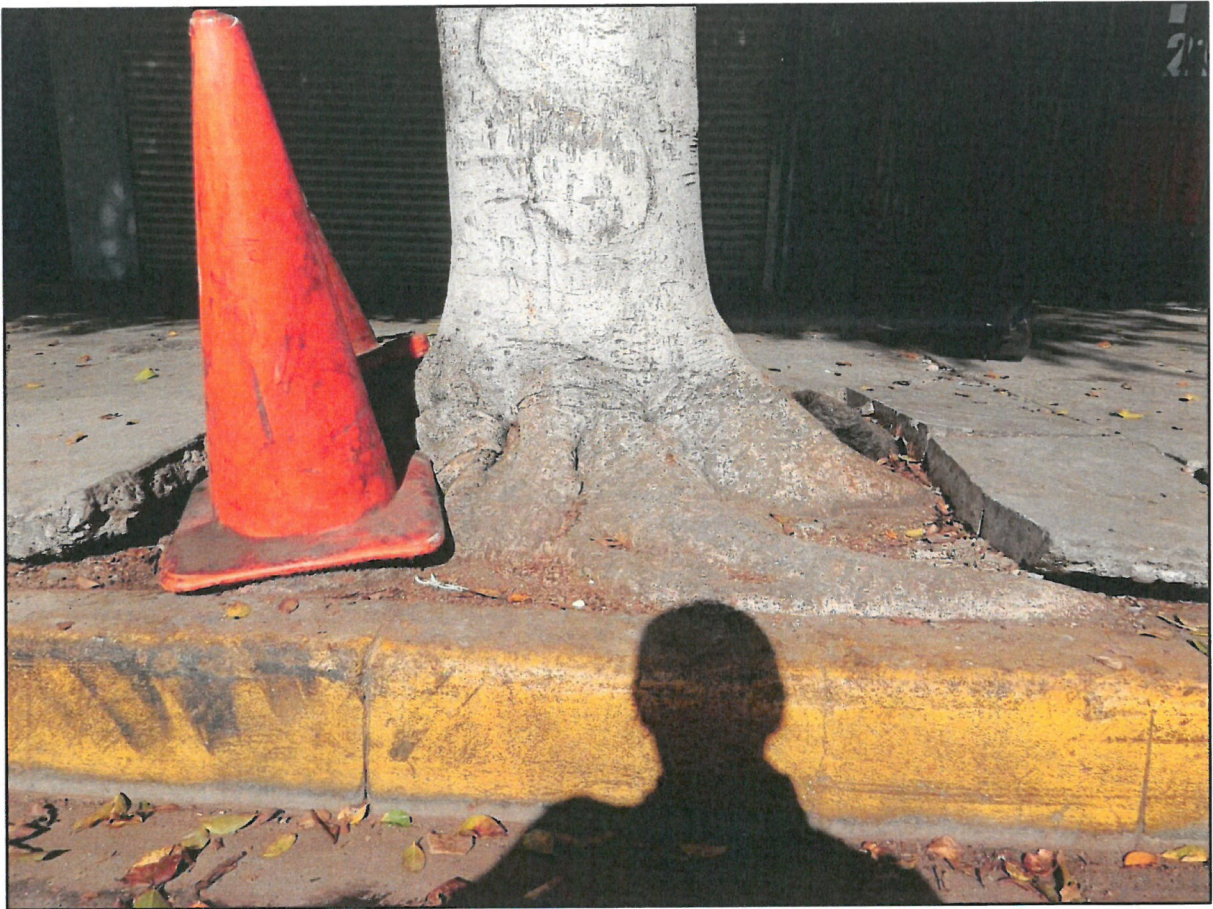
Extensive surface roots from ficus tree no. OS-1 that are causing destructive damage to surrounding sidewalk and city hardscape.

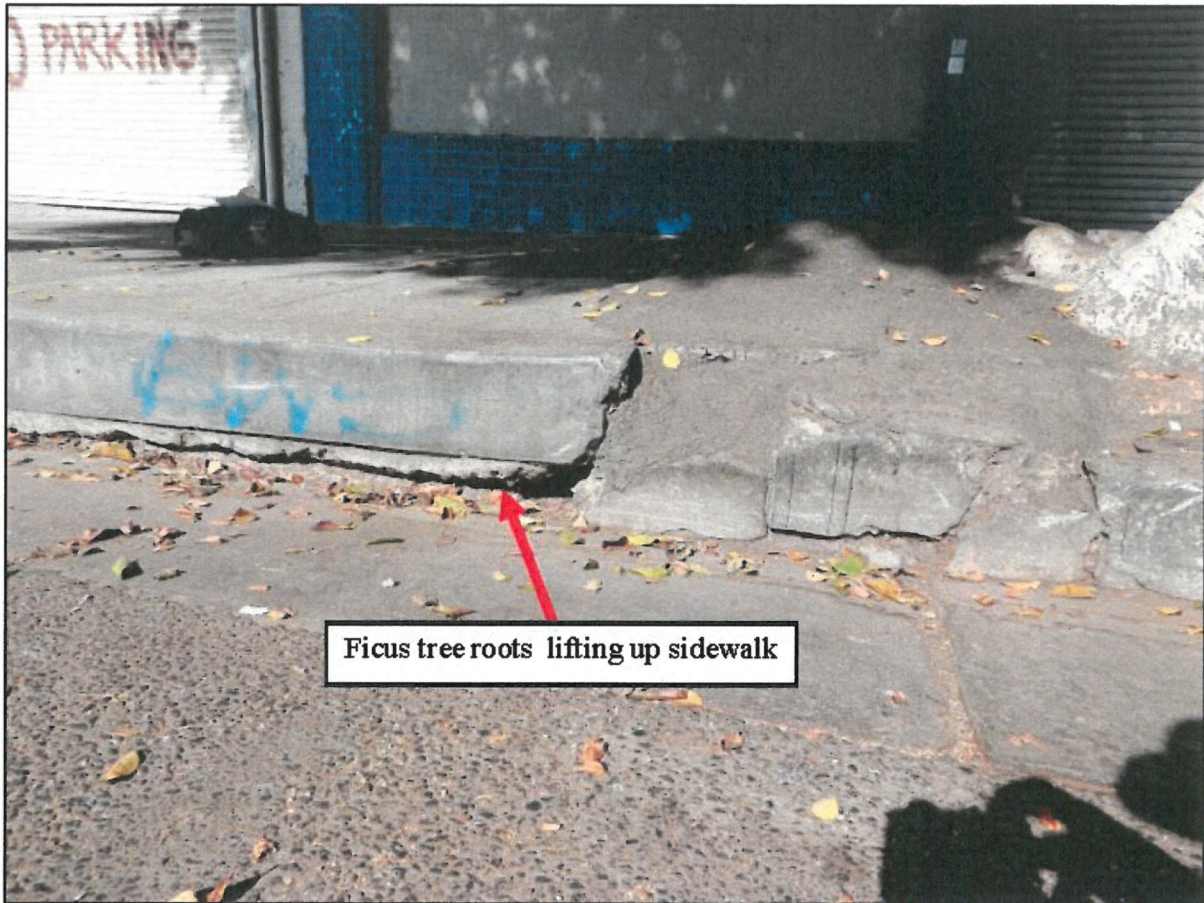
Extensive surface roots from ficus tree no. OS-2 that are causing destructive damage to surrounding sidewalk and city hardscape.

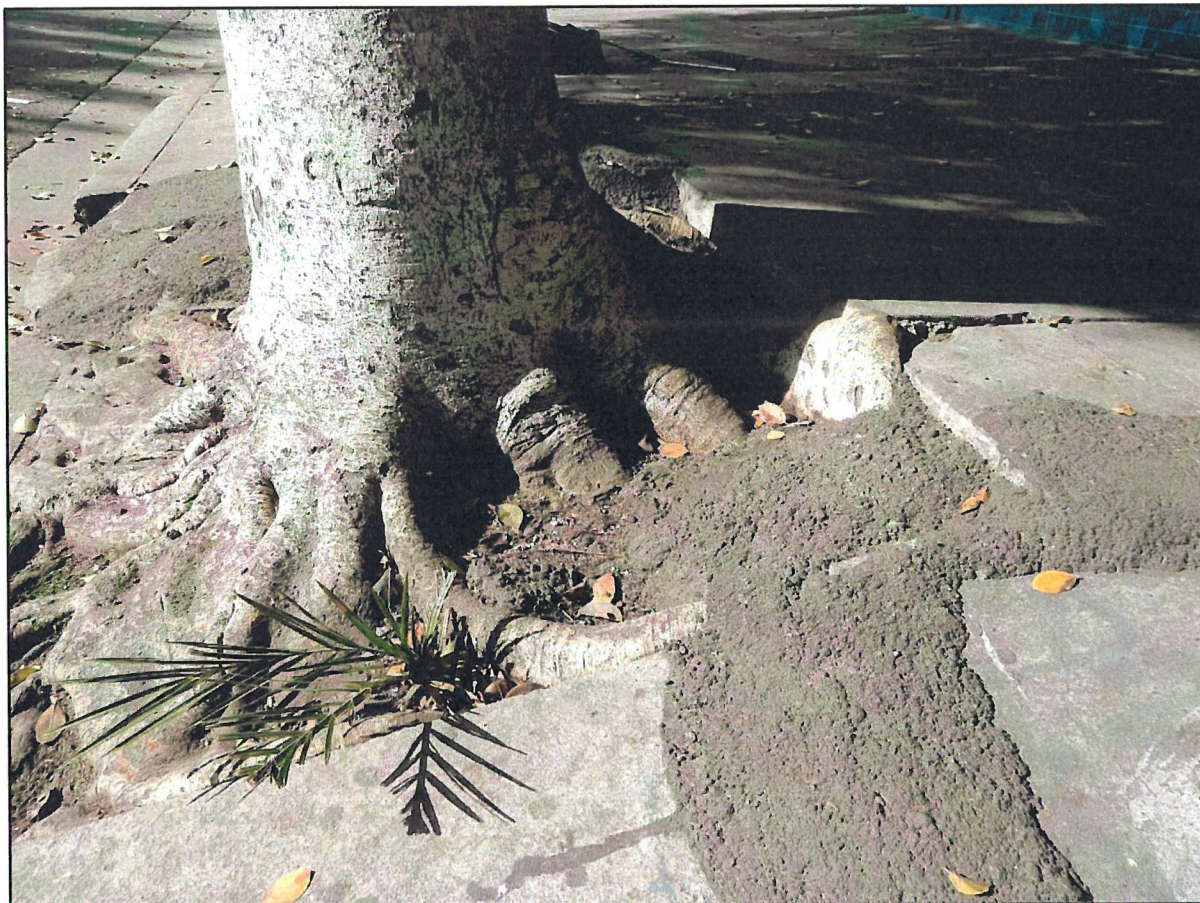
Extensive surface roots from ficus tree no. OS-2 that are causing destructive damage to surrounding sidewalk and city hardscape.

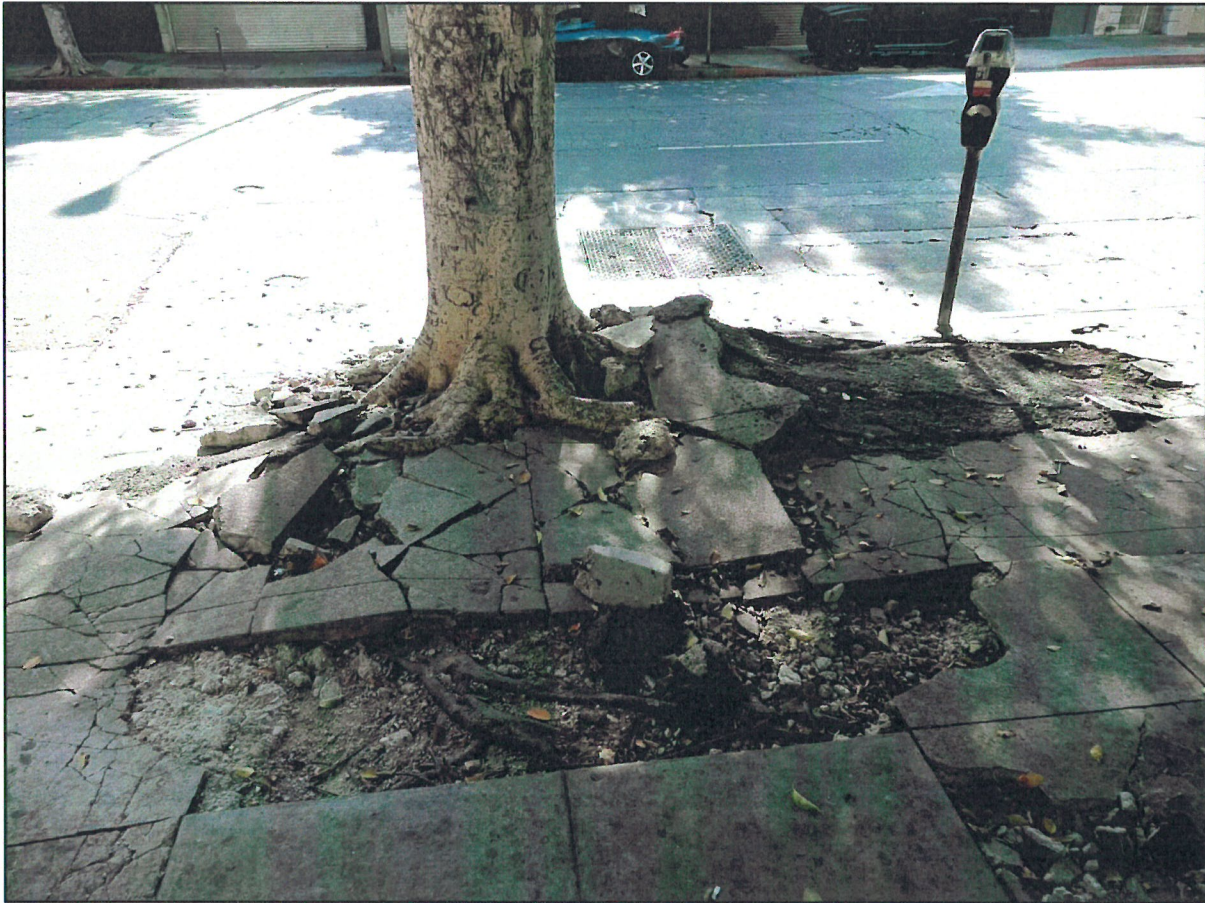
Extensive surface roots from ficus tree no. OS-3 that are causing destructive damage to surrounding sidewalk and city hardscape.

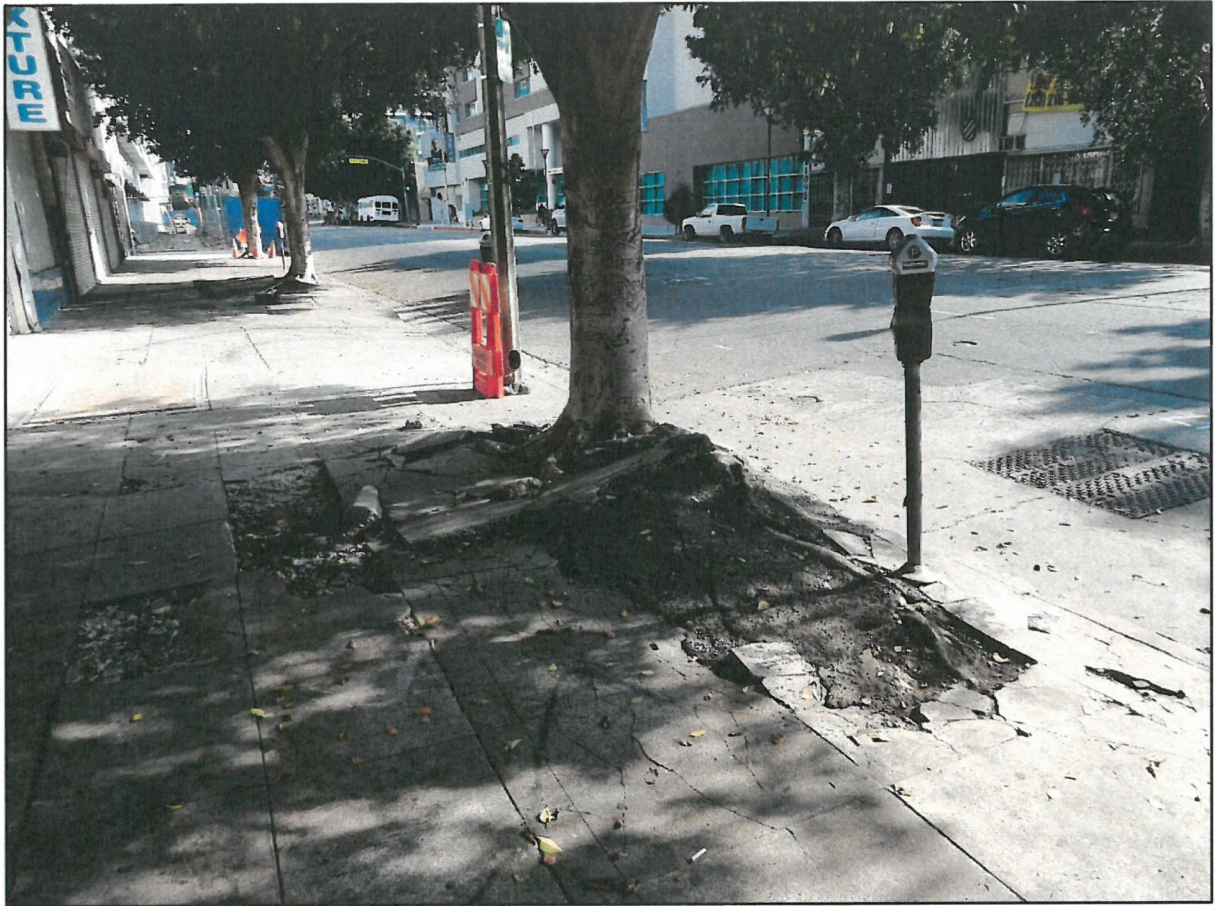
Extensive surface roots from ficus tree no. OS-3 that are causing destructive damage to surrounding sidewalk and city hardscape.

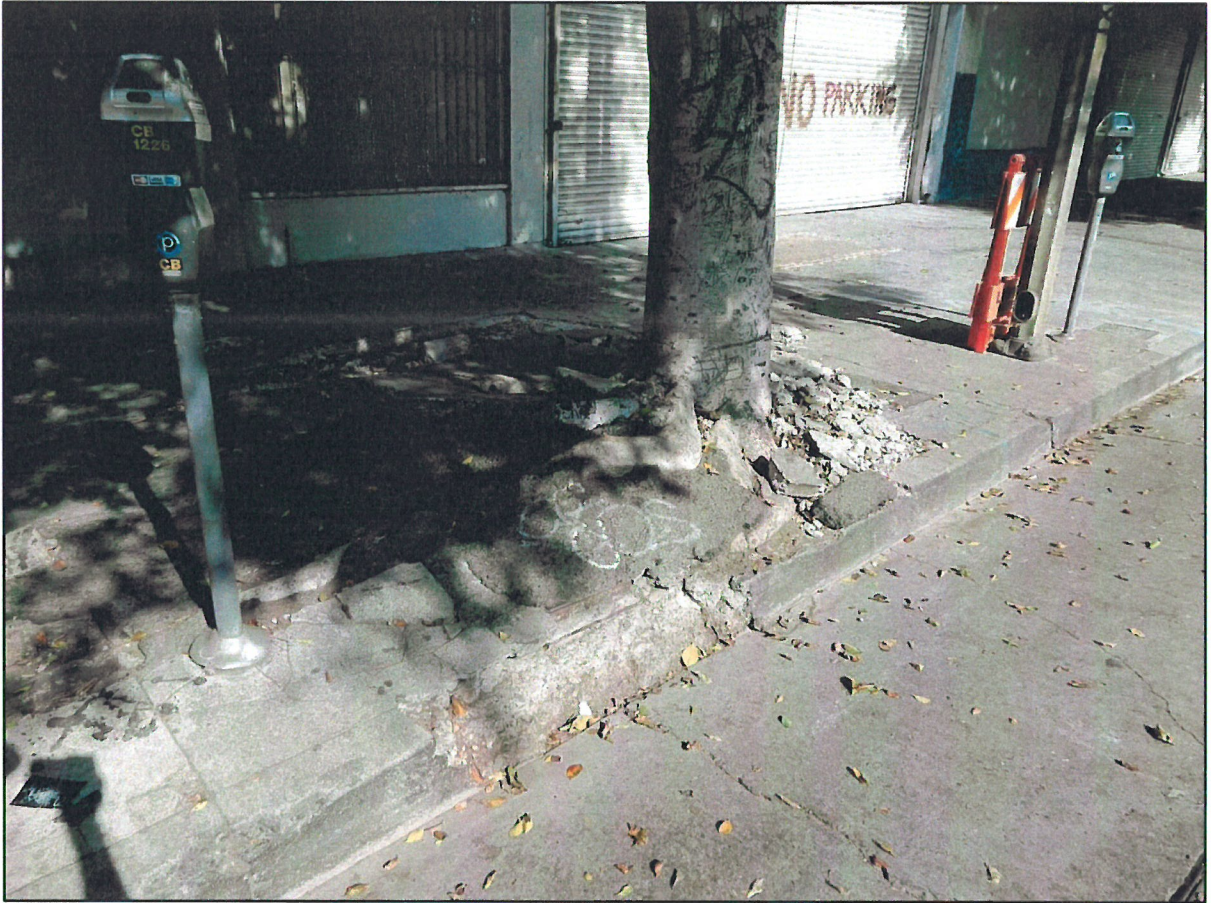
Extensive surface roots from ficus tree no. OS-3 that are causing destructive damage to surrounding sidewalk and city hardscape.

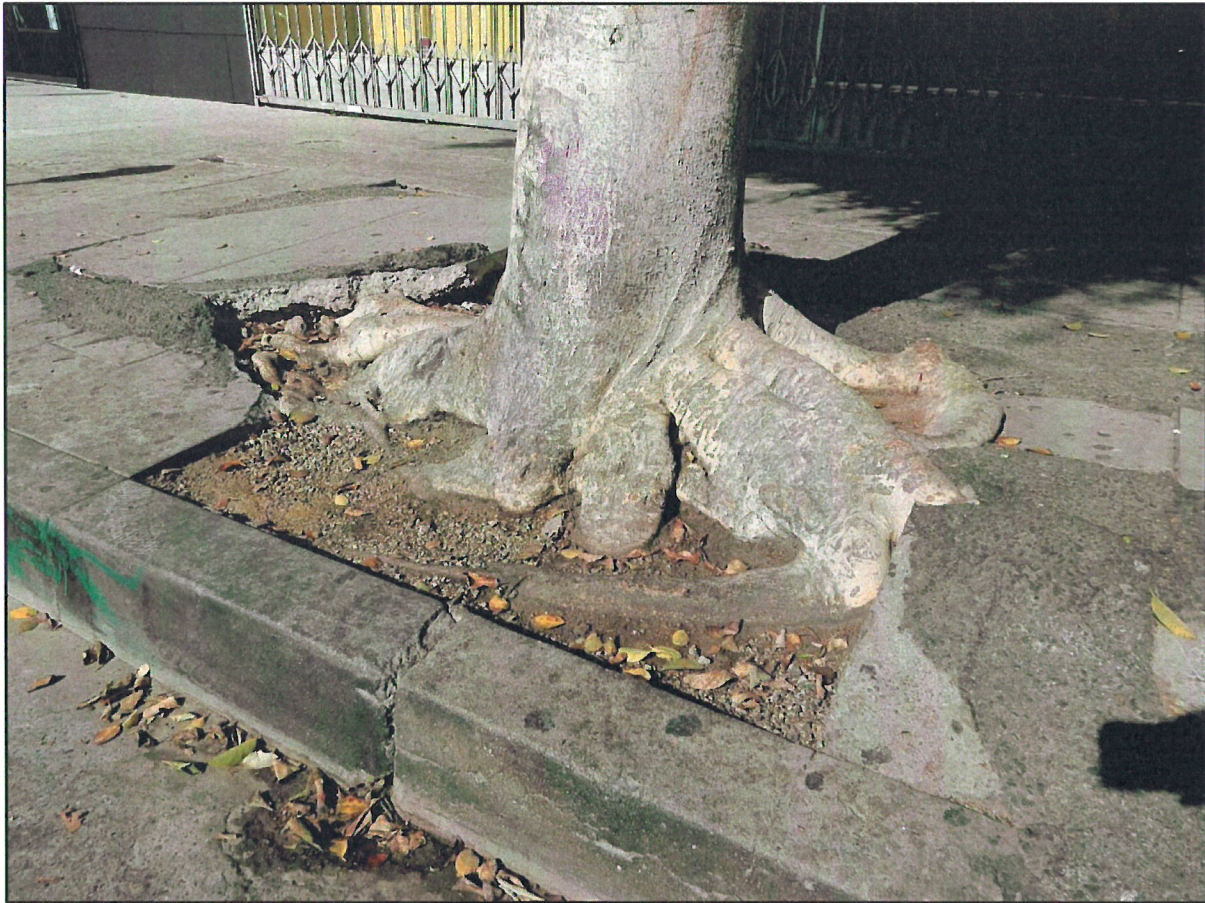
Extensive surface roots from ficus tree no. OS-4 that are causing destructive damage to surrounding sidewalk and city hardscape.

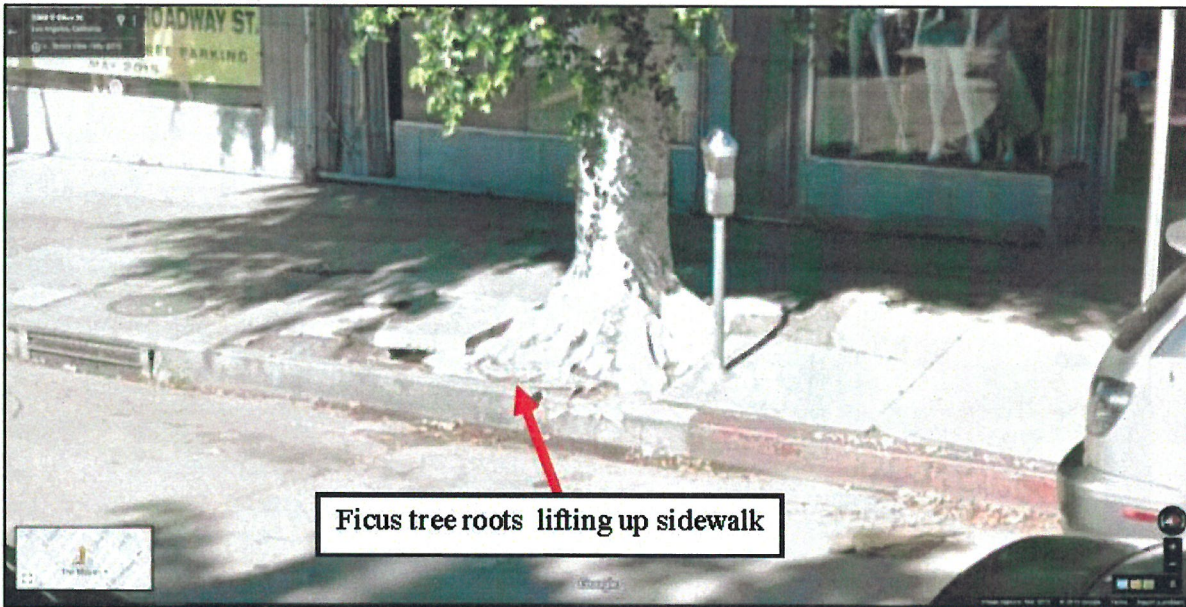
This photo, dated March 2015, depicts the ficus tree that existed prior to the planting of the current street tree no. OS-5 pink trumpet tree. The previously existing ficus tree had extensive surface roots that were causing damage to surrounding sidewalk and city hardscape.
