GROUP DELTA

February 12, 2015
GDC Project LA-1183E

Subject: RESPONSE TO CITY OF LOS ANGELES GEOLOGY CORRECTION LETTER #85579
Reference: Fault Activity Investigation
Yucca-Argyle Apartments - Champion Site
SE Corner of Yucca Street and Argyle Avenue
1756 and 1760 Argyle Avenue
Hollywood District, City of Los Angeles, California

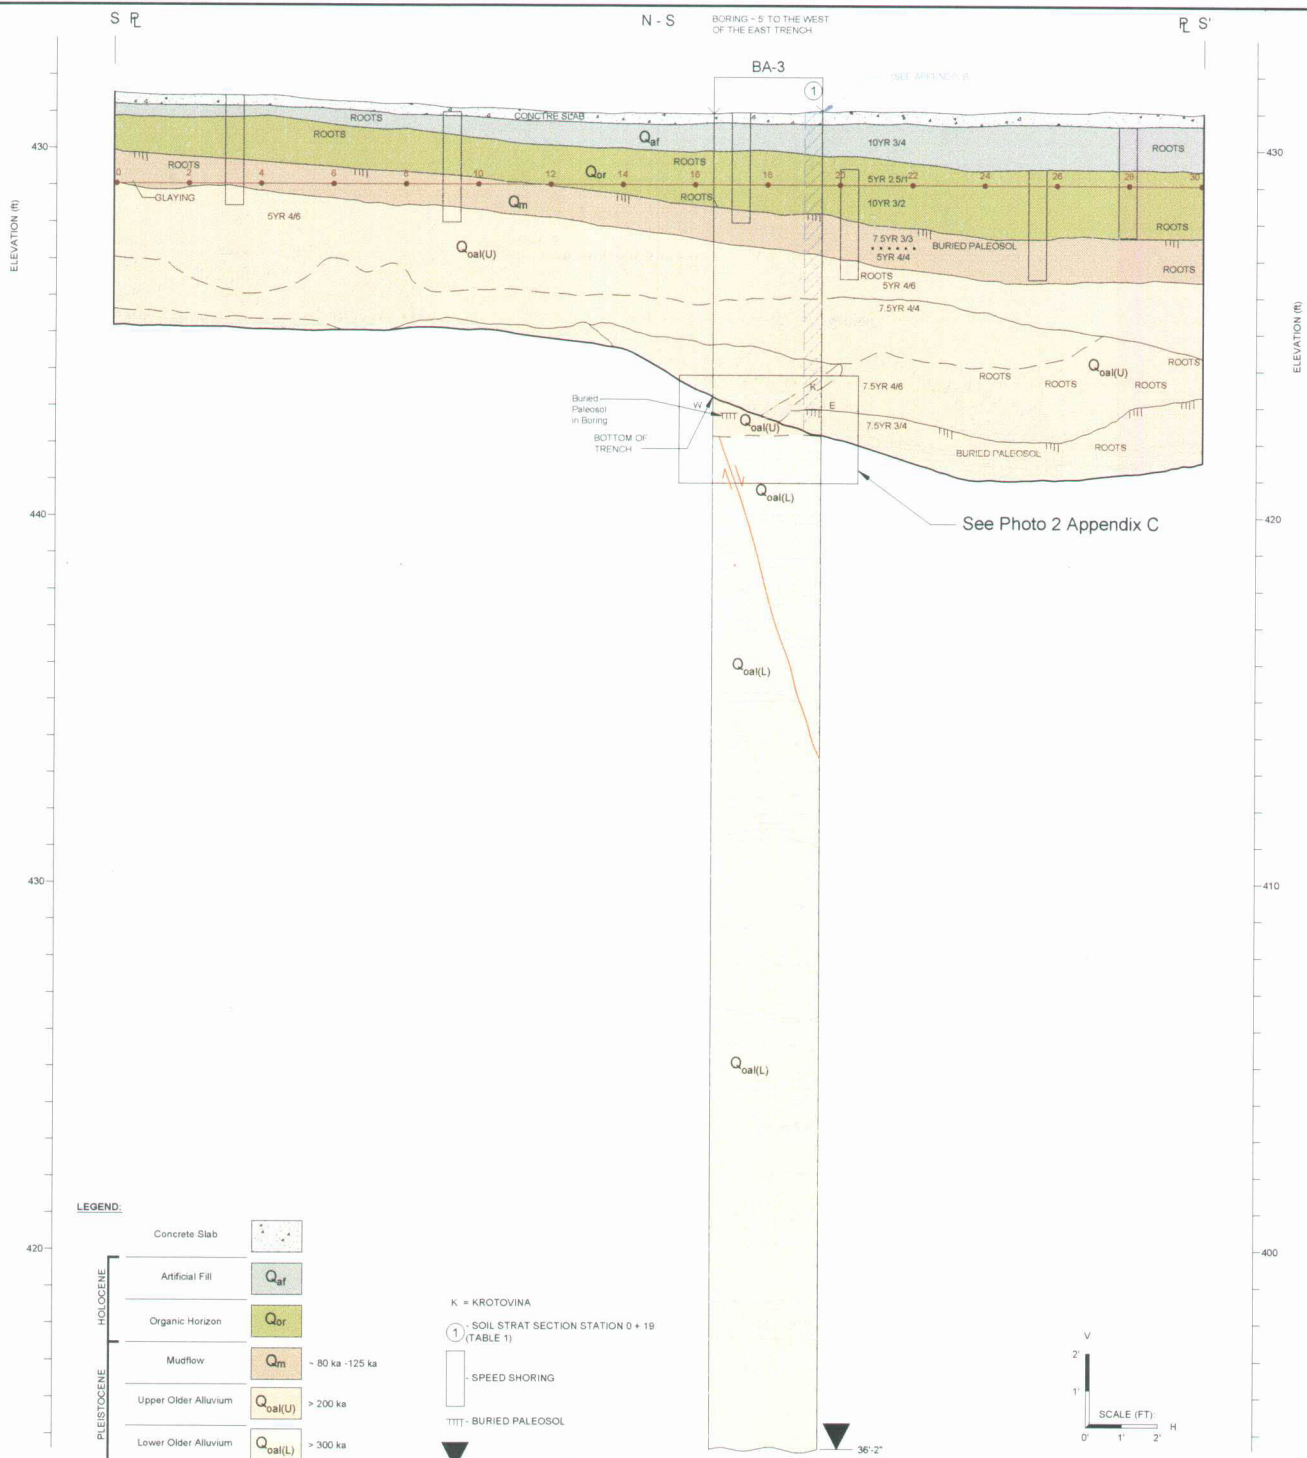
DATE: 2/4/2015	DESIGNED BY: JMT	GROUP DELTA CONSULTANTS, INC. 370 Arroyo Ave. Suite 212 Torrance, CA 90501	CROSS SECTION S-S' EAST TRENCH - EAST WALL	PROJECT: LA-1183E
REVISION:	APPROVED BY: SK	DELTA	CHAMPION EAST TRENCH	AS SHOWN
DATE:				8a

The well-stratified trench deposits are intact (not broken by faults). BA-3, about five feet west of the trench, provided the geological information regarding age of the anticline-related faults. That boring (approximately 44 feet deep), penetrated both the upper older alluvium and the subjacent folded upper Pleistocene lower older alluvium. Water was encountered at about 36 feet and equilibrated to that depth. The upper 36 feet were downhole observed and logged by geologists with GDC and by the City Technical Reviewers. An easily identifiable, mainly normal fault entered the boring at approximately 17 feet and is truncated by unbroken older colluvium at about 10 feet (Plate 8A; Photograph 2). The fault trends N76E and dips 74SE. Reasonable projections of the anticline-related fault intercept the East Champion Trench as shown on Plates 1 and 14, yet the ~135ka (minimum) sediments are not broken. Thus, the boring and the trench combine to bear witness to the absence of Holocene slip along the anticline-related faults.

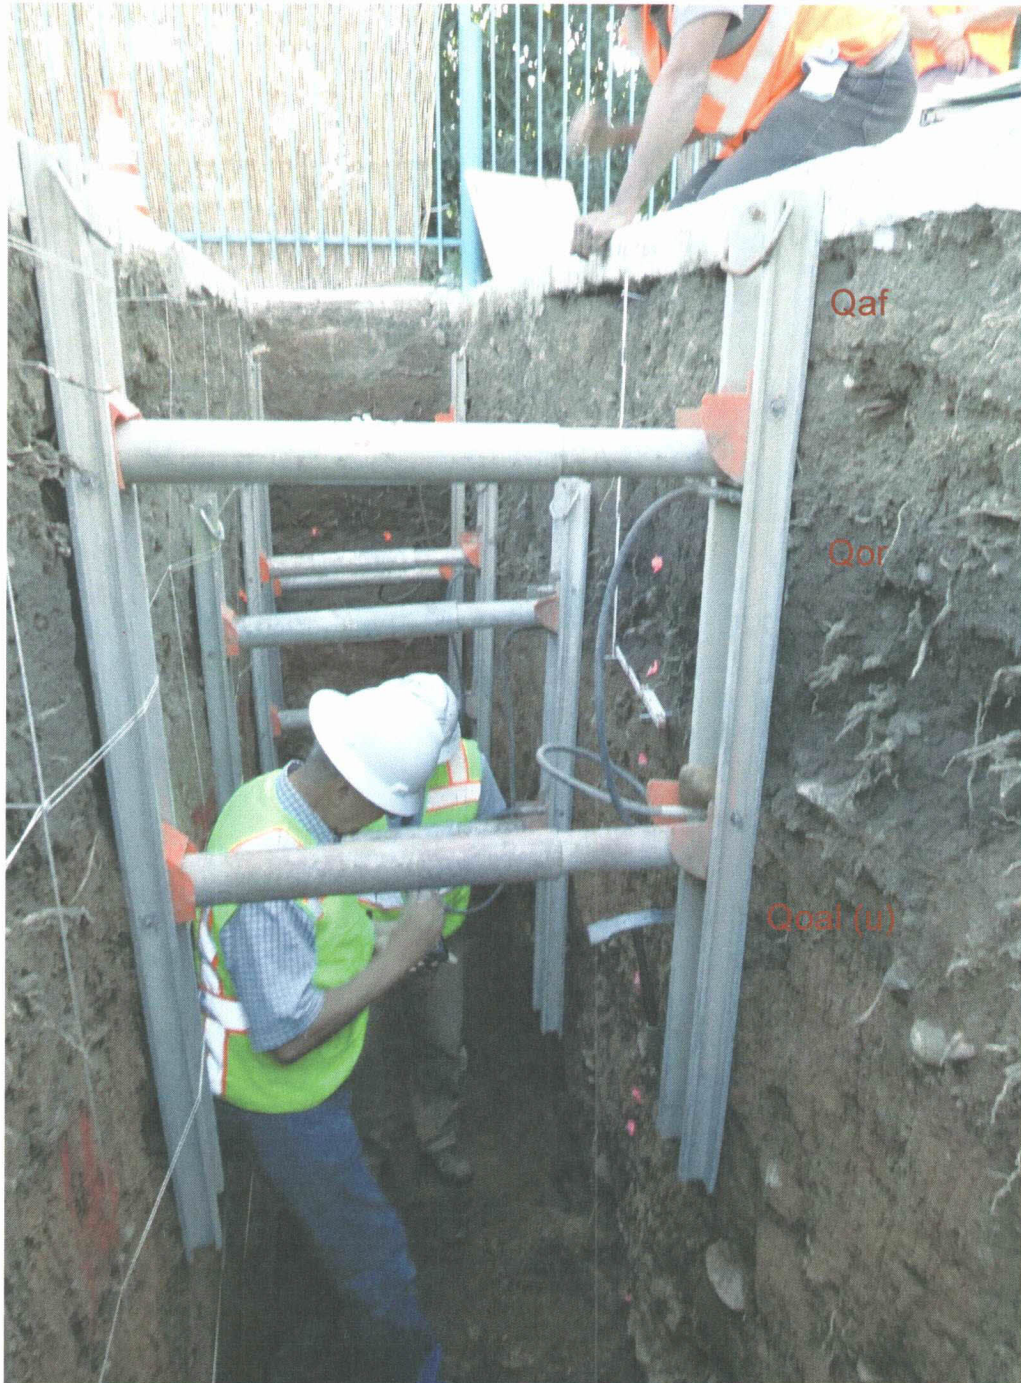
Photo 1:

Champion East Trench looking south. Pink flags indicate the the location of the soil stratigraphic section found in Appendix B. Note the layers grading downward from artificial fill on top, to the organic layer (abundant with modern roots), to the Old Alluvium Upper Unit on bottom.

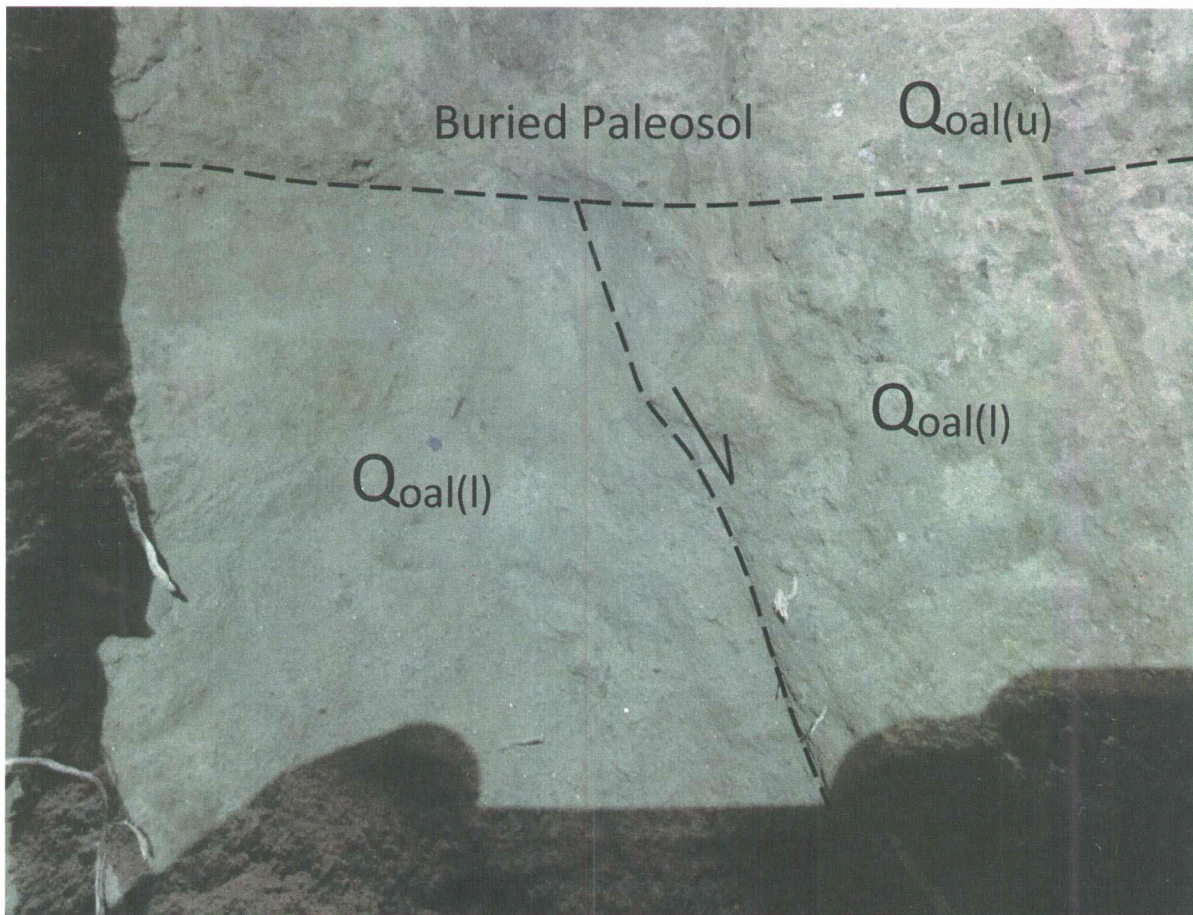
Photo 2:

BA-3 exposed about eight feet of upper Pleistocene, upper older alluvium ($> \sim 135\text{ka}$) overlying lower older alluvium ($> \sim 300\text{ka}$). A fault trending east-northeast intercepts the boring at about seventeen feet and is truncated by upper older alluvium (Photograph 2; Plate 8A). It trends N76E and dips about 74SE, and thus trends toward the Champion East Trench, where it passes beneath unfaulted upper older colluvium.

Champion Bucket Auger BA-3. This photo shows a fault truncated by a buried paleosol at ~ 8 feet below the ground surface with an attitude of N76°E, 74° south. The fault plane leaves the boring at ~ 17 feet below the ground surface. The paleosol that the fault terminates on, is in older alluvium, ~ 200 ka.
