**HISTORIC RESOURCES GROUP, HISTORICAL  
TREATMENT PLAN, JANUARY 16, 1998**

# **HUGHES INDUSTRIAL HISTORIC DISTRICT**

## **Historic Resource Treatment Plan**

**January 16, 1998**

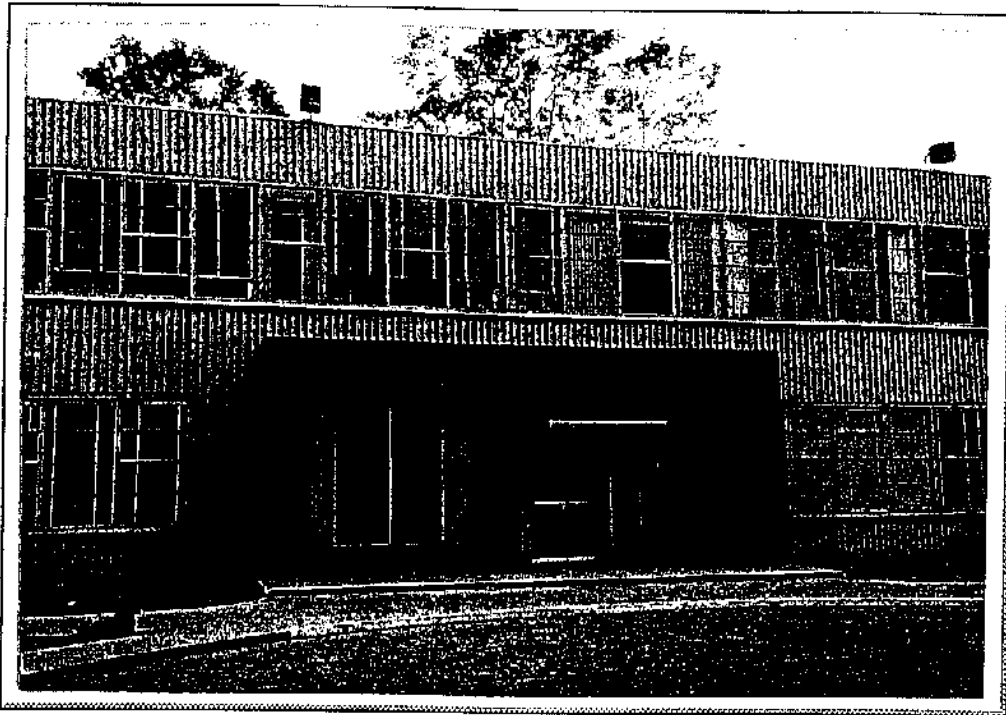
Building 1

The general condition of the building is poor due to a) lack of maintenance, b) possible structural damage to the building superstructure, and c) possible moisture problems at grade. However, the condition of interior fine wood paneling and casework is good.

Water and pigeon damage due to roof leaks and broken windows are not as extensive as in Building 2, but severe in small areas. Roof leaks near the southwest corner have caused extensive damage on both floors. A pattern of moisture damage at the floor near the west wall in the south half of the building raises concern about possible ground water or surface drainage problems.

Of greatest concern is the observed racking of the building out of vertical alignment along both the north-south and east-west axes. Ceiling and wall finishes have separated along a widening crack in the east-west direction in many spaces. A number of doors in the central corridors, aligned in a north-south plane, are jammed in their frames. There are several severe diagonal cracks in partition finishes. This evidence indicates the need for structural assessment, and the possible need for strengthening.

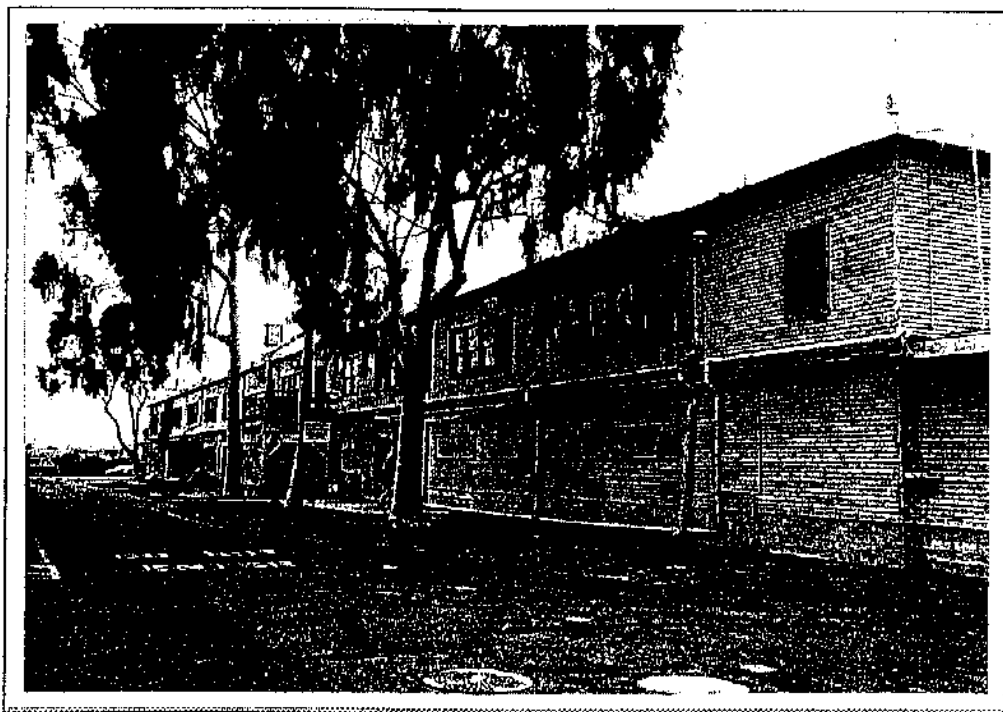
Building 2

The general condition of the building is poor due to a) lack of maintenance, and b) structural and moisture problems at grade. Water and pigeon damage due to roof leaks and broken windows can be readily repaired since the superstructure of the building and the windows are in fair to good condition. However, efflorescence at the ground floor slab and a subsiding floor slab in one bay indicate the need for investigation of soil and moisture conditions. Failure to stabilize the building envelope by roof repairs and sealing window openings will allow continued deterioration of the wood structure and interior finishes.

Exterior walls are constructed of wood stud framing and finished with painted shiplap siding. There is flush wood siding up to the first floor window stool line; the stool line continues as a projecting belt course. The Second floor framing extends beyond the wall line to form a small pendant roof continuously at the mid-elevation. Paint is in poor condition, though the siding is generally sound.

The unusual roof shape is formed by two bowstring trusses of unequal dimensions placed end to end, connected by wood framing tangent to the top of the two arches, forming a low pitched sloping roof which curves down to the eaves on the east and west. The roof is in poor condition, resulting in substantial water damage inside. Concealed gutters at the eaves trim need repair and cleaning. Gutters are collapsing at the cantilevered canopy at the east entrance.
