**Consulting Arborist's Report
June 20, 2016**

Non-Protected Tree Report

2800 Casitas, Los Angeles

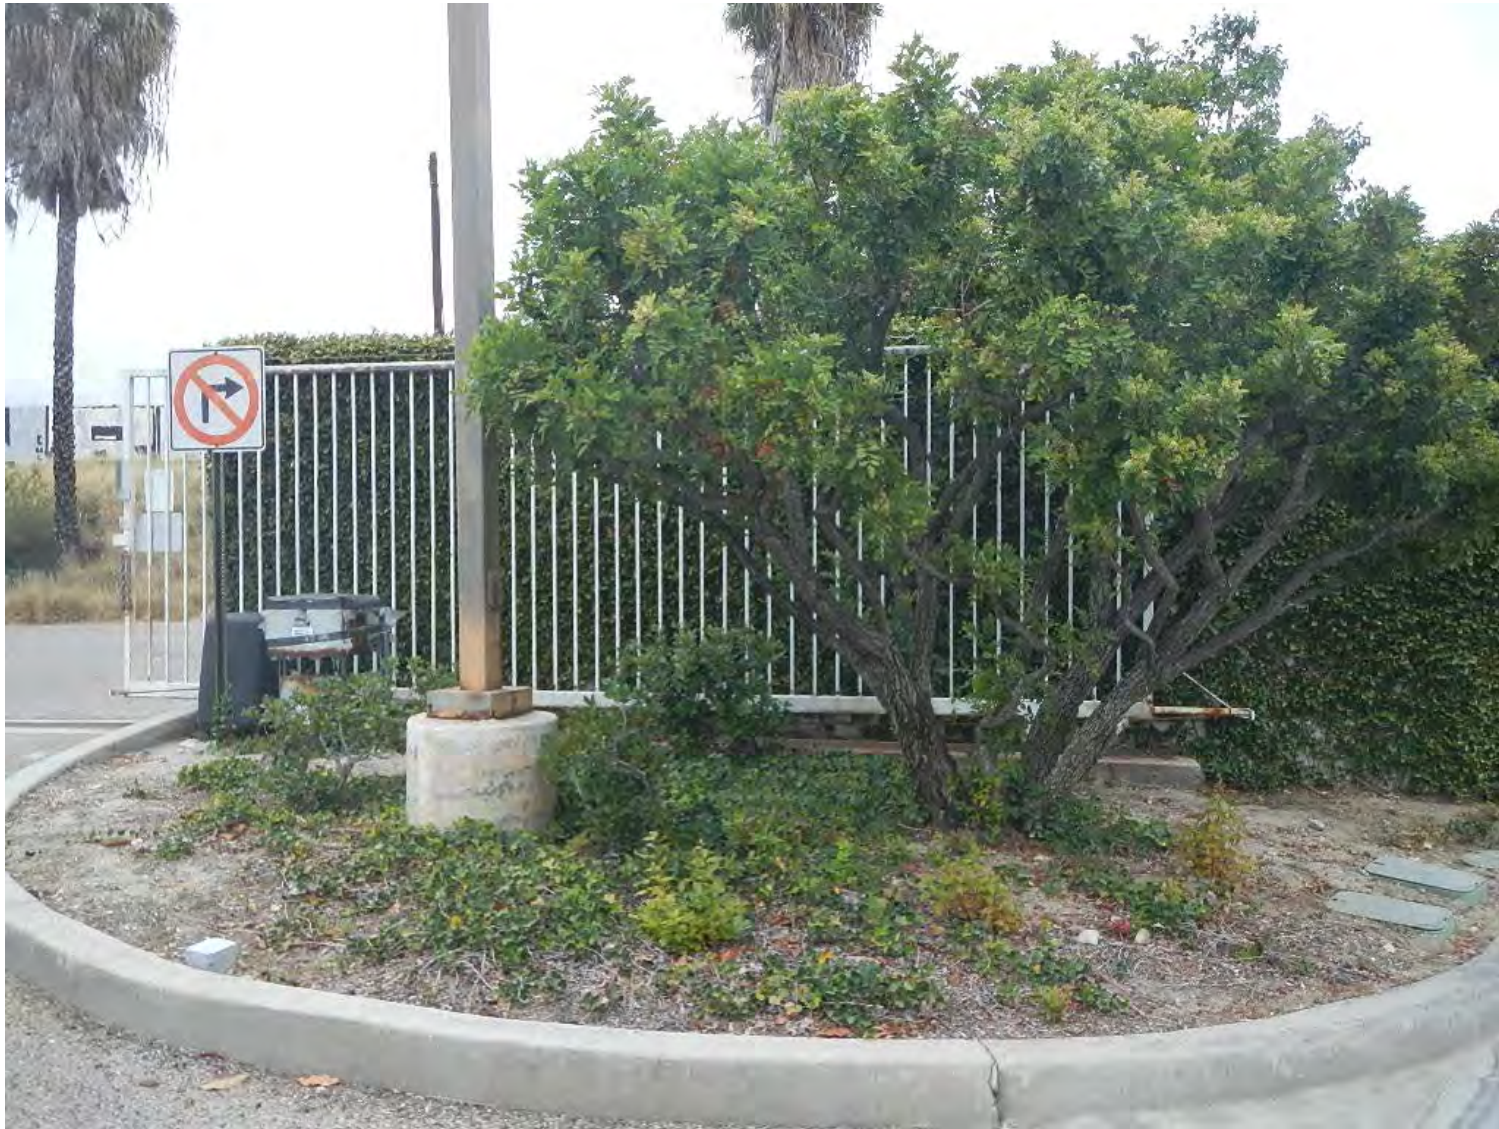
Tree #1 – Brazil pepper inside the front gate on the right

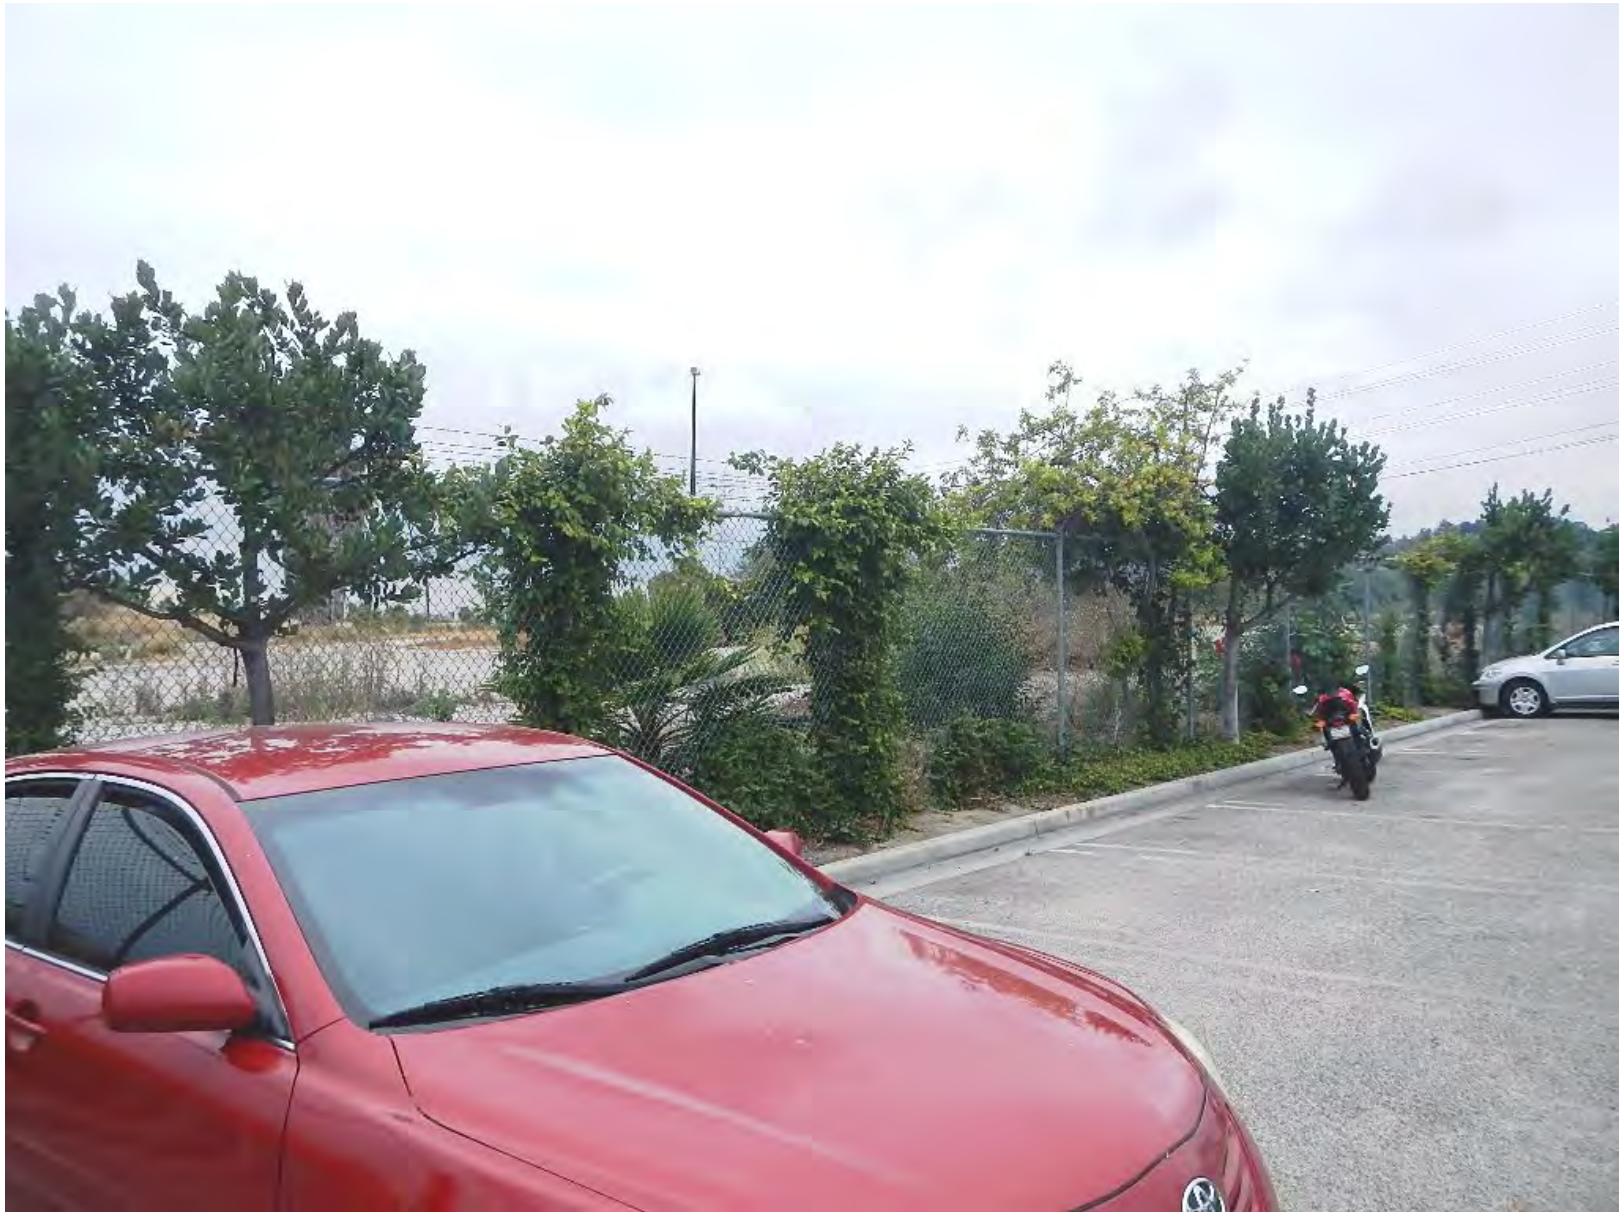
The Saratoga laurels along the east edge are about a foot from the curb and badly pruned.

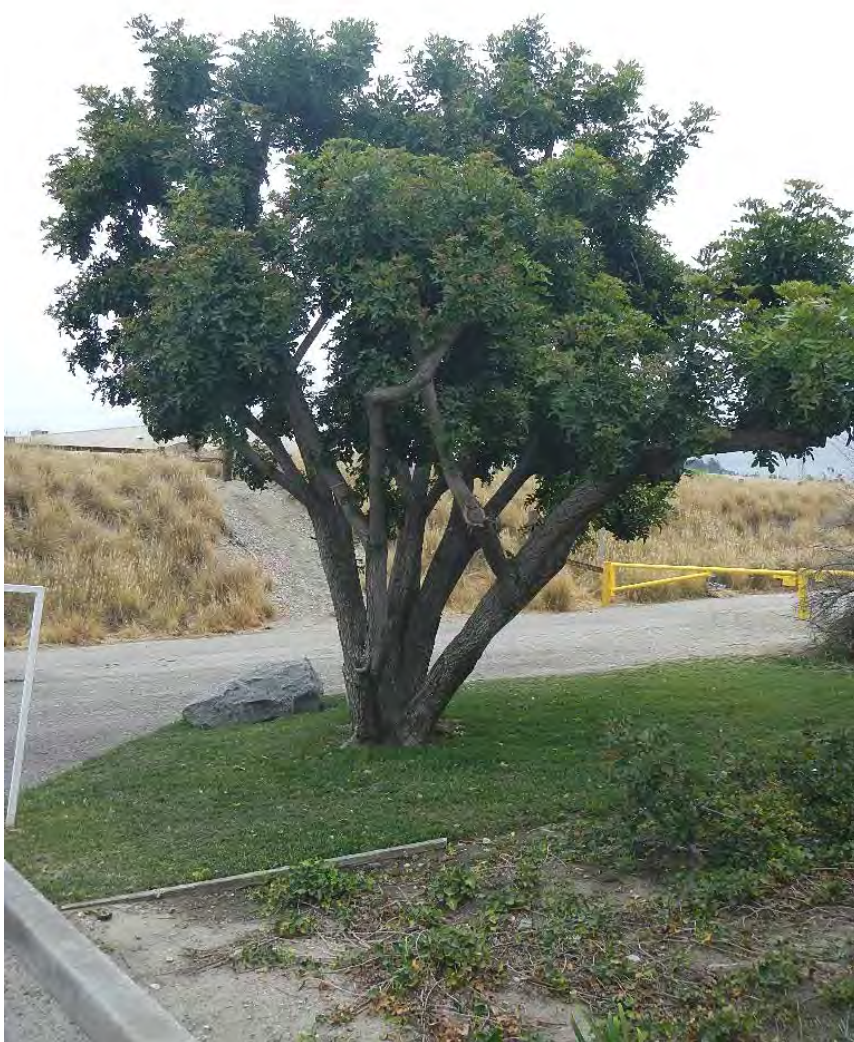
The Brazil peppers have crowded trunks likely to split out.
The turf should be carefully removed or kept several feet from the trunks.

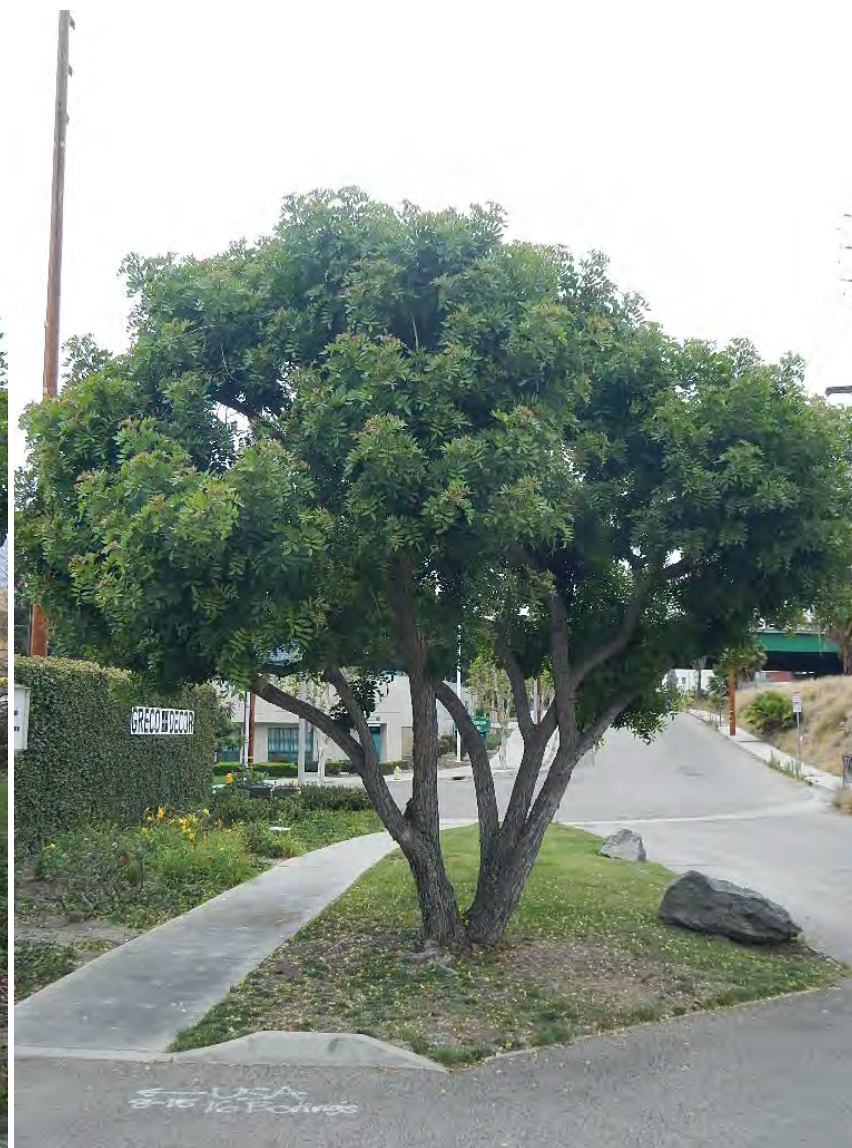
These 2 trees are small and young, but not bad looking.

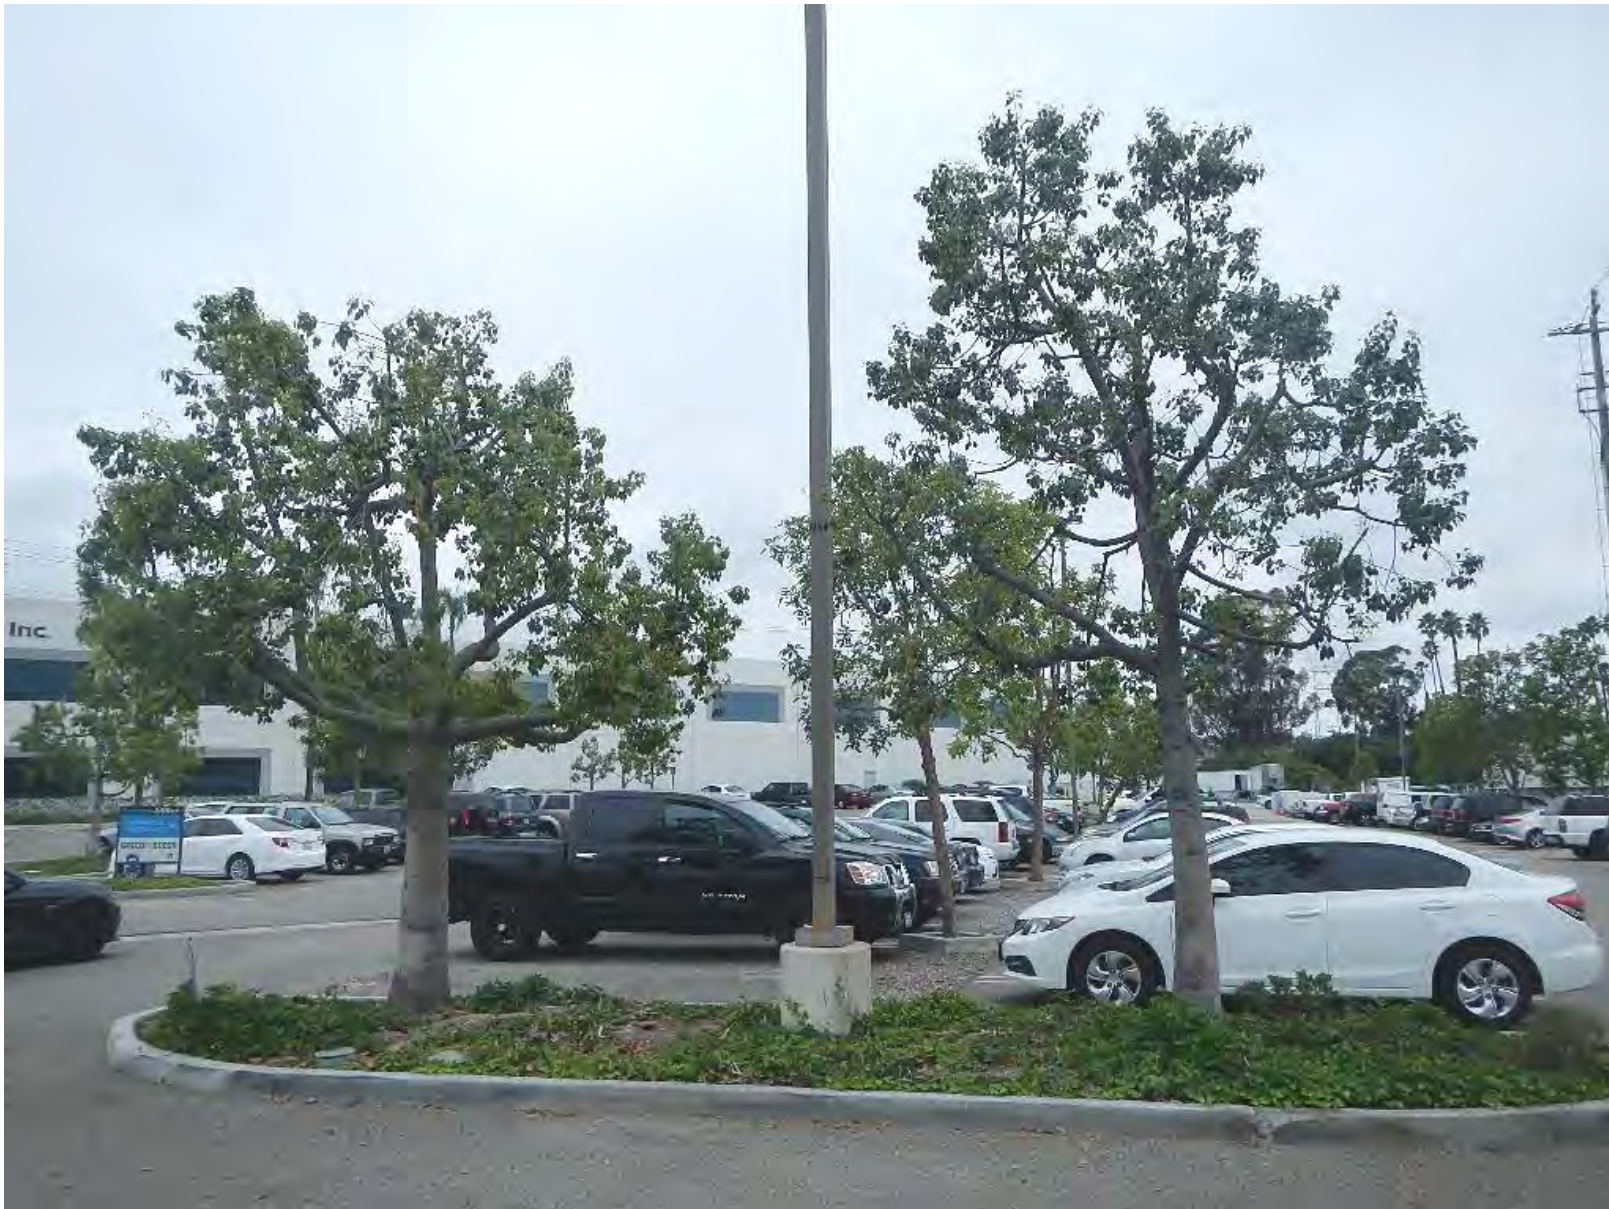
Nearly all the bottle trees have been topped. This island is too small for two trees. One could eventually outgrow it.

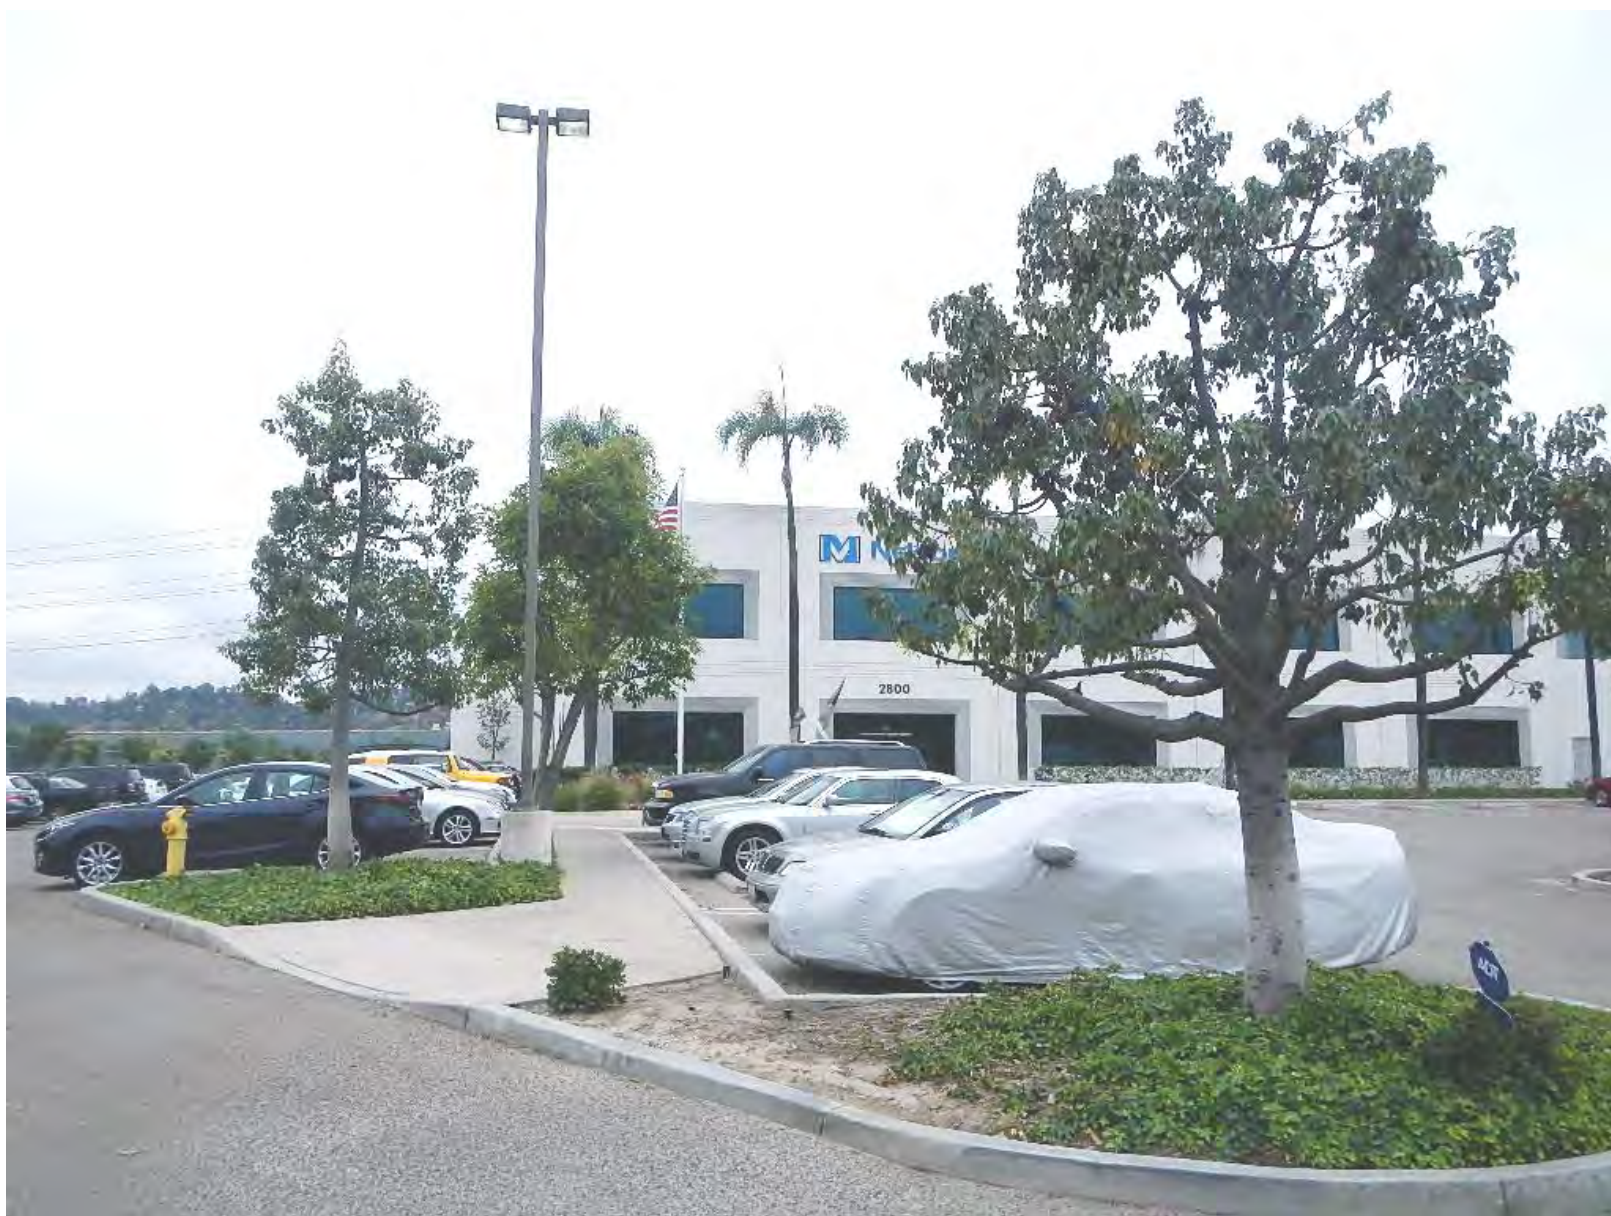
Besides the other issues, bare soils like this may indicate soil chemistry issues. Agronomic testing is recommended.

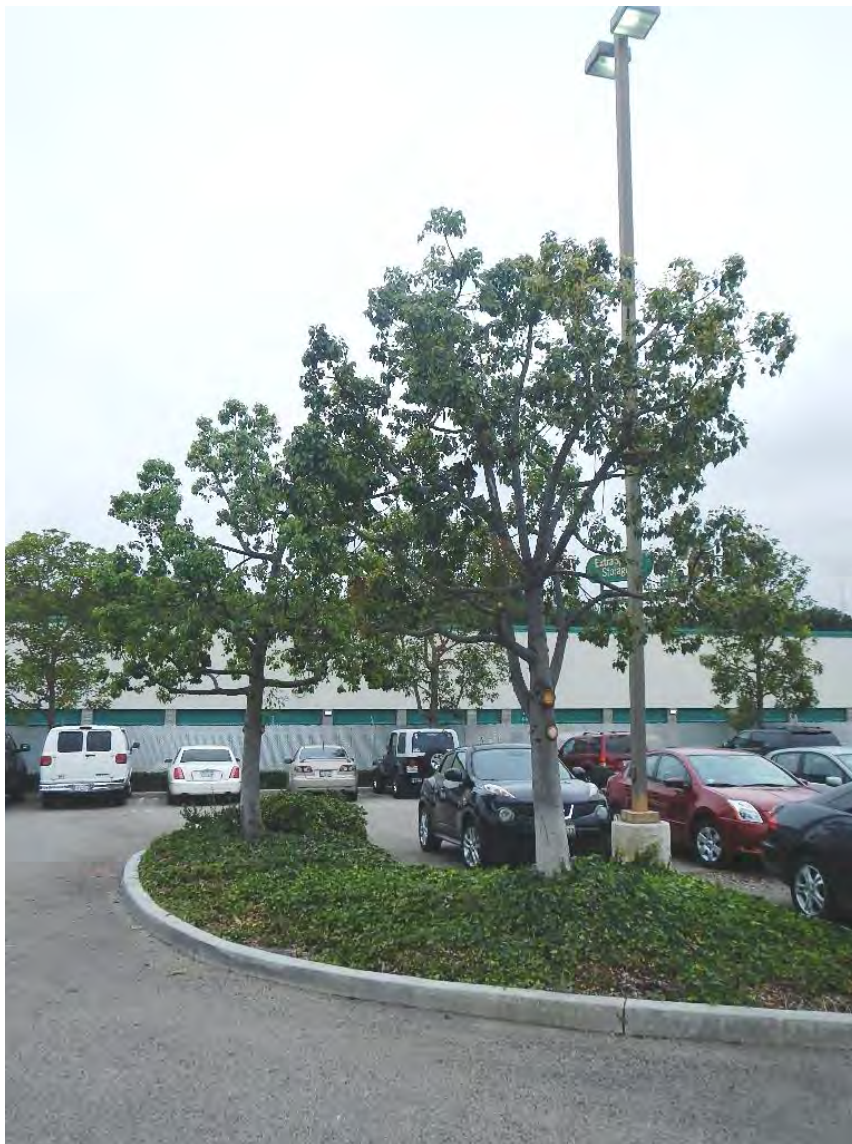
Note the large pruning cuts. Those limbs did not protrude into traffic.

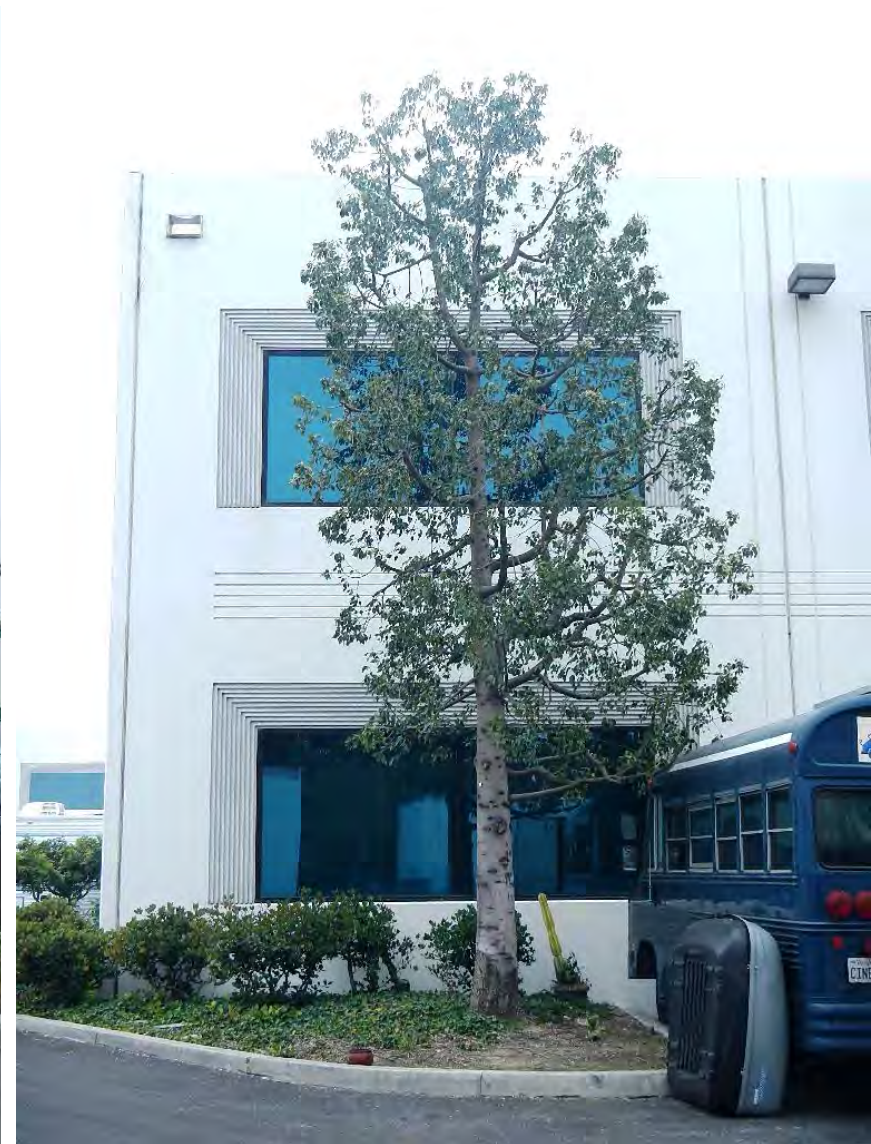
Even this tree was topped.

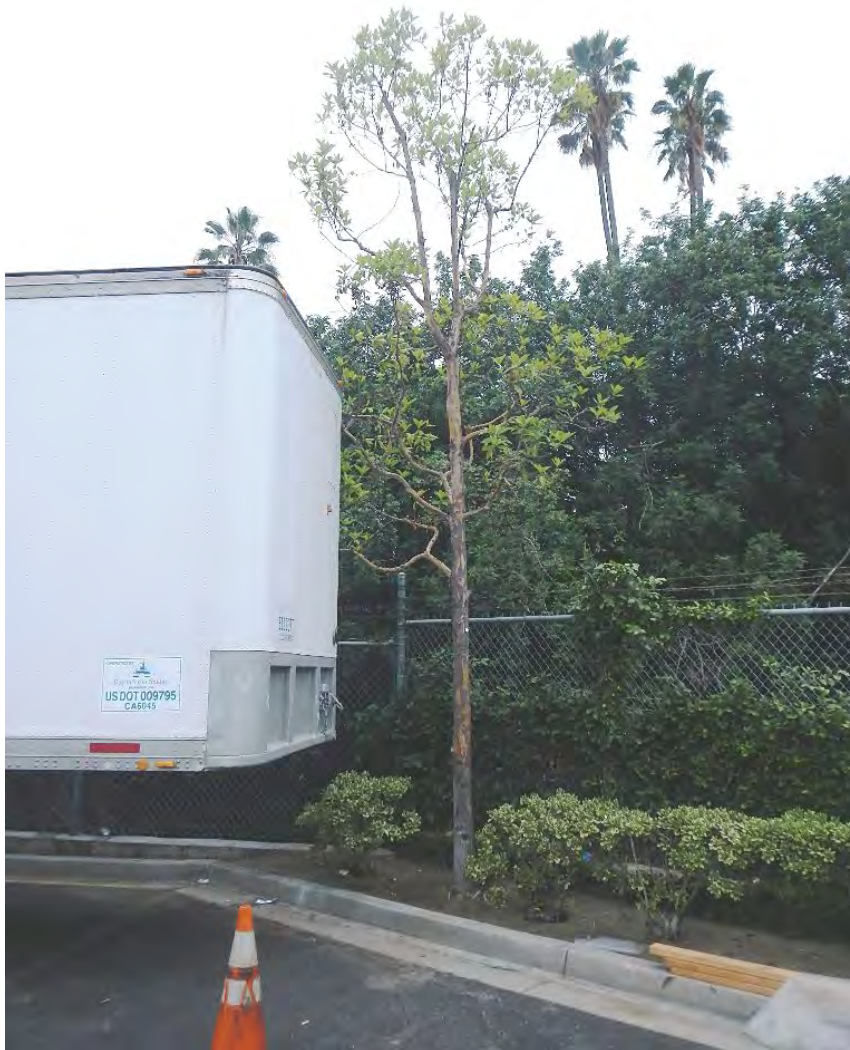
The Brisbane box trees are over pruned.
Note how close the trunk is to the curb.

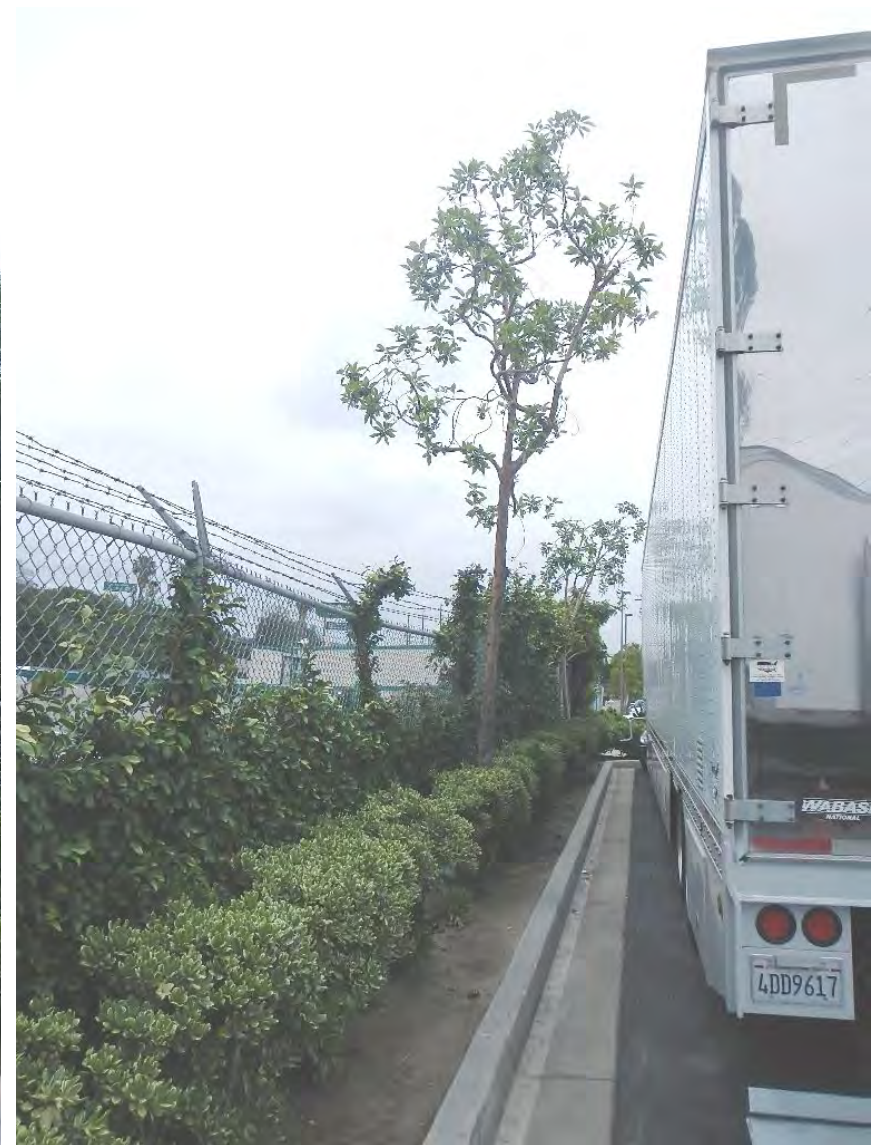
This is the largest planting space for Brisbane box.

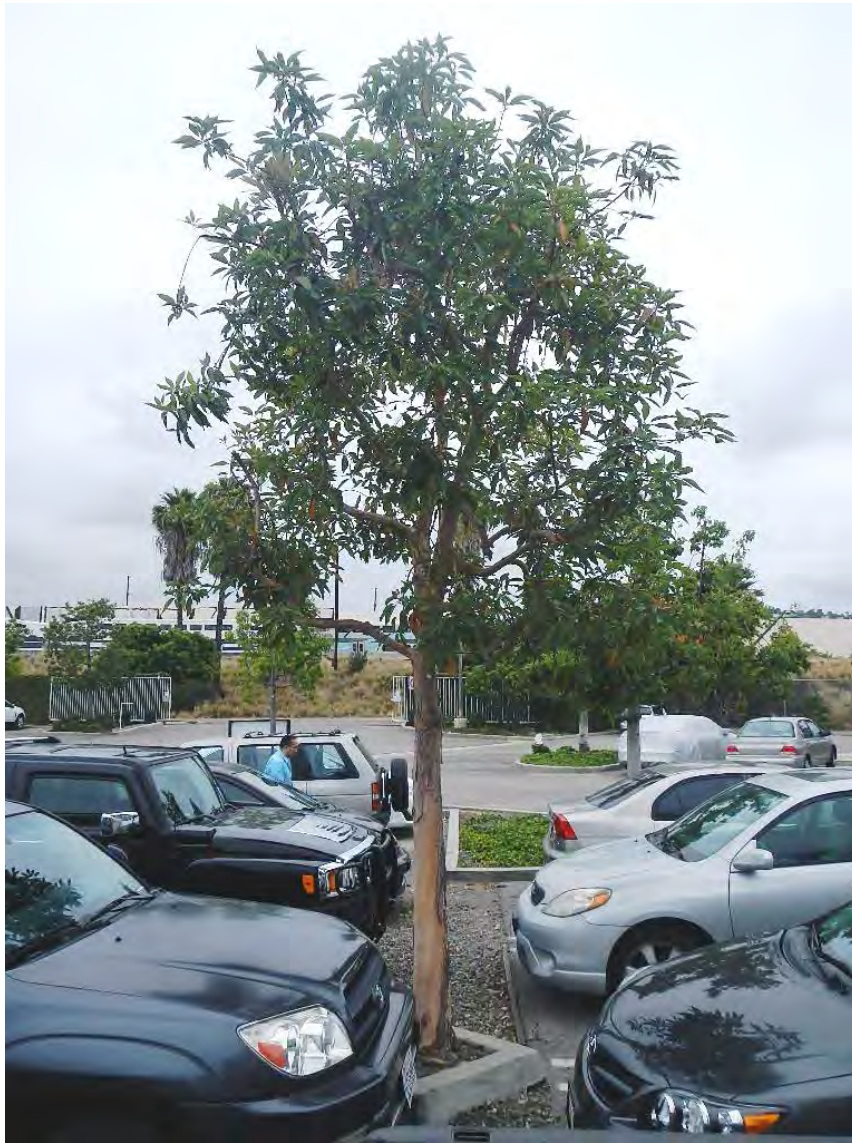
The diamond planters will damage the base of the trunk in time.

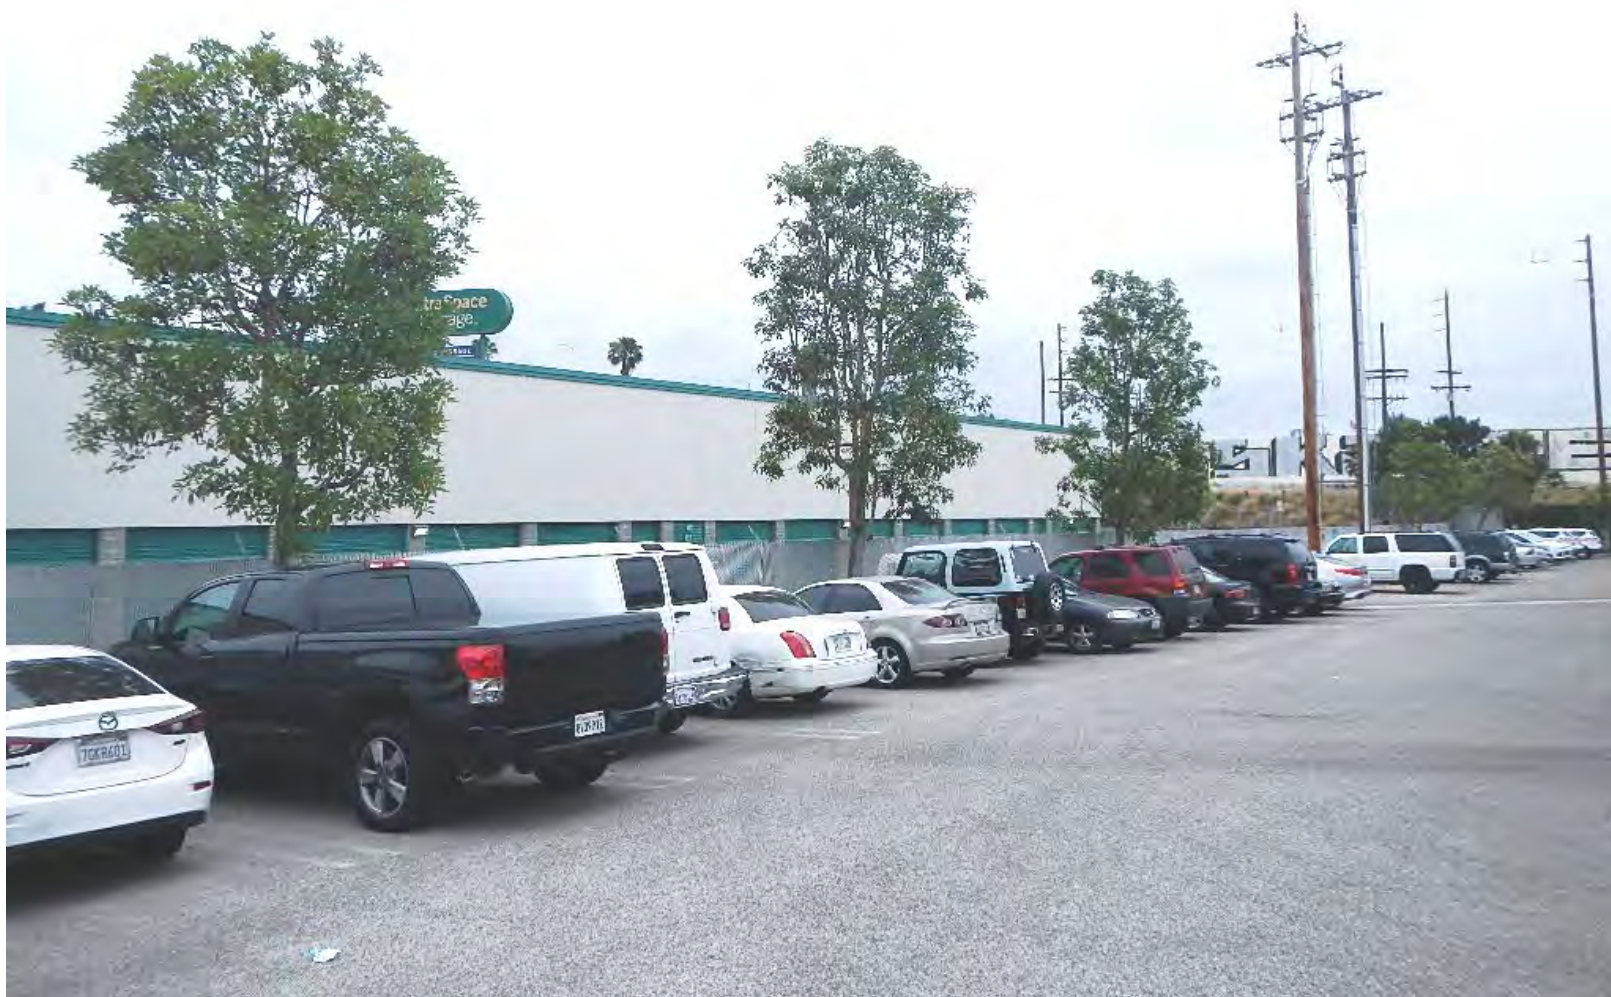
These are nicer Brisbane box, but their trunks are about a foot from the curb.

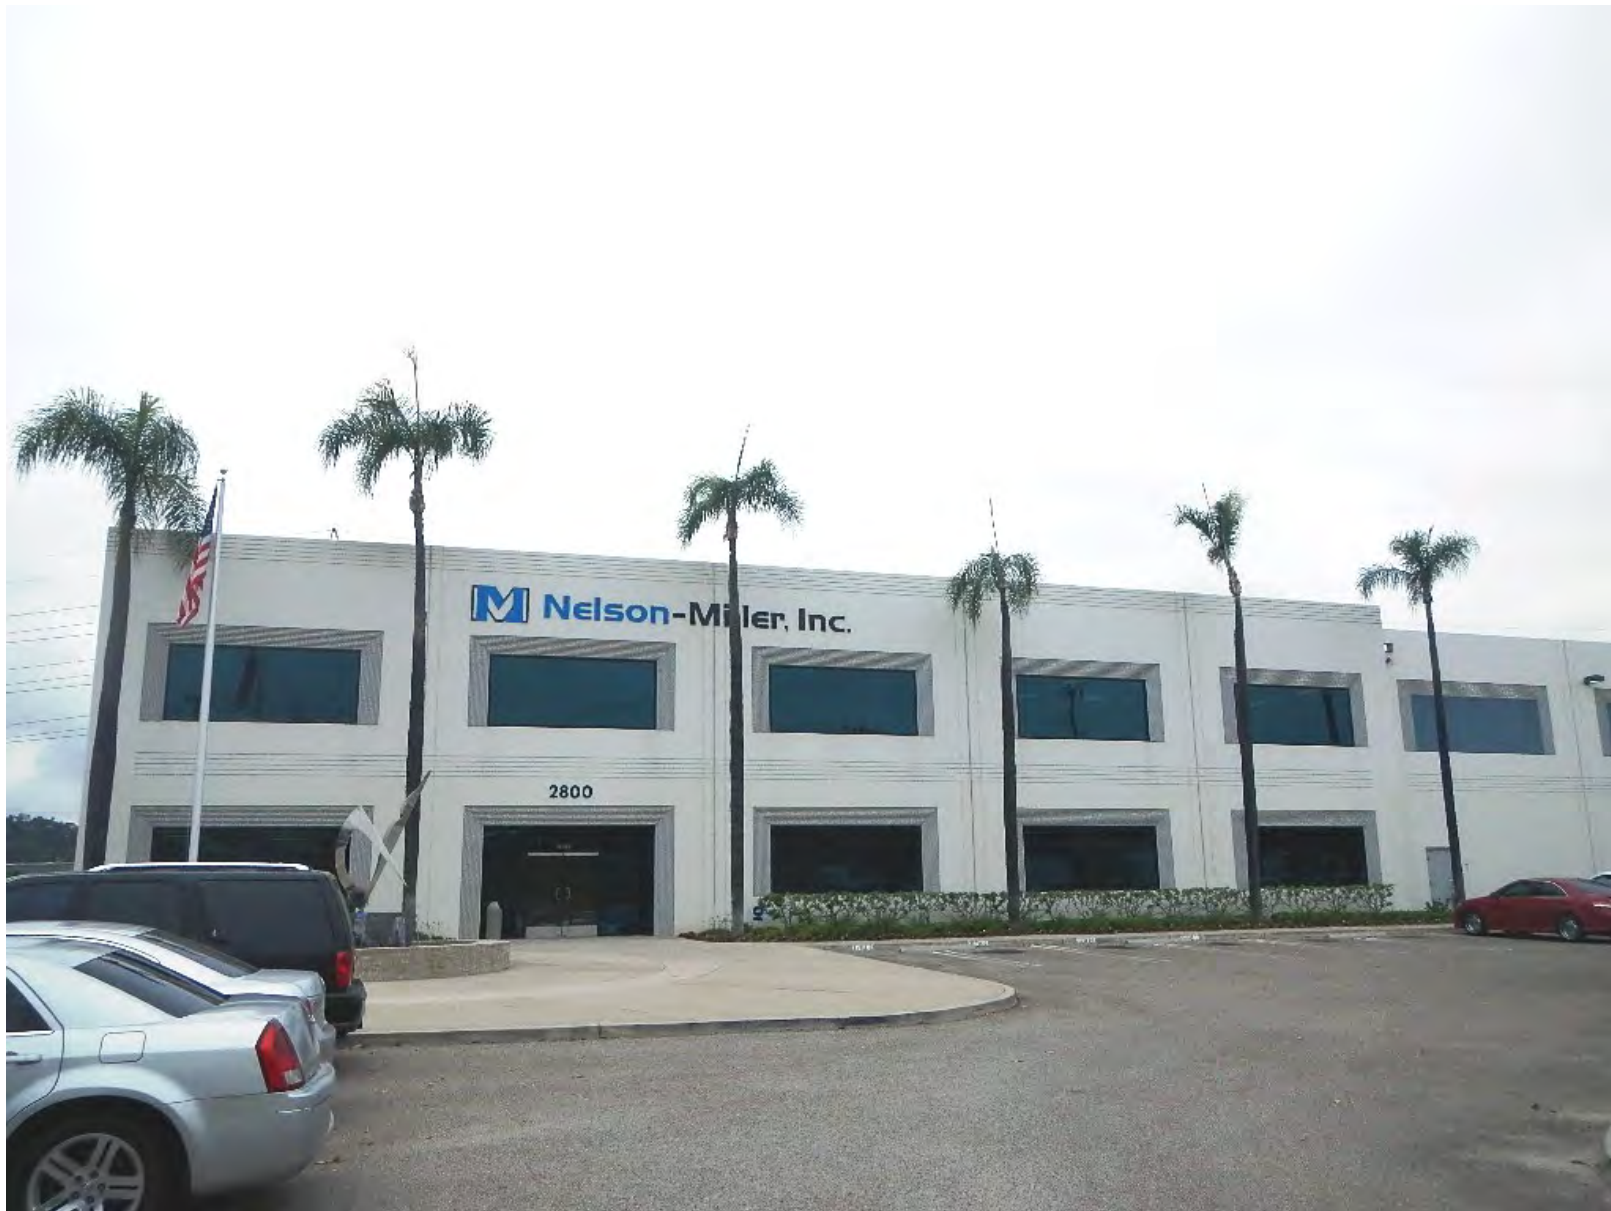
The thin trunks and small heads are evidence of chronic over-pruning.

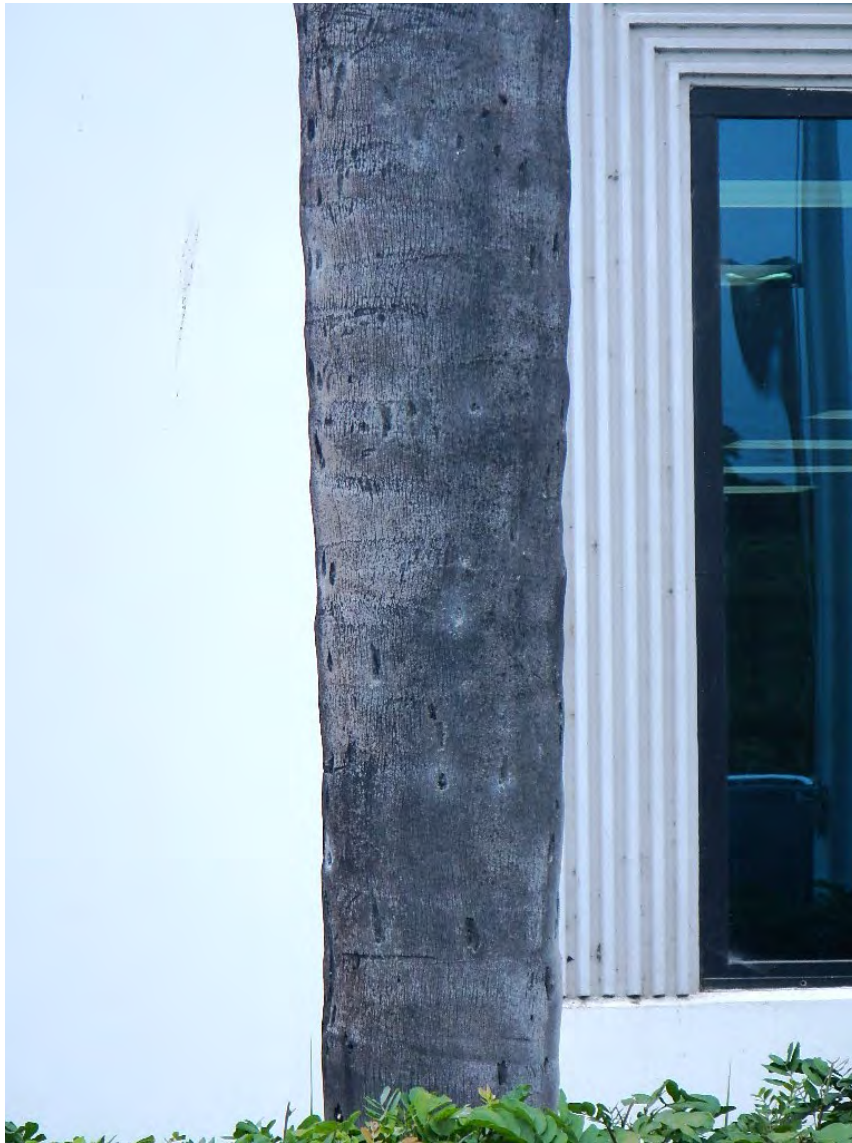
Note gaff scars on the trunk. They never “heal” or close.

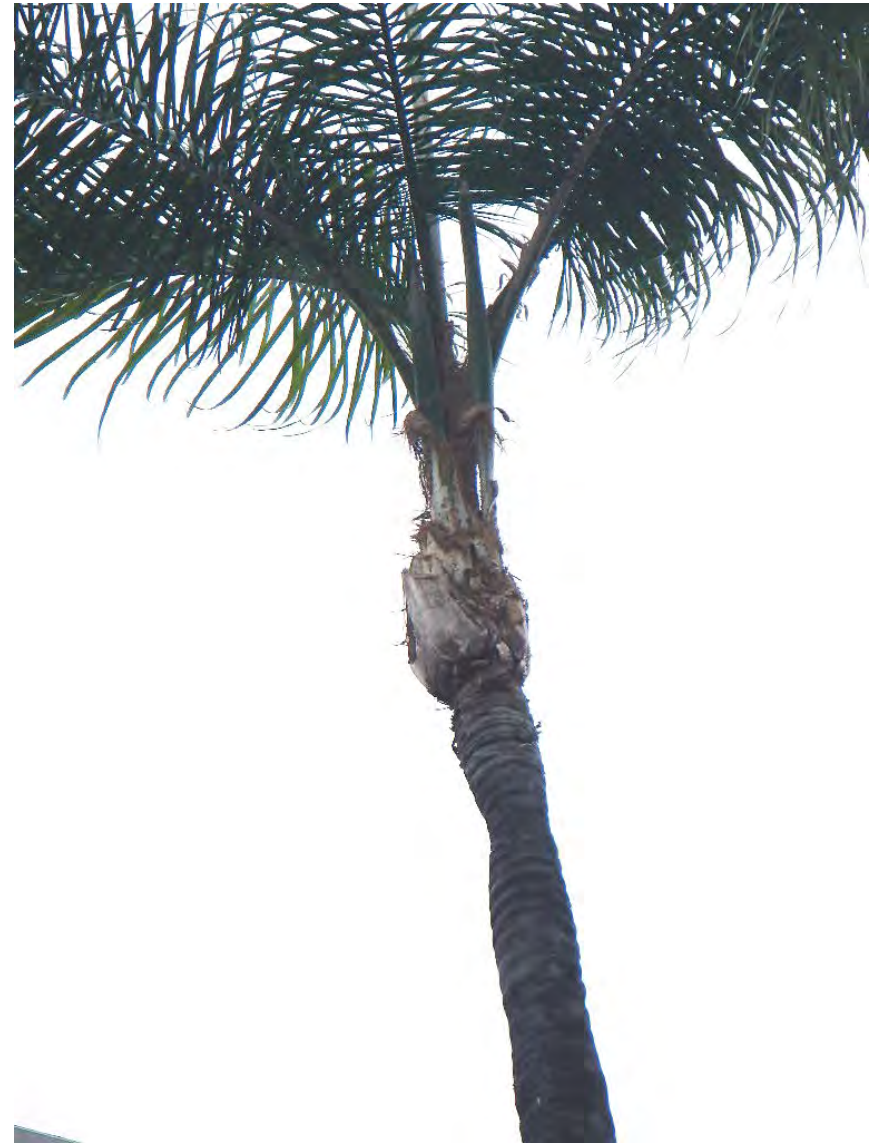
The trunk constriction below the head is a weak point.

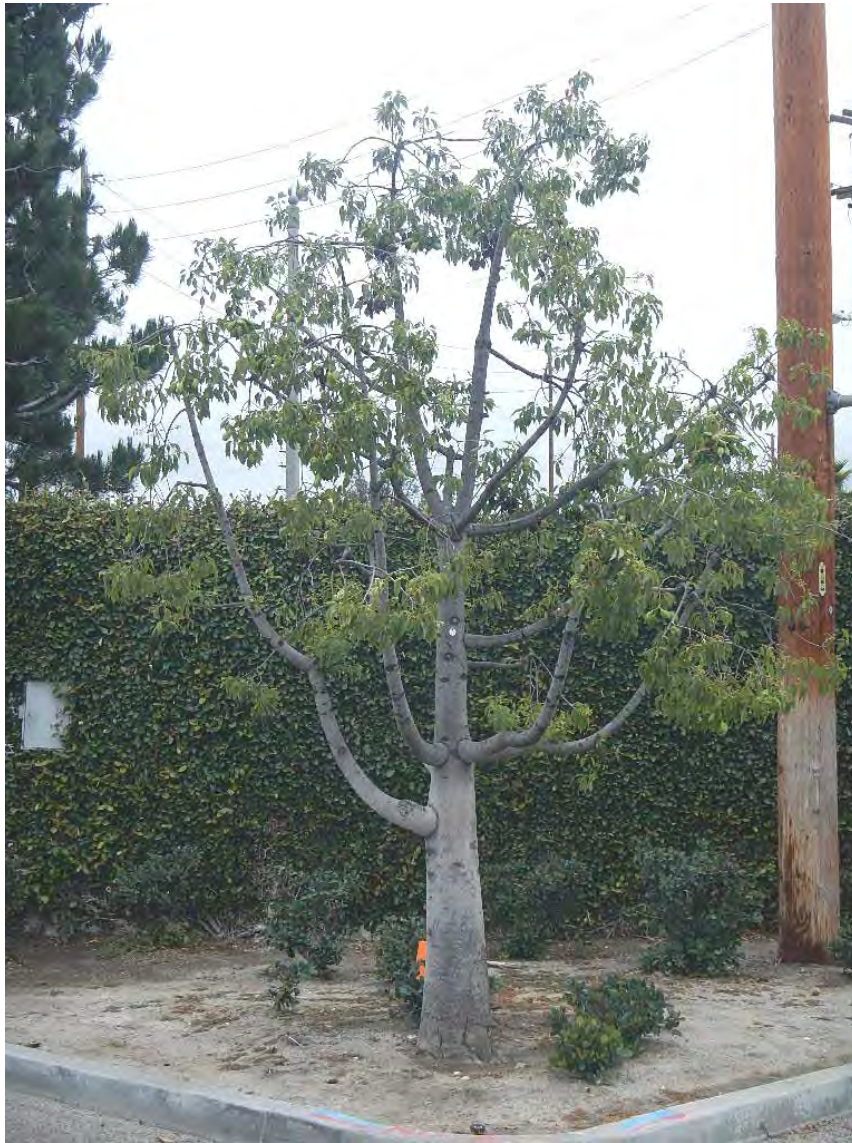
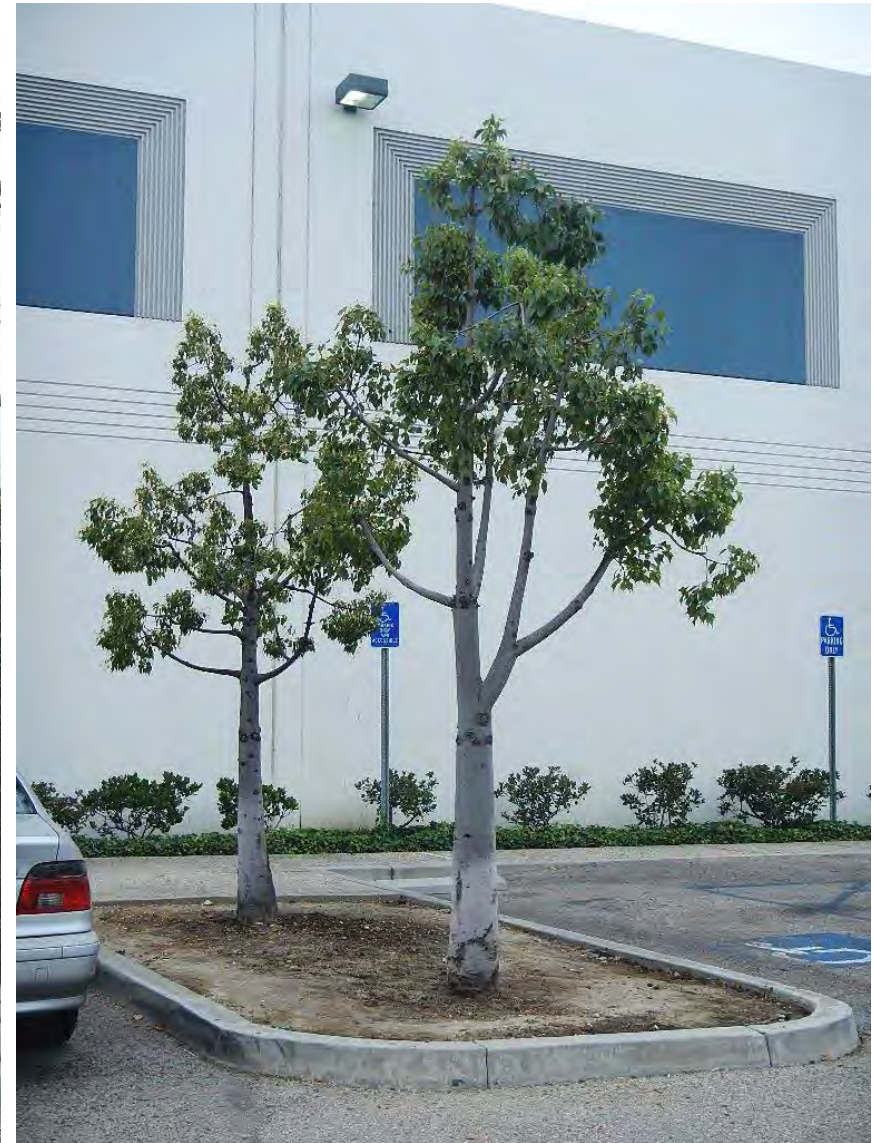
Bare soil will crust over and reduce root health and depth. After planting new trees, apply a 2-3 inch deep layer of coarse mulch.
