Tree Evaluation Report and Update

Subject: Tree Evaluation Report for the 3443 South Sepulveda Boulevard Project Site, City of Los Angeles, California

Subject: Update to the Tree Evaluation Report for the 3443 South Sepulveda Boulevard Project Site,
City of Los Angeles, California

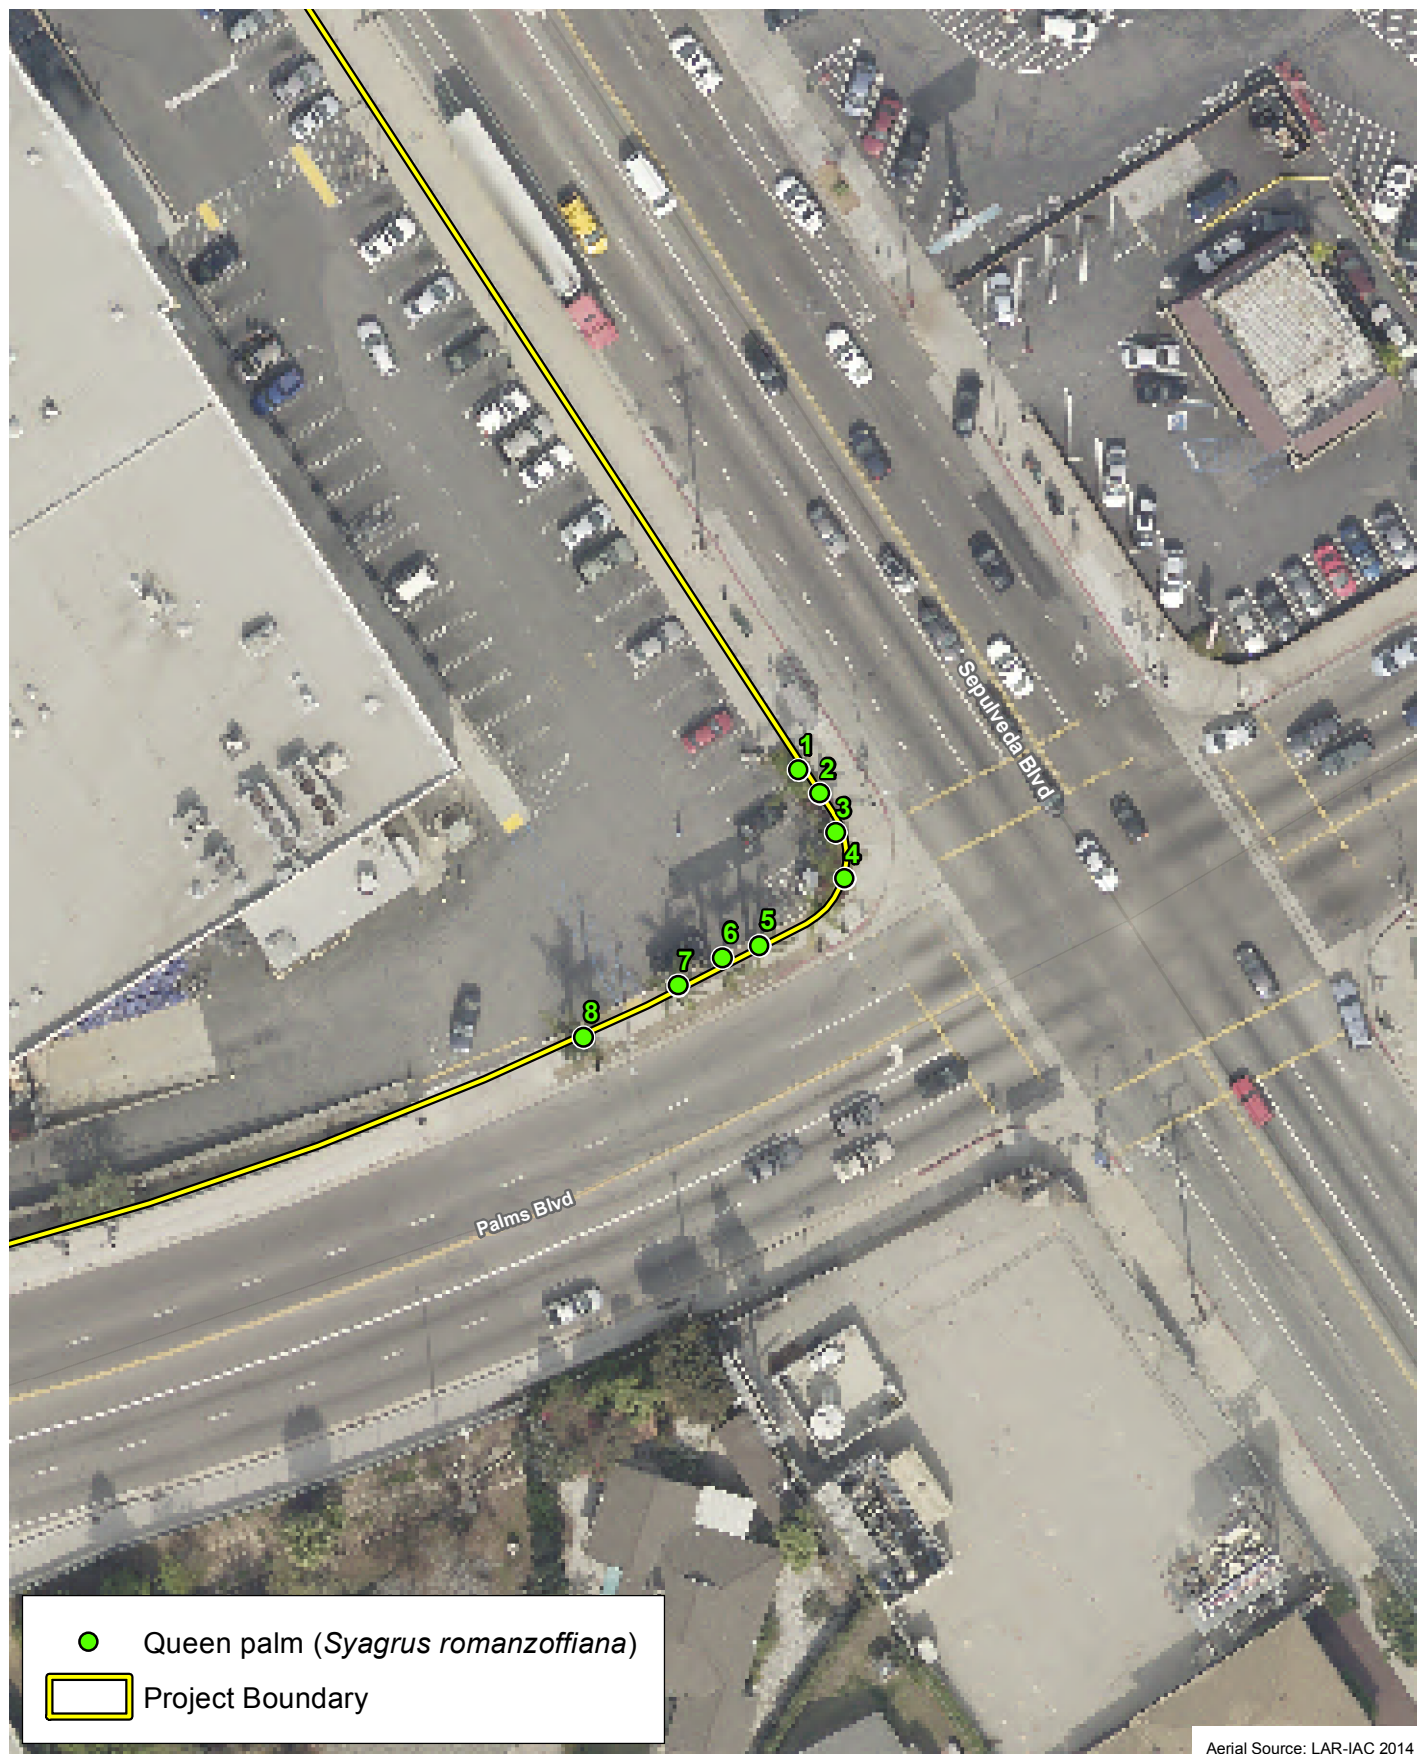
Exhibit 2

The project site is currently occupied by a single commercial structure surrounded by a parking lot. The only trees on the site consist of eight queen palms (*Syagrus romanzoffiana*) located along the sidewalk in the southeastern corner of the site (Exhibit 2). Table 1 provides a summary of tree data collected during the site visit. Exhibits 3a through 3d provide photographs of these palm trees.

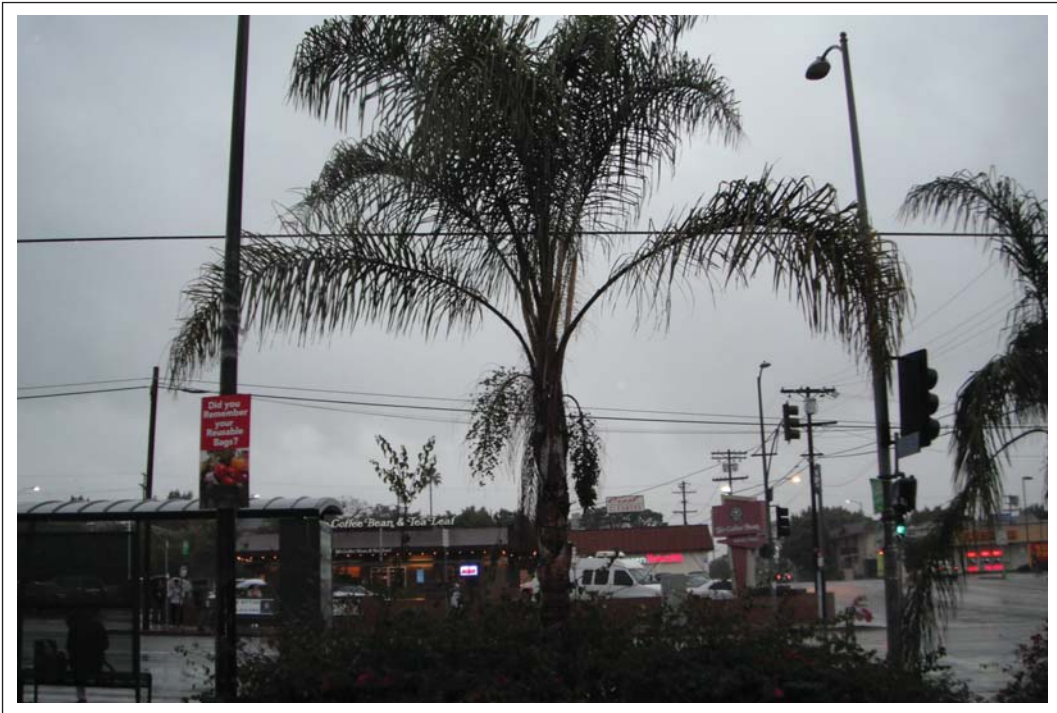
January 5, 2016. View of tree number 1.

All of the trees are in moderate health, with some sclerosis observed on the leaves of each palm, which is likely the result of ongoing drought conditions. The planting areas allotted to each palm are quite small, but this likely has only a minor impact on tree health as palm root systems are fibrous and do not require as much space. Evaluation of all trees on or adjacent to the project site was based on a visual assessment from the ground. Because no significant indicators of stress were observed, no samples were taken from the trees or soil.
