**Sunshine Canyon Landfill  
Independent Monitor  
Quarterly Site Monitoring Status Report  
April 1, 2019 – June 30, 2019**

**City of Los Angeles Department of City Planning**

**County of Los Angeles Department of Regional Planning**

July 18, 2019

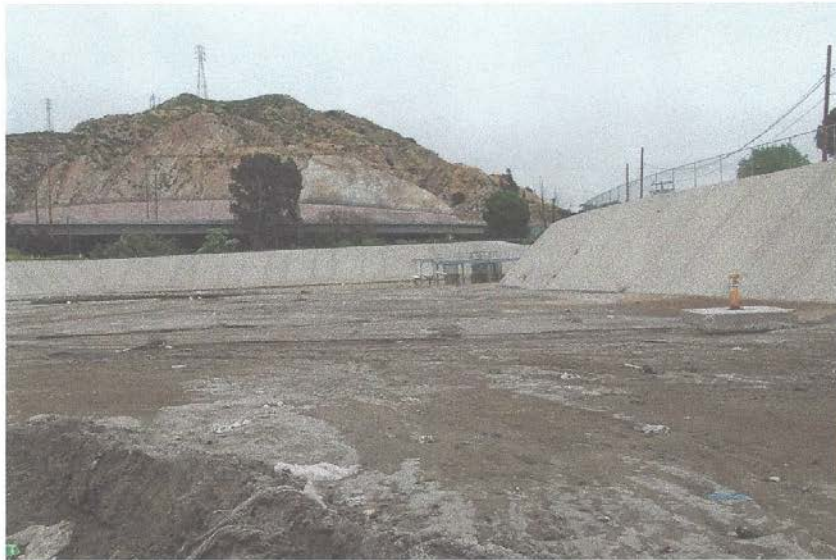
In early May, a significant amount of sediment was observed in the eastside channel behind velocity humps and gabions. The terminal basin had standing water that covered 50% of the area east of the gabion wall. Deep wet sediment (8 feet to 10 feet deep) covered most of the basin. Water being discharged was free of sediment, but was iron oxide-colored. Basin A had some standing water near the outlet risers. There was a significant amount of wet sediment in the basin. Basin B was dry, with minimal sediment on the basin's floor. There were two areas of soil sloughing into the basin from the native hillsides that needed to be trucked away.

Photo 3: Sediment level in Terminal Basin

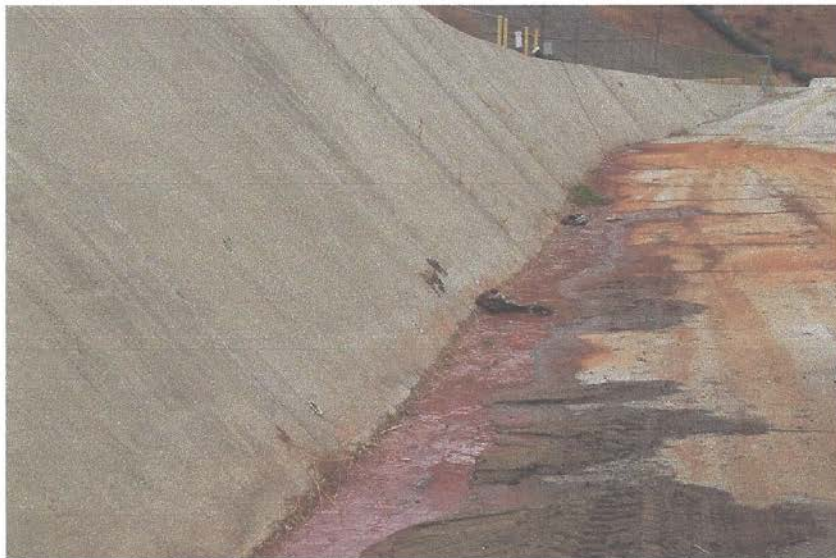
Photo 4: Water flowing out between floor slab and wall joints at Terminal basin

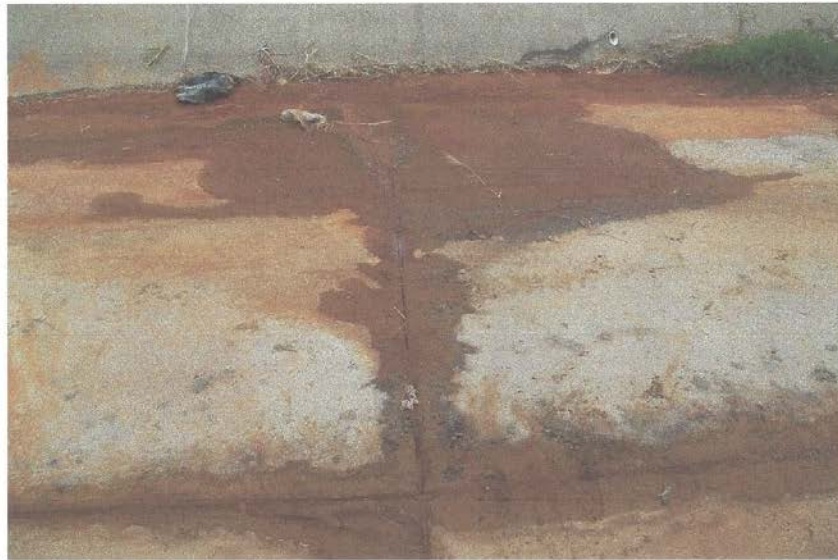
Photo 5: Water flowing out between floor slab joints at Terminal basin

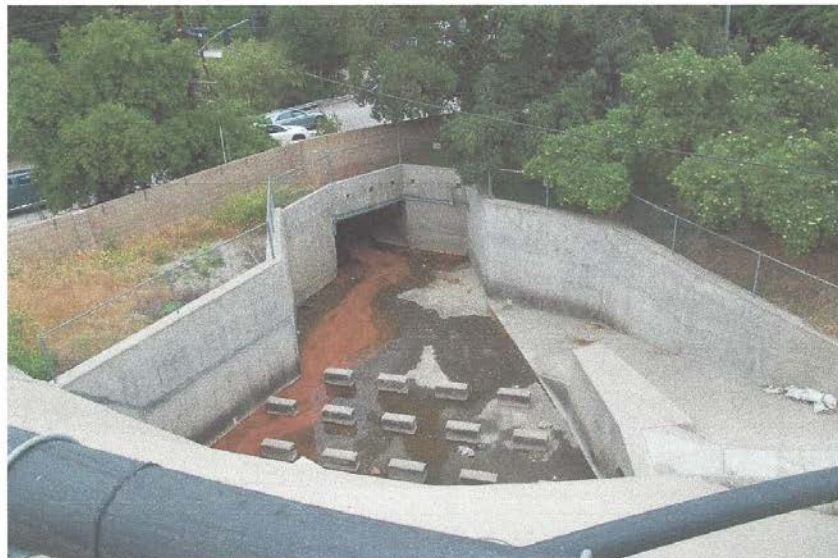
Photo 6: Reddish water leaving the landfill

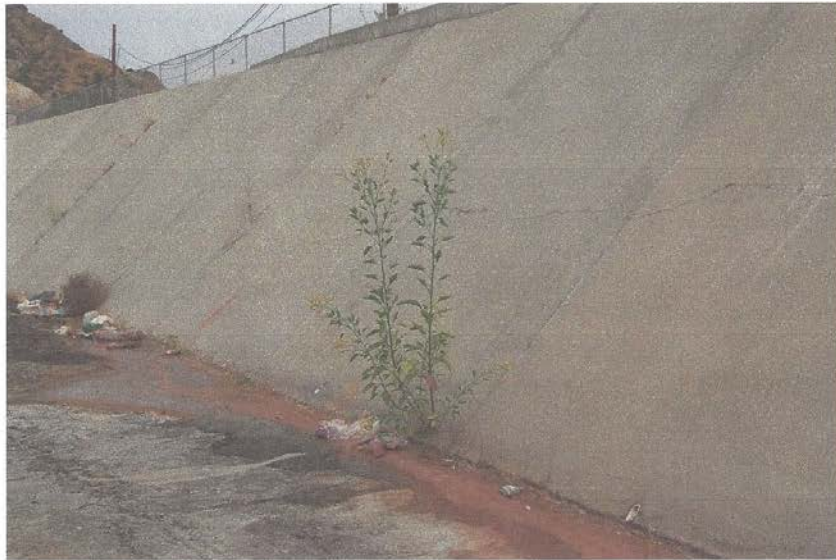
During the 2nd Quarter, the high-flow spillway for Basin D into the westside drainage had cracks and spalling that should be repaired. The riser that discharges into the eastside channel does not have top guards to restrict unauthorized access. The Basin B high-flow outlet spillway was cracked in multiple places. The terminal basin had vegetation growing in the interior concrete sidewalls.

Photo 7: Vegetation growing in weep hole and cracks of Terminal basin wall

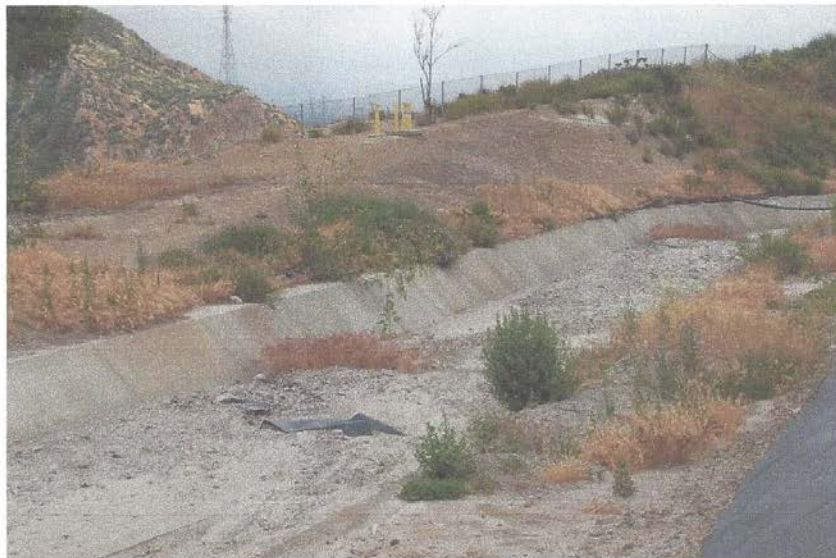
Photo 8: Vegetation, sediments, and detritus in channel between Basin B and Terminal Basin

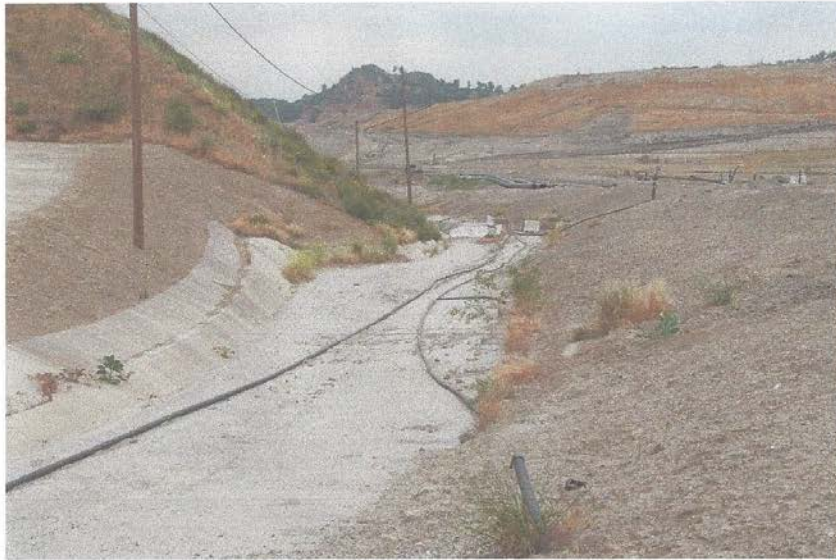
Photo 9: Vegetation in channel near Basin B

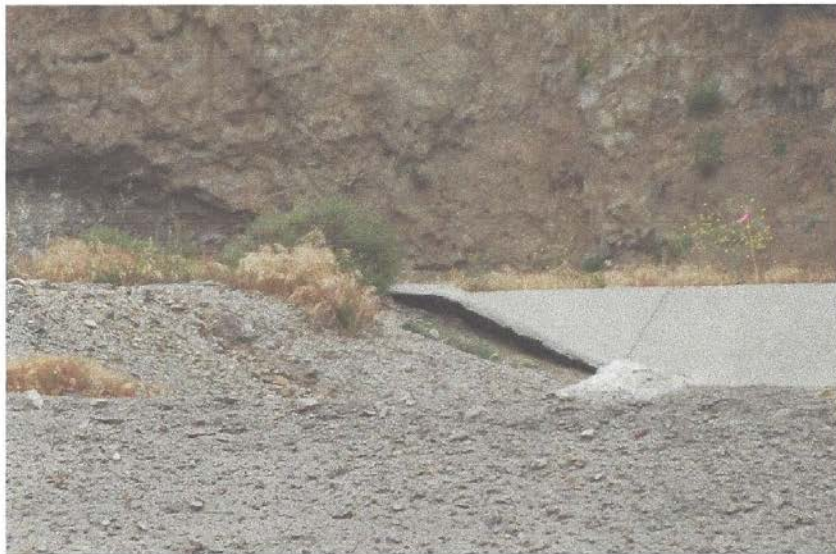
Photo 10: Undermined shotcrete spillway at Basin D

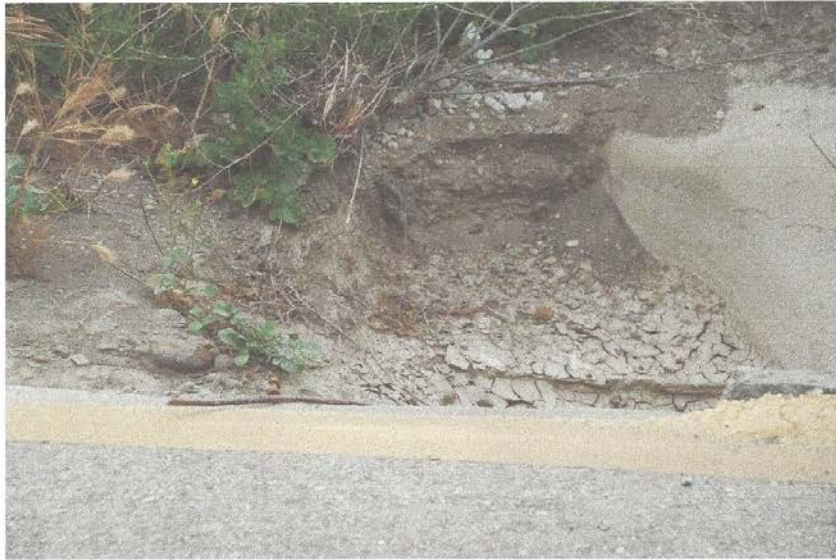
Photo 11: Sediments plugging drain at end of ditch along access road to Flares 9-11

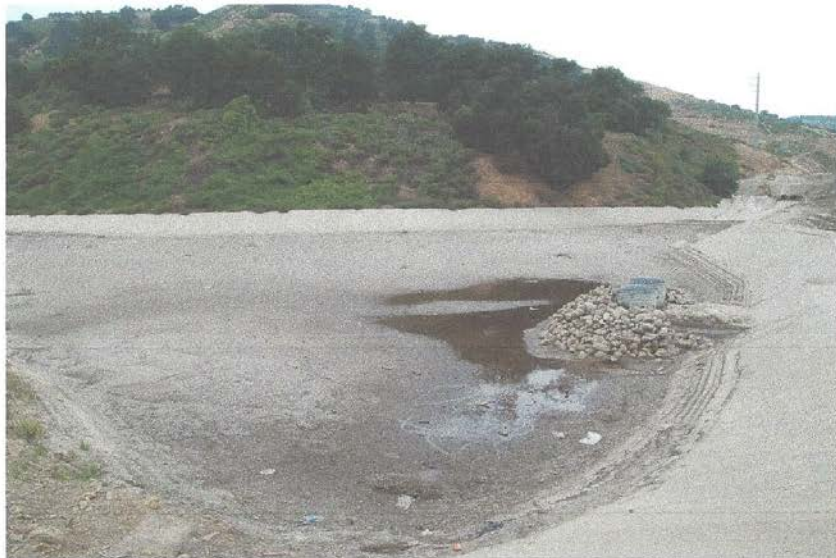
Photo 12: Sediments in Basin A

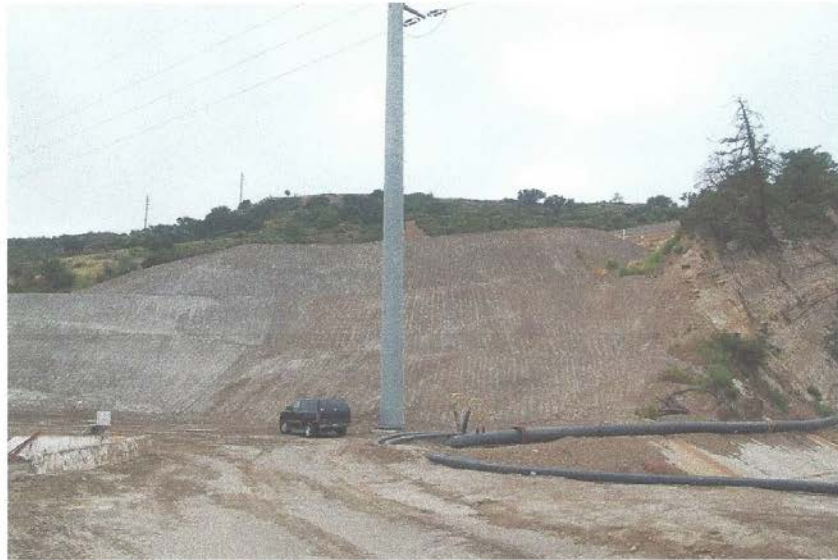
Photo 13: Reworked slopes beneath Flare 3 and near Basin A

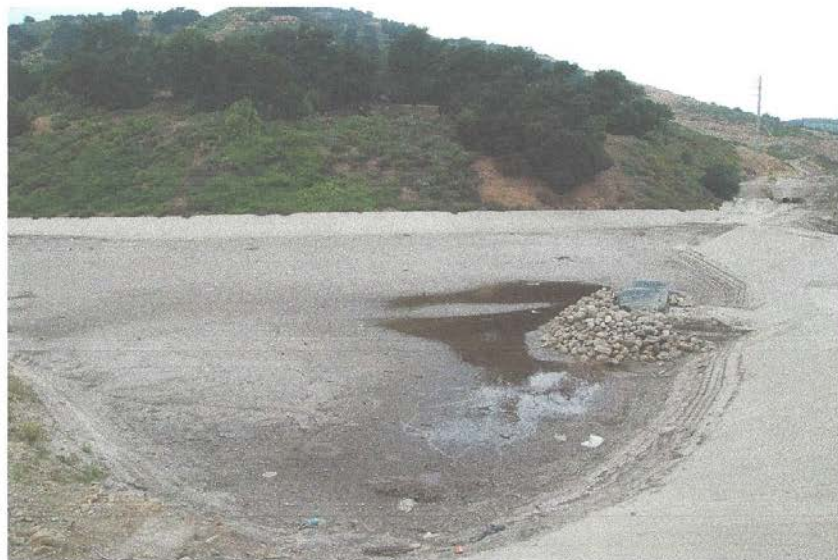
Photo 13: Sediments in Basin A

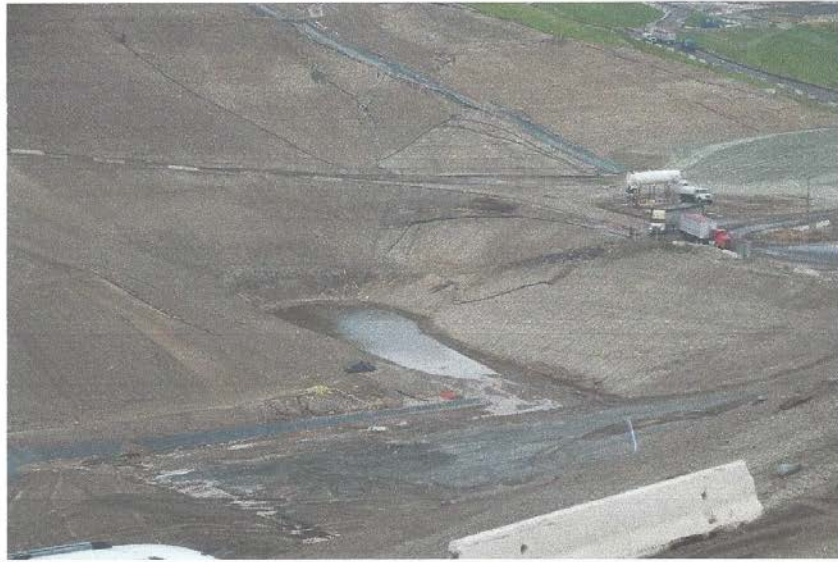
Photo 14: Water in moat around Cell CC4 Phase 3
