# Sunshine Canyon Landfill Independent Monitor Quarterly Site Monitoring Status Report January 1, 2014 - March 31, 2014

# **City of Los Angeles Department of City Planning**

# **County of Los Angeles Department of Regional Planning**

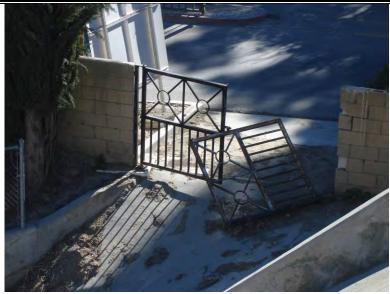
Photo 106: Terminal Basin Broken Access Gate: January 15, 2014

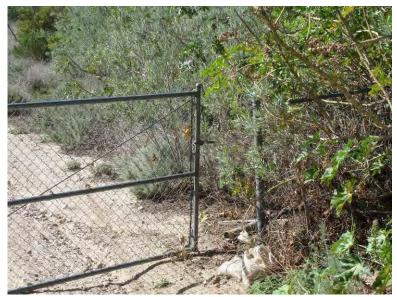
Photo 239: Southern Perimeter Gate in Oil Field Unlocked: March 12, 2014

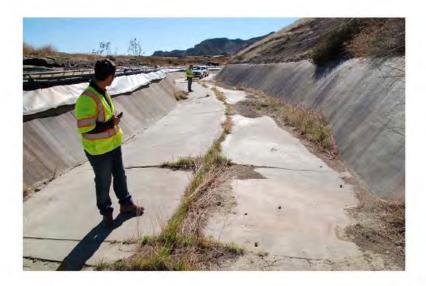
<u>Current Status/Comments</u> – During the January 15, 2014 site monitoring it was observed that along a portion of the westside drainage channel between Basin A and Basin D, the floor of the basin is uplifted in the middle with large cracks and weeds growing. This indicates the presence of moisture interacting with possible swelling soils and/or adjacent hillside movement. At the connection between the V-ditch feeding the channel, there is a gap between shotcrete and soil which is a conduit for water to infiltrate beneath the channel shotcrete into the subbase soil. Cracks mentioned in previous visits on the westside (native soil side) of the channel are getting worse, with concrete spalling and pieces falling off. On the eastside (landfill side) a tree is growing bigger, causing sidewall damage. In a large storm, the conditions noted above could worsen leading to significant damage to the channel.

Photo 3: Cracked and uplifted bottom of concrete channel between Basin A and Basin D

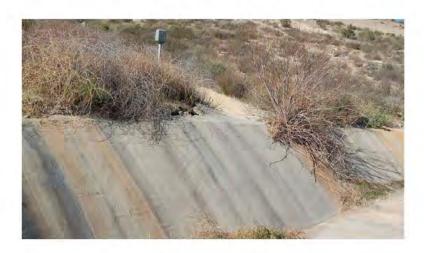
Photo 4: V ditch feeding the channel – Note gap between shotcrete and soil at connection V-ditch channel

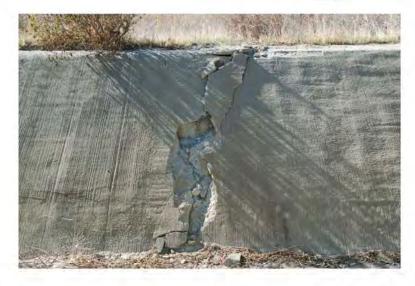
Photo 5: V Spalling and falling concrete on channel between Basin A and Basin D
