**Sunshine Canyon Landfill
Independent Monitor
Quarterly Site Monitoring Status Report
January 1, 2018 – March 31, 2018**

City of Los Angeles Department of City Planning

County of Los Angeles Department of Regional Planning

May 25, 2018

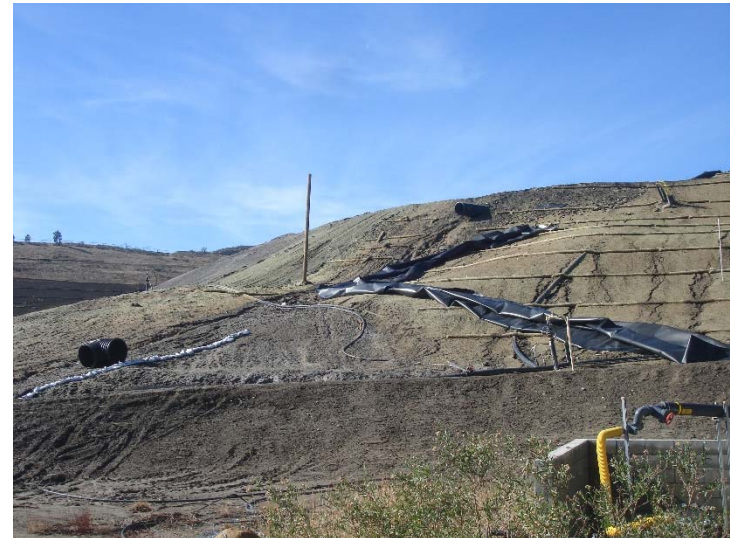
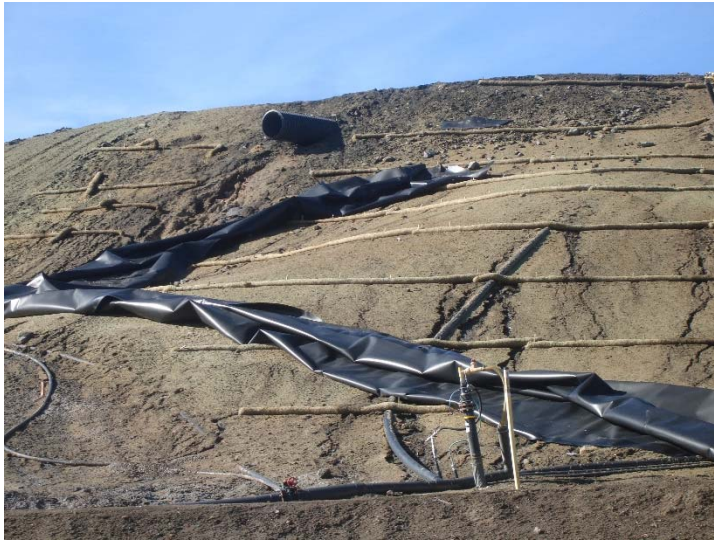
Photo 340: CC3B Slope Drainage Failure: January 10, 2018

Photo 341: CC3B Slope Drainage Failure: January 10, 2018

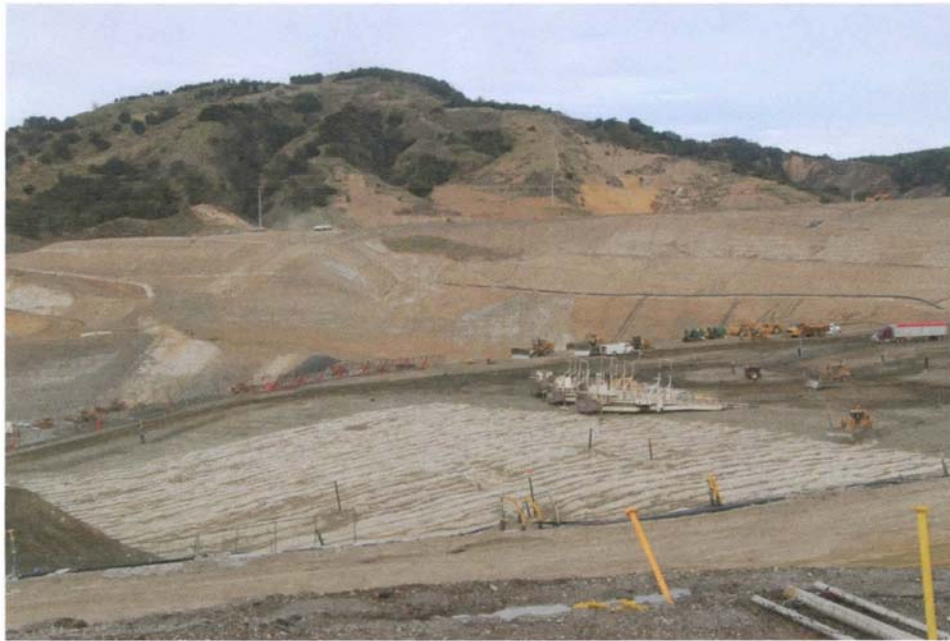
Photo 1: ADC Cell CC4 Phase 1

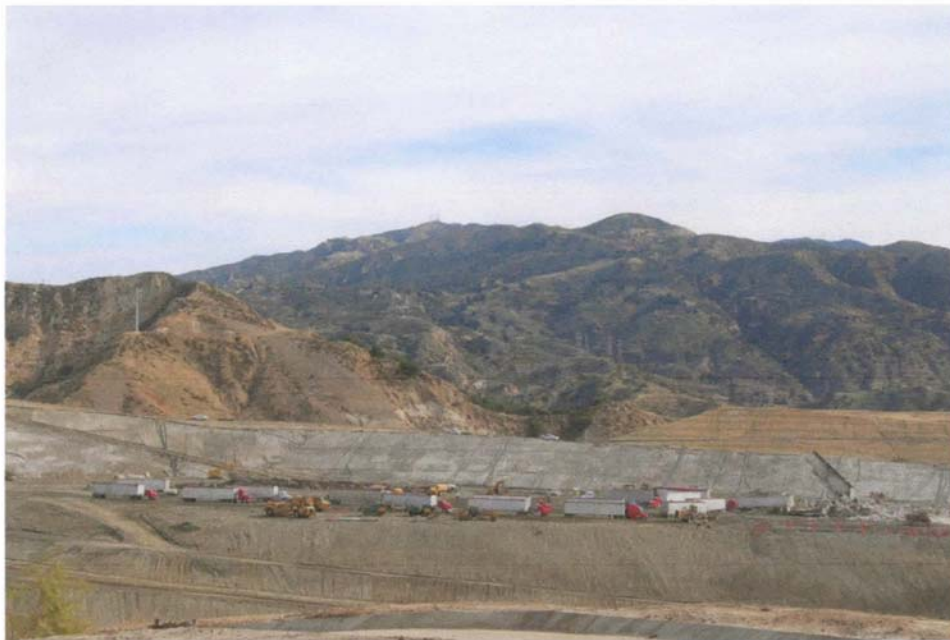
Photo 2: Waste Disposal in Cell CC4 Phase 1

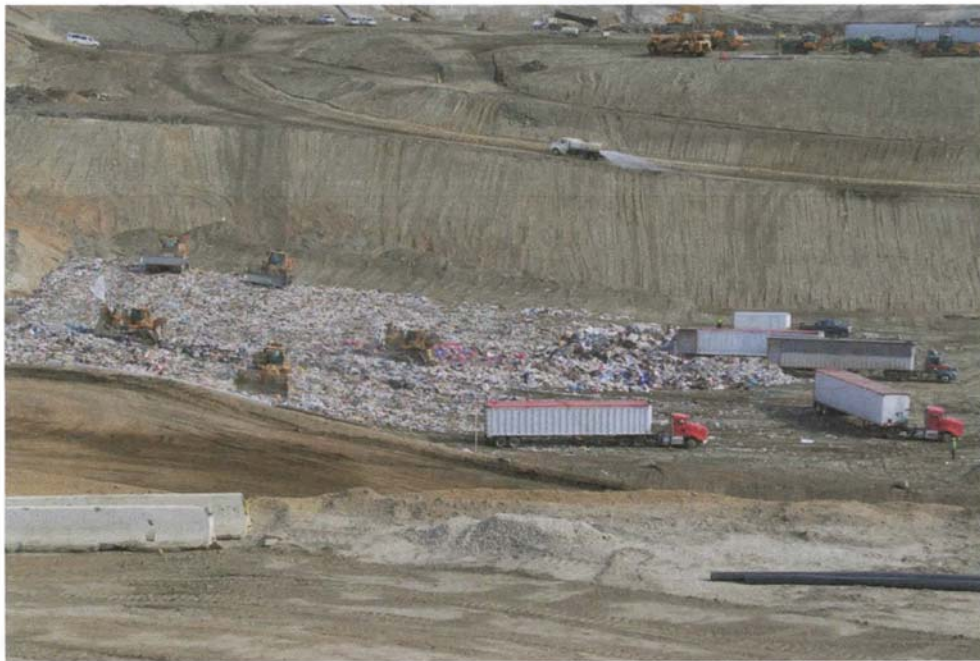
Photo 3: Waste Disposal in Cell CC4 Phase 2

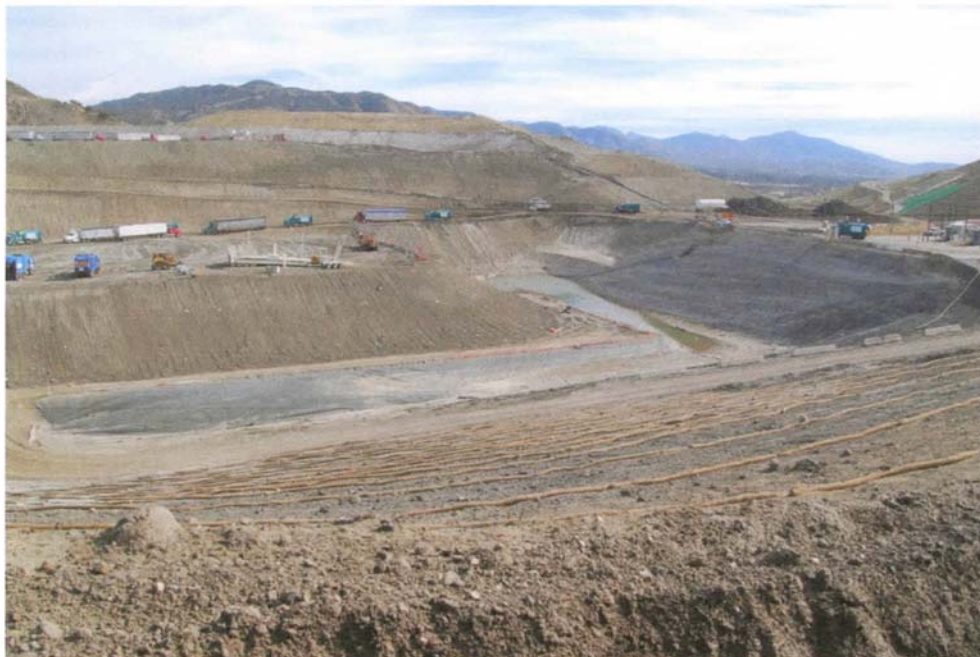
Photo 4: Water Channel Collection and Pond at Cell CC4 Phase 2

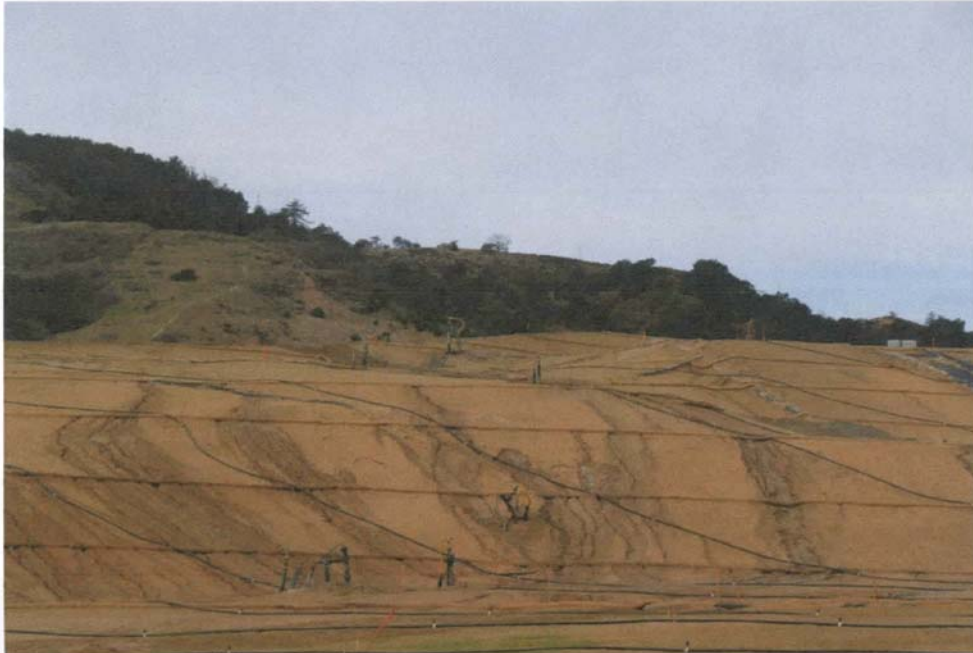
Photo 5: Gullies on Hydro seeded Slope – Note Gullies Under Wattles

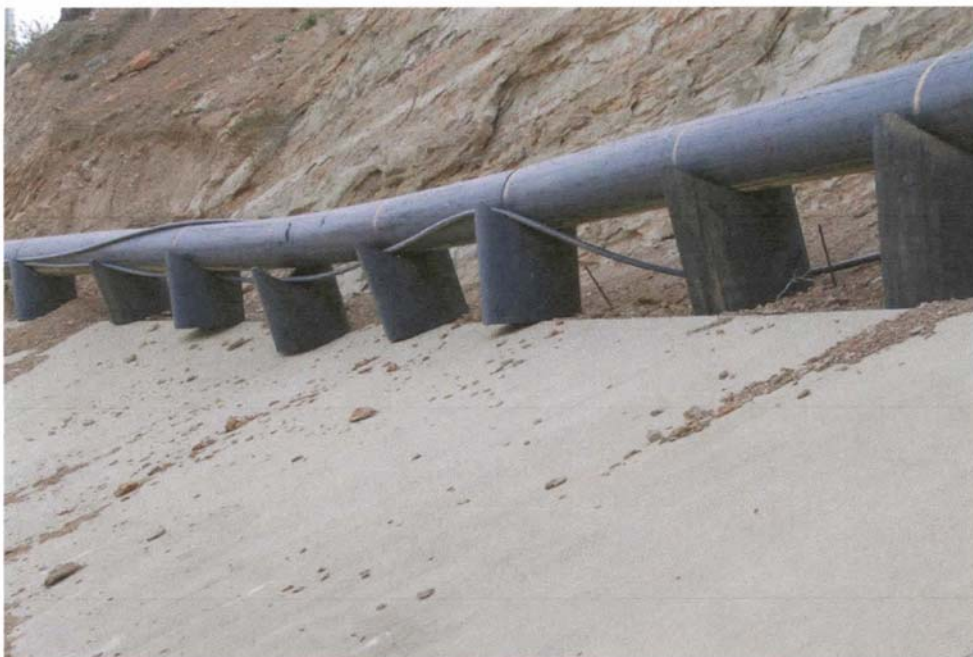
Photo 6: Leaning Supports of LFG Header to Flare 3 in Basin A

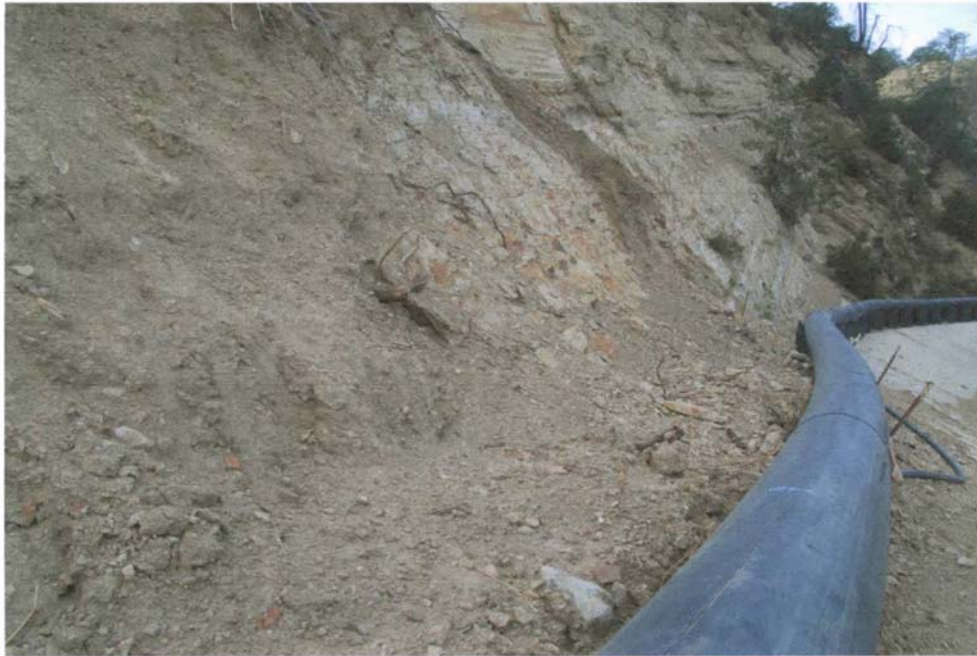
Photo 7: Sloughed Soil and Pushing Against f LFG Header to Flare 3 in Basin A

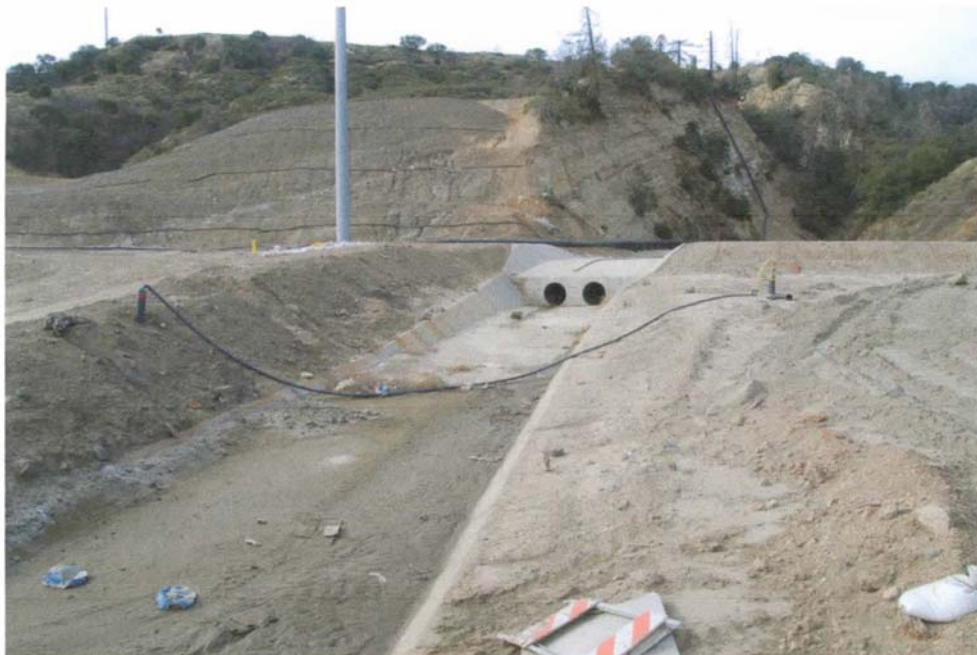
Photo 8: Cleaned up Drain Pipes of Basin A

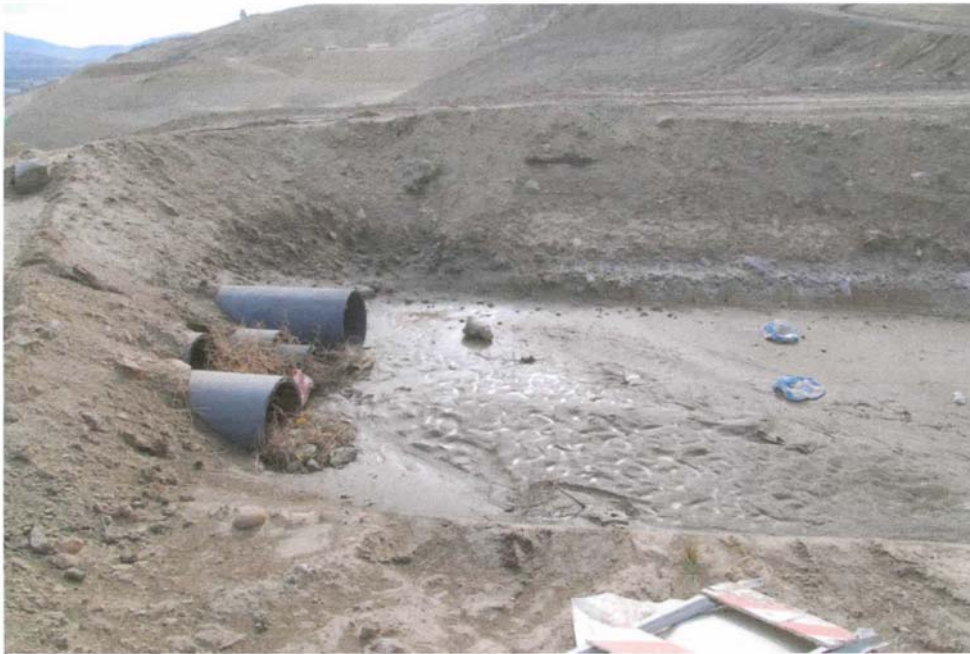
Photo 9: Sediments Accumulation Downgradient from Basin A – Pipes do not offer enough flow capacity

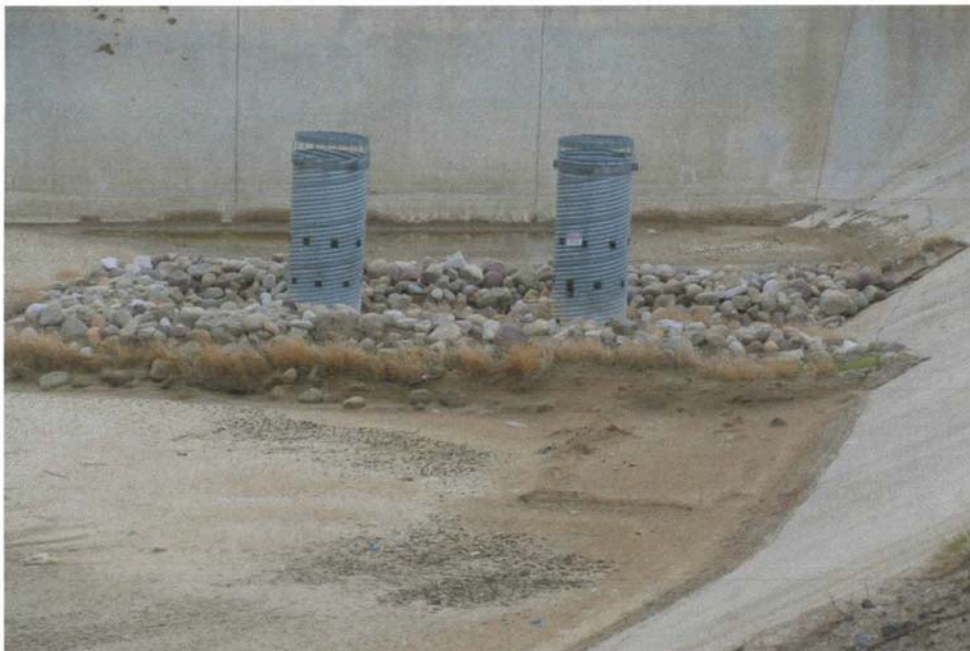
Photo 10: Sediments Accumulated in Basin B

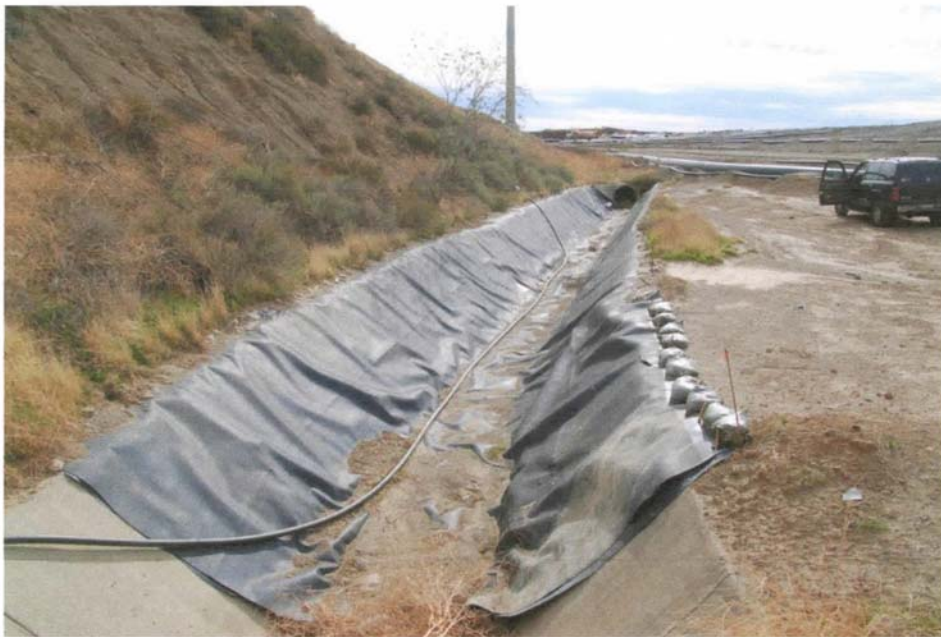
Photo 11: Repaired and Re-attached Geomembrane in Shotcrete Channel between Basin D and Access Road to Flare 9 and 10

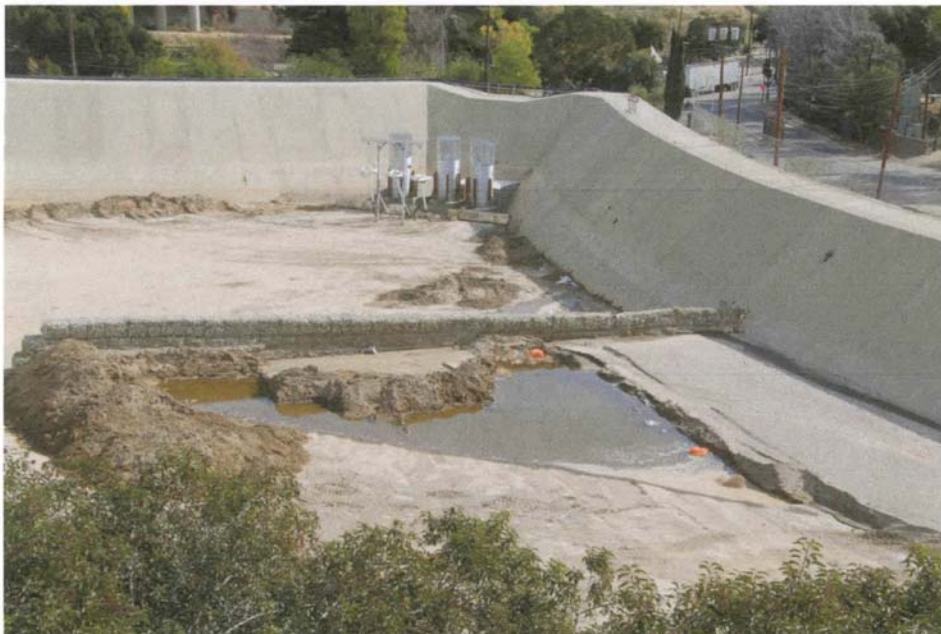
Photo 12: Condition at Terminal Basin

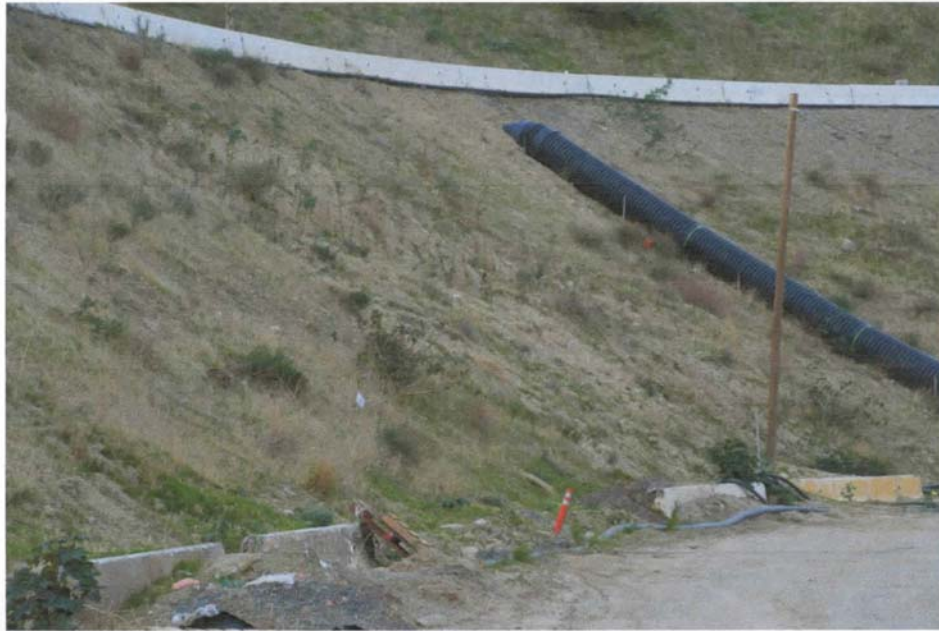
Photo 13: Sloughing Tilted Utility Pole on Embankment of Main Access Road near Entrance of Terminal Basin

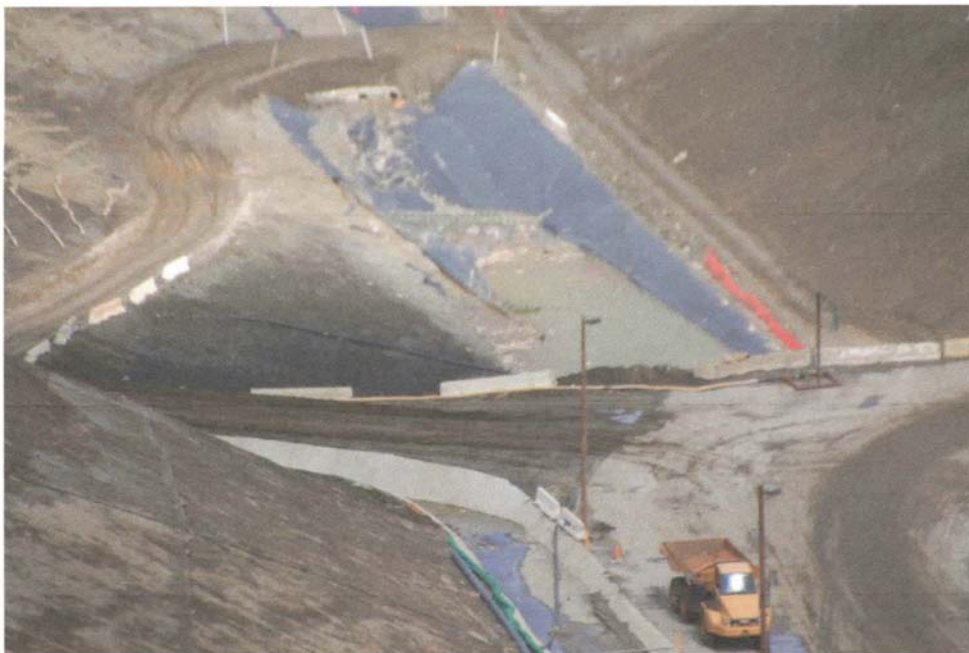
Photo 2: Water and refuse in lined collection area around Cell CC4 Phase 2

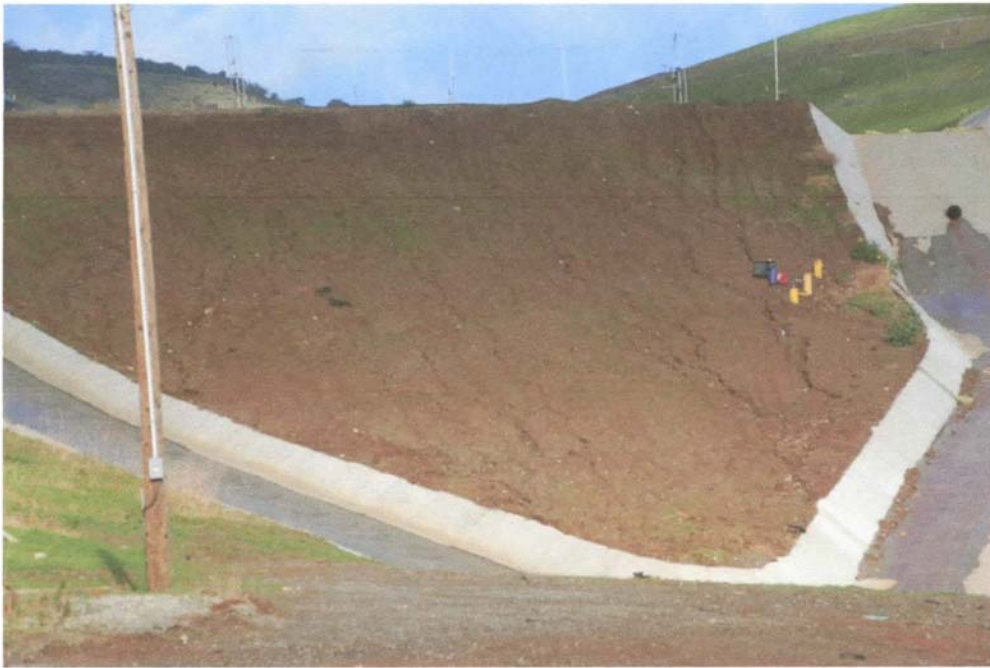
Photo 3: Erosion on upstream face of earthen basin embankment at Cell CC3

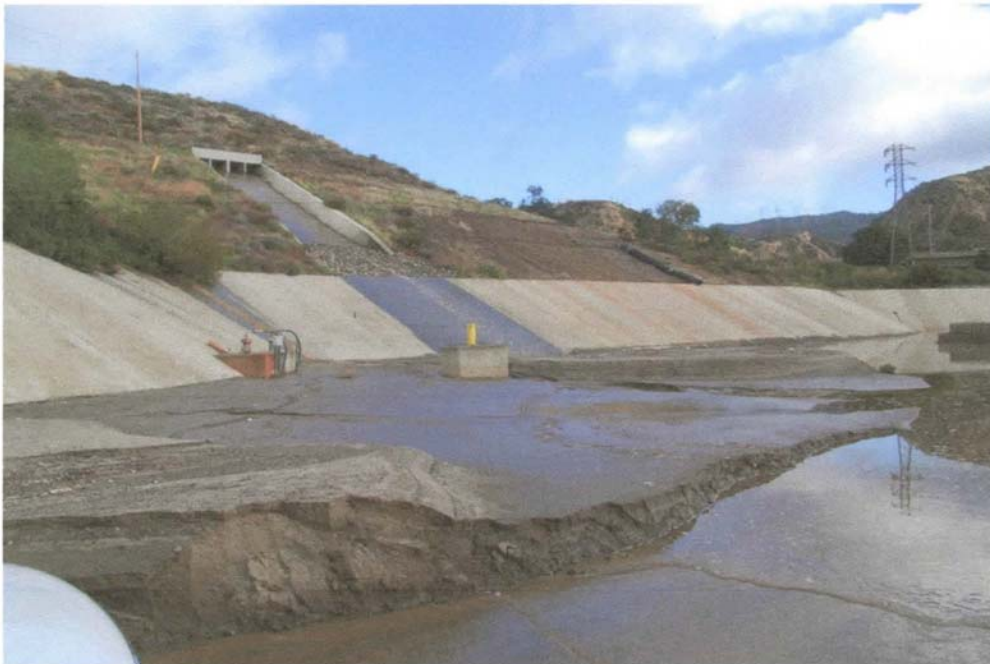
Photo 4: Sediments in Terminal Basin Upstream of Gabion Wall

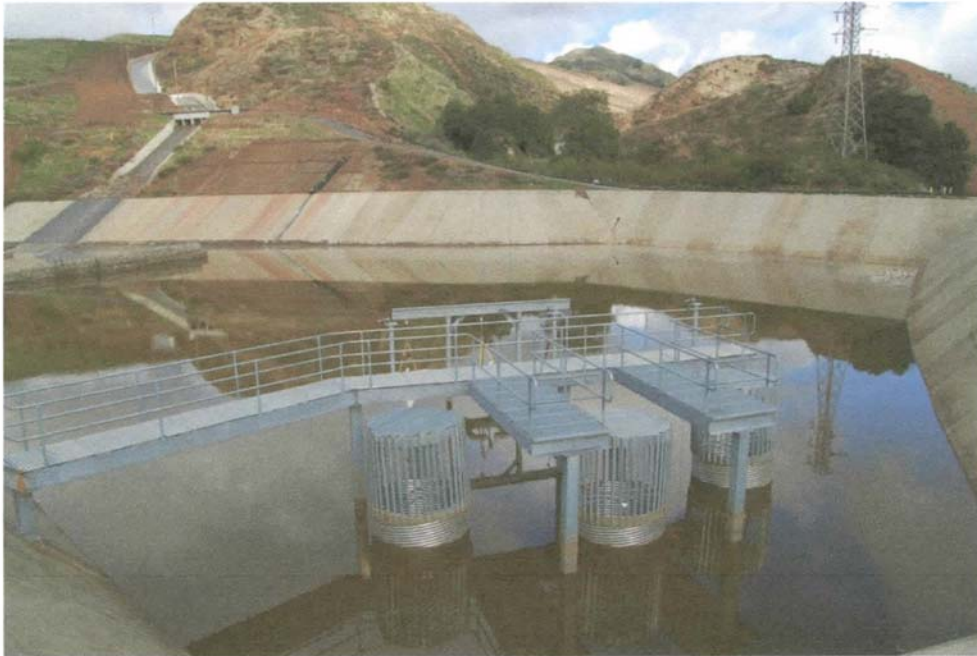
Photo 5: Water Accumulation in Terminal Basin

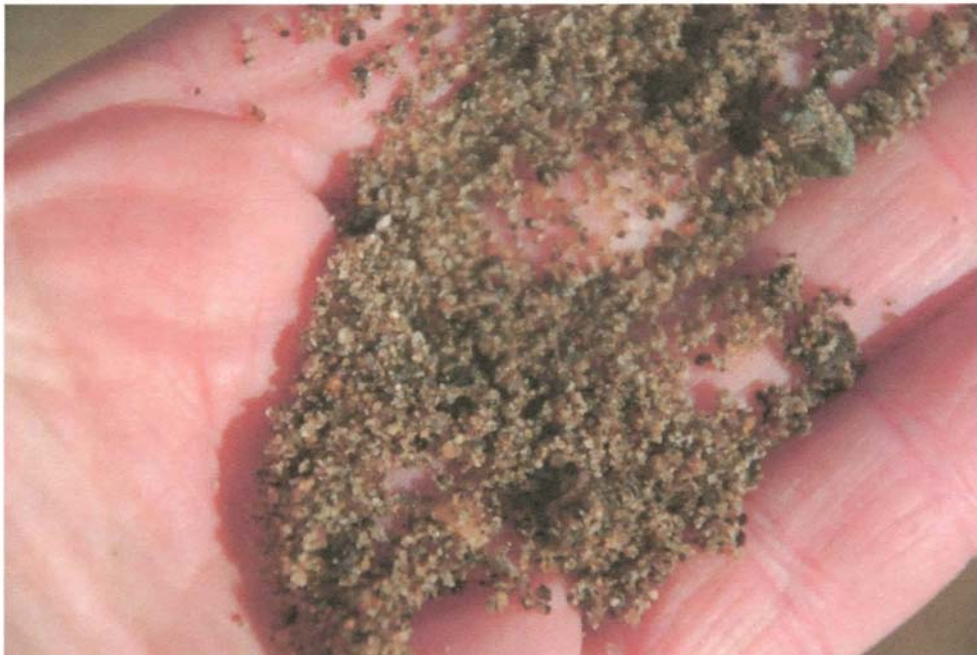
Photo 6: Coarse Sand Observed in Sediments in Terminal Basin

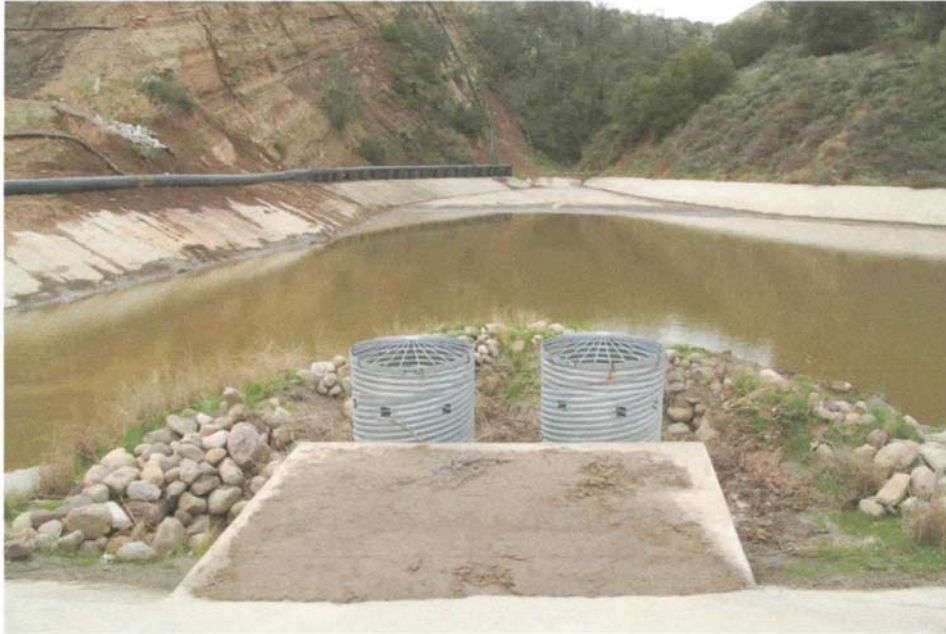
Photo 7: Stormwater Accumulation in Basin A

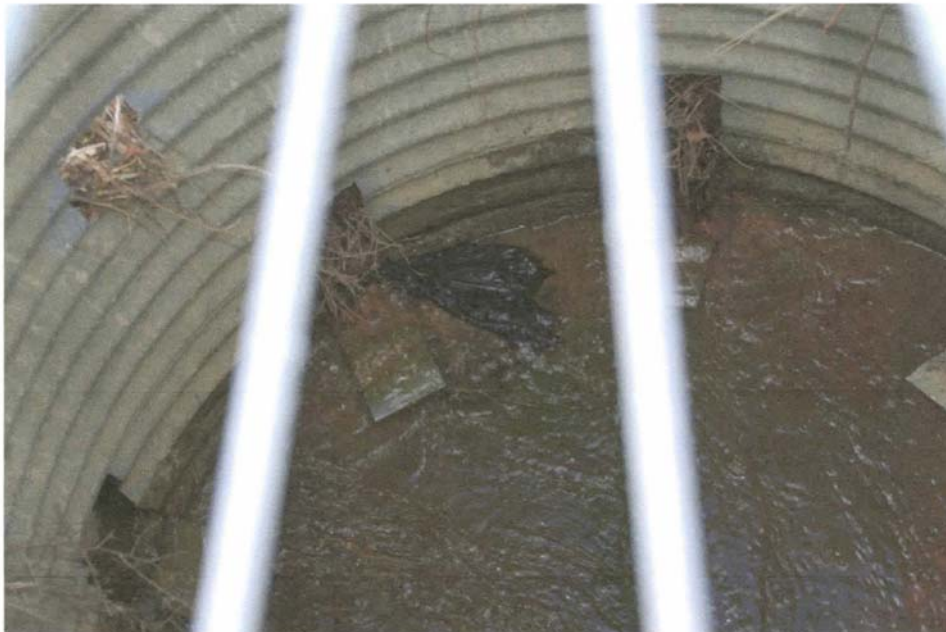
Photo 8: Stormwater Draining through Weepholes in Risers in Basin A

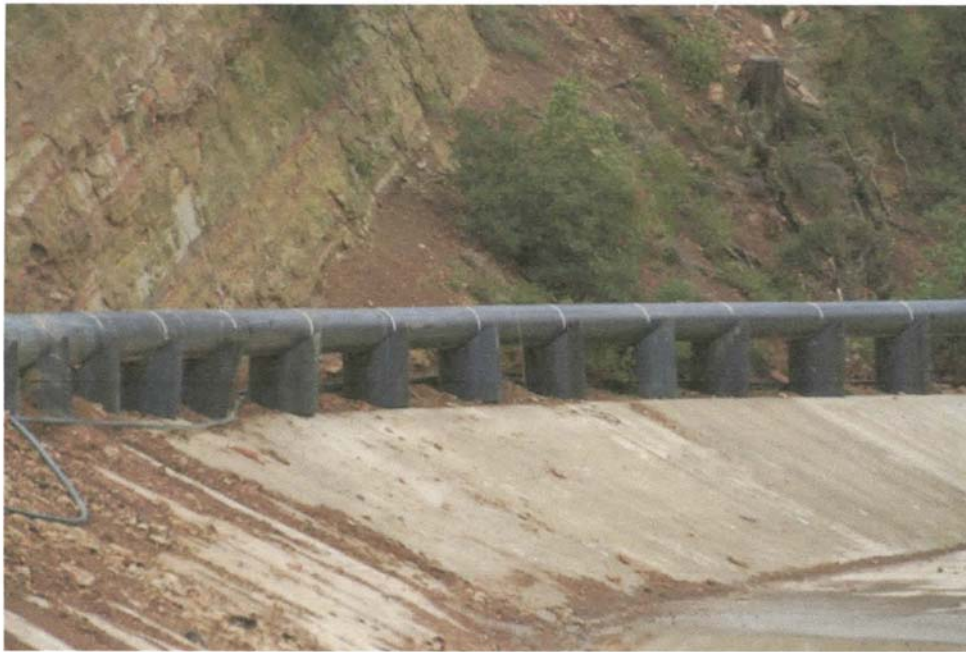
Photo 9: Leaning Supports of LFG Header to Flare 3 in Basin A

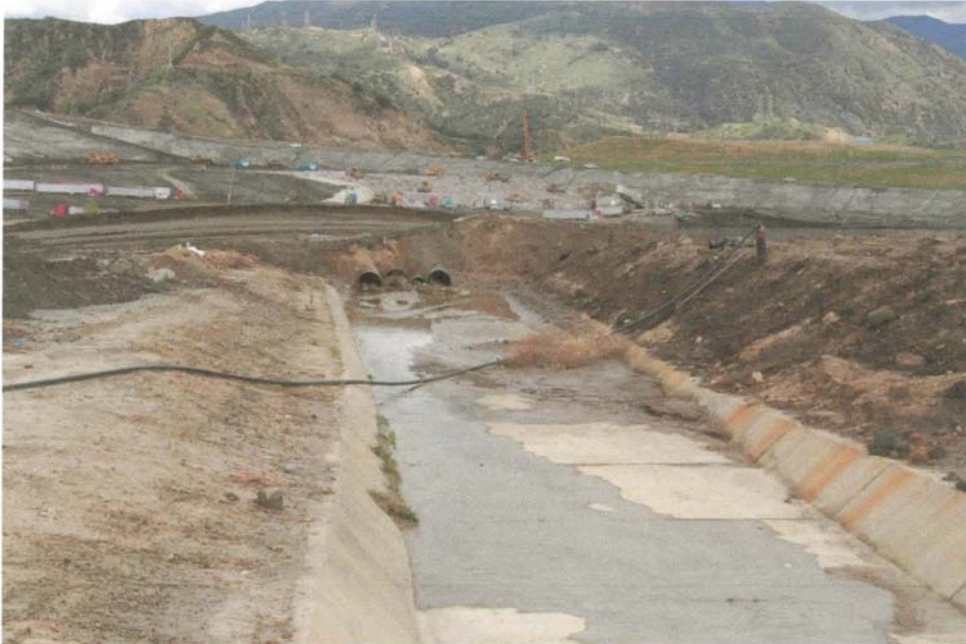
Photo 10: Sediments Accumulation Downgradient from Basin A – Pipes may not offer enough flow capacity

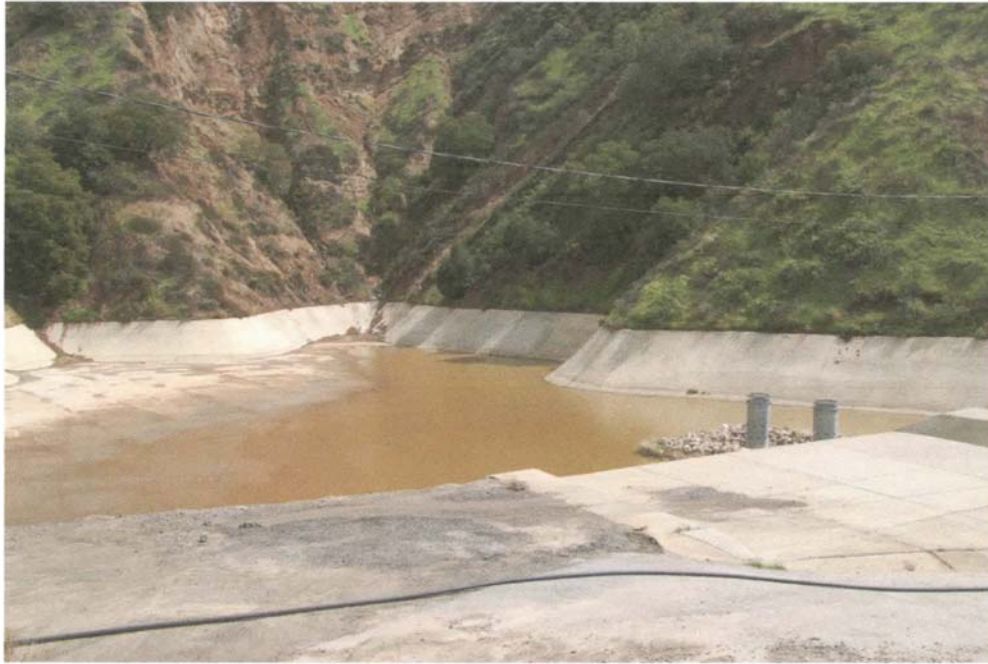
Photo 11: Water accumulated in Basin B

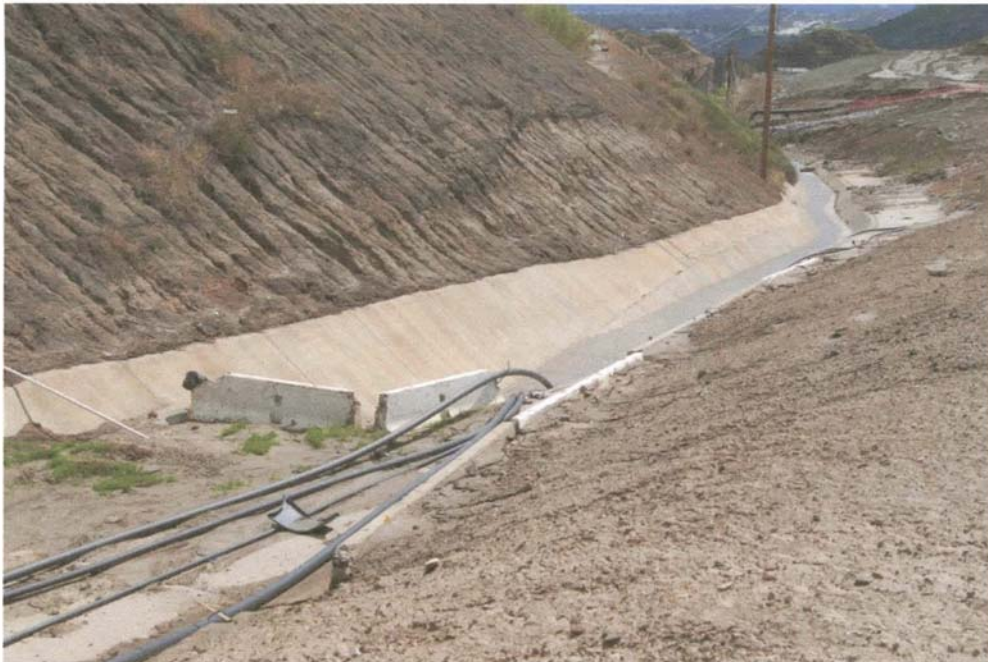
Photo 12: Water draining out of basin B in concrete channel

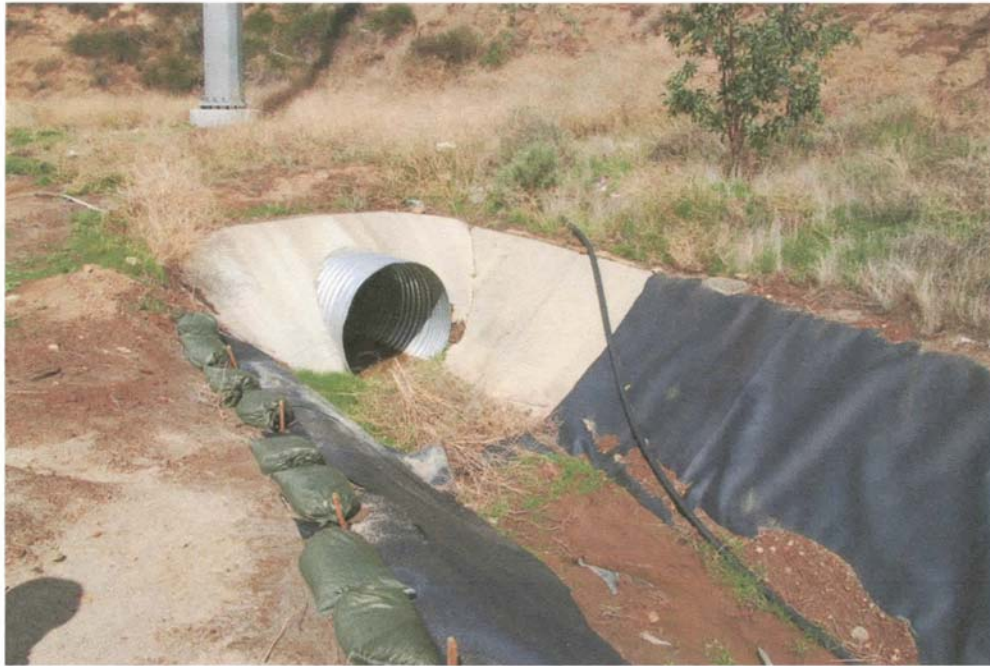
Photo 13: Sediment and debris on geomembrane lined channel between Basin B and Basin D

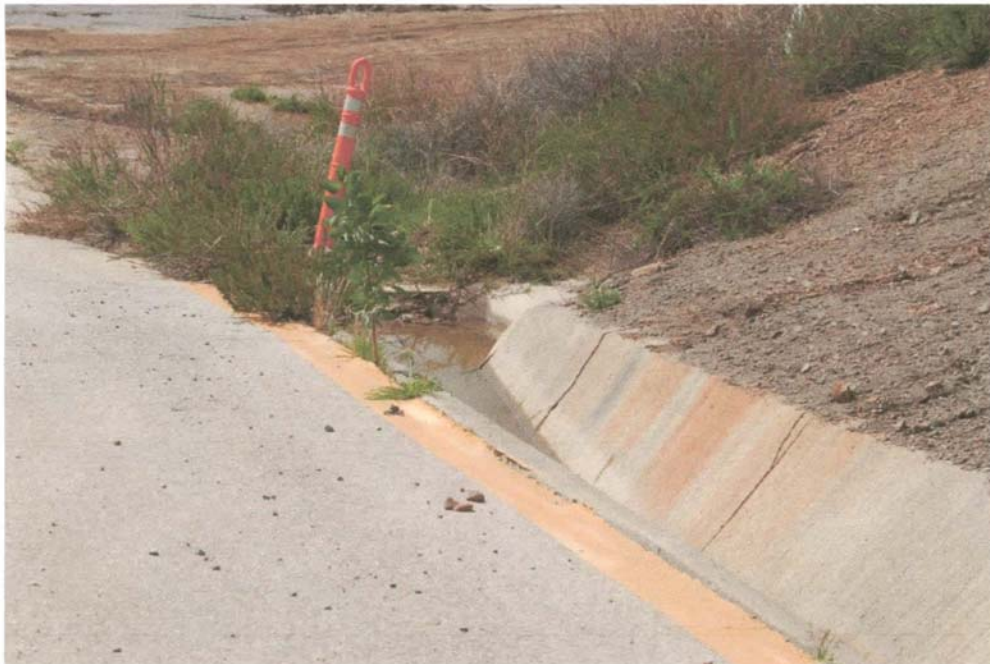
Photo 14: Blocked drainage ditch along access road to Flare 9-11

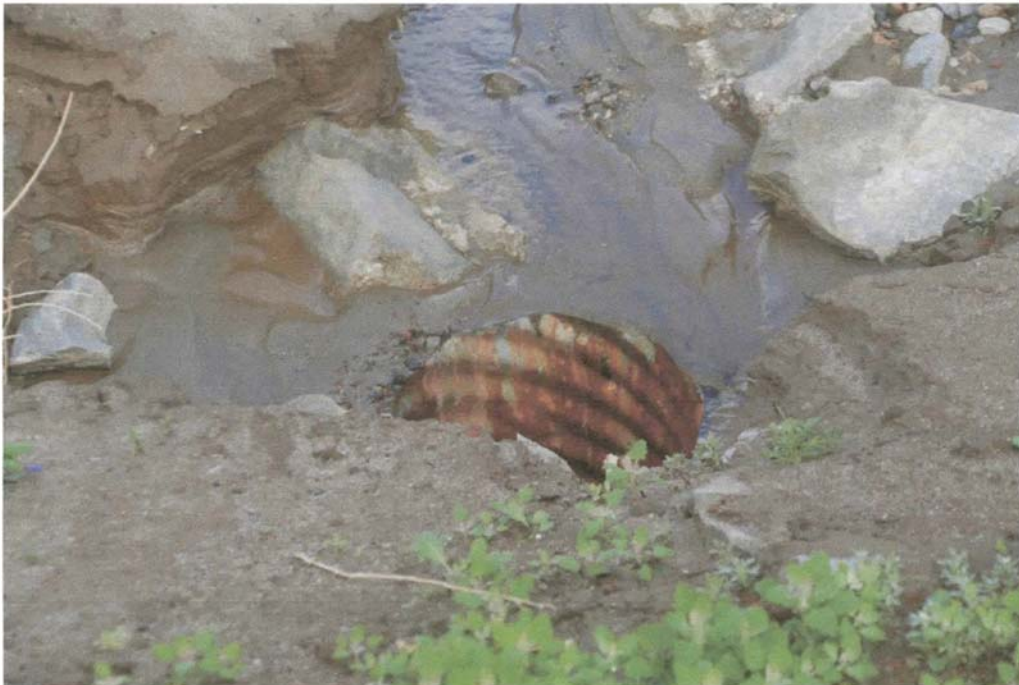
Photo 15: Unguarded intake to drain pipe in earthen basin at Cell CC3

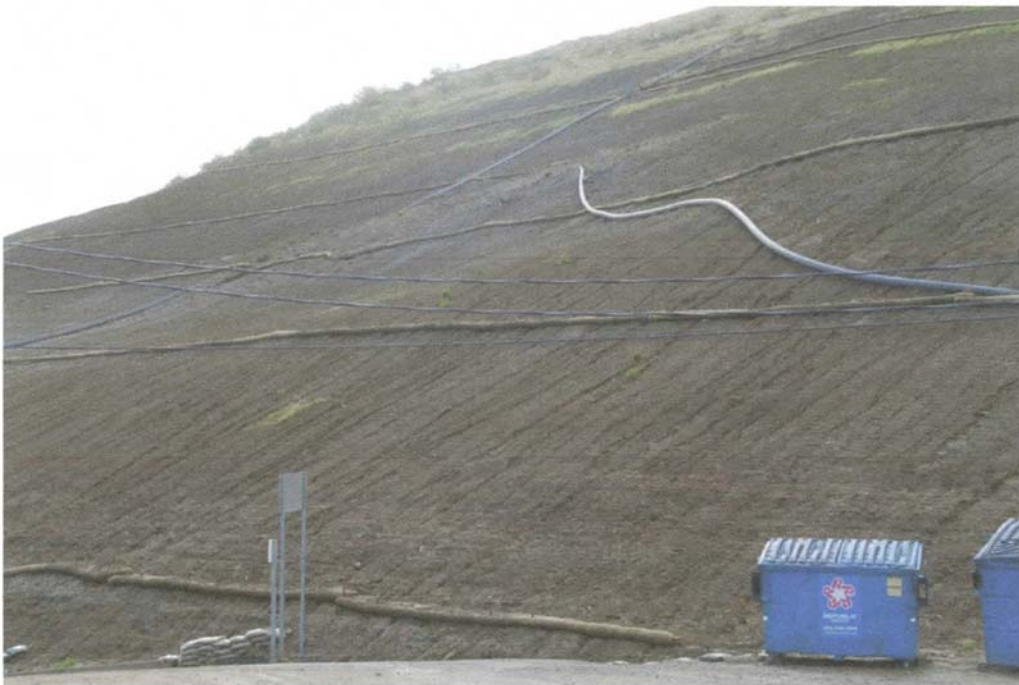
Photo 16: Slump near Administration Pad

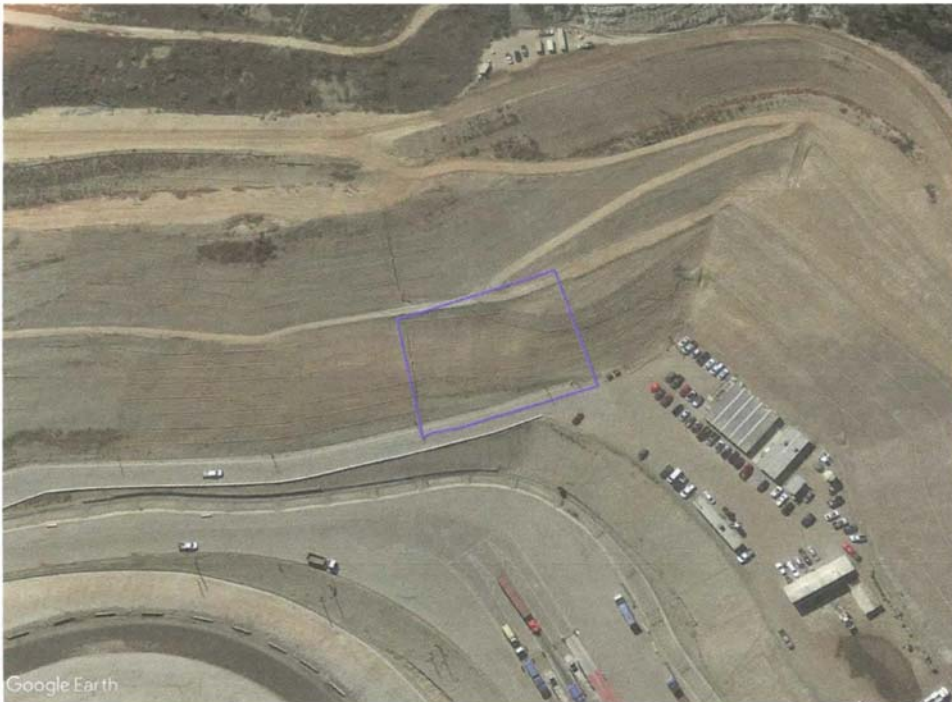
Figure 1: Area along Access Road to Administration Pad with Slump

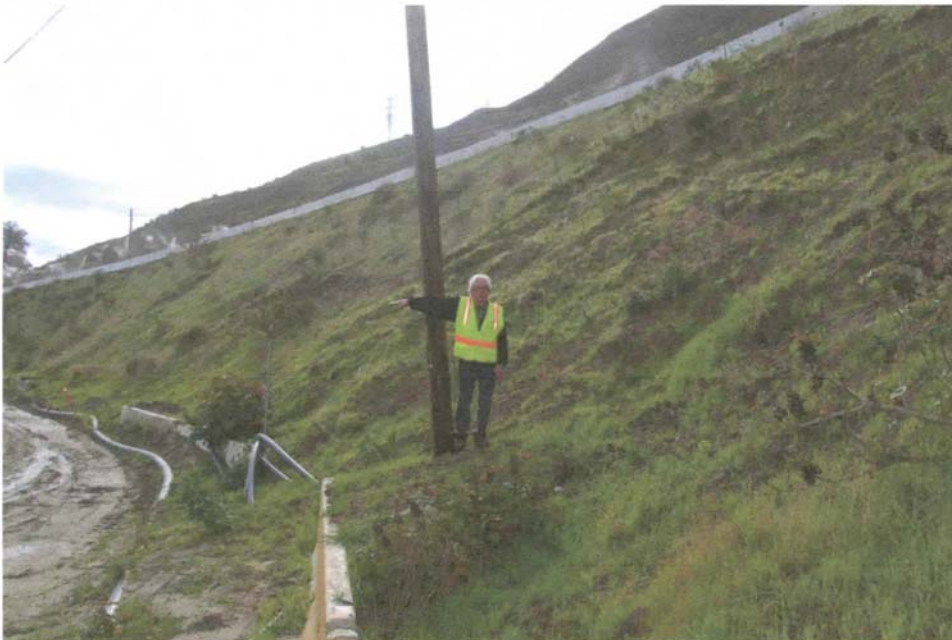
Photo 17: Sloughing and Tilted Utility Pole on Embankment of Main Access Road near Entrance of Terminal Basin

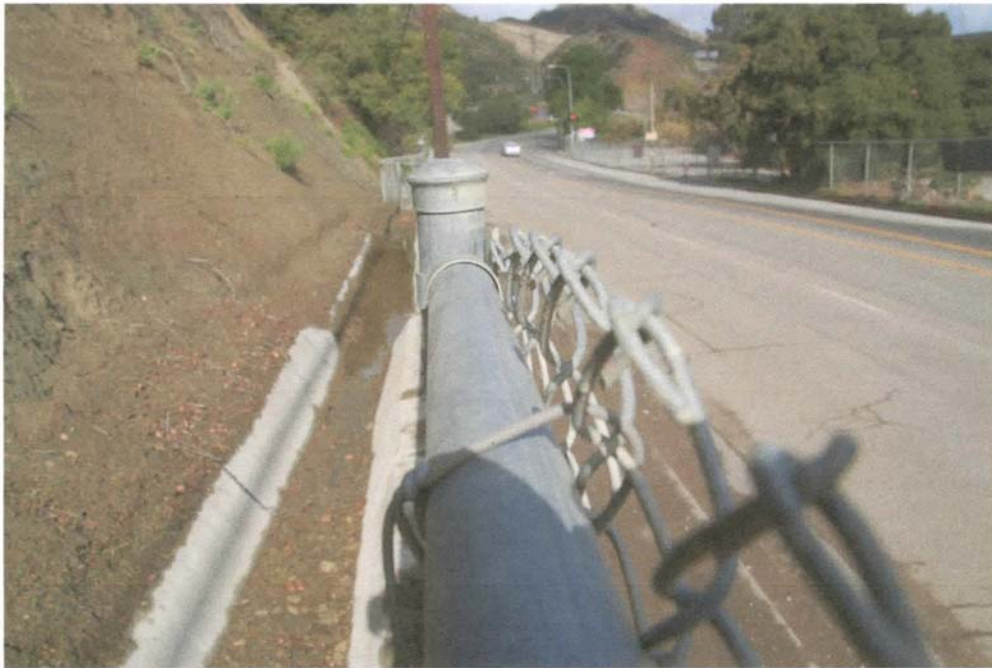
Photo 18: Soil in drainage swale on top of wall along San Fernando Road

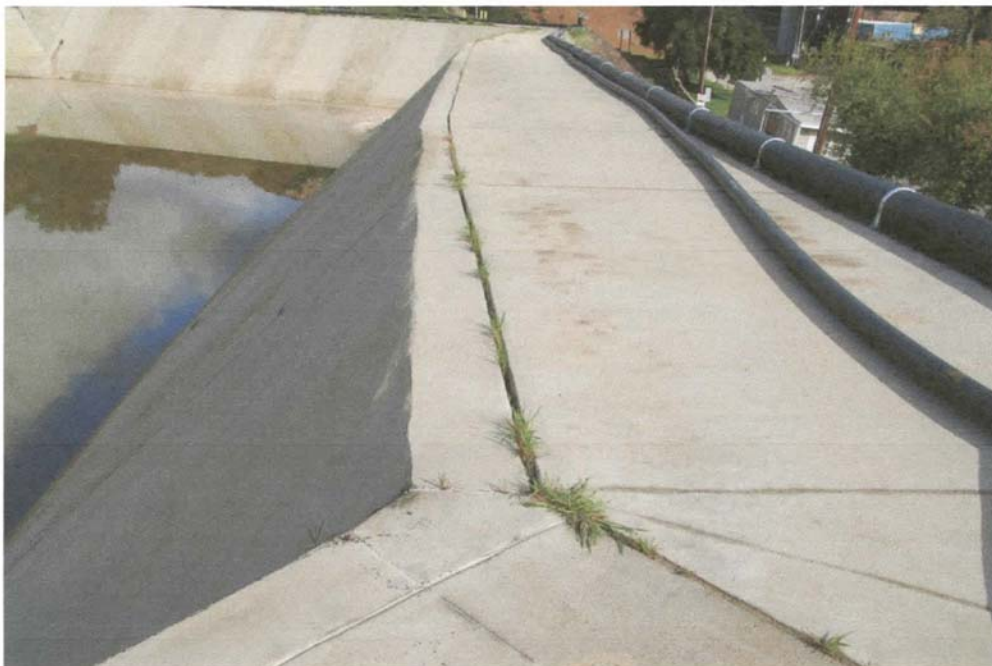
Photo 19: Gap between slabs at Terminal Basin

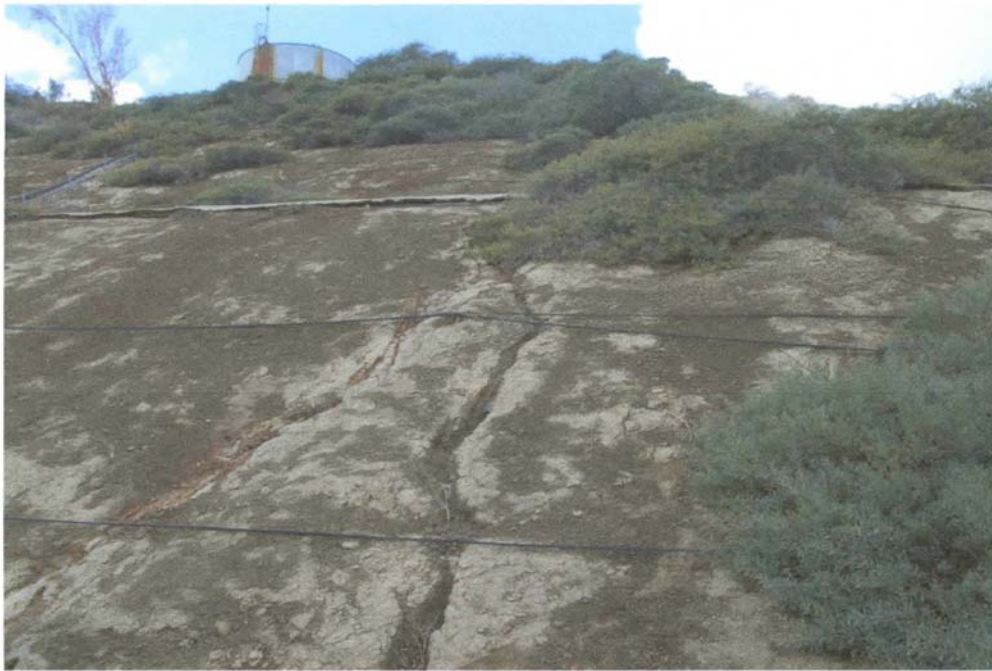
Photo 20: Undermined drainage channel on hillside near Flare 1

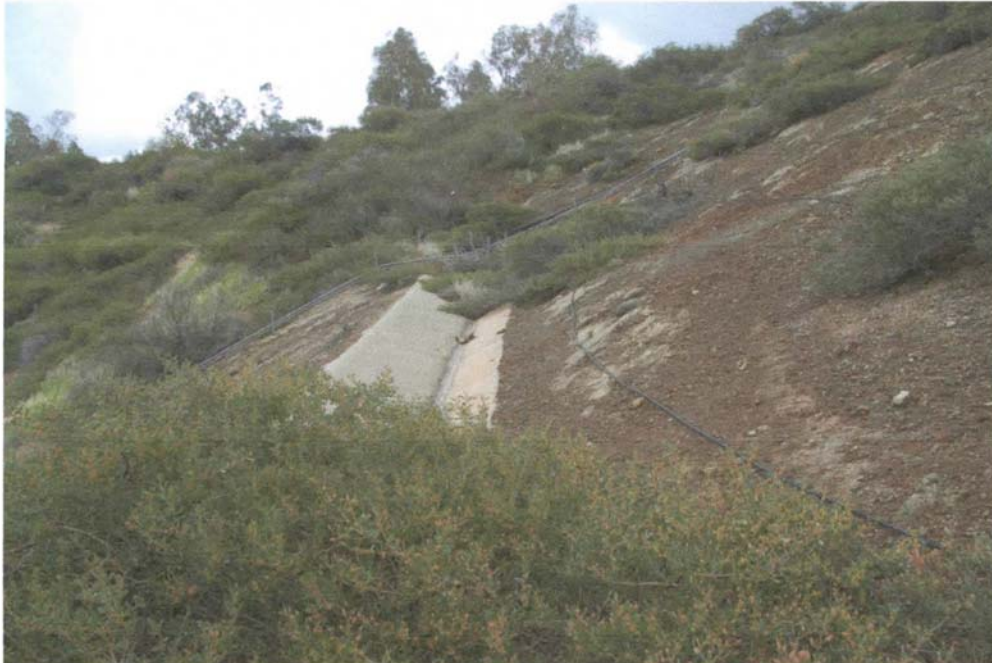
Photo 21: Sediment and vegetation in drainage channel on hillside near Flare 1
