**Sunshine Canyon Landfill
Independent Monitor
Quarterly Site Monitoring Status Report
January 1, 2018 – March 31, 2018**

City of Los Angeles Department of City Planning

County of Los Angeles Department of Regional Planning

May 25, 2018

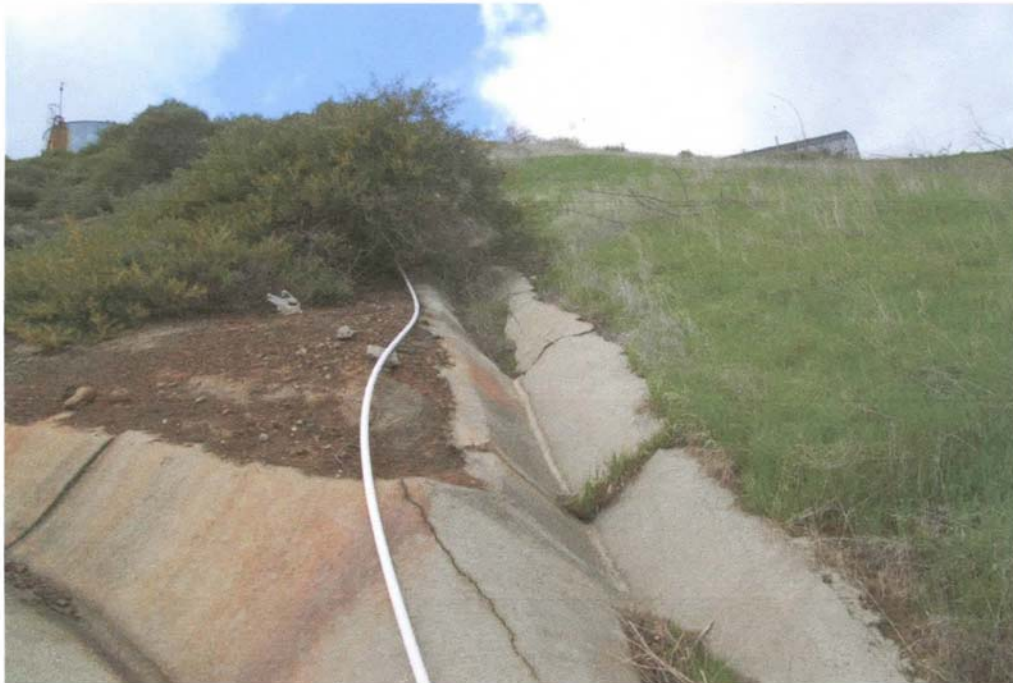
Photo 22: Cracks in drainage channel on hillside near Flare 1
