**Sunshine Canyon Landfill  
Independent Monitor  
Quarterly Site Monitoring Status Report  
July 1, 2016 – September 30, 2016**

**City of Los Angeles Department of City Planning**

**County of Los Angeles Department of Regional Planning**

December 22, 2016

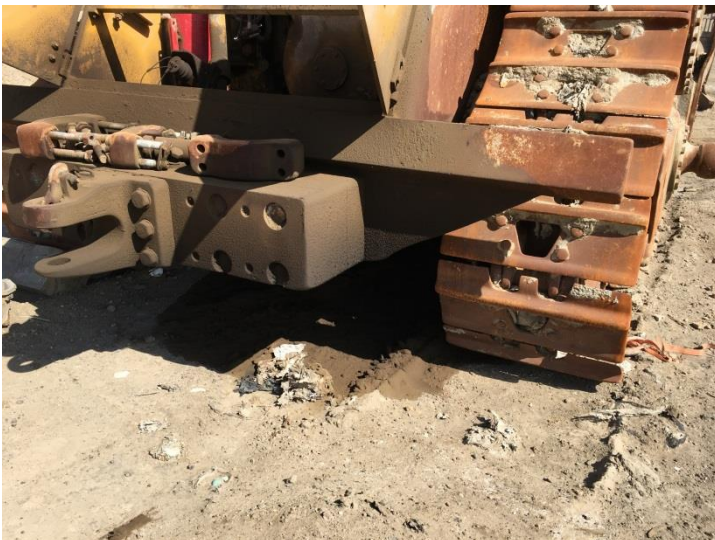
**Photo 11: D-6 Leaking Oil near Basin A: July 12, 2016**

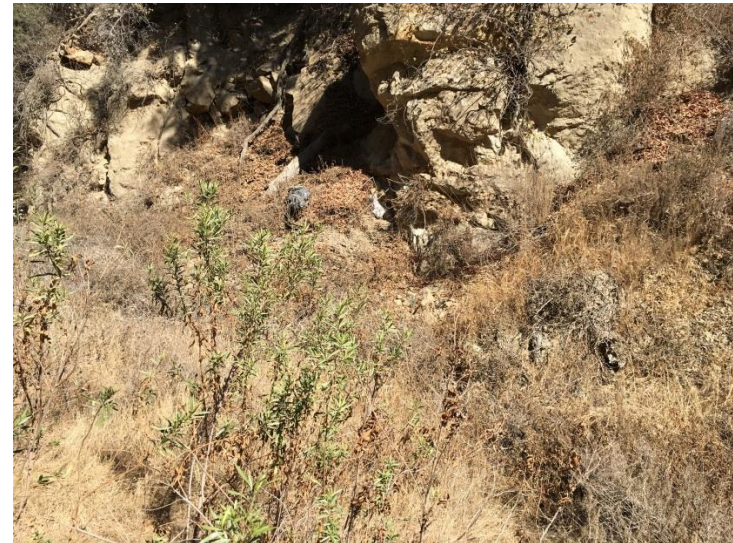
**Photo 32: Basin A Litter & Trash: September 14, 2016**

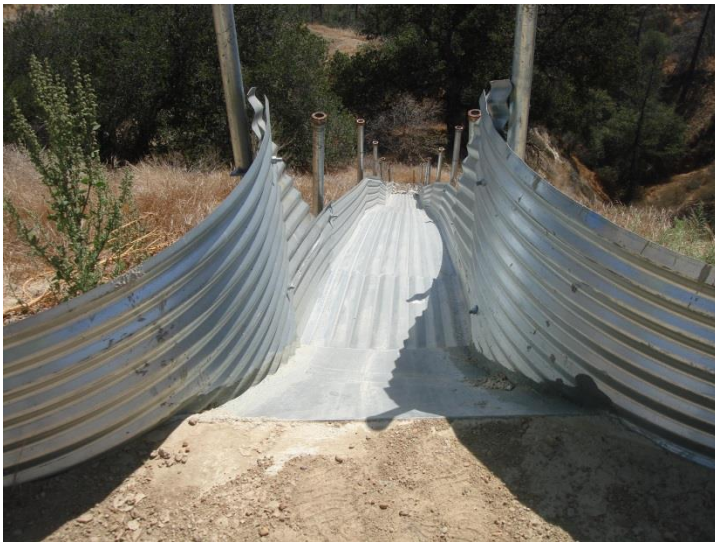
**Photo 67: Edison Drainage Hazard: July 12, 2016**

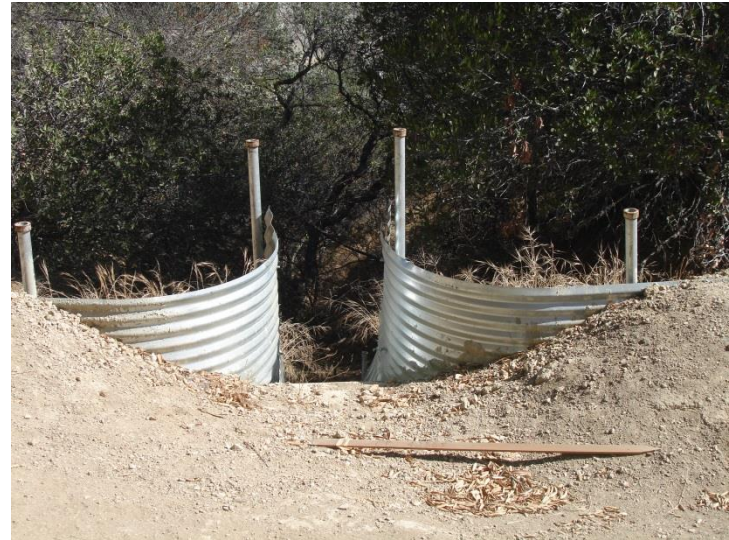
**Photo 68: Edison Unprotected Drainage Hazard at pole 38:  
September 14, 2016**

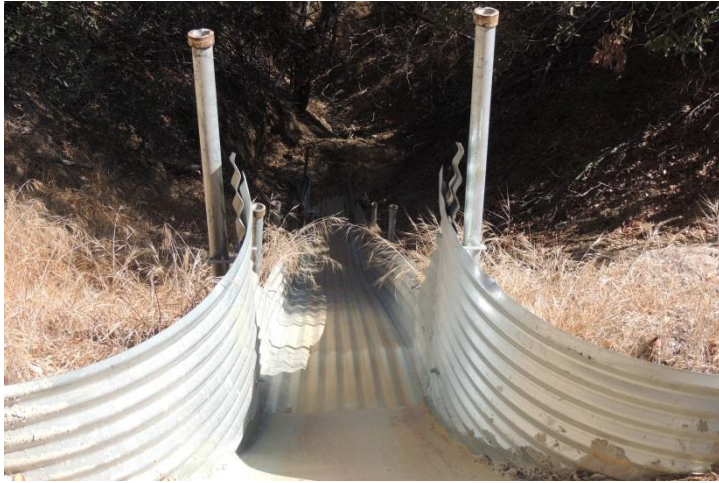
**Photo 69: Edison Unprotected Drainage Hazard at pole 38:  
September 14, 2016**

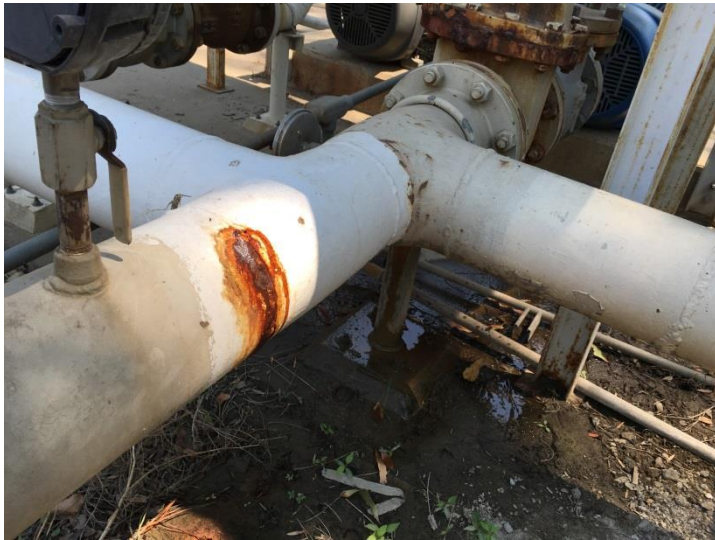
**Photo 217: Potable Water Piping Leaks: August 24, 2016**

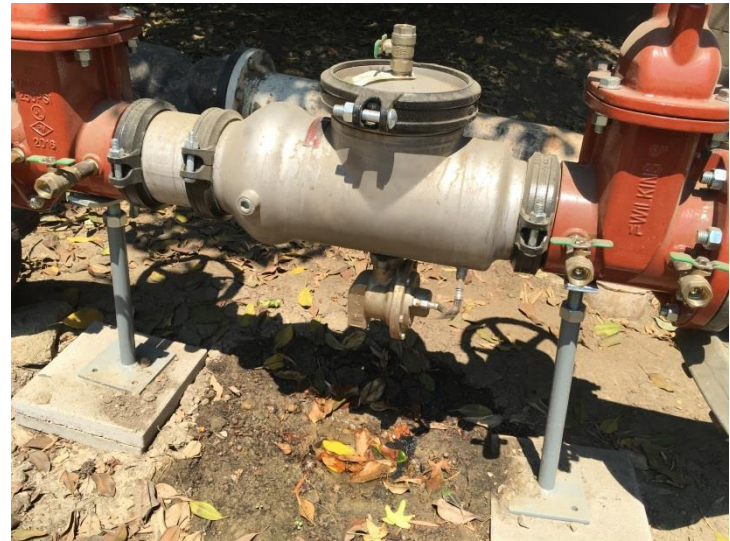
**Photo 218: Potable Water Piping Leaks: August 24, 2016**

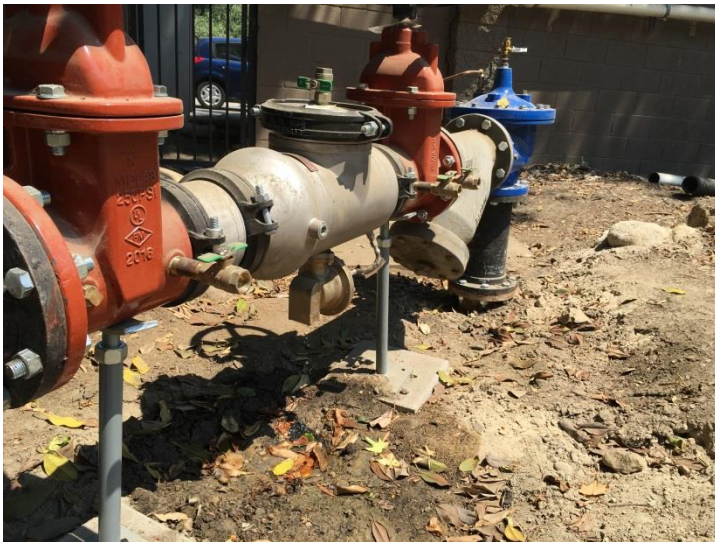
**Photo 219: Potable Water Piping Leaks: August 24, 2016**

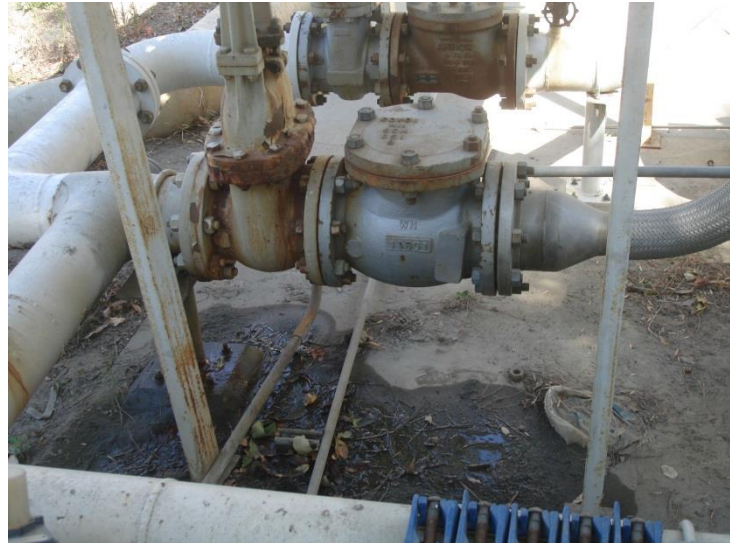
**Photo 220: Potable Water Supply Piping Leak: September 27, 2016**

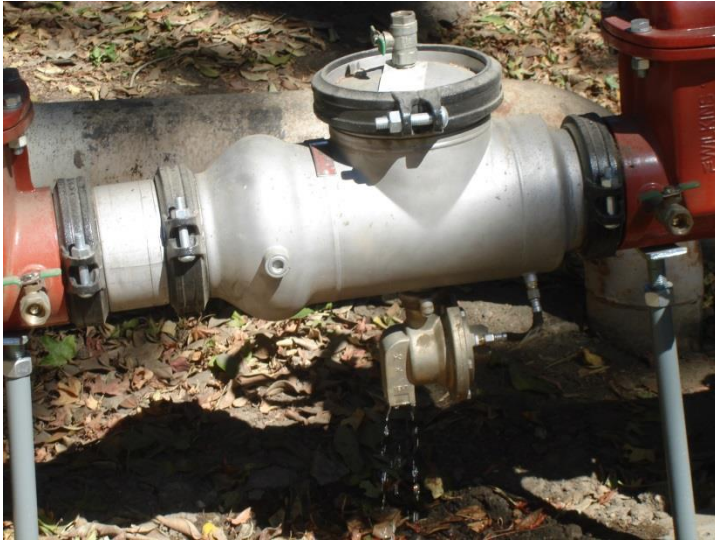
**Photo 221: Potable Water Supply Piping Leak: September 27, 2016**

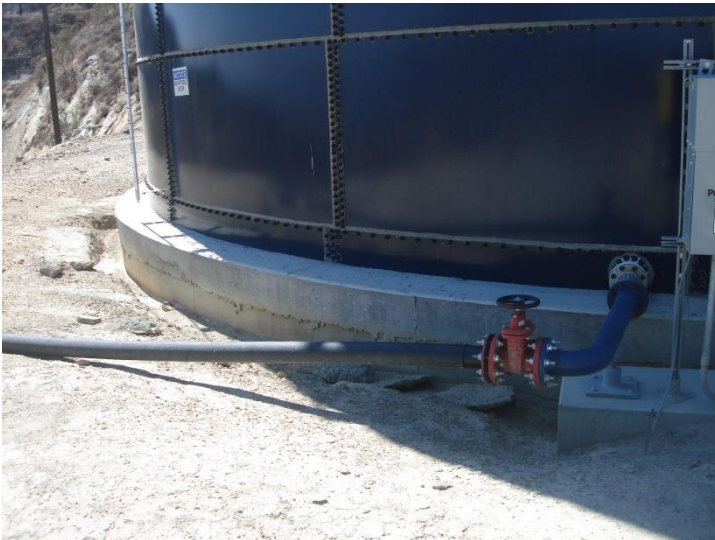
**Photo 227: Deck A Water Tank Foundation Not Backfilled:  
September 14, 2016**

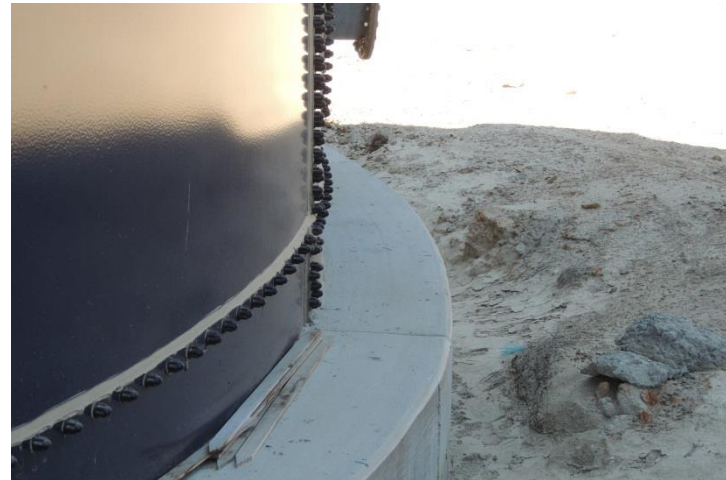
**Photo 228: Deck A Water Tank Foundation Not Backfilled:  
September 14, 2016**

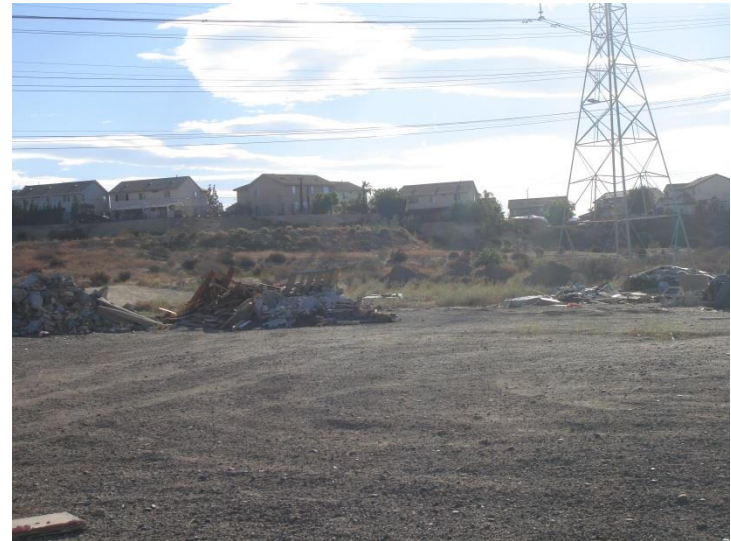
**Photo 414: Rancho Cascades Illegal Dumping: September 27, 2016**

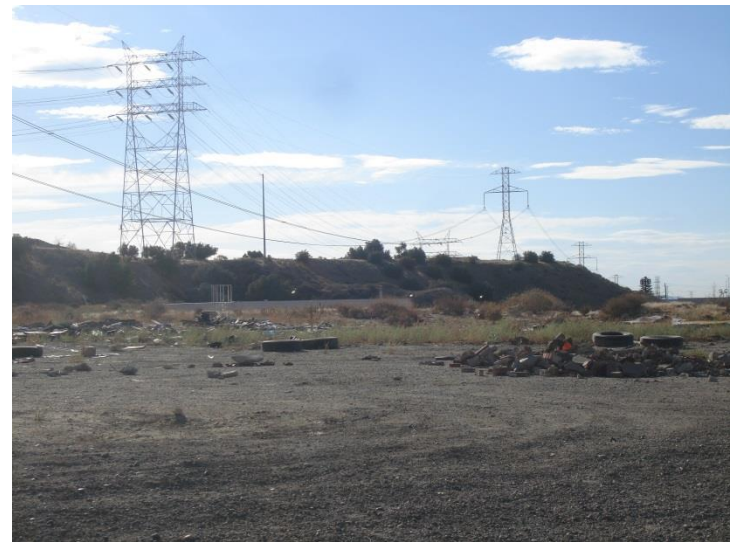
**Photo 416: Rancho Cascades Illegal Dumping: September 27, 2016**

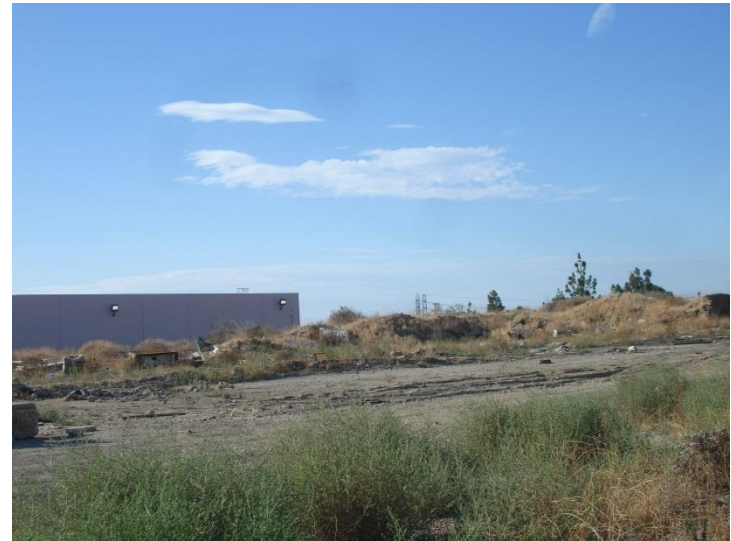
**Photo 418: Rancho Cascades Illegal Dumping: September 27, 2016**

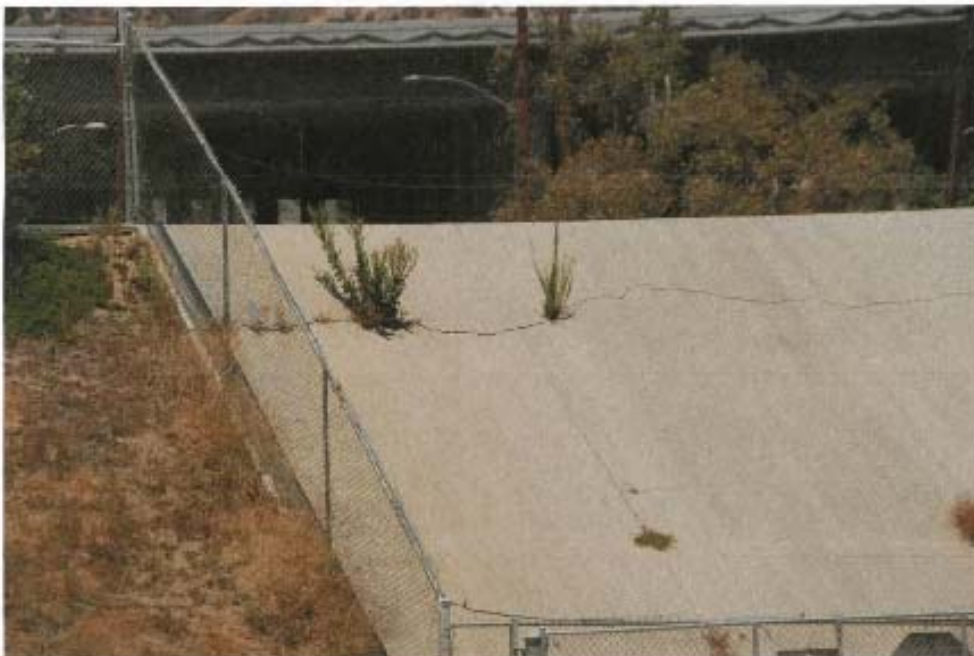
In early July, vegetation was growing out of cracks in the terminal basin concrete sidewall. Cracks in the concrete should be repaired.

Photo 6: Vegetation in cracks on outside wall of the Terminal Basin
