**Sunshine Canyon Landfill  
Independent Monitor  
Quarterly Site Monitoring Status Report  
April 1, 2017 – June 30, 2017**

**City of Los Angeles Department of City Planning**

**County of Los Angeles Department of Regional Planning**

October 10, 2017

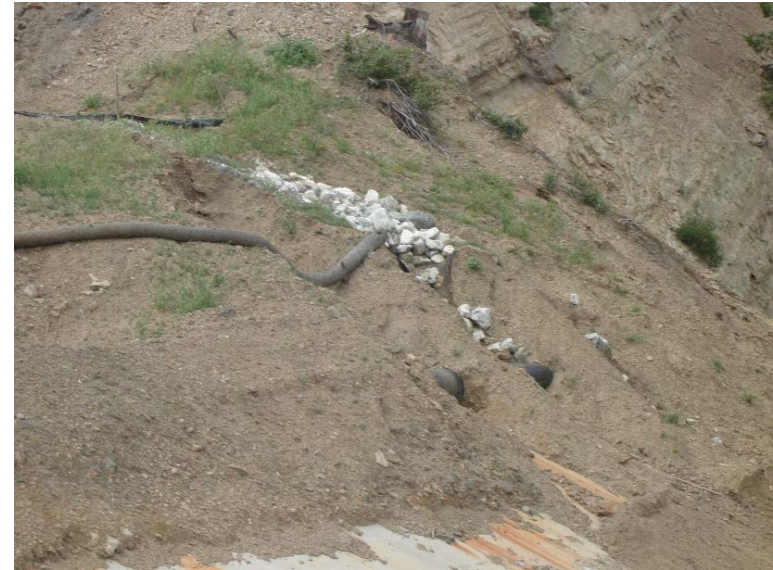
**Photo 2: Basin A: April 18, 2017**

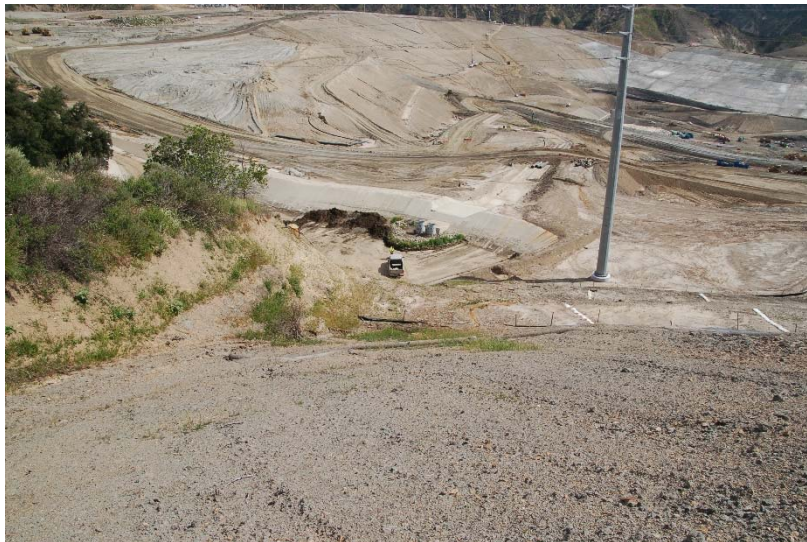
**Photo 3: Slope Erosion near Basin A: April 18, 2017**

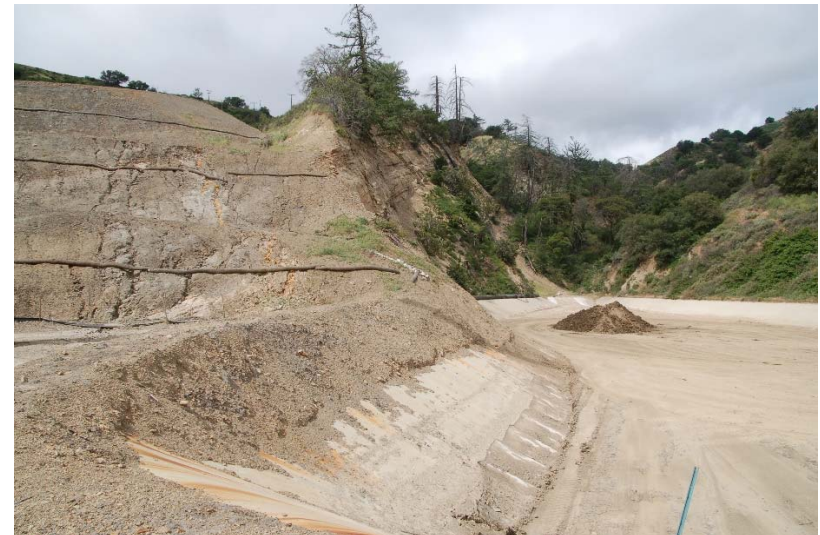
**Photo 4: Slope Erosion near Basin A: April 18, 2017**

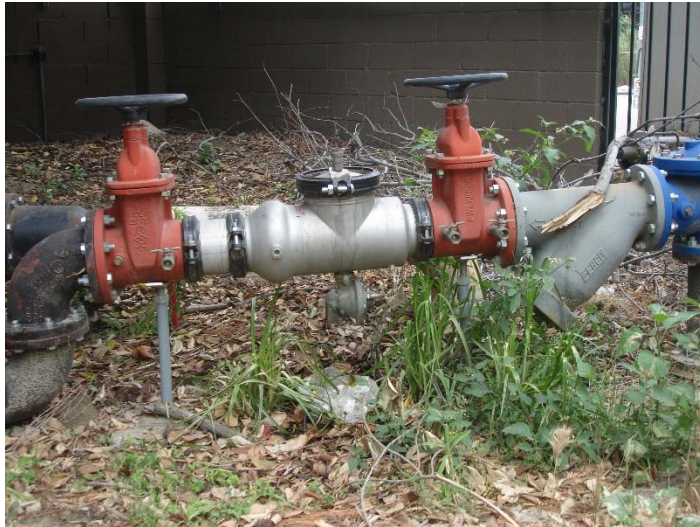
**Photo 237: Potable Water Supply Leak: May 9, 2017**

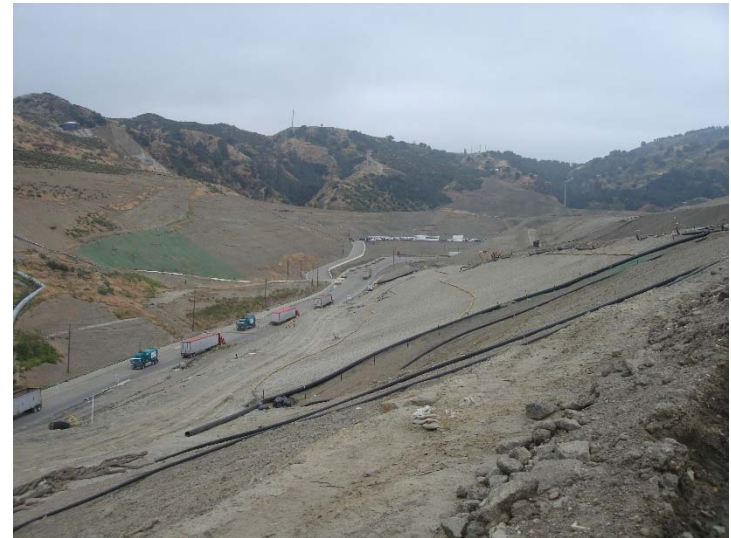
**Photo 288: CC3A Slope Repair: May 9, 2017**

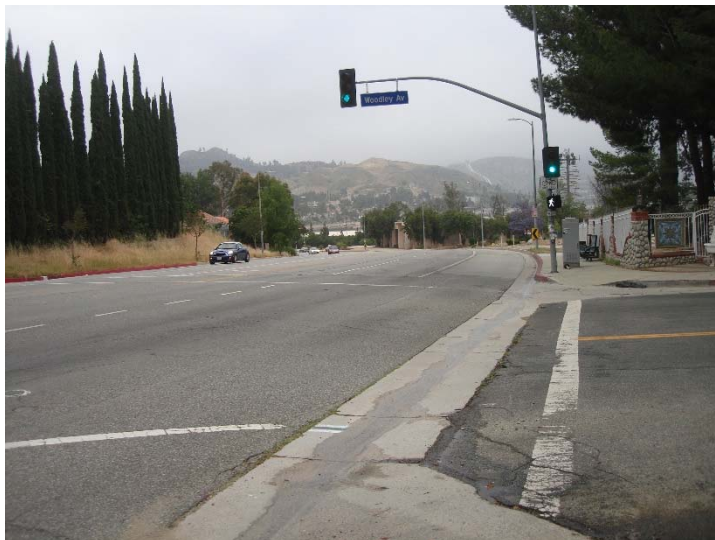
**Photo 483: Balboa Blvd at Woodley Ave Road Liquid Stains:  
May 9, 2017**

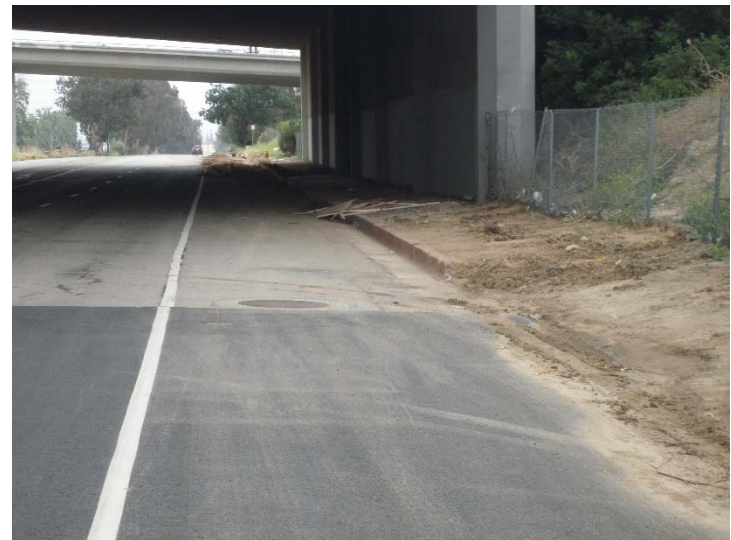
**Photo 484: San Fernando Road near I-5 Overpass: May 9, 2017**

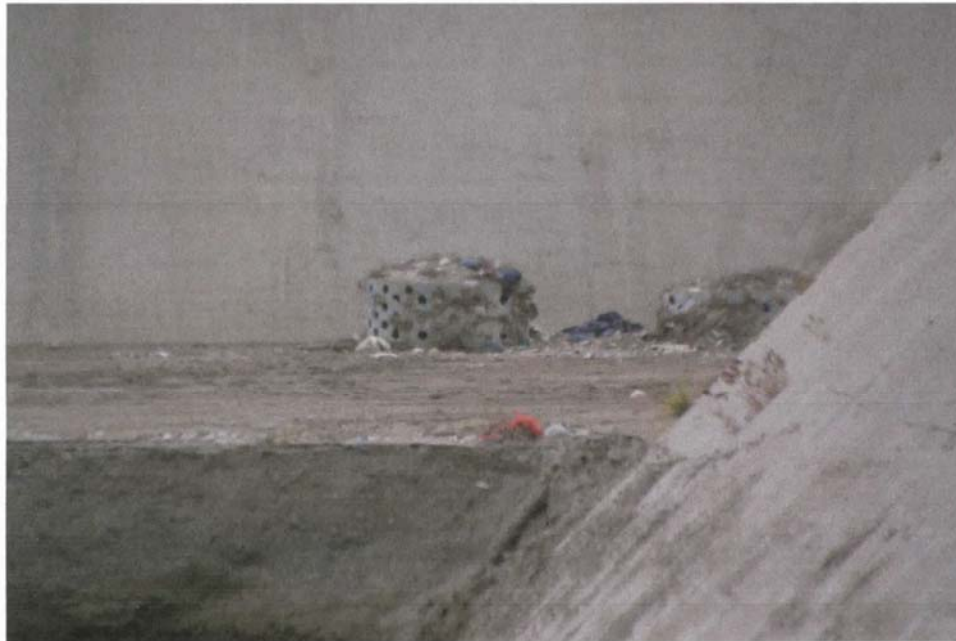
Photo 8: Removal of sediments from Basin A

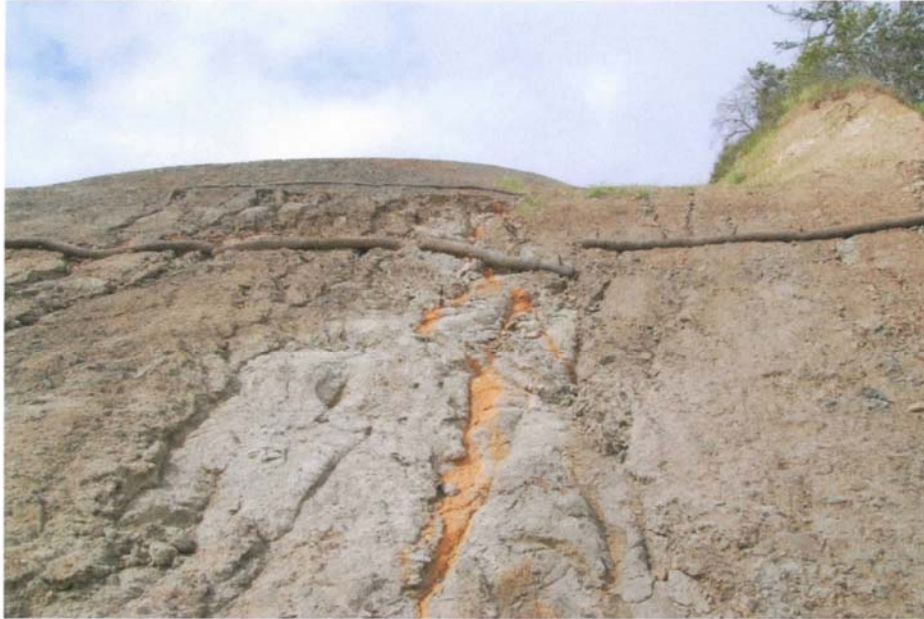
Photo 10: View of water gullies between native and fill supporting access road to Flare 3

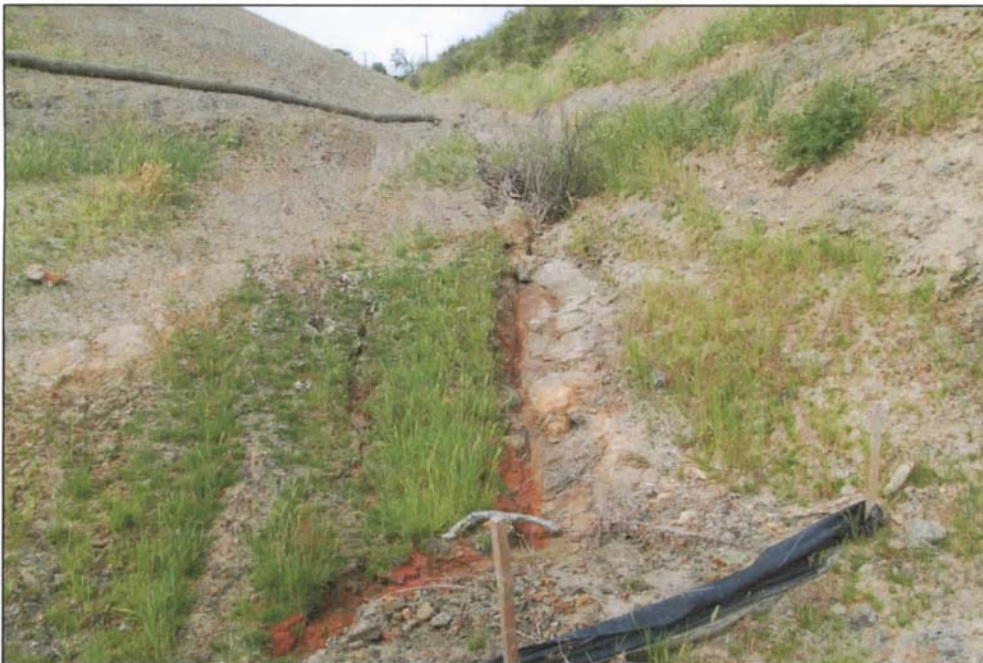
Photo 11: Detail of Erosion gullies toward Basin A from water running down slope

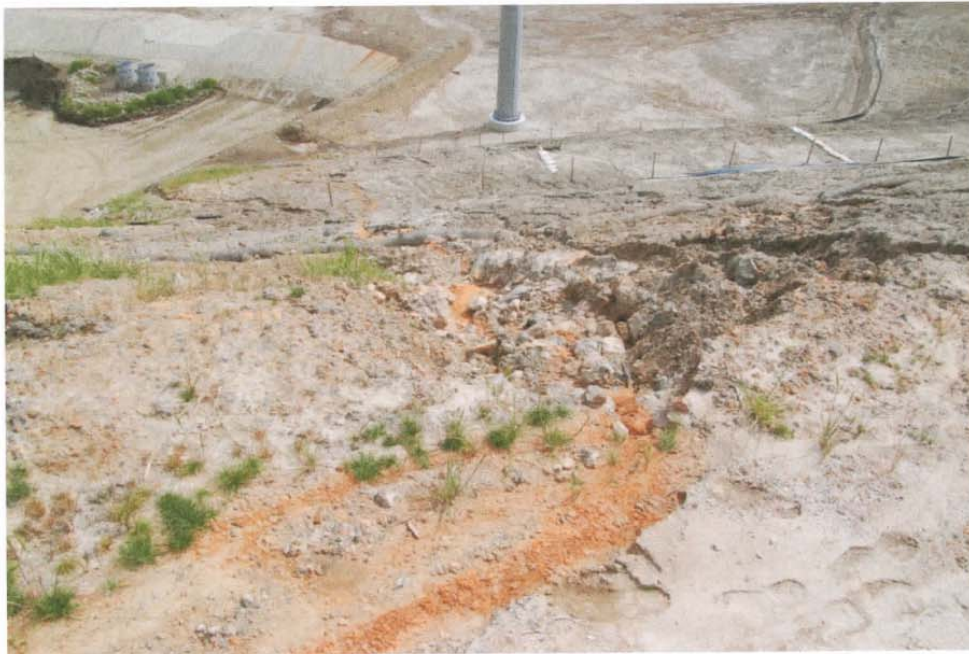
Photo 12: Basin B cleaned up

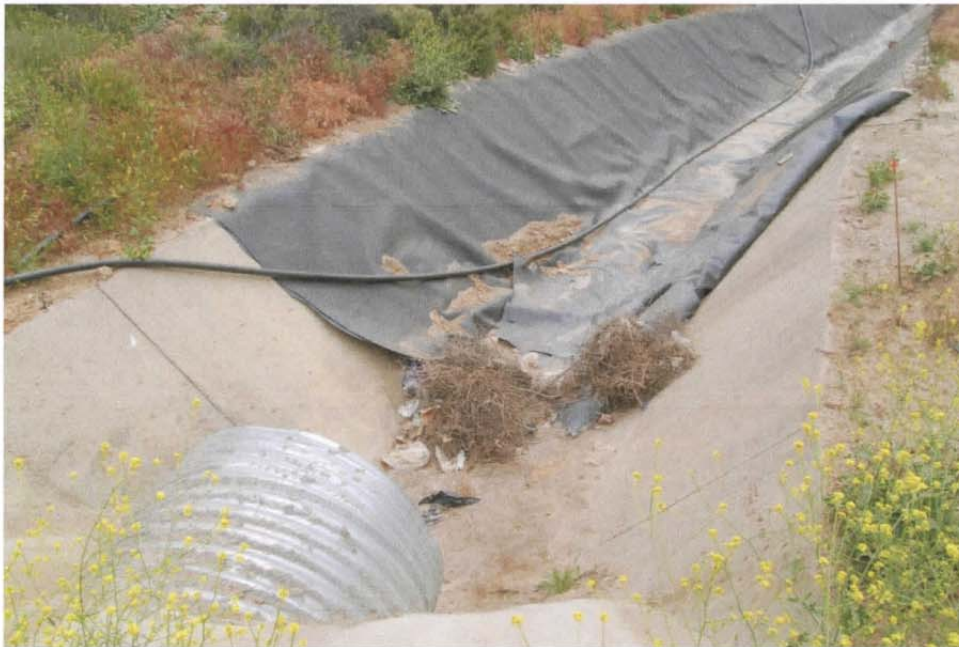
Photo 16: Geomembrane detached from headwall at drainage channel between Basin D and access road to Flare 9 and 10

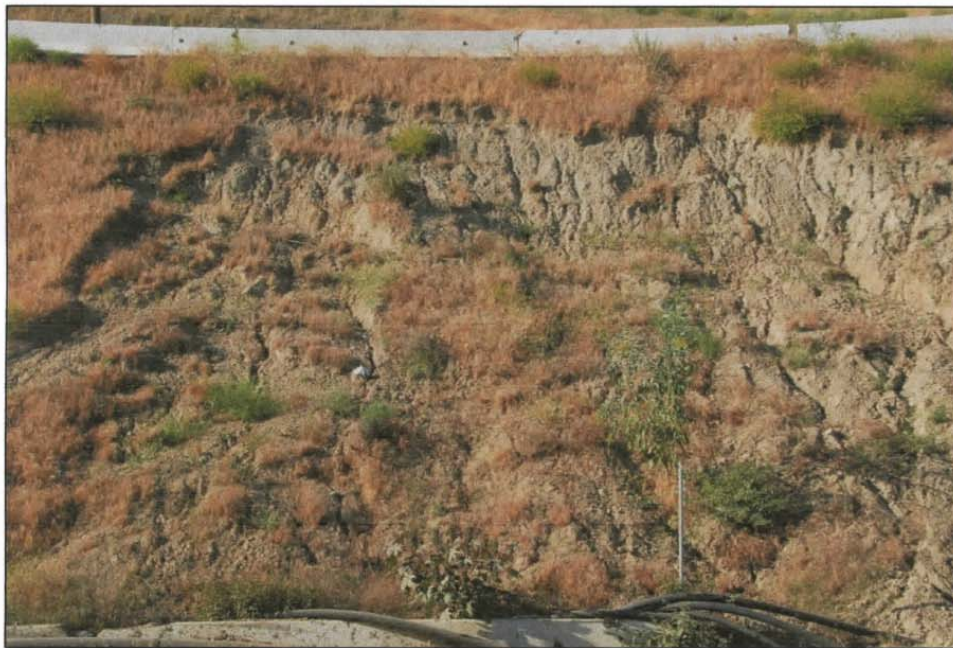
Photo 10: Soil sloughing and small slide on Access Road Embankment

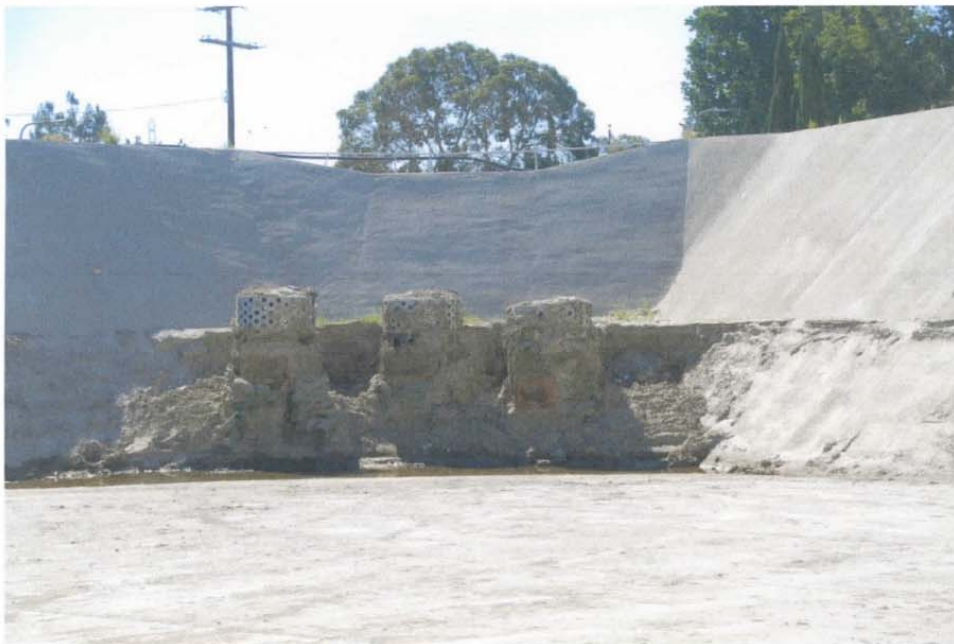
In late June, the terminal basin inlet was blocked and there was standing water in back of a dirt berm. There was no pump observed at the berm. There was standing water at the gabion wall inside the basin and at the outlet risers.

Photo 2: Sediments behind decant towers at Terminal Basin

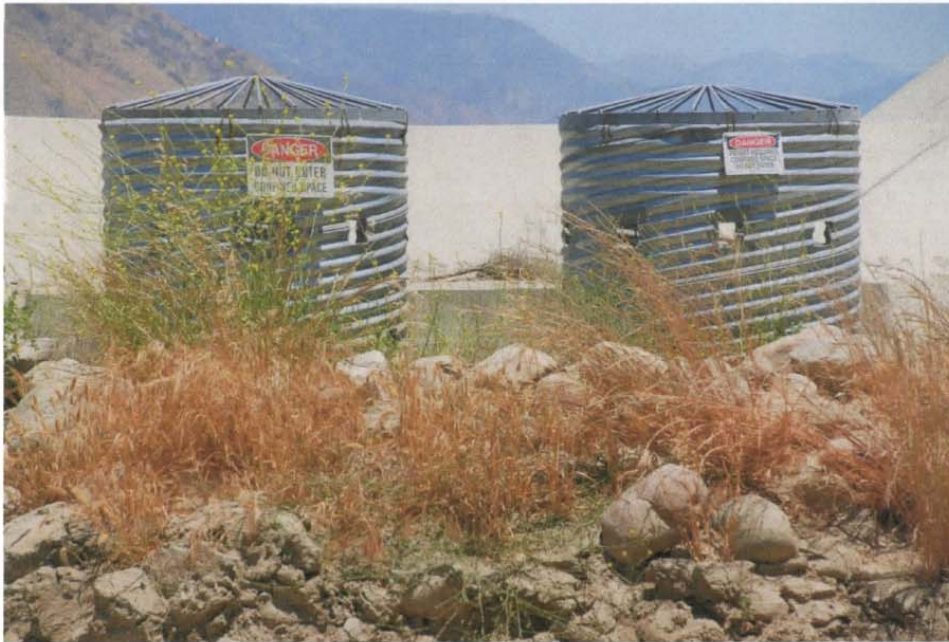
Photo 3: Vegetation growing in Basin A

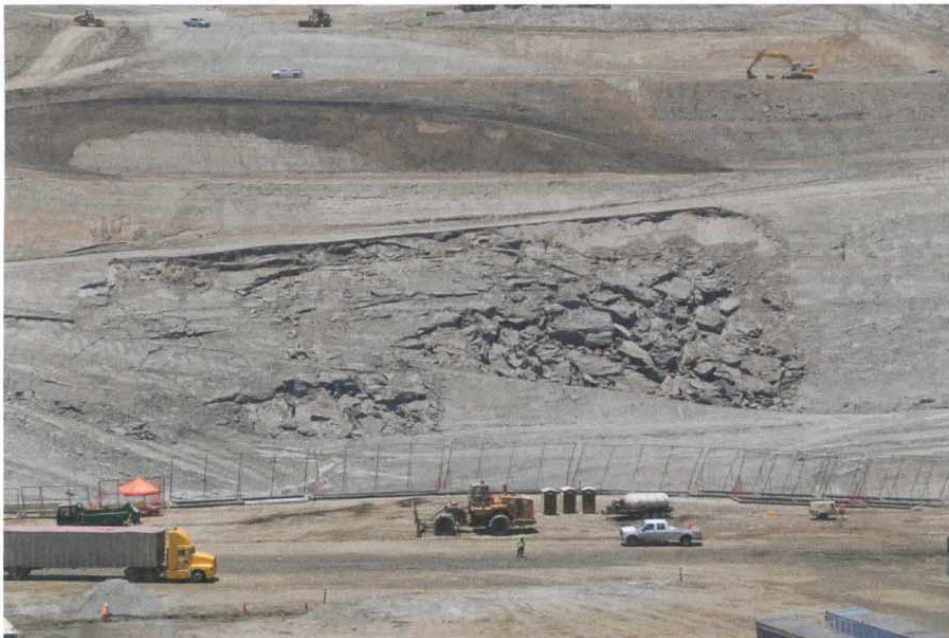
Photo 4: Landslide on west side of excavation for Cell CC4 Phase 2

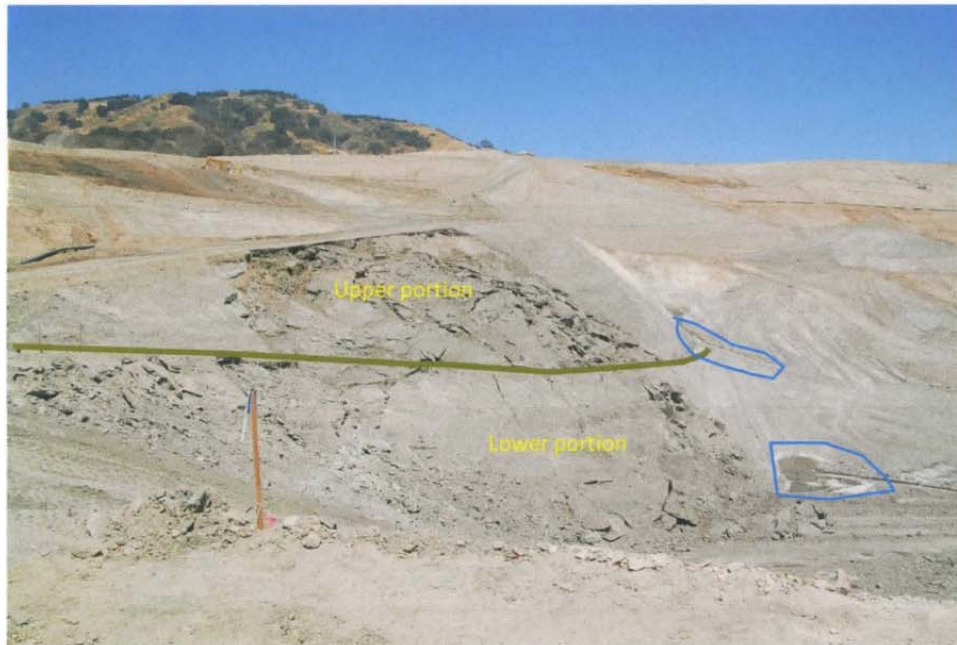
Photo 5: Details of slide in Cell CC4 Phase 2

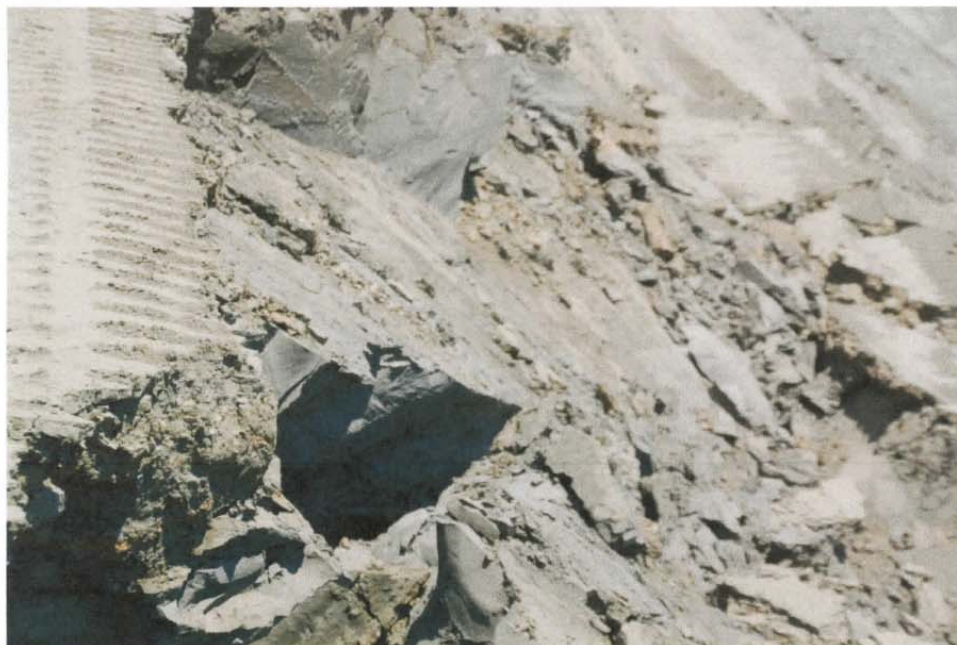
Photo 6: Plane of slickenslide in debris of excavation of Cell CC4
