**Sunshine Canyon Landfill  
Independent Monitor  
Quarterly Site Monitoring Status Report  
January 1, 2017 – March 31, 2017**

**City of Los Angeles Department of City Planning**

**County of Los Angeles Department of Regional Planning**

April 26, 2017

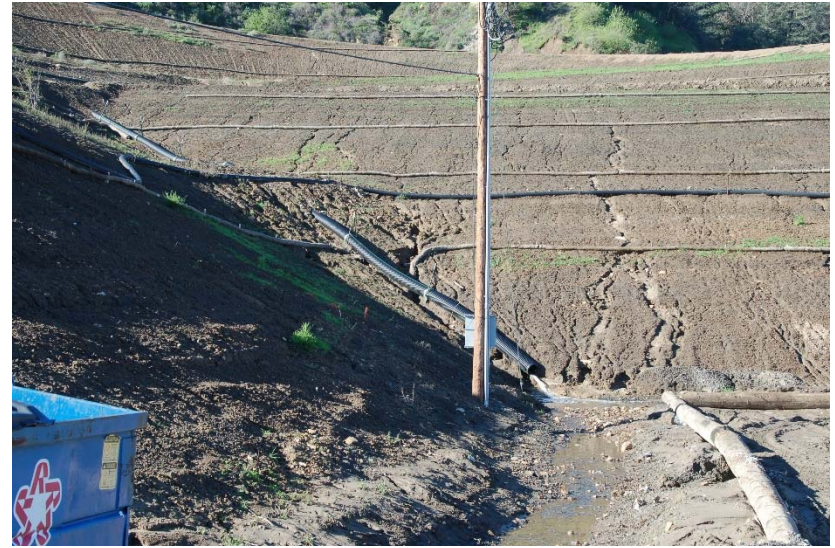
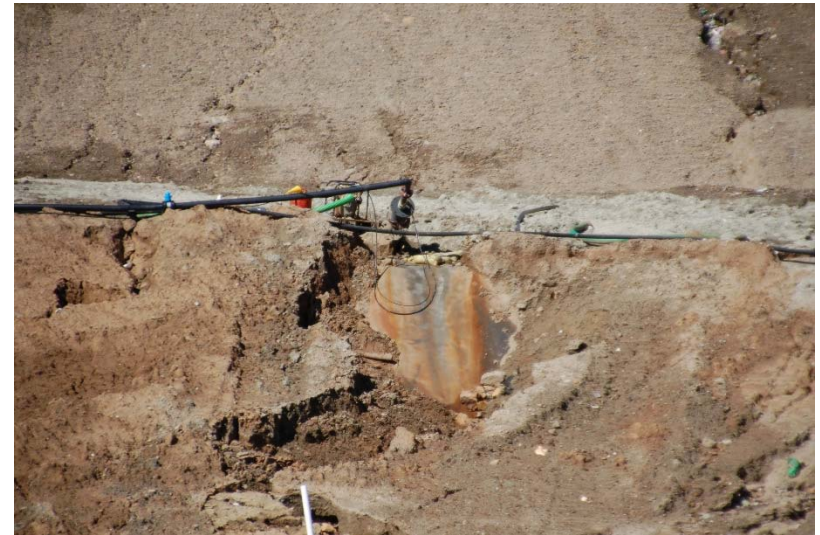
**Photo 125: Slope Erosion near CC4 Liner Area: February 23, 2017**

**Photo 126: Slope Erosion near CC4 Liner Area: February 23, 2017**

**Photo 127: Slope Erosion near CC4 Liner Area: February 23, 2017**

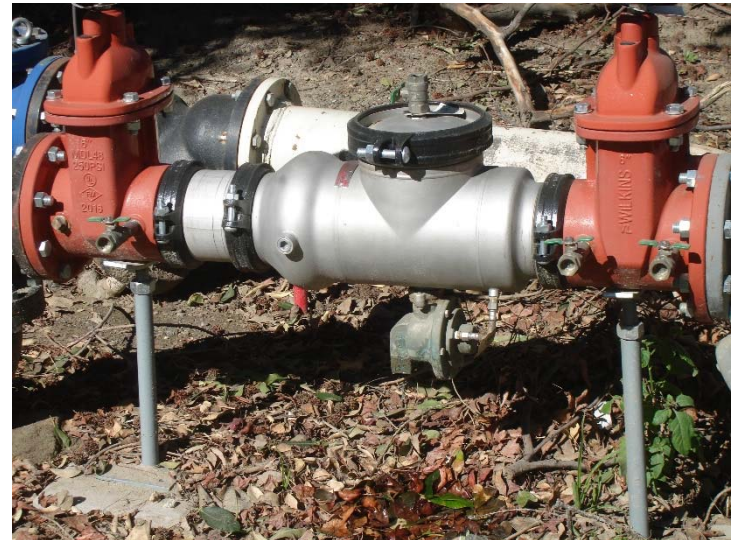
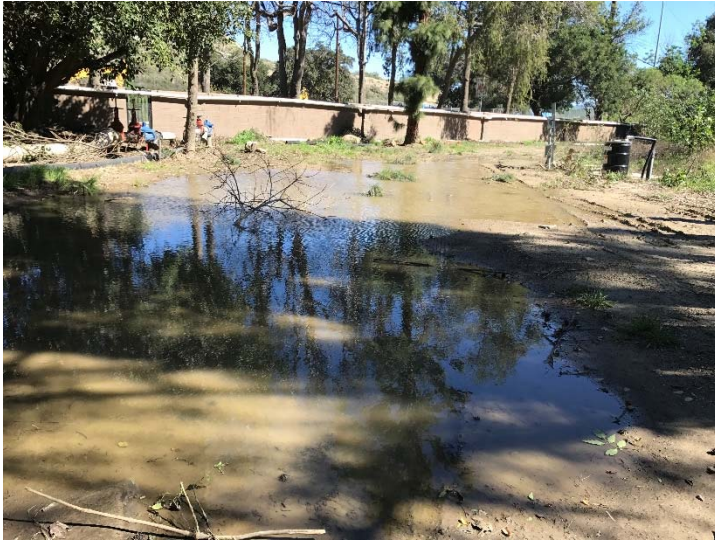
**Photo 371: Potable Water Supply Leak: January 31, 2017**

**Photo 372: Potable Water Supply Leak: January 31, 2017**

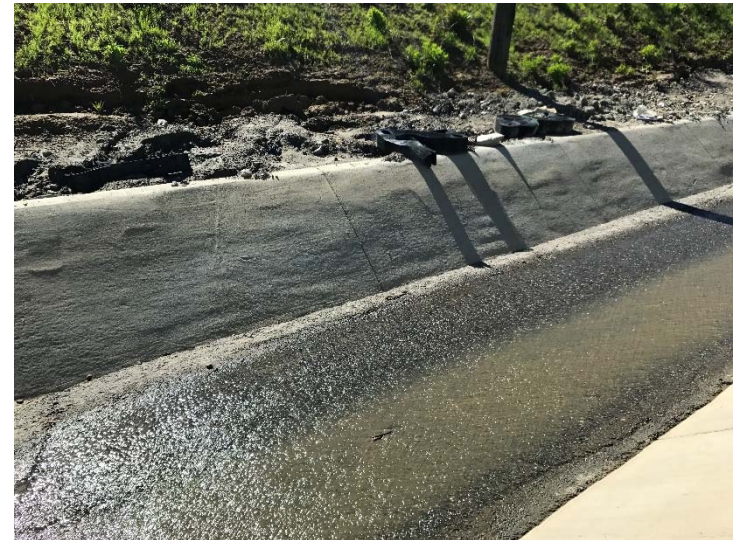
**Photo 410: City South Slope Slump: February 23, 2017**

**Photo 412: City South Slope Slump: February 23, 2017**

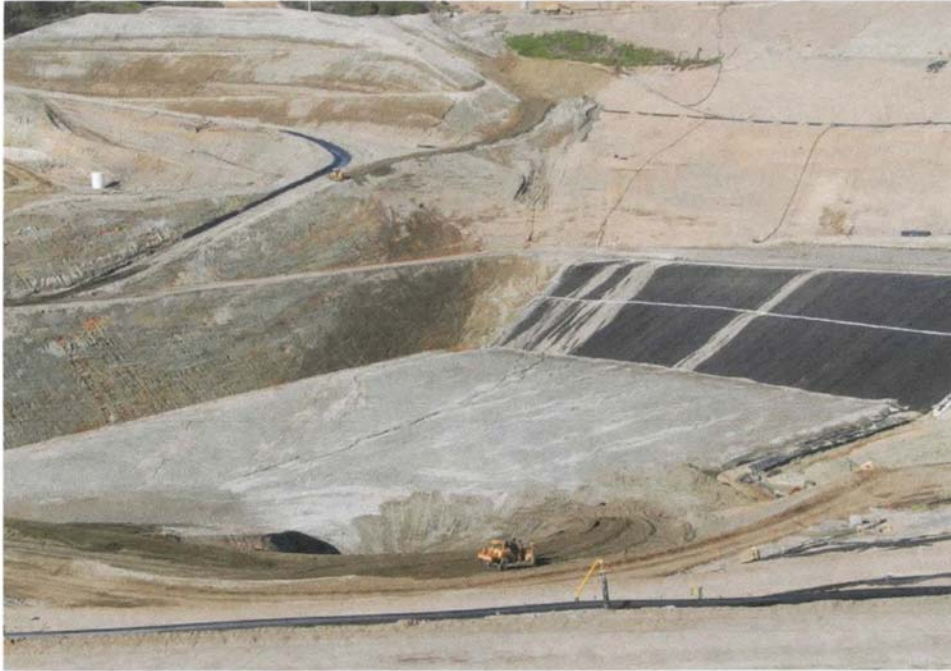
Photo 1: Base of Cell CC4 Protect by operation layer – Some erosion gullies

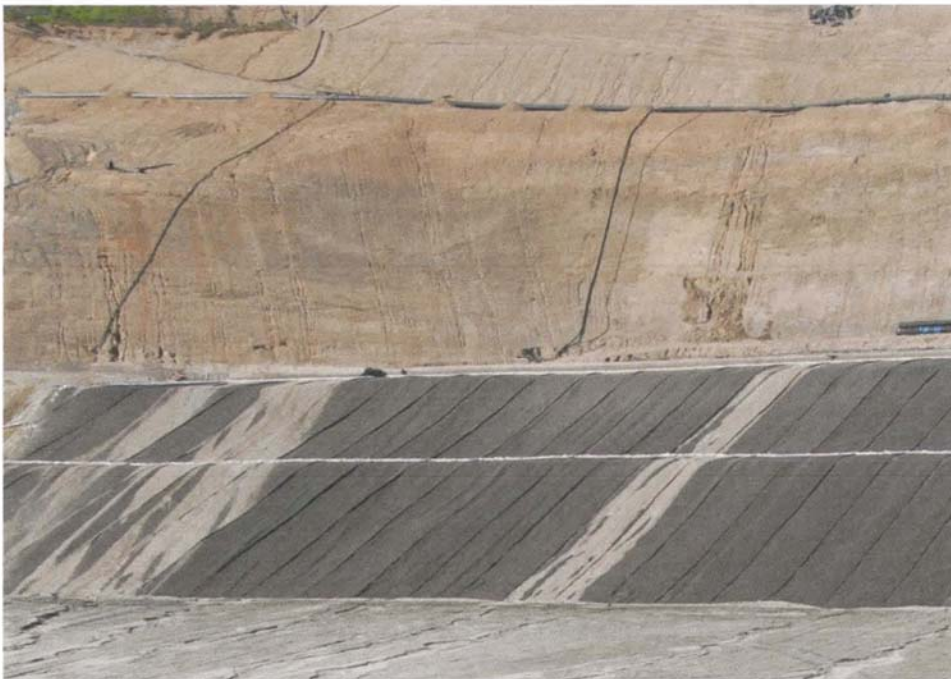
Photo 2: Geosynthetics on slope of CC4 – no damage visible

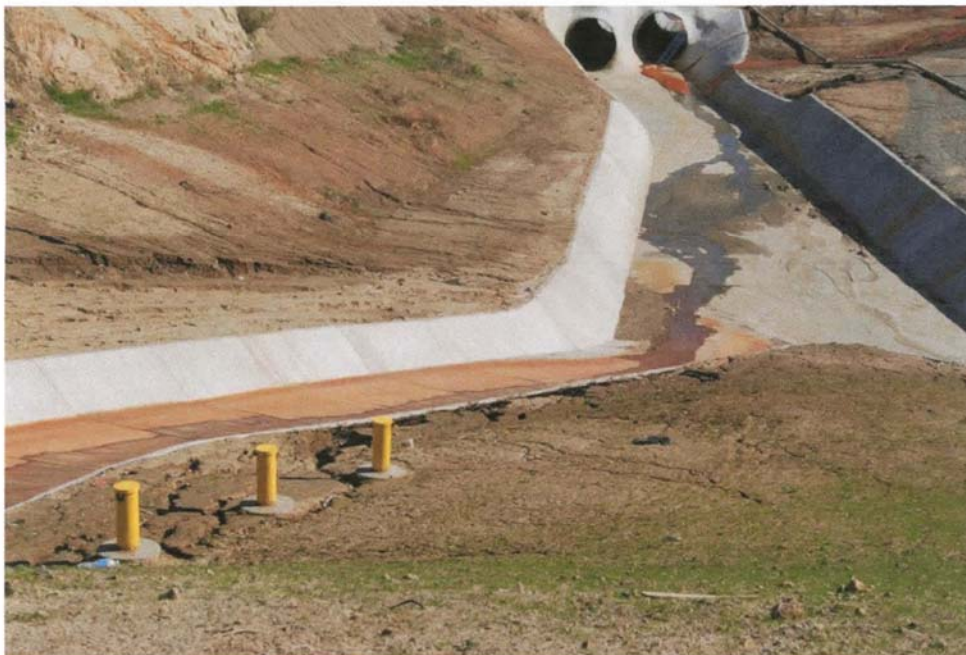
Photo 6: Erosion on slope of new temporary unlined earthen basin at toe of landfill

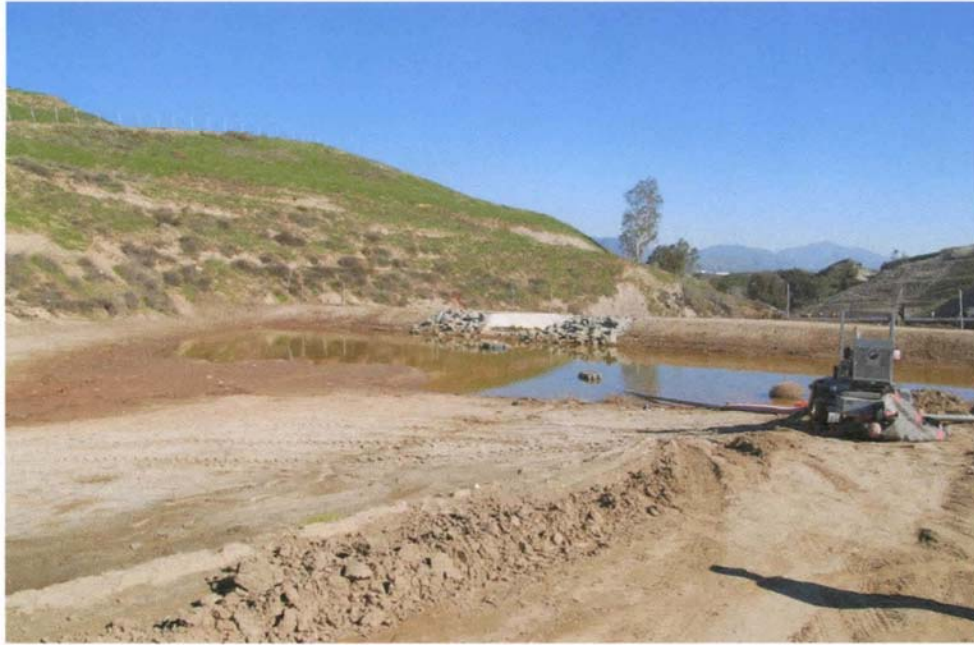
Photo 7: New temporary unlined earthen basin at toe of landfill filled up with sediment

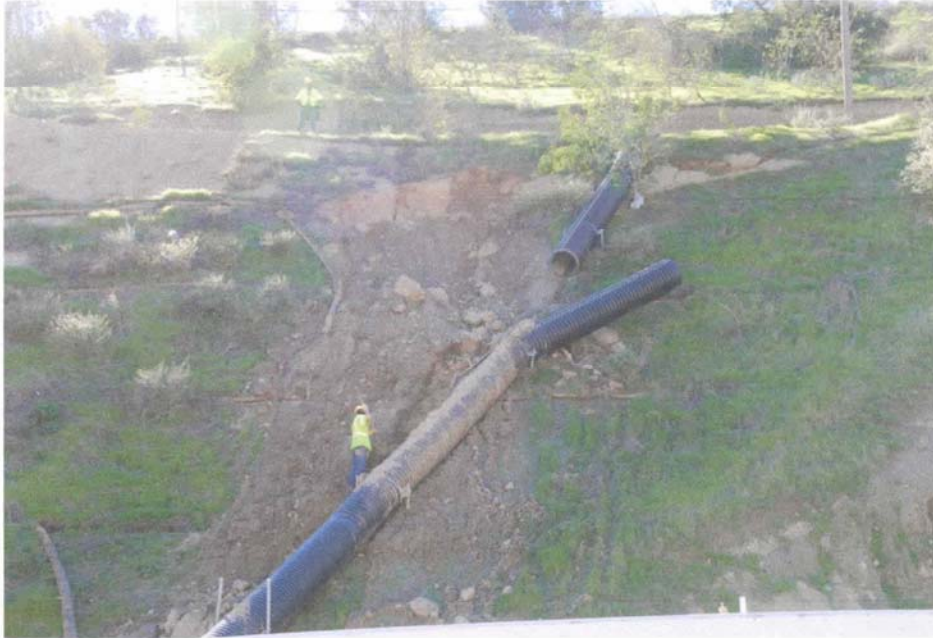
Photo 9: Ruptured downchute undergoing repair

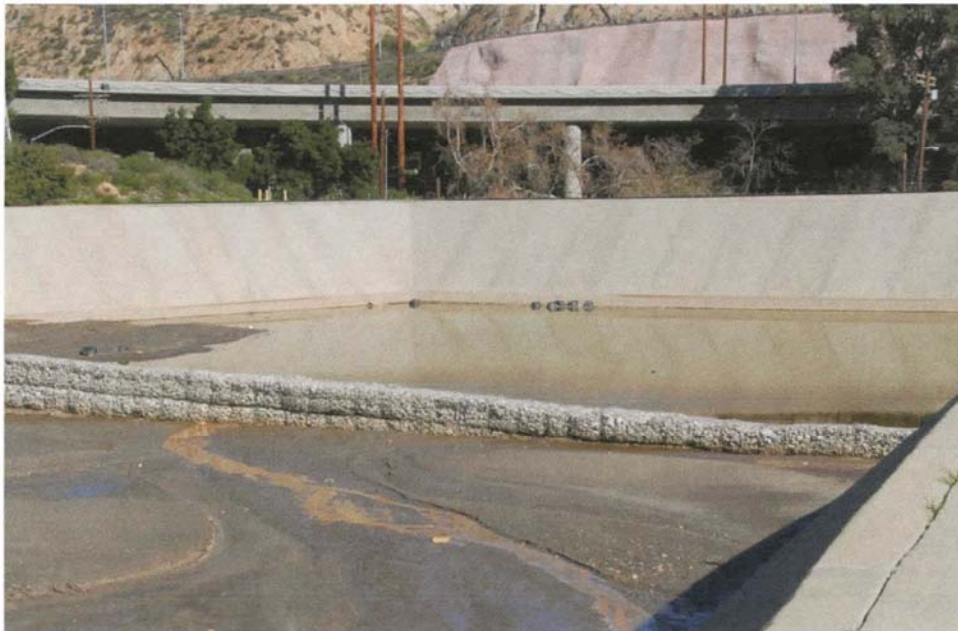
Photo 11: Sediment against gabions in terminal basin

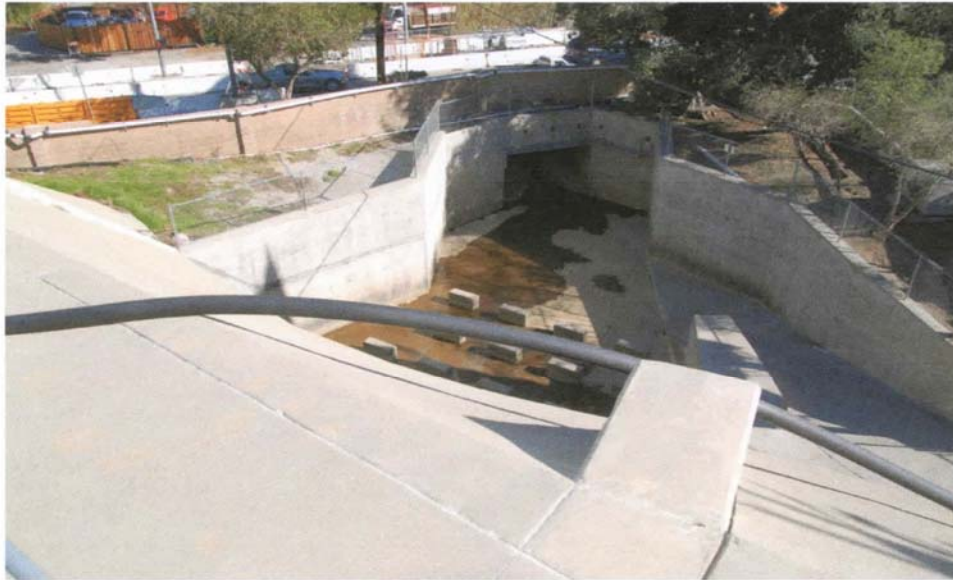
Figure 13: Low water flow out of the terminal basin

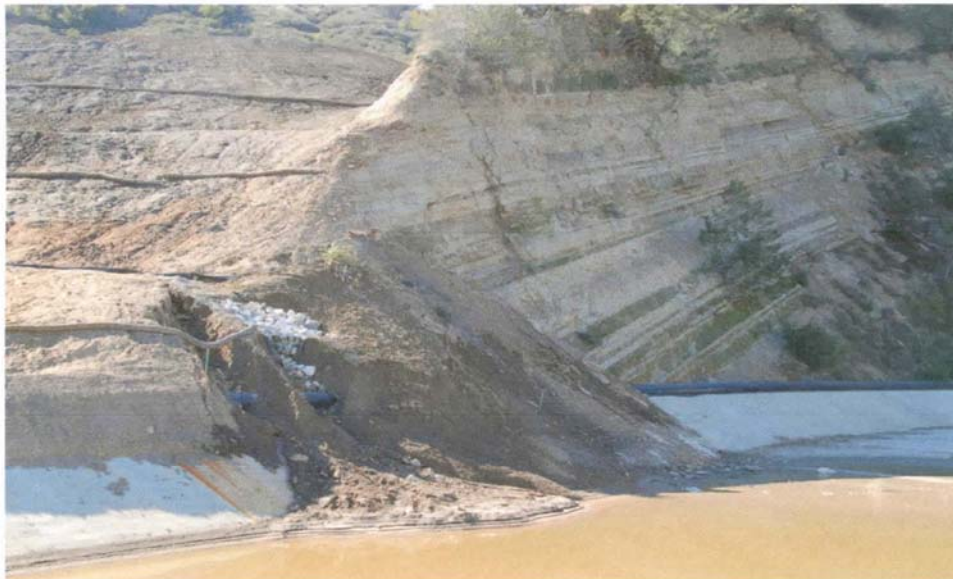
In late January, the monitors observed a significant amount of sediment in Basin A with soil sloughing from the prior adjacent Edison pole grading. The outlet risers were not draining rainwater and there was a large area of ponding rainwater. The outlet channel was blocked with sediment and trash. The native hillside had wind-blown trash. The westside channel inlet was blocked with tumbleweed. Basin D was observed and was free of sediment and ponding water. Basin B had no ponding water and a minimal amount of sediment. The temporary dirt basin below Cell CC-3B was filled with dirt and was not draining. A pump was being used to drain it. The dirt slopes on the eastside of the basin adjacent to the concrete outlet channels had significant uncontrolled erosion. The Terminal Basin had a significant amount of sediment. The outlet risers were significantly covered with sediment and there was water ponding. There was minimal water being released.

Figure 14: Sloughed soil at Basin A

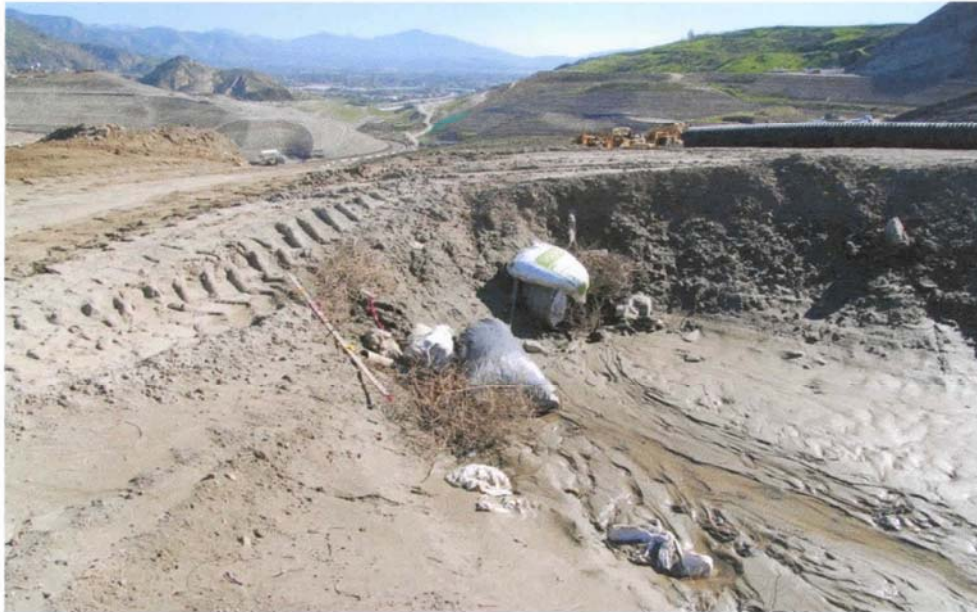
Figure 15: Debris in ditch outside Basin A

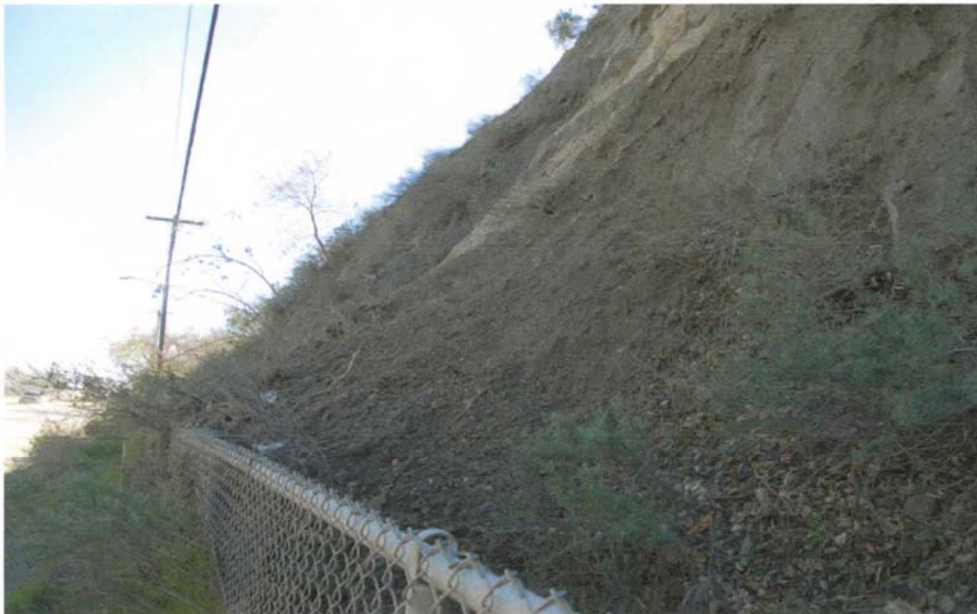
Figure 16: Soil against fence on retaining wall on San Fernando Road

- Republic geotechnical consultant has looked at the retaining wall along San Fernando Road and it is the understanding from all stakeholders that work cannot commence till the dry season.

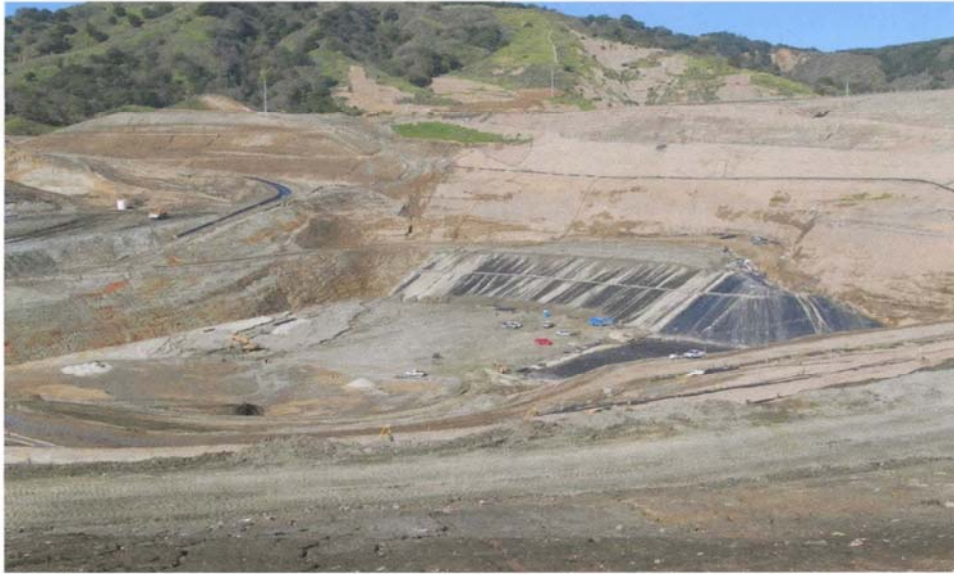
Photo 1: Base of Cell CC4. – Erosion gullies in operation layer

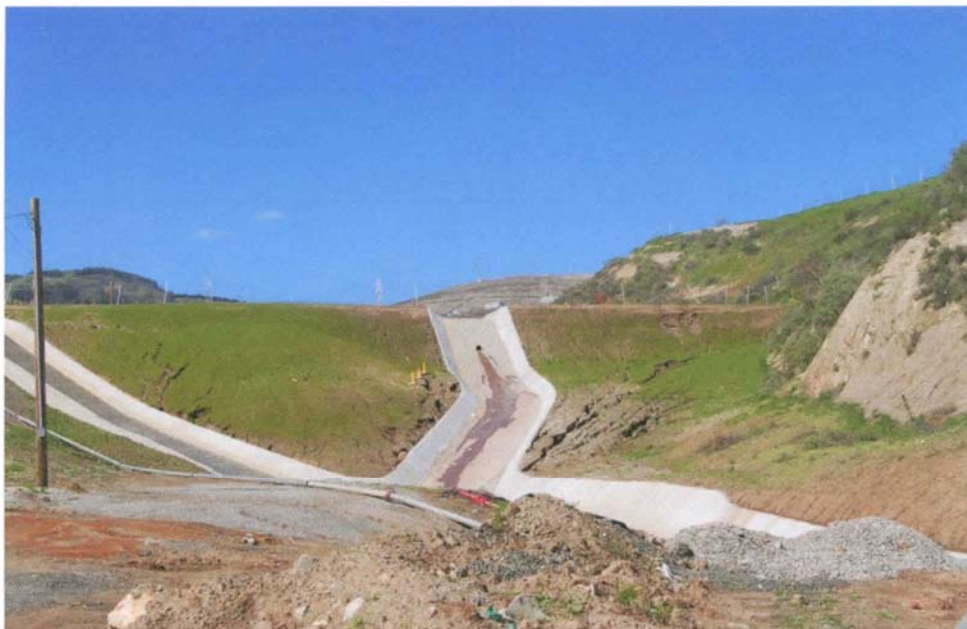
Photo 4: Erosion gullies along spillway of interim basin

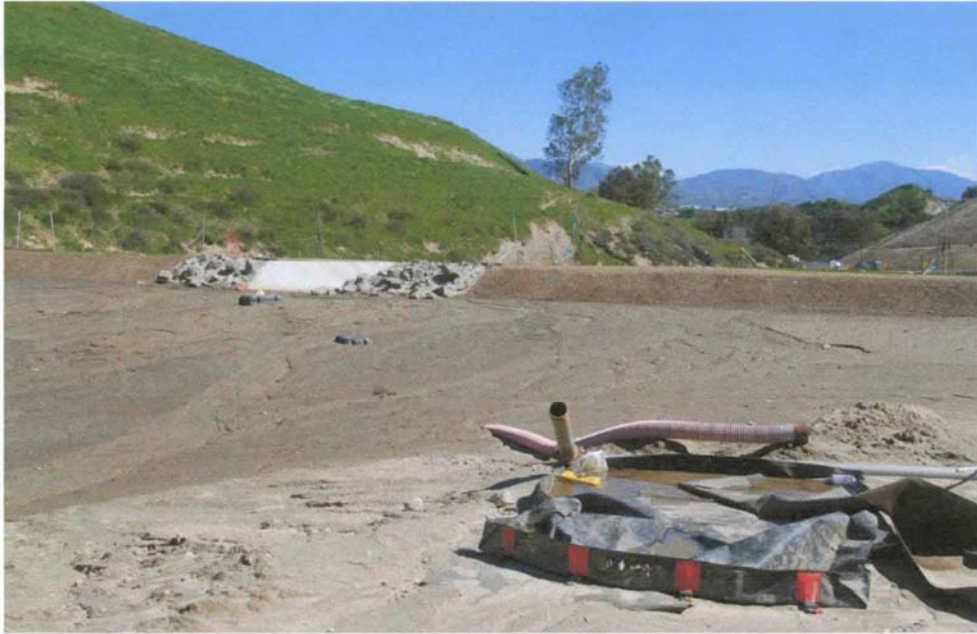
Photo 5: Interim Basin completely full of sediment

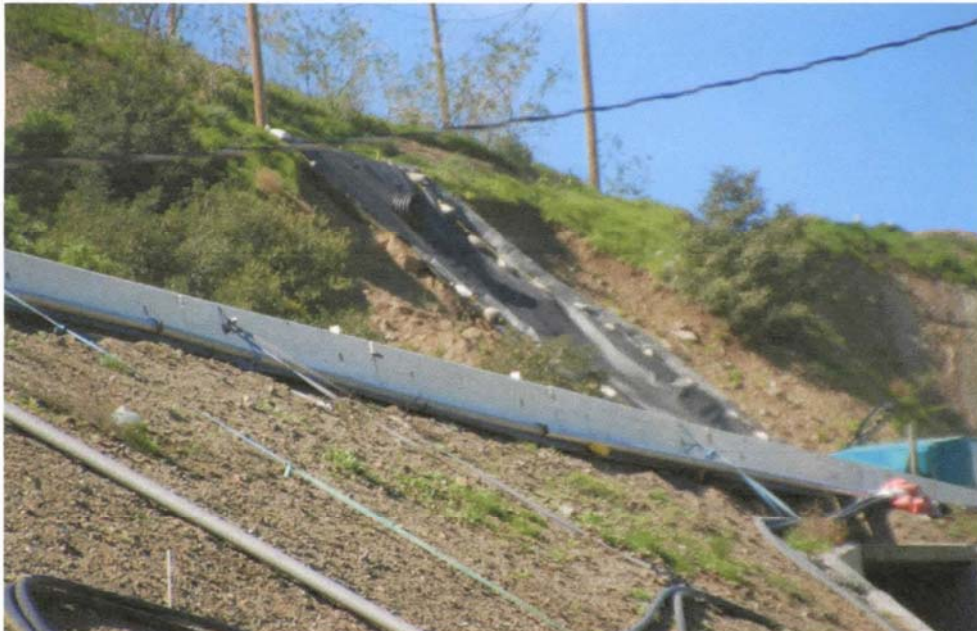
Photo 6: Slip liner installed as repair of downchute on slope along main access road

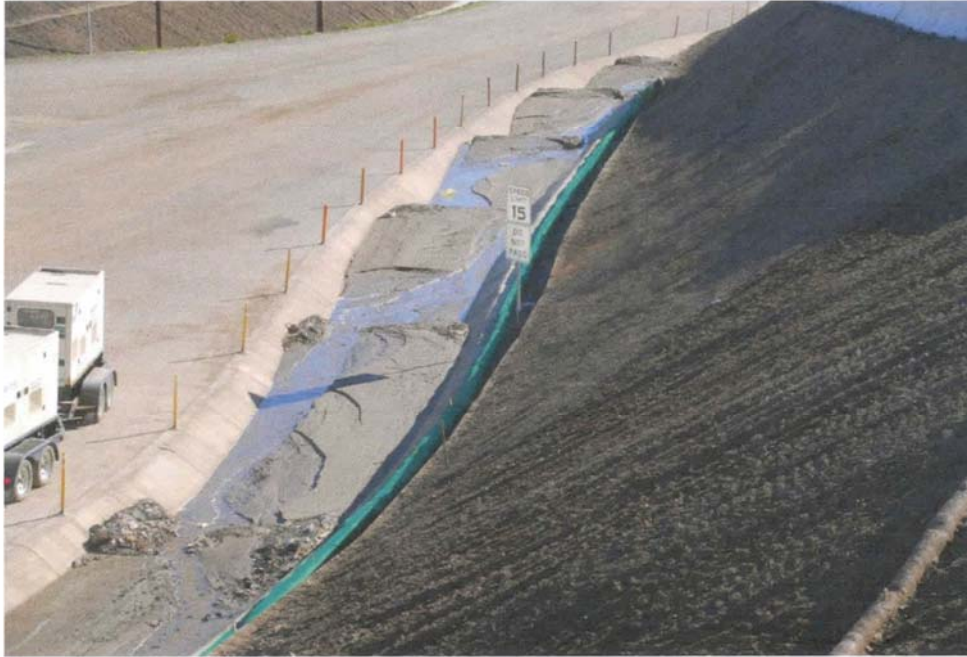
Photo 7: Sediment trapped in South drainage channel reducing area of channel

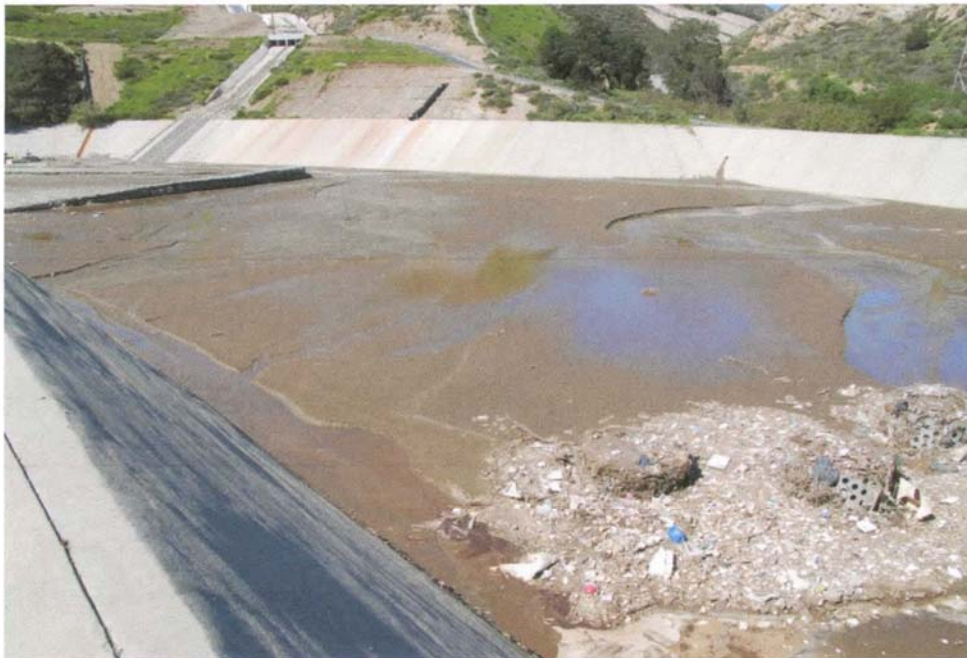
Photo 8: Sediment in Terminal Basin

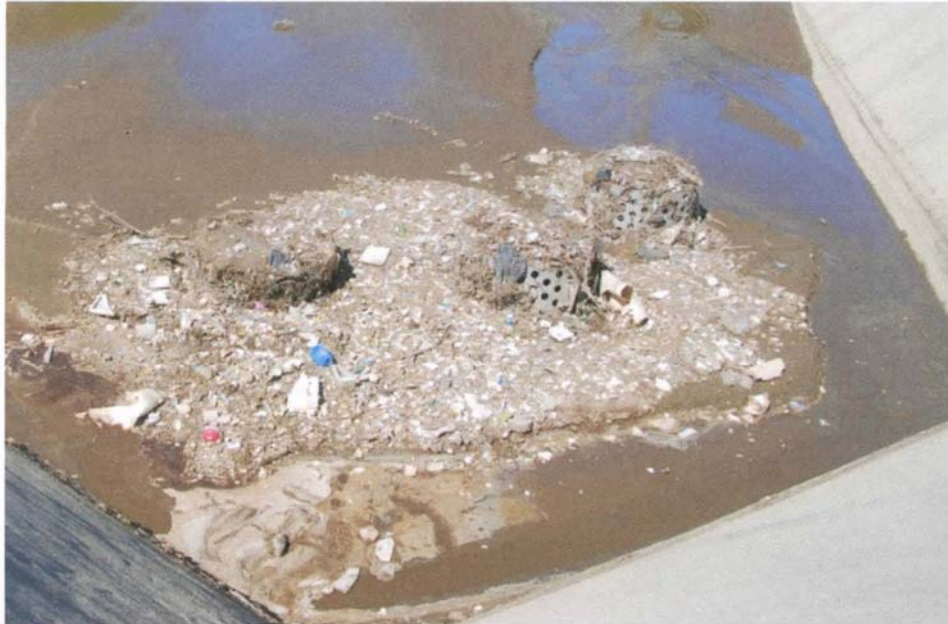
Photo 9: Refuse against decant Tower at Terminal Basin

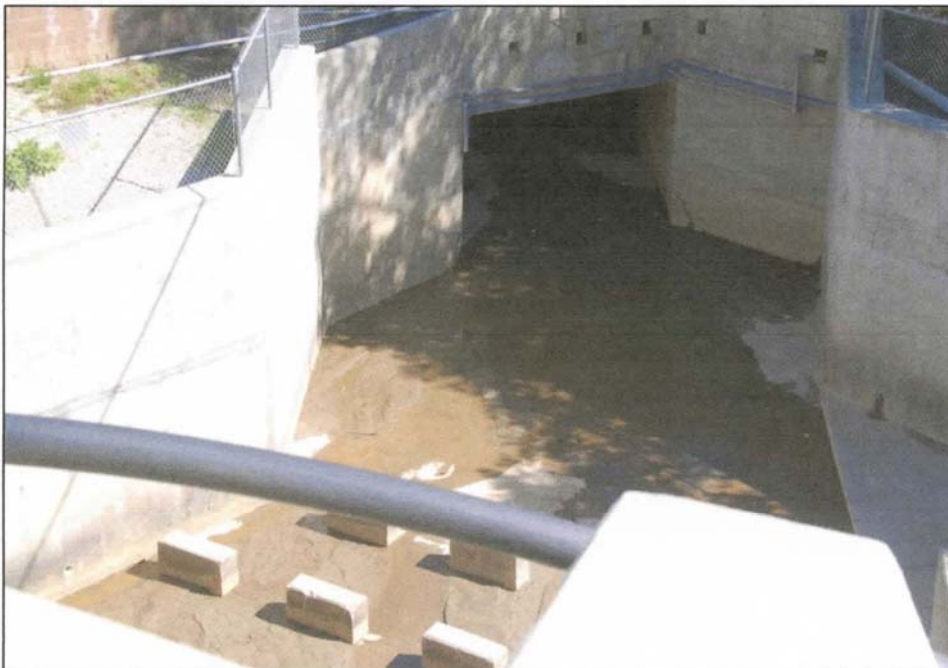
Photo 10: Sediment flowing outside Terminal Basin

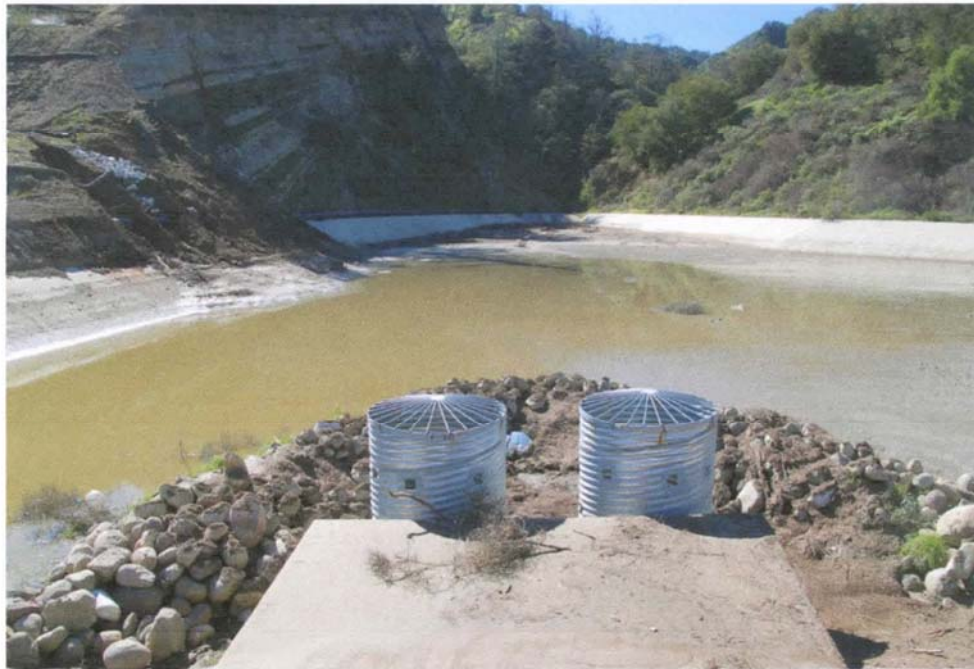
Photo 11: Water and Sediments in Basin A

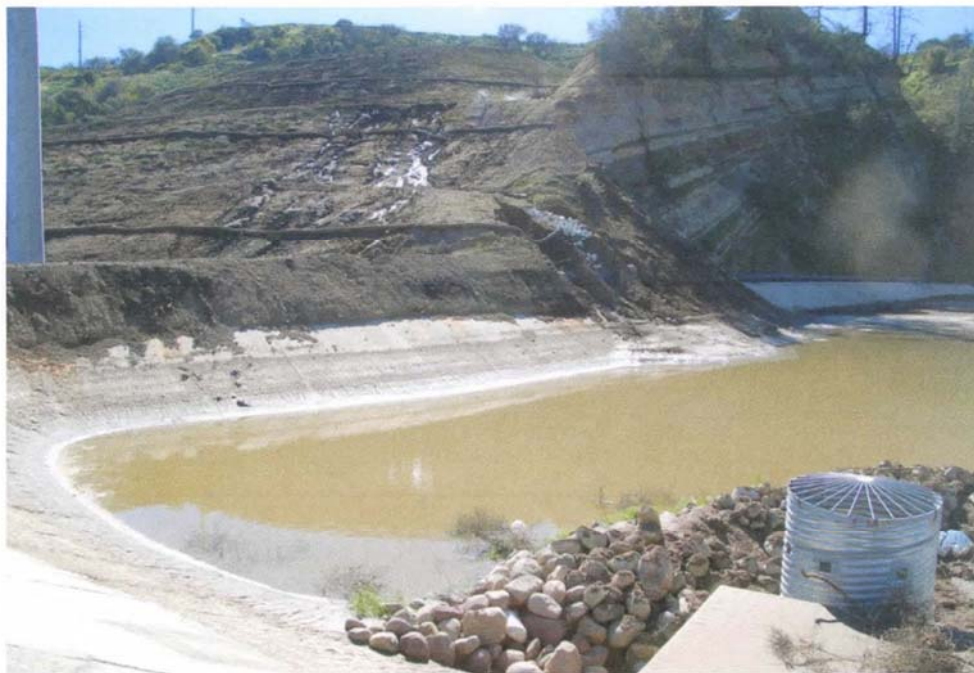
Photo 12: Sloughed soil in Basin A and seep on graded cut slope

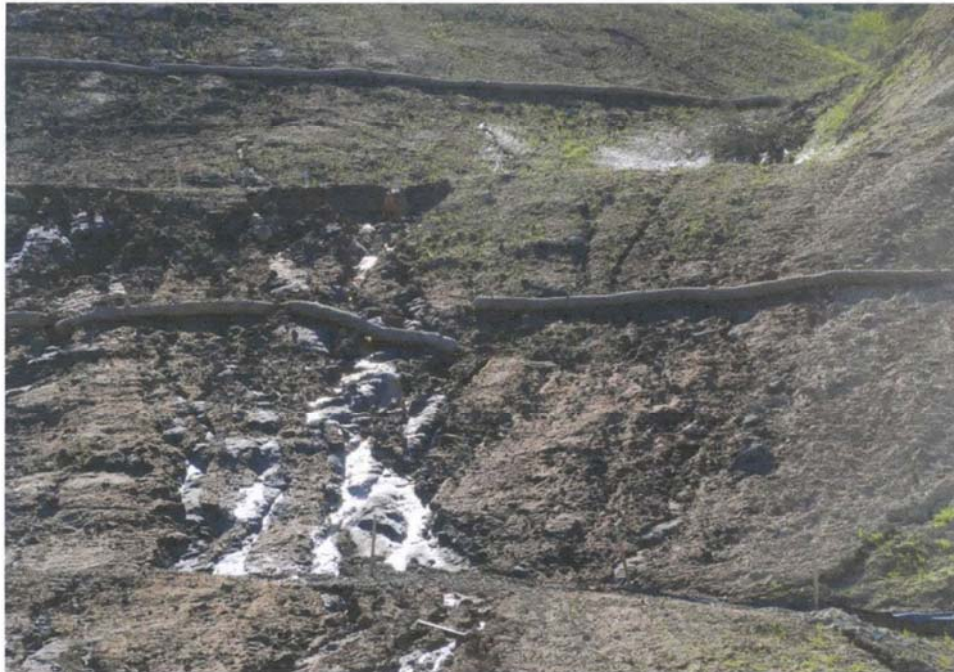
Figure 13: Seep , erosion and sloughed soil on graded cut slope at Basin A

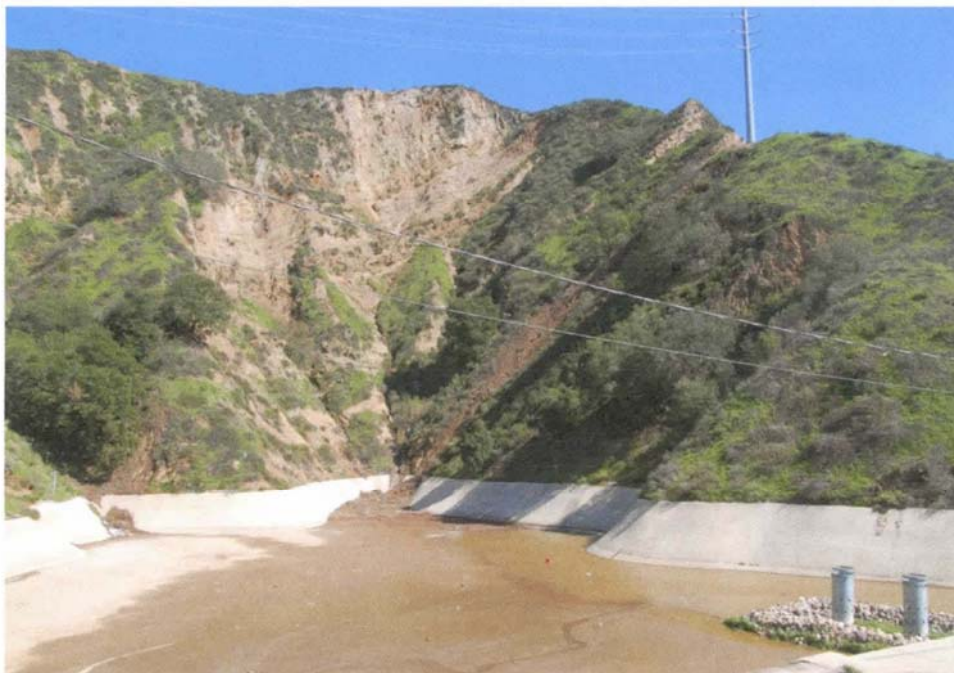
Figure 14: Soil accumulation from small slide in rear of Basin D

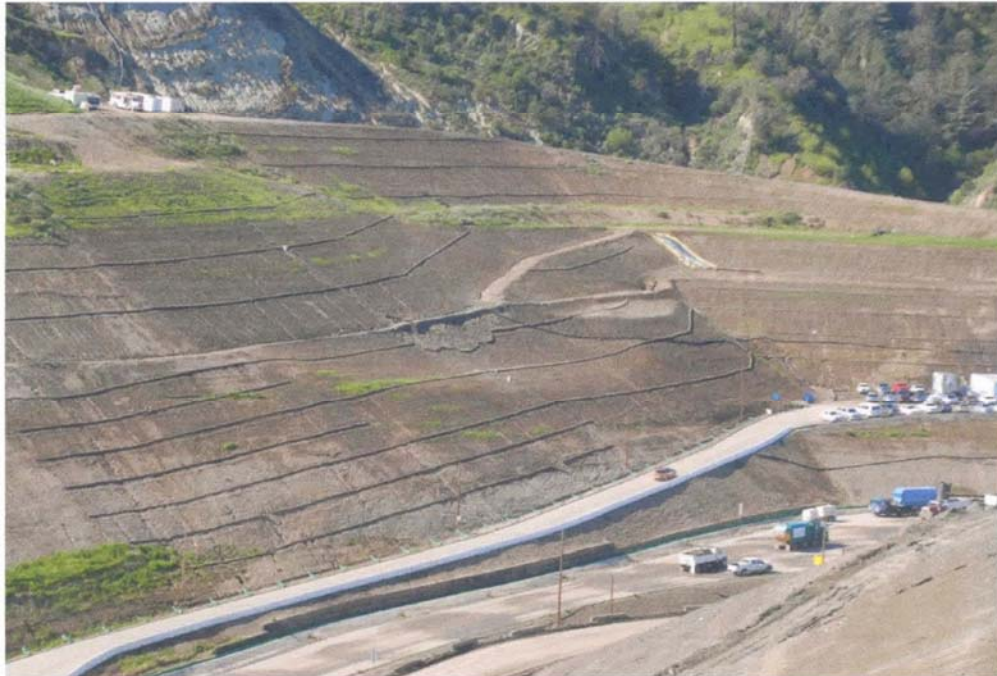
Figure 15: Area exhibiting soil movement above access road to Administration Pad

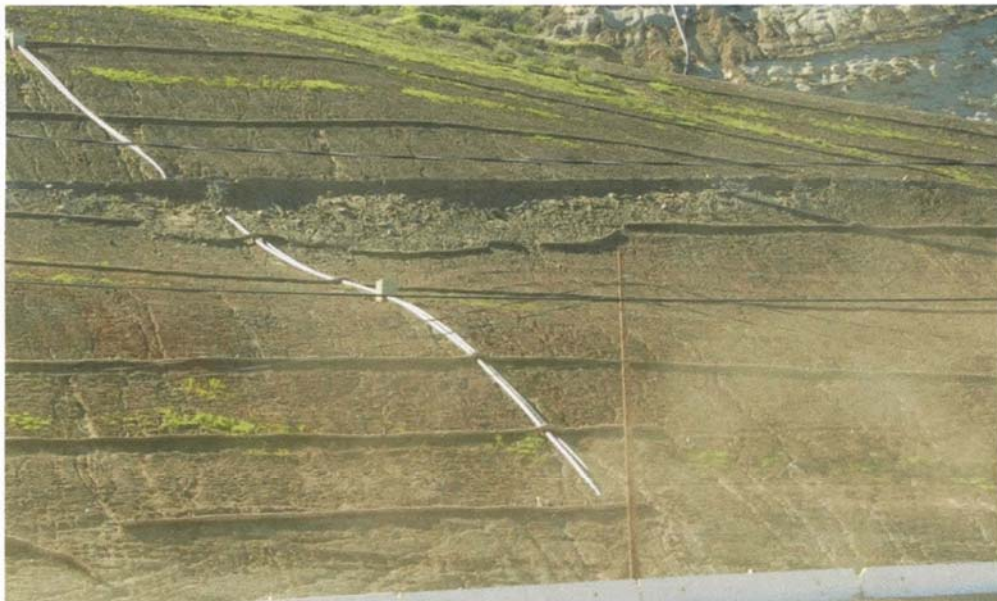
Figure 16: Close-up view of Figure 15
