**Sunshine Canyon Landfill
Independent Monitor
Quarterly Site Monitoring Status Report
July 1, 2021 – September 30, 2021**

January 3, 2022

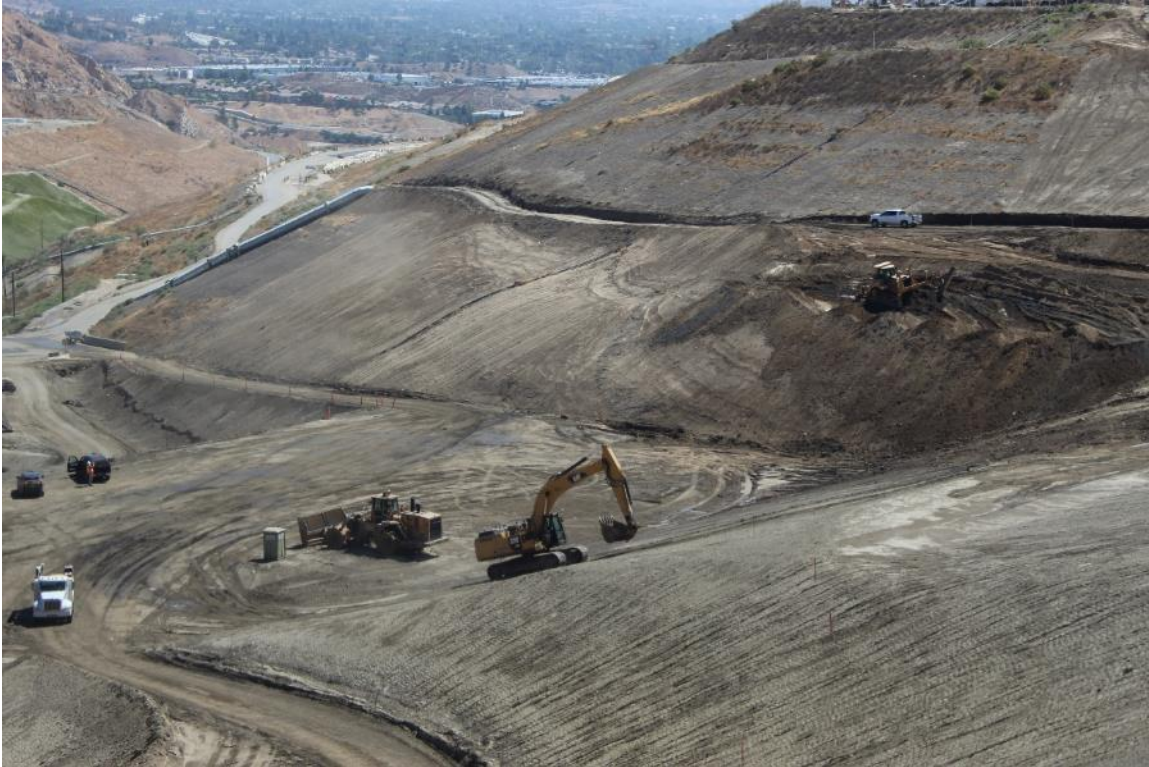
Photo 1 : Waste slope above old administration pad

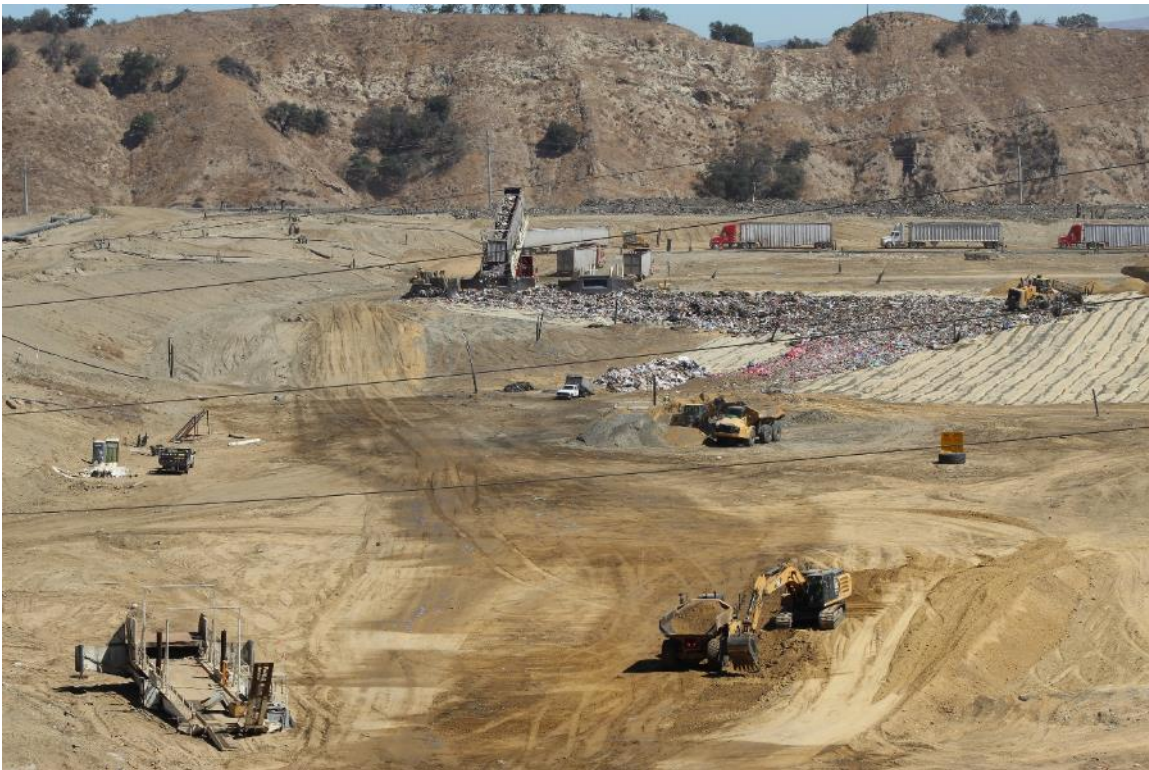
Photo 2: Waste disposal on top of Cell CC4 Phase 3

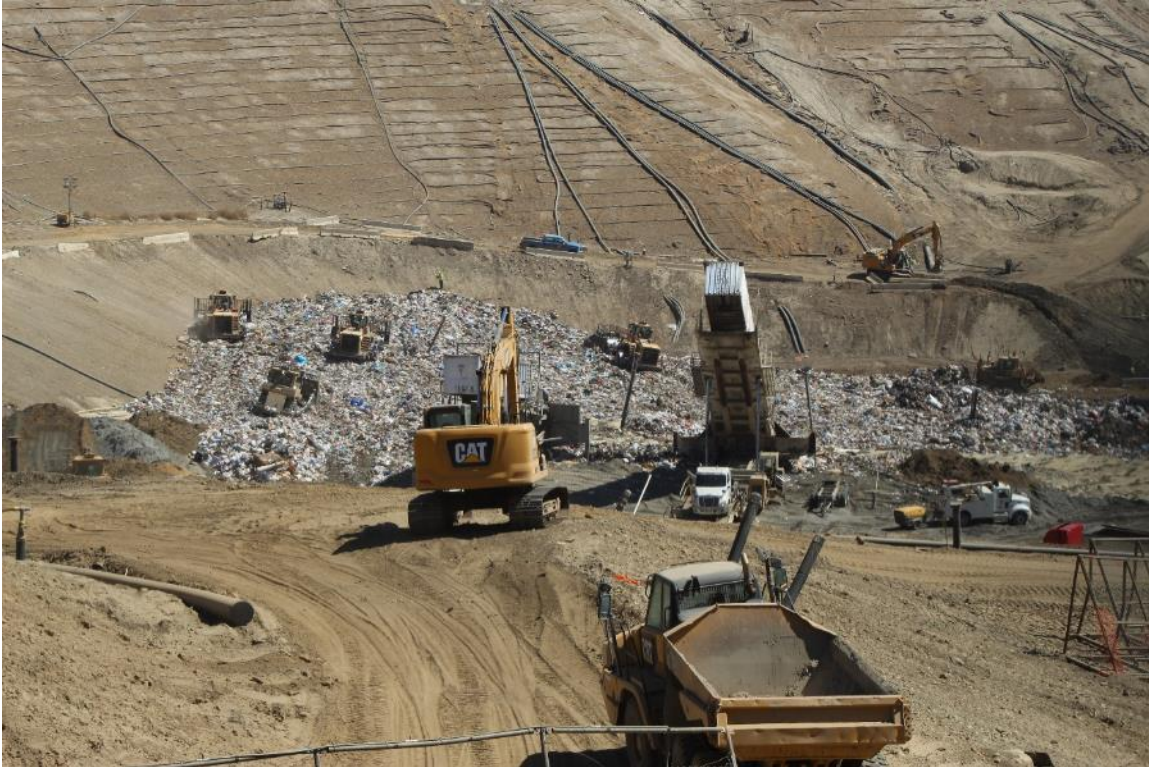
Photo 3: Waste disposal on top of Cell CC4 Phase 4

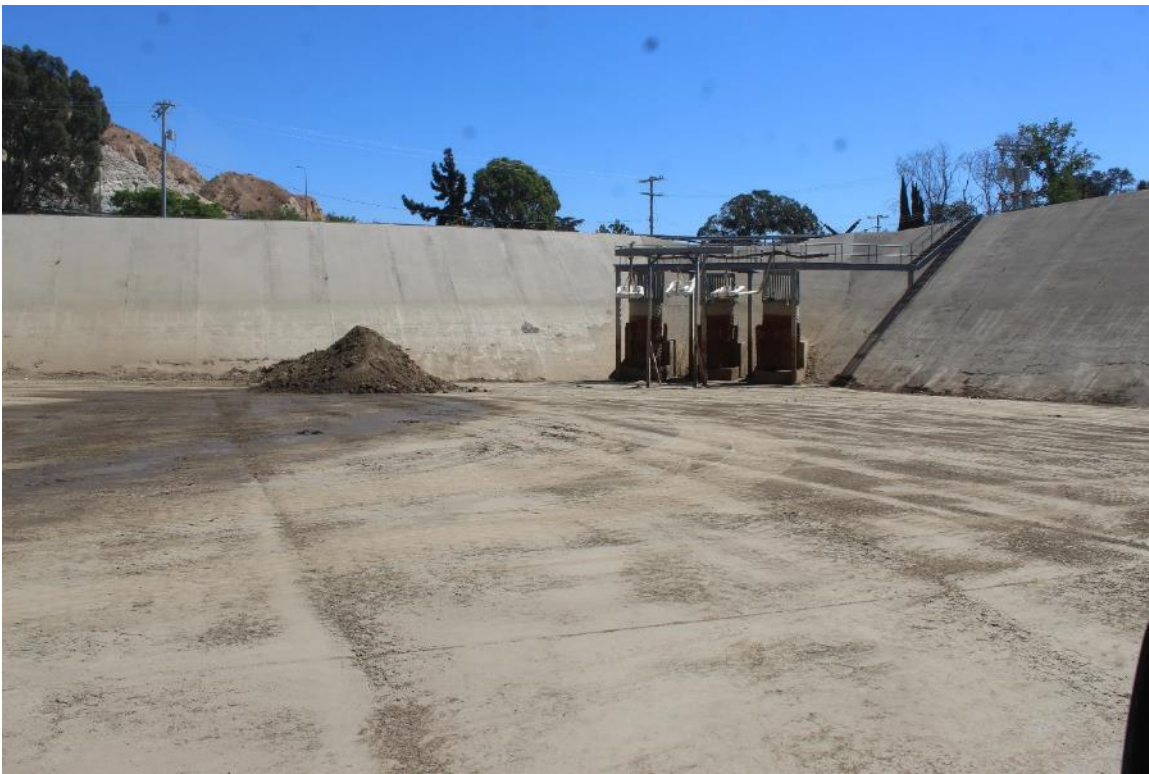
Photo 4: Clean Terminal basin

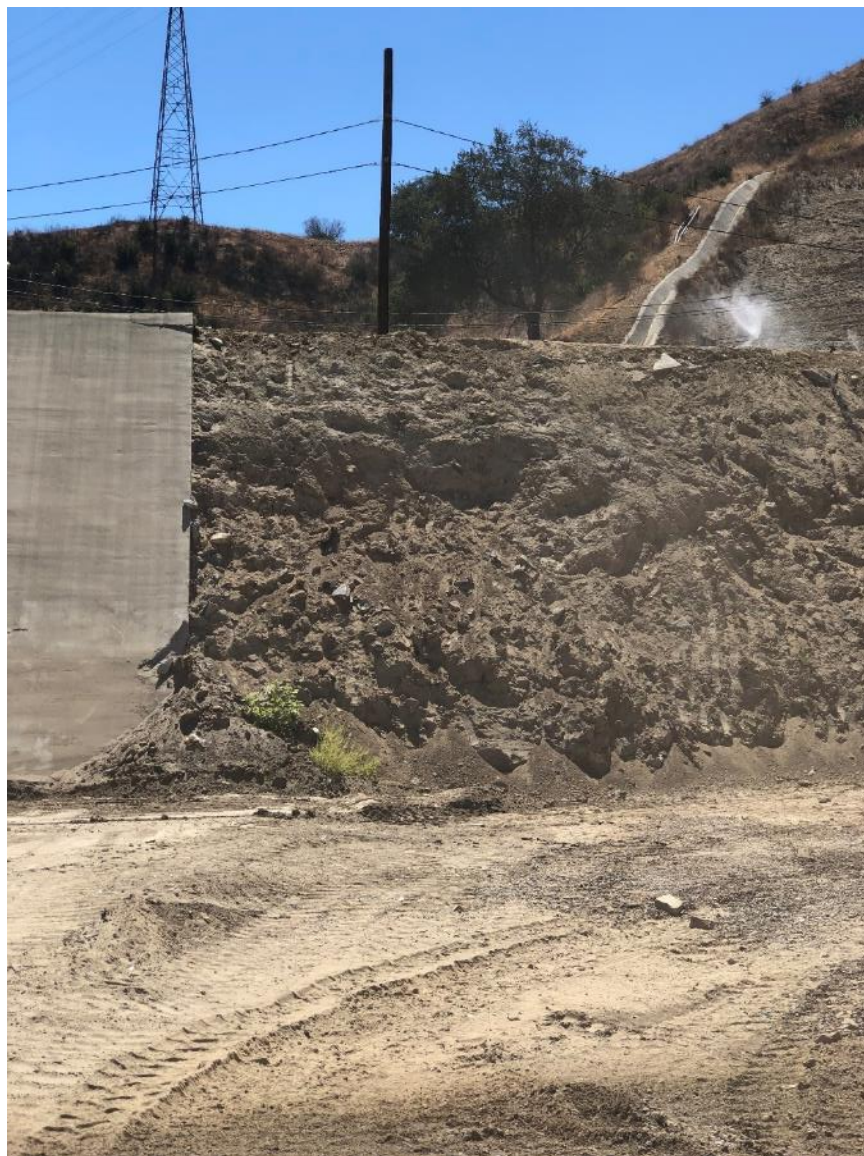
FURTHER REVIEW NEEDED
<ul style="list-style-type: none"> N/A
COMMENTS
<ul style="list-style-type: none"> Exposed soil on slopes of terminal basin (Photo 5) may need to be protected by rainy season time The watershed to the terminal basin has increased with the addition of the new access road. Furthermore the size of basin will be reduced. Was a new hydrology analyses conducted? What is the plan to address the excavated areas on Phase 4-3
Signed:

Photo 5: Exposed soil slope at terminal basin

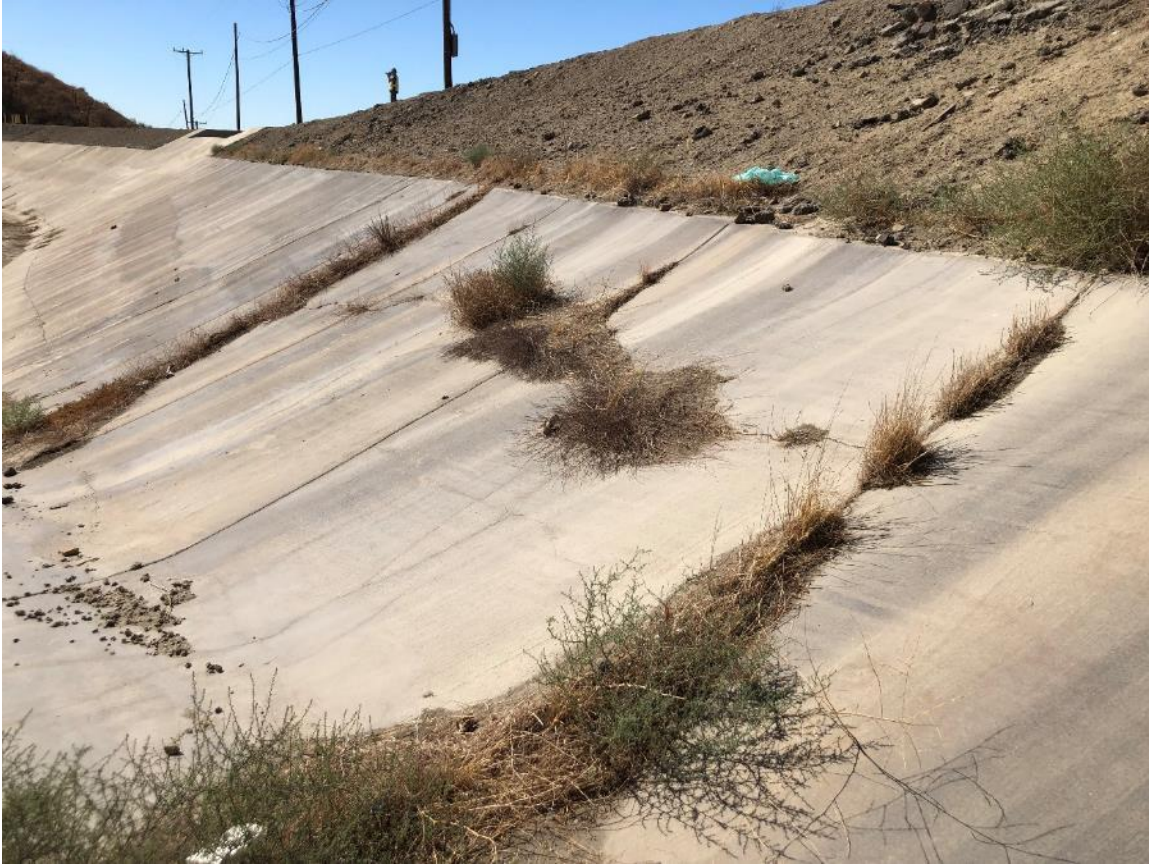
In the 3rd Quarter, it was observed that vegetation was growing out of numerous cracks in the water retention basins and drainage conveyance channels' concrete. There were areas of the channels and basins that needed the growing vegetation to be removed, and repair of the concrete and sealing of cracks. These clean-up and maintenance tasks are put on the monthly preventative maintenance program work list and were scheduled to be done by October 1st. Other activities postponed working on these tasks.

Photo 6: Vegetation growing in cracks at Basin B wall

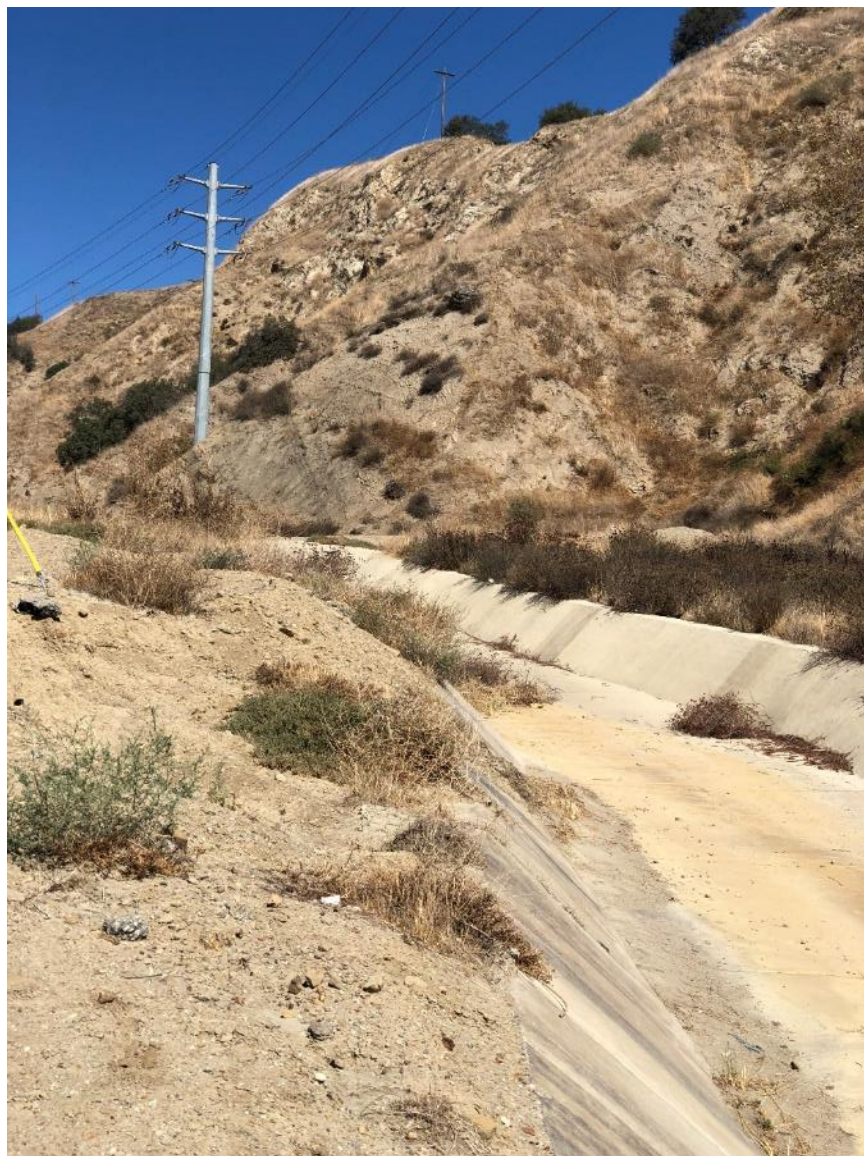
Photo 7: Bush growing between side and bottom slab along ditch

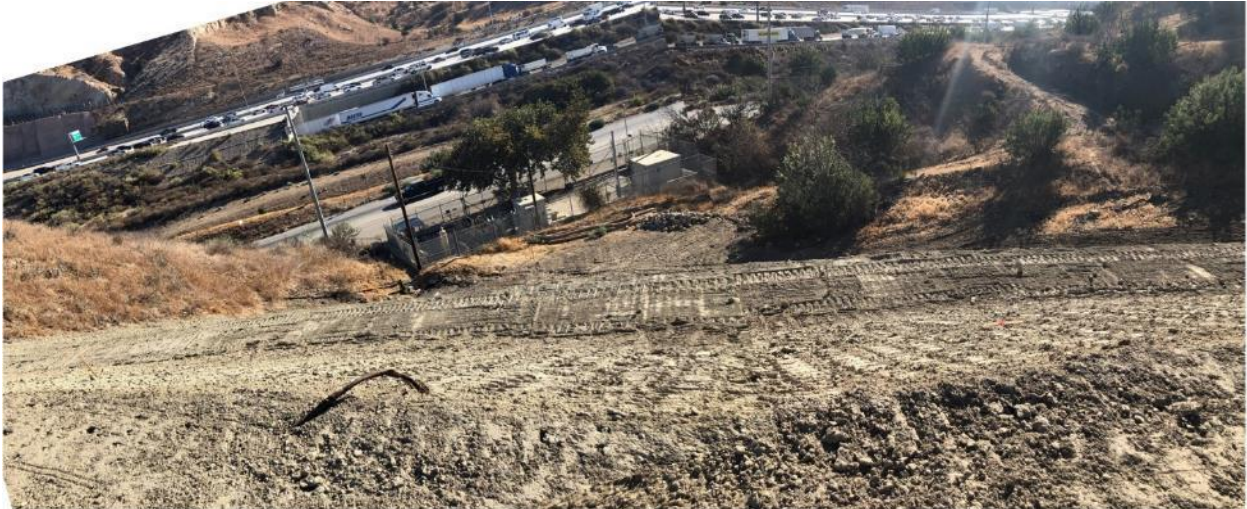
Photo 8: Embankment facing San Fernando Road

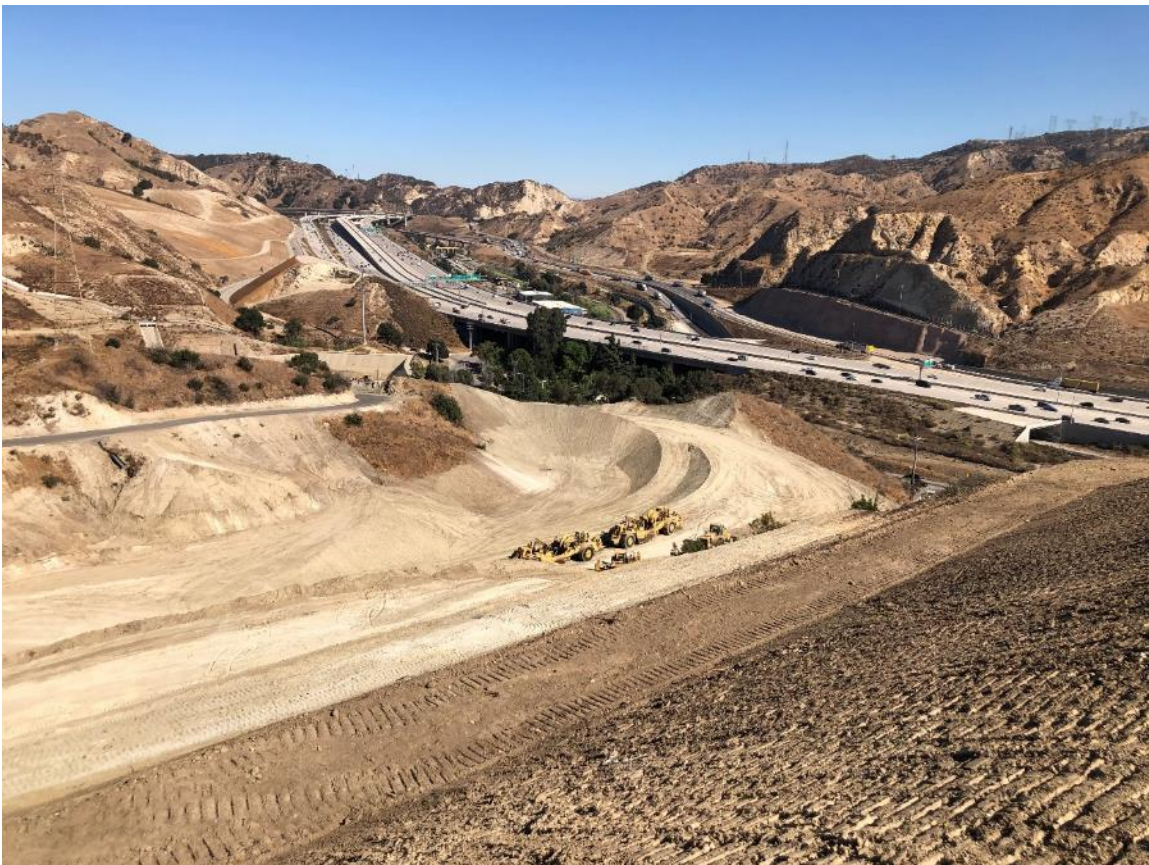
Photo 9: New sedimentation basin on new access road

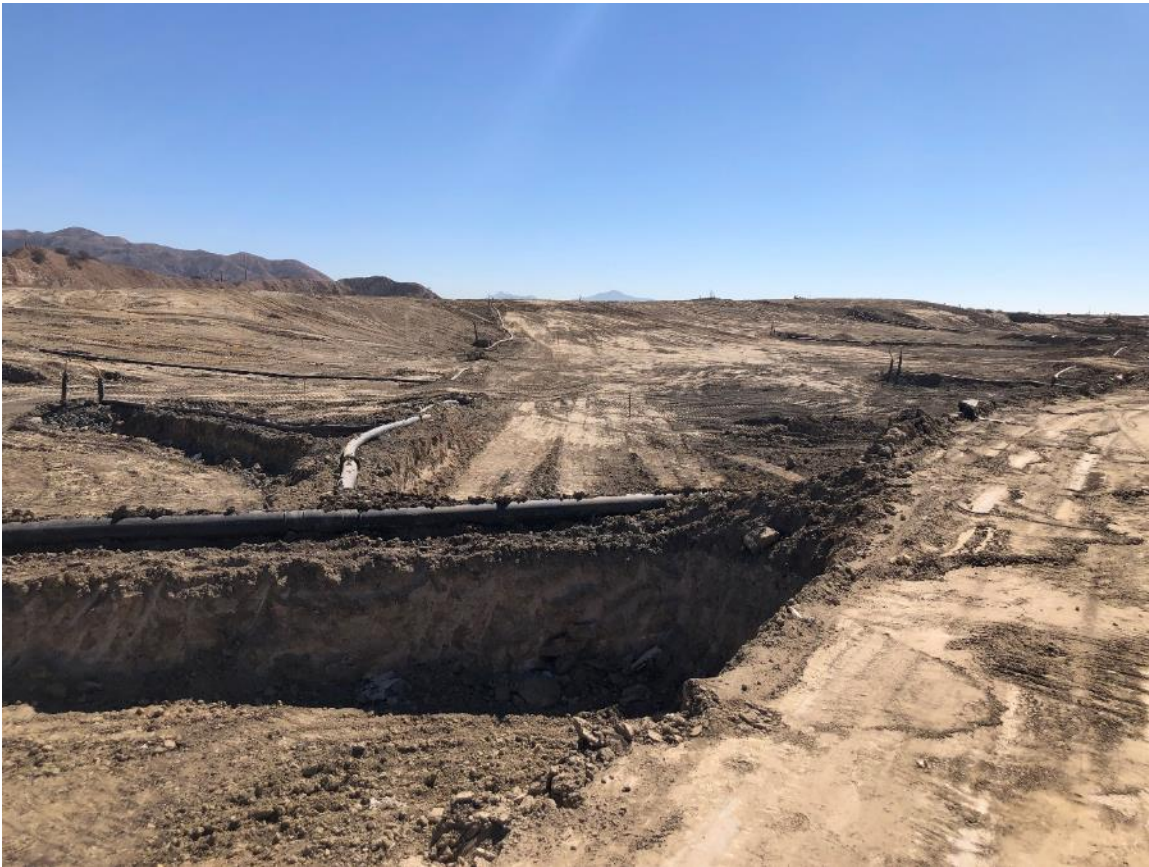
Photo 10: Excavated areas on deck of Phase 4-3
