**Sunshine Canyon Landfill
Independent Monitor
Quarterly Site Monitoring Status Report
April 1, 2018 – June 30, 2018**

City of Los Angeles Department of City Planning

September 26, 2018

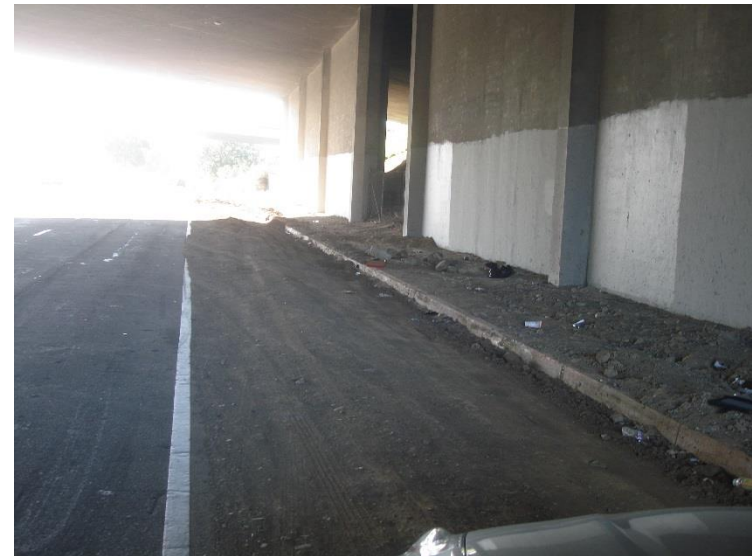
**Photo 664: Illegal Dumping San Fernando Road at I-5 Overpass:
May 22, 2018**

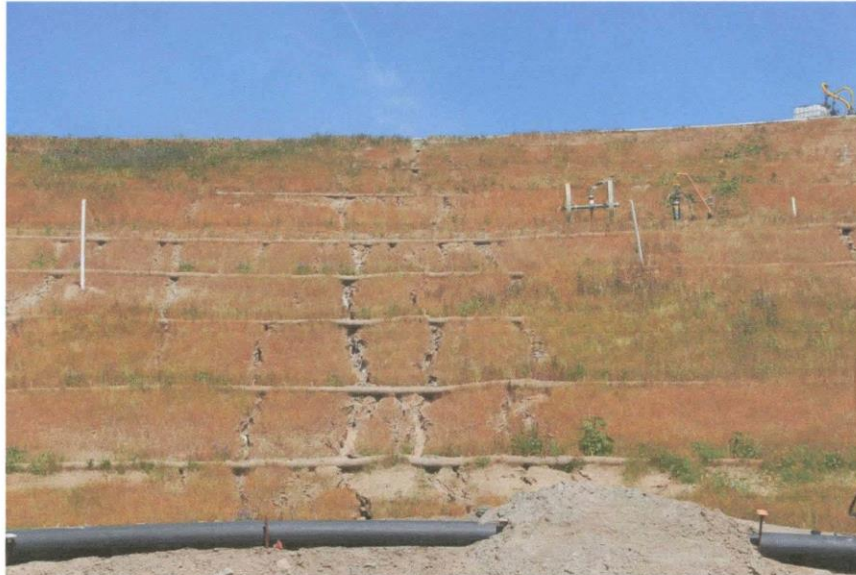
In late April, the eastern slopes of CC-3A had areas with erosion rills from rainwater runoff that need repair, with possible additions of temporary HDPE-lined downslope channels. The stockpiled soil adjacent to the east and west Closure Turf edges had deep erosion rills. County Bowl slopes had extensive erosion rills.

Photo 3: Erosion on east facing slope of Cell CC3

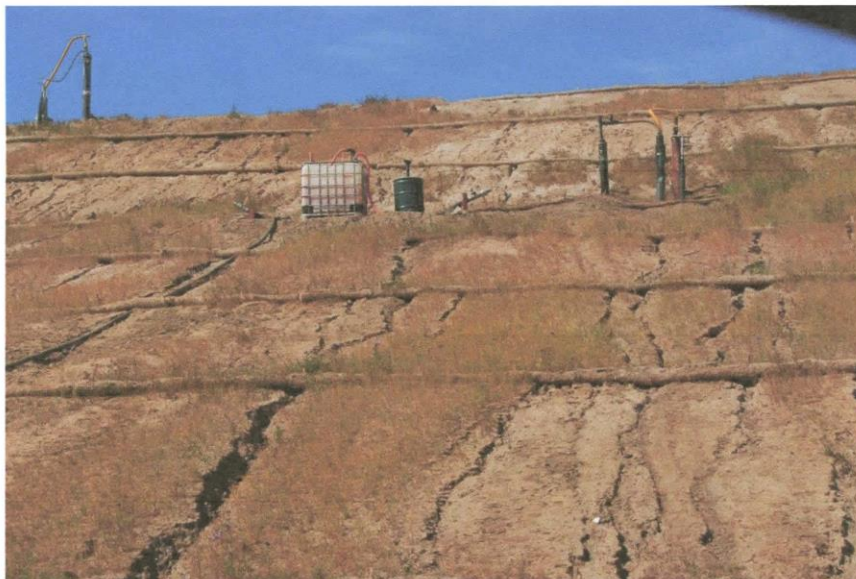
Photo 4: Erosion on north facing slope of Cell CC3

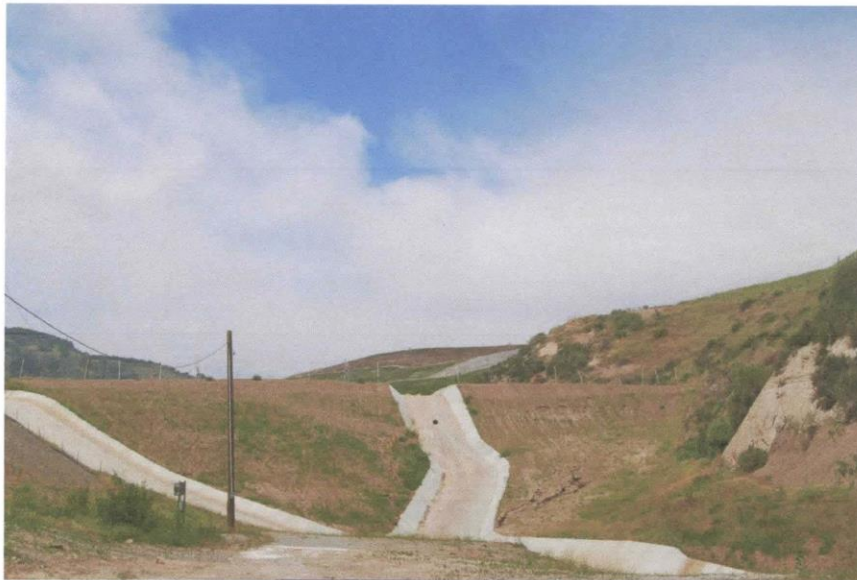
Photo 5: Erosion on earthen basin at eastern end of Cell CC3

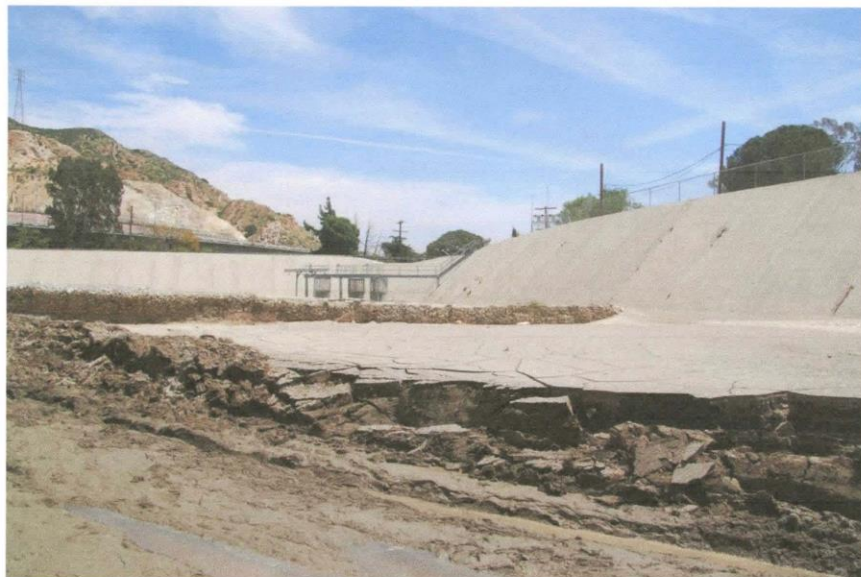
Photo 6: Sediments in Terminal Basin Upstream of Gabion Wall

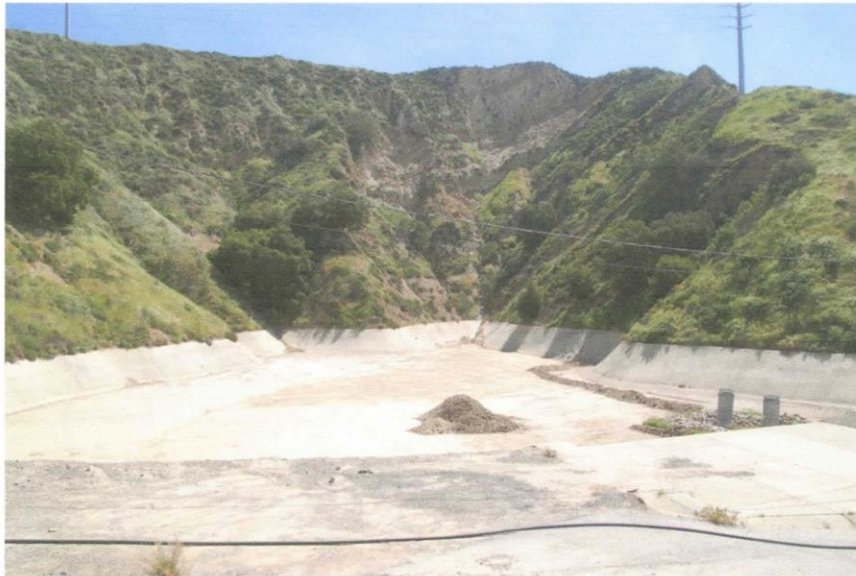
Photo 7: Residual amounts of sediments in Basin B

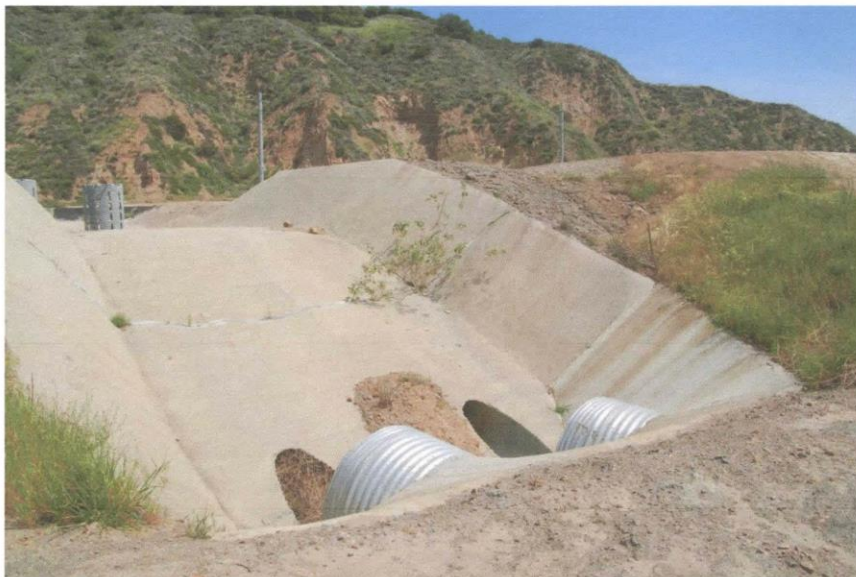
Photo 8: Cracked concrete spillway between two parts of Basin D and vegetation in crack

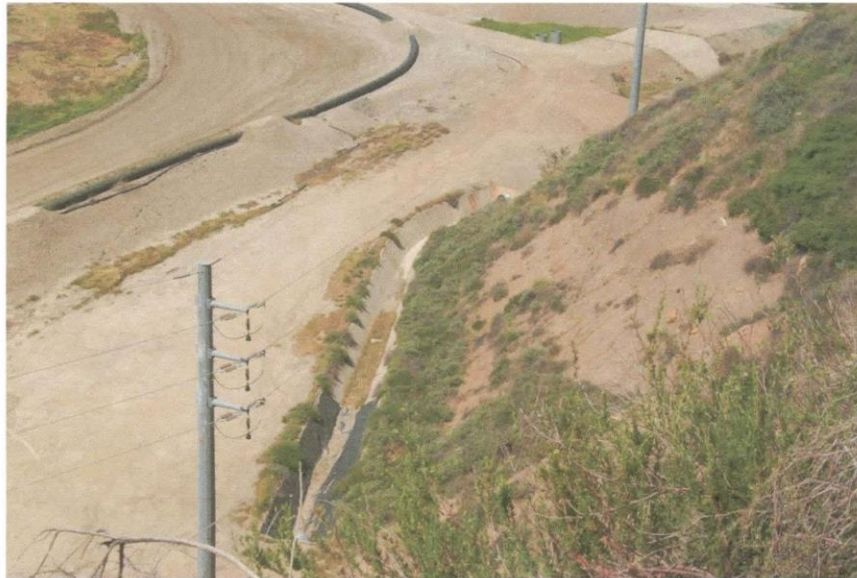
Photo 9: Vegetation in channel between Basin D and the access road to Flares 9-11

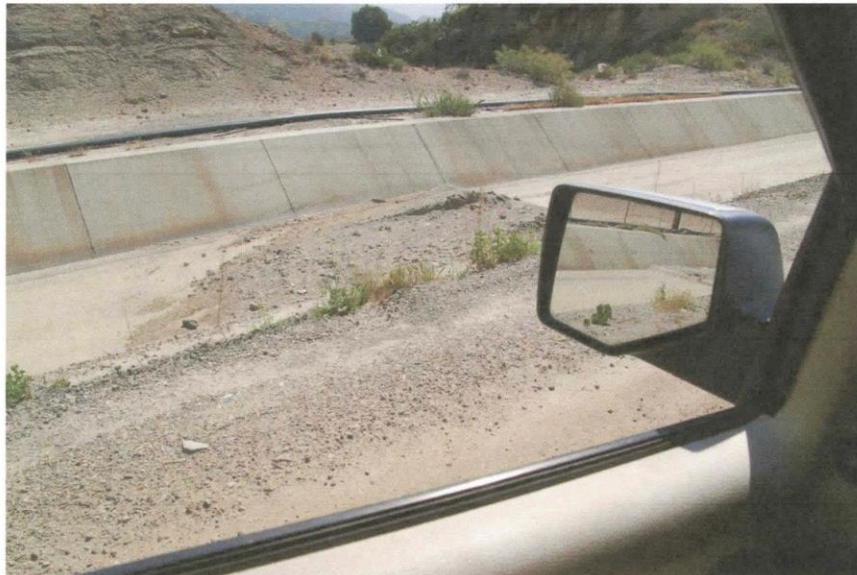
Photo 10: Sediments accumulation against asphalt berm in northern portion of main channel to terminal Basin

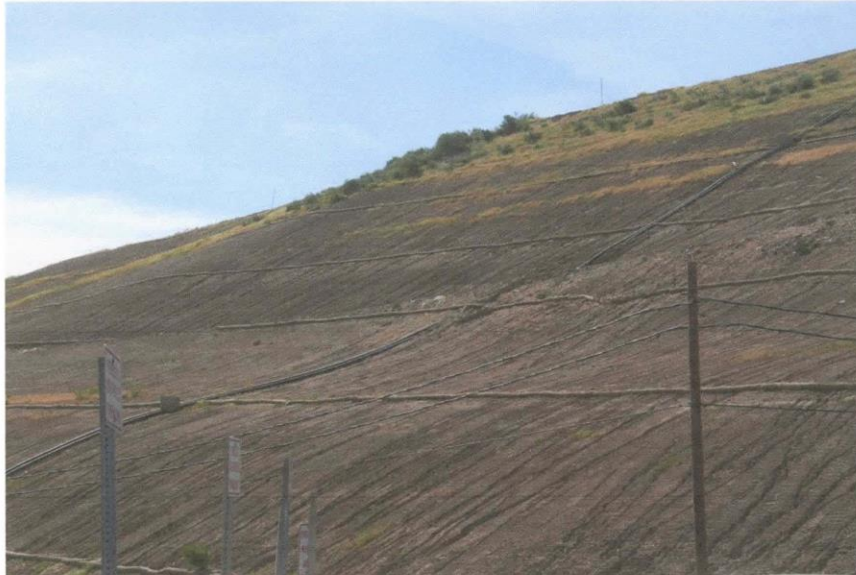
Photo 11: Slump near Administration Pad

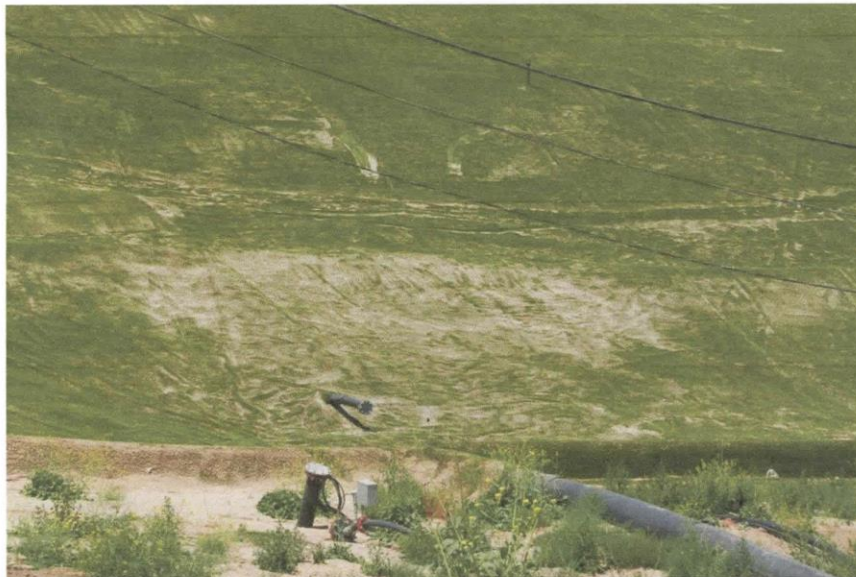
Photo 12: Sand washed out of the ClosureTurf on steep slope

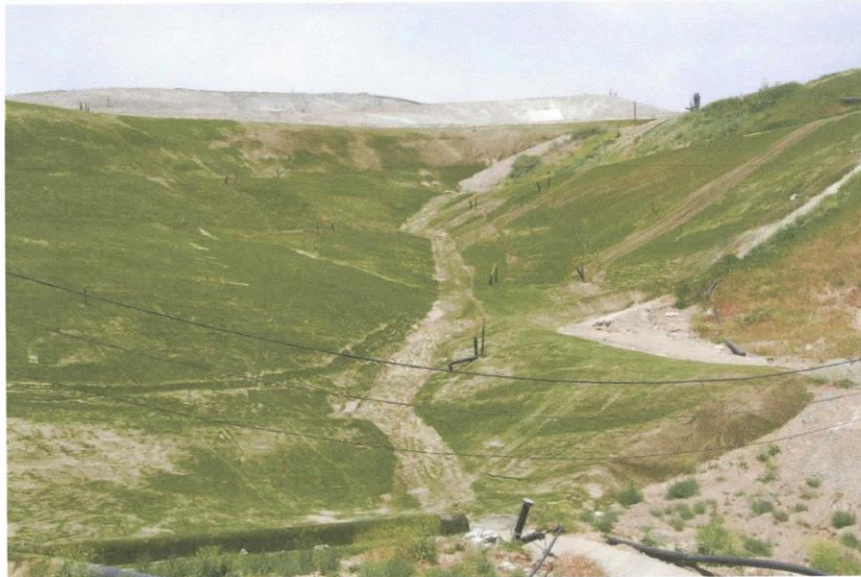
Photo 13: Sand washed out of the ClosureTurf in drainage path

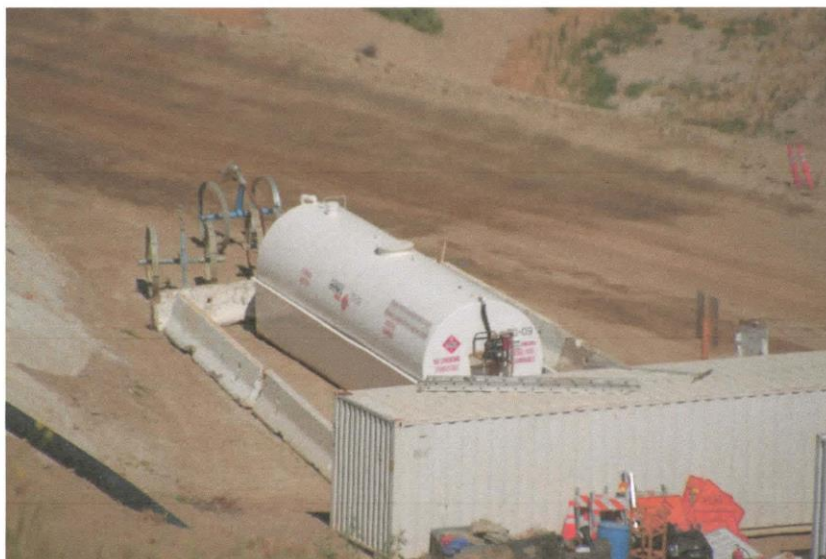
Photo 1: Petroleum product tank on city landfill bench – no drip pan under nozzle

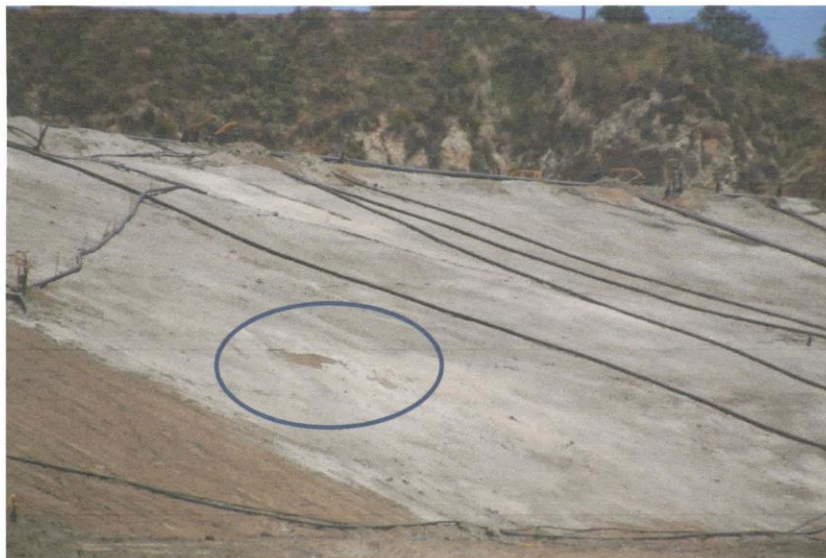
Photo 4: Bold spots on PosiShell on slope of Cell CC3

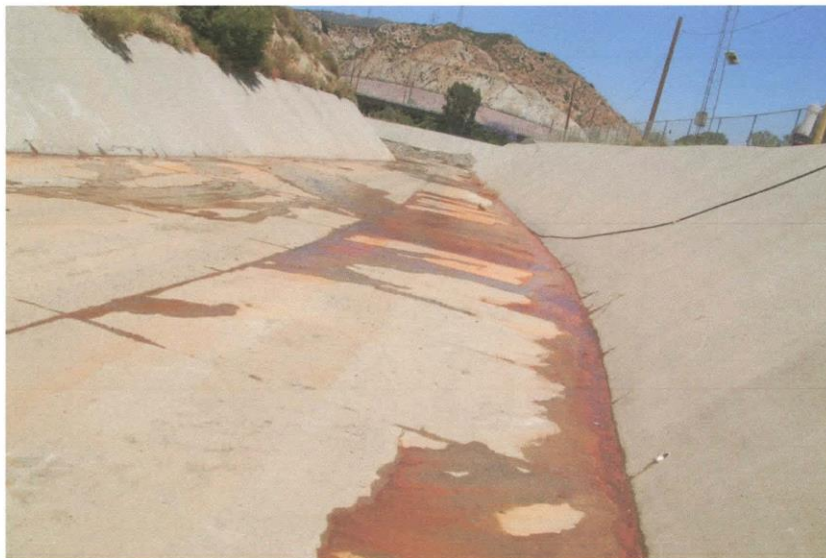
Photo 6: Reddish water oozing at intersection of bottom slab and slope slabs at terminal Basin

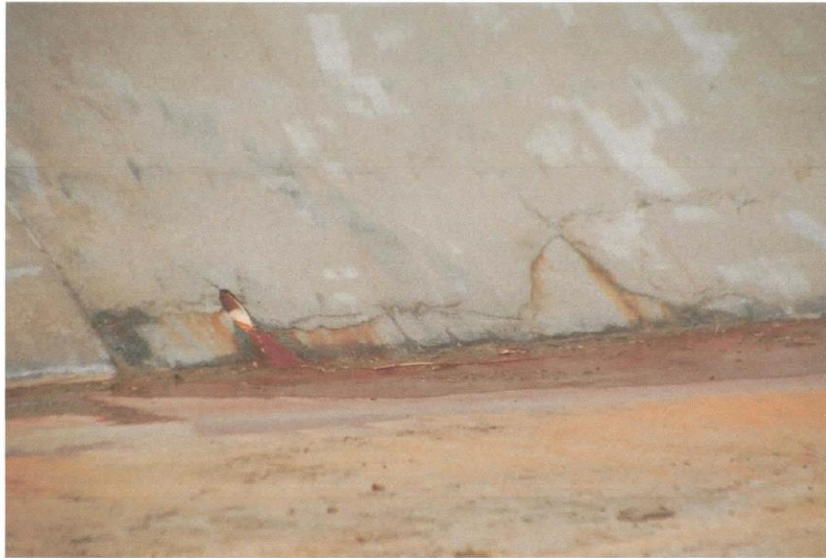
Photo 7: Reddish water oozing from weep hole in slope slabs at terminal Basin

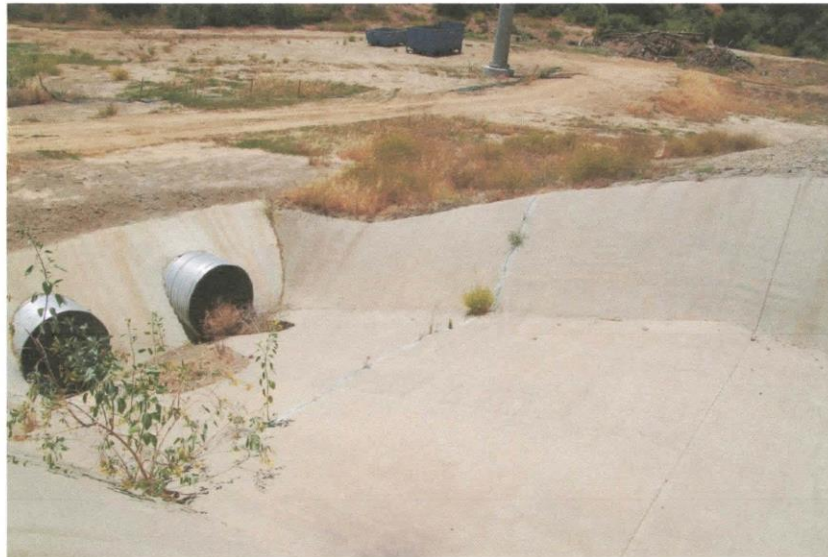
Photo 9: Cracked concrete spillway between two parts of Basin D and vegetation in crack

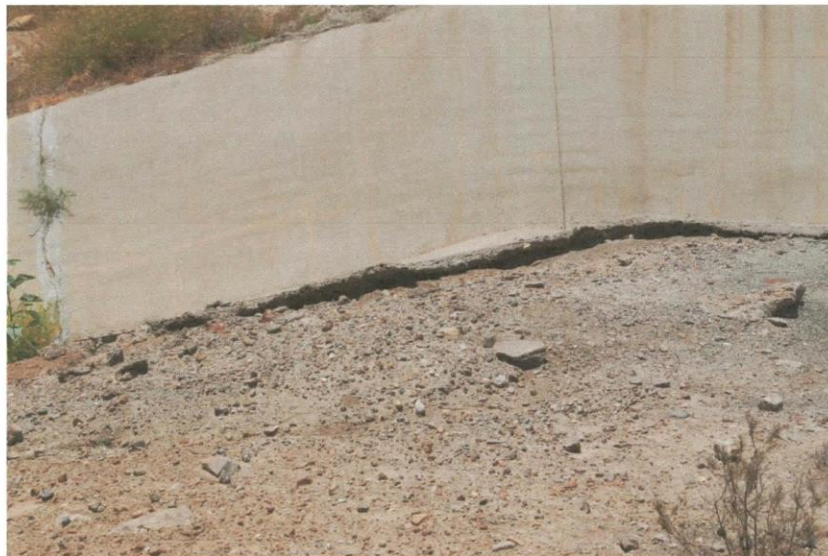
Photo 10: Separation between soil and spillway concrete at Basin D

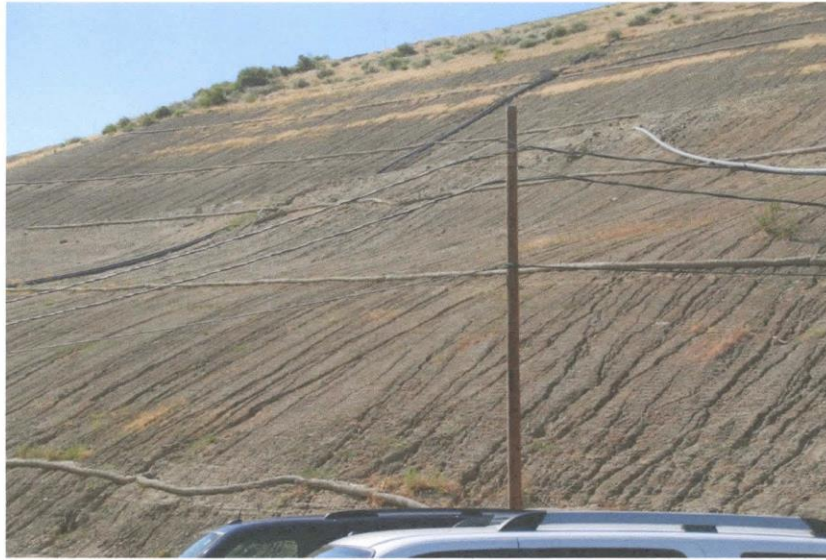
Photo 11: Slump near Administration Pad
