**Sunshine Canyon Landfill
Independent Monitor
Quarterly Site Monitoring Status Report
July 1, 2015 – September 30, 2015**

City of Los Angeles Department of City Planning

County of Los Angeles Department of Regional Planning

February 9, 2016

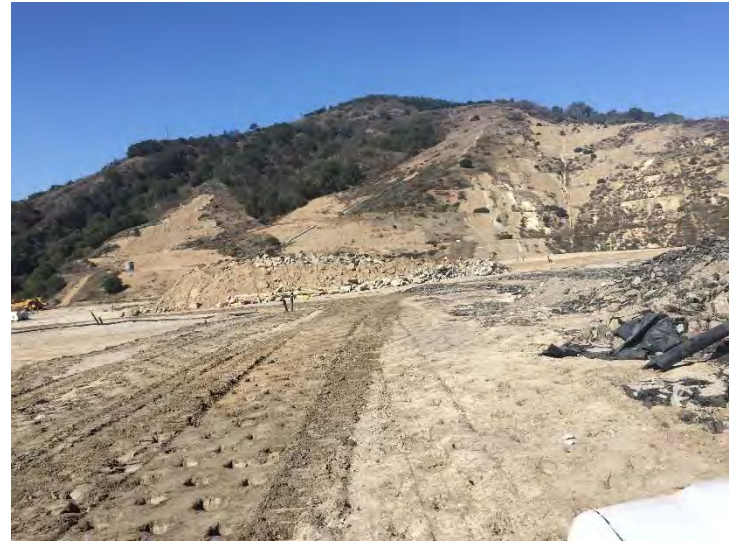
Photo 109: County Top Deck Low Point Ponding: September 23, 2015

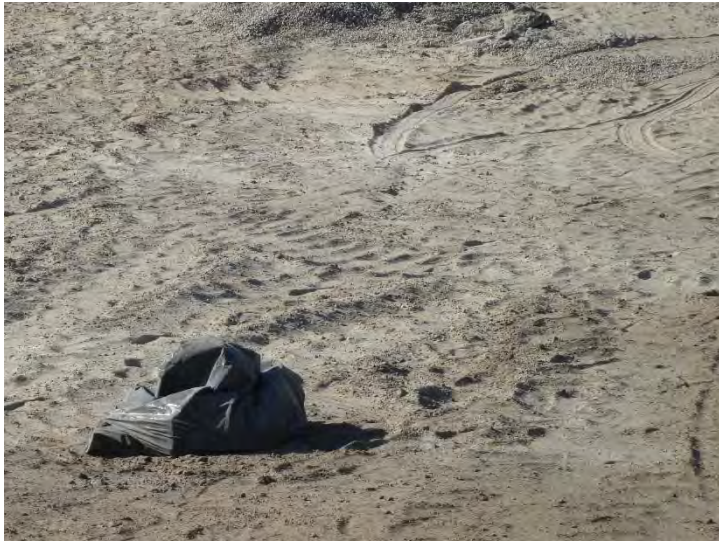
Photo 332: Loose Soils at New Water Tank Site: August 26, 2015

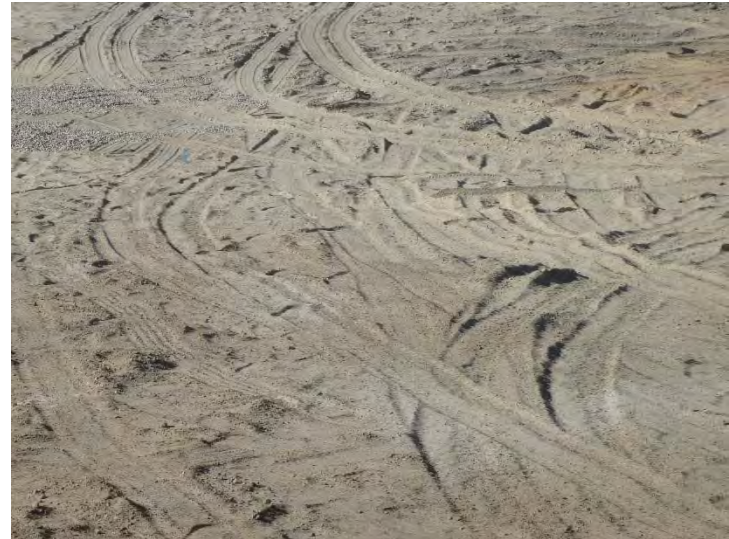
Photo 333: Loose Soils at New Water Tank Site: August 26, 2015

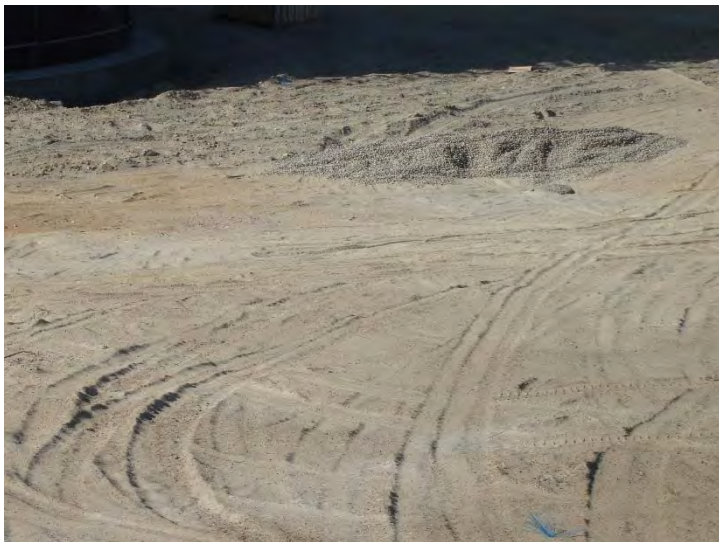
Photo 334: Loose Soils at New Water Tank Site: August 26, 2015

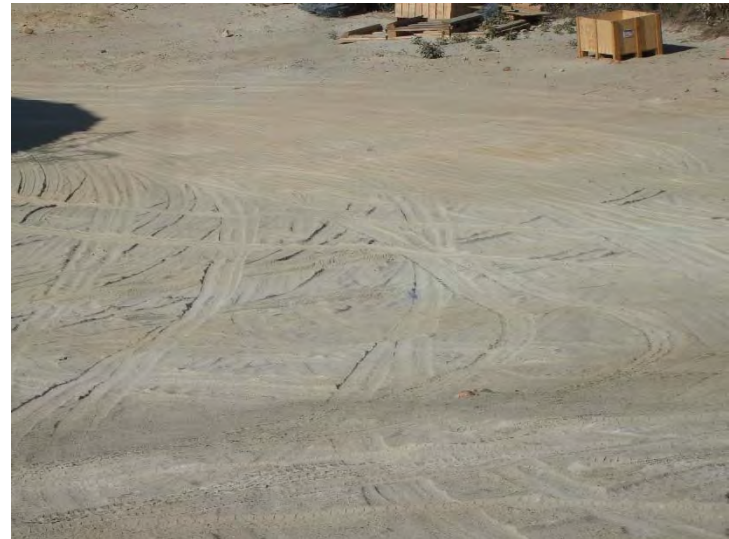
Photo 335: Loose Soils at New Water Tank Site: August 26, 2015

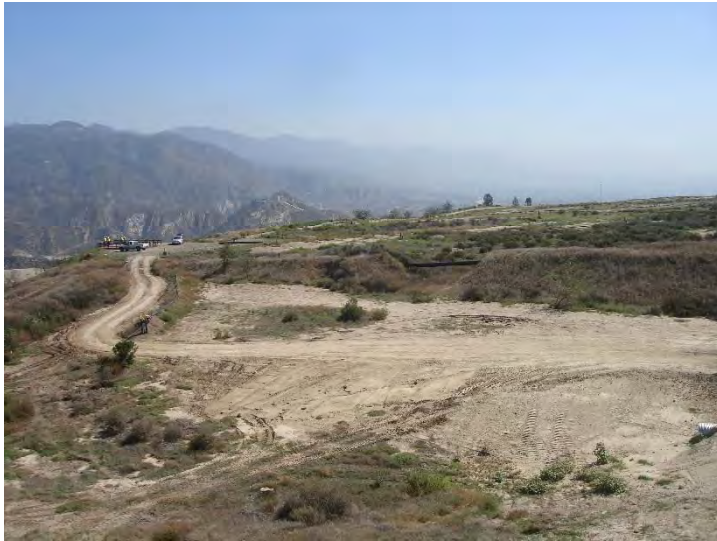
Photo 336: Loose Soils at New Water Tank Site: August 26, 2015

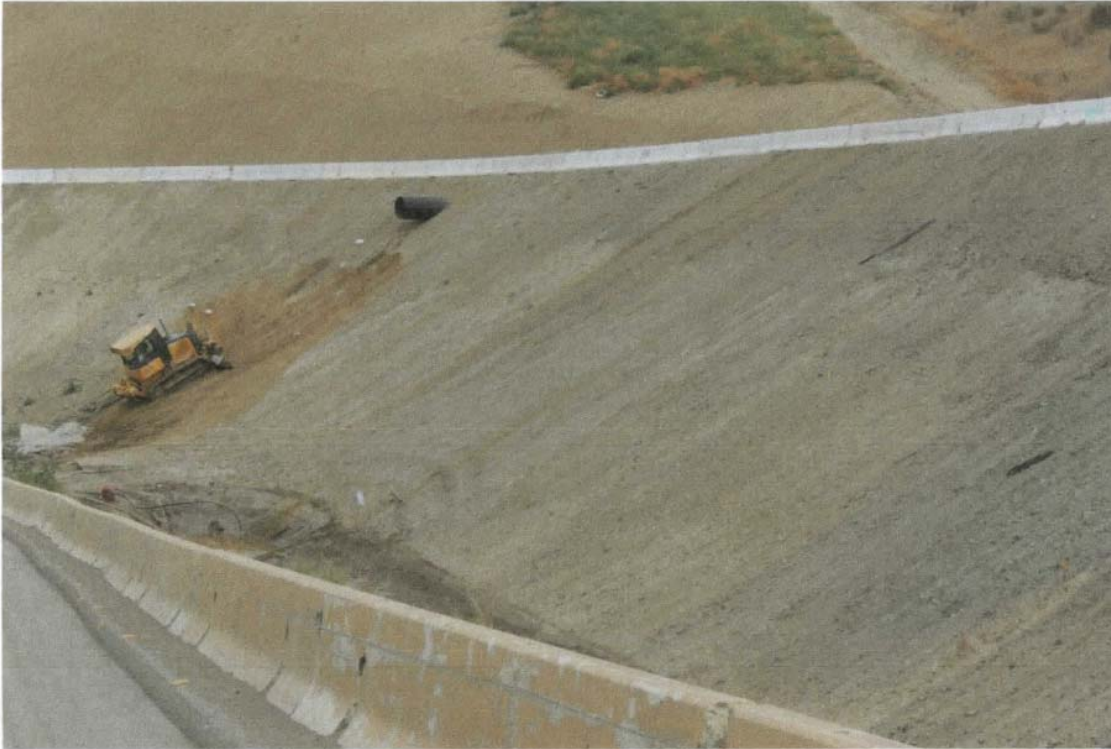
In July, significant erosion to the realigned access road slopes from the early rainstorm were observed at the 36" drainage pipe outlet and twin 36" box culvert outlet, located under the realigned access road. Repairs were ongoing. The monitors anticipate that a pipe will be connected to the corrugated drainage pipe and that a conveyance structure will be installed to connect the box culvert to allow both to flow runoff directly to the terminal basin.

Photo 1: Damage repair at drainage pipe under new access road

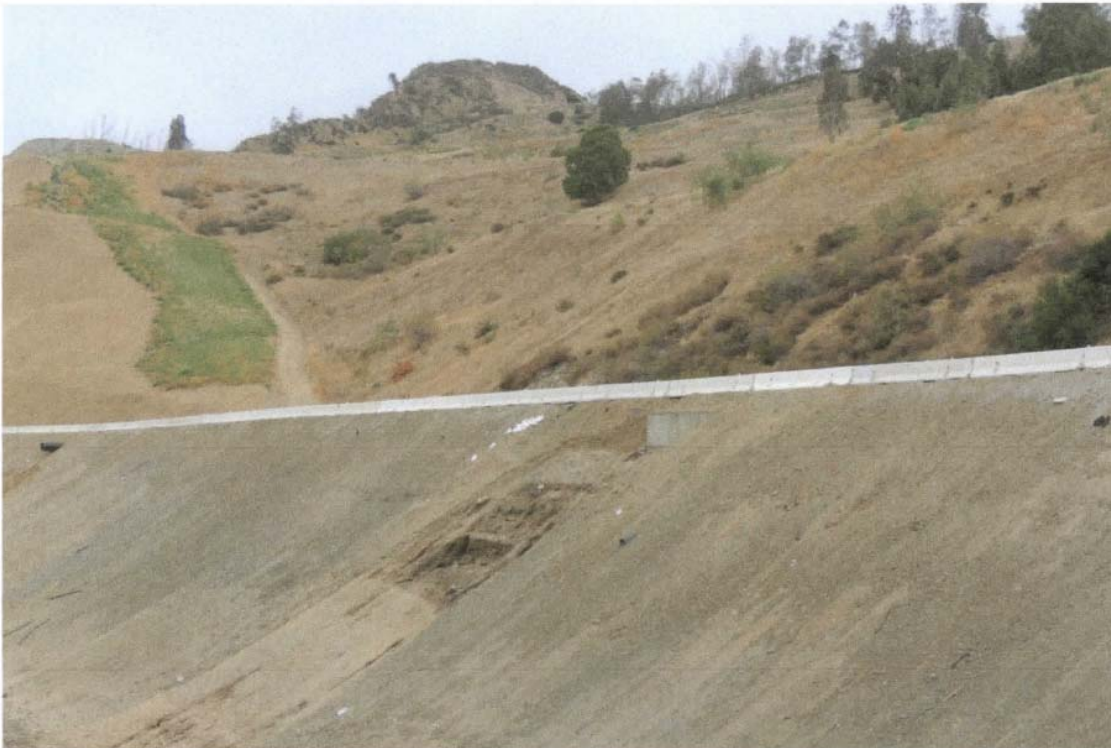
Photo 2: Damage under box culvert on new access road

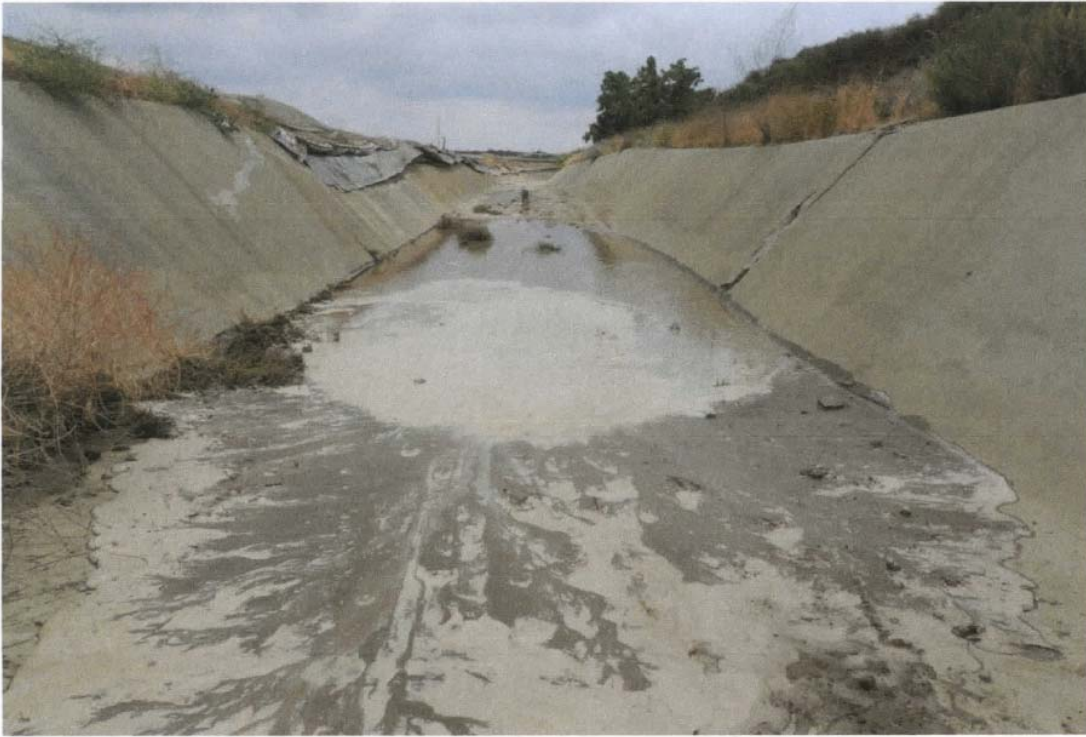
Figure 3: Conditions of drainage channel between basin A and D

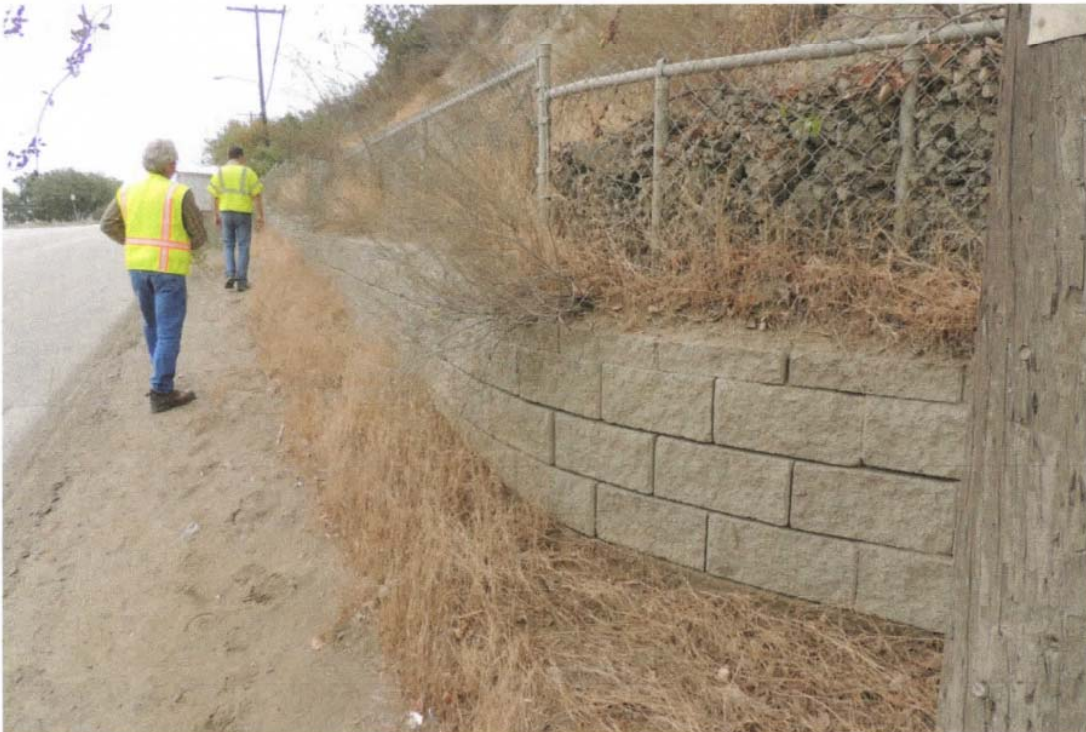
Current Status/Comments – In July, it was observed that the block wall hillside retaining wall along the San Fernando Road south frontage has a significant amount of soil and debris accumulating on top of the wall. The top drainage was blocked and the fence was nearly being topped with debris in several areas. This retaining wall was not designed for this type of loading. The two-foot-wide walkway in front of the wall was also piled with soil. The westside drainage channel still had the floor slabs uplifting and water infiltration behind the sidewalls. Repairs are not scheduled until 2016. Minor temporary repairs may be needed to withstand a wet winter.

Photo 4: Debris on top of wall along San Fernando Road

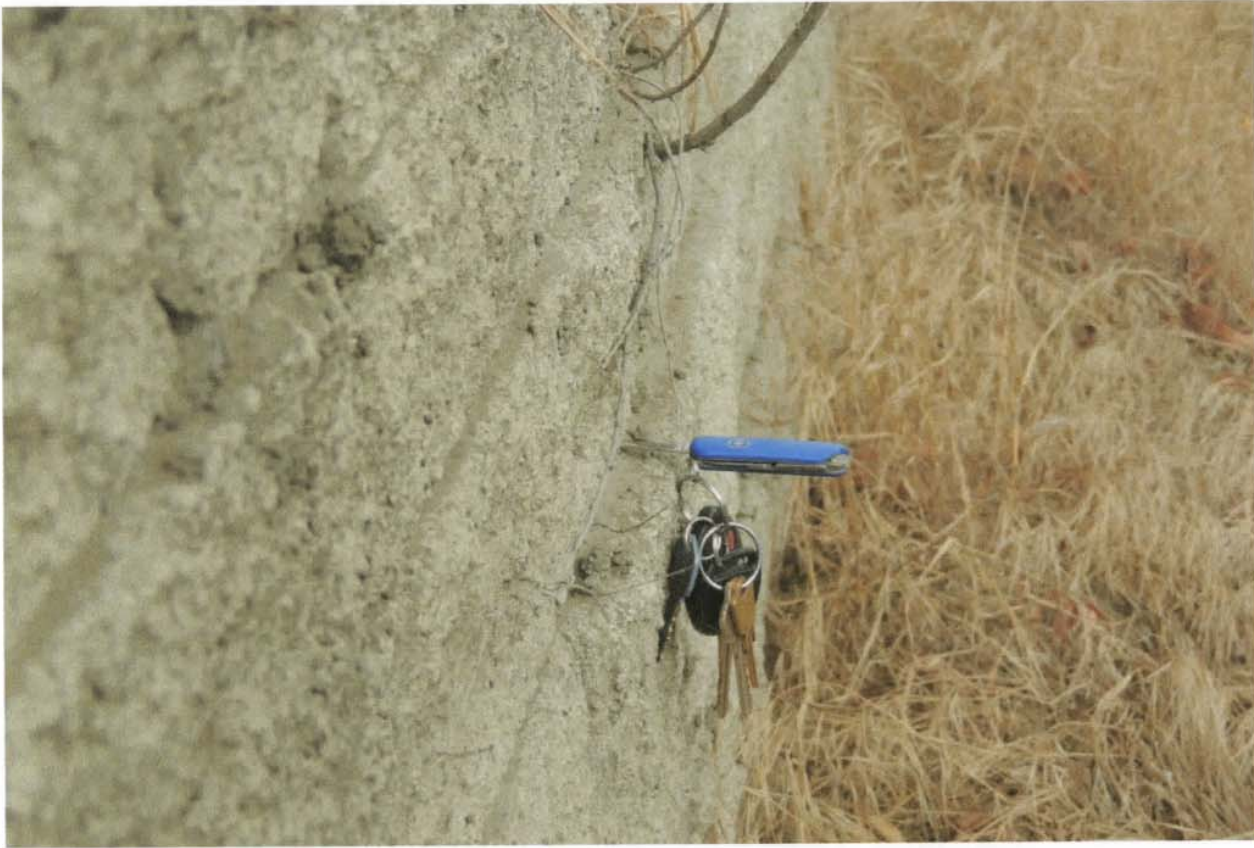
Photo 5: Blocks off alignment on wall along San Fernando Road

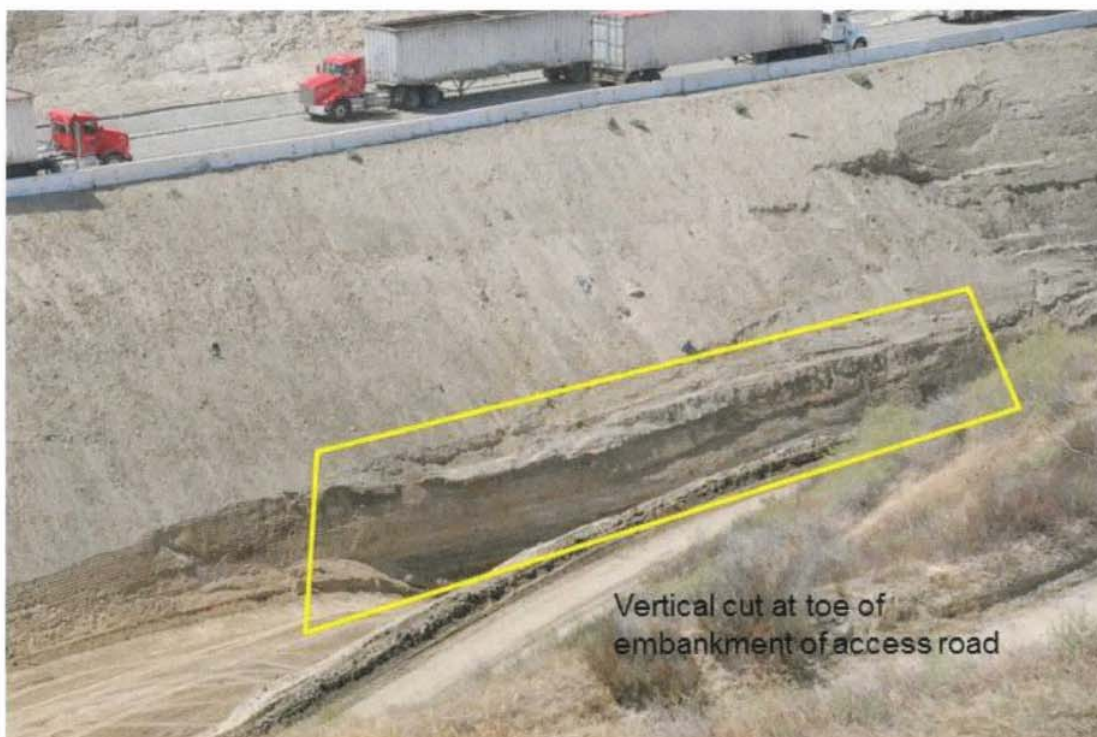
Photo 1: Vertical Cut at Toe of Access Road Embankment

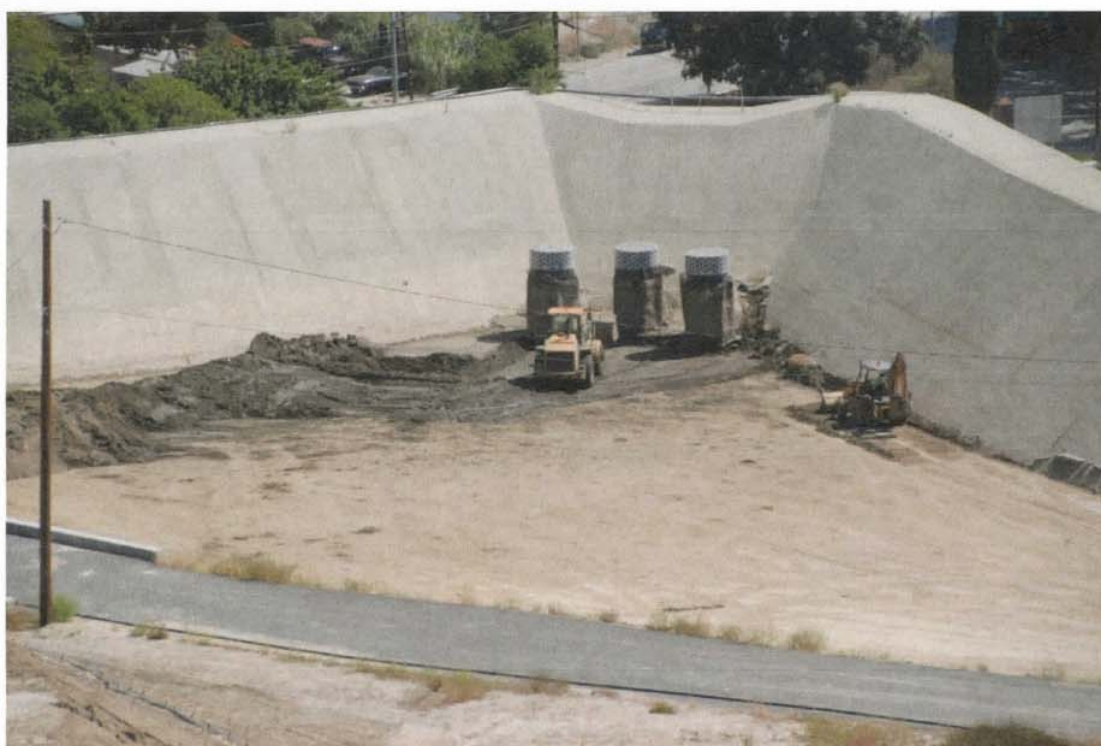
In late August, the monitors observed that the terminal basin was cleared of sediment. The rock around the outlet risers was not yet in place. In addition, Basin A was cleared of sediment. The sediment in the drainage riser's rock had not been cleaned.

Photo 2: Terminal Basin Undergoing Clean-up

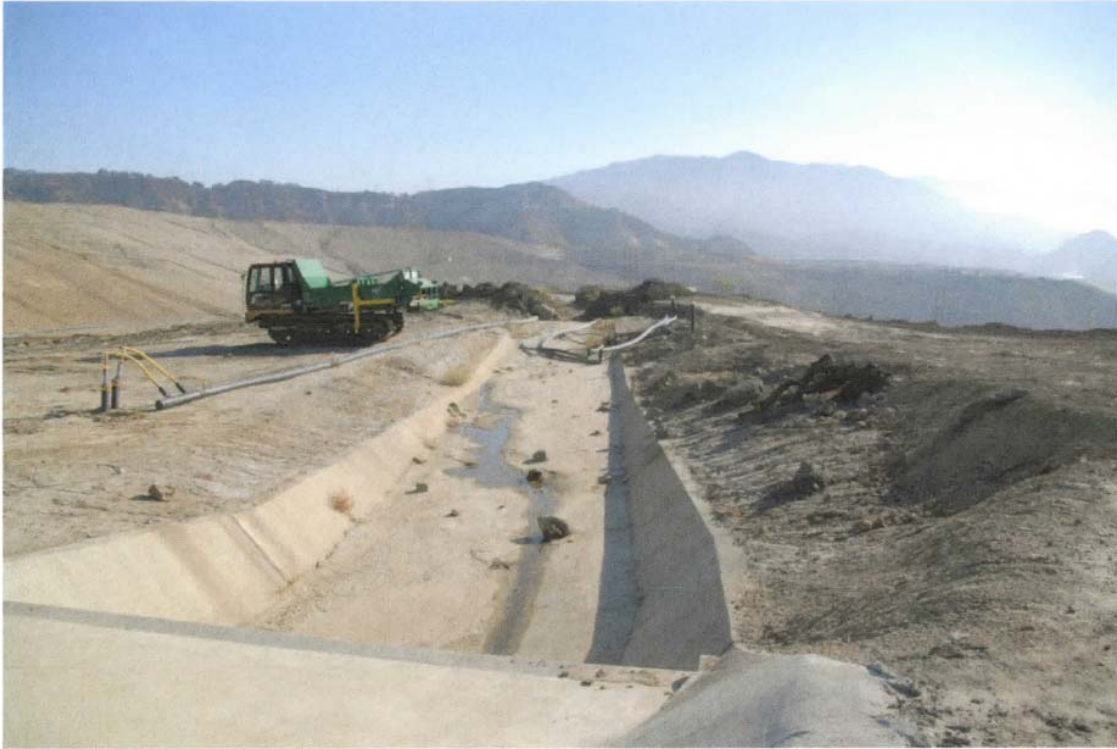
Figure 3: Channel out of Basin A Partially Blocked

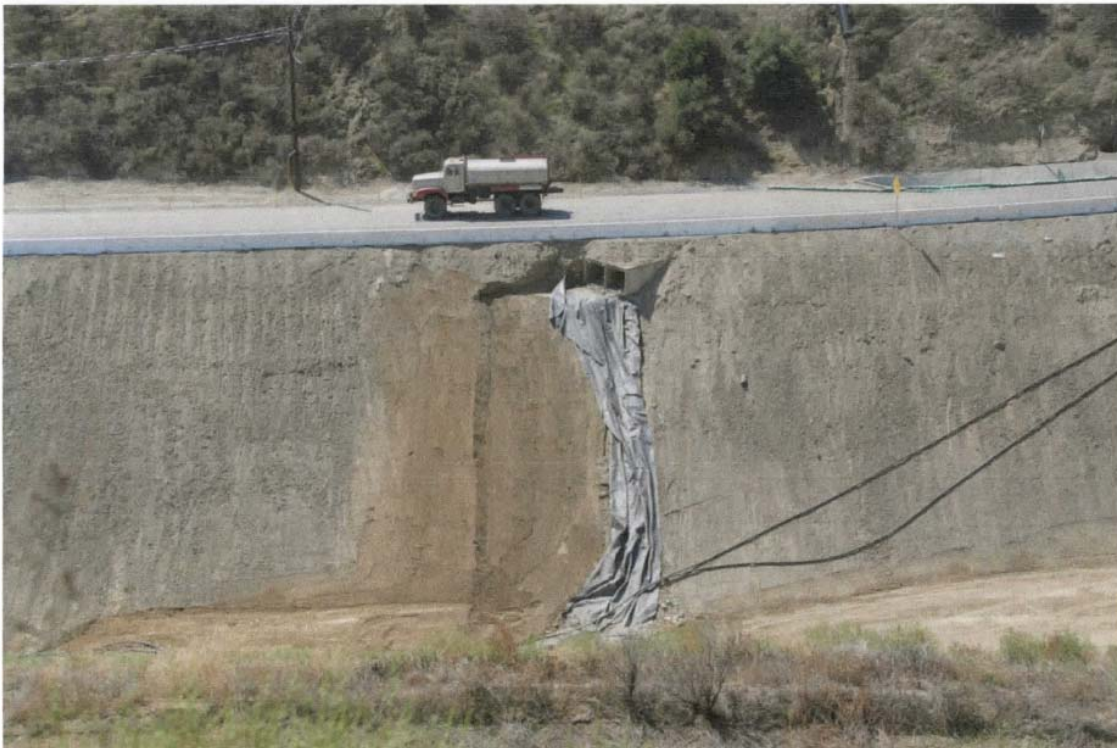
Photo 4: Geomembrane at Box Culver on Access Road

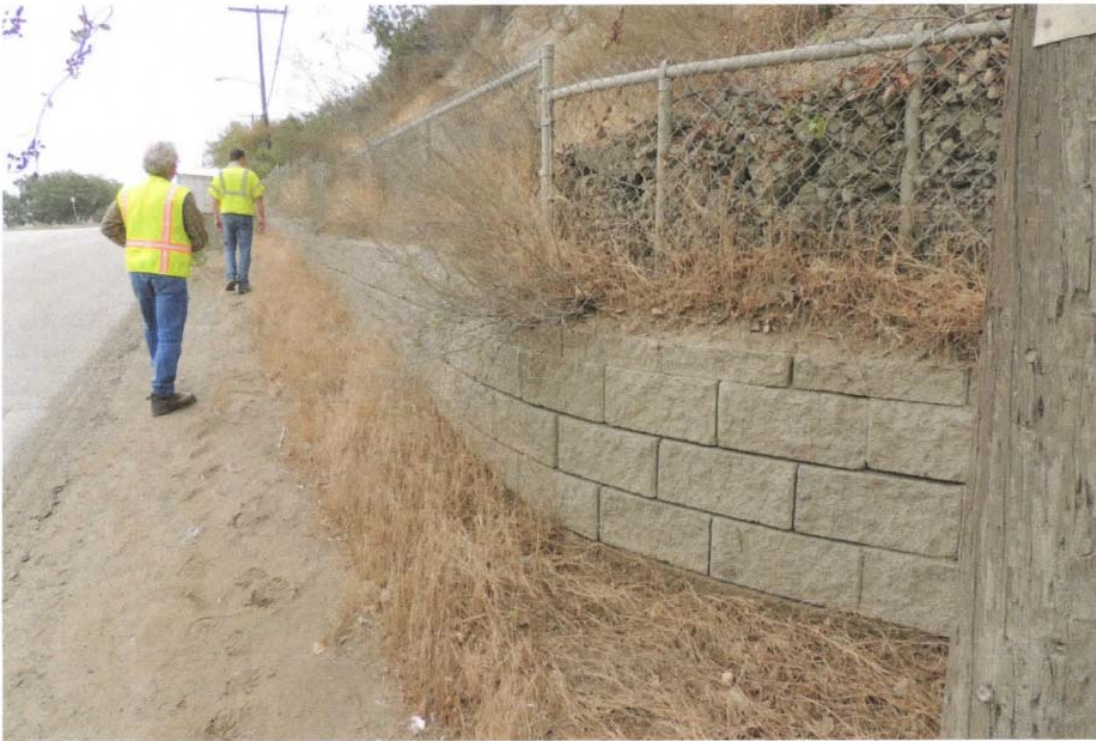
Photo 5: Debris on top of wall along San Fernando Road
