**Sunshine Canyon Landfill  
Independent Monitor  
Quarterly Site Monitoring Status Report  
July 1, 2022 – September 30, 2022**

**City of Los Angeles Department of City Planning**

**County of Los Angeles Department of Regional Planning**

January 9, 2023

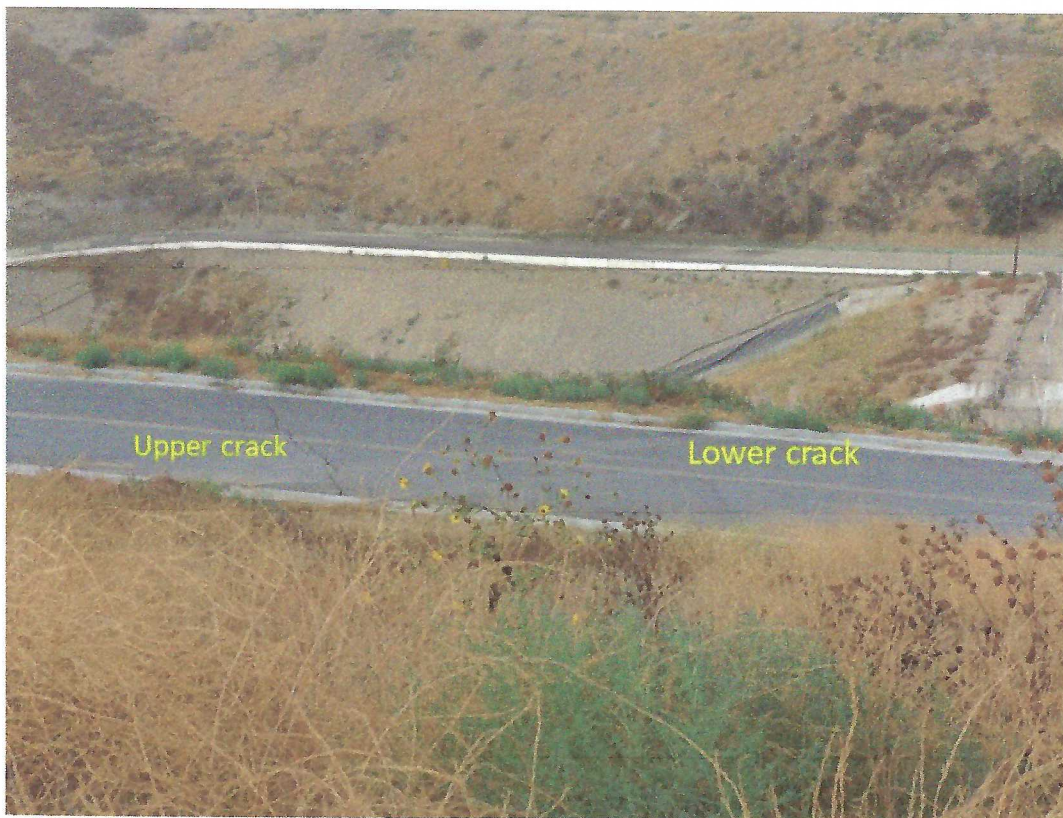
Figure 1 : Two cracks on access road to the administration pad

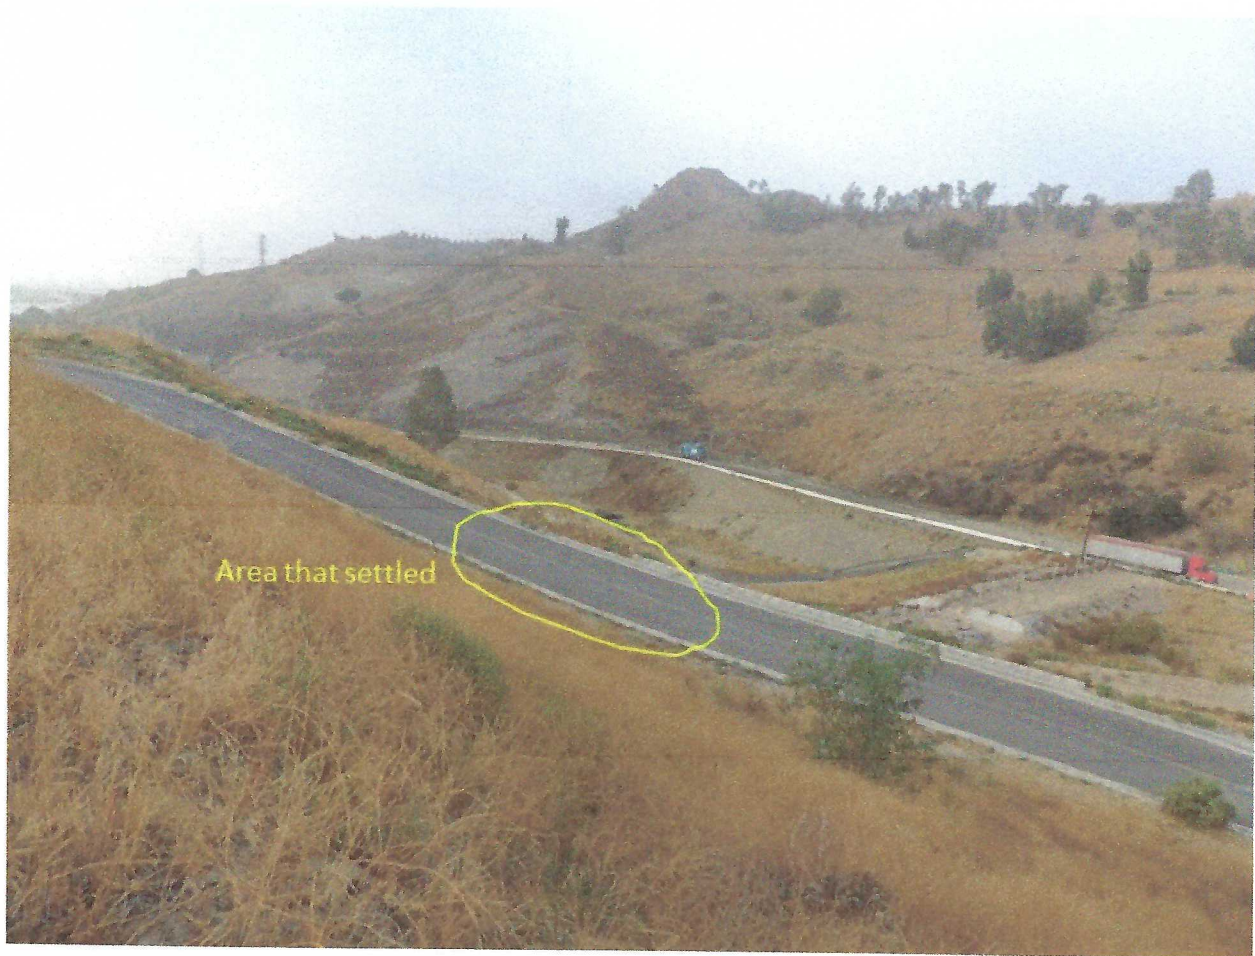
Figure 2 : Slight depression on the road to the administration pad

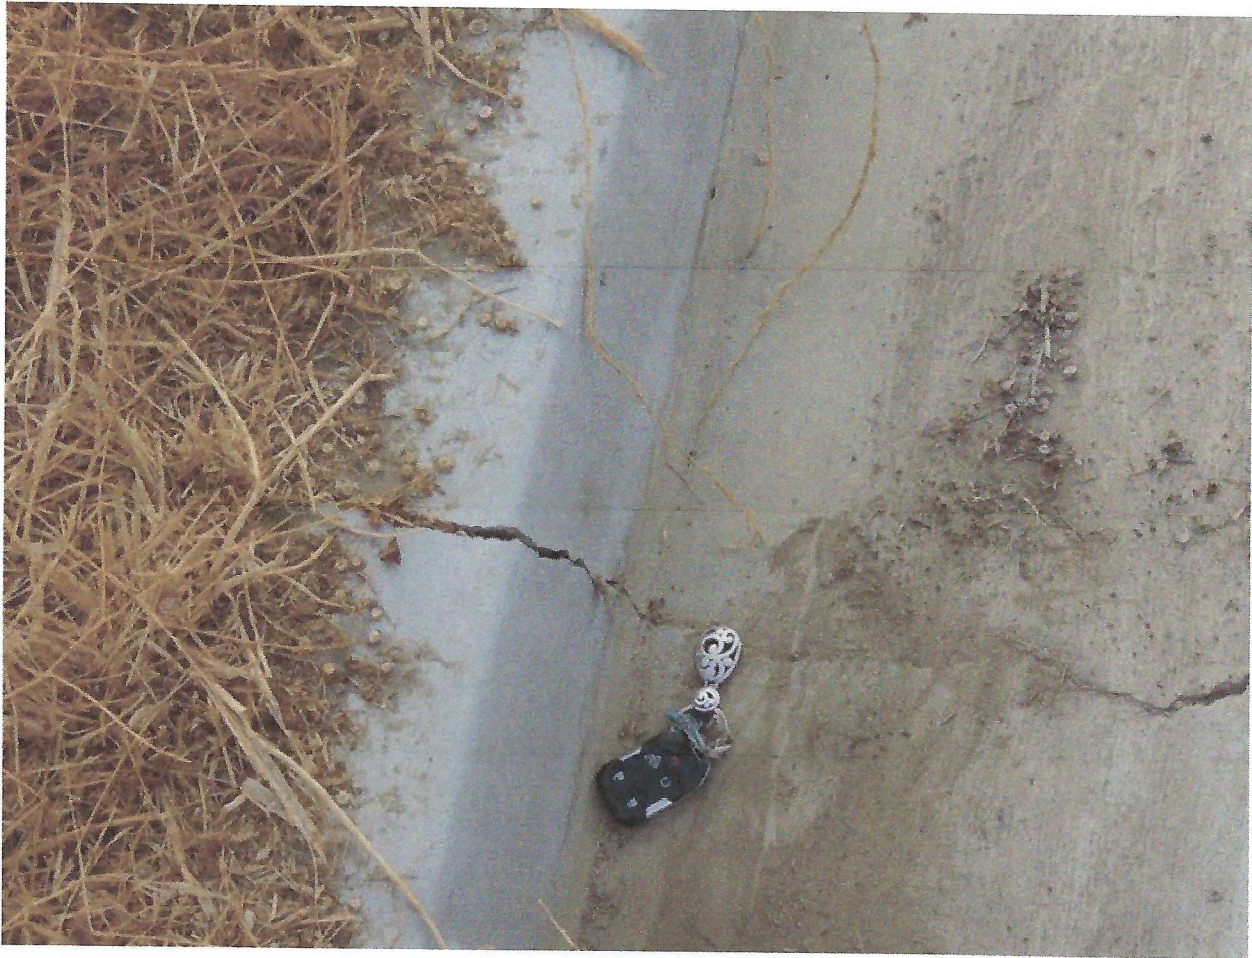
Figure 3: Crack in the curb at end of upper crack – slight vertical offset

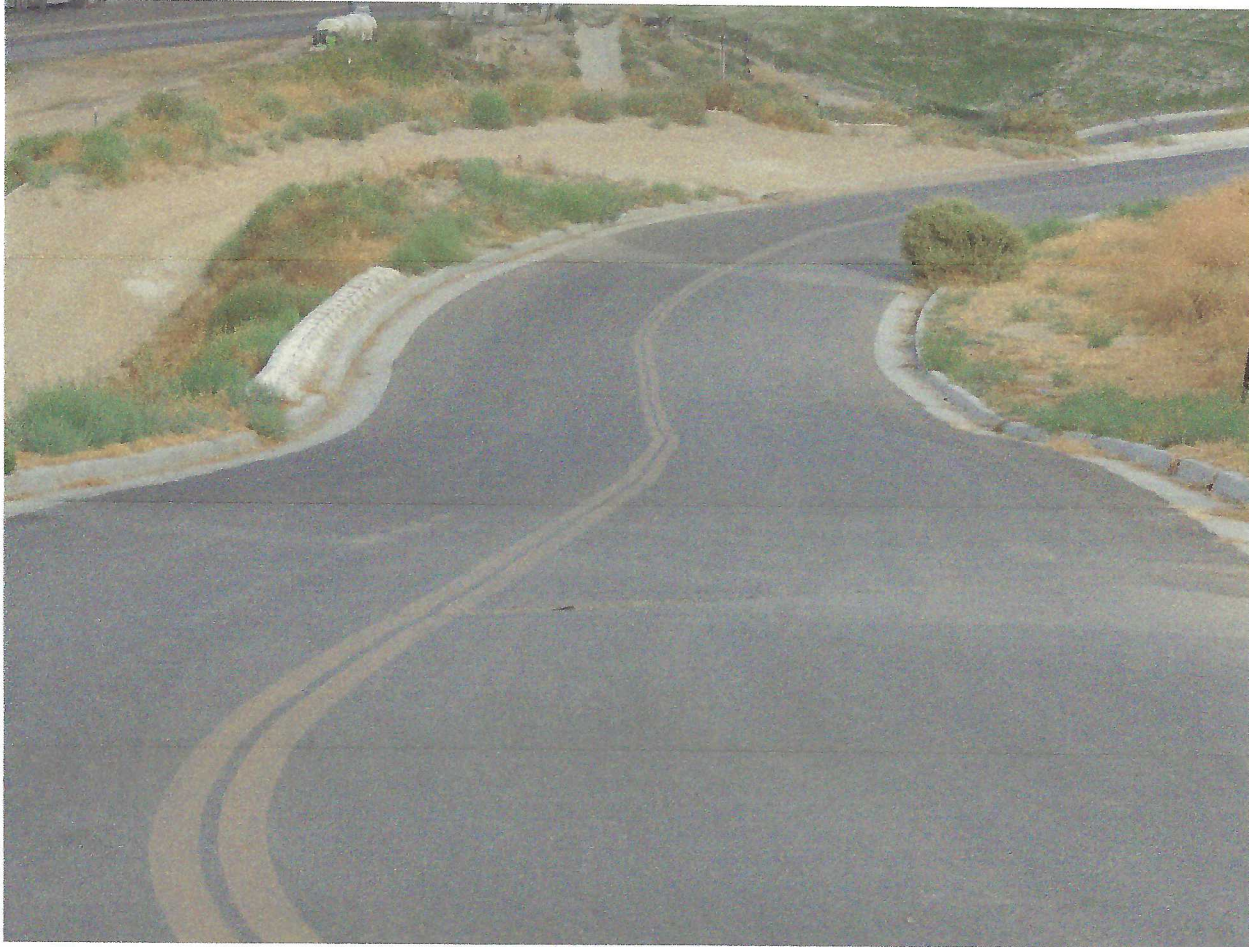
Figure 4 : Slight horizontal offset (yellow lines) at second crack on access road to the administration pad.

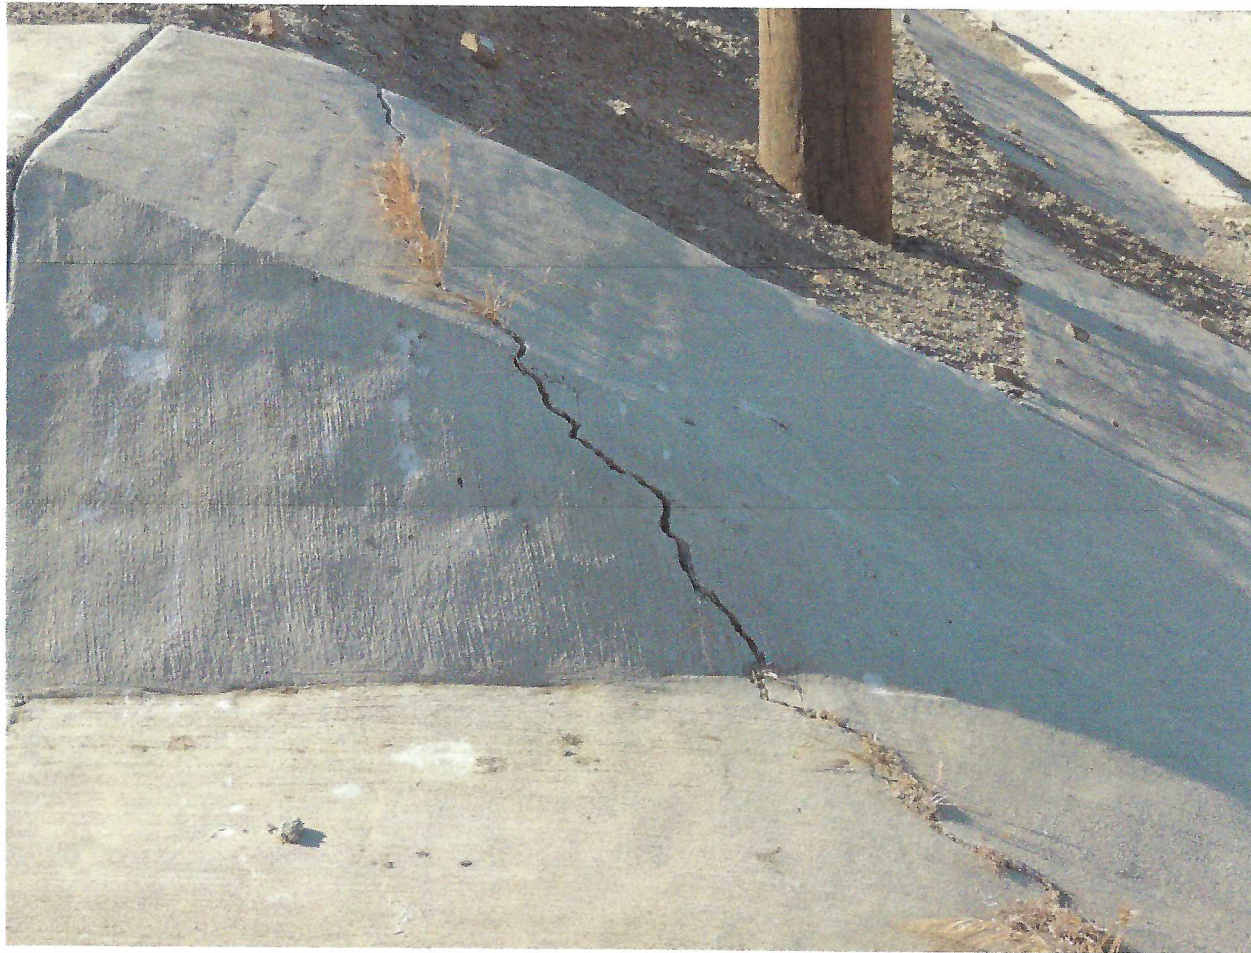
Figure 5: Cracks in spillway at Basin B

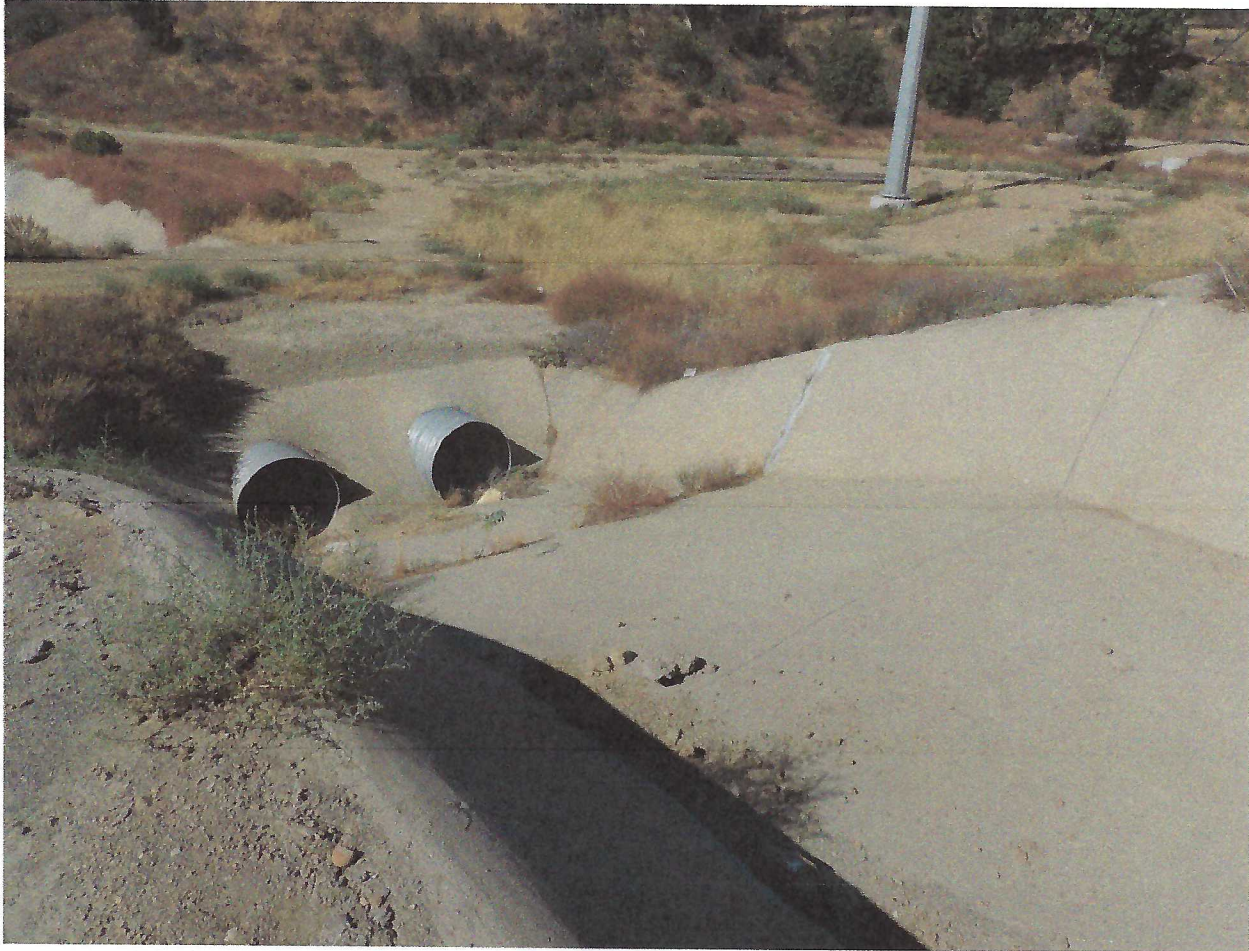
Figure 6: Vegetation in cracks at Basin D spillway

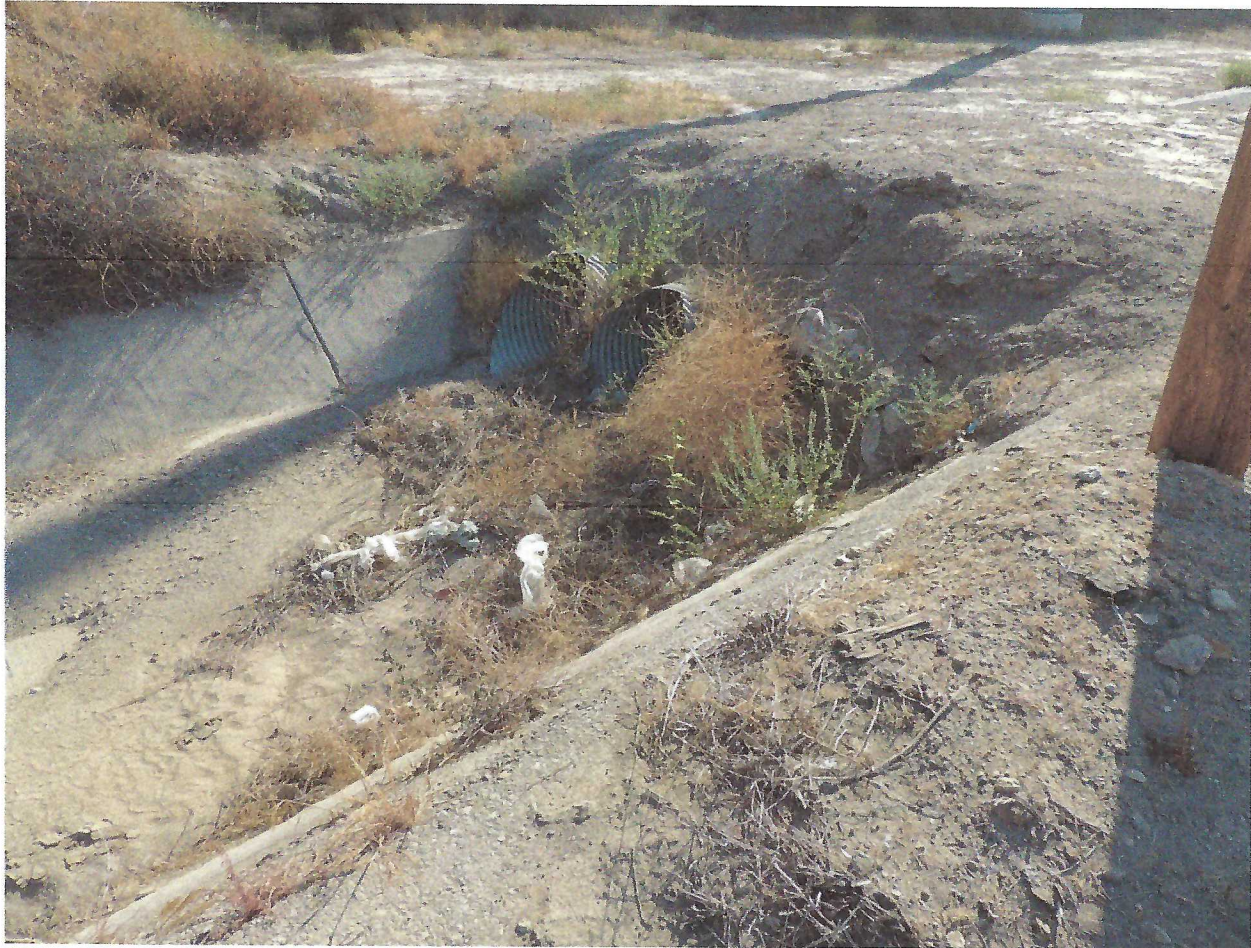
Figure 7: Soil and waste accumulated at intake pipe along channel

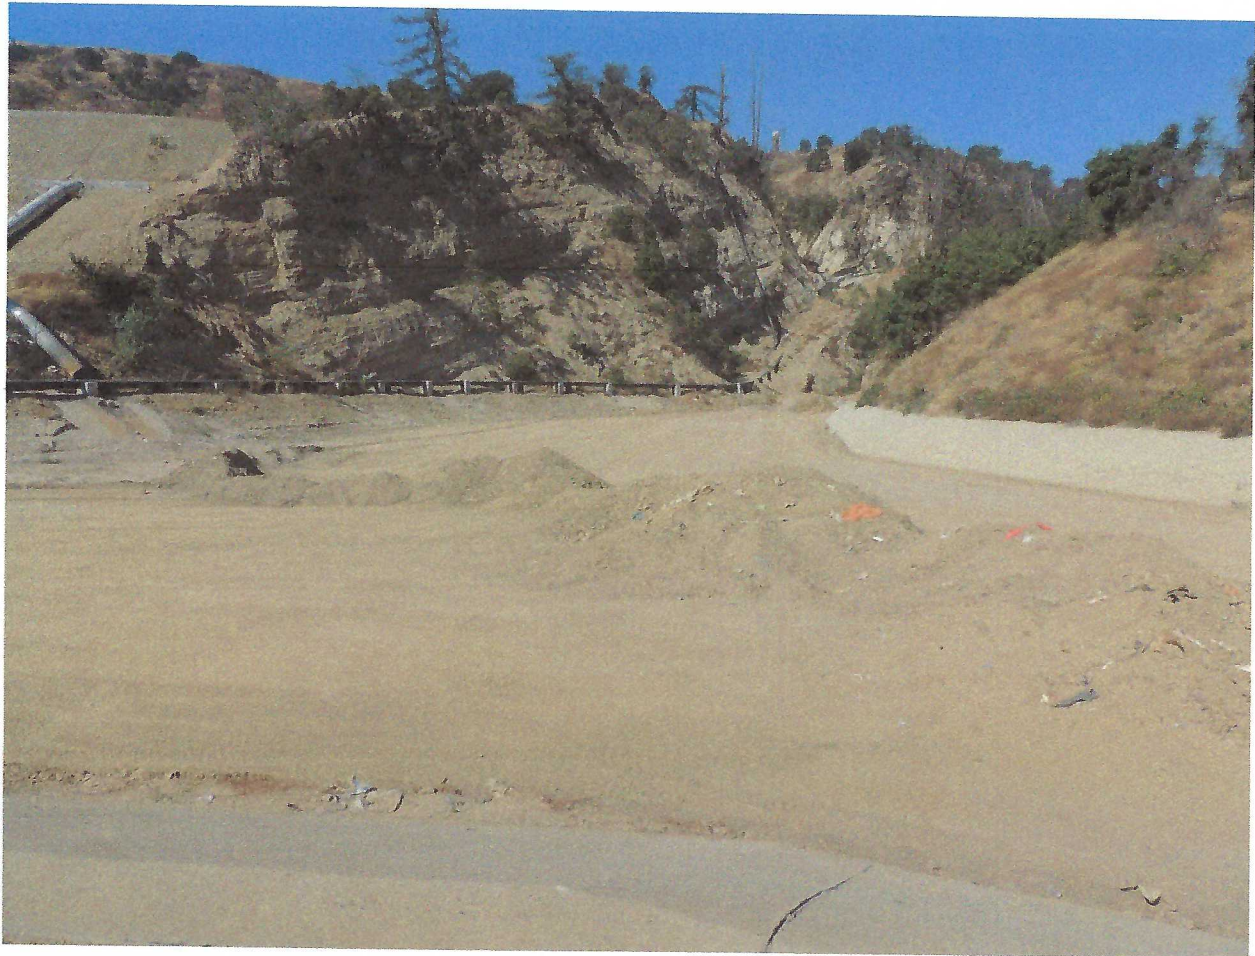
Figure 8: Soil piles in Bassin A
