**Sunshine Canyon Landfill  
Independent Monitor  
Quarterly Site Monitoring Status Report  
April 1, 2015 – June 30, 2015**

**City of Los Angeles Department of City Planning**

**County of Los Angeles Department of Regional Planning**

August 5, 2015

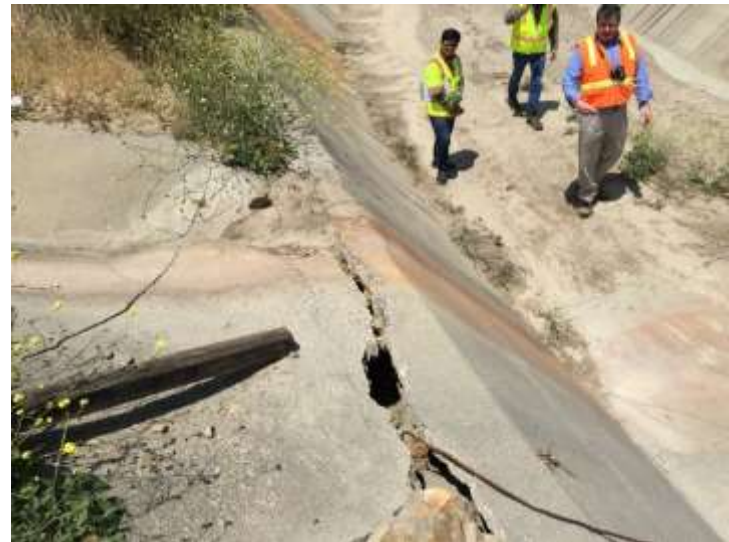
**Photo 59: Westside Drainage Channel: May 27, 2015**

During the May 27, 2015 site monitoring, it was observed that conditions of channel of the westside between Basin A and Basin D was getting worse. Floor slabs were uplifted more than ever with heavy vegetation growing. Side walls were cracked. The downchute V-ditch from the County sage area did not drain over the wall as designed but was separated from the wall, and water flowed behind the wall and under the floor. The preventative maintenance plan should be available on site for review along with report of inspection of the structures and status or scheduling necessary repairs.

At the June 9, 2015 site monitoring, Republic had their geotechnical consultant evaluate the westside drainage channel condition and they are preparing a plan for necessary repairs. Republic will budget repairs for 2016.

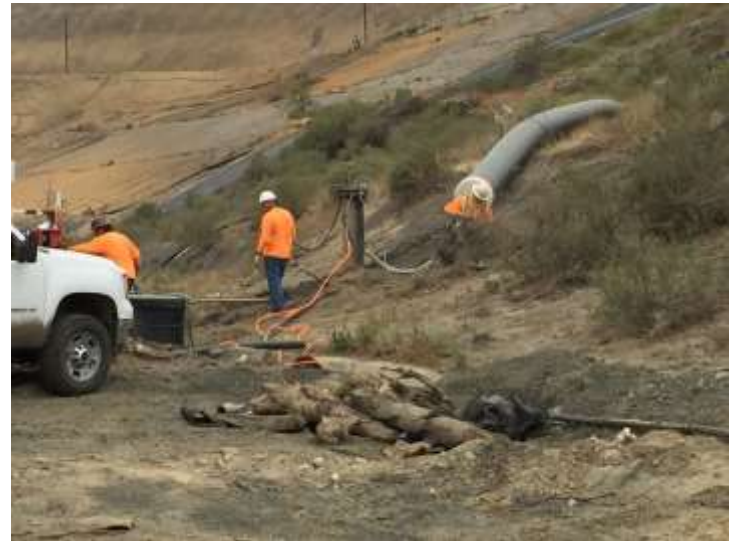
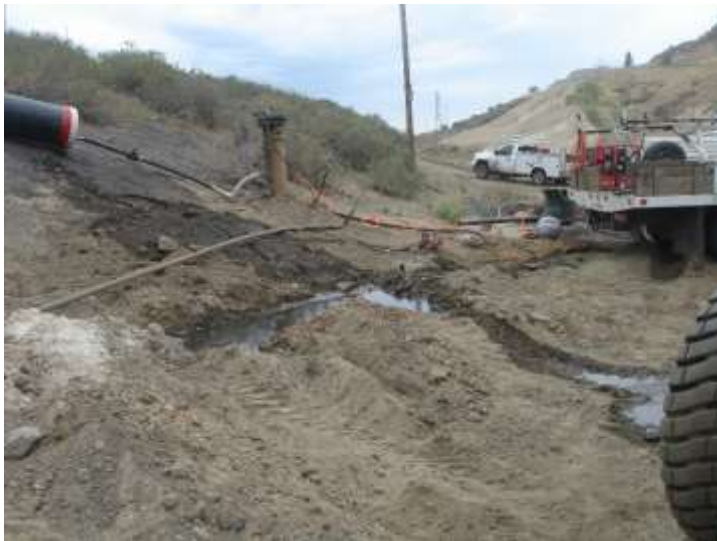
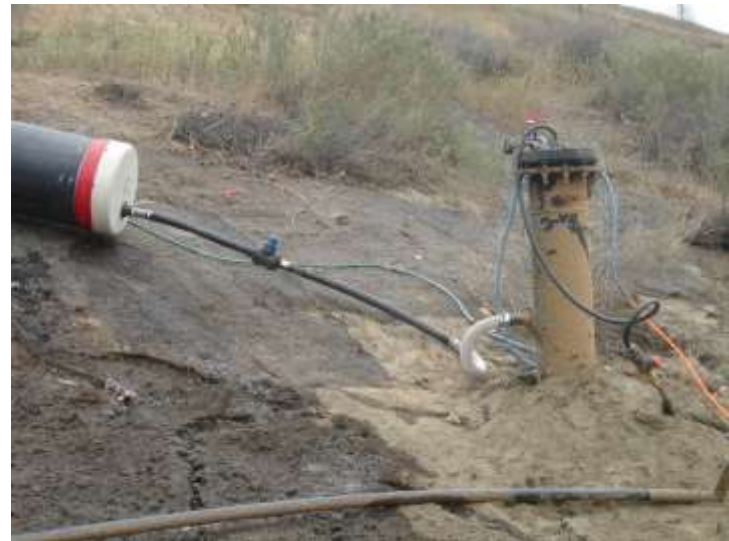
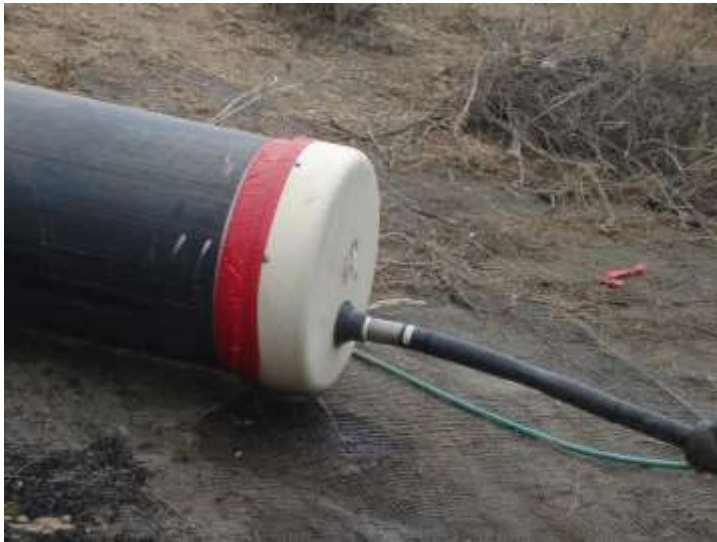
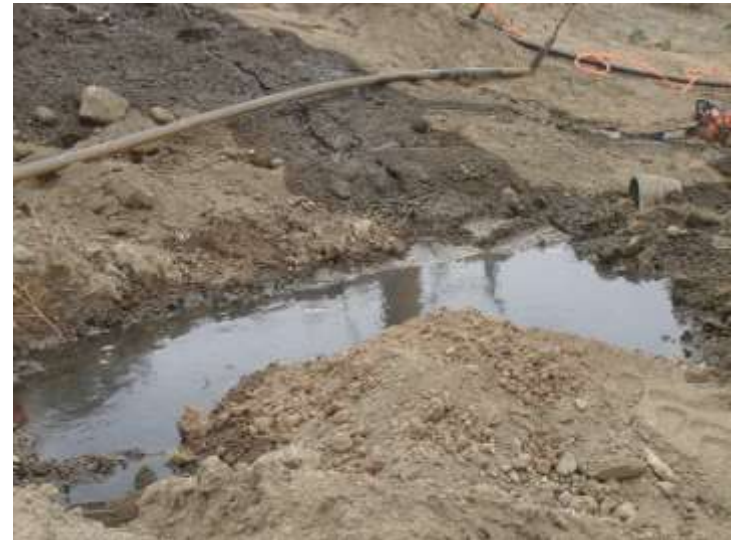
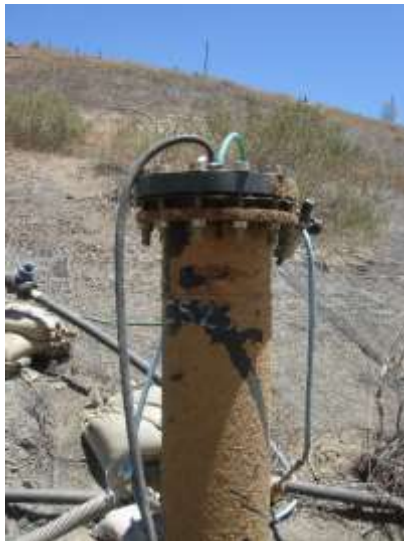
**Photo 449: Gas Condensate Sump Replacement & Piping: June 9, 2015**

During the June 9, 2015 site monitoring, it was observed that a new gas condensate sump was being installed near the old City truck scales site. The sump was being commissioned by BAS/Tetra Tech personnel. The 24-inch HDPE line feeding gas condensate to the sump was leaking liquid from a temporary PVC cap taped to the end of the line. Liquid was ponding on the ground. Republic staff was notified and aware of the condition, and had the contractor working on it. At the end of monitoring when leaving the site, the condensate wetted soil was being removed, the leak was stopped and new soil was being placed at the location.

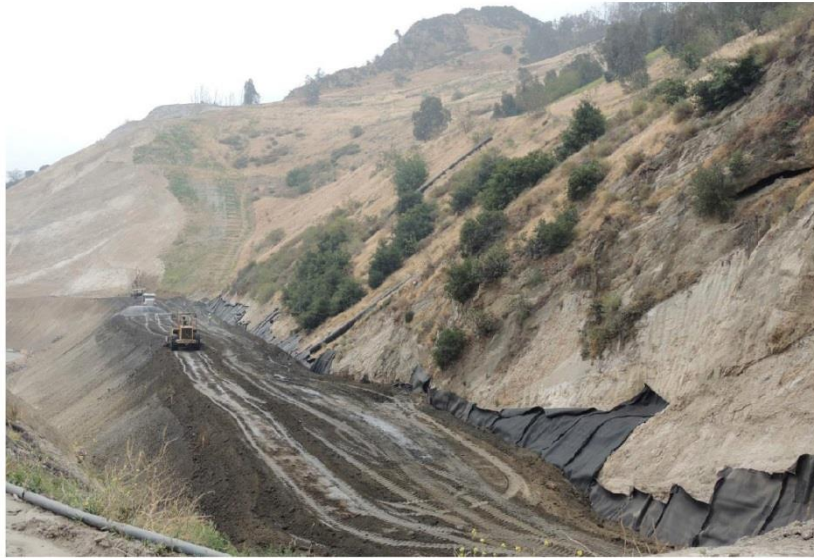
Photo 1: Construction of New Access Road

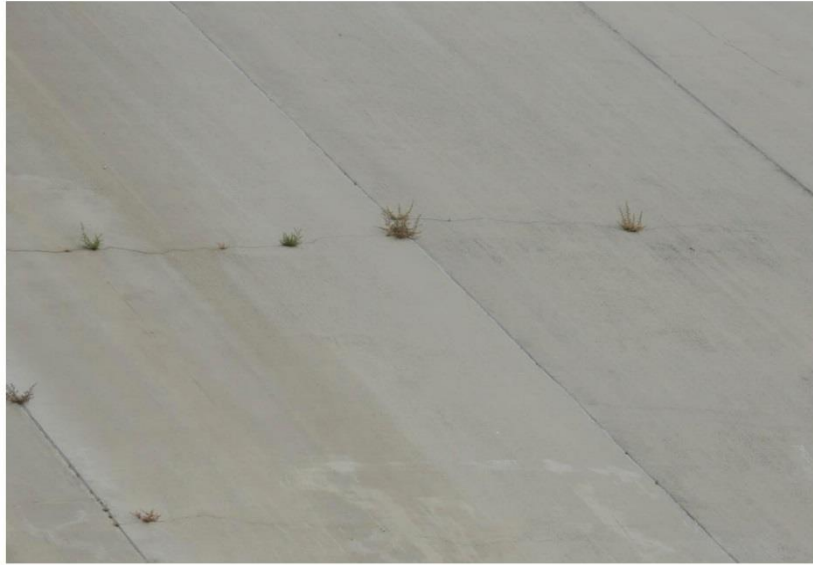
Photo 3: Vegetation growing through cracks of shotcrete face

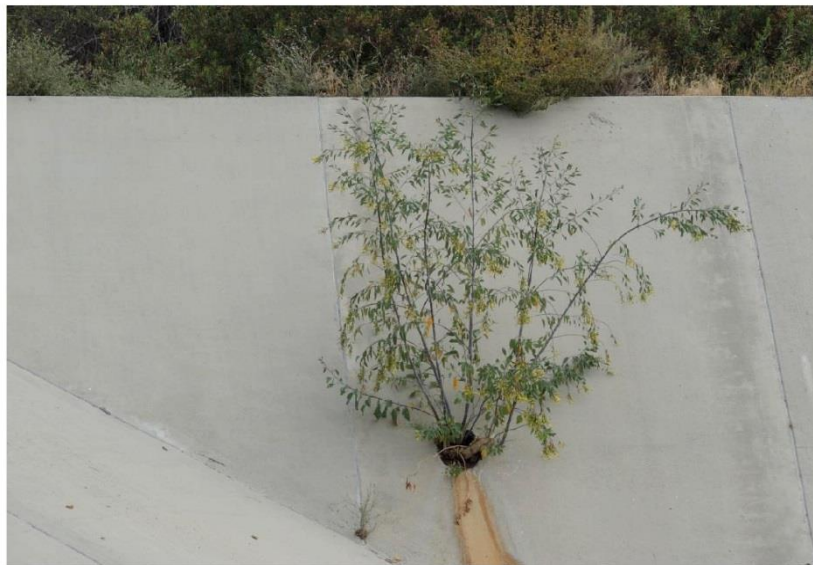
Photo 4: Bush growing in drain pier at terminal basin

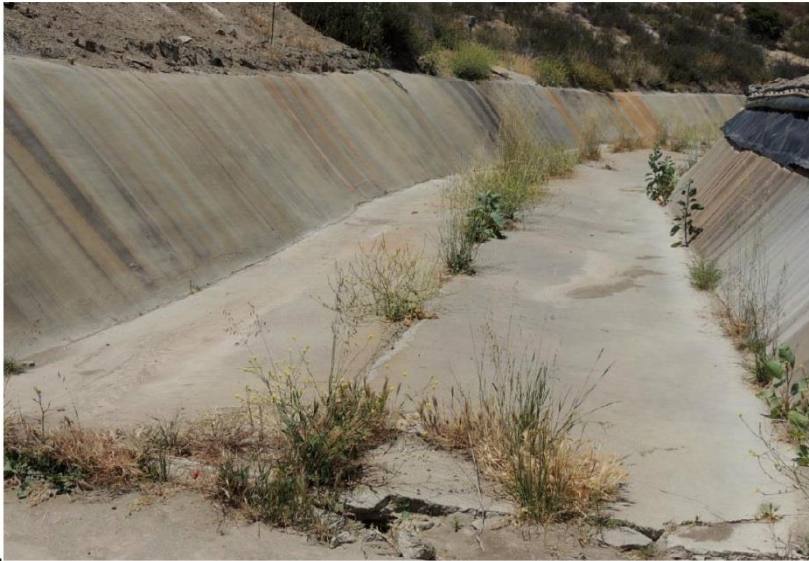
Photo 5: Uplifted bottom slab of drainage channel

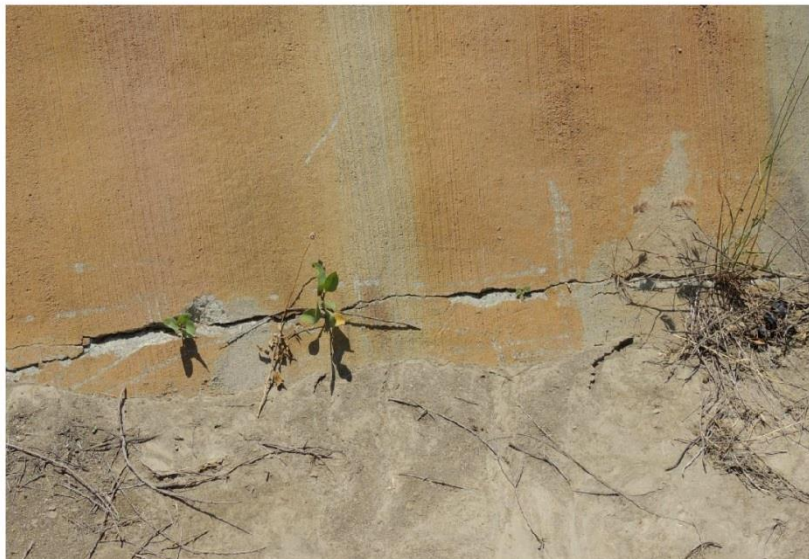
Photo 6: Cracked sidewall of drainage channel with vegetation growing

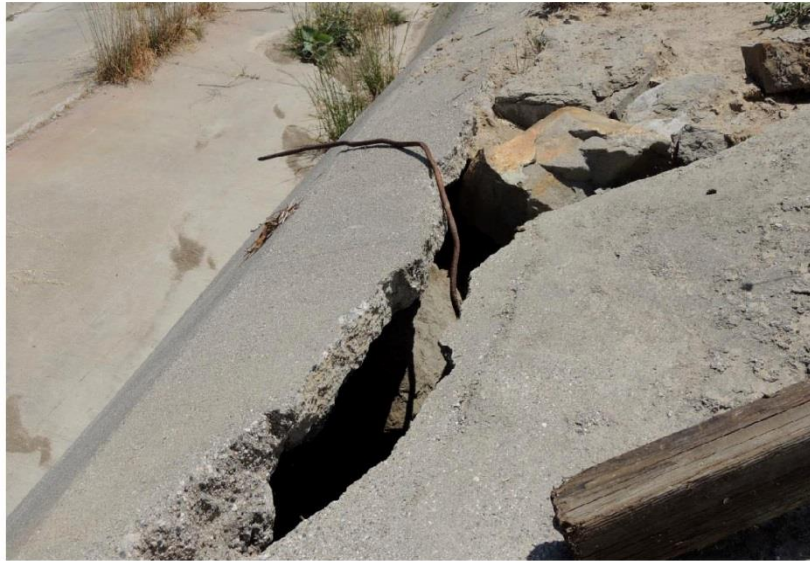
Photo 7: Broken Connection between downchute and drainage channel

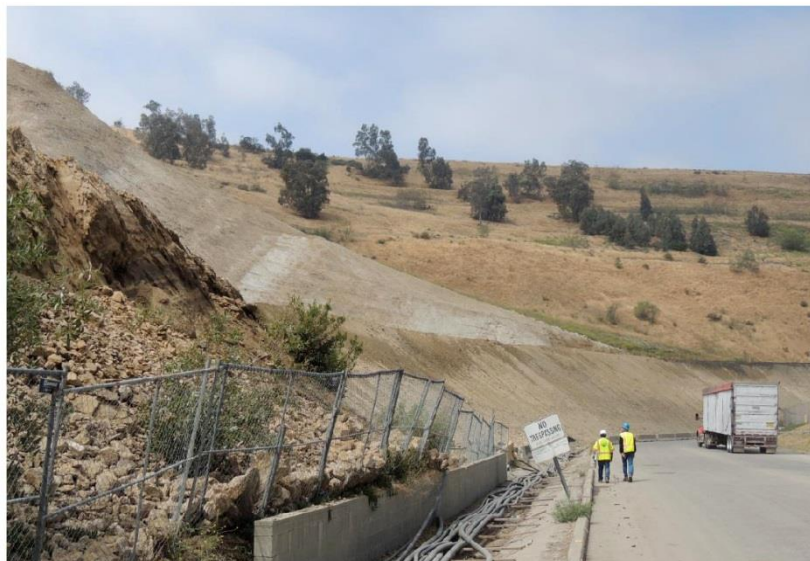
Photo 8: Soil loading block wall
