**Sunshine Canyon Landfill
Independent Monitor
Quarterly Site Monitoring Status Report
October 1, 2017 – December 31, 2017**

March 6, 2018

The attached Quarterly Site Monitoring Status Report for the Sunshine Canyon Landfill dated March 6, 2018 is the Fourth Quarterly Report for 2017, issued by UltraSystems. This report covers the monitoring period from October 1, 2017 through December 31, 2017 and is prepared for the City of Los Angeles Department of City Planning and the County of Los Angeles Department of Regional Planning.

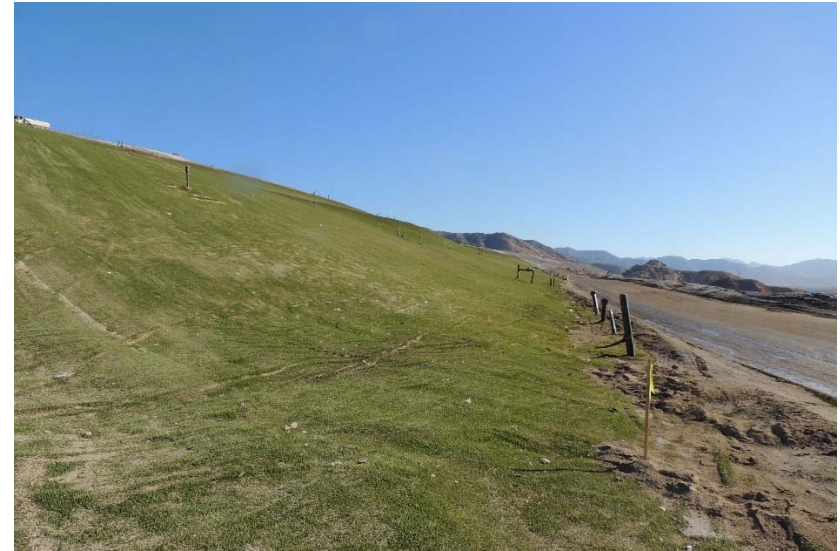
Photo 174: Cell CC3A Liquid Break-Out Area: October 26, 2017

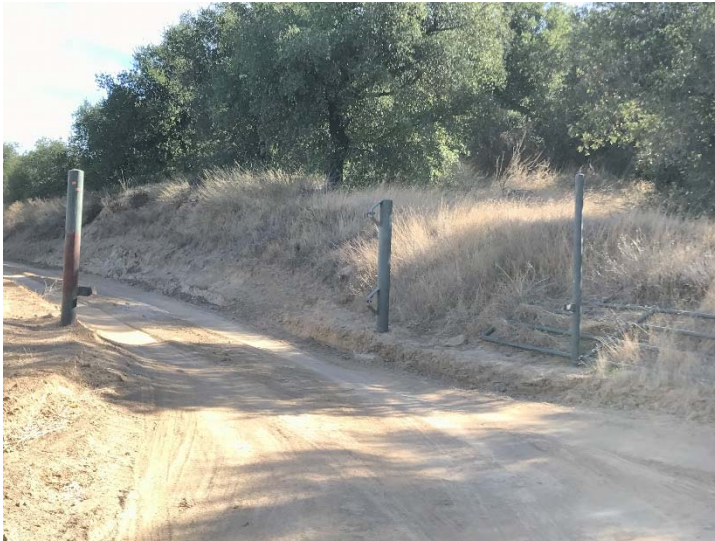
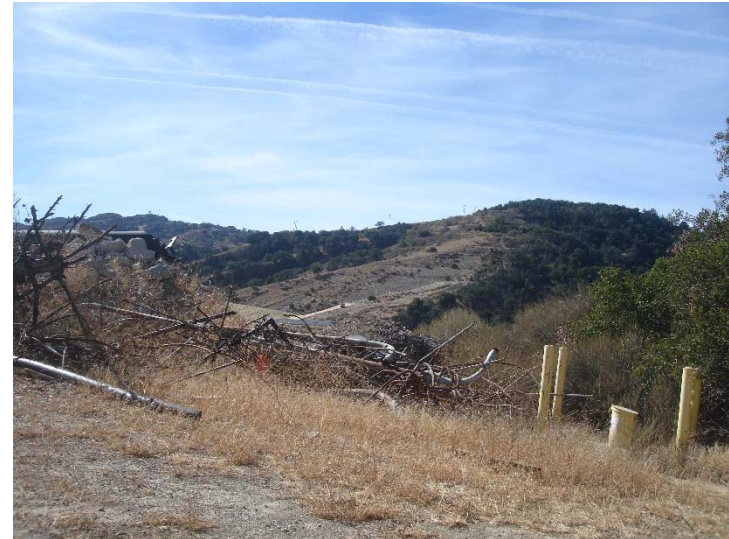
Photo 405: Broken Northern Site Access Gate: November 21, 2017

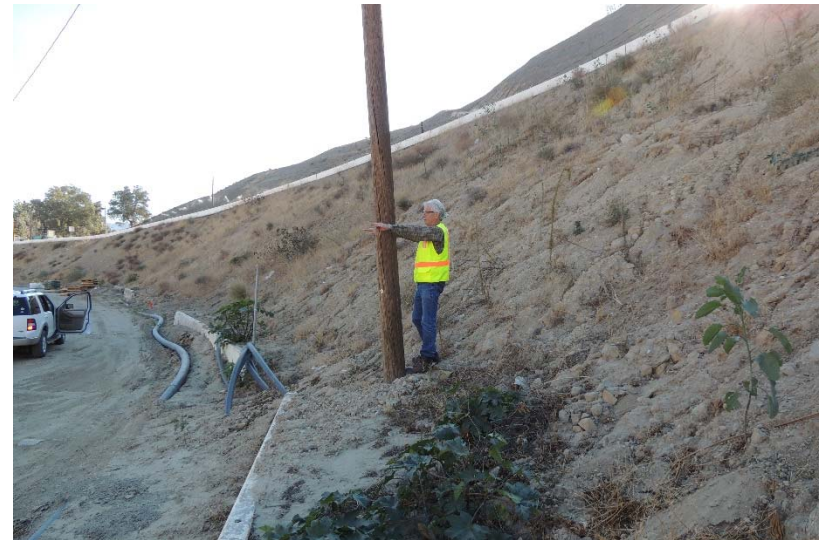
**Photo 520: Access Road Slope Movement Area near Terminal
Basin: December 12, 2017**

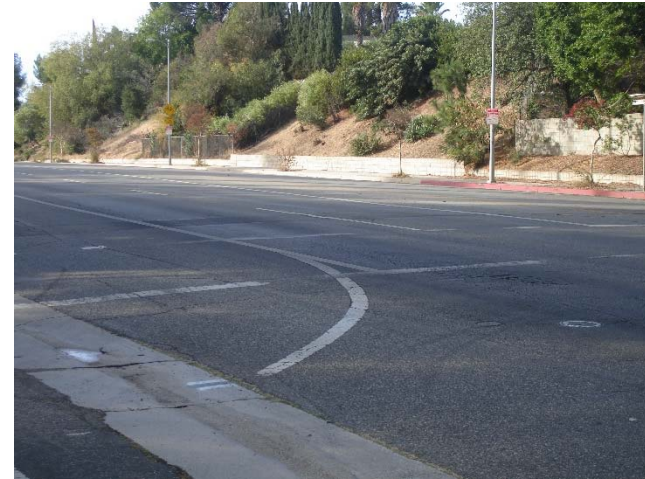
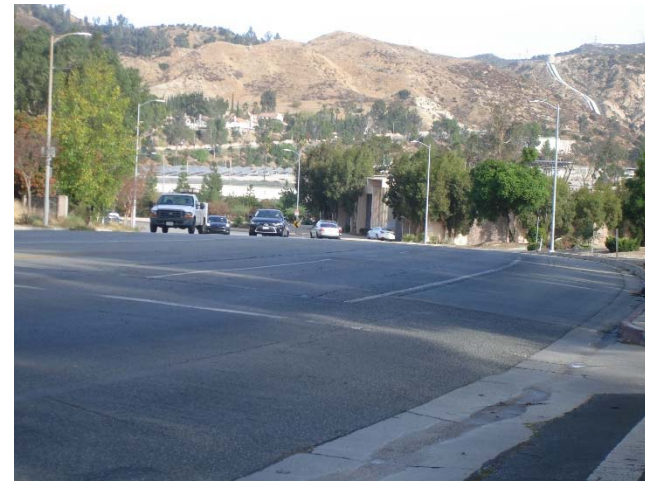
In late November, the monitor drove the Granada Hills neighborhood area from 6:30 to 7:15 a.m. and there were no landfill odors detected. The slow lane on Balboa Boulevard at Woodley Avenue had liquid stain marks that appear to be from leaking packer trucks. There was no garbage odor detected when standing near the stains. A strong greenwaste odor was detected on Blucher Avenue near the North Hills Recycling facility. Smoldering greenwaste was being moved by equipment.

Photo 630: Liquid Stains on Pavement- Balboa Blvd at Woodley Ave: November 21, 2017

Photo 632: Liquid Stains on Pavement- Balboa Blvd at Woodley Ave: November 21, 2017

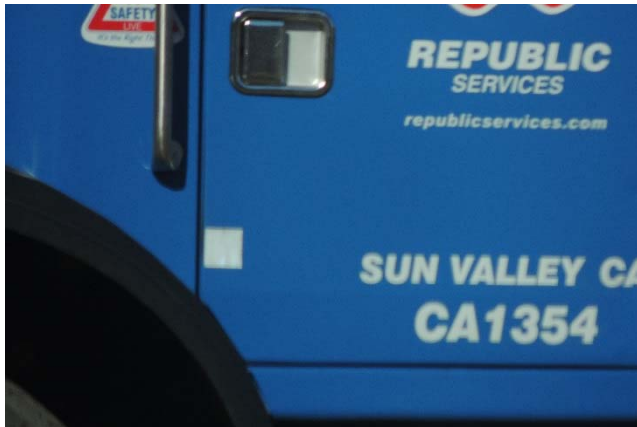
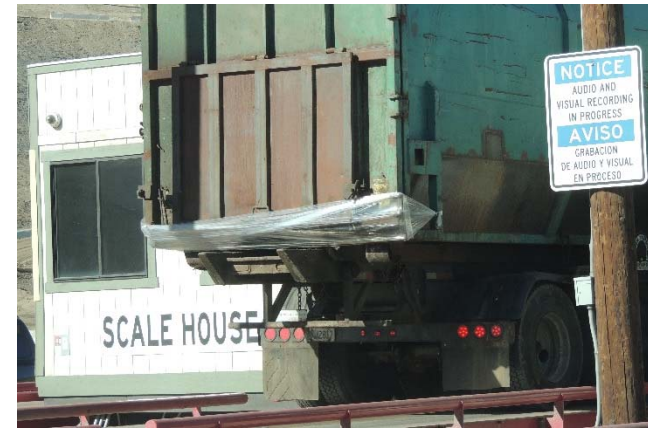
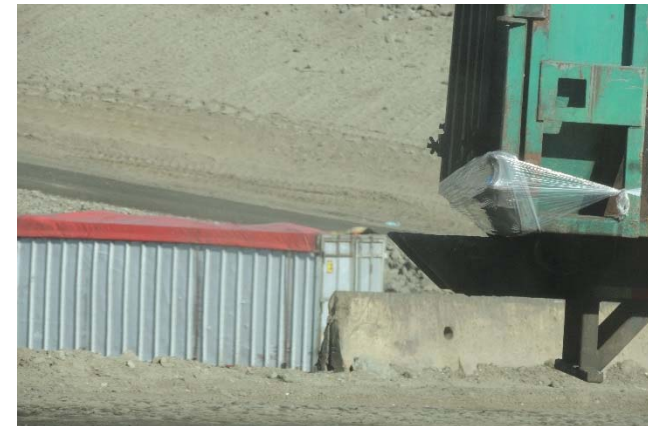
Photo 635: Truck Leaking Liquids: December 12, 2017

Photo 634: Truck Leaking Liquids: December 12, 2017

Photo 636: Truck Leaking Liquids: December 12, 2017

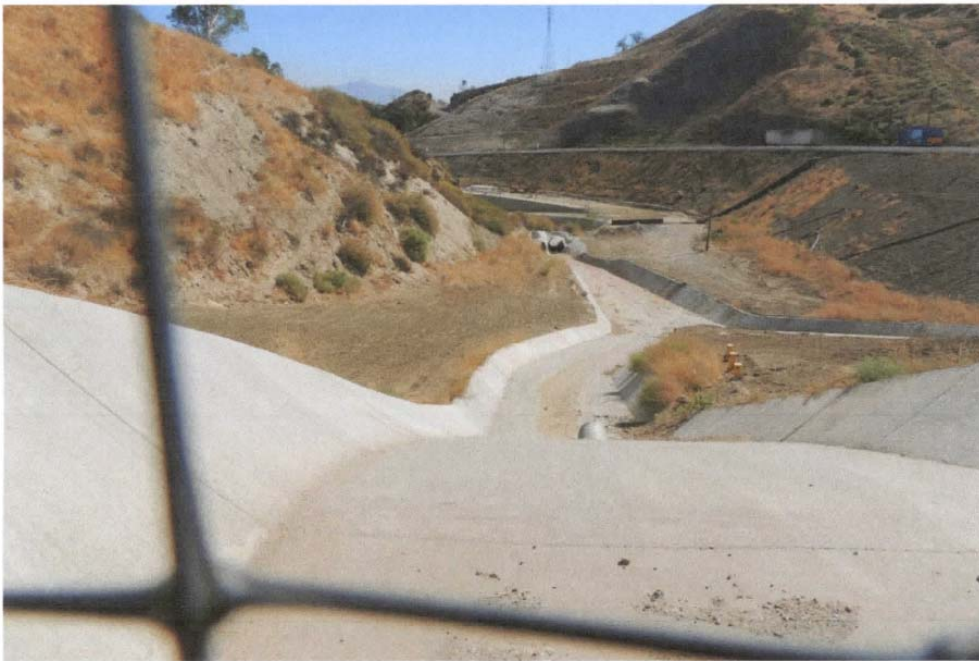
Photo 4: Spillway and blocked pipe on apron at temporary earthen basin near terminal basin

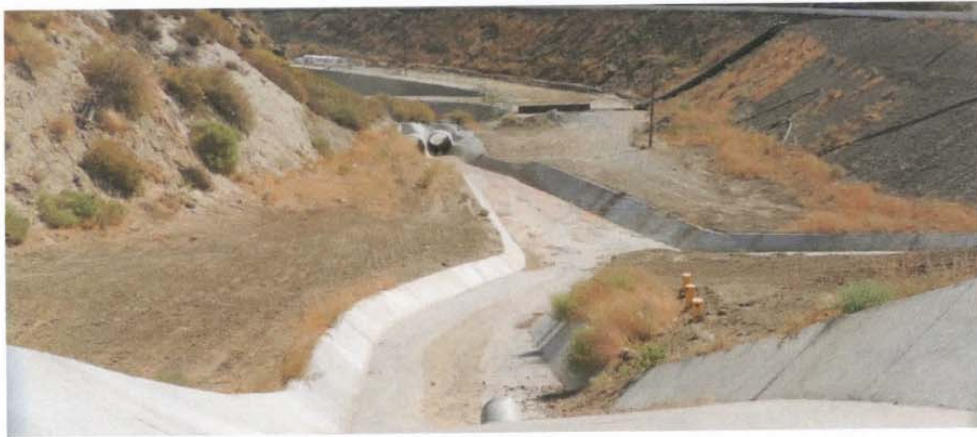
Photo 5: Repaired erosion gullies at temporary earthen basin above Terminal Basin

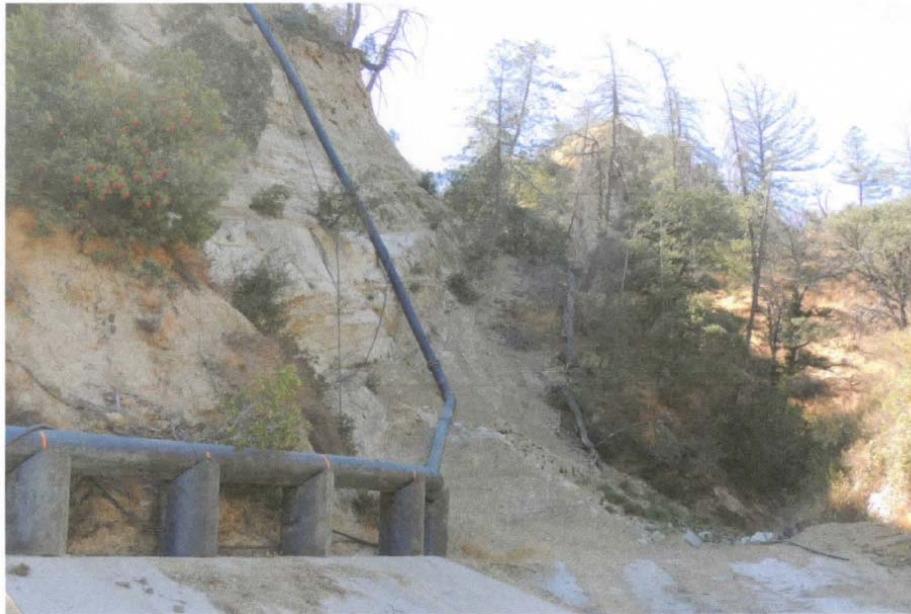
Photo 7: HDPE supports for gas header at Basin A

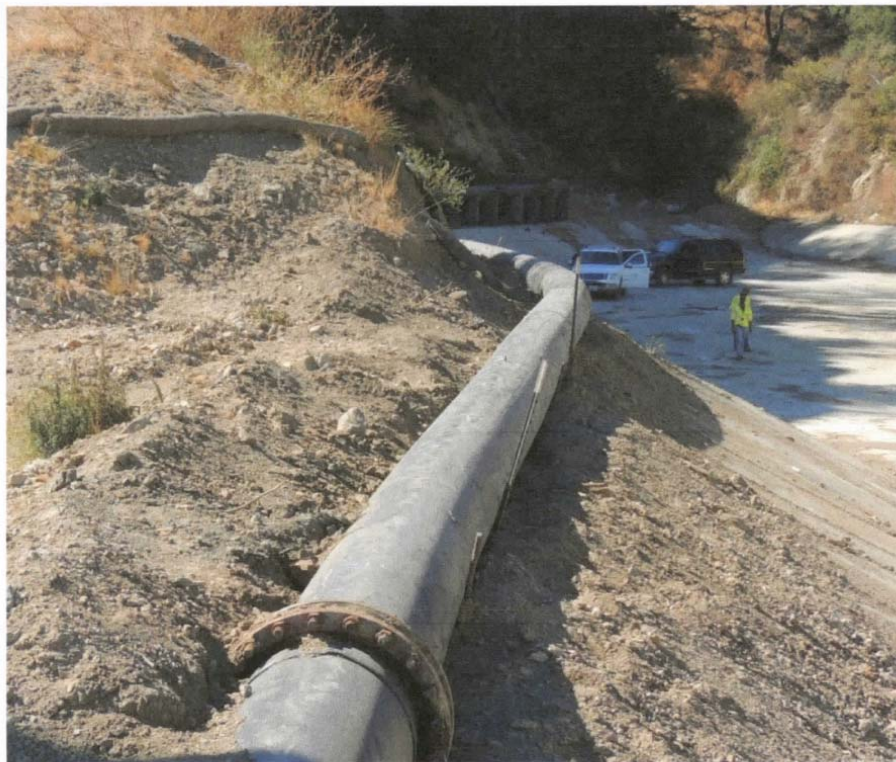
Photo 8: Steel bars support for gas header at Basin A near toe of slope

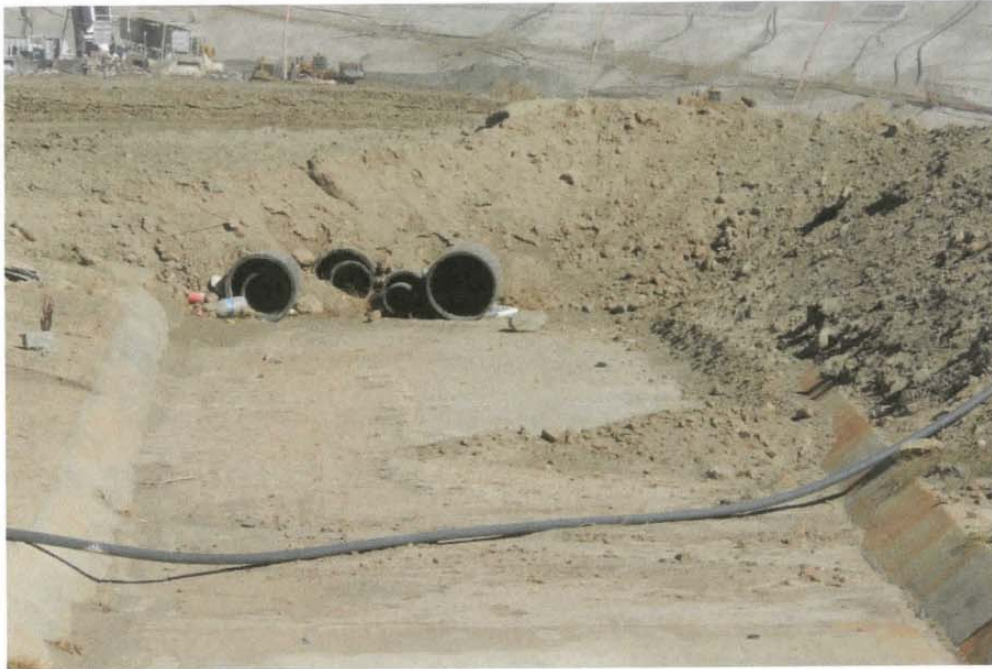
Photo 9: Partially obstructed channel downstream of basin A

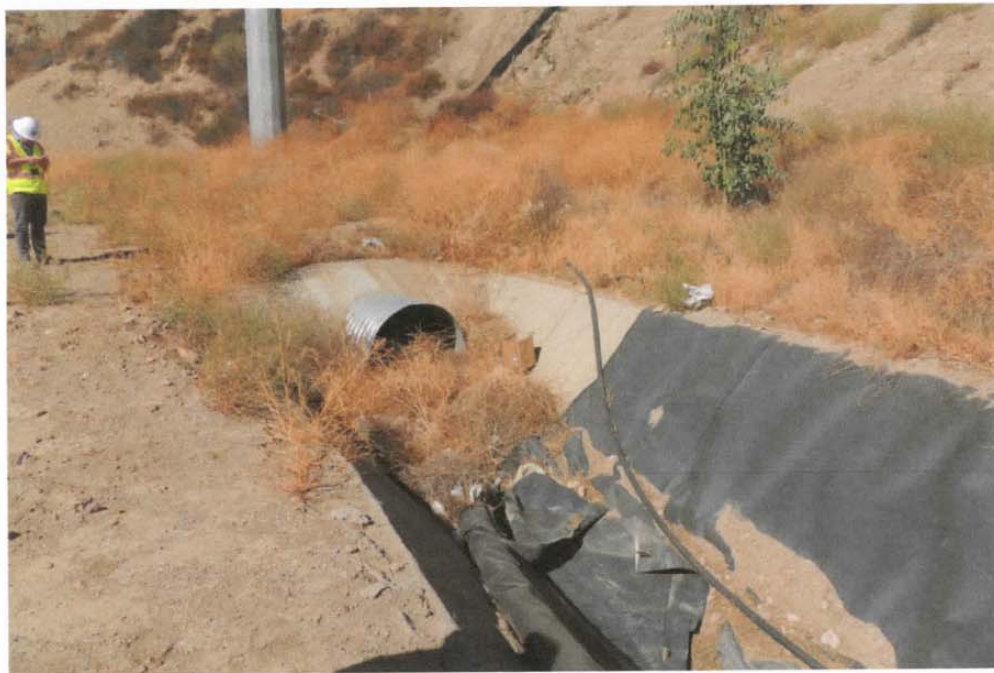
Photo 10: Torn-up geomembrane, tumbleweeds, and soil in Channel between Basin B and D

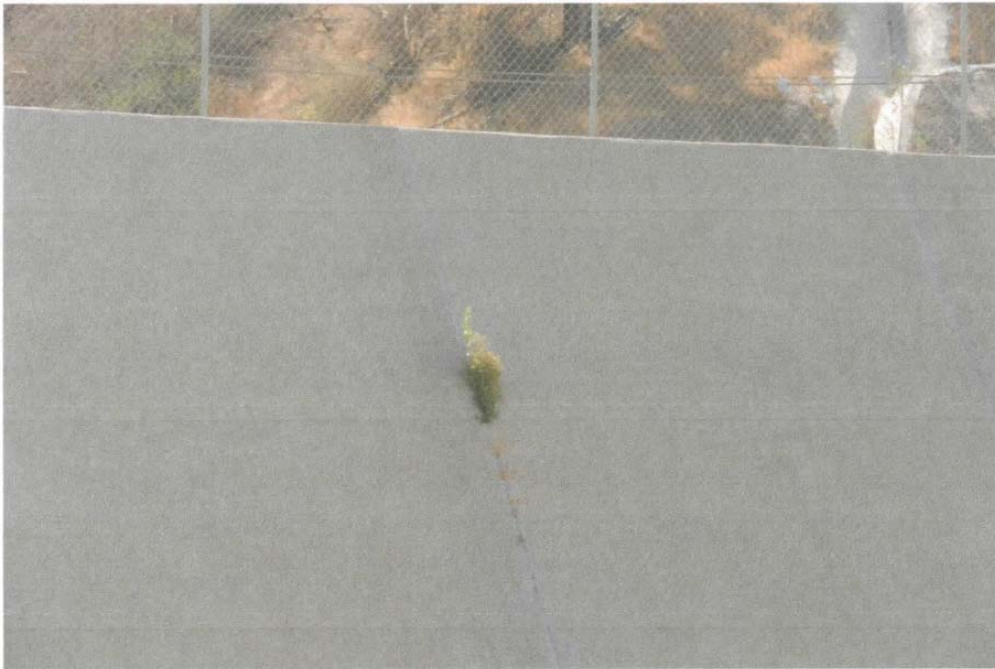
Photo 11: Weeds in crack on shotcrete wall of Terminal Basin

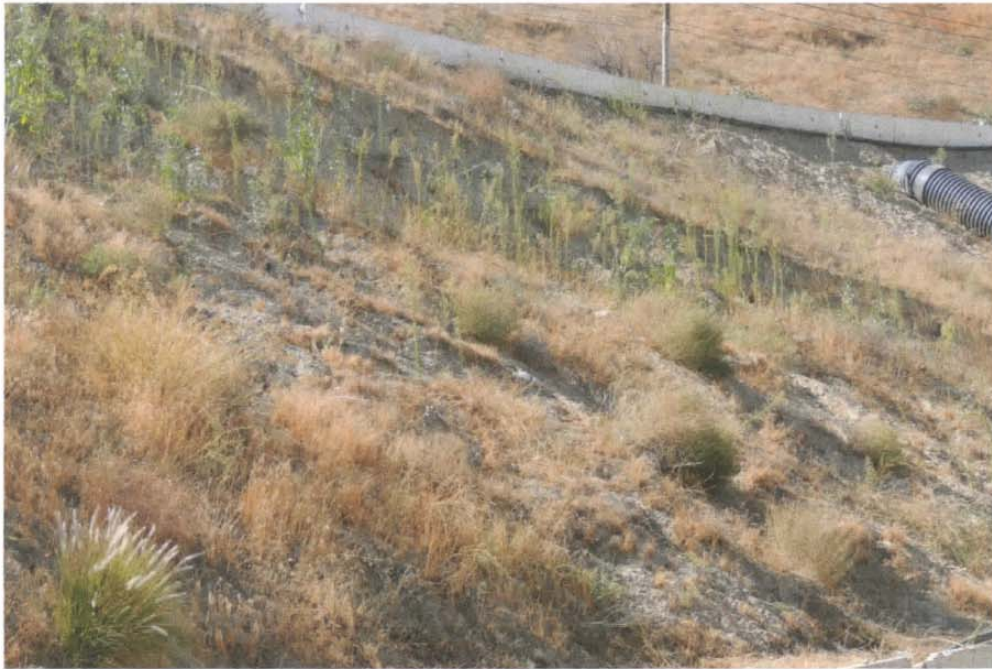
Photo 15: Sloughing on embankment of main access road near entrance of Terminal Basin

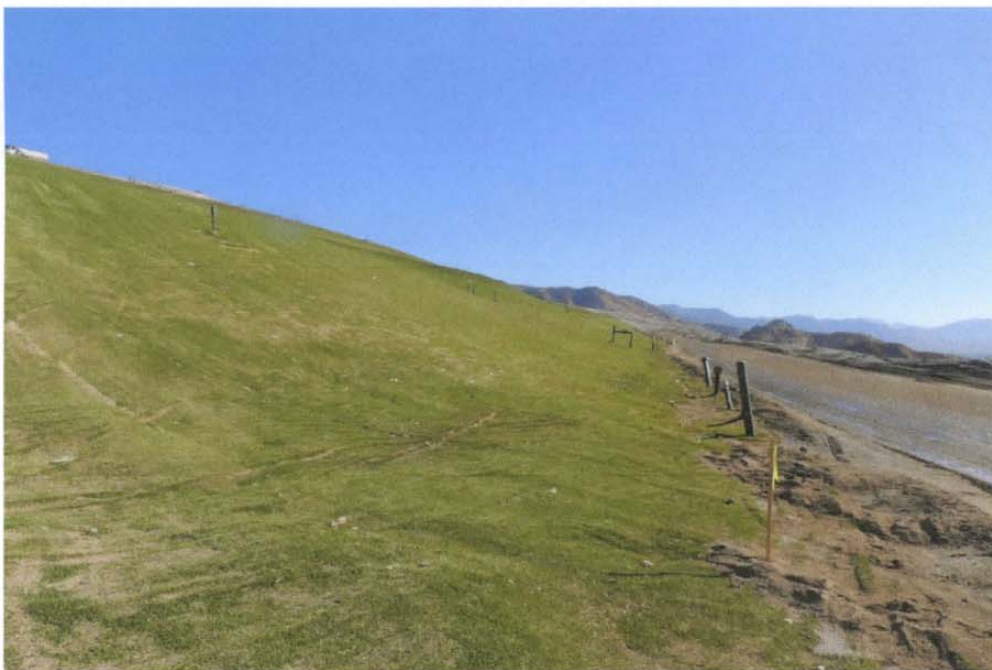
Photo 16: Repaired breakout on Closure Turf along access road to deck of Cell CC3b

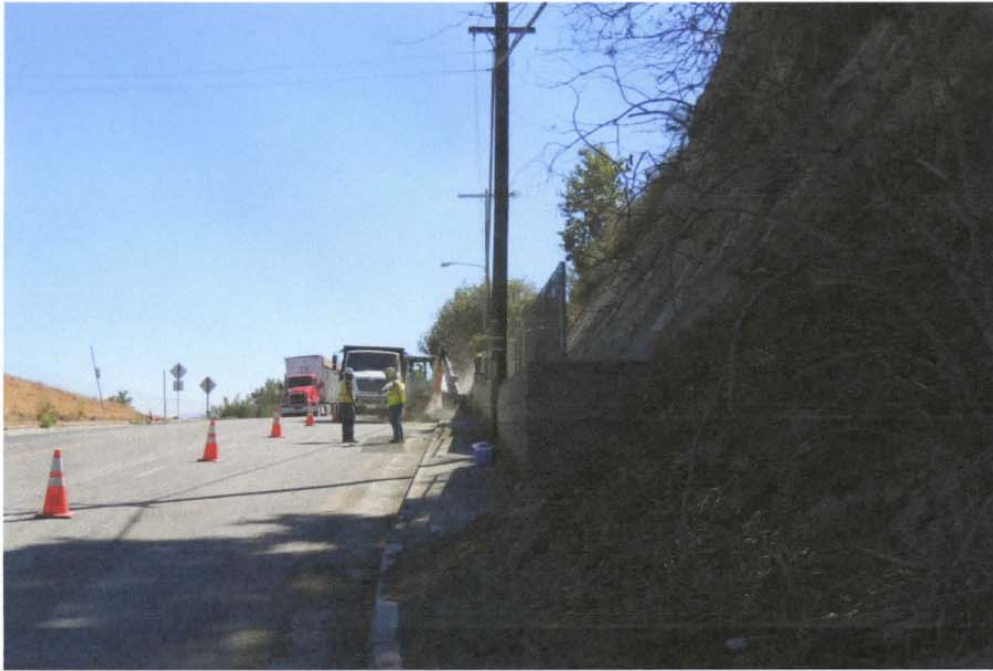
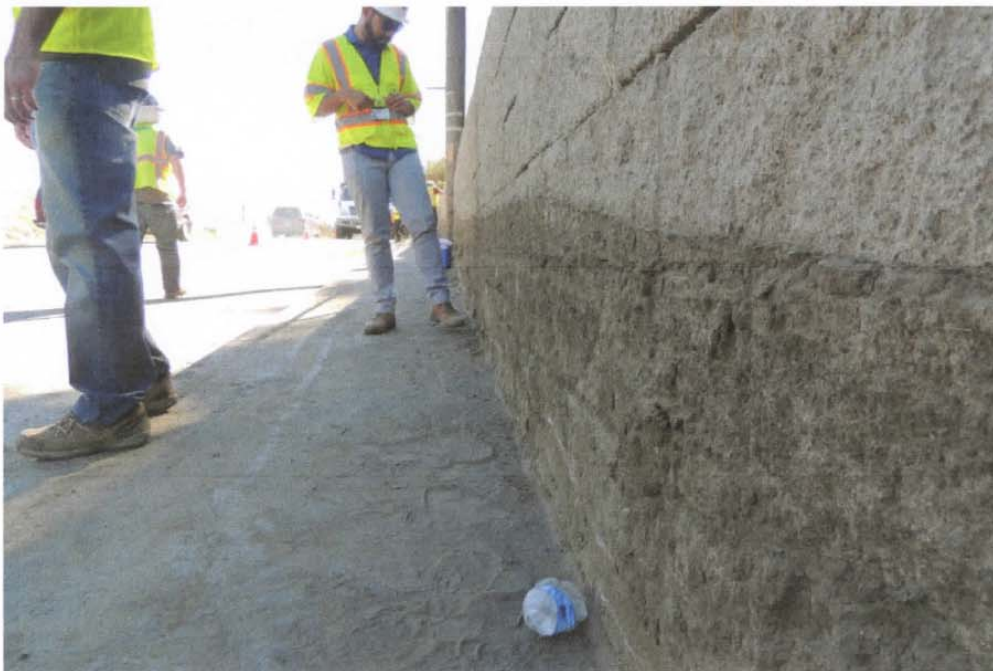
In late October, the San Fernando Road retaining wall was being cleared of soil and rock against the fence and in front of the wall. The slope above the wall was graded to remove loose material, and one oak tree was removed. The wall top drainage channel was cleaned and re-established. Soil sloughing on the main access road slope facing the terminal basin had more movement. This movement and any potential impacts on the main access road should be monitored during the winter season. Basin D outlet channel has the HDPE liner material torn, lifted, and could block stormwater flow. Debris and tumbleweed was observed in multiple areas and could block flow. The HDPE header to Flare 3 around the top of the south basin A wall was modified and put on HDPE supports. On the slope area near the basin outlet, the steel bars driven into the ground may not hold if the slope soils slide. This could cause the entire support system to fail.

Photo 17: Cleaning operations at wall on San Fernando Road

Photo 18: Cleaning operations at wall on San Fernando Road – Cleared sidewalk

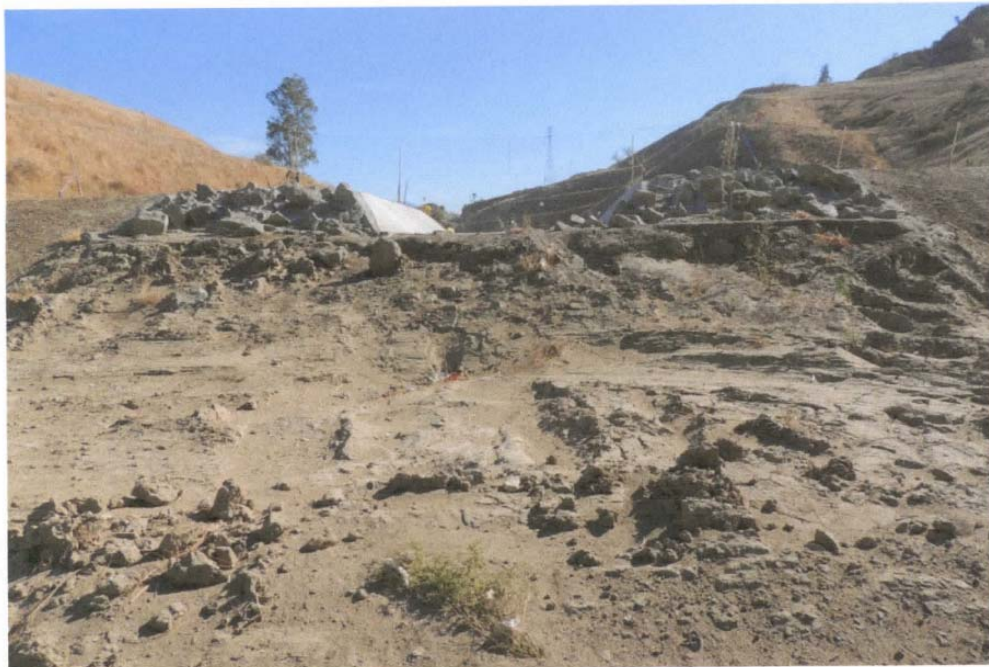
Photo 4: Inlet to Low Flow Pipe Out Temporary Earthen Basin Near Terminal Basin is Not Open

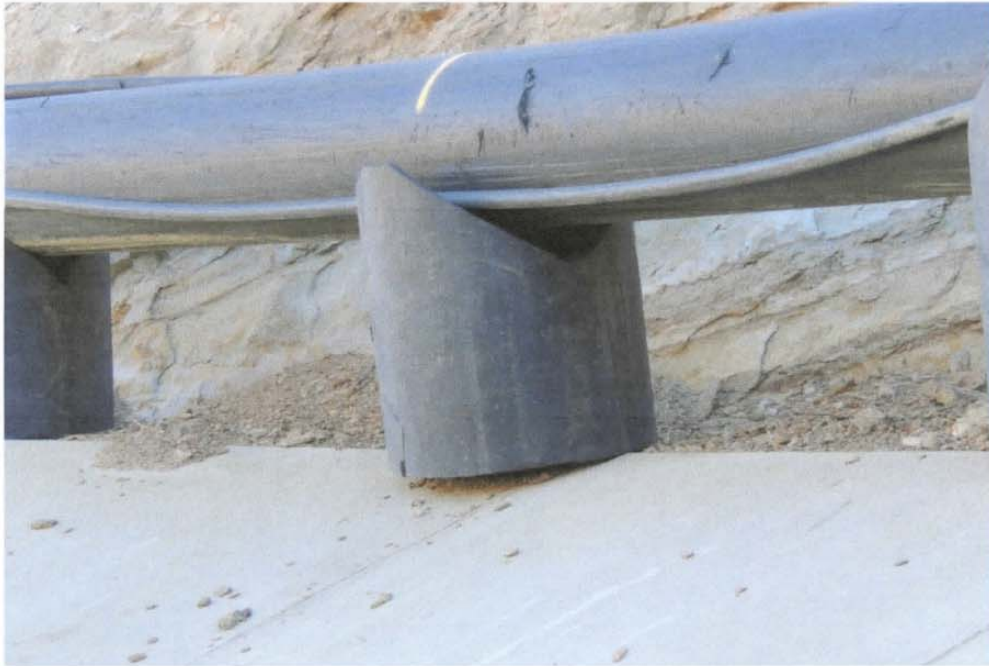
Photo 5: Potentially Unstable HDPE Supports for Gas Header at Basin A

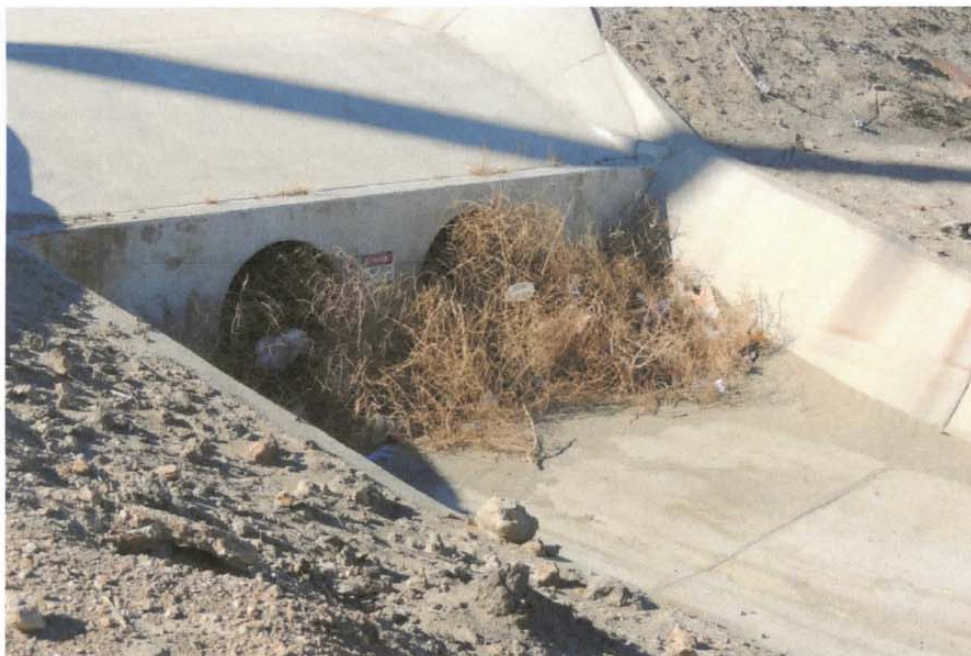
Photo 6: Outlets for Basin A Coletanche by Tumbleweed

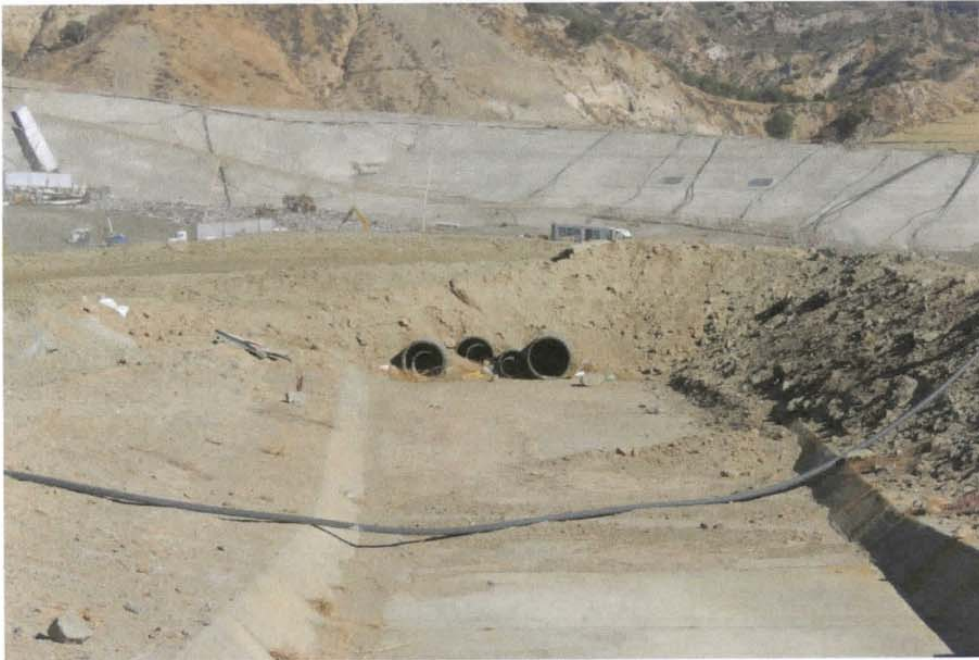
Photo 7: Partially Obstructed Channel Downstream of Basin A

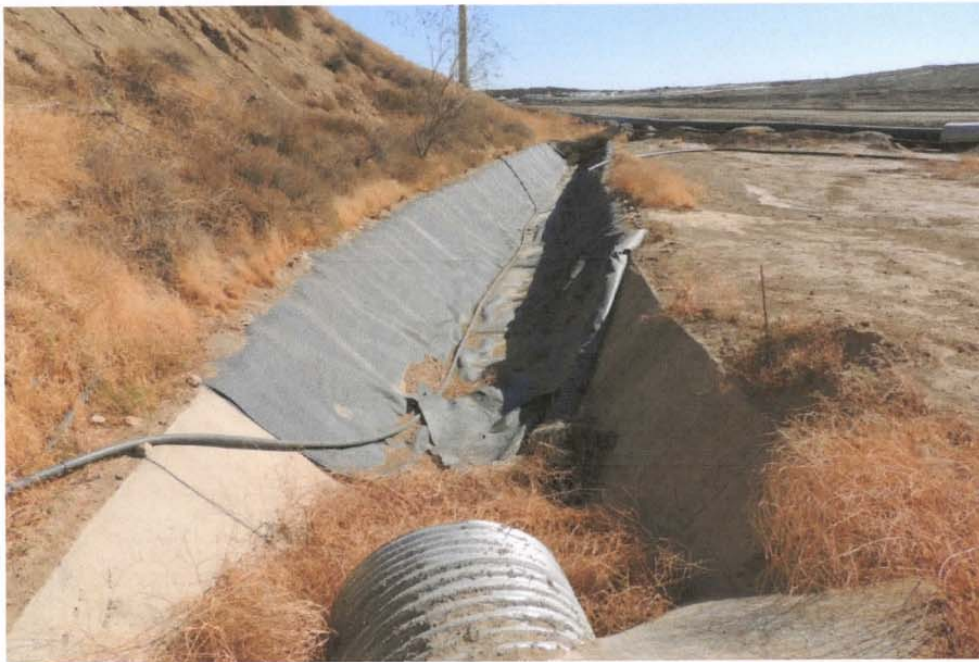
Photo 8: Torn-up Geomembrane, Tumbleweeds, and Soil in Channel between Basin B and D

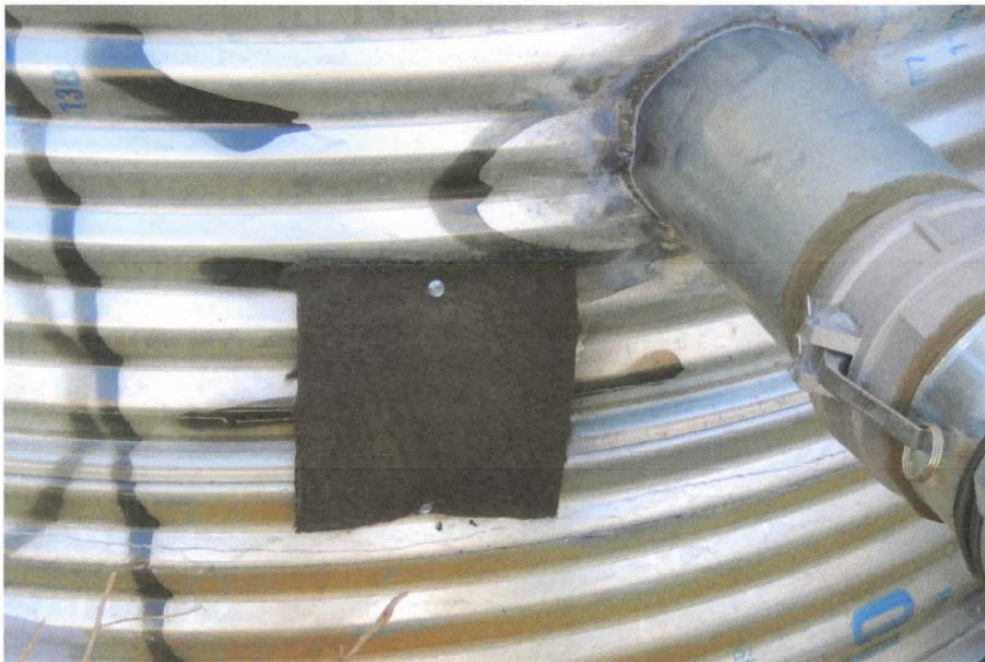
Photo 10: Drain Holes with Geocomposite Patch on Riser at Terminal Basin

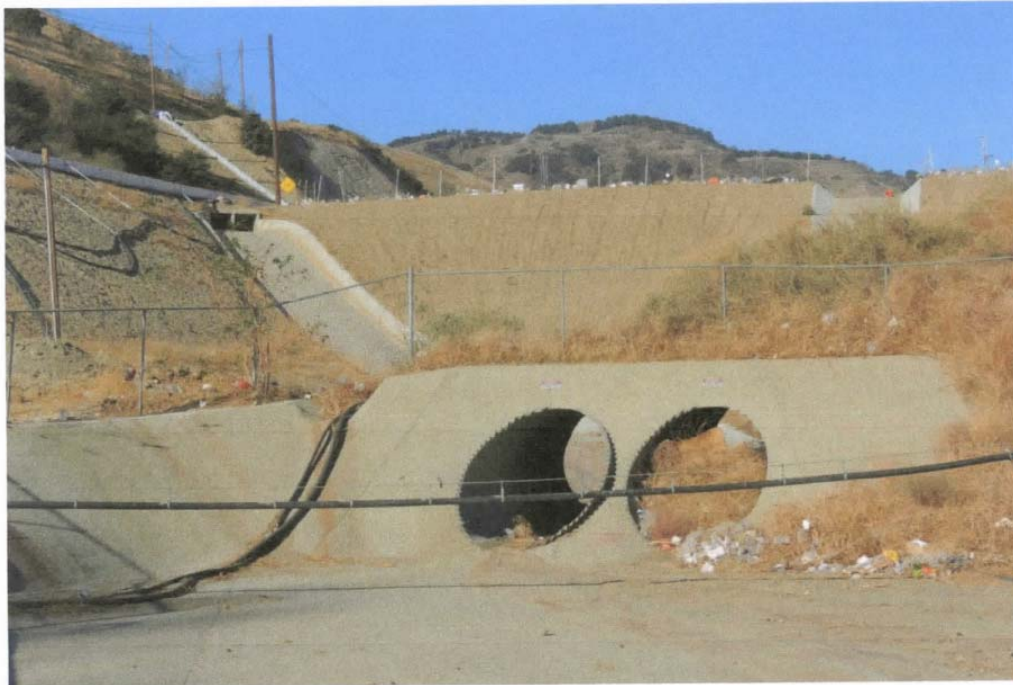
Photo 11: Culvert into Terminal Basin plugged with Tumbleweed

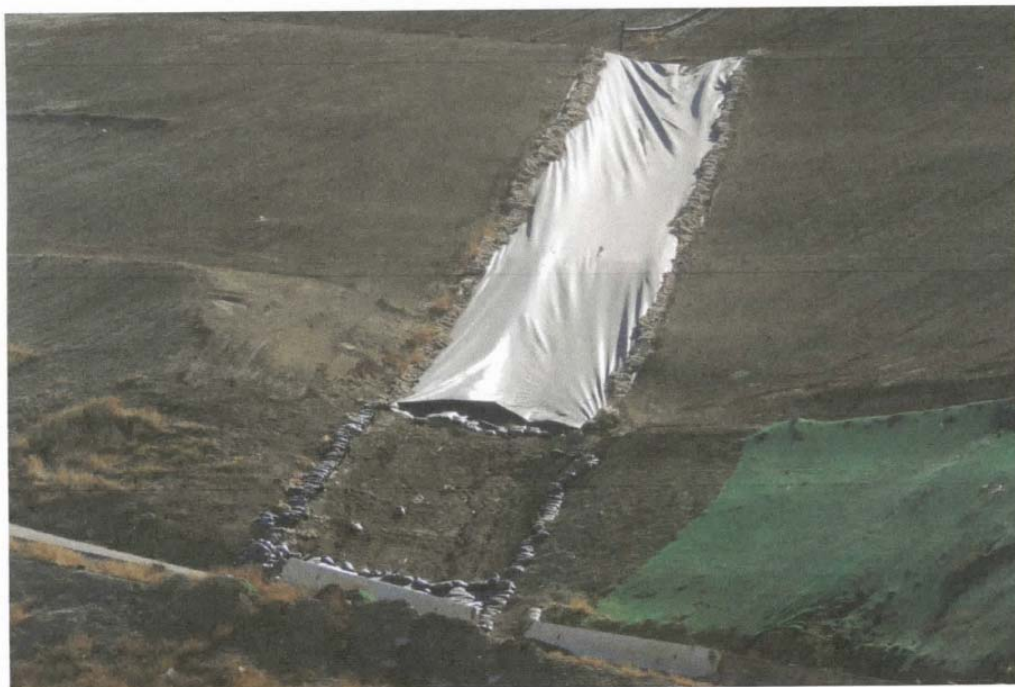
Photo 12: Geomembrane Slip-side Needing Repair on Old City Landfill Slope

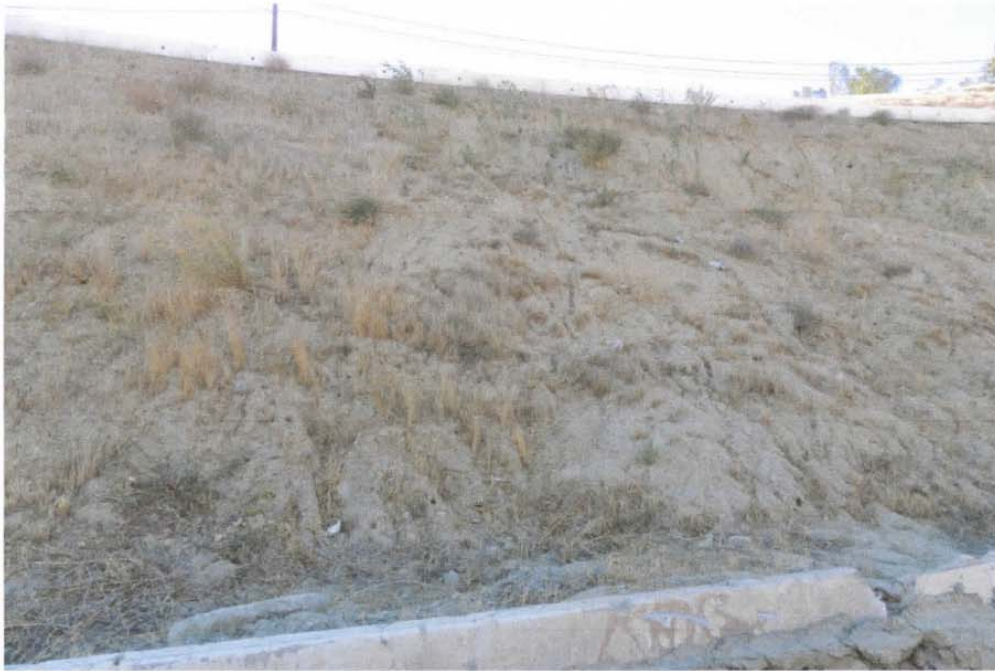
Photo 13: Sloughing on embankment of main access road near entrance of Terminal Basin

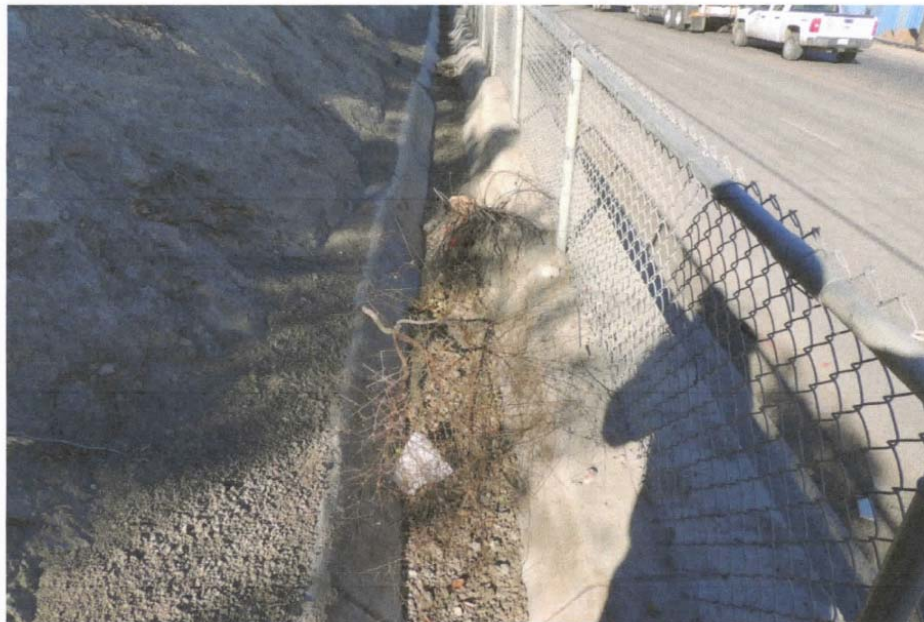
Photo 16: Soil Accumulating in Drainage Ditch on Top of San Fernando Wall
