**Sunshine Canyon Landfill
Independent Monitor
Quarterly Site Monitoring Status Report
October 1, 2018 – December 31, 2018**

January 9, 2019

CERTIFICATION STATEMENT

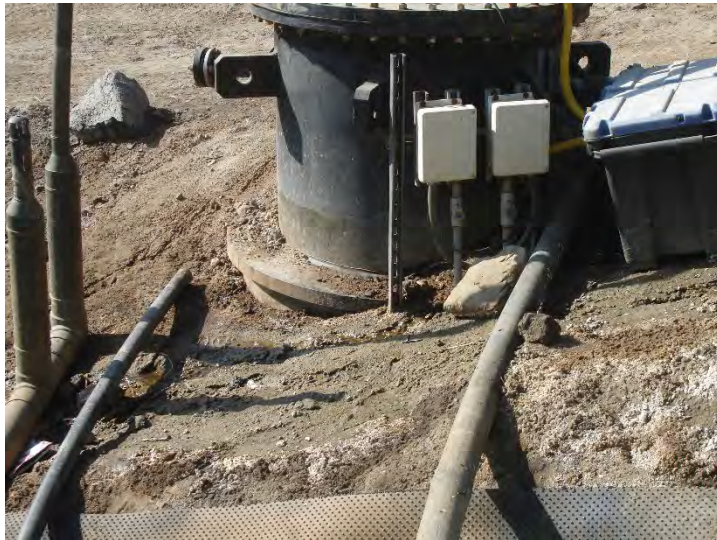
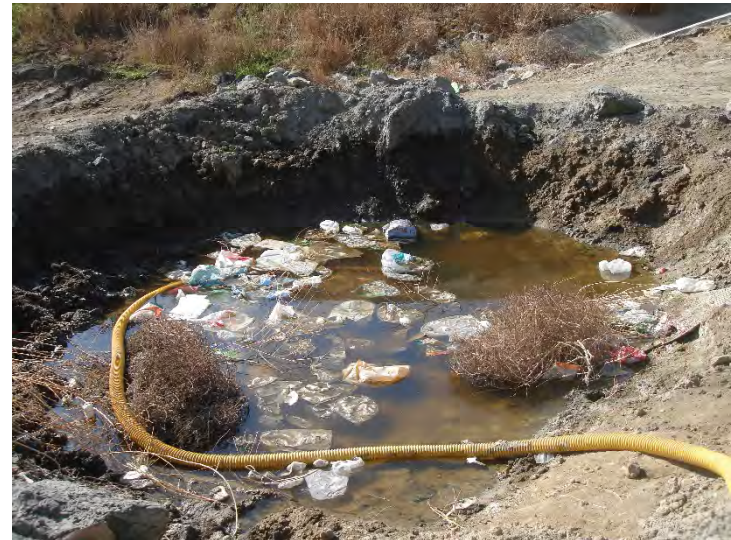
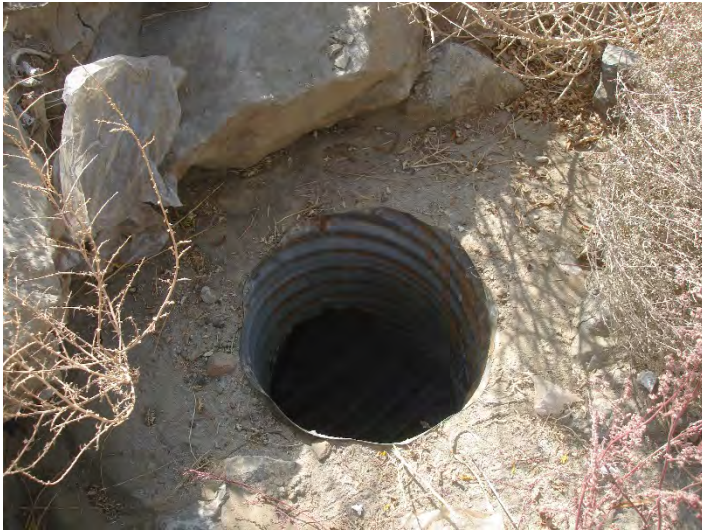
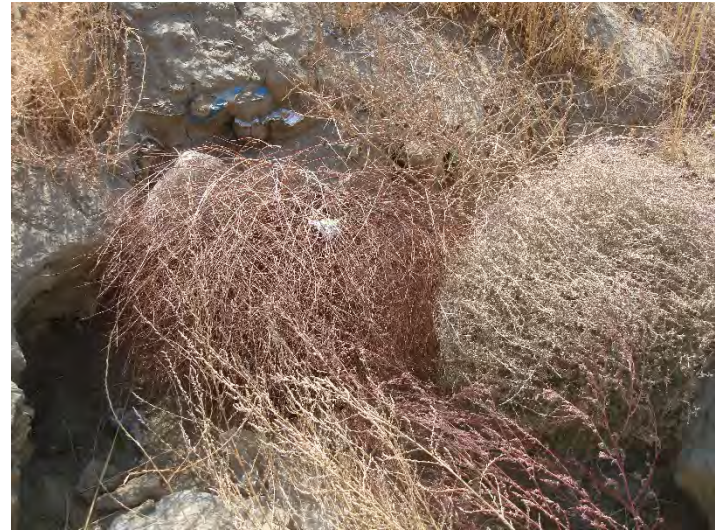
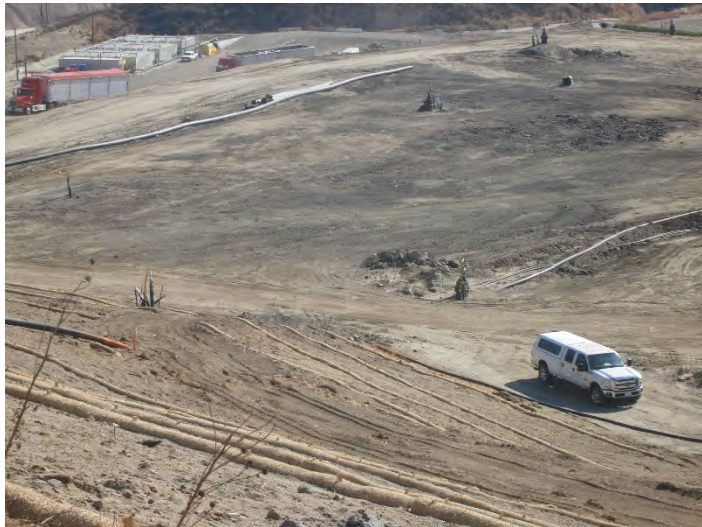
Photo 258: CC3B Alluvial Slope Leak: November 6, 2018

Photo 259: CC3B Alluvial Slope Leak: November 6, 2018

Photo 260: CC3B Alluvial Slope Leak: November 6, 2018

Photo 261: CC3B Alluvial Slope Leak: November 6, 2018

Photo 262: CC3B Alluvial Slope Leak: November 6, 2018

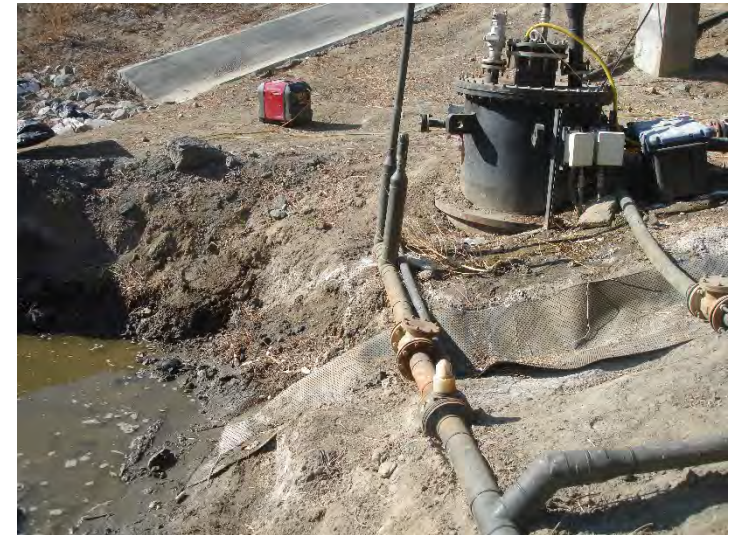
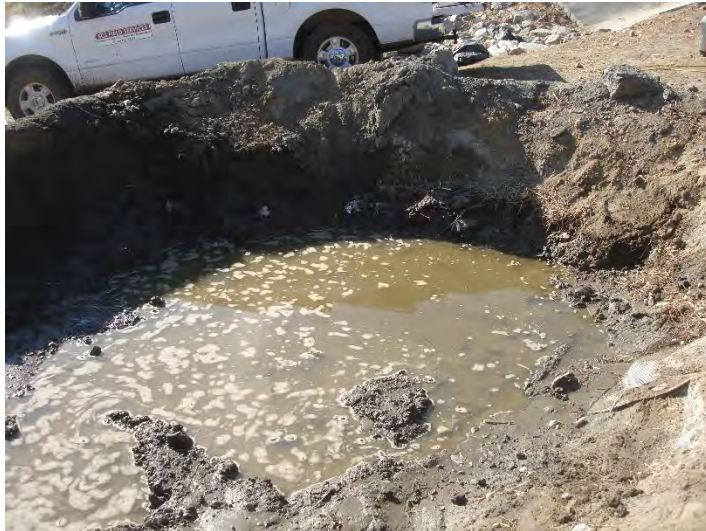
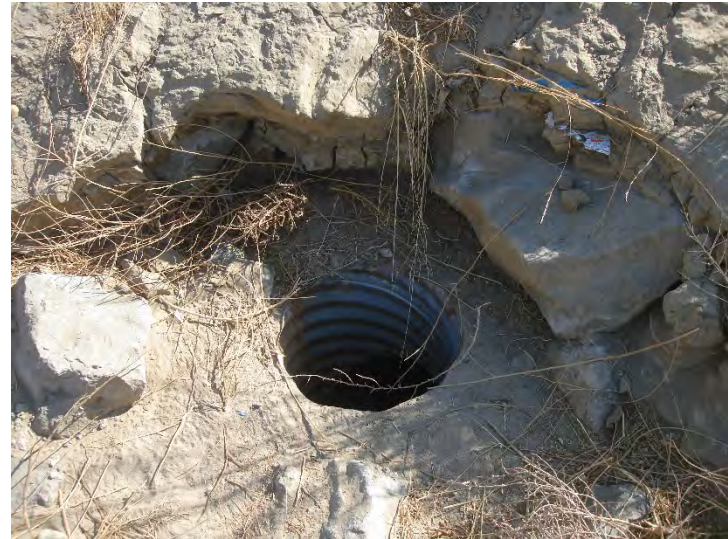
Photo 275: CC3B Alluvial Slope Leak: November 20, 2018

Photo 276: CC3B Alluvial Slope Leak: November 20, 2018

Photo 277: CC3B Alluvial Slope Leak: November 20, 2018

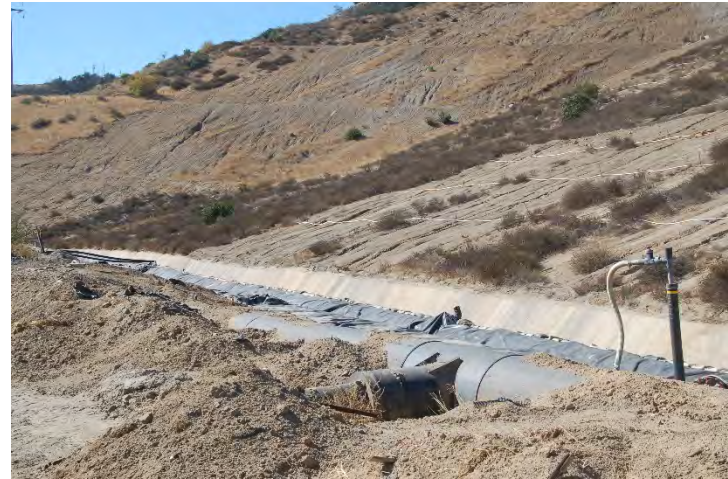
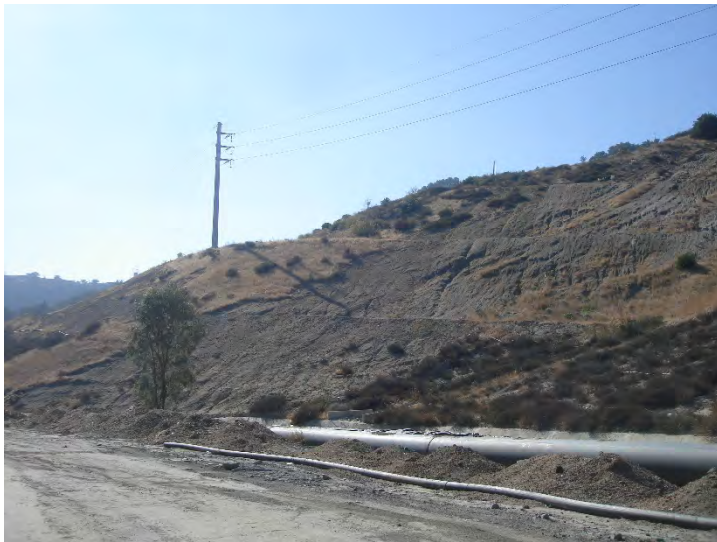
**Photo 285: Sacrificial Liner Replacement Near County Sage:
October 13, 2018**

In the 4th Quarter, the sacrificial liner to the westside drainage channel near the County sage mitigation area was being excavated and replaced. A gas collection horizontal collection system was also being installed under this new liner to reduce and prevent any gas migration to any perimeter probes.

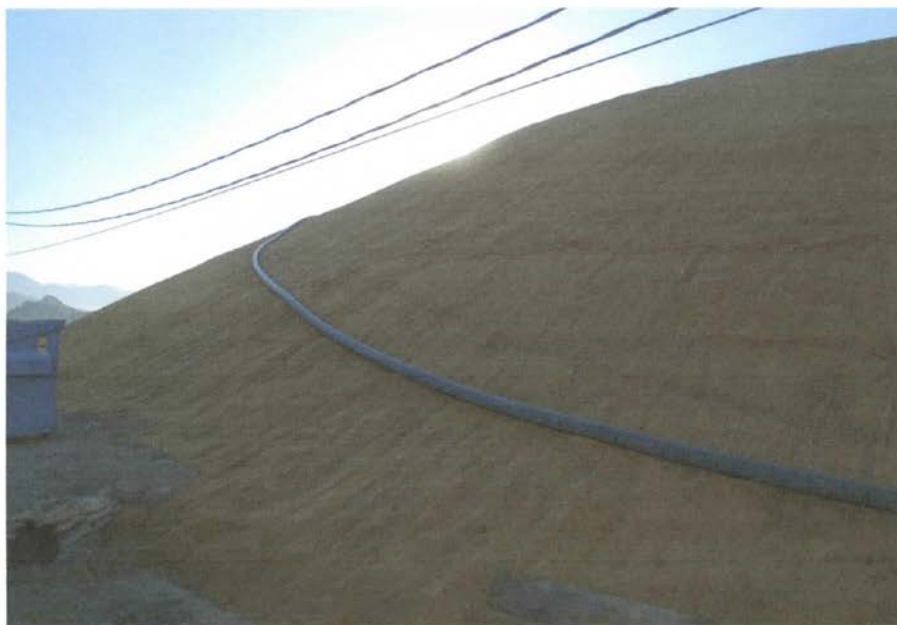
Photo 1: Erosion control blanket on access road near administration pad

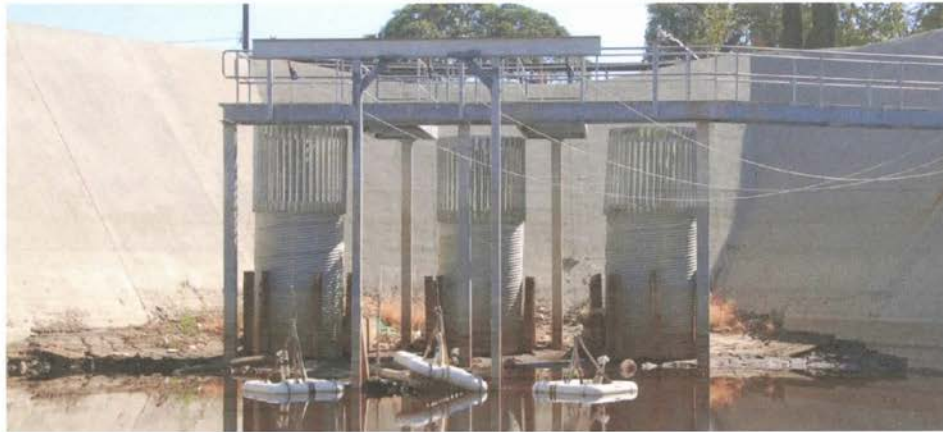
Photo 5: Sediment behind the decant towers of Terminal Basin

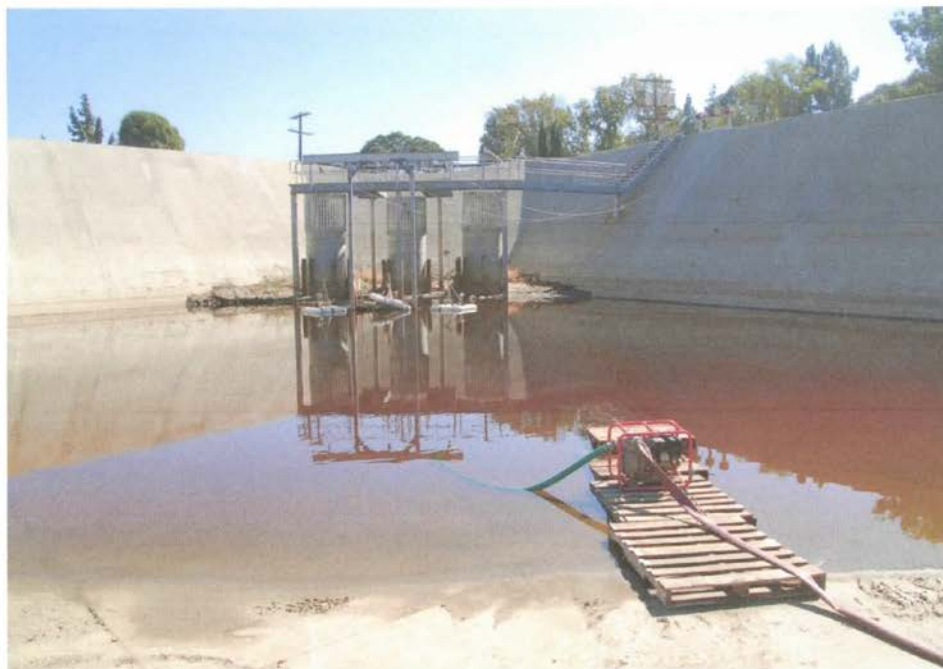
Photo 6: Lowered skimmers and ponding water at Terminal basin

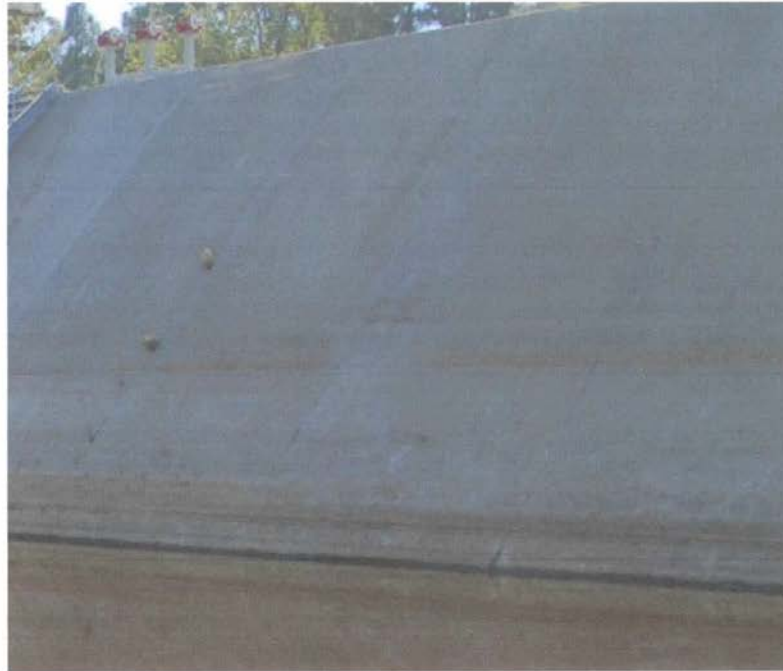
Photo 7: Vegetation in cracks of inside wall of Terminal basin

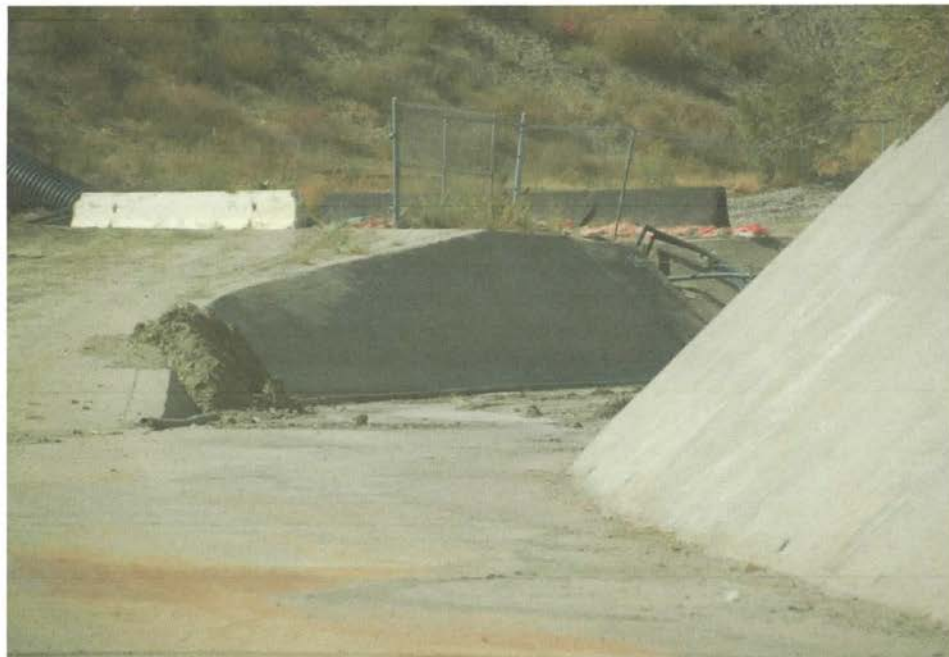
Photo 8: Earth check dam removed at Terminal basin

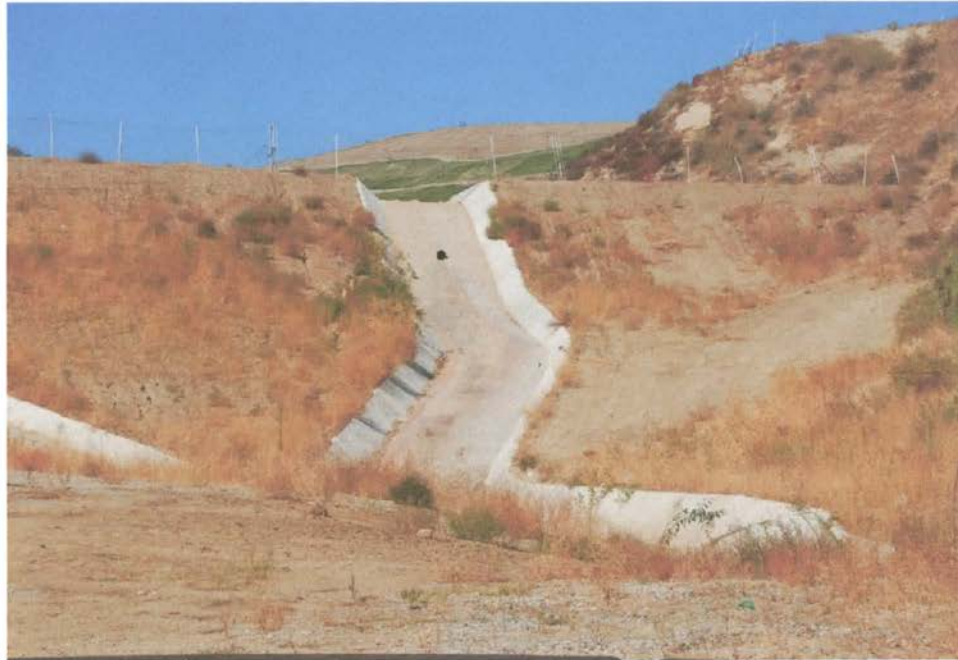
Photo 9: Repaired erosion gullies on downstream side of embankment of cell CC3 basin

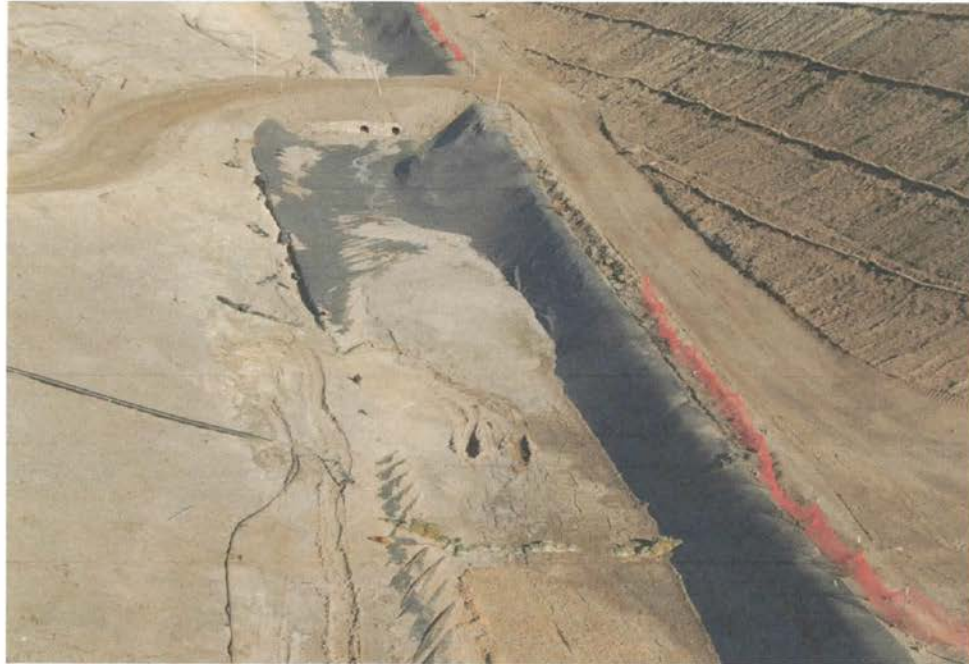
Photo 11: Sediments in moat around Cell CC4 Part 2

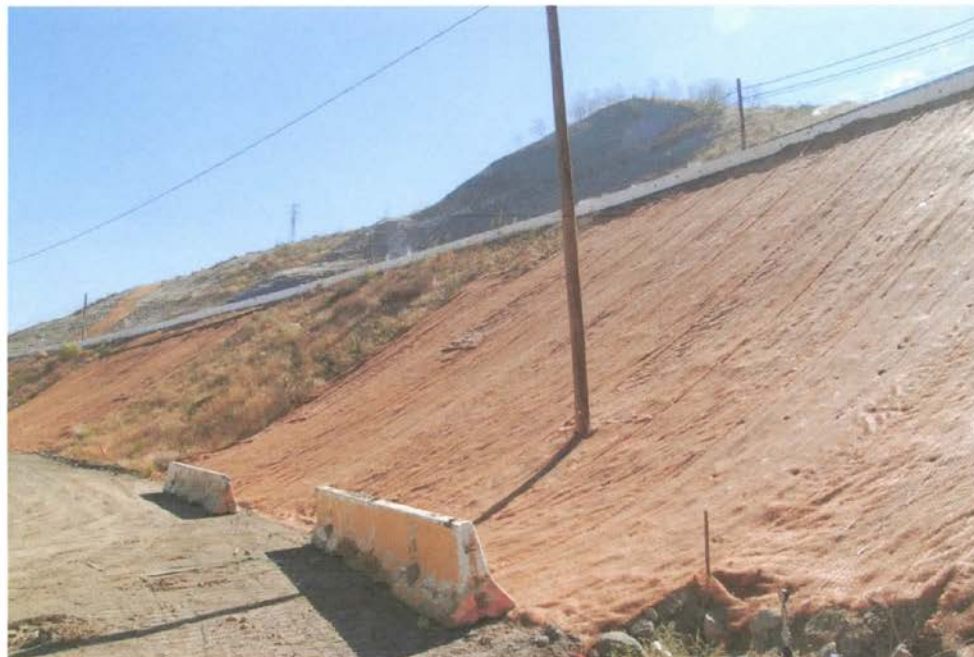
Photo 15: Repaired sloughed areas on slope of access road embankment at Terminal basin

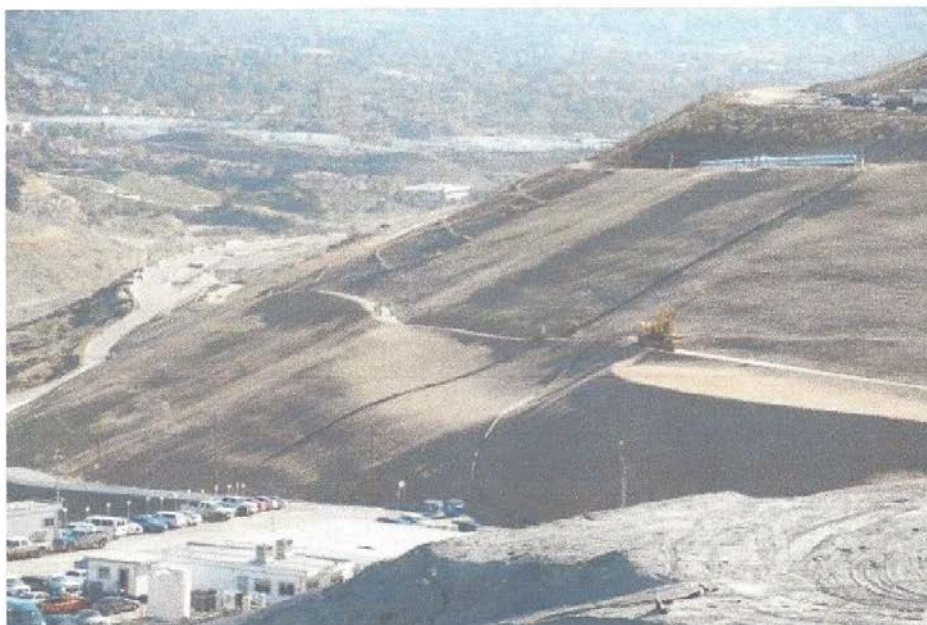
Photo 1: Settlement depression on slope above access road near administration pad

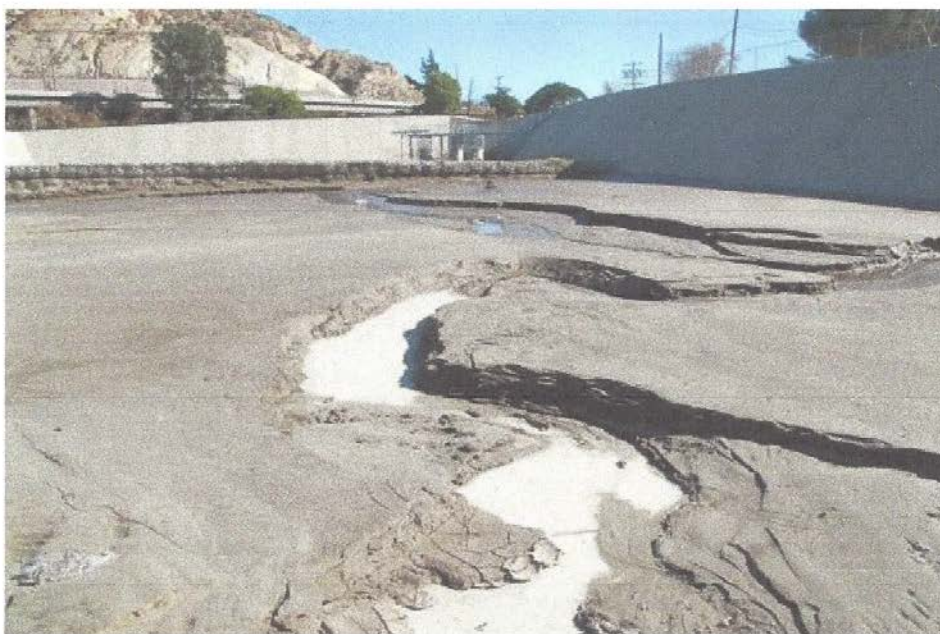
Photo 4: Sediment behind the separator gabion wall of Terminal Basin

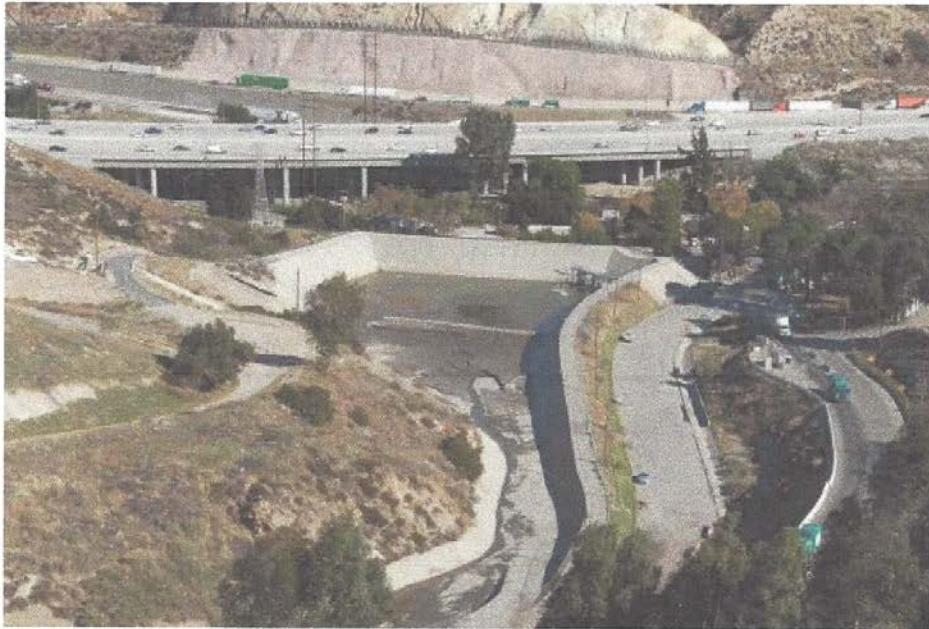
Photo 5: Lowered skimmers and ponding water at Terminal basin

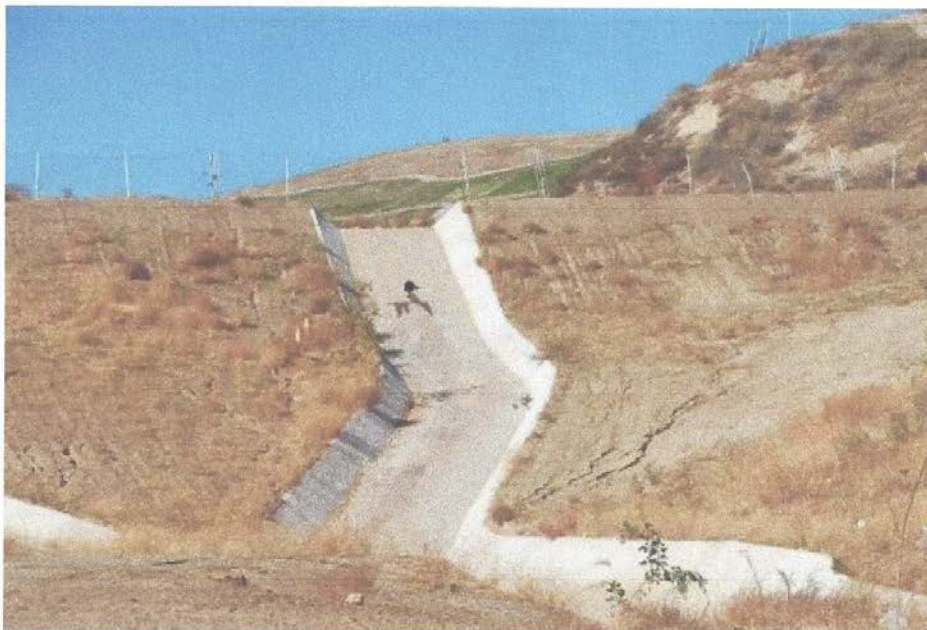
Photo 6: Erosion gullies on downstream side of embankment of cell CC3 basin have reappeared

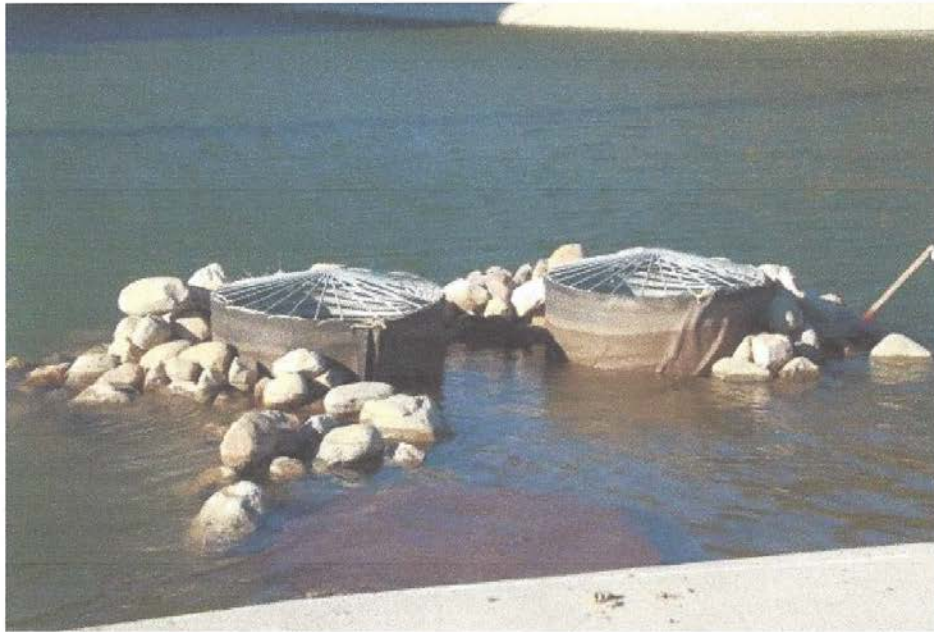
Photo 7: Basin A – water level in basin is near spillway crest

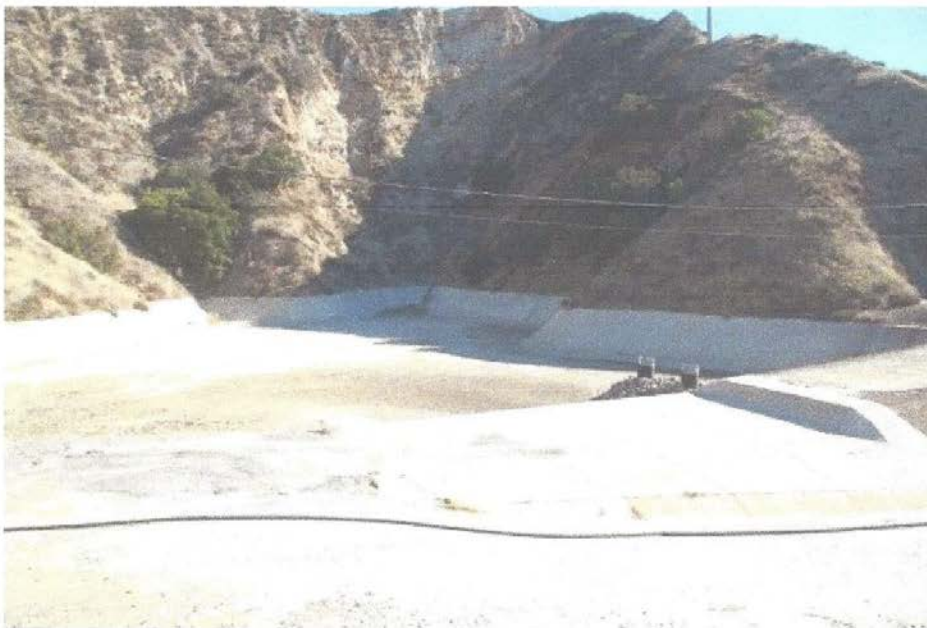
Photo 10: Basin D – small amount of sediments near intake towers

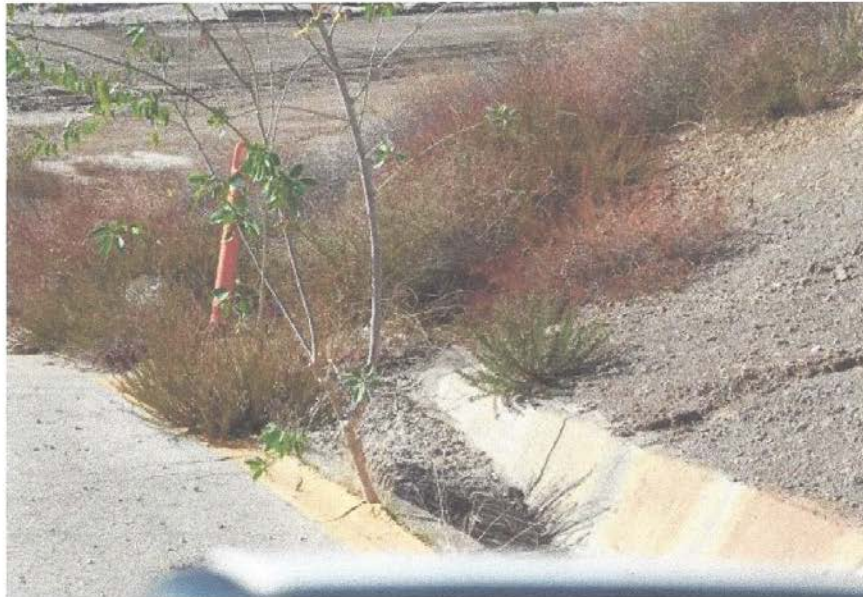
Photo 11: Sediments blocking drainage of ditch along access road to Flares 9-11

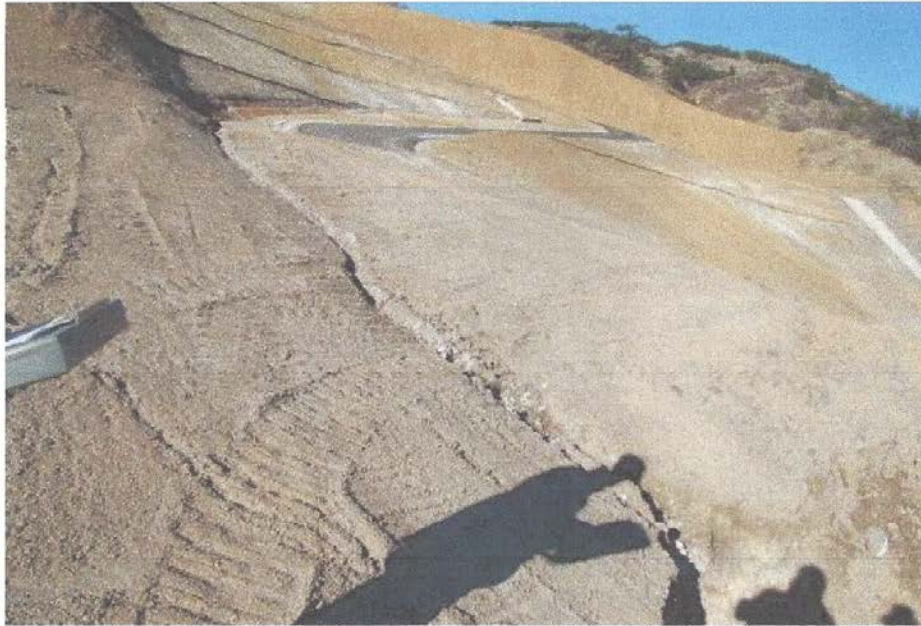
Photo 13: Erosion gully at end of unfinished drainage ditch along road to Flare 3

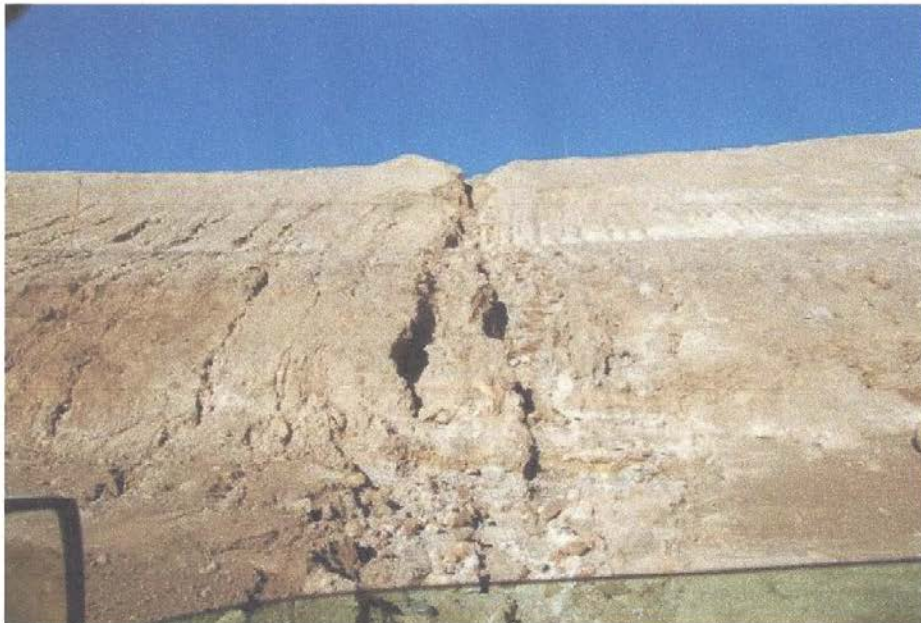
Photo 14: Damage to fill supporting road to Flare 3 from erosion gully shown in Photo 14

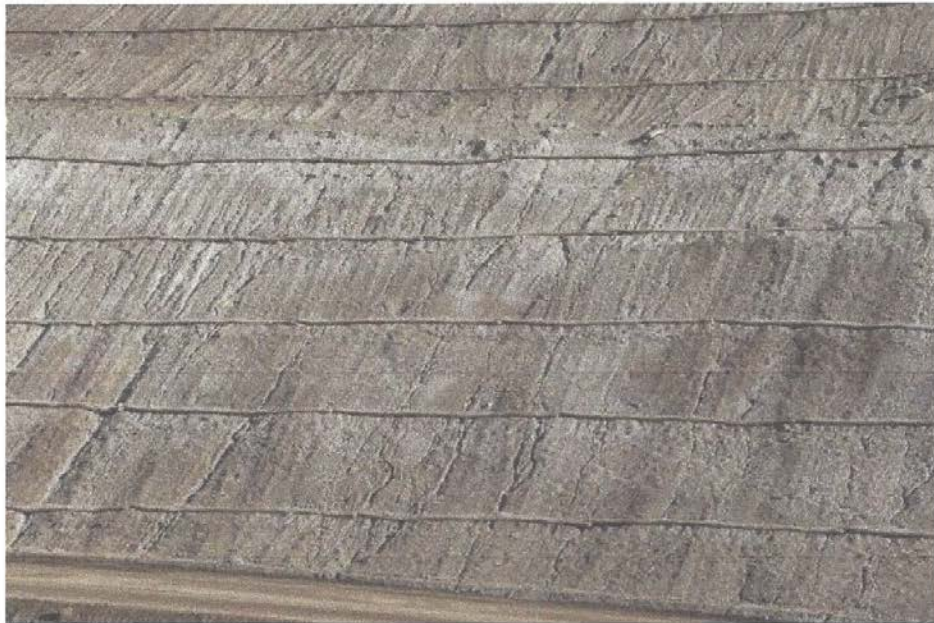
Photo 15: Minor erosion gullies on wattle protected slopes
