Corporate Office – Orange County 16431 Scientific Way Irvine, CA 92618-4355 Telephone: 949.788.4900 Facsimile: 949.788.4901 Sunshine Canyon Landfill Independent Monitor Quarterly Site Monitoring Status Report January1, 2013 – March 31, 2013

May 6, 2013

Appendix II Relevant Site Photos

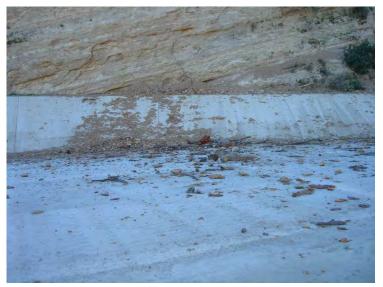
Photo 1: Basin A: January 16, 2013

Current Status/Comments – In January, Basin A had sediment and standing water from recent rain events. The section of the westside channel bottom that was broken had worsened due to uplifting. In the same area, the broken channel sidewalls had worsened and a new horizontal crack was observed in the sidewalls. The Basin D North drainage HDPE lined area was repaired and the drainage channel was no longer blocked by the HDPE material. Basin B was dry and had 4-6 inches of sediment around the outlet risers. The terminal basin had some water with approximately 3 feet or more of sediment at the outlet risers. The terminal basin exterior concrete sidewall cracks were worsening.

A preventative maintenance program with scheduled maintenance tasks for maintaining the drainage systems should be developed and implemented to address observed conditions. This program should be sent to the Los Angeles Department of City Planning and the County Department of Regional Planning.

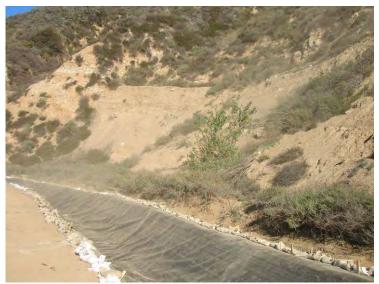
Photo 35: Basin D North Drainage Blowing Dust: January 16, 2013

Current Status/Comments – During the January 16, 2013 site visit, blowing dust was observed coming from the bare soil areas adjacent to the Basin D North drainage and areas of the County top deck near Basin B. The gusty winds made dust control by water only not fully effective. On February 1, 2013 these bare soil areas were noted to have been treated with a soil sealant and no blowing dust was observed.

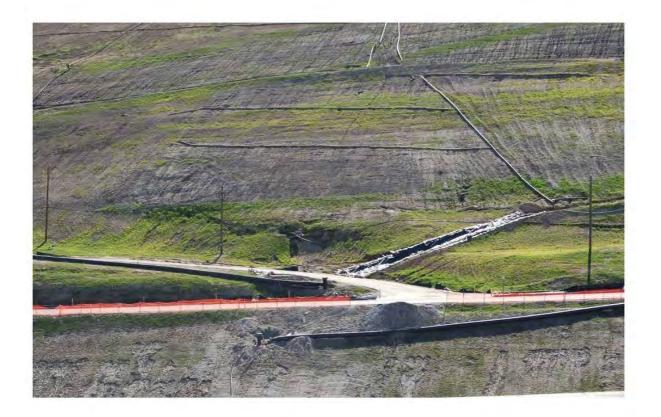
Photo 41: Sloughing at toe of slope above access road at level of Cell CC3
