Tree Report

Tree Inventory
Panorama Mall
8401 Van Nuys Blvd.
Panorama City, CA 91402

Tree Inventory Report
Panorama Mall
8401 Van Nuys Blvd.
Panorama City, CA 91402

TREE SITE MAP

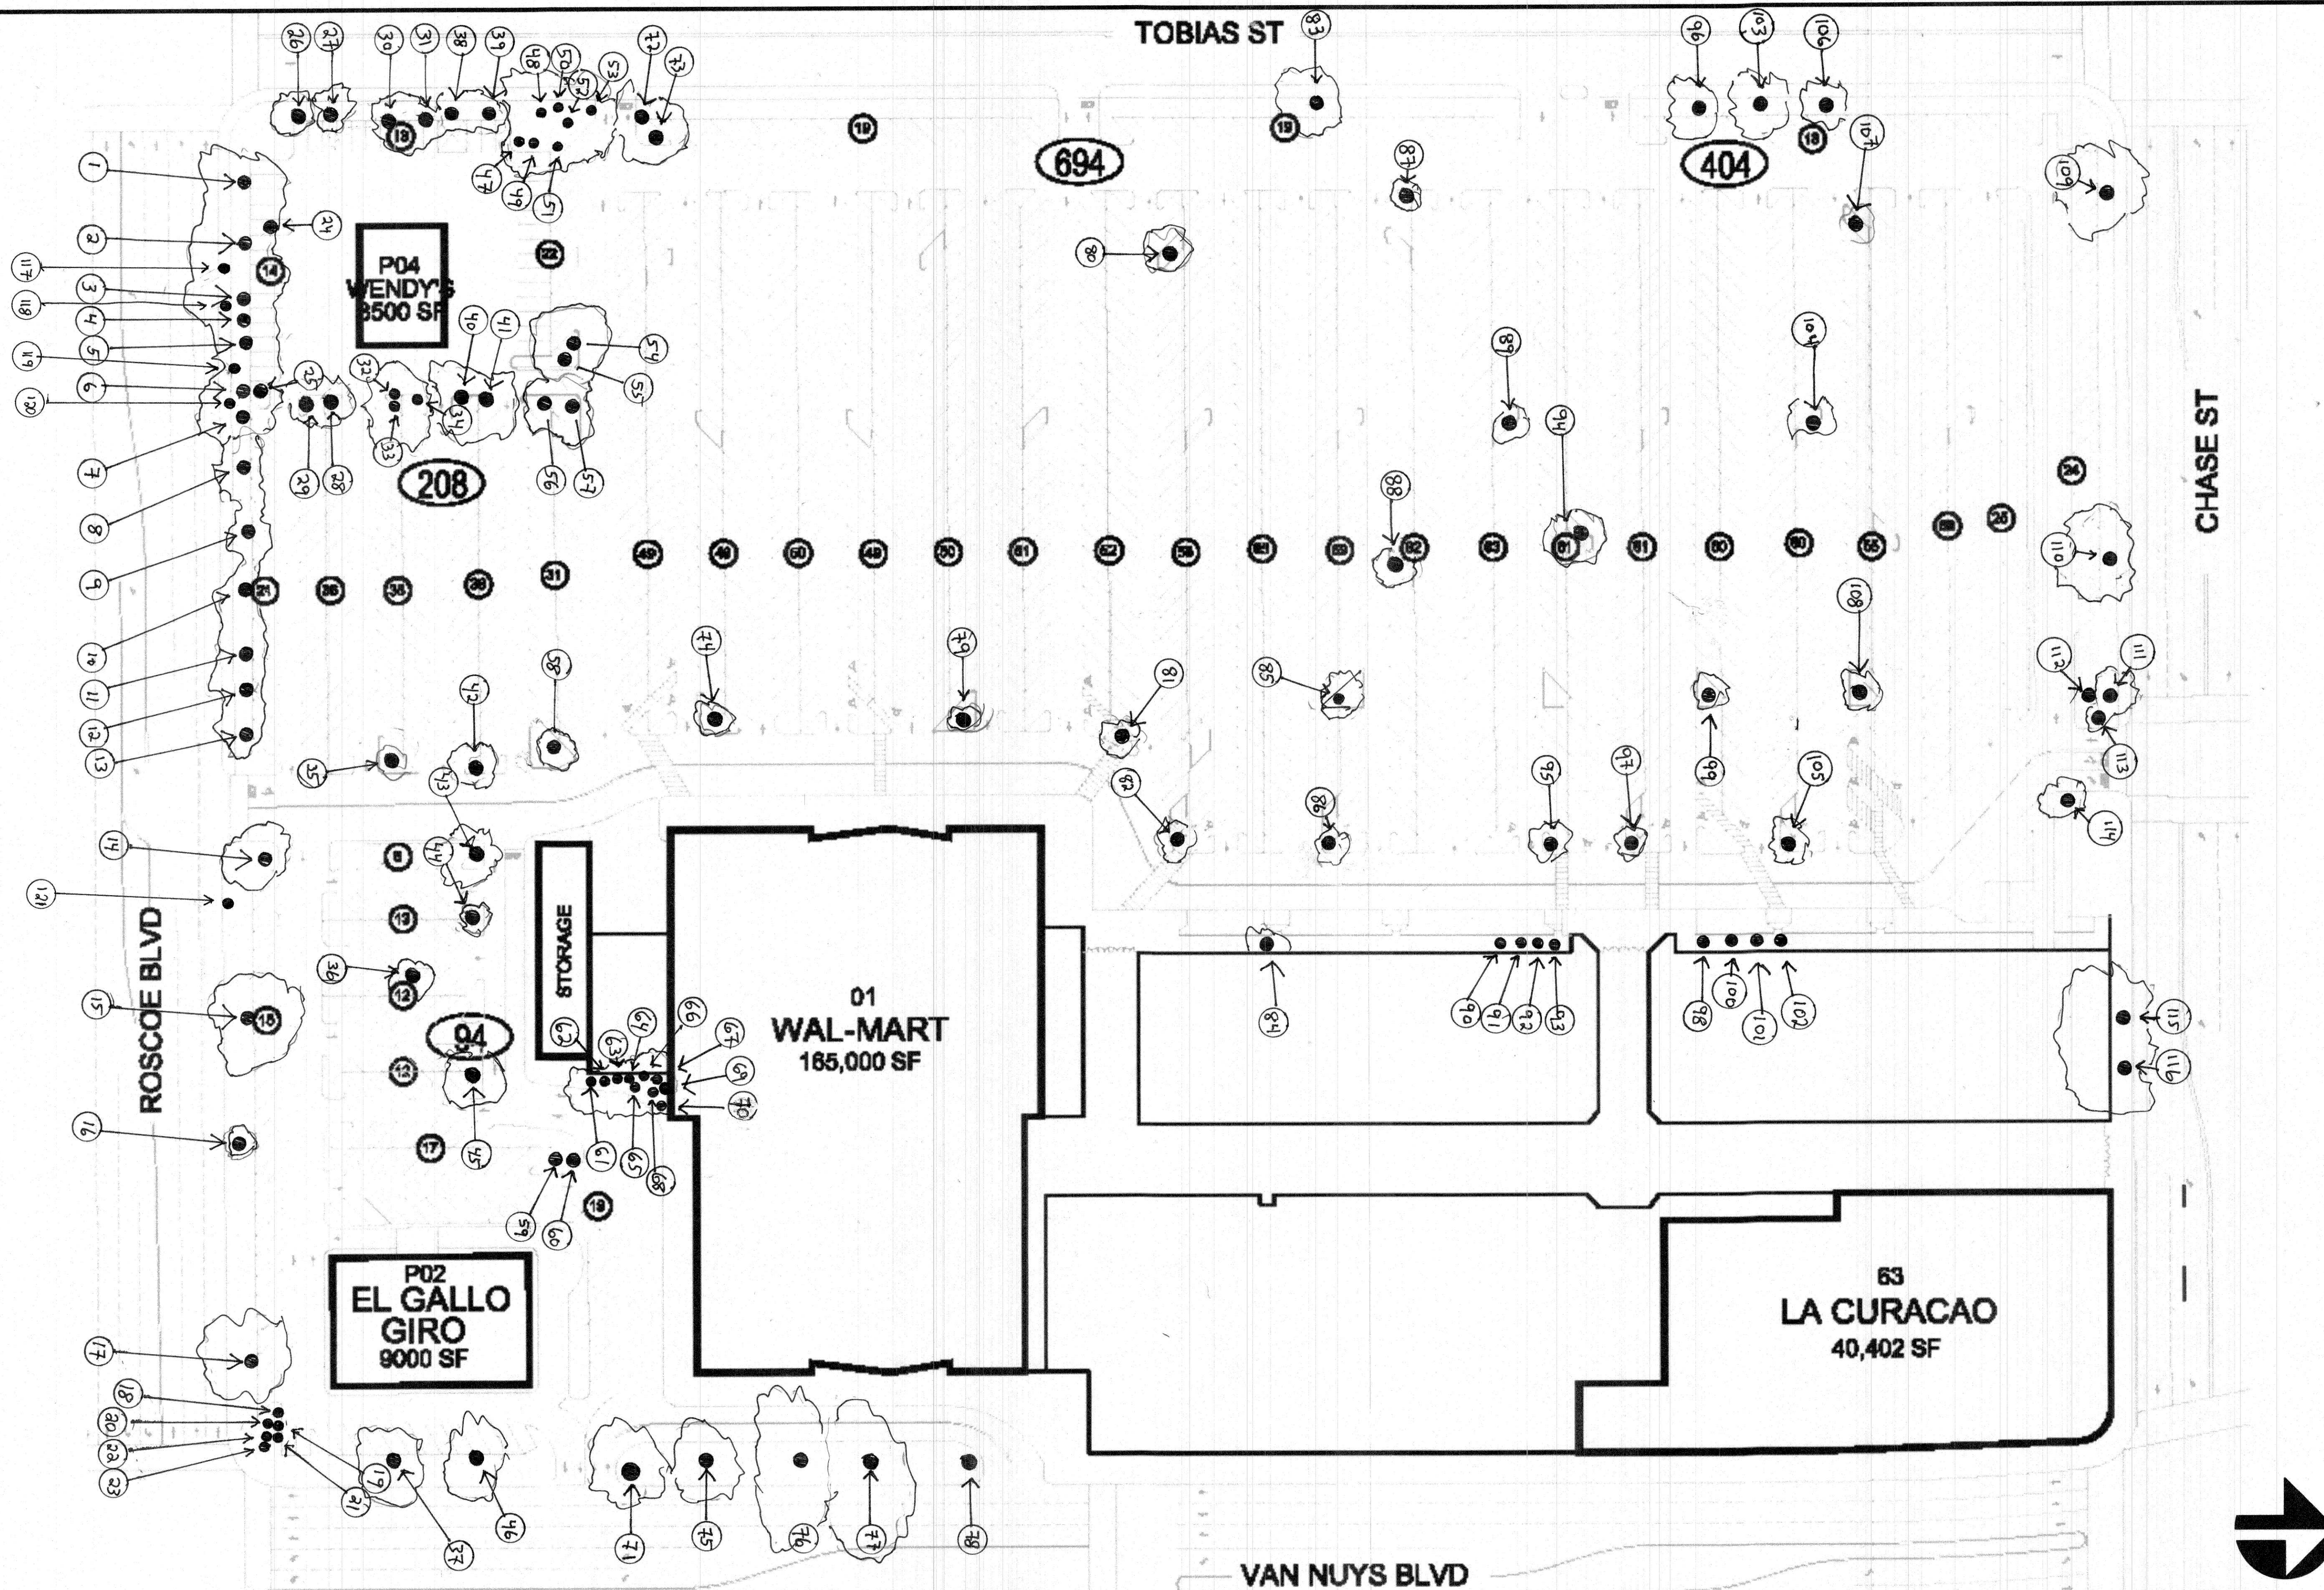
This inventory consists of 3 components – the text report you are now reading, the Index of Trees where each tree is describes as detailed above and a modified Site Plan showing the location of each of the 116 numbered trees with an approximation of their existing canopy.
