January 23, 2014

**Sunshine Canyon Landfill
Independent Monitor
Quarterly Site Monitoring Status Report
October 1, 2013 – December 31, 2013**

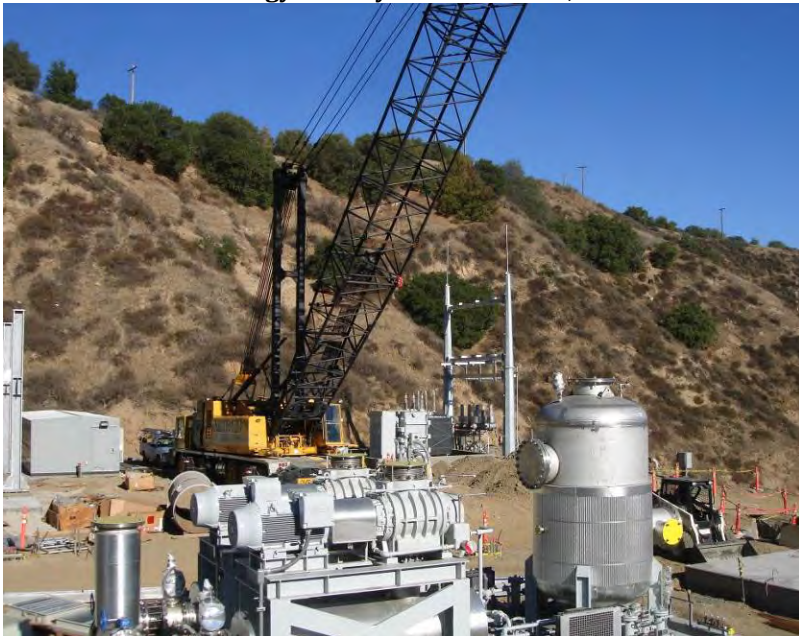
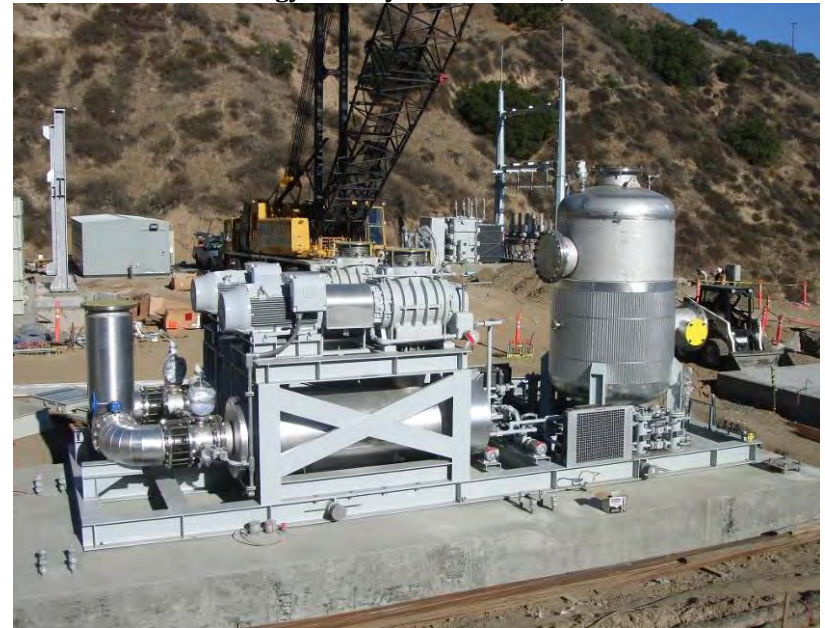
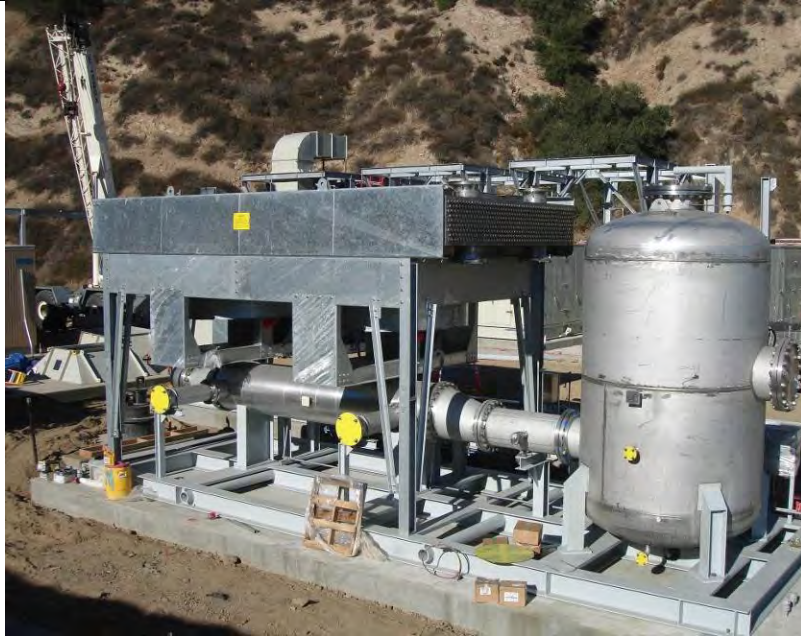
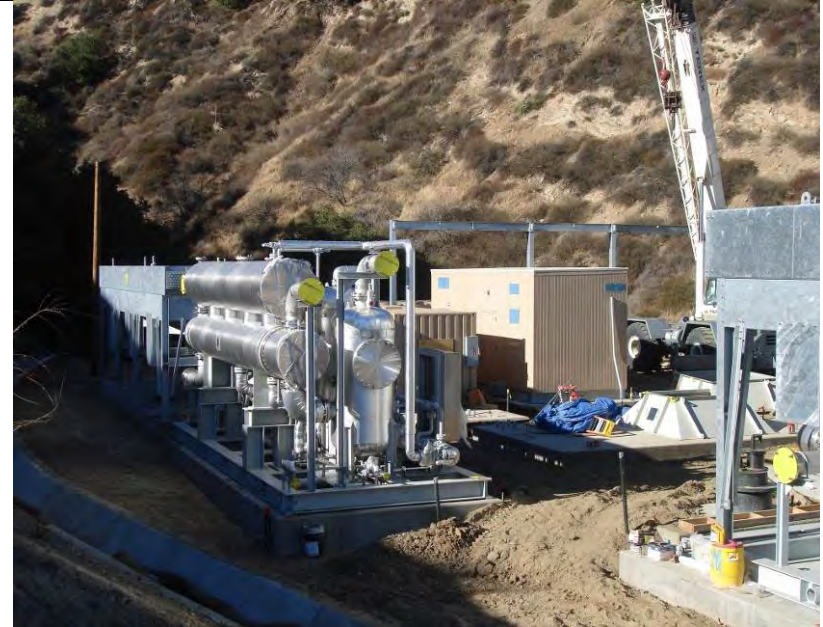
Current Status/Comments – The gas-to-energy and Edison facilities were observed during this quarter. Progress can be seen by the photos taken. The Edison facility appeared complete and ready for commissioning on December 4, 2013. On December 18th, the gas-to-energy facility still had work to be accomplished. The expected schedule for commissioning of both facilities is the end of the 1st Quarter or early 2nd Quarter of 2014.

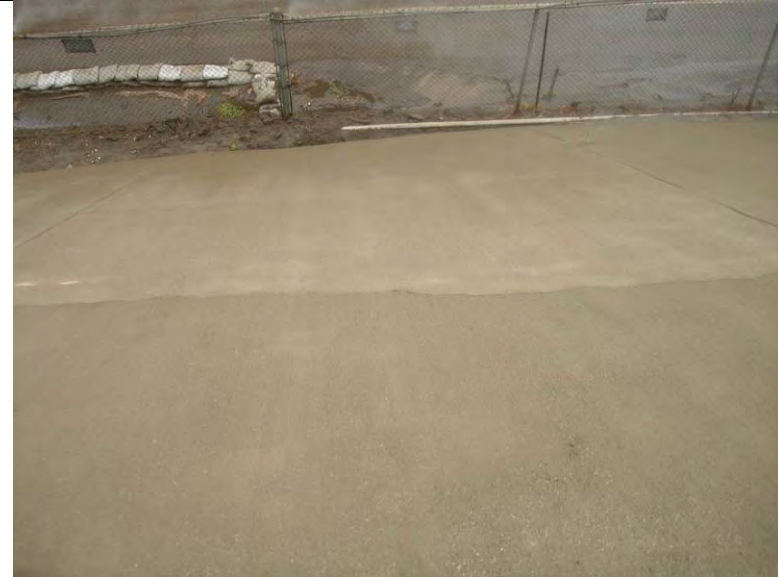
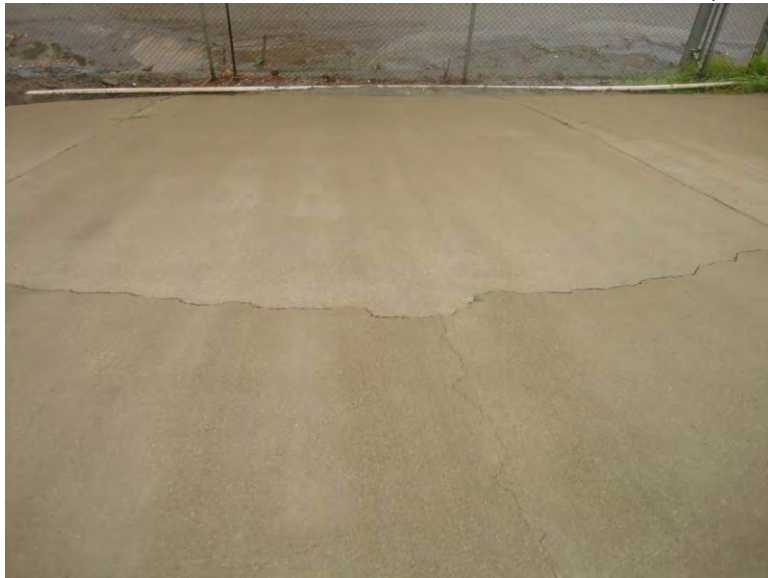
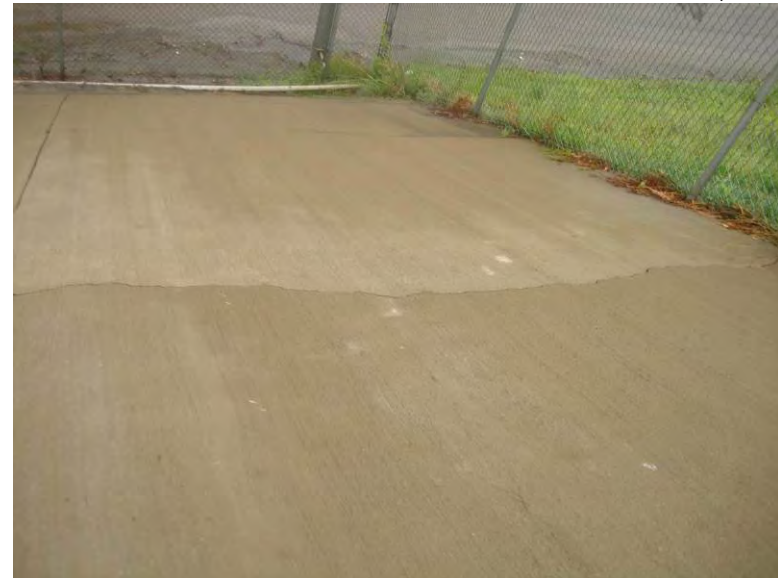
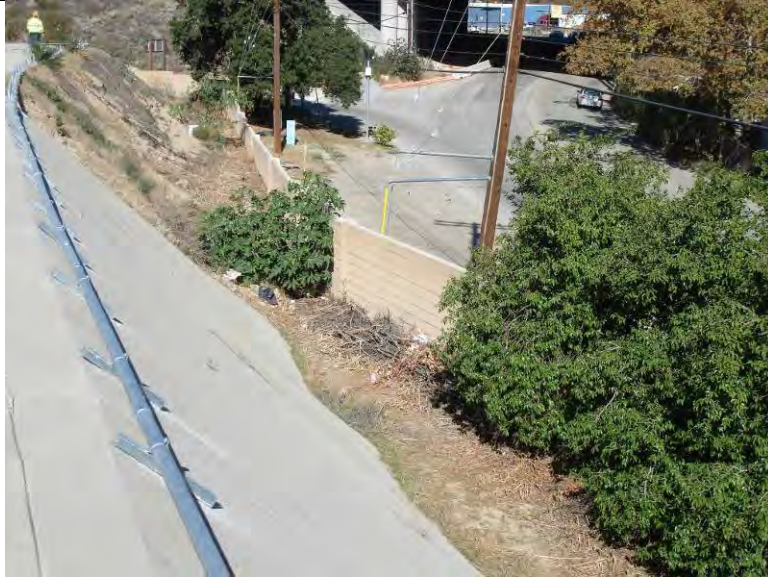
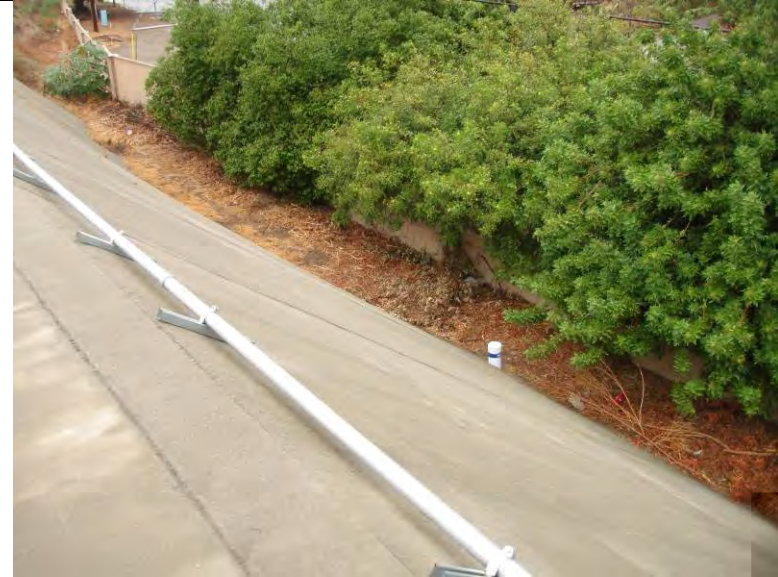
Photo 218: Terminal Basin Exterior Wall Crack: October 9, 2013

Photo 219: Terminal Basin Exterior Wall Crack: October 9, 2013

Photo 220: Terminal Basin Exterior Wall Crack: October 9, 2013

Photo 221: Terminal Basin Exterior Wall Crack: December 4, 2013

Photo 222: Terminal Basin Exterior Front Wall: October 9, 2013

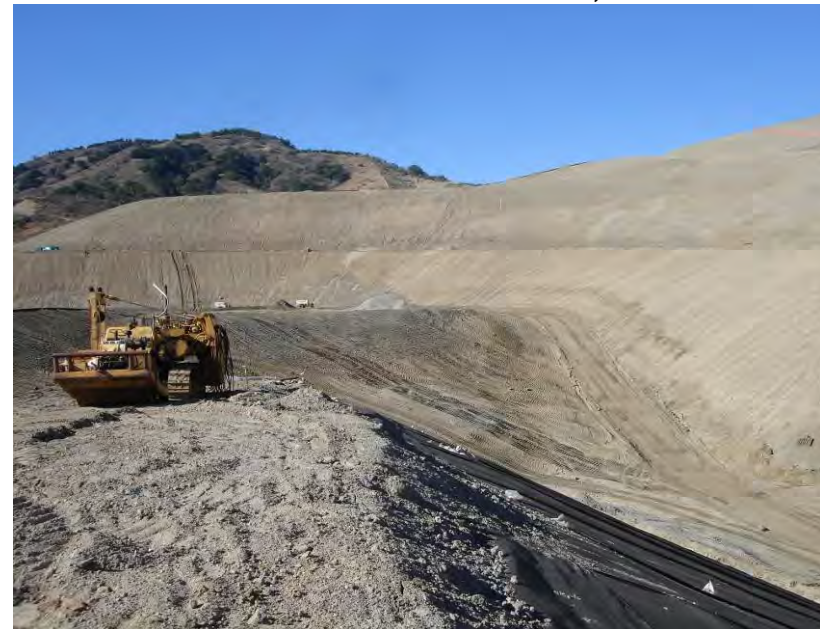
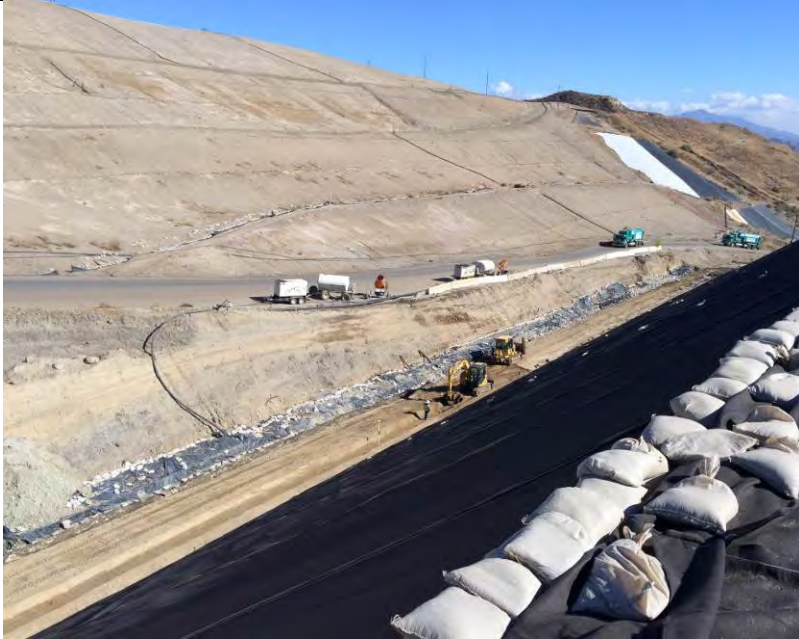
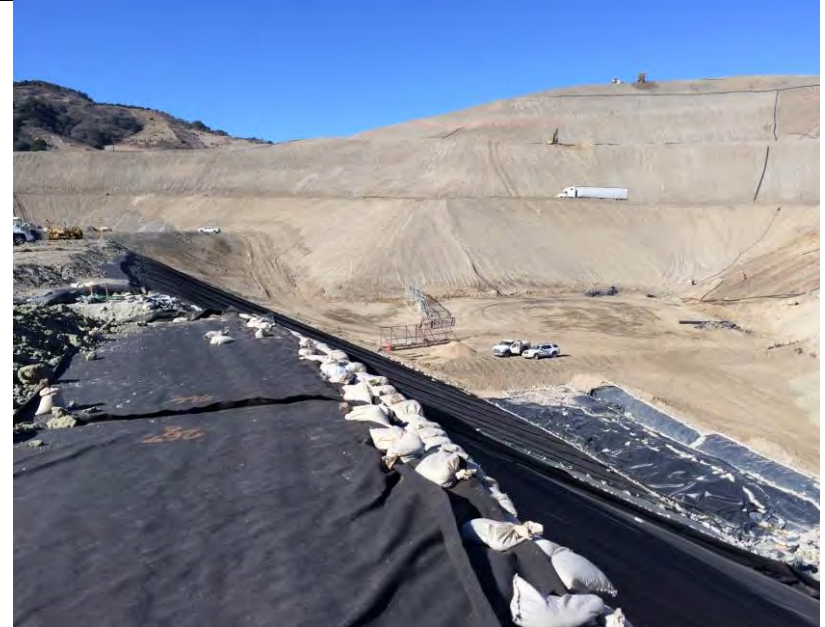
Current Status/Comments – It was observed in the August monitoring that the City south waste slope had fissures and cracks in the vicinity of the buttress area. Vertical and horizontal offsets in the roadway and hillside were observed in the October monitoring visit. The cause of these cracks and their potential impact should be addressed by Republic's geotechnical engineer. In November, waste was being placed in Cell CC3A Part II, and the cracks and offsets were repaired.

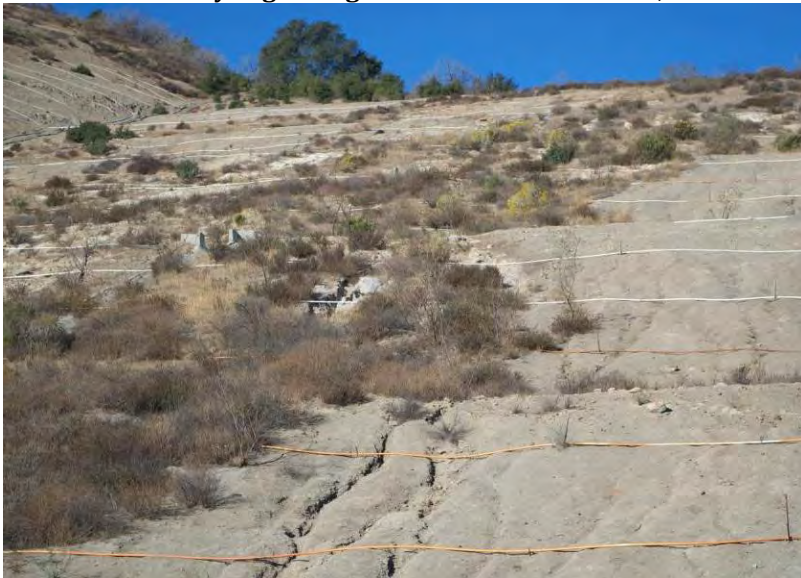
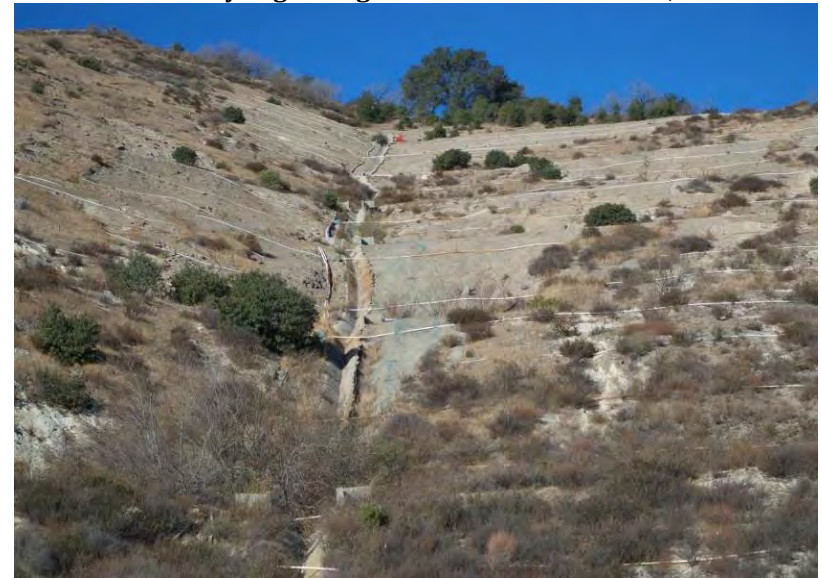
Current Status/Comments – The County Sage Mitigation Area was observed. Joe Decruyenaere (County biologist) and Joe Thompson (Monitor biologist) observed that no mitigation activity was occurring at this location. The lower areas that are void of sage vegetation appear to have friable soils that if terraced or if benches are created and supported by straw wattles, the flat areas could be vegetated with sage. A further investigation of the site soils condition is warranted. Re-activating the irrigation system may be beneficial. Refer to Joe Thompson's mitigation monitoring site reports and the December 17, 2013 memo for detailed biological assessment.

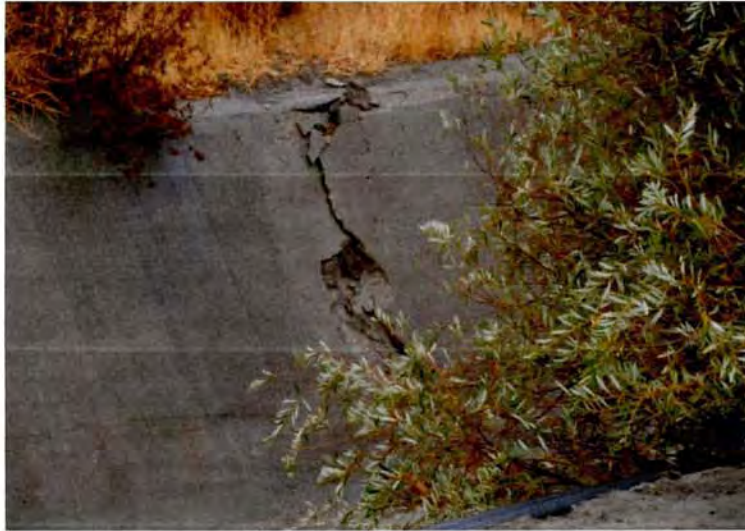
Current Status/Comments – In October, the westside drainage channel had cracking and spalling in the concrete sidewalls and uplifting in the concrete bottom. Trees were growing next to the channel wall possibly causing the cracking in the concrete walls. The cause of the damage to the drainage structure should be determined and necessary repairs made to the structure.

Photo 1: North channel – crack in concrete wall

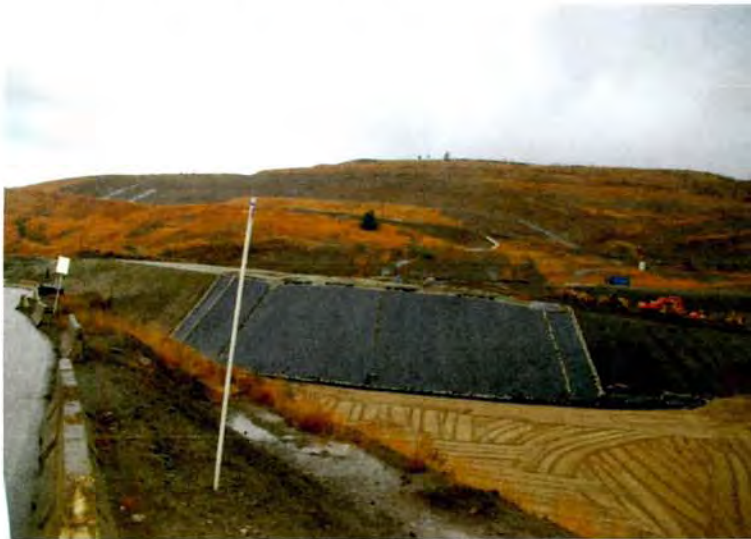
Photo 2: Stability berm in place at Cell CC3a Part 1
