August 5, 2013

**Sunshine Canyon Landfill
Independent Monitor
Quarterly Site Monitoring Status Report
April 1, 2013 – June 30, 2013**

Sunshine Canyon Landfill Mitigation Monitoring – 2013 Second Quarter Summary/ City
(see Excel spreadsheets)

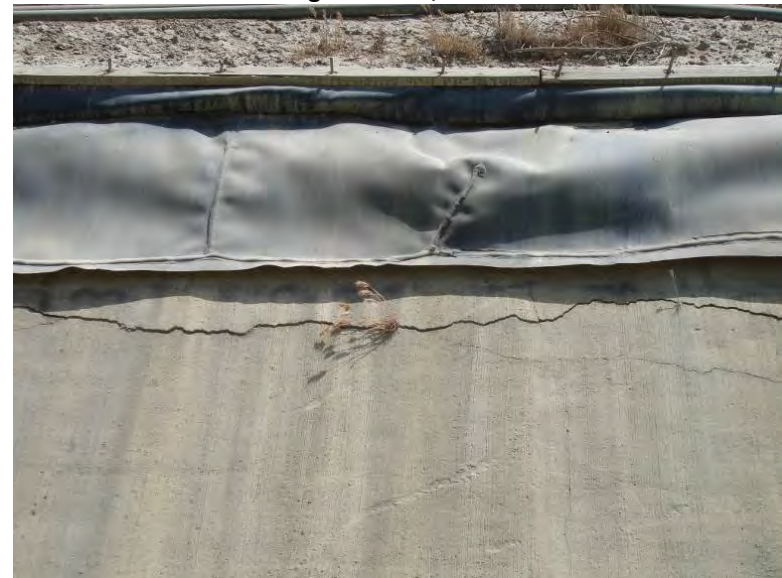
Photo 71: Westside Drainage: June 12, 2013

Current Status/Comments – The western drainage into Basin A is partially plugged. The westside drainage system's concrete had areas with sidewall and bottom cracking and spalling. Trees in two areas could possibly be causing the sidewall cracking. The Basin D North Drainage v-ditch HDPE liner was windblown and crumpled, causing a potential drainage blockage. The terminal basin exterior sidewall facing the entrance road has a crack that had worsened since it was first observed. A preventative maintenance program with a schedule should be implemented to satisfy the above mitigation measures.

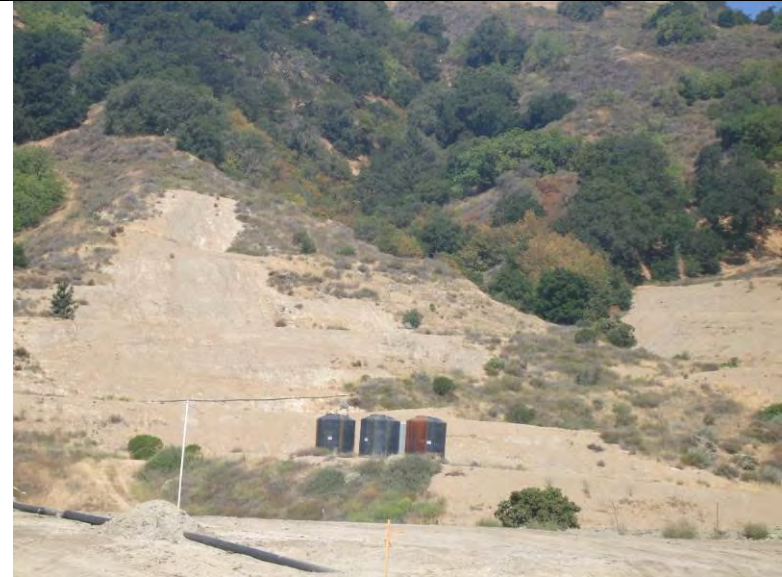
Photo 89: County Sage Mitigation Area: May 29, 2013

Current Status/Comments – The county sage mitigation area has had minimal success. A plan to stabilize and retain the loose erosive soils along with a revegetation plan should be investigated. Re-activating the irrigation system may be beneficial. Republic's consulting biologist should evaluate options to implement. Soils type and erosion appeared to be the main cause for lack of sage revegetation. Employing erosion control methods, along with reseeding, could prove successful.

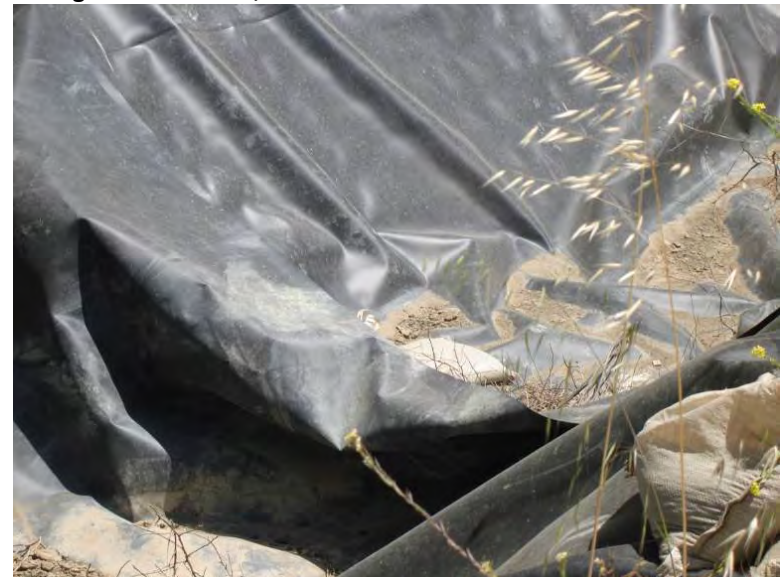
Photo 107: Basin D North Drainage: May 1, 2013

Current Status/Comments – During the May 29, 2013 monitoring, wind gusts caused dust to be released from the Basin D floor, areas adjacent to the Basin D north drainage, and the City/County top decks near the City/County line. The need to apply soil sealant should be planned and applied to bare soil areas prior to the start of the Santa Ana wind season.

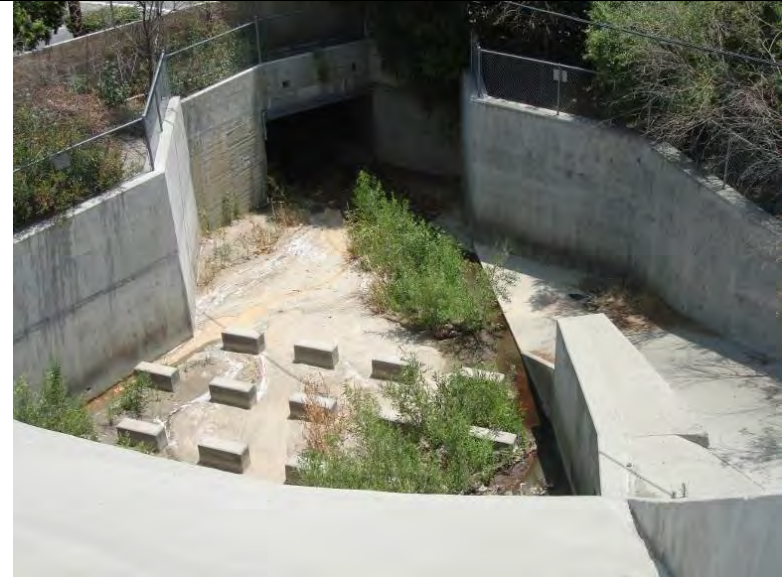
Photo 185: Terminal Basin: June 12, 2013

Current Status/Comments – The water level at the monitoring well on the embankment of the terminal basin was approximately 4.75 feet below the embankment manhole cover. This high a water level would indicate a high water table in the embankment. However, there was no evidence of a high water level on the concrete side of the basin (i.e., moisture, seeping out of cracks) nor on the earthen side of the embankment. The reason for a high water level within the monitoring well should be determined.

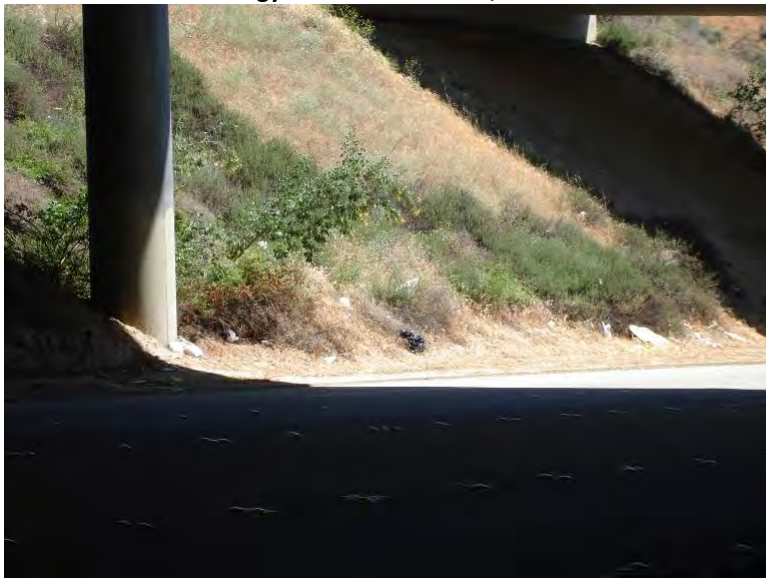
Photo 322: Gas to Energy Edison Pole Foundation: June 25, 2013

The construction is now scheduled to start in July with completion and start-up before the end of 2013. The construction for the tie-in to Edison started in June, with all the foundations for the new transmission line poles completed by the end of June and concrete foundations curing.
