**Sunshine Canyon Landfill
Independent Monitor
Quarterly Site Monitoring Status Report
October 1, 2015 – December 31, 2015**

February 12, 2016

The attached Quarterly Site Monitoring Status Report for the Sunshine Canyon Landfill dated February 12, 2016 is the Fourth Quarterly Report for 2015, issued by UltraSystems. This report covers the monitoring period from October 1, 2015 through December 31, 2015 and is prepared for the City of Los Angeles Department of City Planning and the County of Los Angeles Department of Regional Planning.

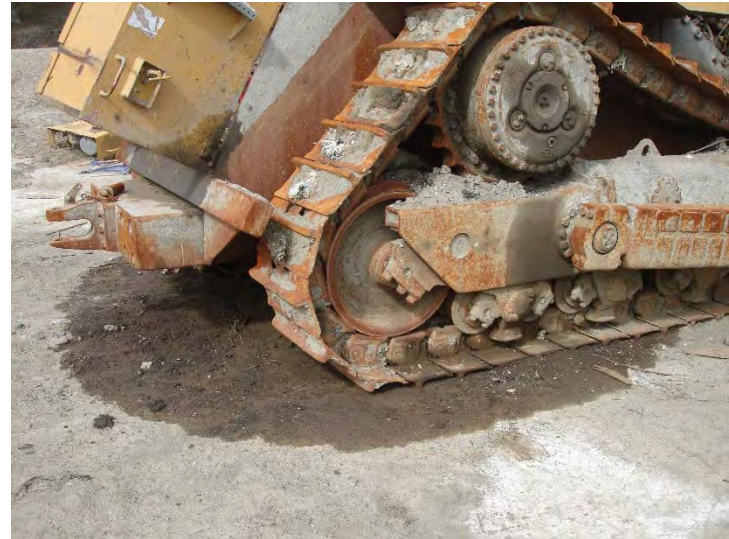
Photo 37: Equipment Leaking Oil Near Basin A: October 28, 2015

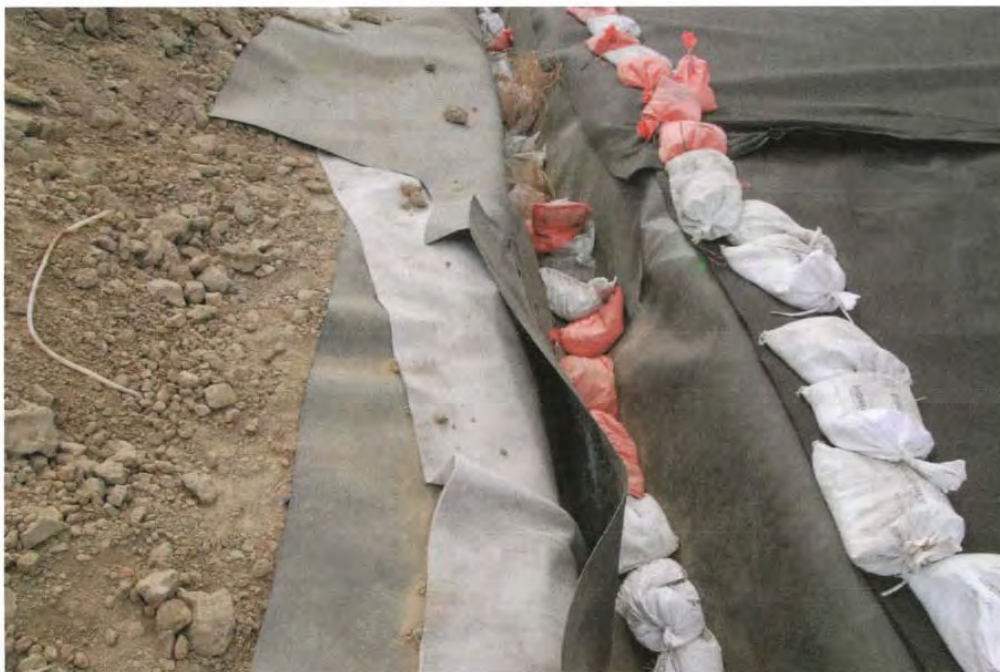
Photo 1: Liner system on slope

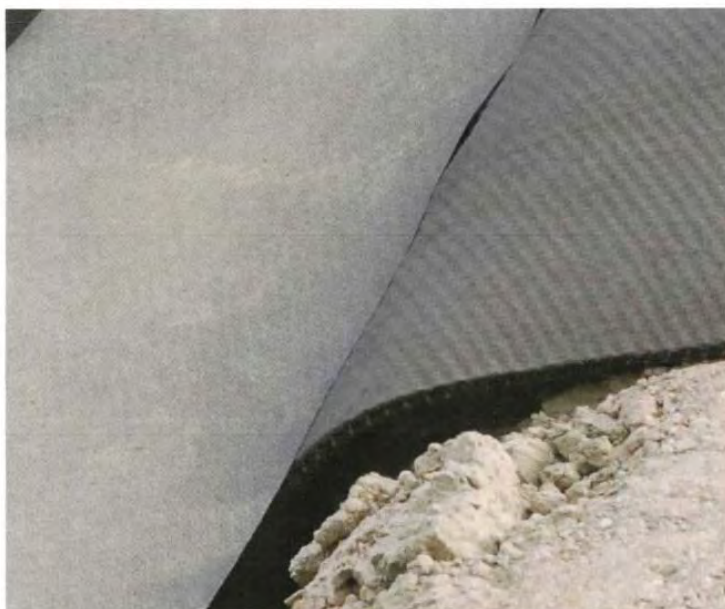
Photo 2: Geocomposite gas collection layer under liner

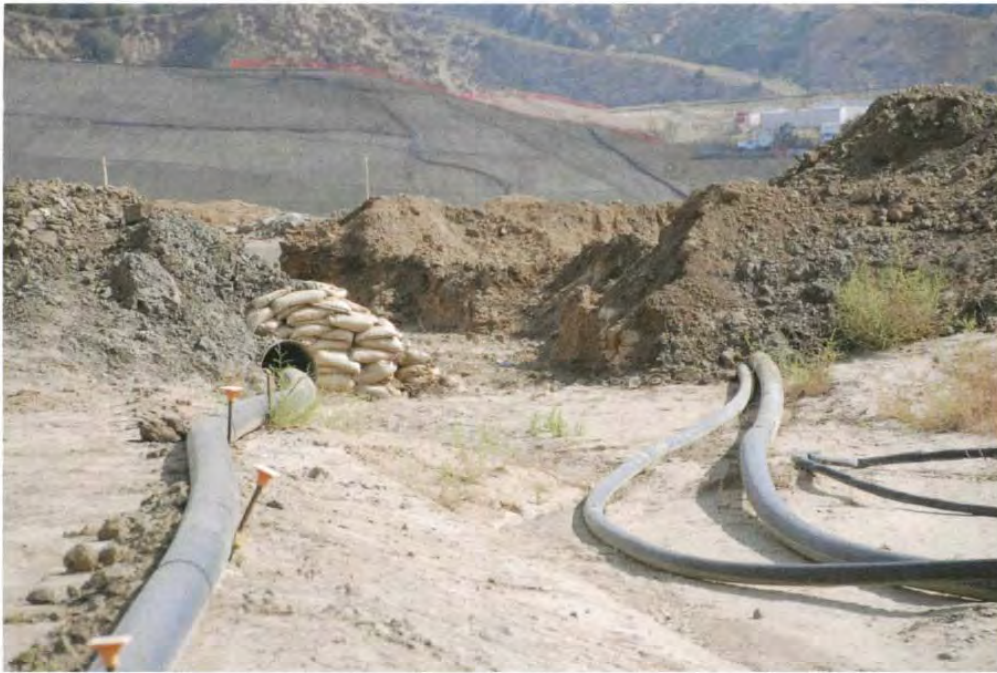
In mid-November, the monitors observed that the Basin A outlet channel was blocked with dirt and sand bags except for a 12-inch HDPE line. There was a temporary road crossing at this location.

Figure 3: Channel out of Basin A Partially Blocked

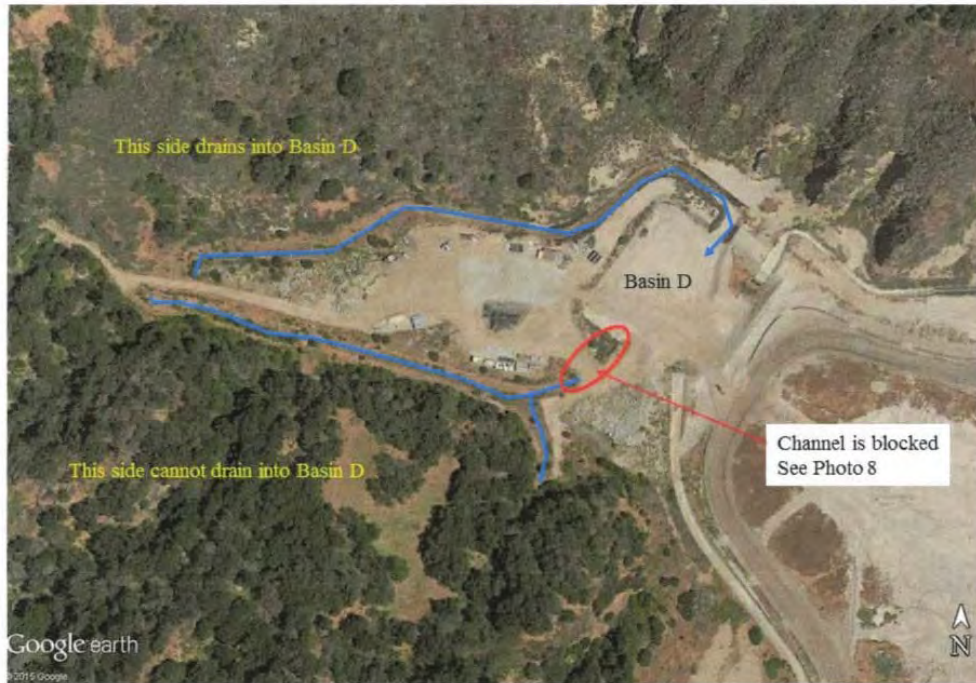
<ul style="list-style-type: none">The southern side drainage channel in the canyon at Basin D/boneyard does not drain into the basin because of the dirt road built across it, unless culverts (which we did not or could not see) were installed under the road. (Photo 7)
FURTHER REVIEW NEEDED
COMMENTS
Signed:

Photo 7: Side drainage ditches near Basin D

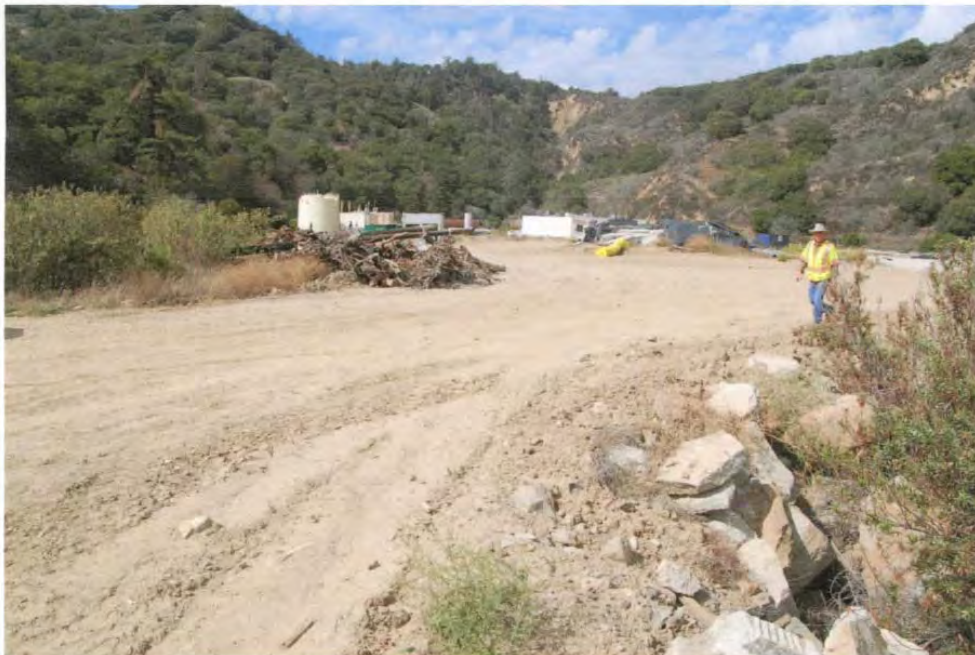
Photo 8: Crossing over southern side ditch at Basin D
