**Sunshine Canyon Landfill
Independent Monitor
Quarterly Site Monitoring Status Report
July 1, 2019 – September 30, 2019**

City of Los Angeles Department of City Planning

County of Los Angeles Department of Regional Planning

December 10, 2019

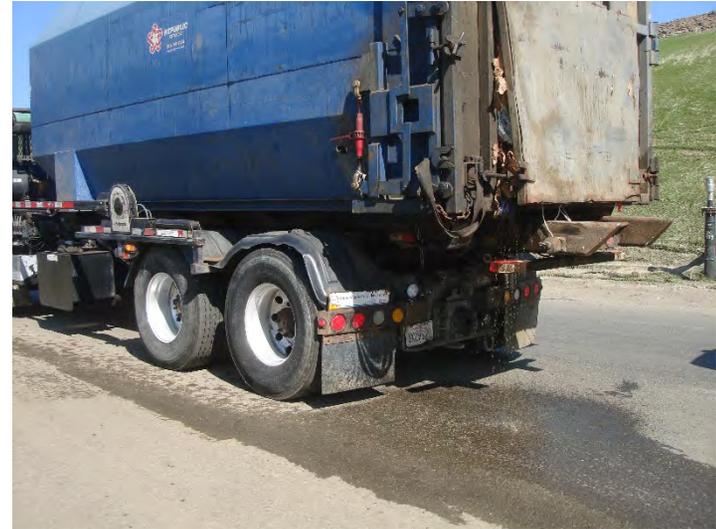
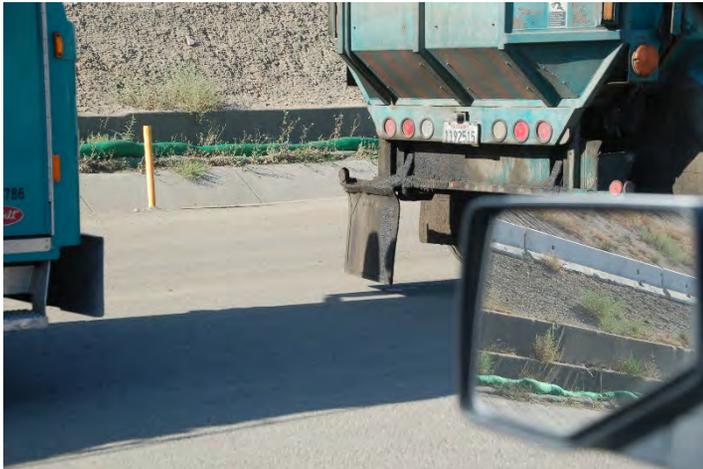
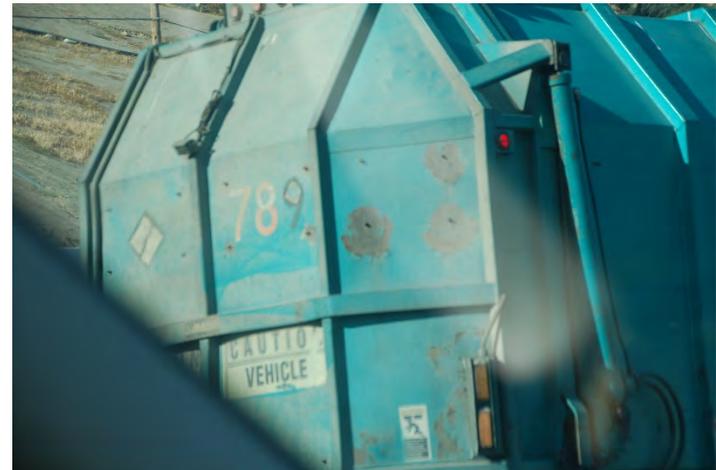
In late August, the monitor drove the neighborhood and school areas from 6:30 to 7:00 a.m. and there were no landfill odors detected. At 8:30 a.m., a trash truck was observed leaving a substantial amount of liquid as it queued in the scale area. The liquid was from the waste and was odorous. The monitor drove the adjacent neighborhood and school area at 9:30 a.m. and no landfill odors were detected. The leachate recovery system below the CC-3B slope was operating and no odors were detected. The alluvial seep was stopped. Localized odors were detected at the north tank of the Adler tank farm leachate and condensate treatment system. Localized odors were coming from a liquids transmission line repair. The repair was completed by approximately 1:00 p.m. Localized odors were detected at Well 3013D on the CC-3A top deck.

Photo 469: Truck Leaking Liquids at Scales: August 27, 2019

Photo 470: Truck Leaking Liquids at Scales: August 27, 2019

Photo 471: Truck Leaking Liquids at Scales: August 27, 2019

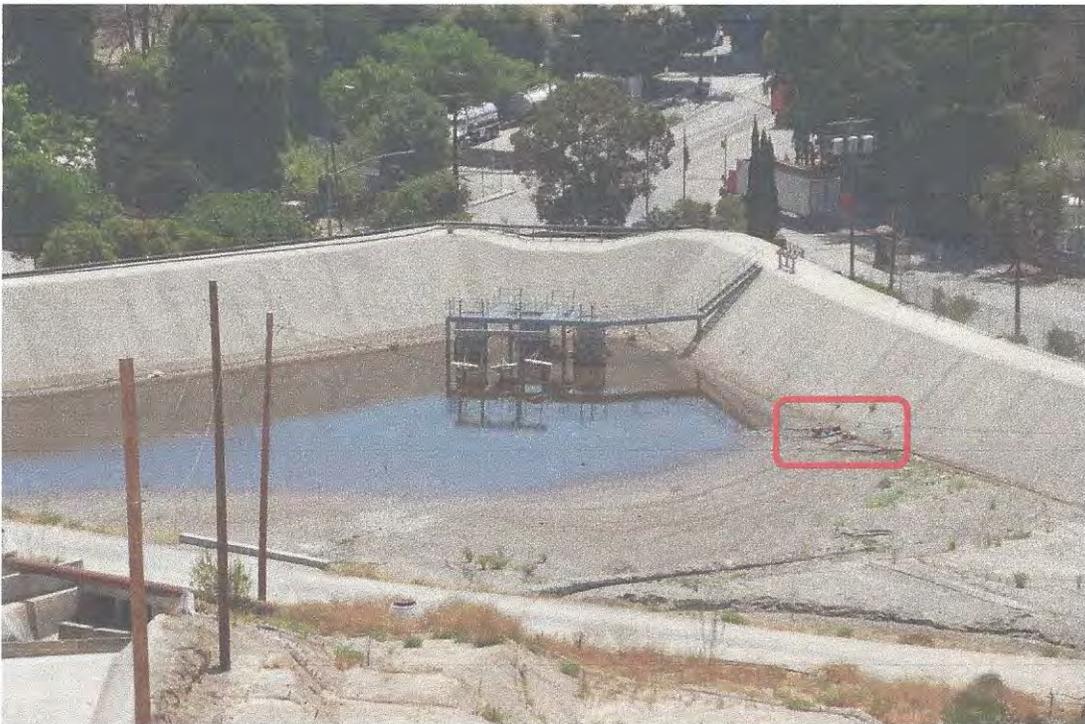
Photo 2: Terminal basin – notice pump on right side near water edge in red box

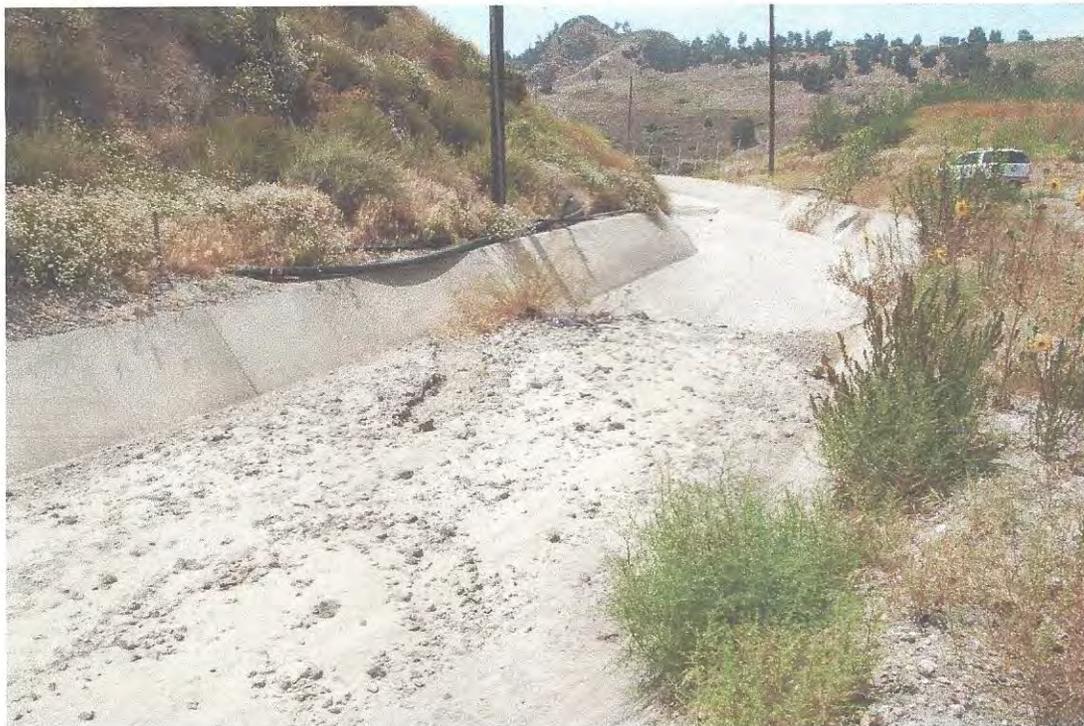
Photo 3: Sediment in east perimeter channel

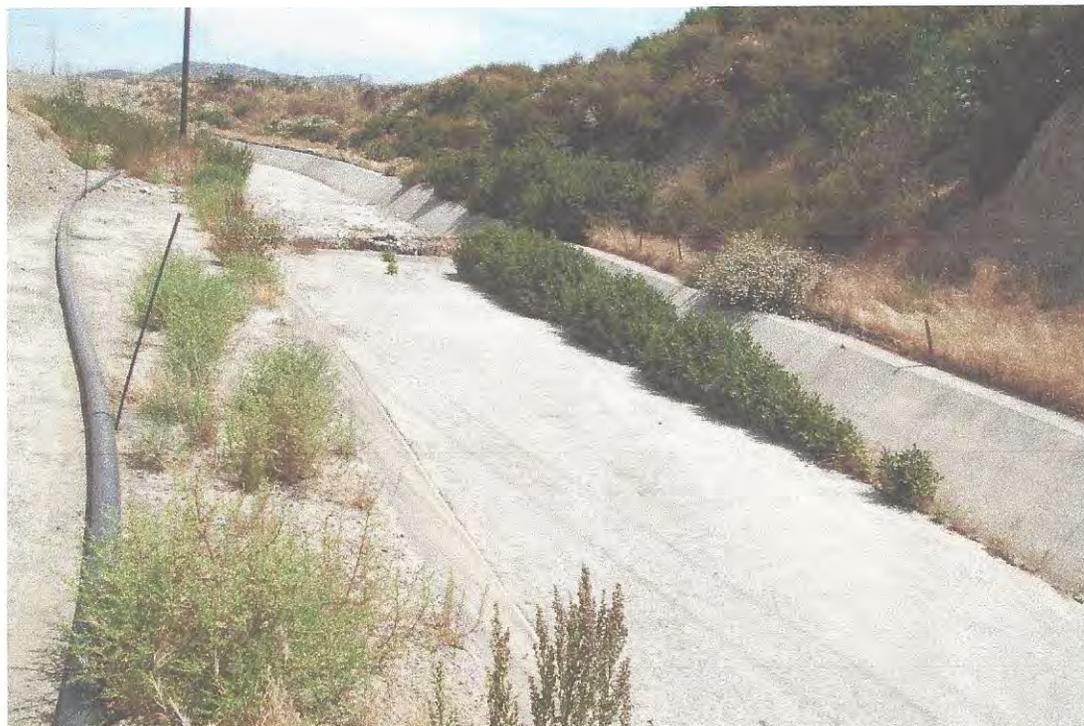
Photo 4: Vegetation growing between floor slab and wall of east perimeter channel

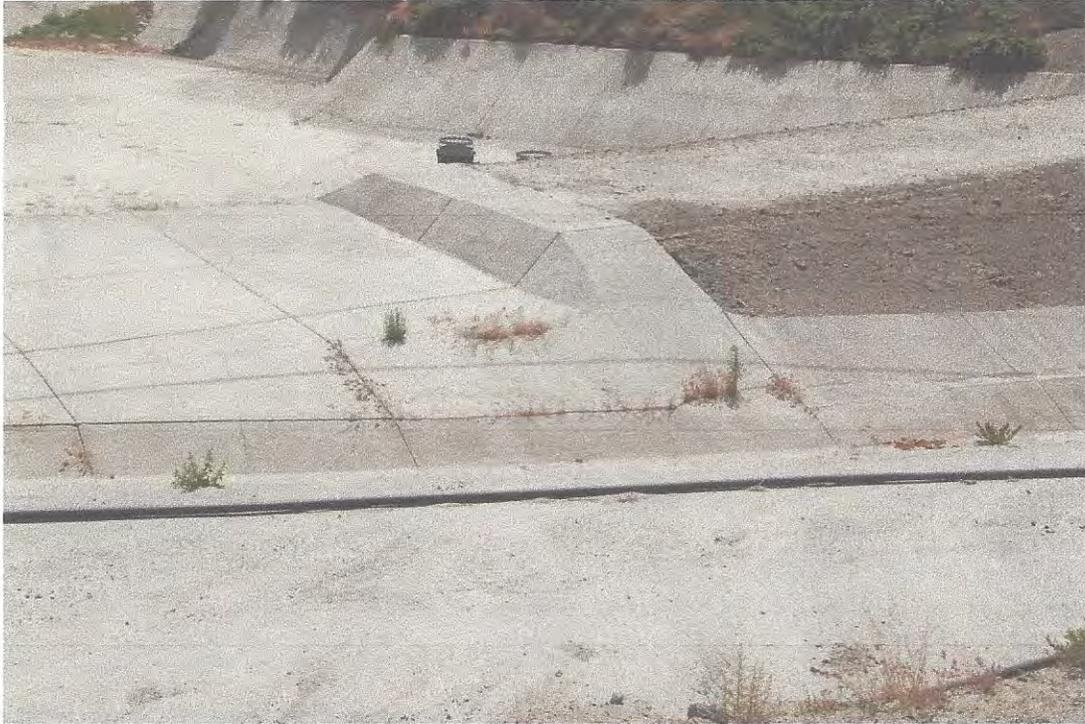
Photo 5: Vegetation in cracks in downstream side of concrete spillway at Basin B

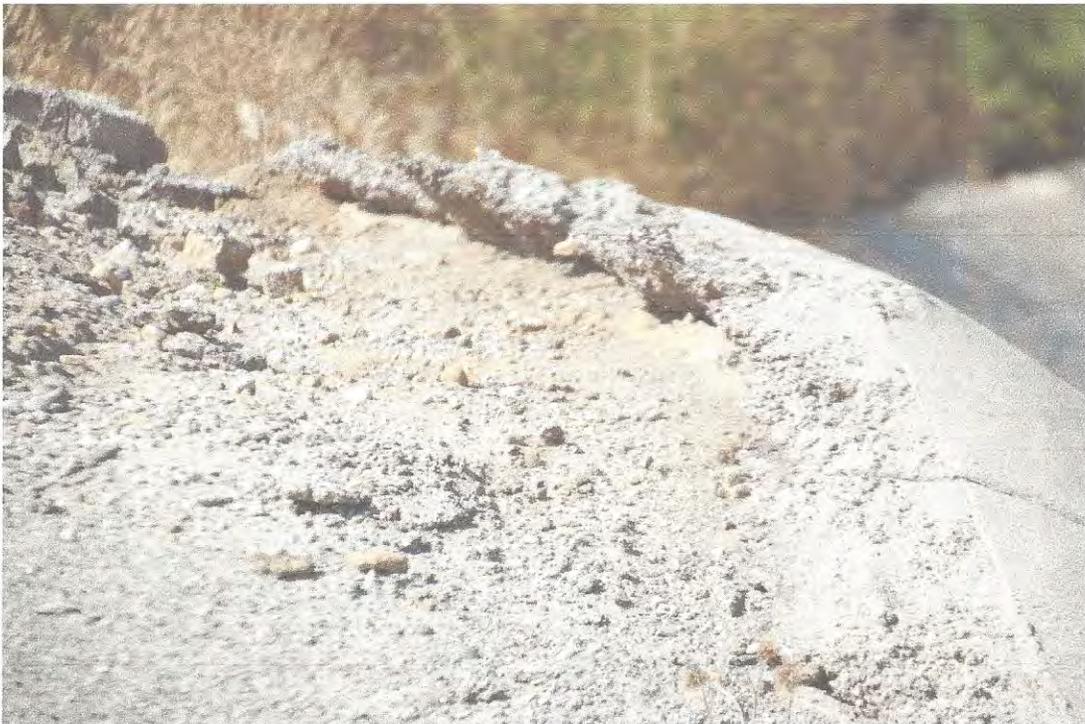
The high-flow spillway for Basin D into the westside drainage has cracks and spalling that should be repaired. The outlet riser that discharges into the eastside channel does not have top guards to restrict unauthorized access. The Basin B high-flow outlet spillway was cracked in multiple places. The terminal basin has vegetation growing in the interior concrete sidewalls.

Photo 6: Undermined concrete of spillway of southern half of Basin D

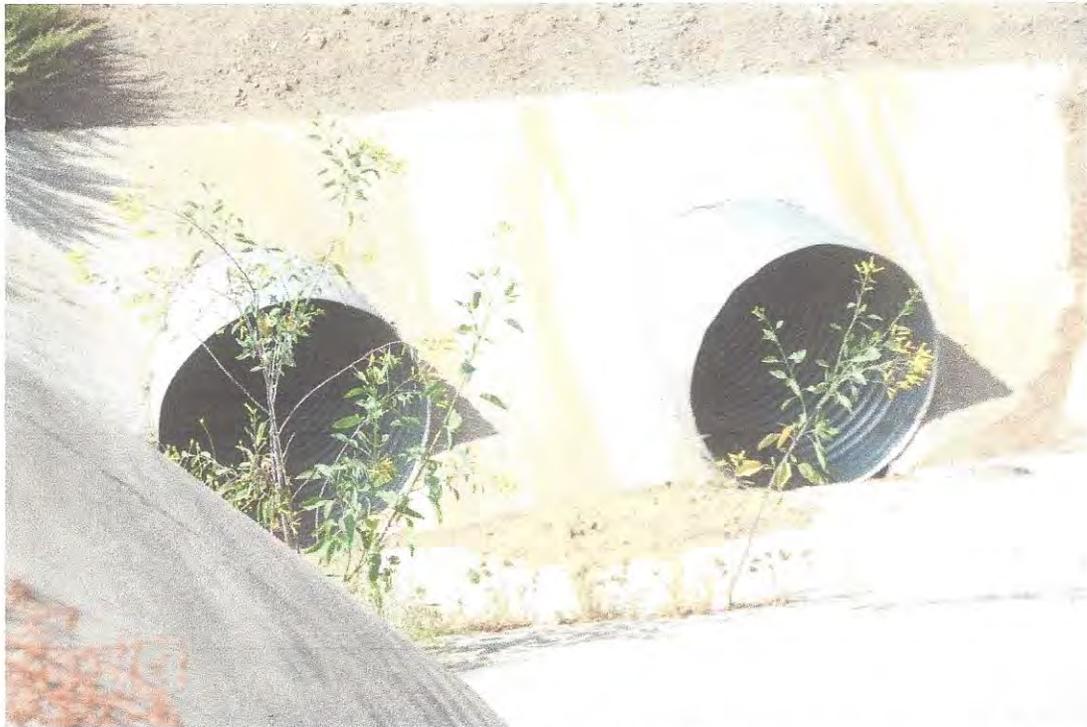
Photo 7: Vegetation growing in downstream side of concrete of spillway of southern half of Basin D

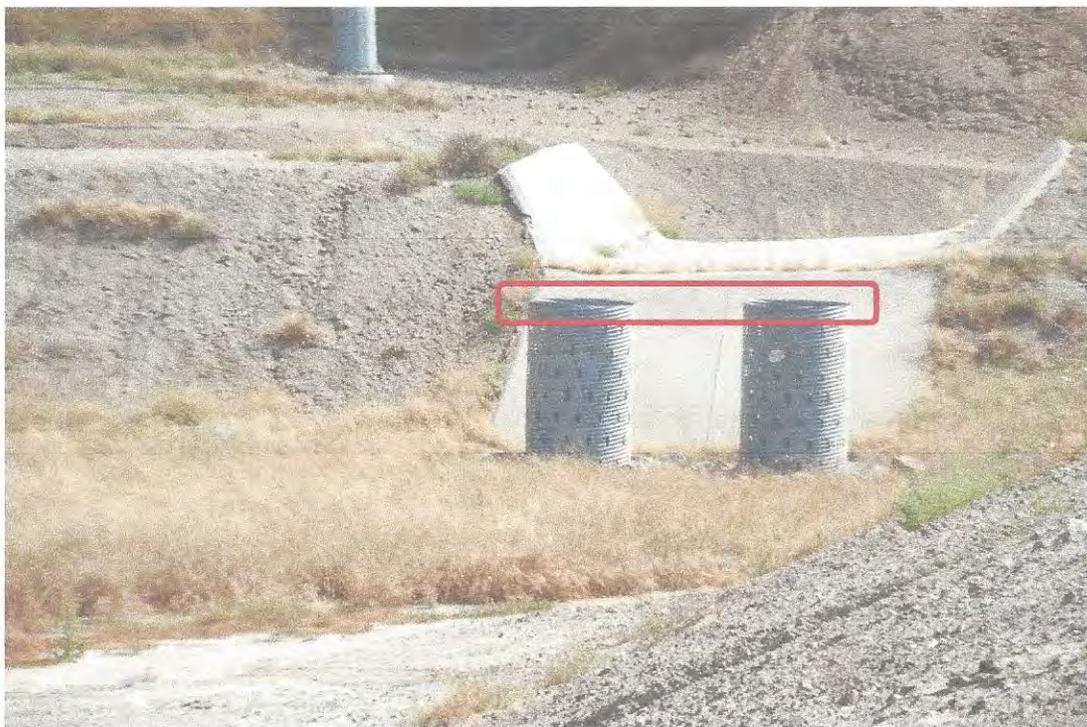
In early July, the Basin D outlet channel was repaired and is ready for winter rains. The concrete outlet structure had the vegetation removed, and cracks and soil erosion repaired. No personnel access limiting guard was on the northern riser.

Photo 8: Missing safety guard bars on top of decant towers at northern half of Basin D

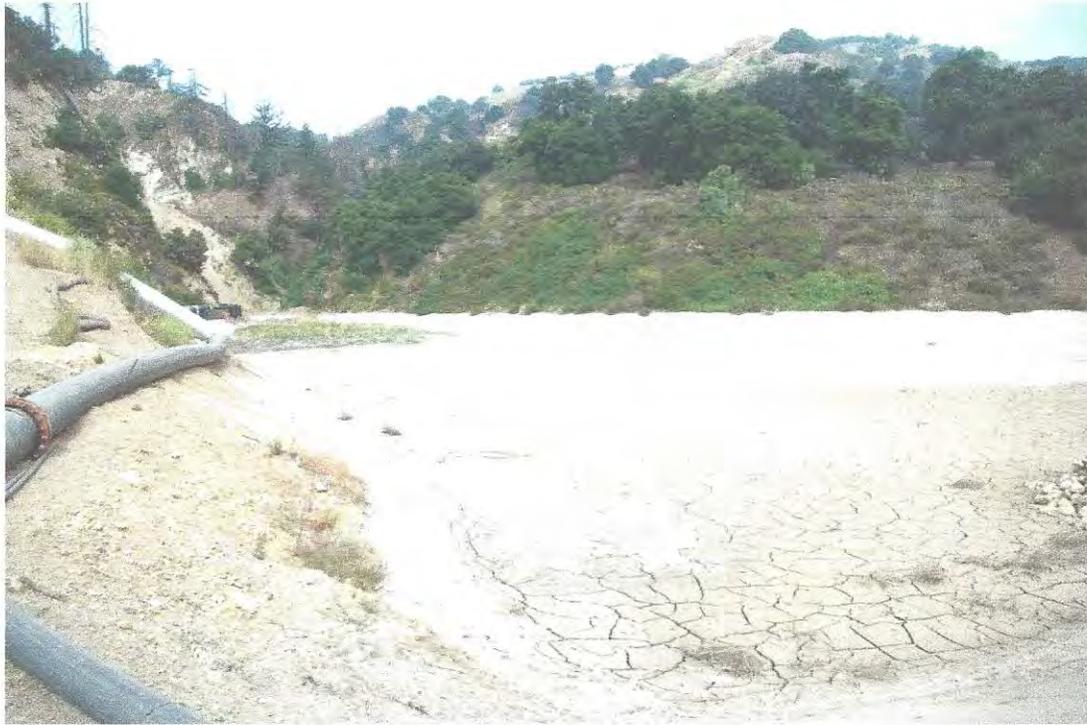
Photo 9: Sediment accumulation in Basin A

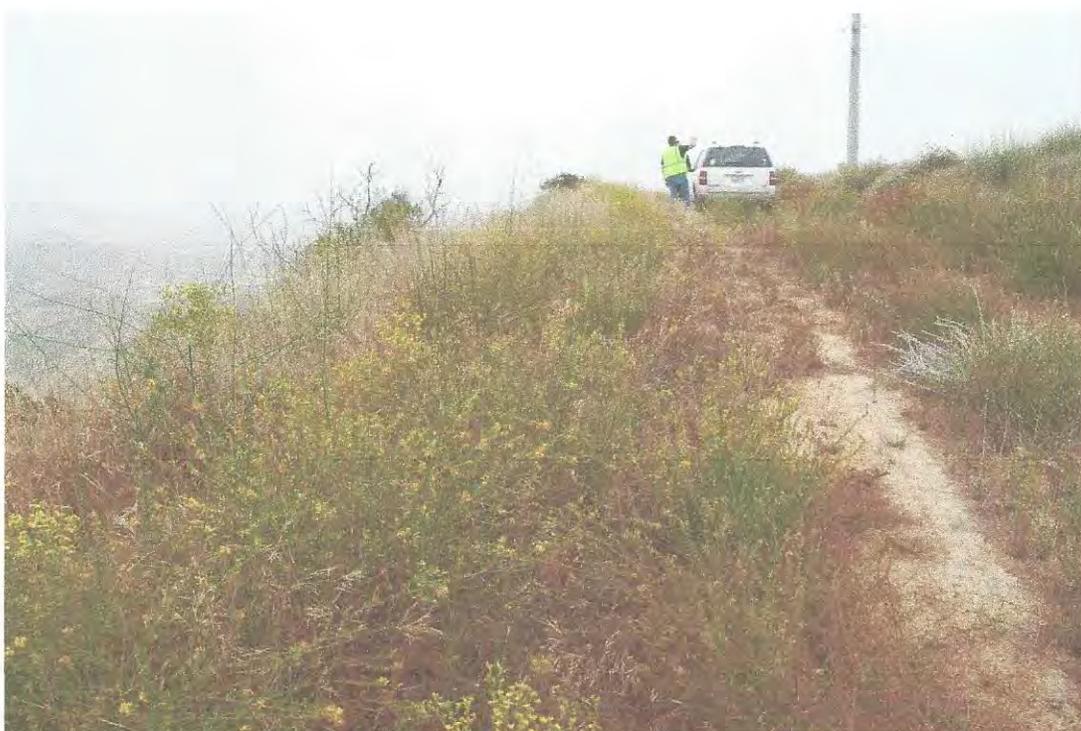
Current Status/Comments – The landfill was surveyed by the monitor for any impacts from the Ridgecrest earthquake, and no cracks, fissures, or land movement were observed. Republic had GLA Engineers inspect the landfill after the large earthquake and no site problems were observed.

Photo 16: Ridge on south edge of landfill – no fissures or cracks noticed

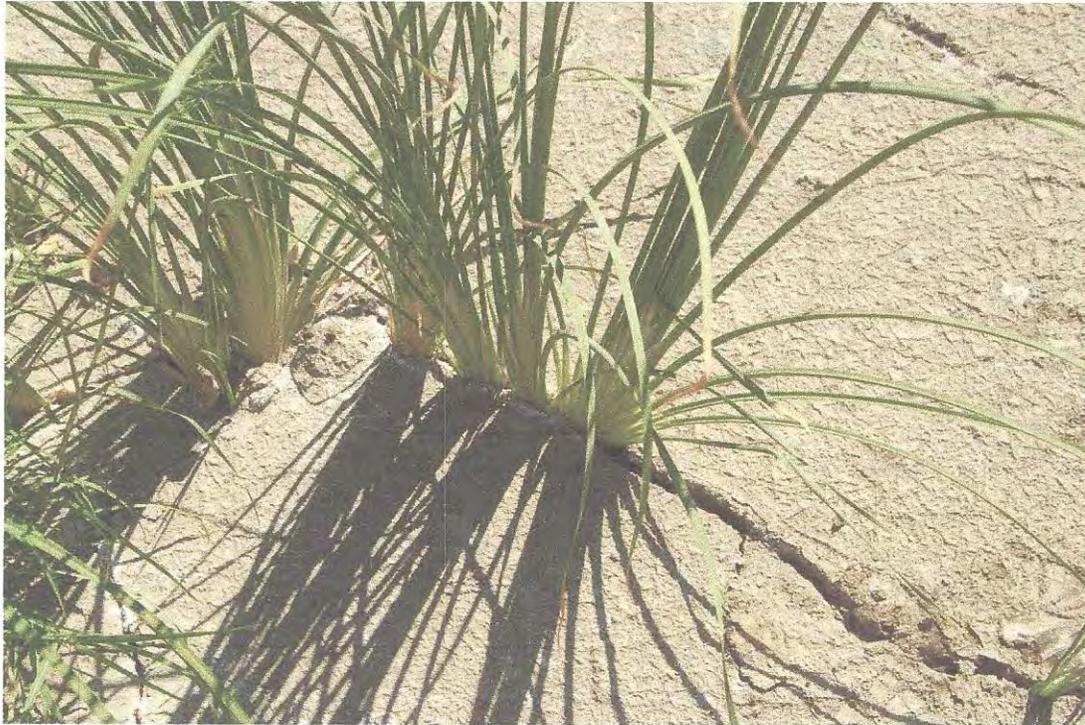
Photo 5: Vegetation growing in sediments at Terminal Basin

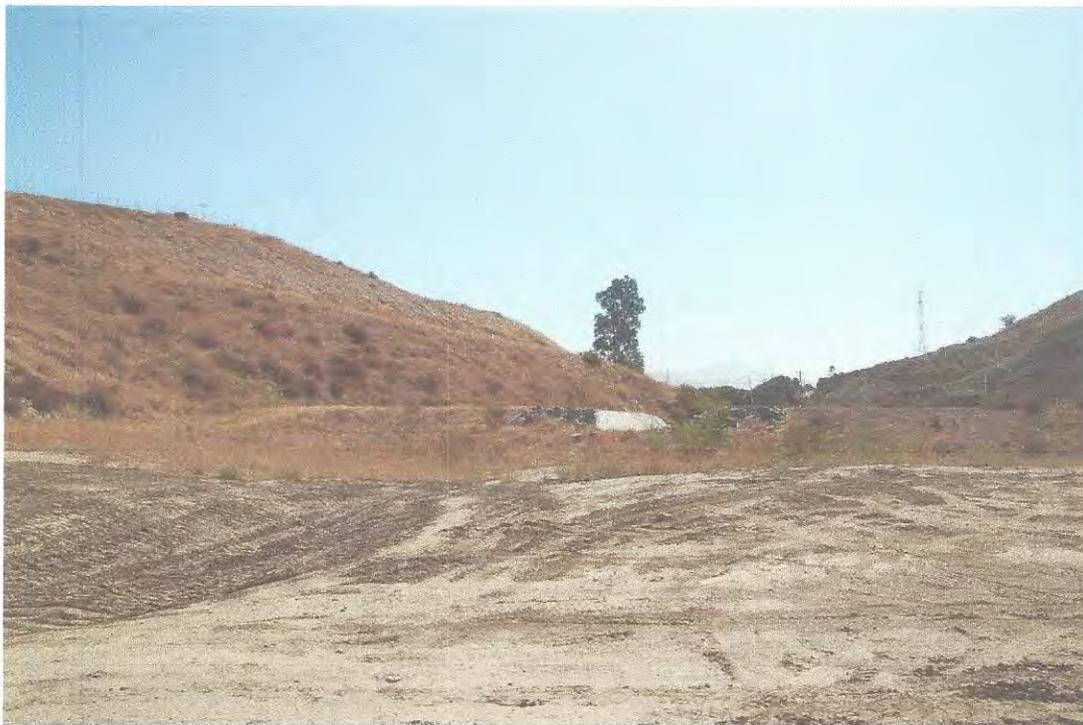
Photo 6: Reggraded erosion gully at basin at toe of Cell CC#

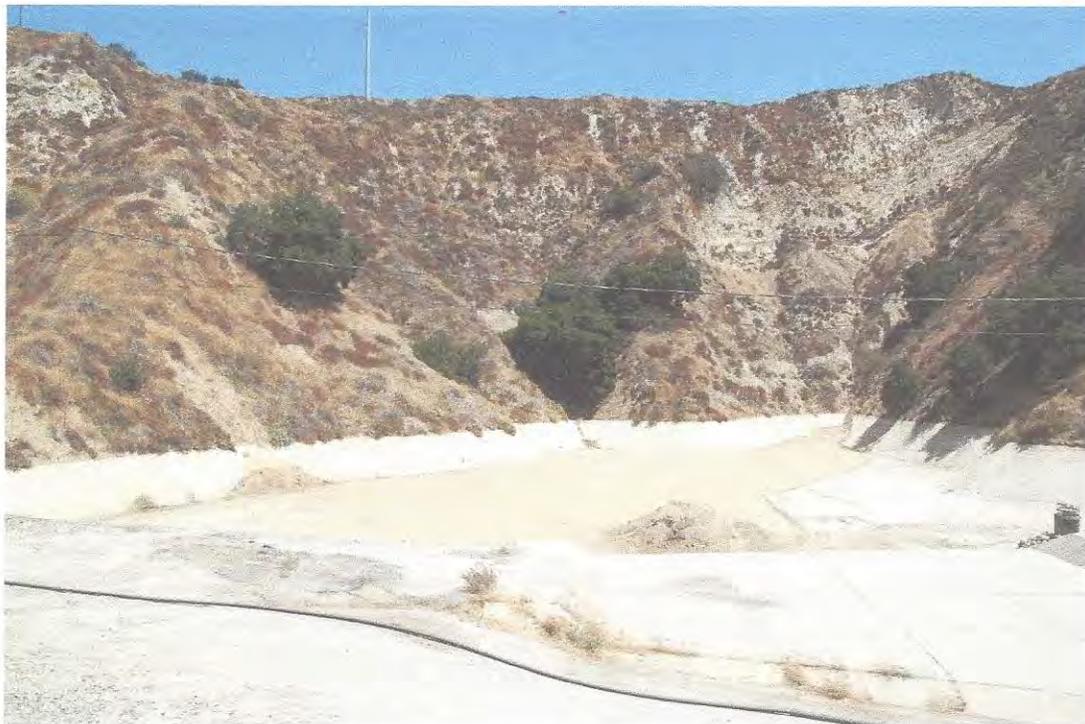
Photo 8: Sediment accumulation in Basin B

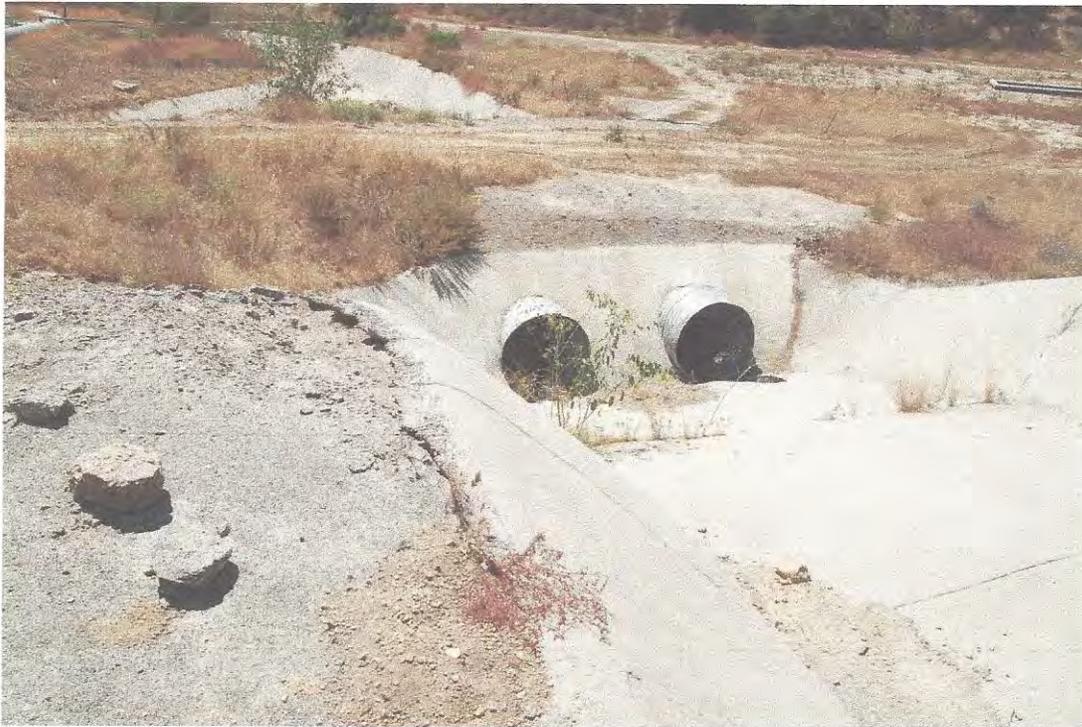
Photo 9: Erosion at contact between shotcrete of spillway and vegetation growing in spillway at southern half of Basin D

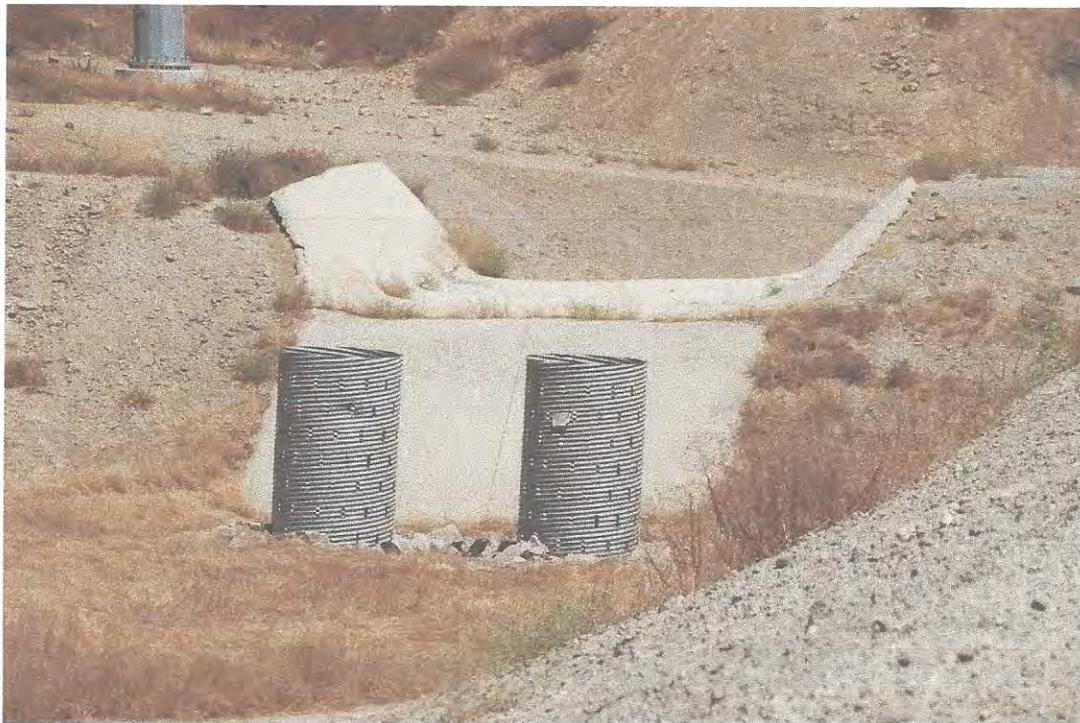
Photo 10: Missing safety guard bars on top of decant towers at northern half of Basin D

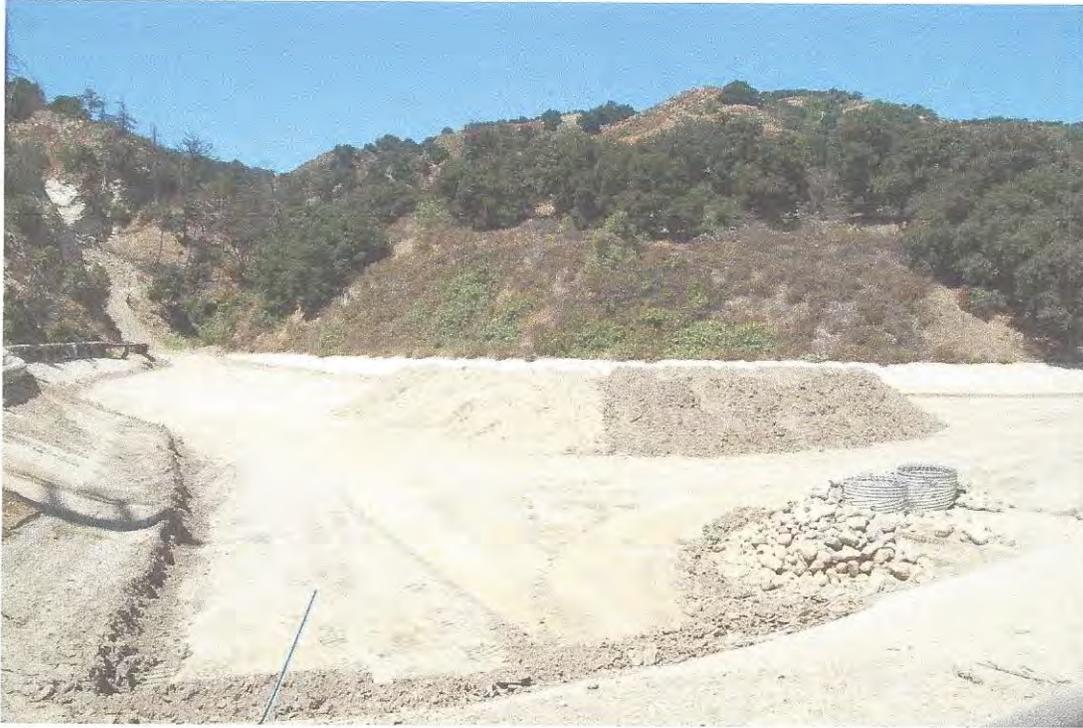
In late August, Basin A had sediment moved to the center of the basin for removal. Basin B had dry sediment moved to a pile ready for removal. The eastside drainage channel was cleaned to the Adler tank farm. Sediment, rock, and debris was not removed from the tank farm to the terminal basin. The terminal basin had the inlet water flow blocked by a dirt berm. Dry sediment was being removed. A significant amount of sediment from the gabion wall to the outlet risers had not been moved into piles to dry. The skimmer system has not yet been repaired.

Photo 11: Sediments stockpiled in Basin A
