**Sunshine Canyon Landfill  
Independent Monitor  
Quarterly Site Monitoring Status Report  
July 1, 2013 – September 30, 2013**

**City of Los Angeles Department of City Planning**

**County of Los Angeles Department of Regional Planning**

October 28, 2013

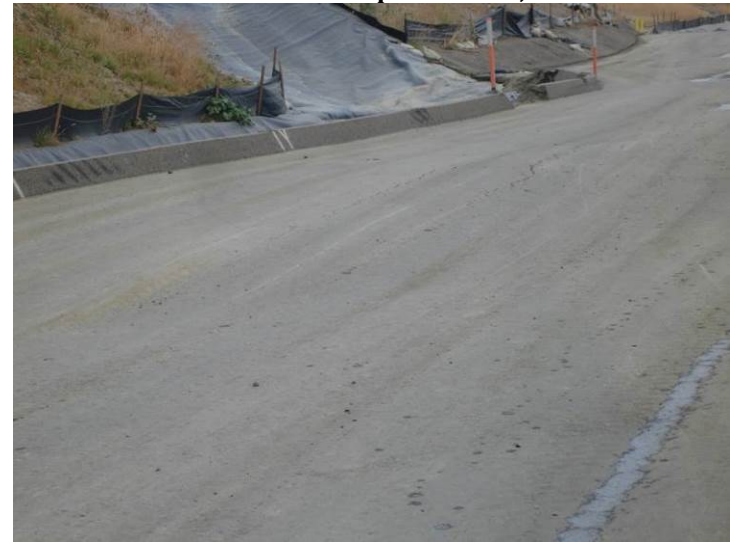
It was observed that the City south waste slope has fissures and cracks. A crack was also observed on the access road near this area. Some vertical offset at the crack and some horizontal offset at the roadway curb was seen. Also when driving in the area, one can feel a small depression. These conditions indicate some downward and outward movement. Cracks on the road and hillside and their potential impact should be addressed by Republic's geotechnical engineer.

**Photo 72: City South Entrance Road Crack: July 10, 2013**

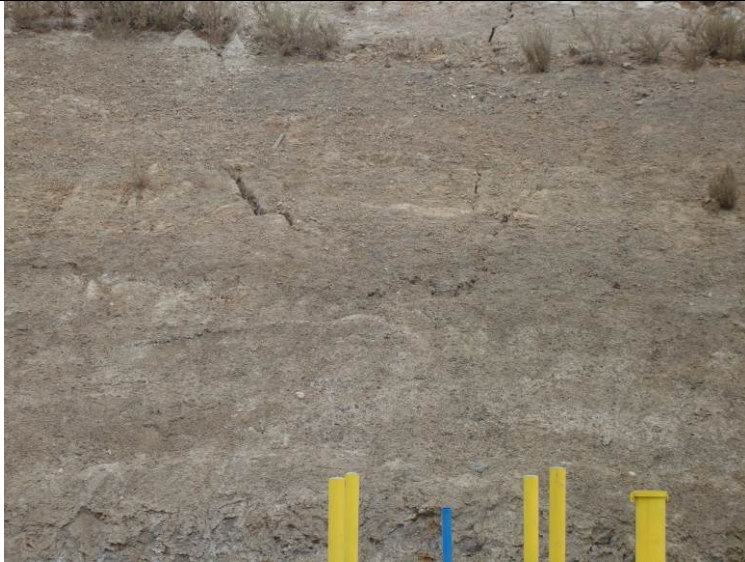
**Photo 73: City South Hillside Slope Crack: July 10, 2013**

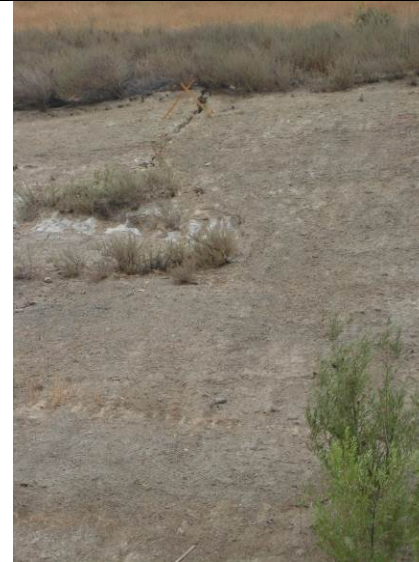
**Photo 74: City South Hillside Slope Crack: July 10, 2013**

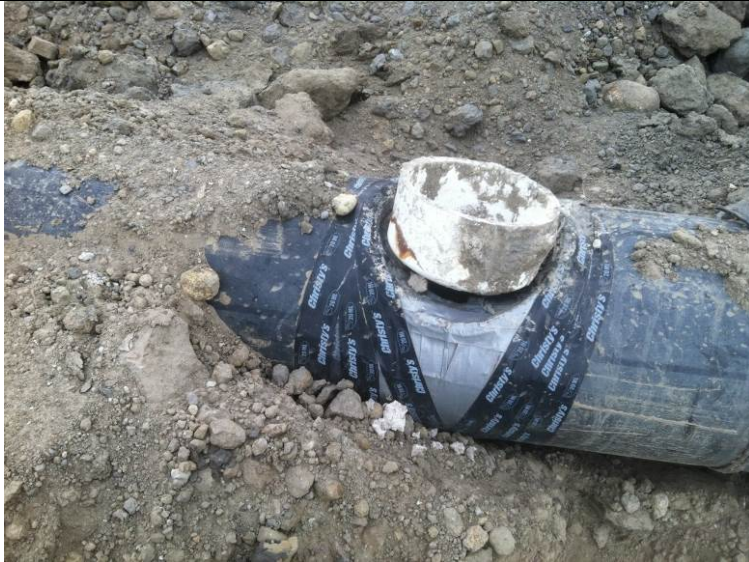
In July, a PVC cap on a tee in a header that was being worked on the County top deck was leaking gas. Republic was notified and a repair was directed to be made by the contractor.

**Photo 209: Head Pipeline Gas Collection Leaking:  
July 10, 2013**

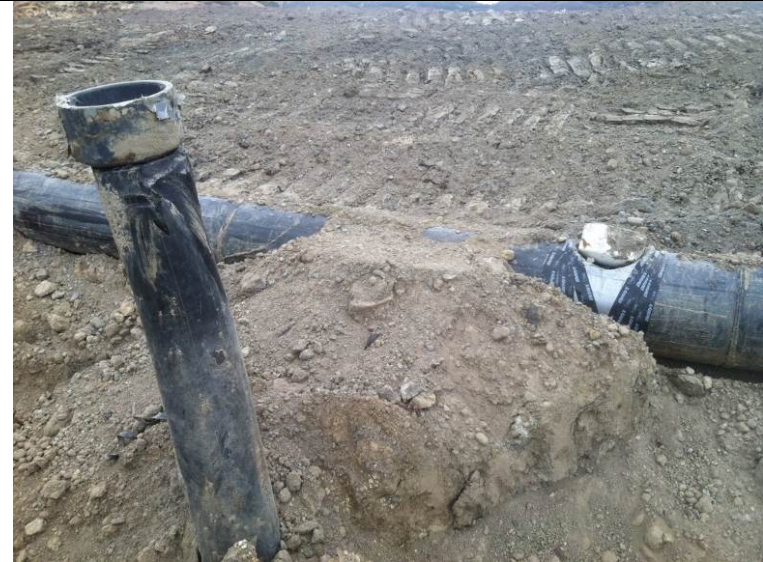
**Photo 210: PVC Cap: July 10, 2013**

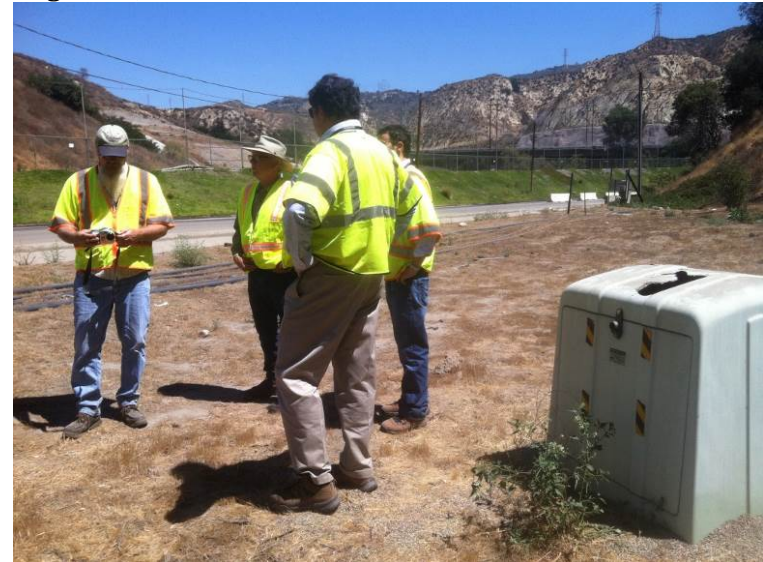
**Photo 223: Accelerometer: August 20, 2013**

**Current Status/Comments** – There is a ground motion mooring station installed at the toe of the City south landfill. In August, it was observed that the protective case was broken and the station may be at risk. Though monitoring the status of the station is not an item in the list of conditions to be monitored, its proper functioning could be helpful to the landfill in case of a seismic event to have site-specific ground motion data to assess the validity of current design parameters as

required by these conditions. This equipment was required by the county DPW for the County Landfill development. The equipment should be check and maintenance performed.

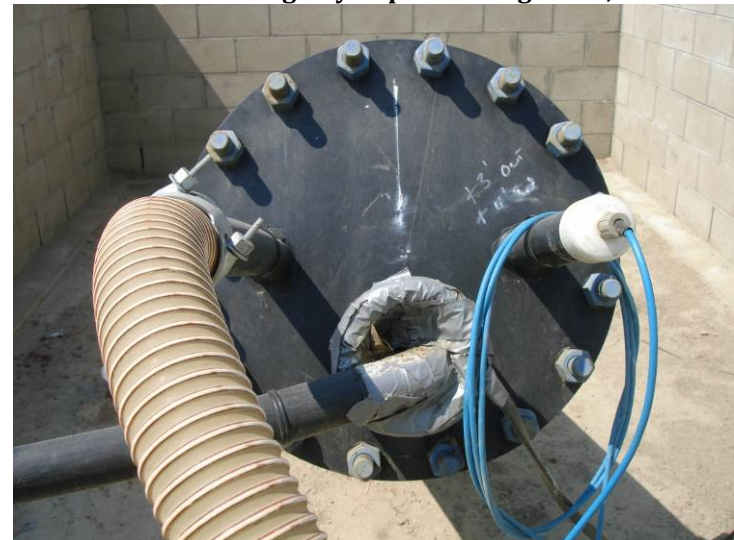
**Photo 228: Leachate Removal Sump Gas Leak: September 11, 2013**

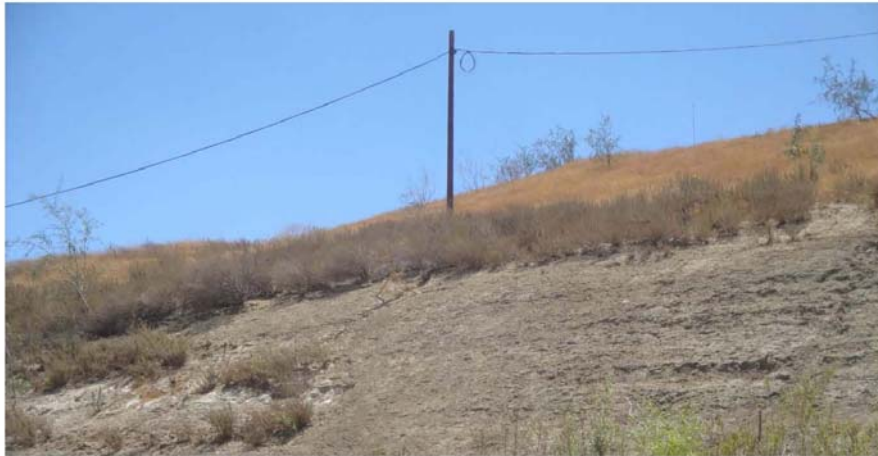
Monitor: Tarik Hadj-Hamou, Ph.D., P.E.	PAGE 2 OF 2
Discipline: Civil – Geotechnical	Date: August 20, 2013
Site Conditions: Sunny	
SITE LOG	
<p>Cell CC3 Phase II</p> <ul style="list-style-type: none"> <li>• The stability berm is in place (Photo 1)</li> <li>• The liner was installed over the berm and floor of the cell</li> <li>• The operation layer was being placed. We noted the use of the thick layer in the area where the dump truck rides. This extra thickness will lead to an acceptable stress level on the geosynthetics</li> </ul>	
<p>Geotechnical Issues</p> <ul style="list-style-type: none"> <li>• A crack was observed on the access road near the cell CC3 buttress (Photo 3). The photo shows some vertical offset at the crack and some horizontal offset of the concrete. Also when driving in the area one can feel a small depression. These indicia indicate some downward and outward movement</li> <li>• Fissures/cracks were also observed on the hillside (Photo 4)</li> </ul>

Photo 4: Crack on fill on hillside

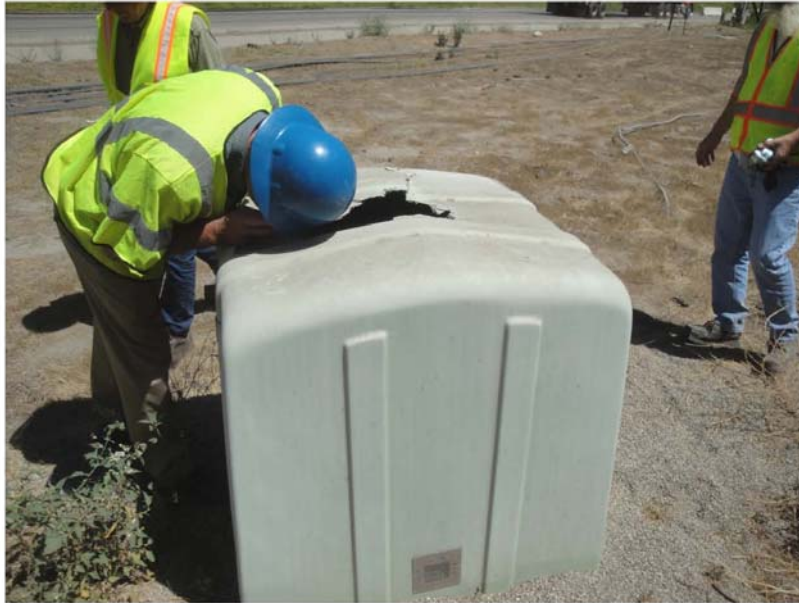
<p>Miscellaneous</p> <ul style="list-style-type: none"> <li>• There is a ground motion mooring station installed at the toe of the landfill (Photo 5). The protective case is broken and the station may be at risk. Though monitoring the status of station is not a item in the list of conditions, its proper functioning could be helpful to the landfill in case of a seismic event to have site specific ground motion to assess the validity of current design parameters</li> </ul>	
FURTHER REVIEW NEEDED	
COMMENTS	
Cracks on road and hillside and potential impact should be addressed by Republic Geotechnical engineer	
Signed:

Photo 5: Damaged protective case for ground motion monitoring station
