Asbestos and Lead-Based Paint Survey Report

Subject: Asbestos & Lead-Based Paint Re-Inspection
508 4th Street
Los Angeles, California 90021
Partner Project No. 19-247394.2

ASBESTOS & LEAD-BASED PAINT SURVEY REPORT

508 4TH STREET
LOS ANGELES, CALIFORNIA 90013

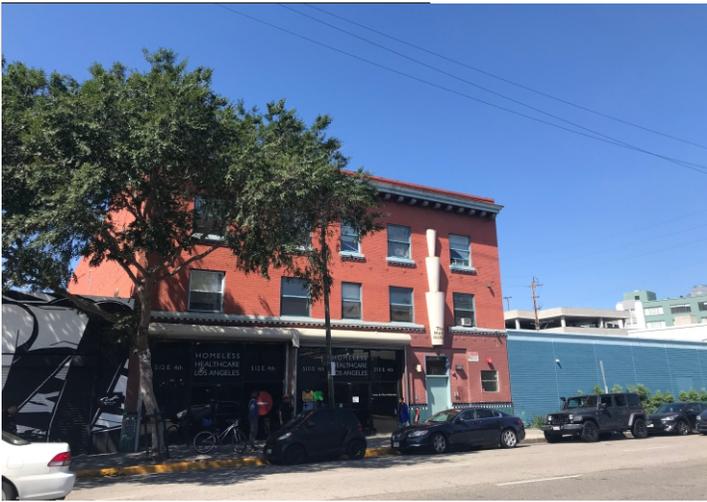
1. View of the exterior facade.

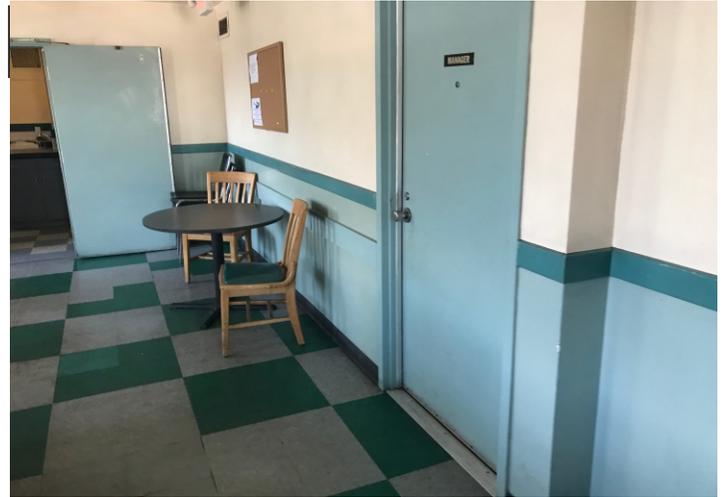
2. View of the blue and green vinyl flooring.

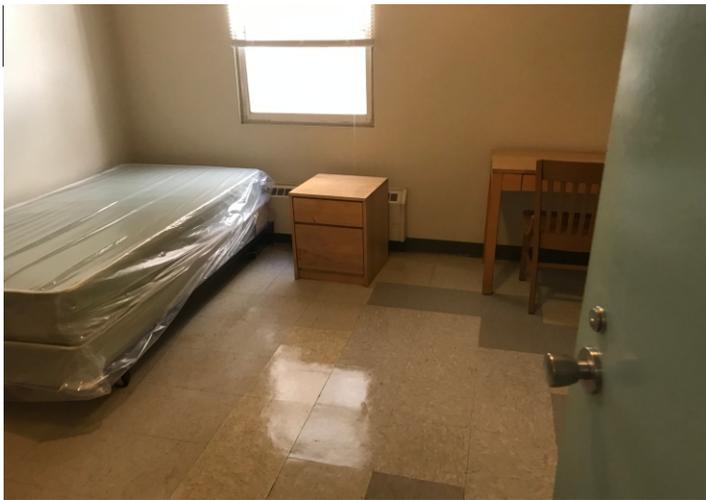
3. View of the unit interiors.

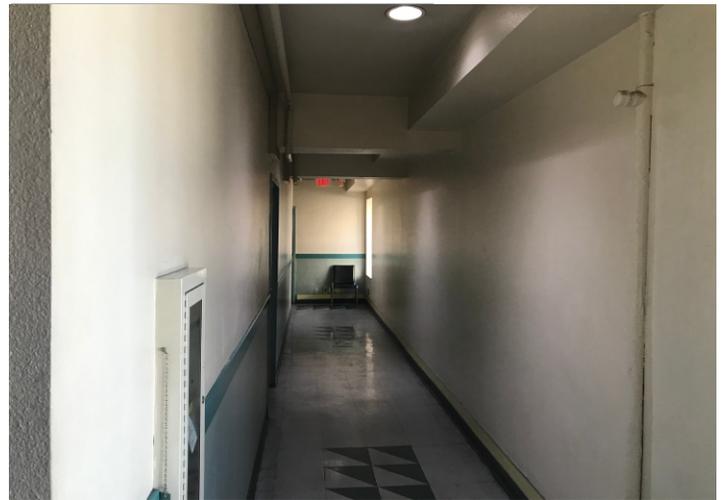
4. View of the interior hallways.

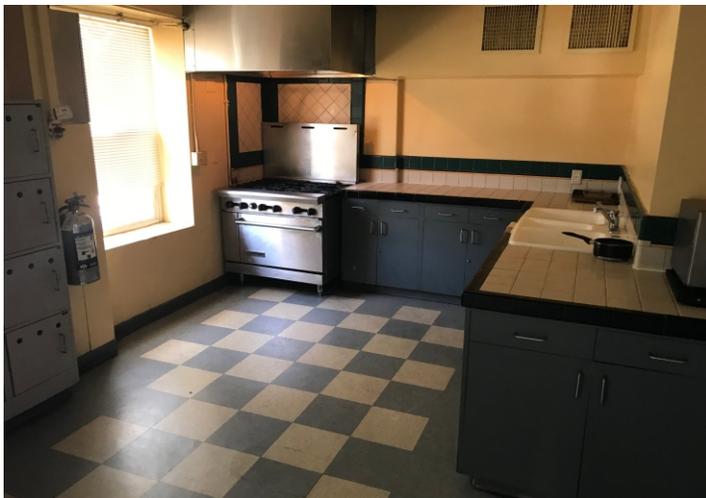
5. View of the kitchen interior.

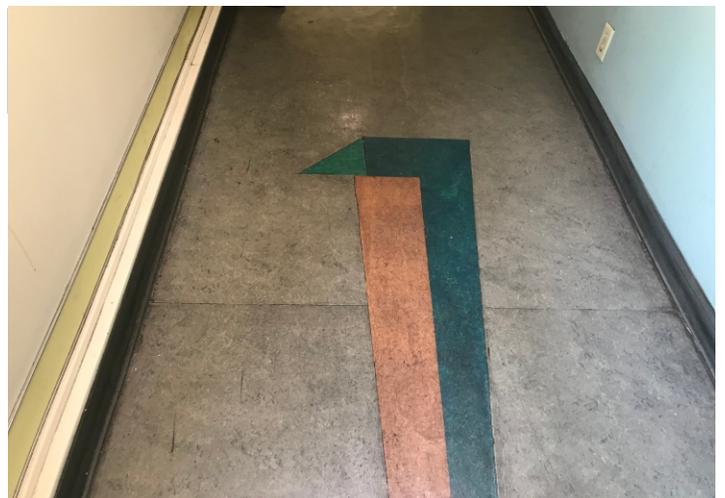
6. View of the hallway flooring.

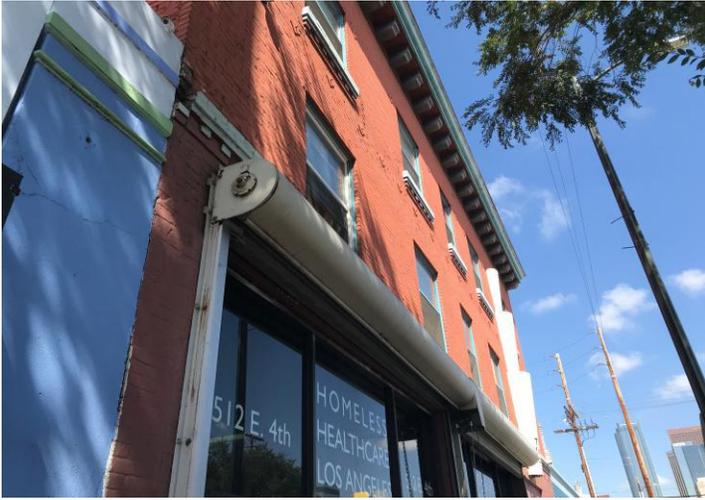
1. View of the exterior facade.

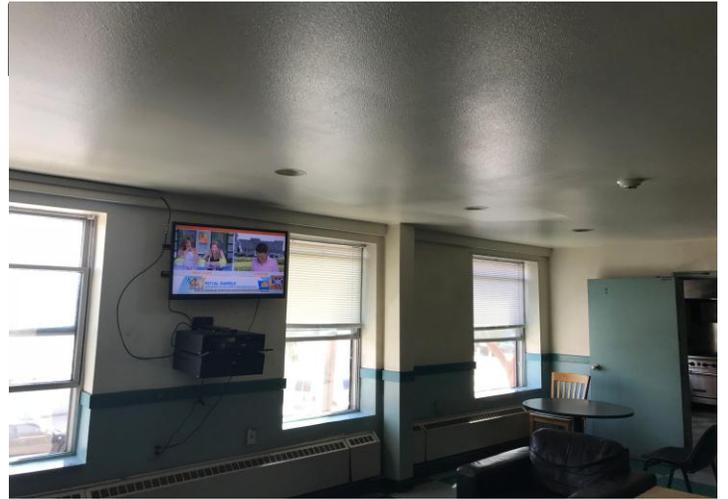
2. View of the interior drywall walls & ceilings.

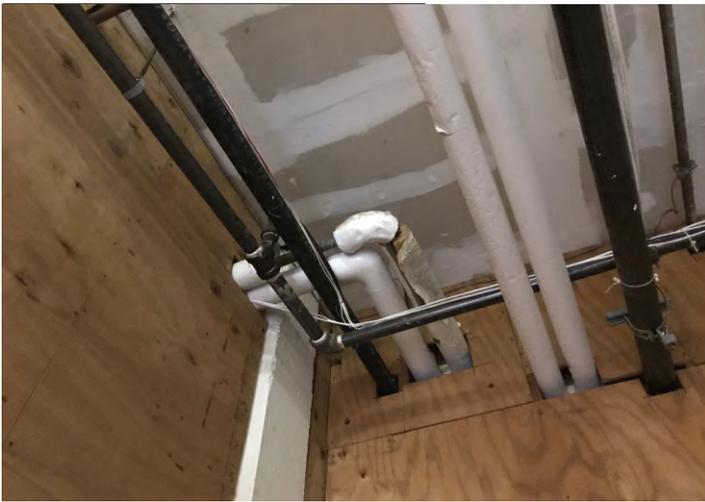
3. View of the fiberglass pipe insulation.

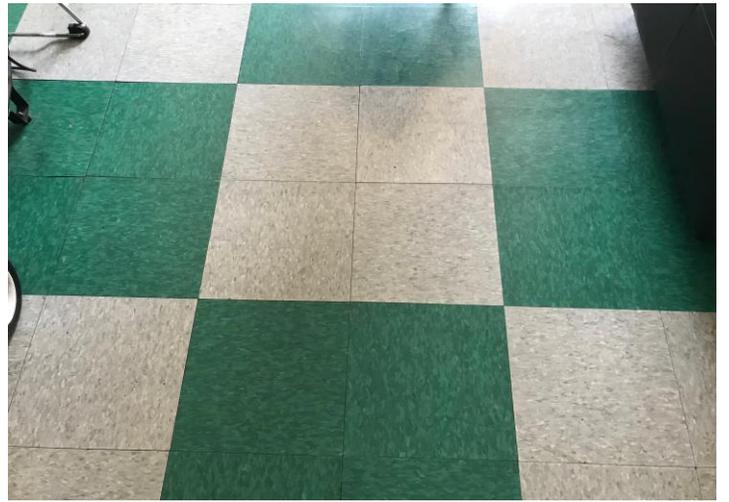
4. View of the grey and green 12x12 vinyl floor tile.

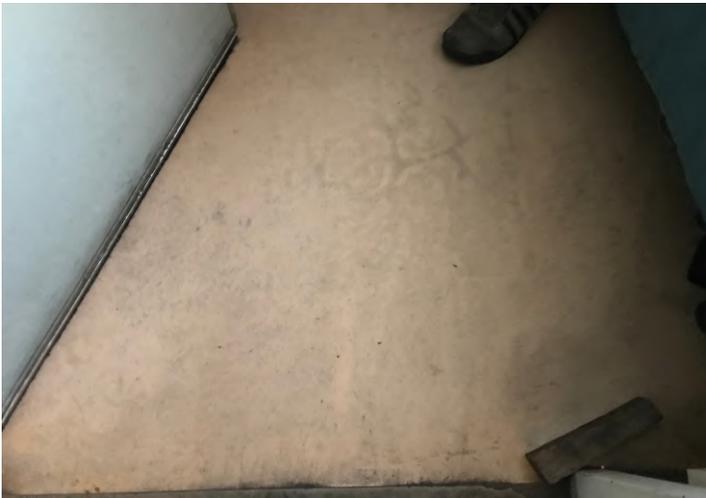
5. View of the beige sheet vinyl flooring.

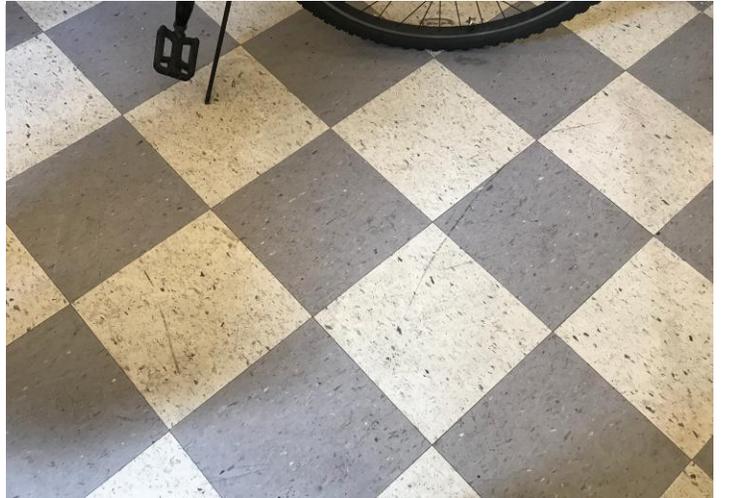
6. View of the white and grey 12x12 vinyl floor tile.
