**TREE REPORT**

**3600 Wilshire Blvd.  
Los Angeles, CA 90010**

Prepared by  
**Harmony Gardens, Inc.**  
12224 Addison Street  
Valley Village, CA 91607  
Phone (818) 505-9783  
Shelley Sparks, RLA # 2896, ASLA  
ISA Certified Arborist #WE-10883A

Revised October 24, 2018

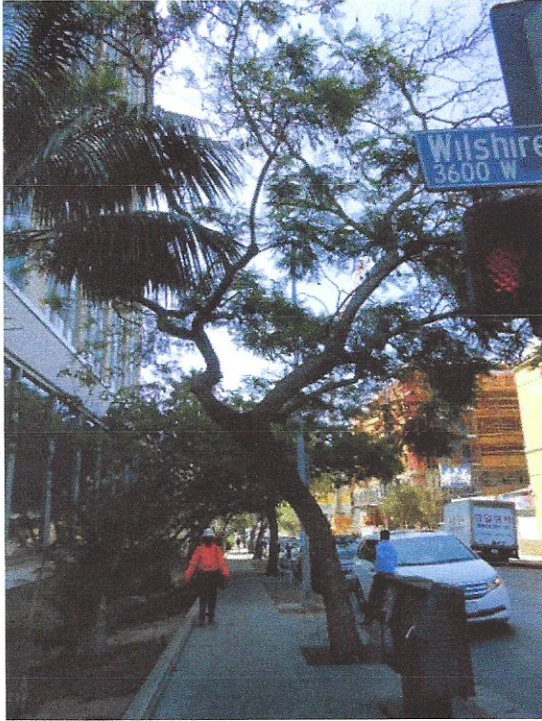
Tree 1 is *Jacaranda mimosifolia*, Jacaranda, in fair condition due to trunk canker, with a caliper of 12", standing 23' high by 20' wide. This tree is scheduled to remain, however, should it require removal, contact Urban Forestry Division for replacement value as it is a STREET TREE.

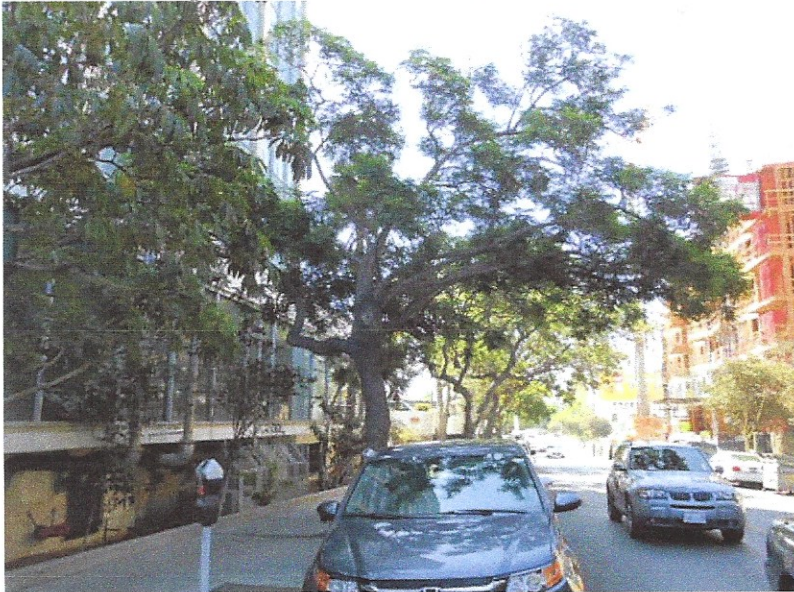
Tree 2 is *Jacaranda mimosifolia*, Jacaranda, in good condition even though it has physical bark damage, with a caliper of 11", standing 23' high by 21' wide. This tree is scheduled to remain, however, should it require removal, contact Urban Forestry Division for replacement value as it is a STREET TREE.

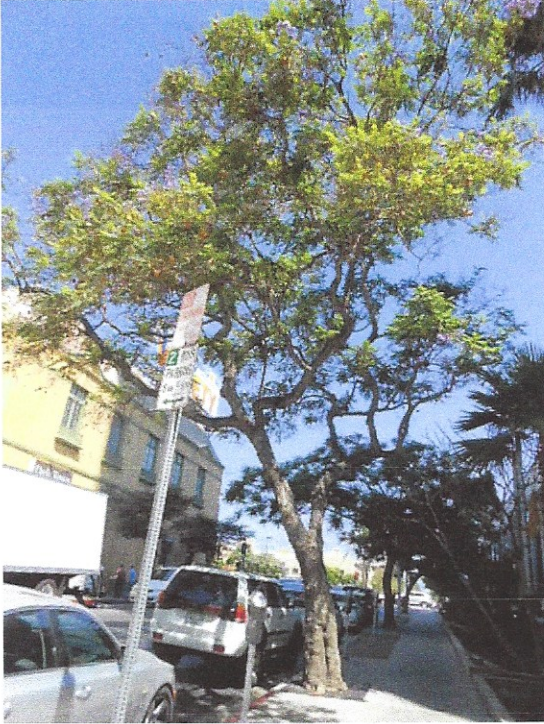
Tree 3 is *Jacaranda mimisifolia*, Jacaranda, in good condition despite trunk canker and branch dieback, with a caliper of 14", standing 26' high by 20' wide. This tree is scheduled to remain, however, should it require removal, contact Urban Forestry Division for replacement value as it is a STREET TREE.

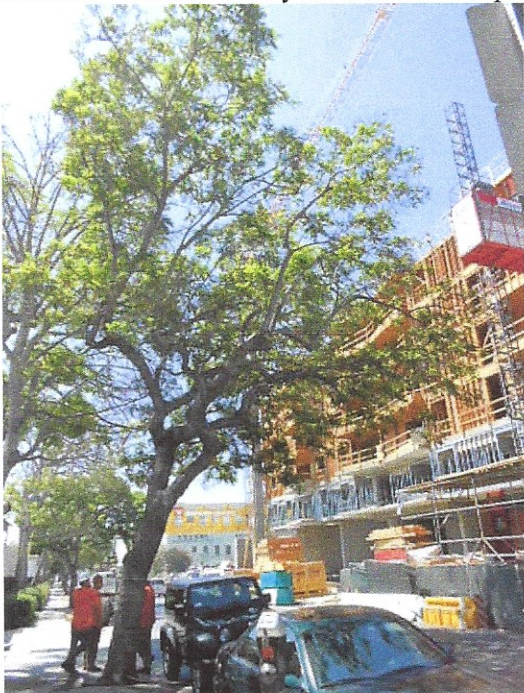
Tree 4 is *Jacaranda mimisifolia*, Jacaranda, in good condition despite lifting pavement and some trunk canker with a caliper of 14", standing 34' high by 20' wide. This tree is scheduled to remain, however, should it require removal, contact Urban Forestry Division for replacement value as it is a STREET TREE.

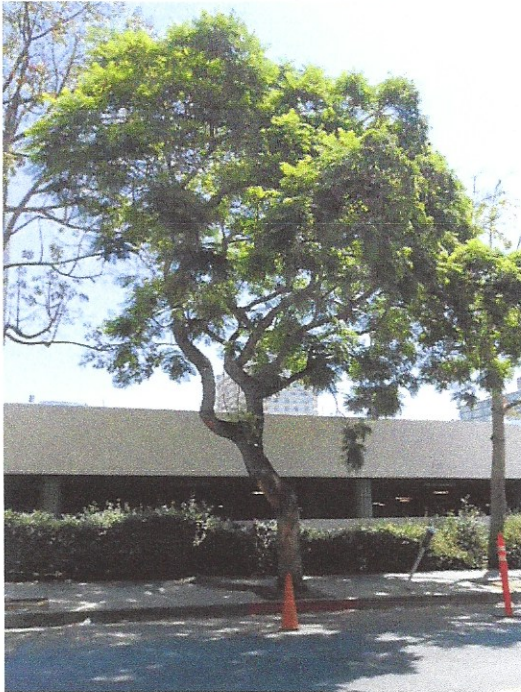
Tree 5 is *Jacaranda mimosifolia*, Jacaranda, in fair condition due to trunk canker with a caliper of 15", standing 26' high by 20' wide. This tree is scheduled to remain, however, should it require removal, contact Urban Forestry Division for replacement value as it is a STREET TREE.

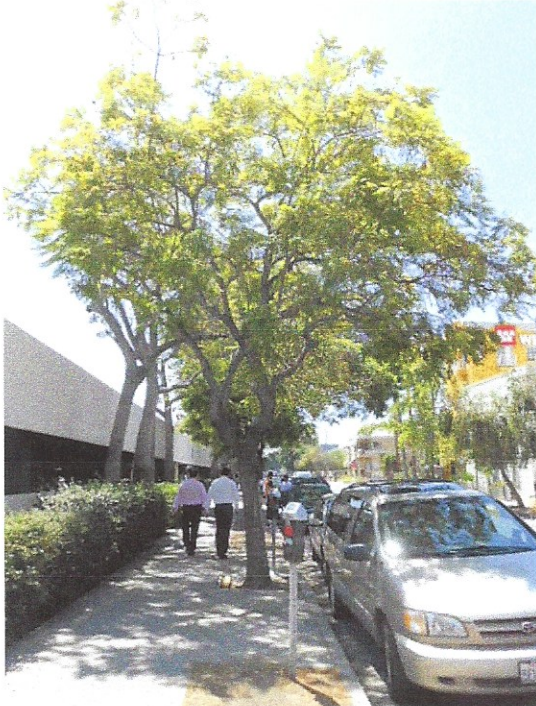
Tree 6 is *Jacaranda mimosifolia*, Jacaranda, in good condition despite some trunk and branch canker with a caliper of 10", standing 22' high by 21' wide. This tree is scheduled to remain, however, should it require removal, contact Urban Forestry Division for replacement value as it is a STREET TREE.

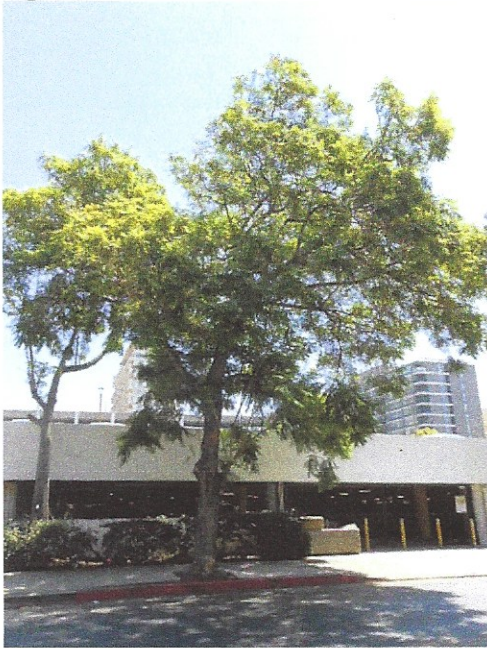
Tree 7 is *Jacaranda mimosifolia*, Jacaranda, in poor condition due to fungus and dieback with a caliper of 17", standing 25' high by 25' wide. This tree is scheduled to remain, however, should it require removal, contact Urban Forestry Division for replacement value as it is a STREET TREE.

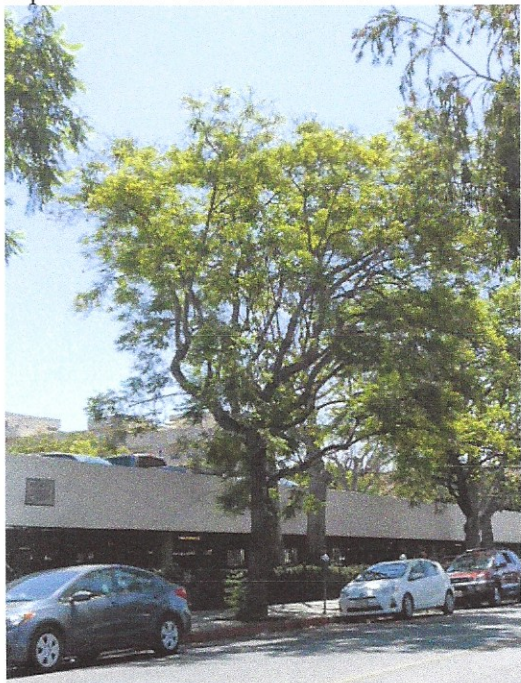
Tree 8 is *Jacaranda mimosifolia*, Jacaranda, in good condition despite some trunk damage with a caliper of 20", standing 24' high by 22' wide. This tree is scheduled to be removed so it will be necessary to contact Urban Forestry Division for replacement value as it is a STREET TREE.

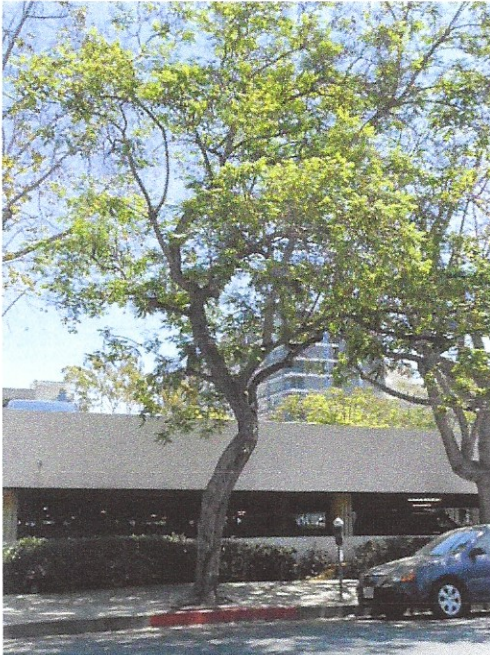
Tree 9 is *Jacaranda mimosifolia*, Jacaranda, in good condition with a caliper of 15", standing 26' high by 18' wide. This tree is scheduled to remain, however, should it need removal, contact Urban Forestry Division for replacement value as it is a STREET TREE.

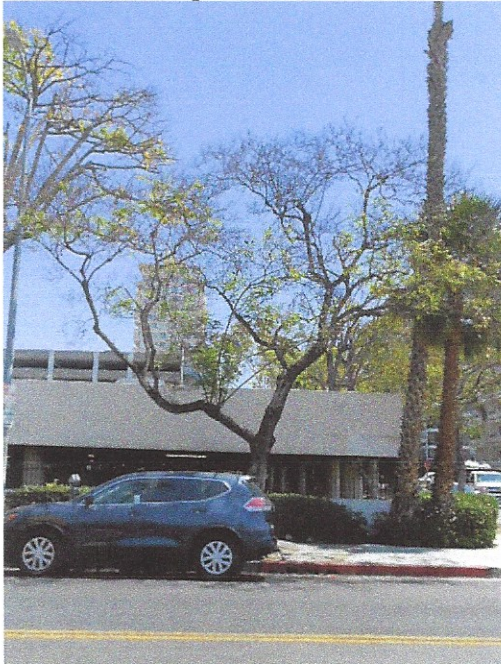
Tree 10 is *Jacaranda mimosifolia*, Jacaranda, in poor condition due to major dieback and canker with a caliper of 12", standing 19' high by 17' wide. This tree is scheduled to remain, however, should it require removal, contact Urban Forestry Division for replacement value as it is a STREET TREE.

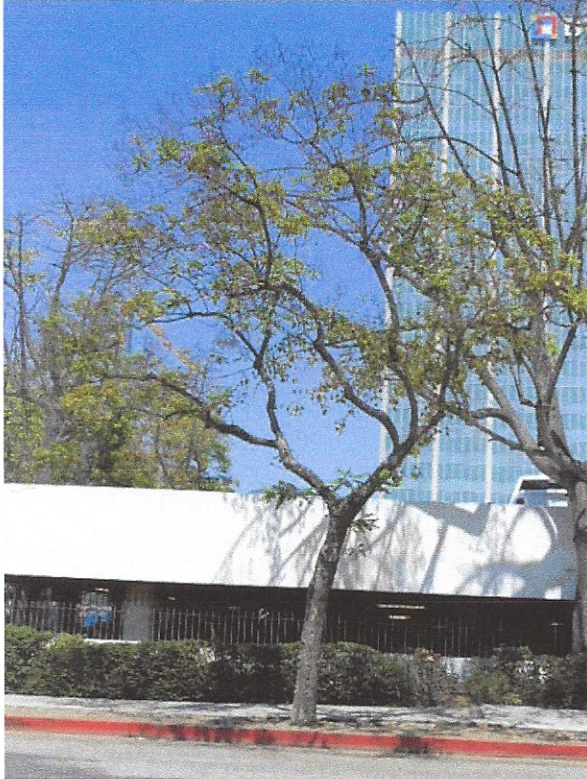
Tree 11 is *Jacaranda mimosifolia*, Jacaranda, in fair condition due to moderately severe dieback with a caliper of 9", standing 21' high by 12' wide. This tree is scheduled to remain, however, should it require removal, contact Urban Forestry Division for replacement value as it is a STREET TREE.

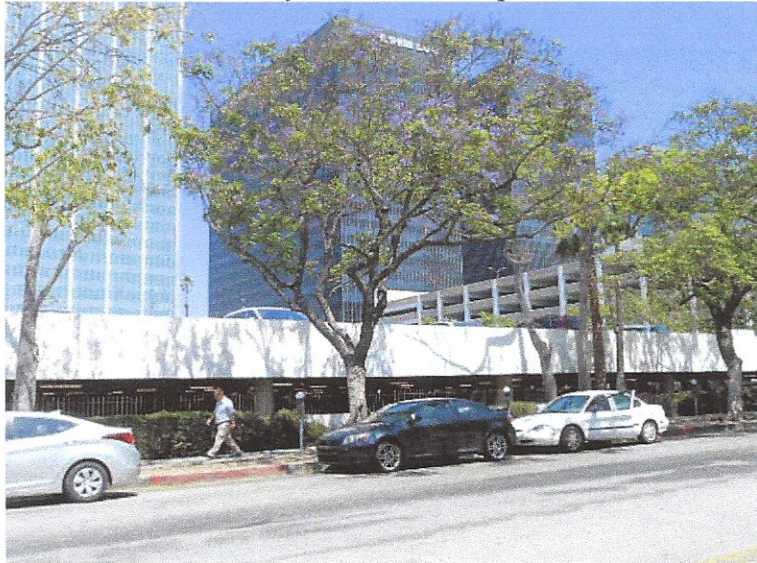
Tree 12 is *Jacaranda mimosifolia*, Jacaranda, in fair condition due to trunk canker, dieback, trunk damage and girdling roots with a caliper of 13", standing 25' high by 20' wide. This tree is scheduled to remain, however, should it require removal, contact Urban Forestry Division for replacement value as it is a STREET TREE.

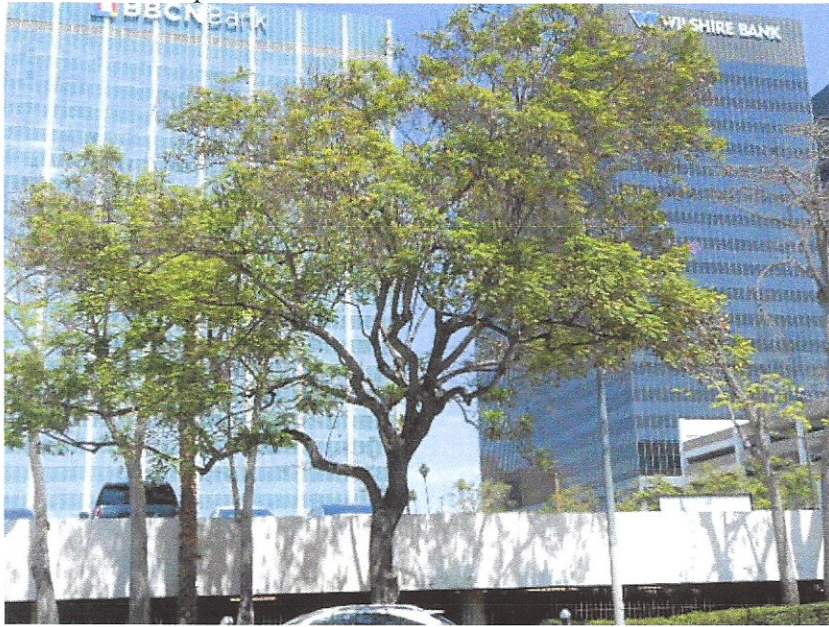
Tree 13 is *Jacaranda mimosifolia*, Jacaranda, in good condition despite slight dieback and canker. This tree has a caliper of 15", standing 30' high by 22' wide. This tree is scheduled to remain, however, should it require removal, contact Urban Forestry Division for replacement value as it is a STREET TREE.

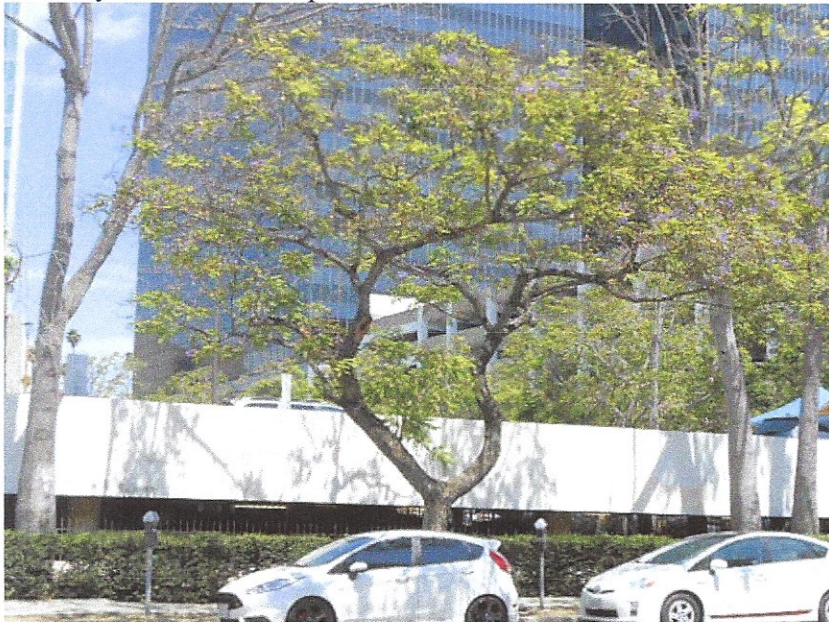
Tree 14 is *Jacaranda mimosifolia*, Jacaranda, in poor condition due to codominant stems that have a severe crack at the crotch that could lead to a hazard. This tree has moderate dieback and canker with a caliper of 12", standing 20' high by 18' wide. This tree is scheduled to remain, however, should it require removal, contact Urban Forestry Division for replacement value as it is a STREET TREE.

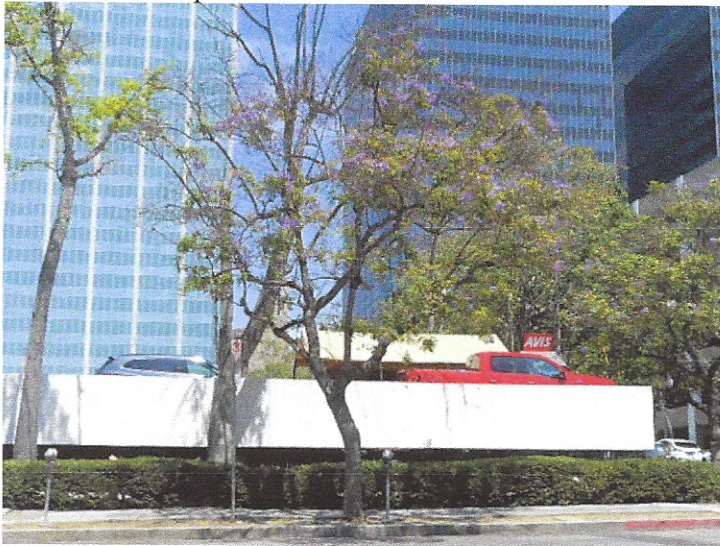
Tree 15 is *Jacaranda mimosifolia*, Jacaranda, in fair condition due to moderate dieback and canker with a caliper of 11", standing 22' high by 13' wide. This tree is scheduled to remain, however, should it require removal, contact Urban Forestry Division for replacement value as it is a STREET TREE.

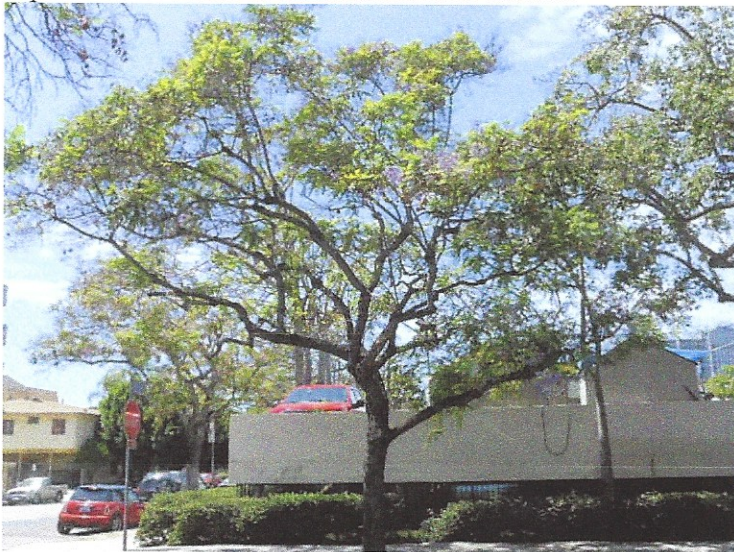
Tree 16 is *Jacaranda mimosifolia*, Jacaranda, in good to fair condition due to canker with a caliper of 12", standing 24' high by 22' wide. This tree is scheduled to remain, however, should it require removal, contact Urban Forestry Division for replacement value as it is a STREET TREE.

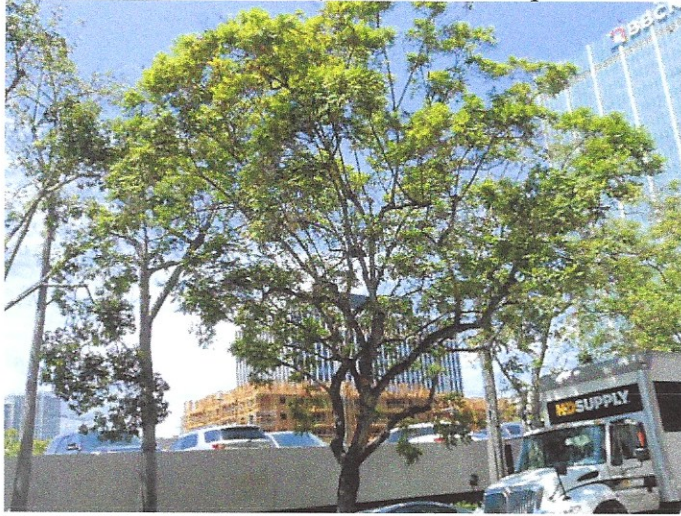
Tree 17 is *Jacaranda mimosifolia*, Jacaranda, in good condition with a caliper of 13", standing 30' high by 25' wide. This tree is scheduled to be removed so it is necessary to contact Urban Forestry Division for replacement value as it is a STREET TREE.

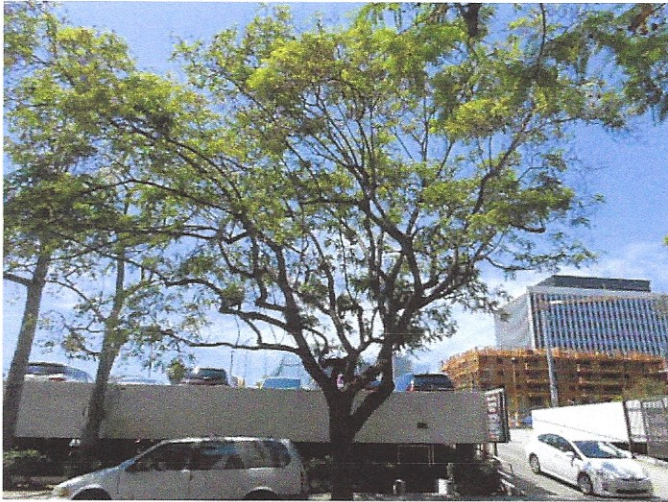
Tree 18 is *Jacaranda mimosifolia*, Jacaranda, in good to fair condition due to canker and trunk damage, with a caliper of 19", standing 29' high by 29' wide. This tree is scheduled to be removed so it is necessary to contact Urban Forestry Division for replacement value as it is a STREET TREE.

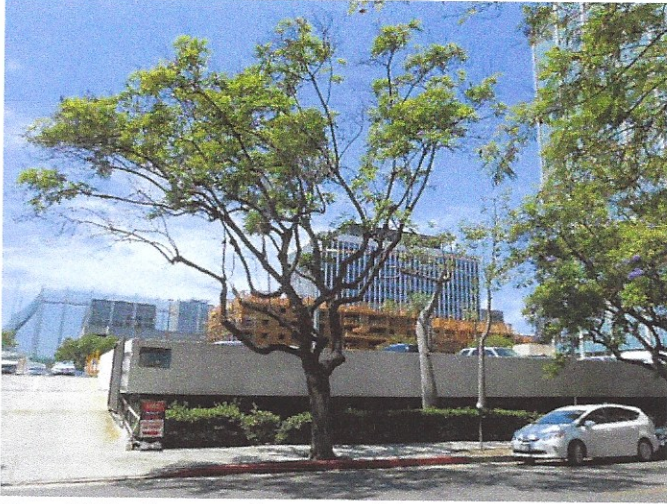
Tree 19 is *Jacaranda mimosifolia*, Jacaranda, in fair condition due to dieback and canker with a caliper of 18", standing 24' high by 20' wide. This tree is scheduled to remain, however, should it require removal, contact Urban Forestry Division for replacement value as it is a STREET TREE.

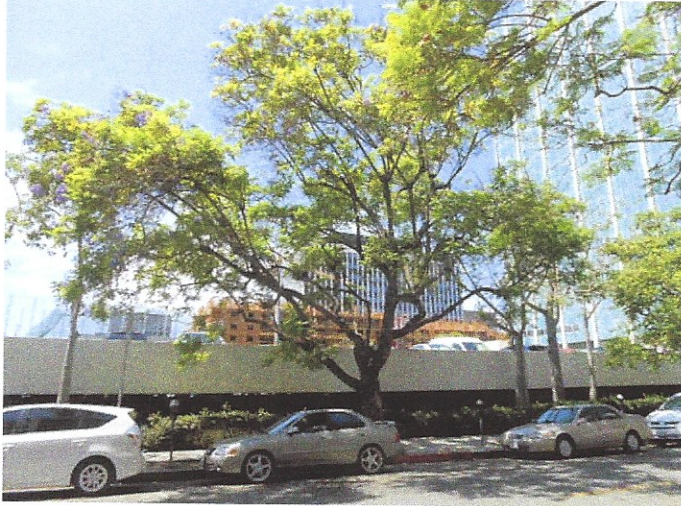
Tree 20 is *Jacaranda mimosifolia*, Jacaranda, in fair condition due to trunk damage, dieback and canker with a caliper of 17", standing 26' high by 31' wide. This tree is scheduled to remain, however, should this tree need removal, contact Urban Forestry Division for replacement value as it is a STREET TREE.

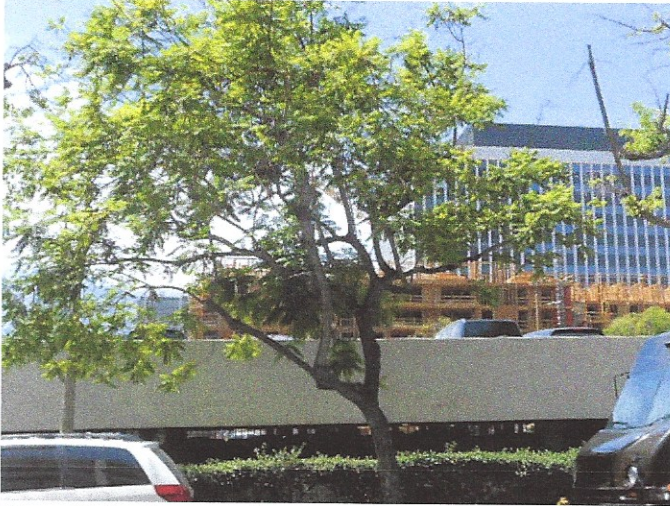
Tree 21 is *Jacaranda mimosifolia*, Jacaranda, in fair condition due to canker with a caliper of 10", standing 19' high by 15' wide. This tree is scheduled to remain, however, should it require removal, contact Urban Forestry Division for replacement value as it is a STREET TREE.

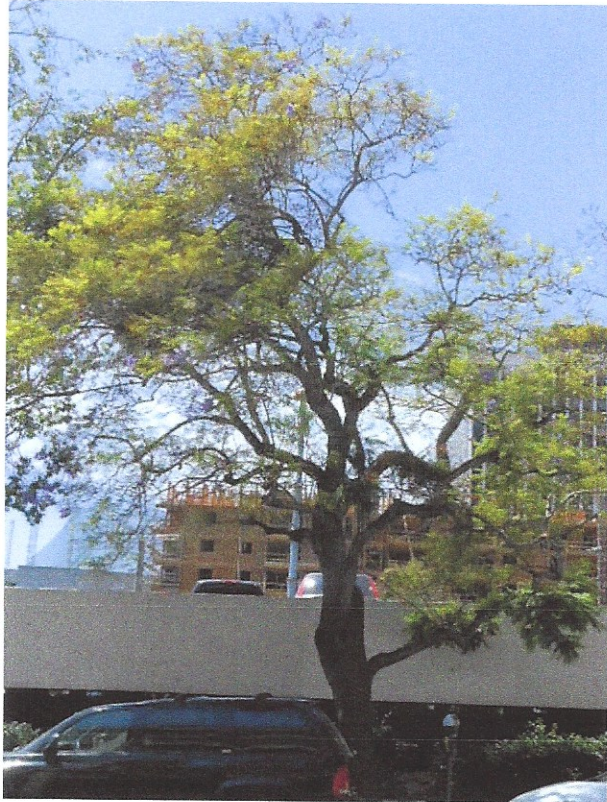
Tree 22 is *Jacaranda mimosifolia*, Jacaranda, in good condition with a caliper of 16", standing 20' high by 18' wide. This tree is scheduled to remain, however, should it require removal, contact Urban Forestry Division for replacement value as it is a STREET TREE.

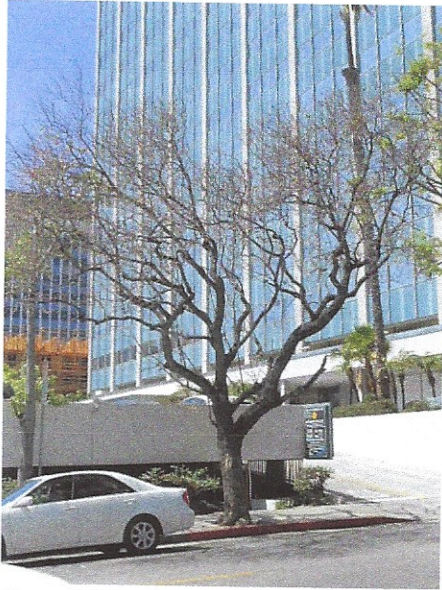
Tree 23 is a dead tree in the street tree well and should be removed to prevent a hazard. This tree is in the way of a future driveway so it will not be replaced and requires no replacement value. This situation should be reviewed with Urban Forestry Division when the other removals are reviewed.

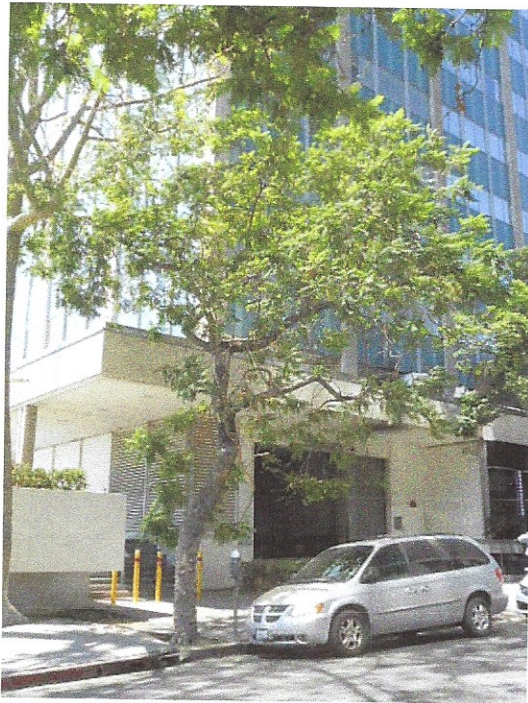
Tree 24 is *Jacaranda mimosifolia*, Jacaranda, in good condition with a caliper of 12", standing 26' high by 22' wide. This tree is scheduled to remain, however, should it require removal, contact Urban Forestry Division for replacement value as it is a STREET TREE.

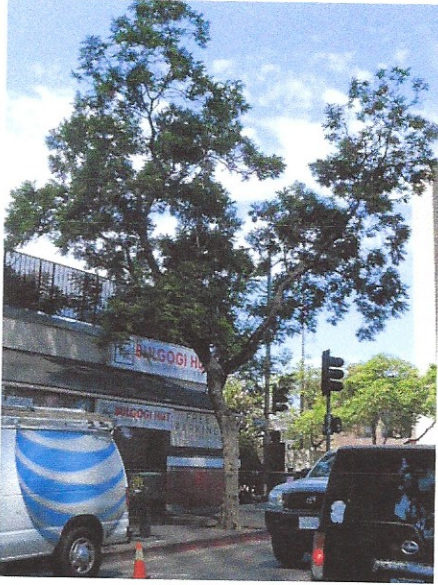
Tree 27 is *Jacaranda mimisifolia*, Jacaranda, in good condition with a caliper of 12", standing 24' high by 23' wide. This tree is scheduled to remain, however, should it require removal, contact Urban Forestry Division for replacement value as it is a STREET TREE.

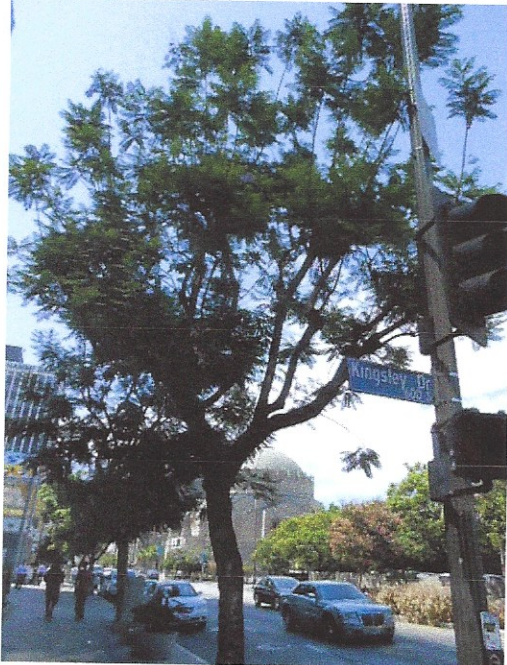
Tree 28 is *Jacaranda mimisifolia*, Jacaranda, in good to fair condition due to canker with a caliper of 13", standing 23' high by 19' wide. This tree is scheduled to remain, however, should it require removal, contact Urban Forestry Division for replacement value as it is a STREET TREE.

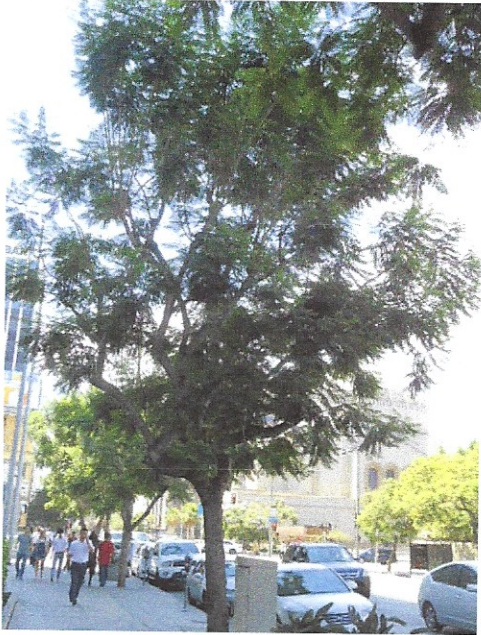
Tree 29 is *Jacaranda mimisifolia*, Jacaranda, in good condition except for poor pruning with a caliper of 13", standing 23' high by 18' wide. This tree is scheduled to remain, however, should it require removal, contact Urban Forestry Division for replacement value as it is a STREET TREE.

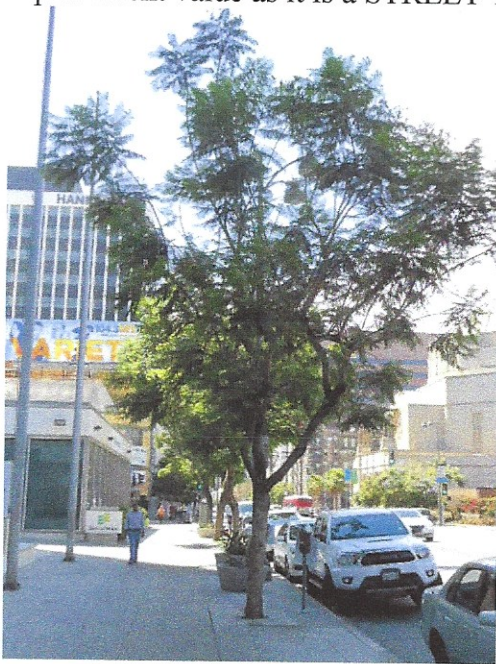
Tree 30 is *Jacaranda mimisifolia*, Jacaranda, in good/fair condition due to poor pruning with a caliper of 9", standing 19' high by 15' wide. This tree is scheduled to remain, however, should it require removal, contact Urban Forestry Division for replacement value as it is a STREET TREE.

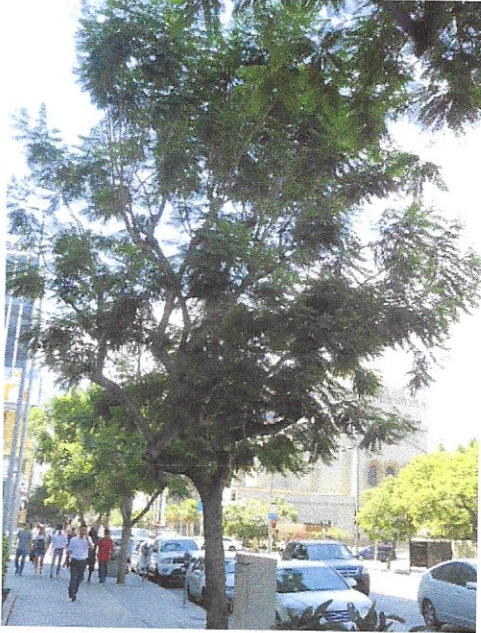
Tree 29 is *Jacaranda mimosifolia*, Jacaranda, in good condition despite poor pruning with a caliper of 13", standing 23' high by 18' wide. This tree is scheduled to remain, however, should it require removal, contact Urban Forestry Division for replacement value as it is a STREET TREE.

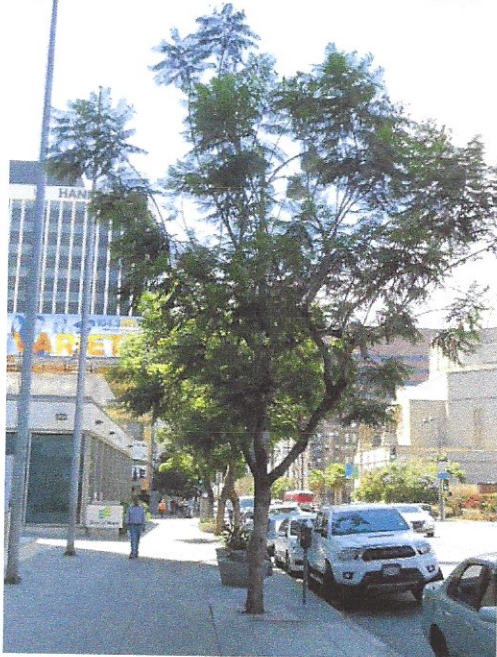
Tree 30 is *Jacaranda mimosifolia*, Jacaranda, in good/fair condition due to poor pruning with a caliper of 9", standing 19' high by 15' wide. This tree is scheduled to remain, however, should it require removal, contact Urban Forestry Division for replacement value as it is a STREET TREE.

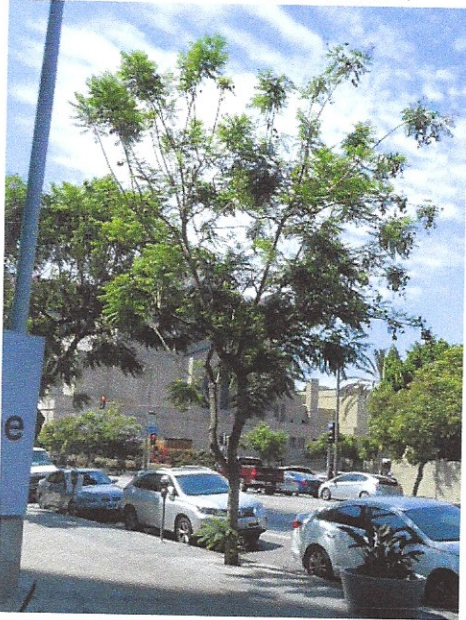
Tree 31 is *Jacaranda mimosifolia*, Jacaranda, in good condition despite poor pruning with a caliper of 8", standing 18' high by 14' wide. This tree is scheduled to remain, however, should it require removal, contact Urban Forestry Division for replacement value as it is a STREET TREE.

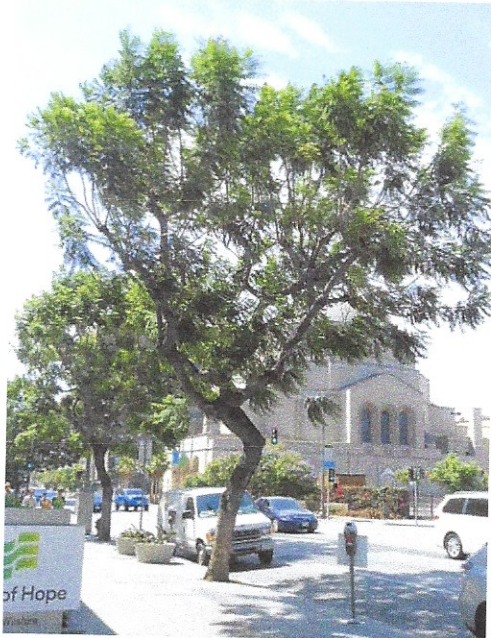
Tree 32 is *Jacaranda mimosifolia*, Jacaranda, in good condition despite poor pruning with a caliper of 17", standing 28' high by 22' wide. This tree is scheduled to remain, however, should it require removal, contact Urban Forestry Division for replacement value as it is a STREET TREE.

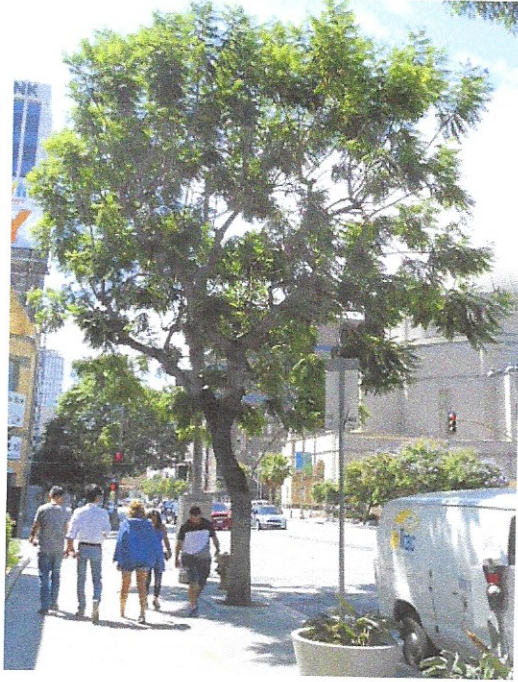
Tree 33 is *Jacaranda mimosifolia*, Jacaranda, in good condition despite poor pruning with a caliper of 14", standing 25' high by 18' wide. This tree is scheduled to remain, however, should it require removal, contact Urban Forestry Division for replacement value as it is a STREET TREE.

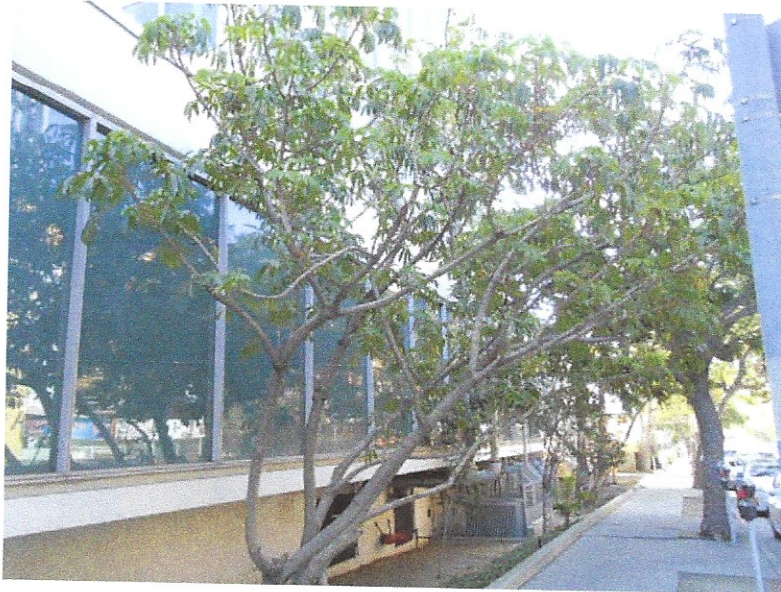
Tree A is *Schefflera pueckleri*, Umbrella Tree in good condition. It is multi-trunked with calipers of 5-5" 4" and 3" and is 20' high by 20' wide. This unprotected tree will remain but should it require removal, replacement value for this tree is a 24" Box tree.

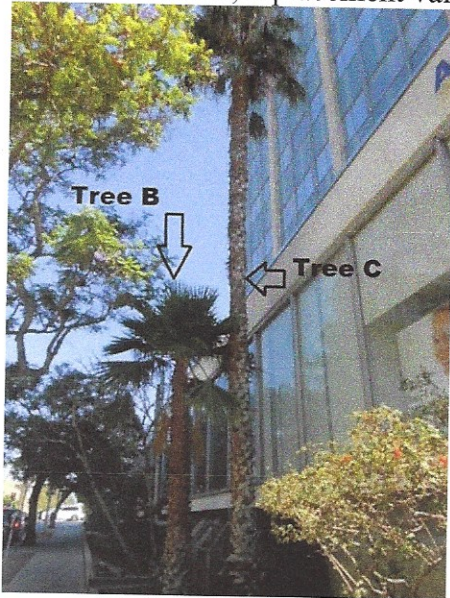
Trees B & C are *Washingtonia robusta*, Mexican Fan Palm in good condition with a dimensions as follows B-caliper 14" and 14' high by 6' wide and C- caliper 13" and 38' high by 7' wide. These trees are scheduled to remain, however, should these trees be removed, replacement value would be 24" box/ tree.

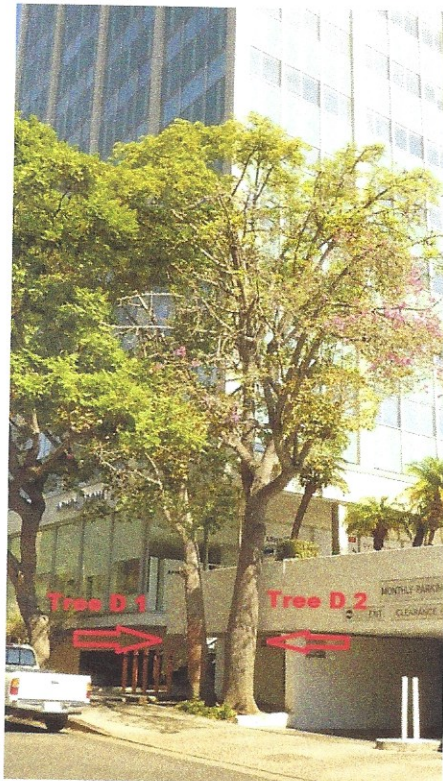
Trees D1 and D2 are *Ceiba speciosa*, Silk Floss Tree in poor and fair condition respectively. Specifications are: D1 severe dieback caliper- 19" standing 30' high by 12' and D2 moderate dieback-caliper- 20" and 36' high by 16' wide. These unprotected trees will be removed and the replacement value for this tree is a 24" Box tree.

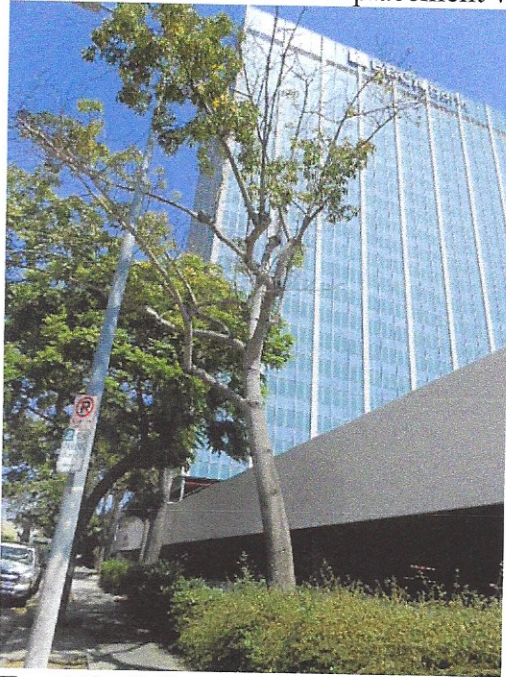
Tree E is *Ceiba speciosa*, Silk Floss Tree in poor condition due to severe dieback of the branches with a caliper of 16" and is 20' high by 20' wide. This unprotected tree will be removed and the replacement value for this tree is a 15 Gallon tree.

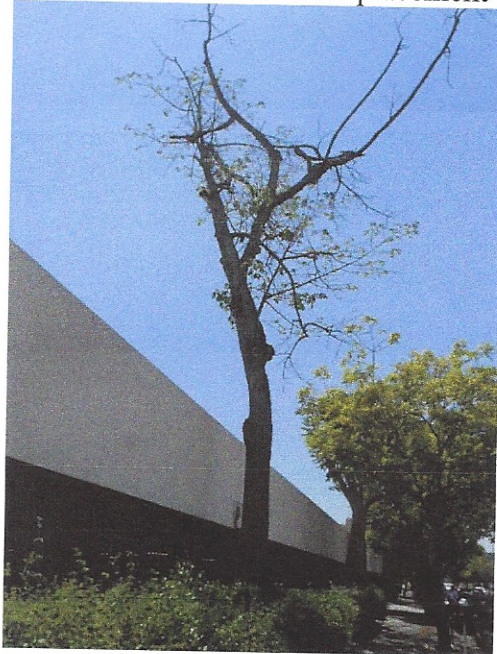
Tree F is *Ceiba speciosa*, Silk Floss Tree in poor condition due to severe dieback of the branches with a caliper of 13" and is 27' high by 13' wide. This unprotected tree will be removed and the replacement value for this tree is a 15 Gallon tree.

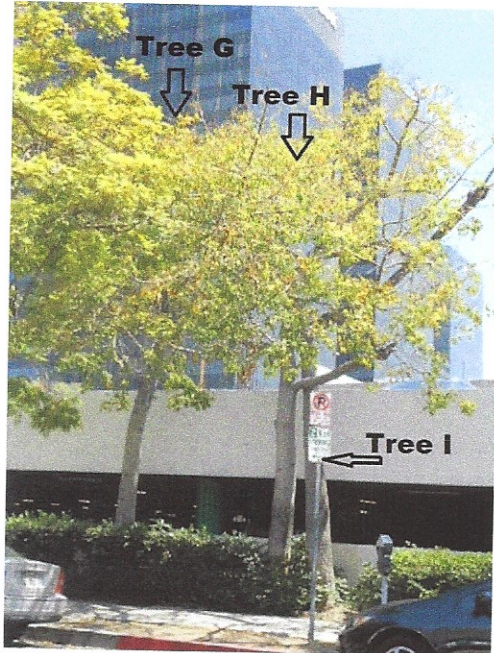
Trees G, H, I are *Ceiba speciosa*, Silk Floss Tree all in poor condition due to severe dieback. Specifications of the trees are as follows: G- caliper-12" with height 19' by 15' wide, H- caliper-14" with height 19' by 18' wide, I- caliper-13" with height 19' by 11'. These unprotected trees will be removed and the replacement values are a 15 Gallon tree/tree.

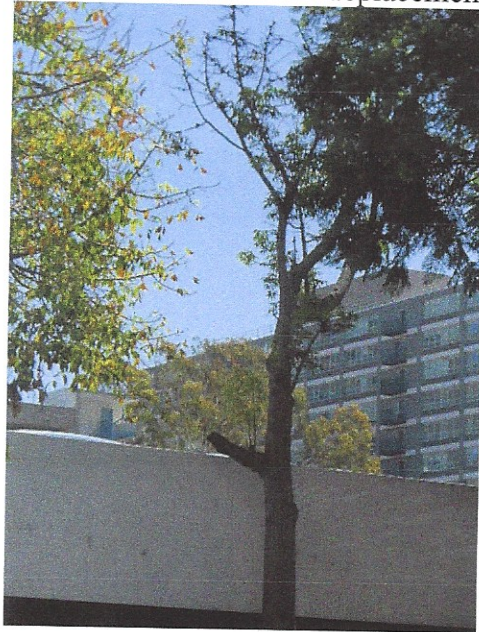
Tree J is *Ceiba speciosa*, Silk Floss Tree in poor condition due to severe dieback of the branches with a caliper of 12" and is 17' high by 6' wide. This unprotected tree will be removed and the replacement value for this tree is a 15 Gallon tree.

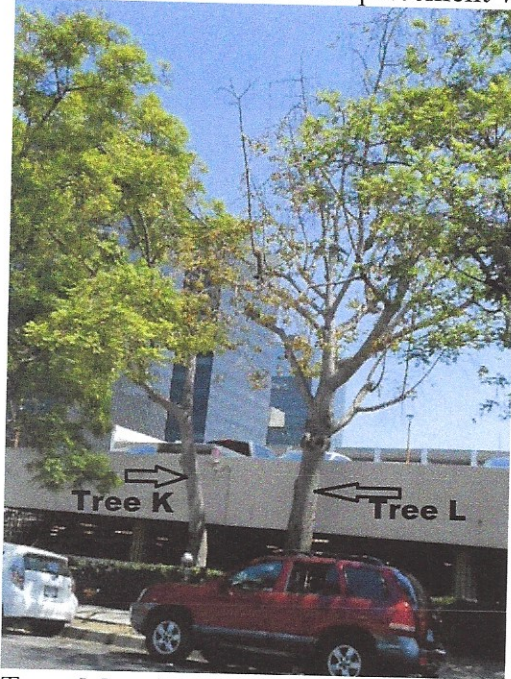
Trees K and L are *Ceiba speciosa*, Silk Floss Tree both in poor condition due to severe dieback. Specifications of the trees are as follows: K- caliper-13" with height 21' by 8' wide, L- caliper-19" with height 22' by 14' wide. These unprotected trees will be removed and the replacement value for these trees are a 15 Gallon tree/ tree.

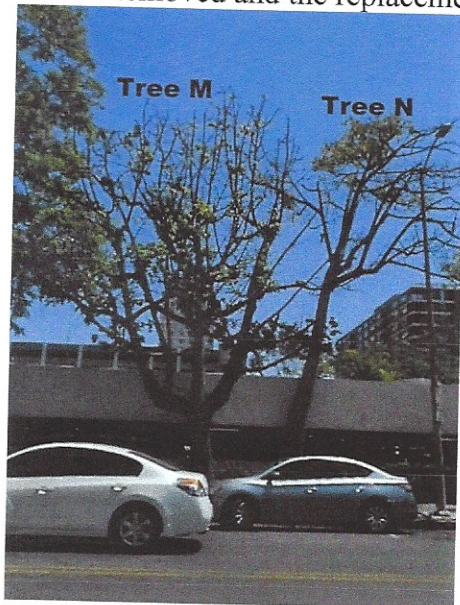
Trees M and N are *Ceiba speciosa*, Silk Floss Tree both in poor condition due to severe dieback. Specifications of the trees are as follows: M- caliper-18" with height 25' by 16' wide, N- caliper-19" with height 25' by 8' wide. These unprotected trees will be removed and the replacement value are a 15 Gallon tree/ tree.

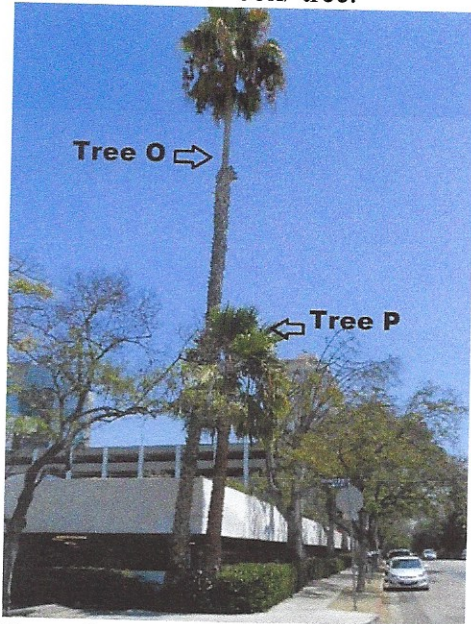
Trees O & P are *Washingtonia robusta*, Mexican Fan Palm in good condition with a dimensions as follows O-caliper 17" and 45' high by 9' wide and P- caliper 15" and 18' high by 7' wide. These trees are scheduled to be removed and replacement value for these are 24" box/ tree.

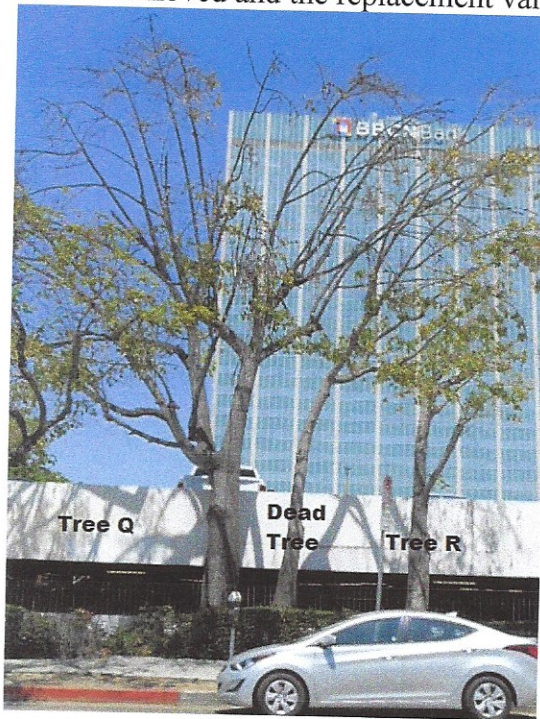
Trees Q and R are *Ceiba speciosa*, Silk Floss Tree both in poor condition due to severe dieback. Specifications of the trees are as follows: Q- caliper-21" with height 25' by 6' wide, R- caliper-16" with height 19' by 5' wide. These unprotected trees will be removed and the replacement value for these trees are a 15 Gallon tree/ tree.

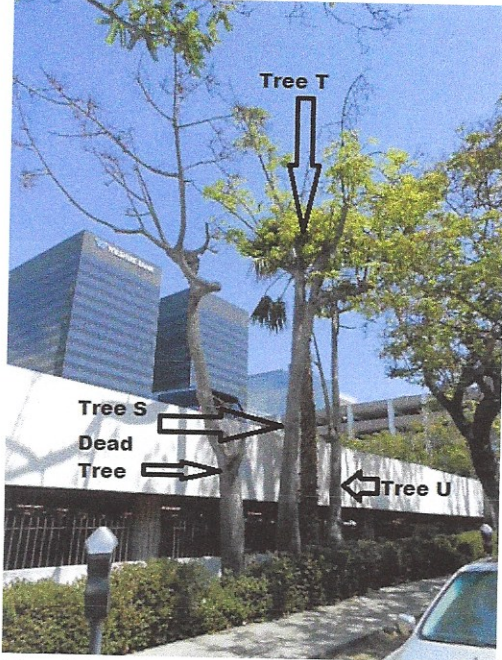
Trees S is *Ceiba speciosa*, Silk Floss Tree in very poor condition due to severe dieback. Tree T is a *Washingtonia robusta*, Mexican Fan Tree in good condition. The former Tree U is dead. Specifications of the trees are as follows: S- caliper-12" with height 21' by 10' wide, T- caliper-12" with height 21' by 5' wide. These unprotected trees will be removed and the replacement value for these trees are a 15 Gallon tree/ tree.

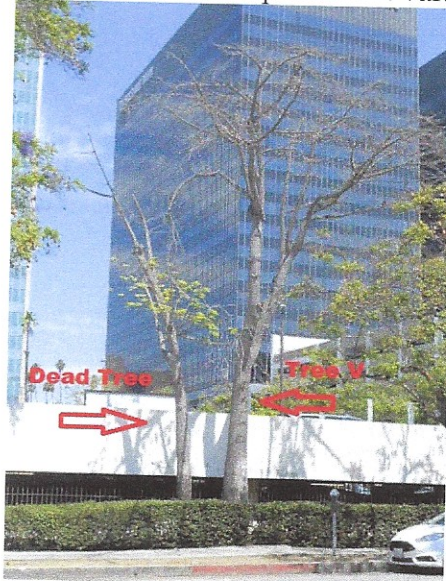
Tree V is *Ceiba speciosa*, Silk Floss Tree in poor condition due to severe dieback with a caliper of 12" and is 13' high by 5' wide. This unprotected tree will be removed and the replacement value for this tree is a 15 Gallon tree.

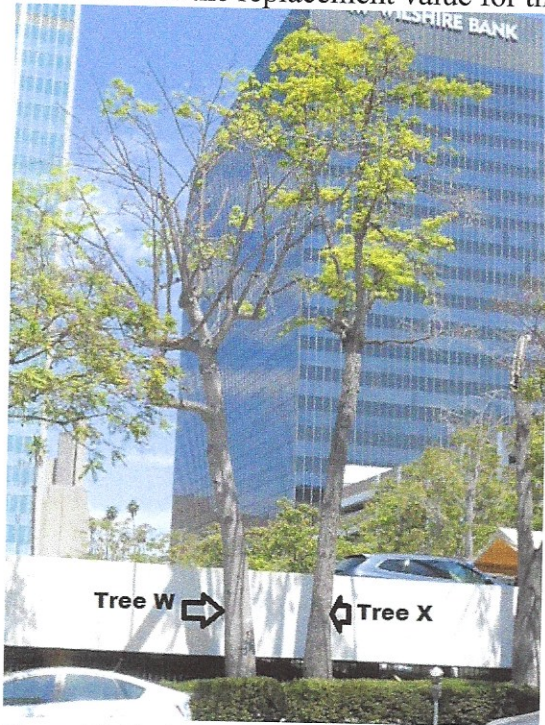
Trees W and X are *Ceiba speciosa*, Silk Floss Tree in poor condition due to severe dieback. Specifications of the trees are as follows: W- caliper-17" with height 26' by 9' wide, X- caliper-15" with height 28' by 8' wide. These unprotected trees will be removed and the replacement value for these trees are a 15 Gallon tree/ tree.

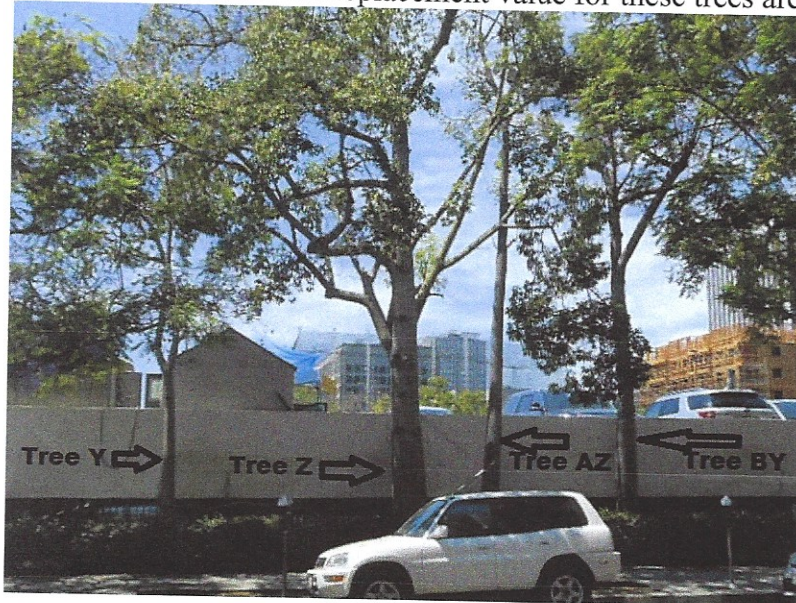
Trees Y, Z, AZ and BY are *Ceiba speciosa*, Silk Floss Tree all in poor condition due to severe dieback. Tree specifications are as follows: Y- caliper 8" with height 20' by 8' wide, Z - caliper 19" with height 26' by 21', AZ- caliper-11" with height 19' by 10' wide, BY- caliper-12" with height 17' by 10' wide. These unprotected trees will be removed and the replacement value for these trees are a 15 Gallon tree/ tree.

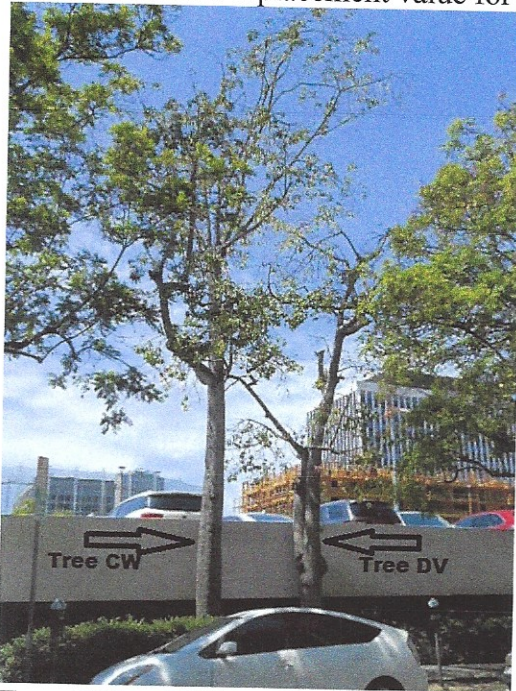
Trees CW and DV are *Ceiba speciosa*, Silk Floss Tree in poor due to severe dieback. Specifications of the trees are as follows: CW- caliper-15" with height 28' by 10' wide, DV- caliper-15" with height 19' by 8' wide. These unprotected trees will be removed and the replacement value for these trees are a 15 Gallon tree/ tree.

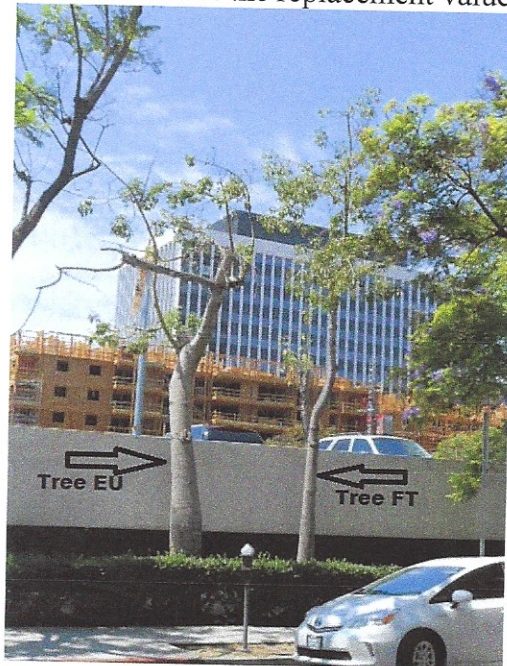
Trees EU and FT are *Ceiba speciosa*, Silk Floss Tree in poor condition due to severe dieback. Specifications of the trees are as follows: EU- caliper-17" with height 14' by 5' wide, FT- caliper-9" with height 16' by 4' wide. These unprotected trees will be removed and the replacement value for these trees are a 15 Gallon tree/ tree.

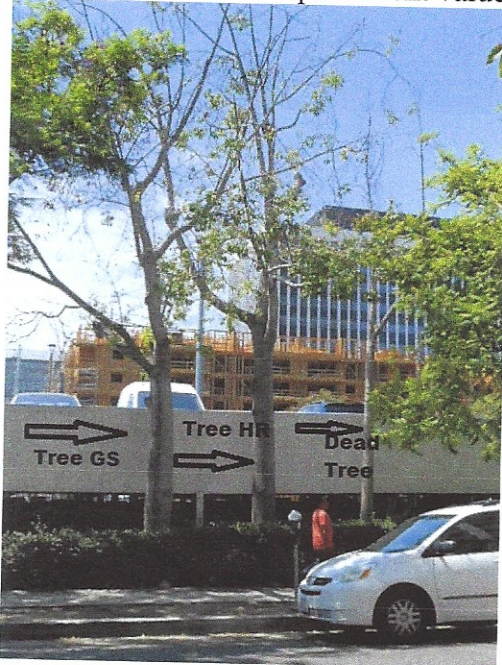
Trees GS and HR are *Ceiba speciosa*, Silk Floss Tree in poor condition due to severe dieback. Specifications of the trees are as follows: GS- caliper-15" with height 20' by 9' wide, HR- caliper-14" with height 20' by 7' wide. These unprotected trees will be removed and the replacement value for these trees are a 15 Gallon tree/ tree.
