**TREE REPORT**

**3600 Wilshire Blvd.  
Los Angeles, CA 90010**

Prepared by  
**Harmony Gardens, Inc.**  
12224 Addison Street  
Valley Village, CA 91607  
Phone (818) 505-9783  
Shelley Sparks, RLA # 2896, ASLA  
ISA Certified Arborist #WE-10883A

Revised October 24, 2018

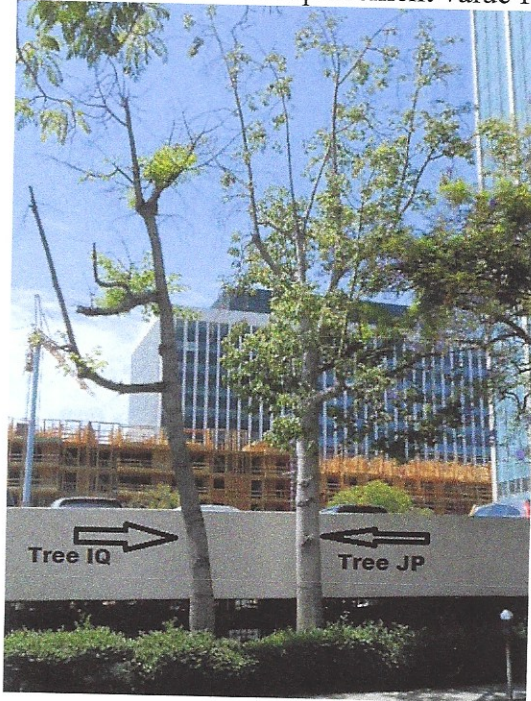
Trees IQ and JP are *Ceiba speciosa*, Silk Floss Tree in poor condition due to severe dieback. Specifications of the trees are as follows: IQ- caliper-14" with height 20' by 5' wide, JP- caliper-15" with height 22 by 8' wide. These unprotected trees will be removed and the replacement value for these trees are a 15 Gallon tree/ tree.

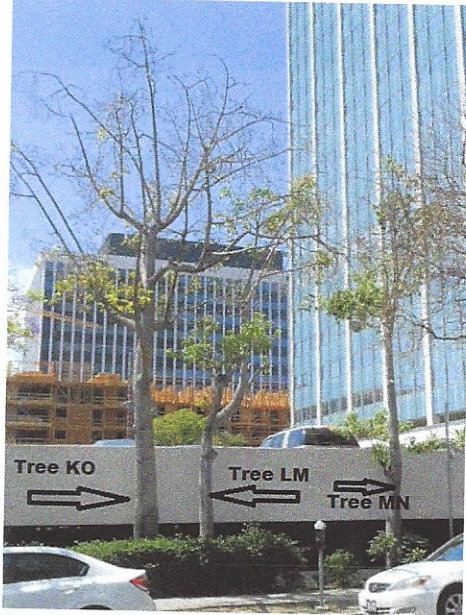
Trees KO, LM and MN are *Ceiba speciosa*, Silk Floss Tree in poor condition due to severe dieback. Specifications of the trees are as follows: KO- caliper-16" with height 19' by 10' wide, LM- caliper- 11" with height 16' by 7' wide and MN- caliper- 10" with height 16' by 5' wide. These unprotected trees will be removed and the replacement value for these trees are a 15 Gallon tree/ tree.

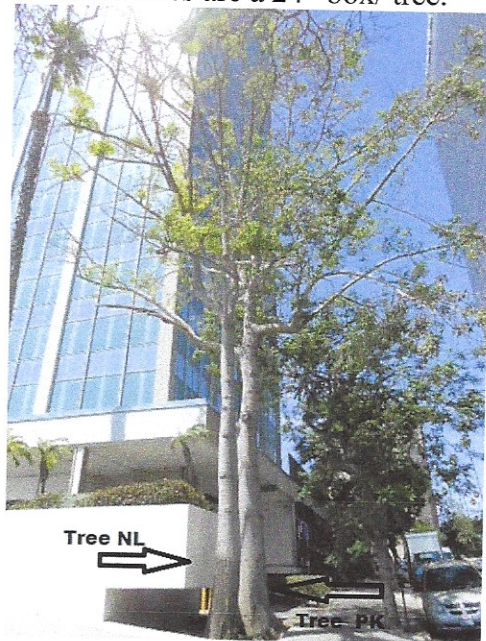
Trees NL and PK are *Ceiba speciosa*, Silk Floss Tree in fair condition, due to moderate dieback for NL and lifting pavement for PK. Specifications of the trees are as follows: NL- caliper-17" with height 38' by 12' wide, PK- caliper-26" with height 40' by 22' wide. These unprotected trees will be removed and the replacement value for these trees are a 24" box/ tree.
