Sunshine Canyon Landfill Independent Monitor Quarterly Site Monitoring Status Report April 1, 2021 – June 30, 2021

Prepared For:

City of Los Angeles Department of City Planning

County of Los Angeles Department of Regional Planning

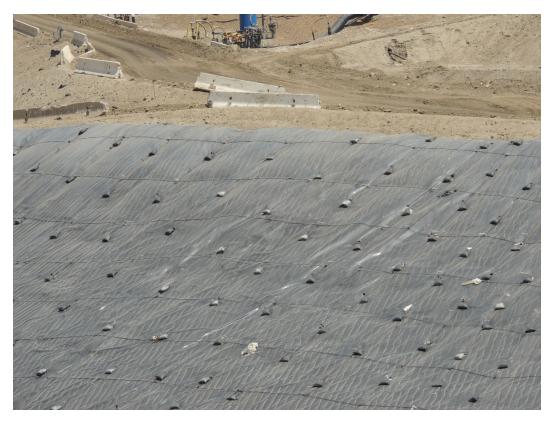
Photo 1: Ballooning of geomembrane on south facing slope of cell CC4 Part 4

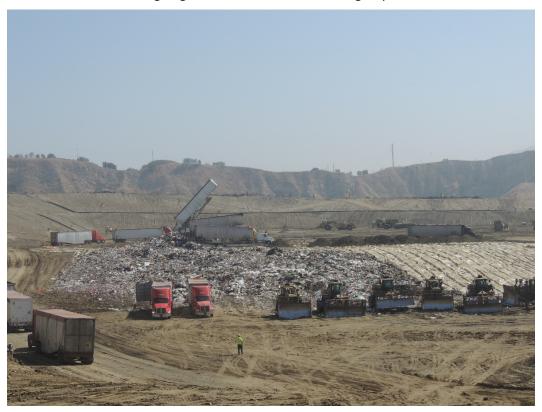
Photo 2: Waste disposal on top of Cell CC4 Phase 2-3

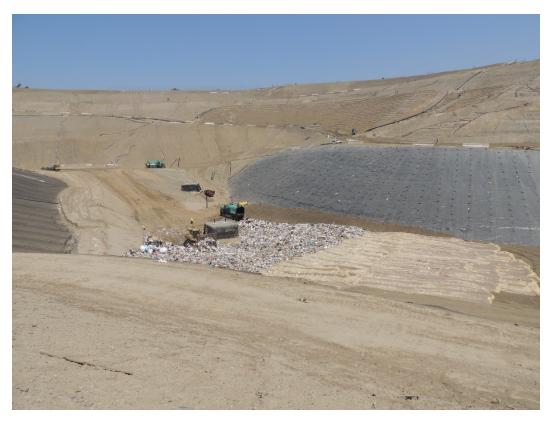
Photo 3: Waste disposal on top of Cell CC4 Phase 4

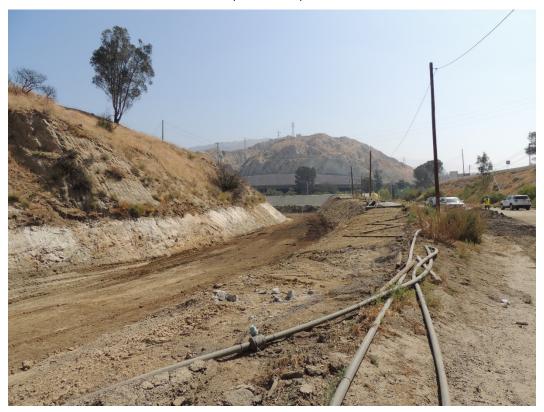
Photo 4: New drainage ditch onto terminal basin

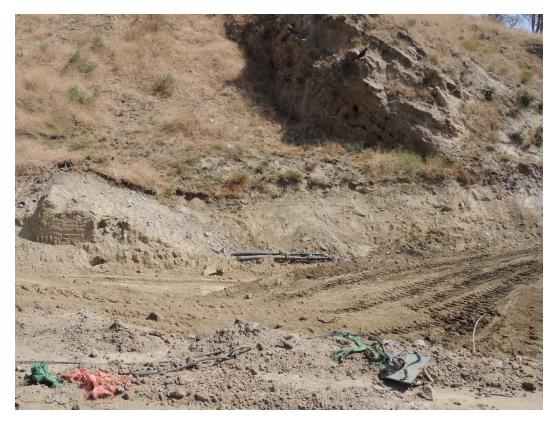
Photo 5: Existing pipe at location of new drainage ditch to terminal basin

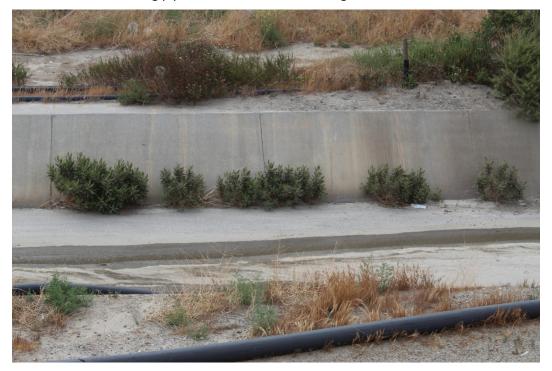
In the 2nd Quarter, it was observed that vegetation was growing out of numerous cracks in the water retention basins and drainage conveyance channels' concrete. There were areas of the channels and basins that needed the growing vegetation to be removed, and repair of the concrete and sealing of cracks. Republic staff stated that these clean-up and maintenance tasks are put on the monthly preventative maintenance program work list and will be done by October 1st.

Photo 6: Vegetation along joint between side and bottom slab – North channel near scale house

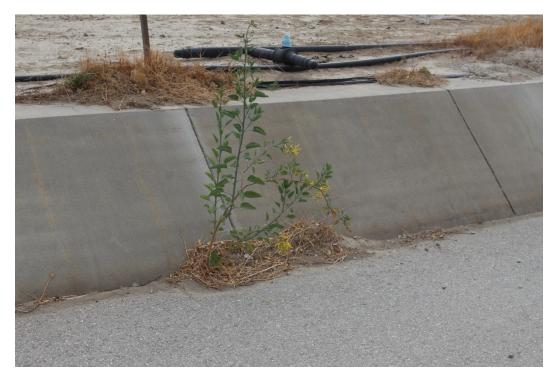
Photo 7: Bush growing between side and bottom slab

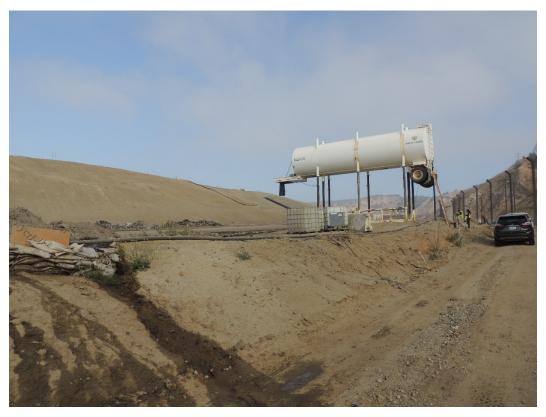
Photo 8: Erosion due to water from water tower

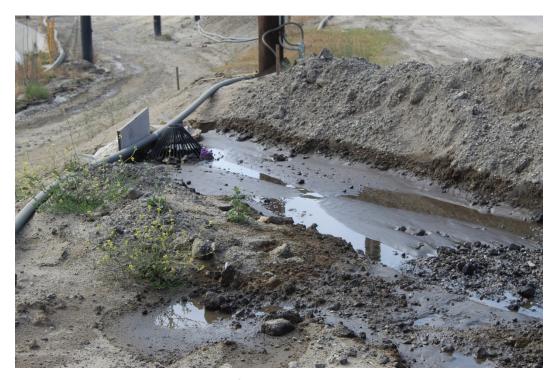
Photo 9: Water leaking form water tower bypassing drop inlet

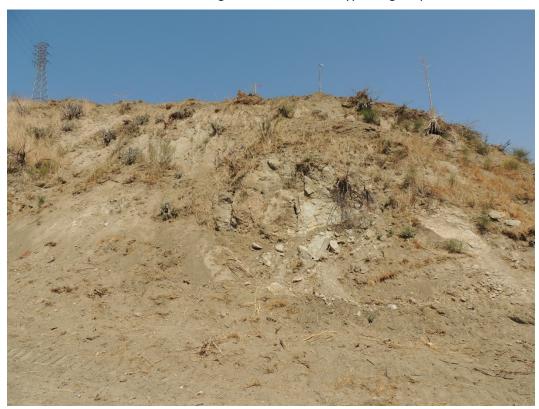
Photo 10: Exposed geological facies at location of future access road

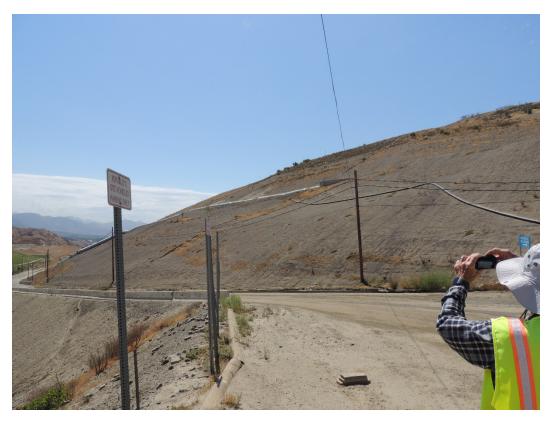
Photo 1: Waste slope above old administration pad

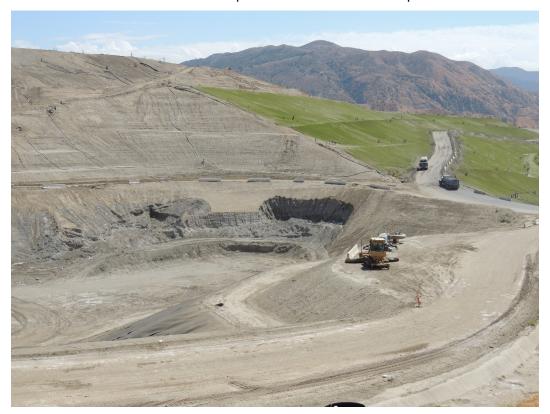
Photo 2: Excavation on south facing slope of cell CC4 Part 4

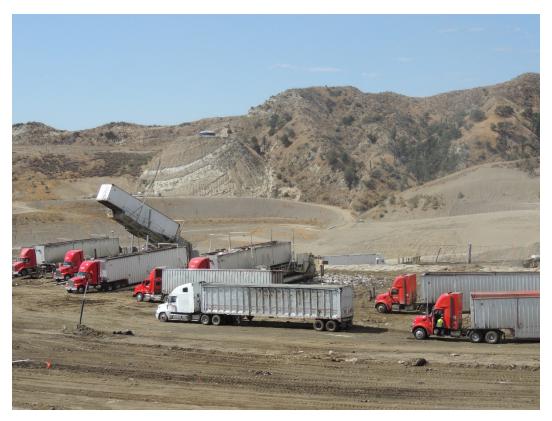
Photo 3: Waste disposal on top of Cell CC4 Phase 3

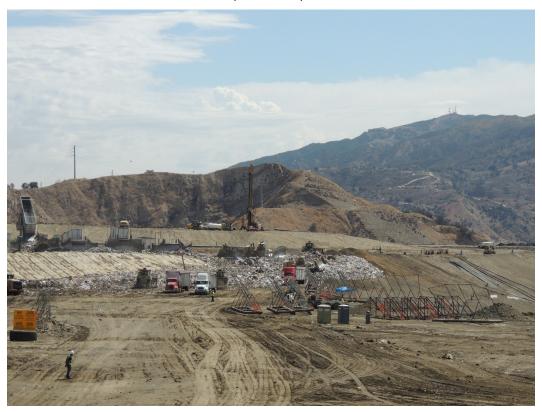
Photo 4: Interim Cover at Waste Face on Cell CC4 Part 3

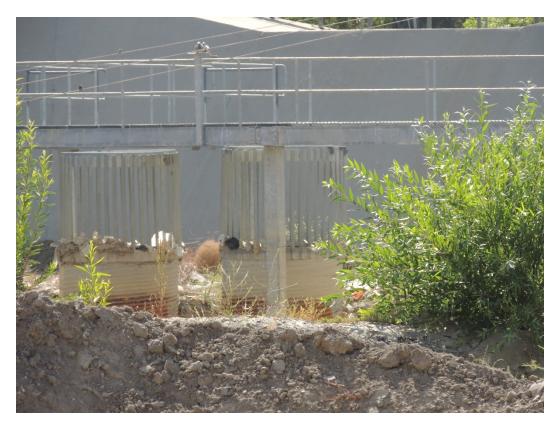
Photo 5: Water between gabion walls and decant towers at terminal basin

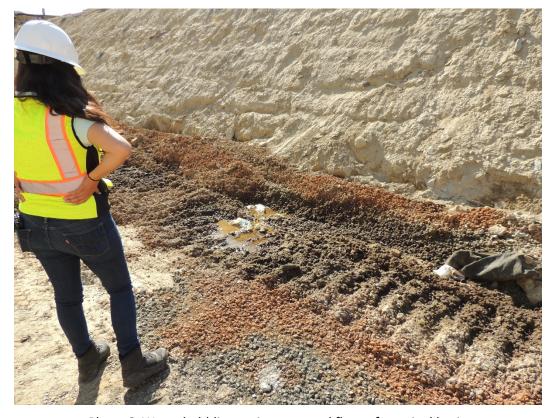
Photo 6: Water bubbling up in excavated floor of terminal basin

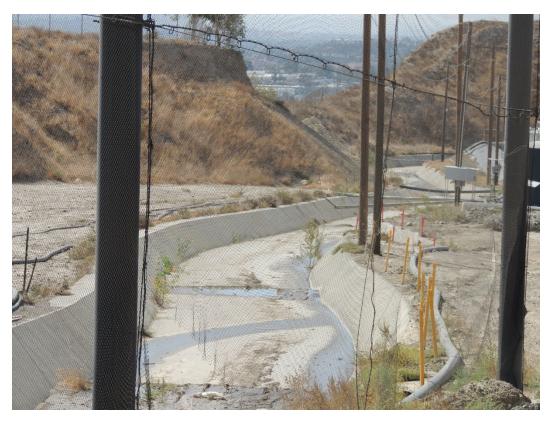
Photo 7: Bush growing between side and bottom slab
