**Sunshine Canyon Landfill
Independent Monitor
Quarterly Site Monitoring Status Report
July 1, 2017 – September 30, 2017**

City of Los Angeles Department of City Planning

County of Los Angeles Department of Regional Planning

December 22, 2017

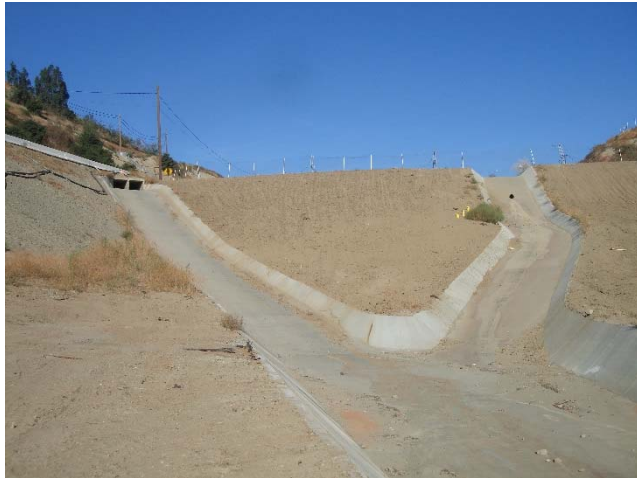
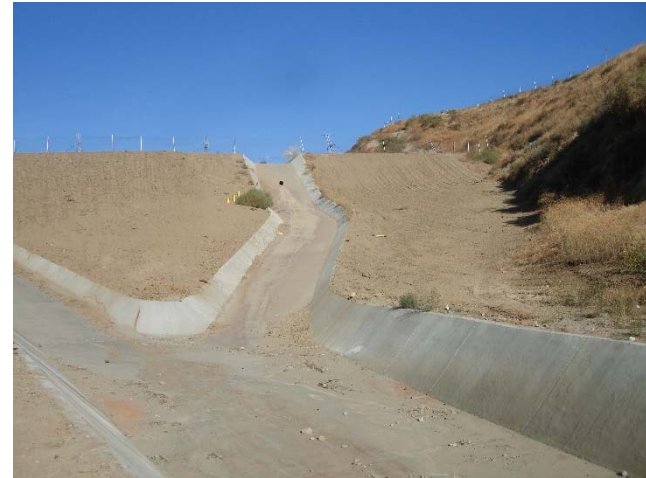
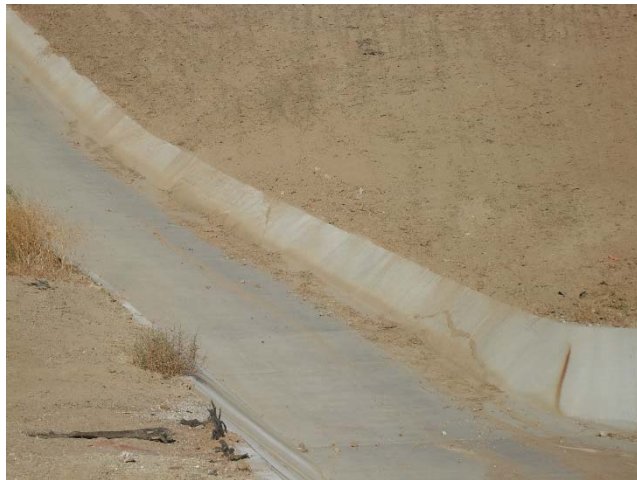
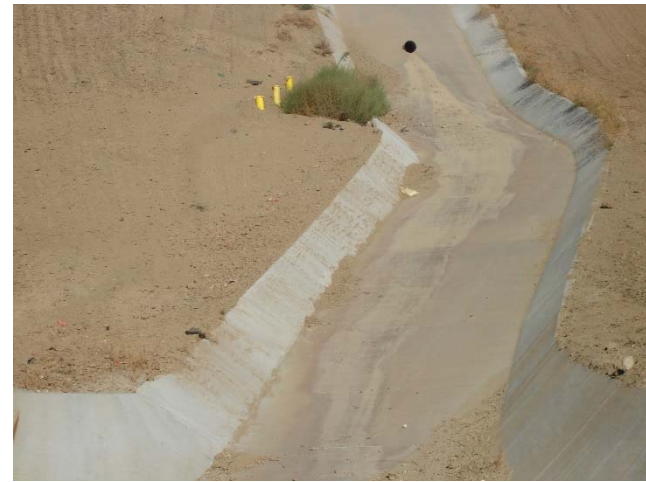
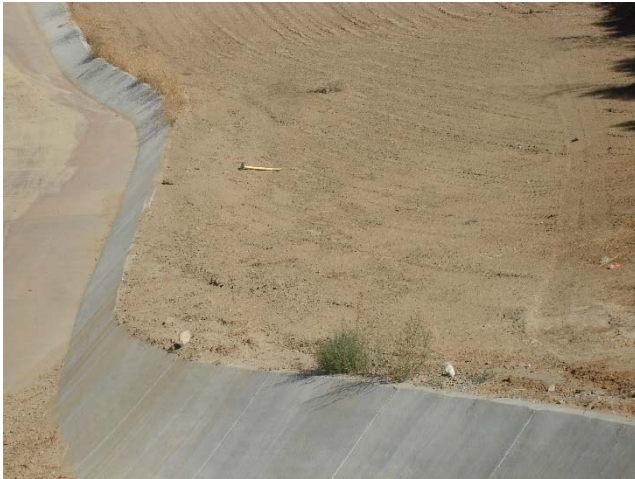
**Photo 417: Terminal Basin Inlet Channel Erosion Repaired:
September 26, 2017**

**Photo 418: Terminal Basin Inlet Channel Erosion Repaired:
September 26, 2017**

**Photo 419: Terminal Basin Inlet Channel Erosion Repaired:
September 26, 2017**

**Photo 420: Terminal Basin Inlet Channel Erosion Repaired:
September 26, 2017**

**Photo 421: Terminal Basin Inlet Channel Erosion Repaired:
September 26, 2017**

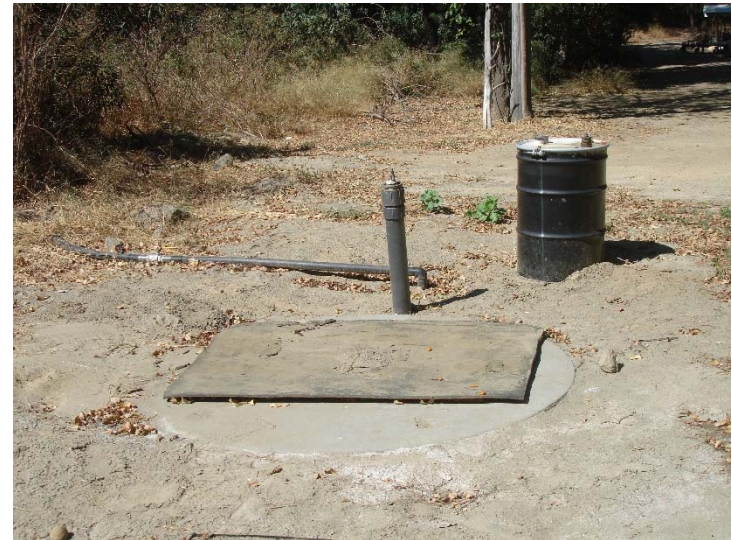
Photo 511: Potable Water Leak near Sewer Pump Repaired: August 14, 2017

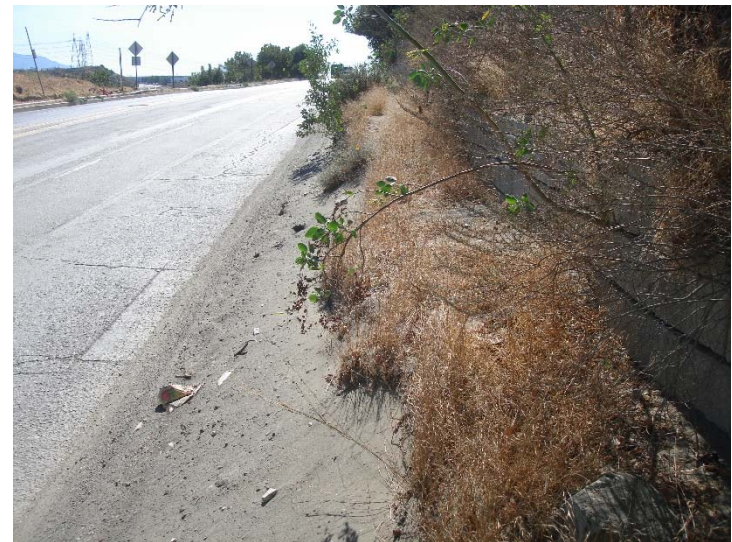
In mid-August, more soil sloughing had occurred at the San Fernando Road retaining wall. The depth of soils and rock behind the fence and soil in front of the wall has increased. The drainage V-ditch above the Flare 1 site had the slope soil sloughed away. The County sage mitigation slope erosion rails have not been repaired and no erosion control wattles installed. The Basin D outlet channel HDPE liner was lifted, and debris and tumbleweed were under the leading edge, which could cause total blockage in a storm.

**Photo 535: Frontage Retaining Wall Slope on San Fernando Road:
September 26, 2017**

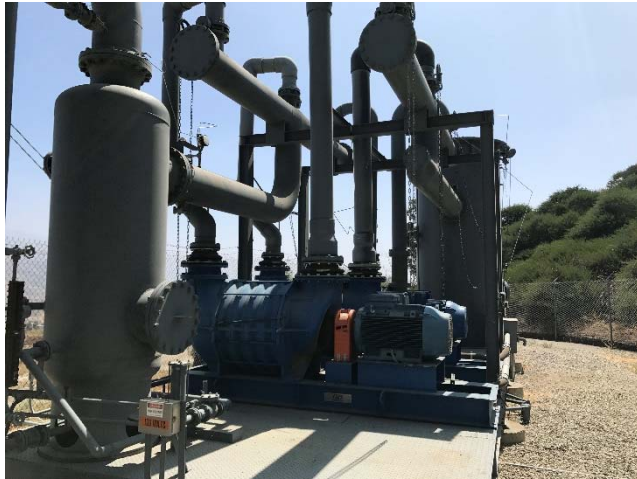
observed liquid trails on the Balboa roadway near Woodley Avenue. They appear to be from packer trucks, possibly from prior days. A localized odor was detected when standing near the stains. A gas leak was detected at the Flare 1 northern-most gas blower's discharge flange.

Photo 632: Flare 1 Leaking Flange: July 25, 2017

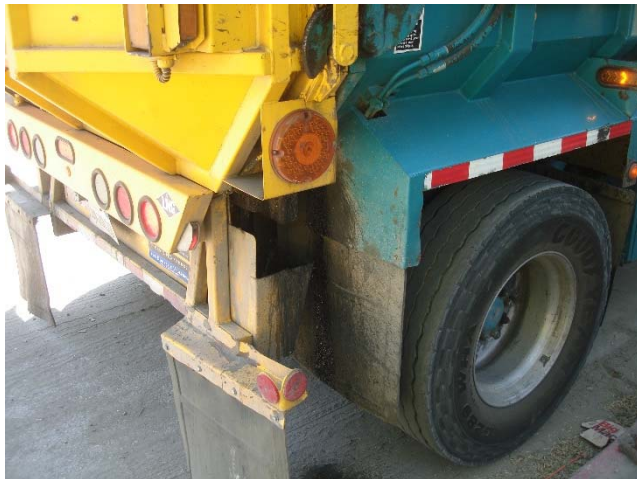
In early July, the monitor drove the Granada Hills neighborhood area from 6:30 to 7:30 a.m. and there were no landfill odors detected in the adjacent neighborhood. There were localized gas odors detected coming from the Cell CC-3A west-facing slope near gas well GW 7041. A packer truck was observed leaking liquids while parked at the exit acceleration lane.

**Photo 651: Empty City Truck Parked on San Fernando Road
Leaking Liquids: July 11, 2017**

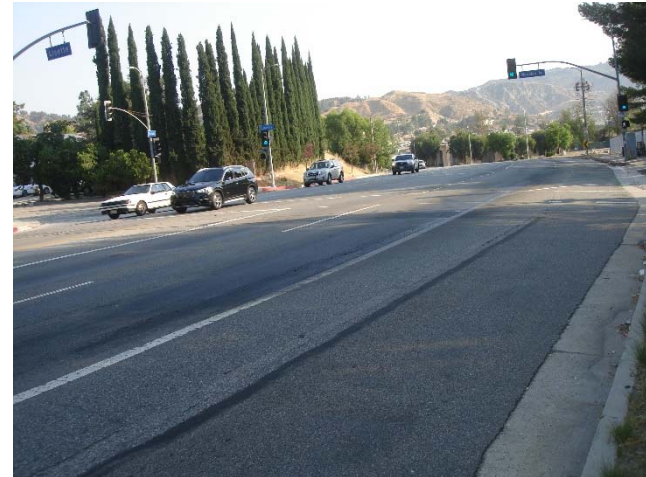
**Photo 652: Liquids on Pavement- Balboa Blvd at Woodley Ave:
July 11, 2017**

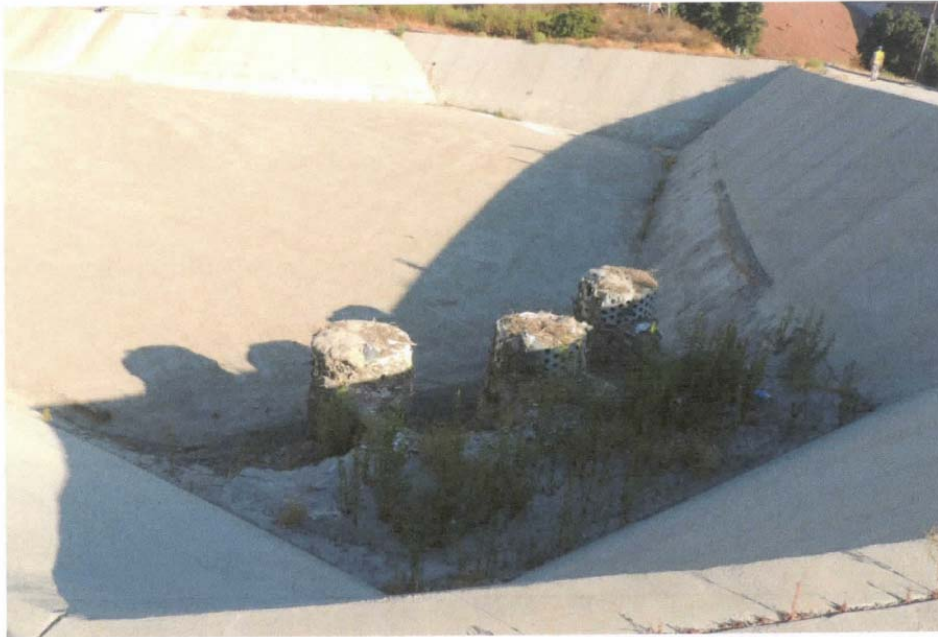
Photo 1: Sediments behind decant towers at Terminal Basin

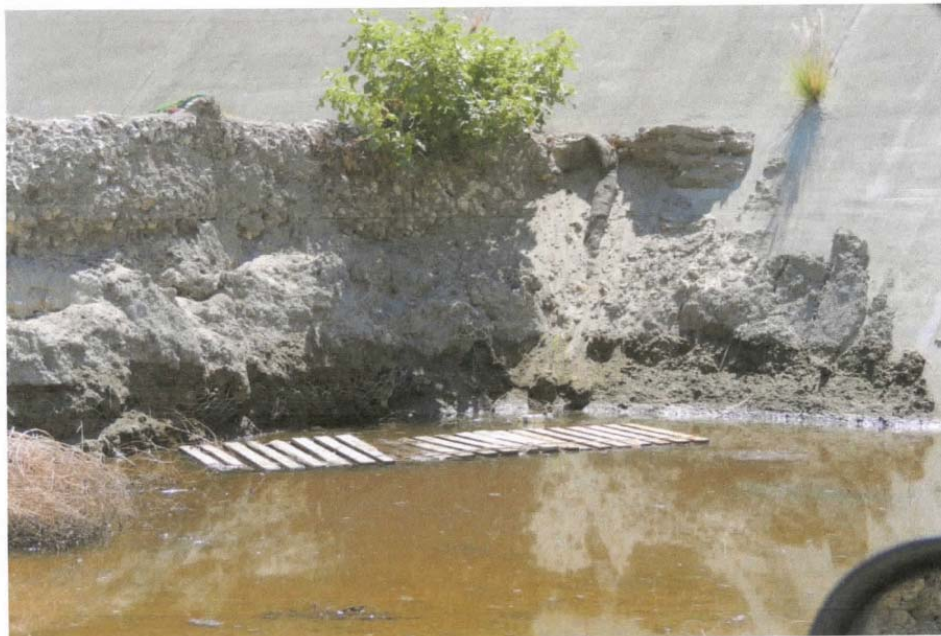
Photo 2: Water behind gabion wall and vegetation growing in Terminal Basin

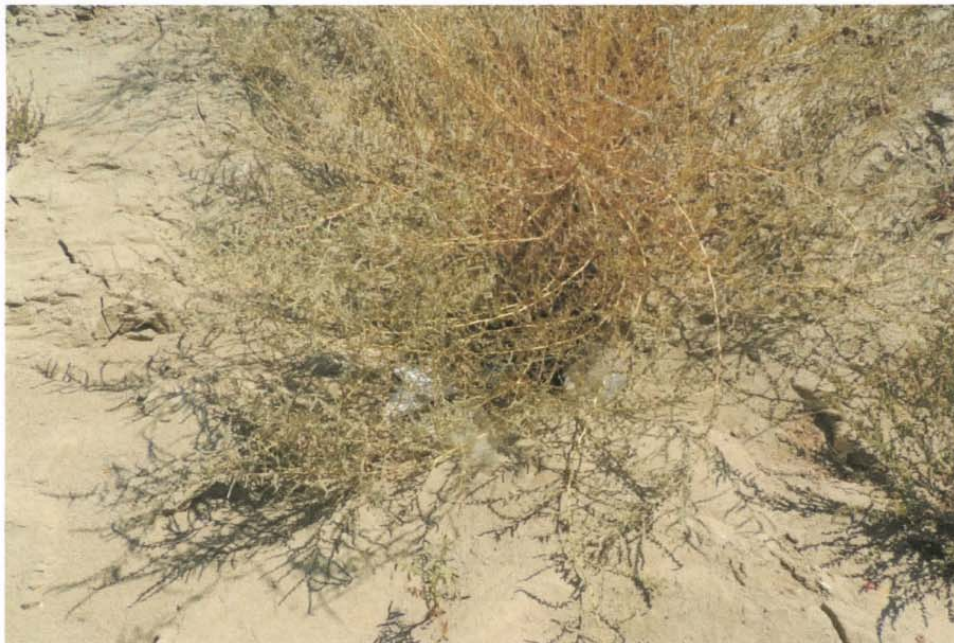
Photo 4: Intake of drain pipe of temporary earthen basin above Terminal Basin

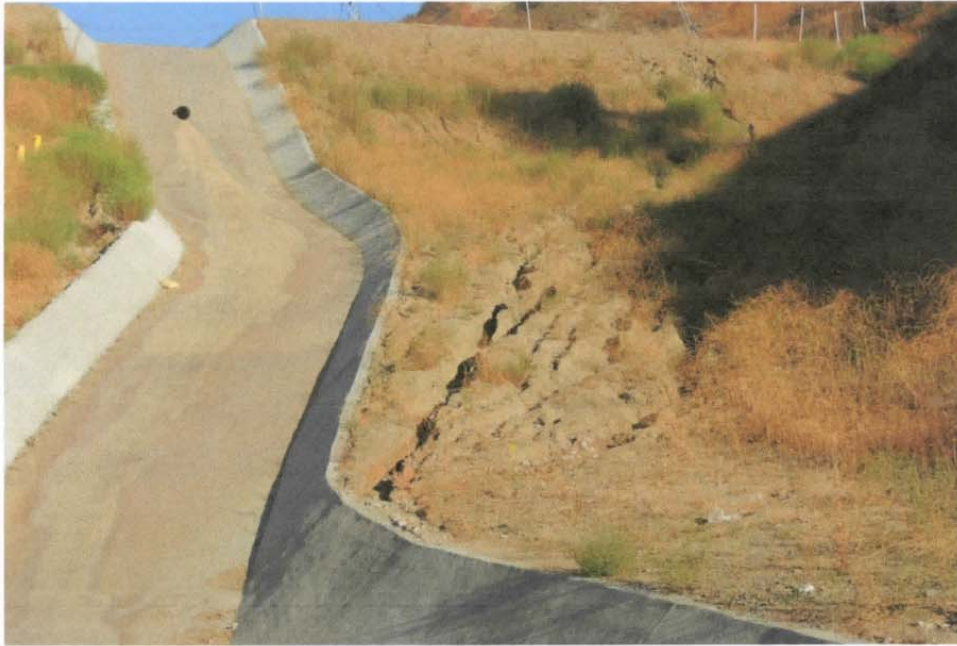
Photo 5: Erosion gullies at temporary earthen basin above Terminal Basin

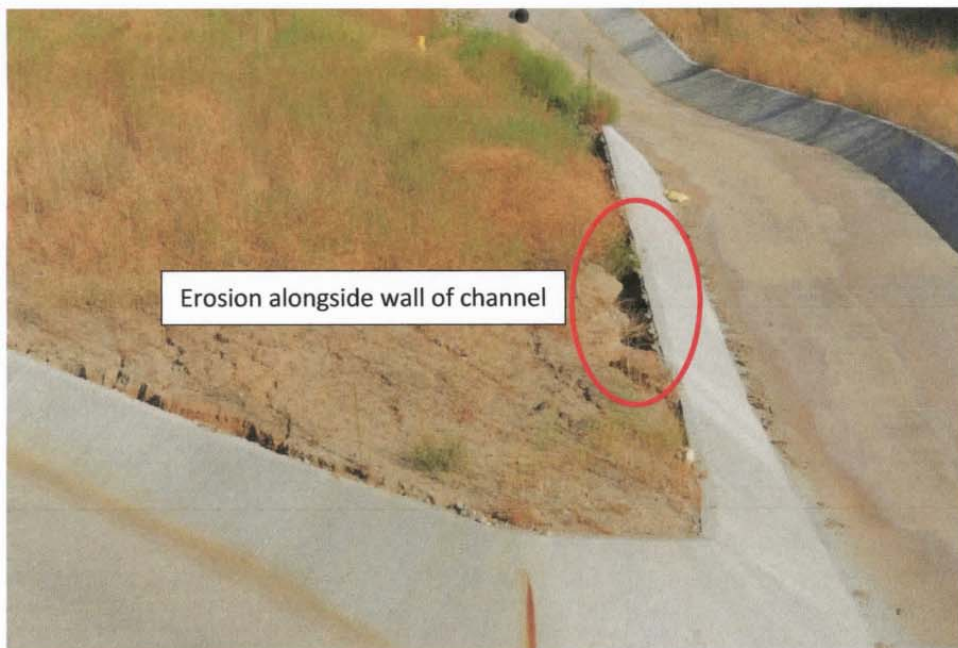
Photo 6: Erosion along shotcrete wall of channels at temporary earthen basin above Terminal Basin

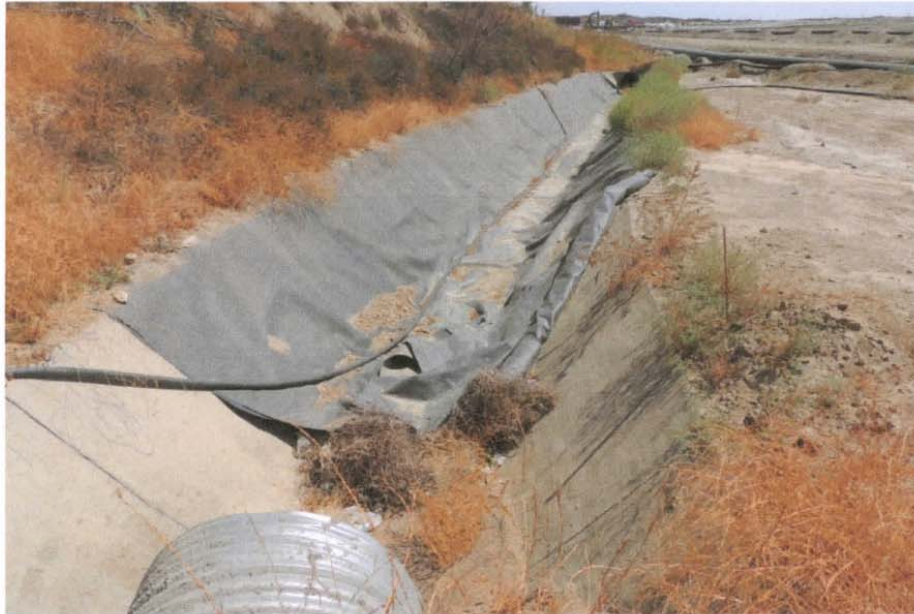
Photo 7: Geomembrane at channel between Basin B and D

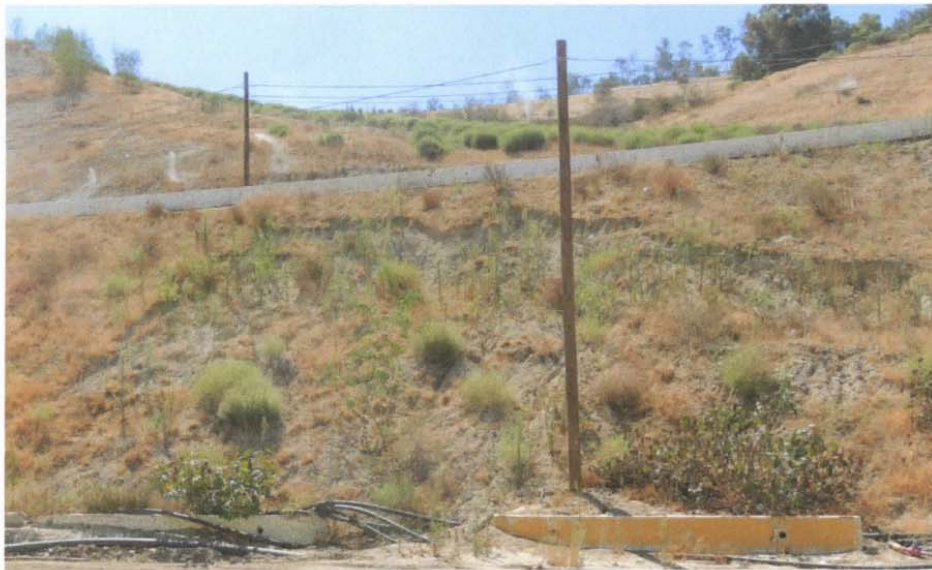
Photo 8: Sloughing on embankment of new access road

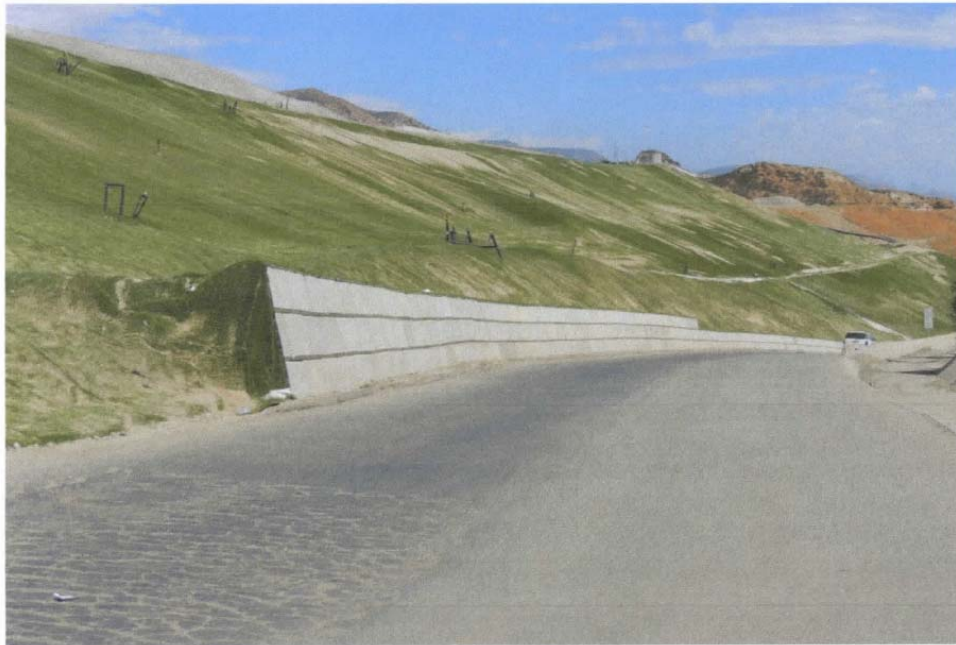
Photo 9: Closure turf on slope of cell CC3 and concrete block retaining wall
