**Sunshine Canyon Landfill  
Independent Monitor  
Quarterly Site Monitoring Status Report  
July 1, 2018 – September 30, 2018**

**City of Los Angeles Department of City Planning**

**County of Los Angeles Department of Regional Planning**

November 5, 2018

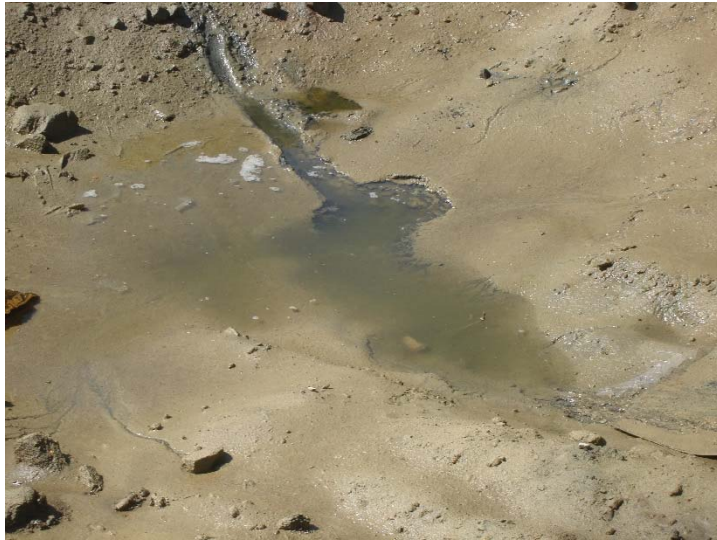
**Photo 220: CC3B Alluvial Slope Leak: July 24, 2018**

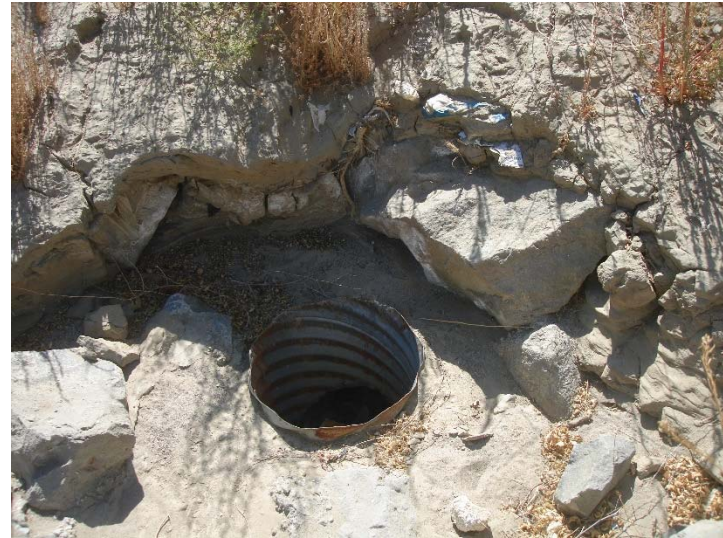
**Photo 221: CC3B Alluvial Slope Leak: July 24, 2018**

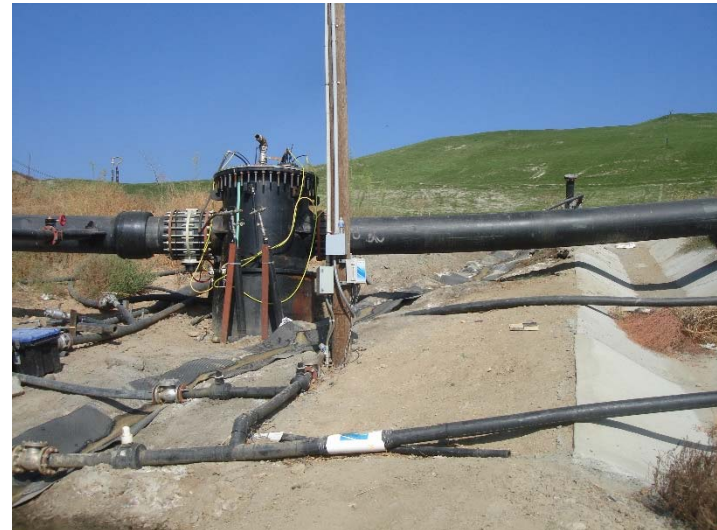
**Photo 239: CC3B Alluvial Slope Leak: September 12, 2018**

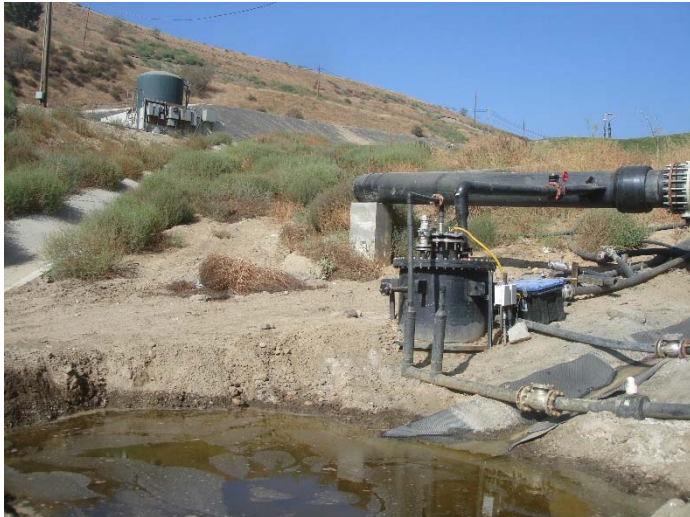
**Photo 240: CC3B Alluvial Slope Leak: September 12, 2018**

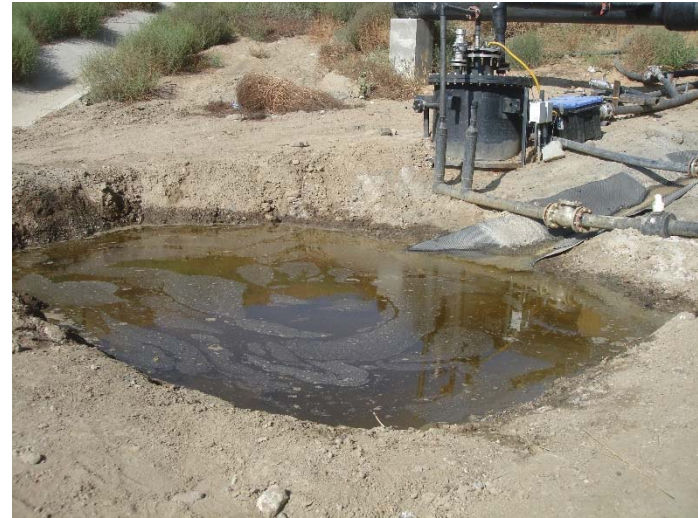
**Photo 241: CC3B Alluvial Slope Leak: September 12, 2018**

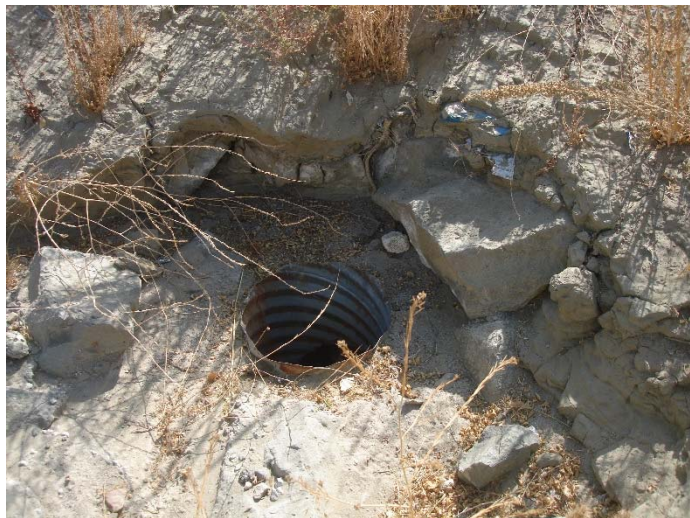
**Photo 242: CC3B Alluvial Slope Leak: September 12, 2018**

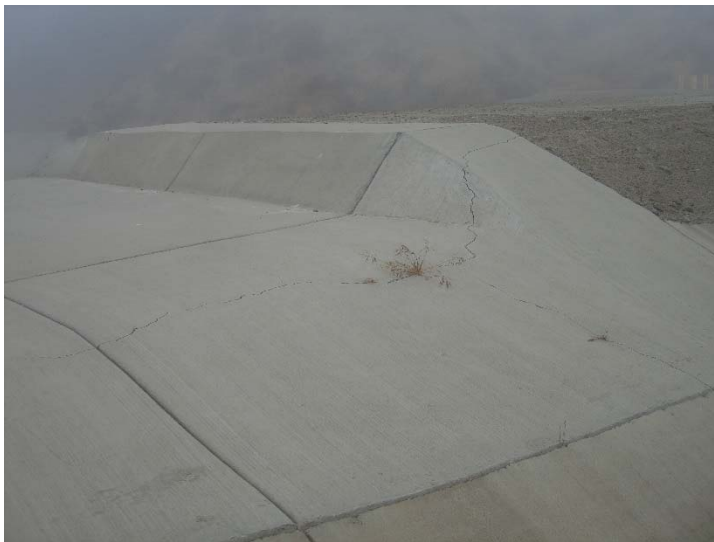
**Photo 466: Basin B High Flow Channel Cracks: September 25, 2018**

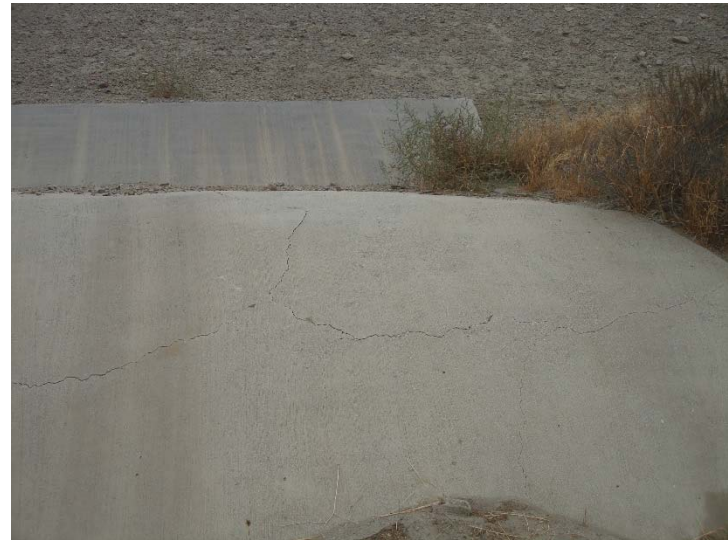
**Photo 467: Basin B High Flow Channel Cracks: September 25, 2018**

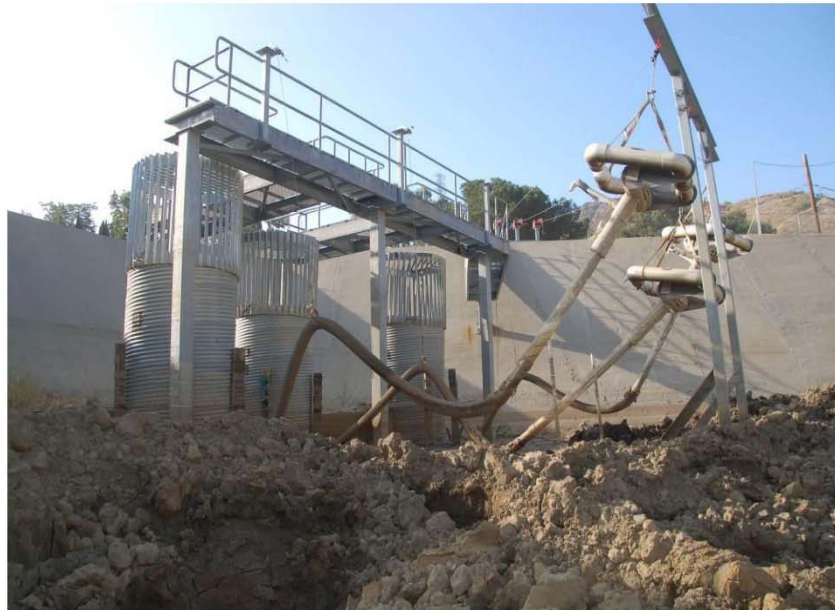
Photo 3: Sediment in terminal basin

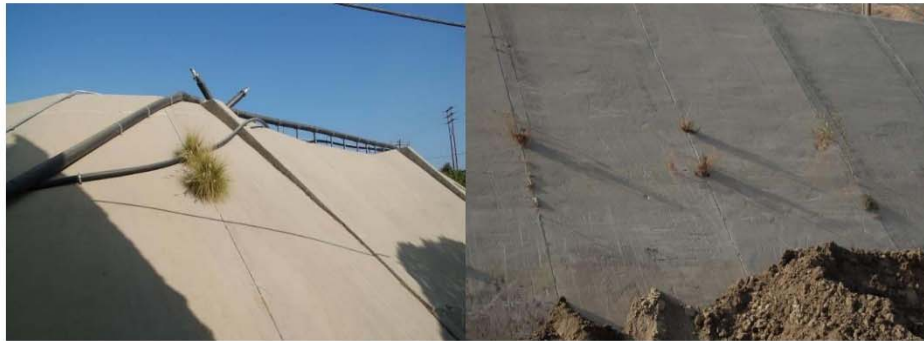
Photo 5: Plants growing in cracks in wall of Terminal Basin

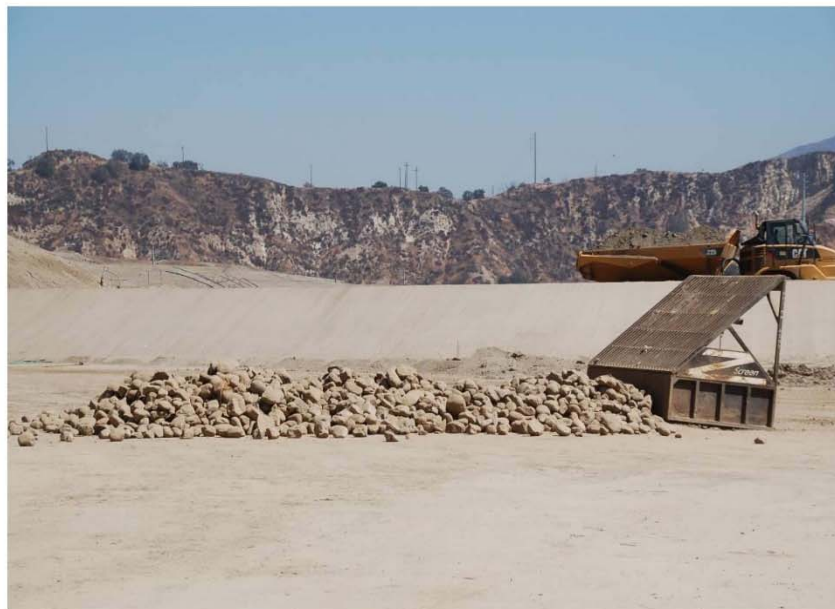
Photo 6: Rocks for drain tower filter at Basin A – leftover sediment to be removed in the back

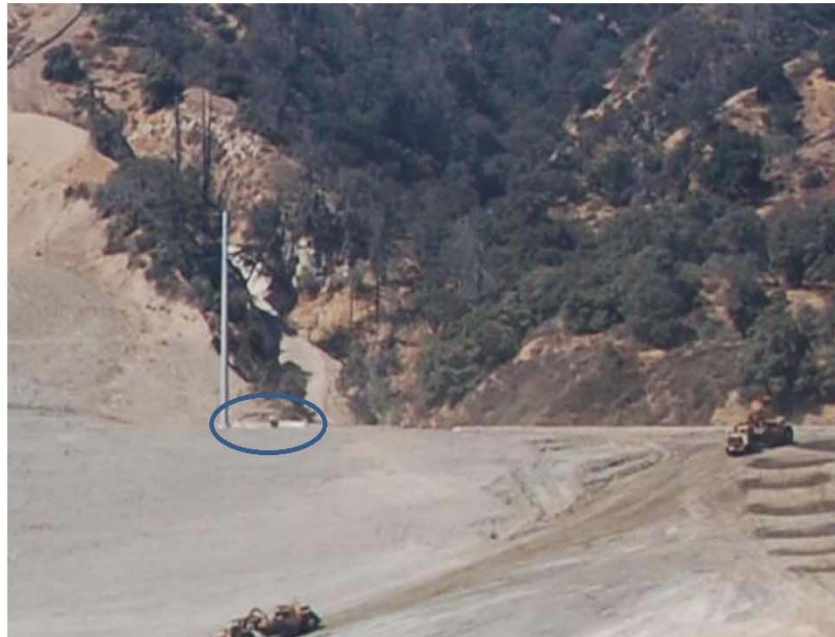
Photo 7: Spillway form Basin A shown in blue circle – Channel was removed downslope of basin

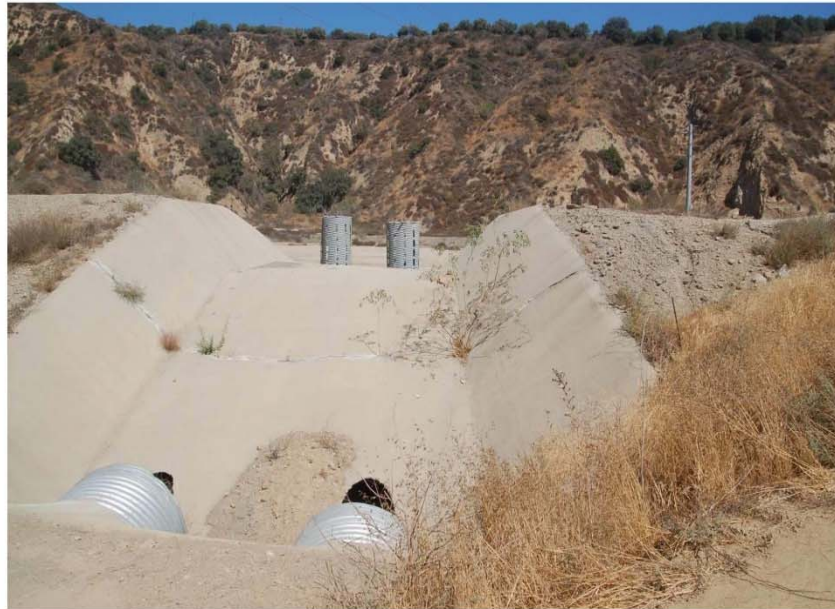
Photo 9: Cracked concrete spillway between two parts of Basin D and vegetation in crack

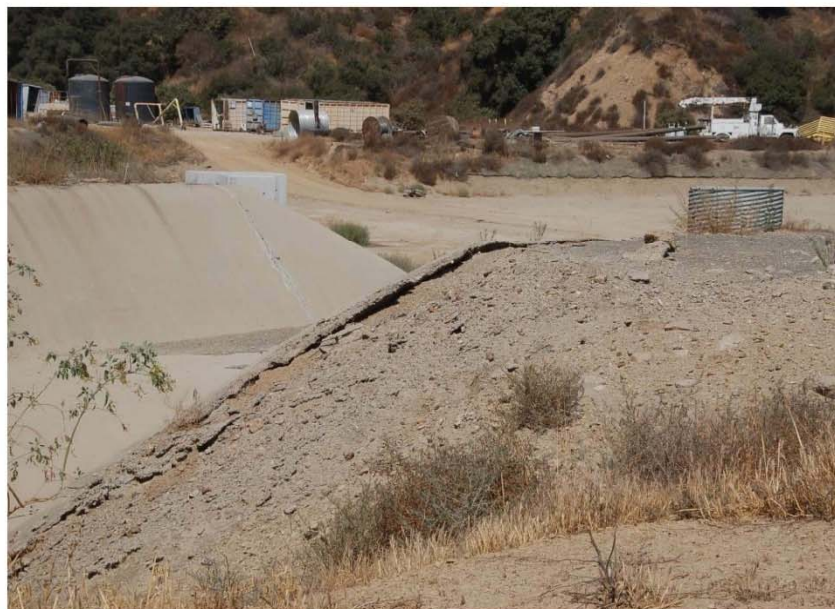
Photo 10: Separation between shotcrete and soil at Basin D

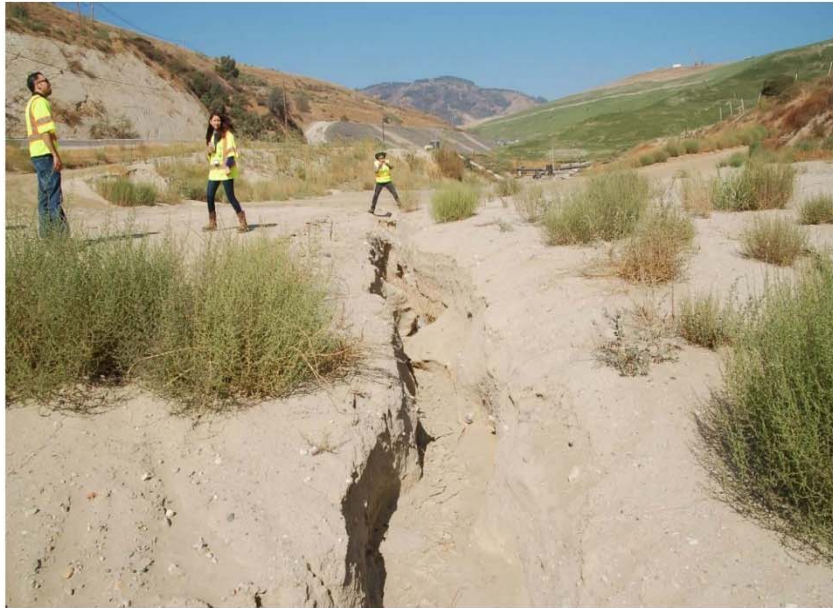
Photo 11: Gully in Cell CC3 basin

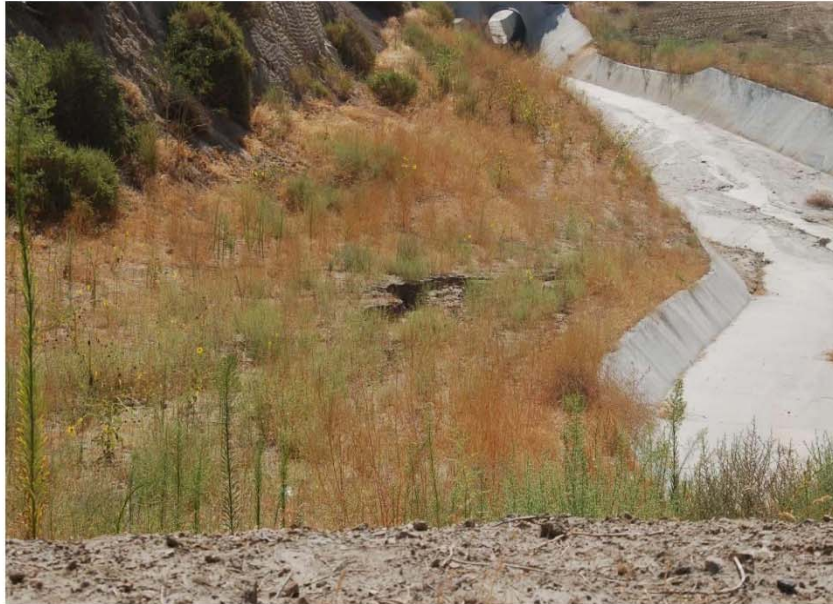
Photo 12: Erosion gully on downstream side of embankment of cell CC3 basin

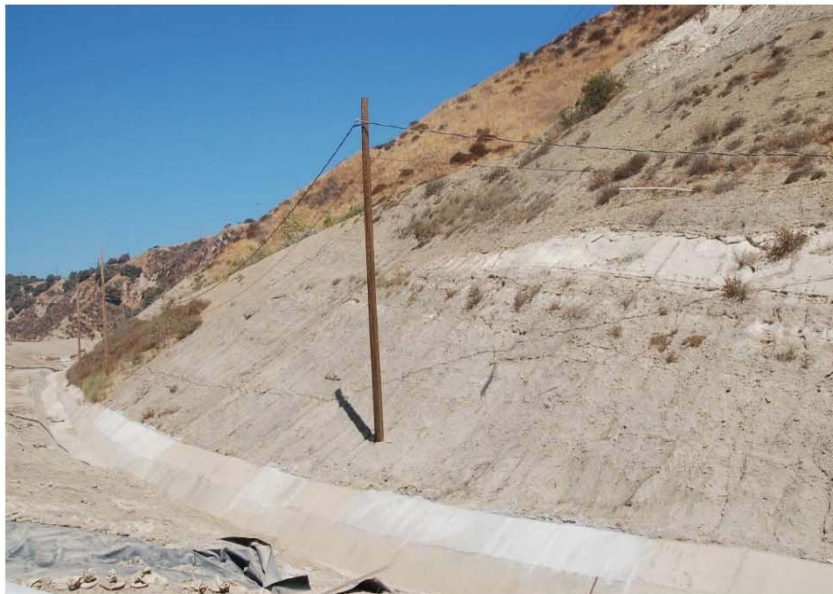
Photo 14: Repaired shotcrete sidewall of eastern drainage channel

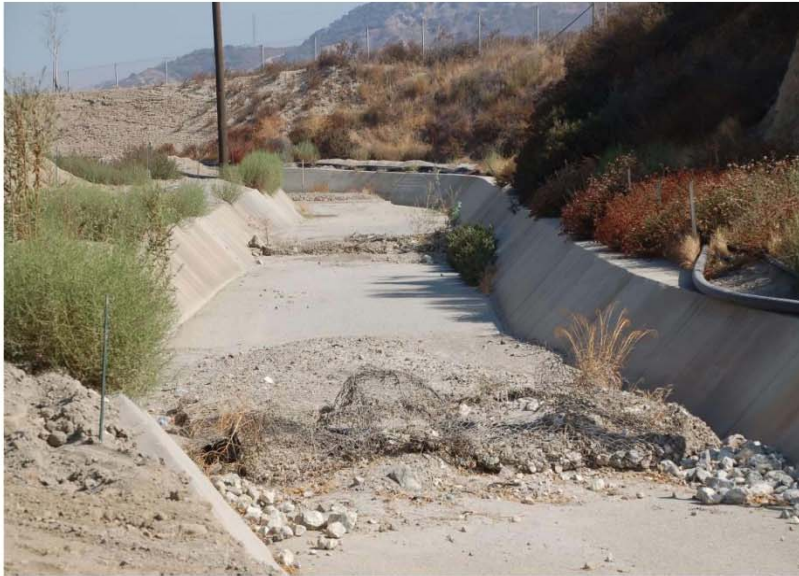
Photo 15: Debris in southern reach of east drainage channel

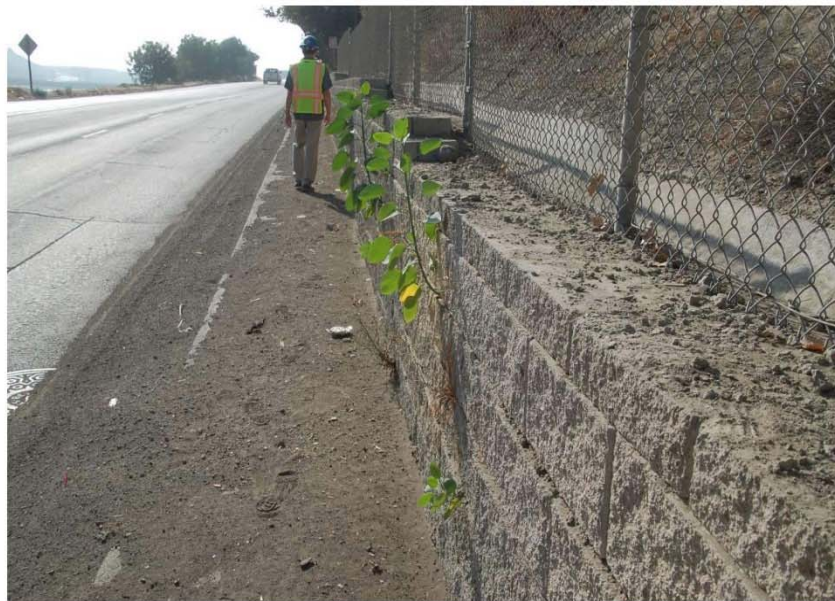
Photo 16: Retaining wall along San Fernando Road: Vegetation growing through precast elements of and sediments against curb blocking drains from swale

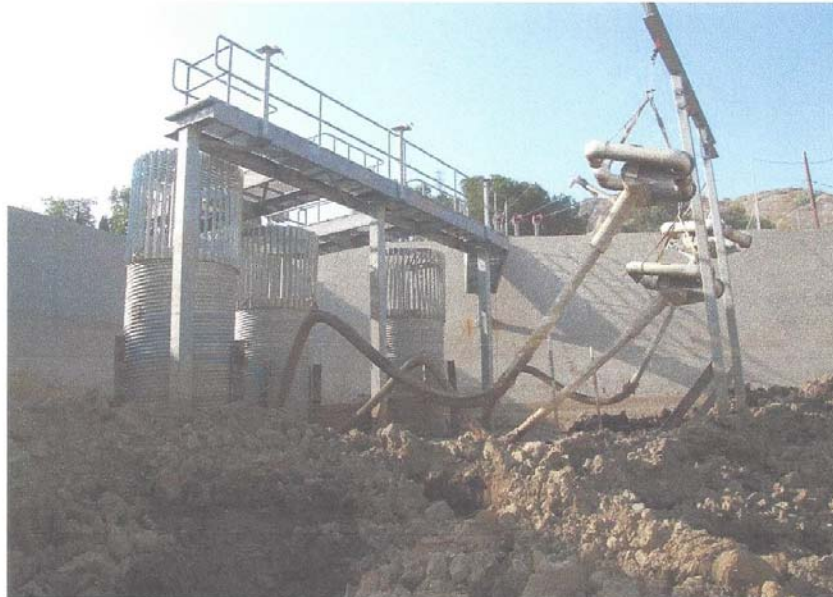
Photo 3: Sediment in terminal basin

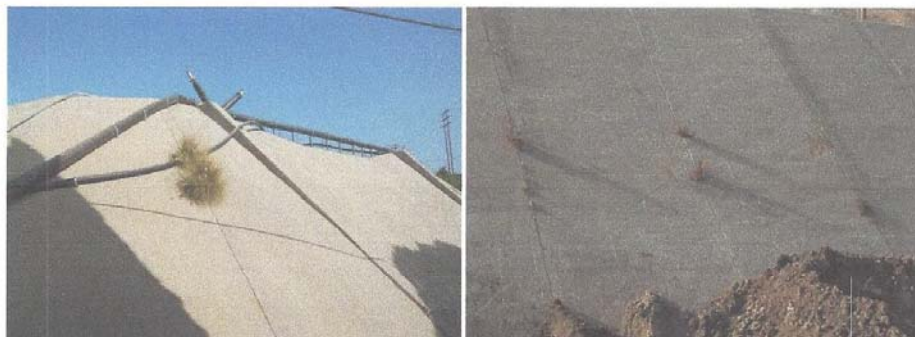
Photo 5: Plants growing in cracks in wall of Terminal Basin

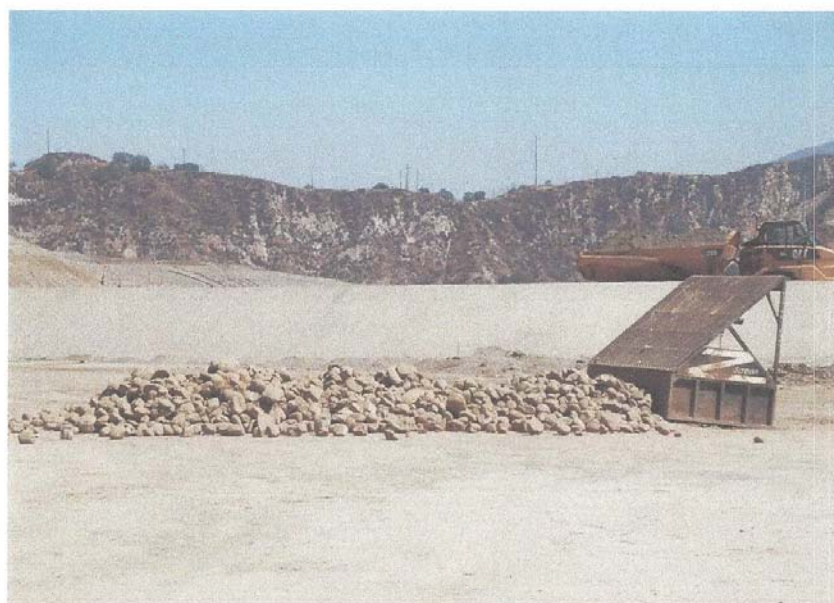
Photo 6: Rocks for drain tower filter at Basin A – leftover sediment to be removed in the back

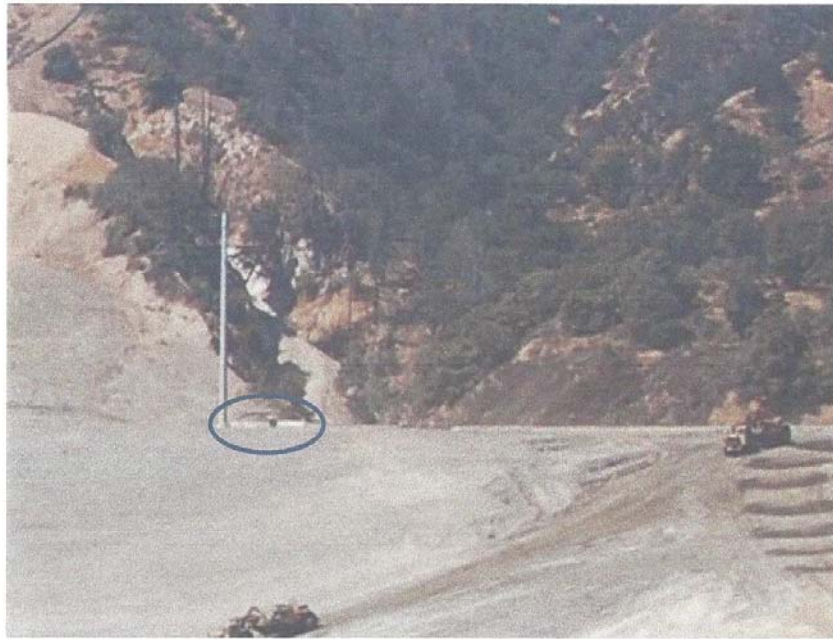
Photo 7: Spillway form Basin A shown in blue circle – Channel was removed downslope of basin

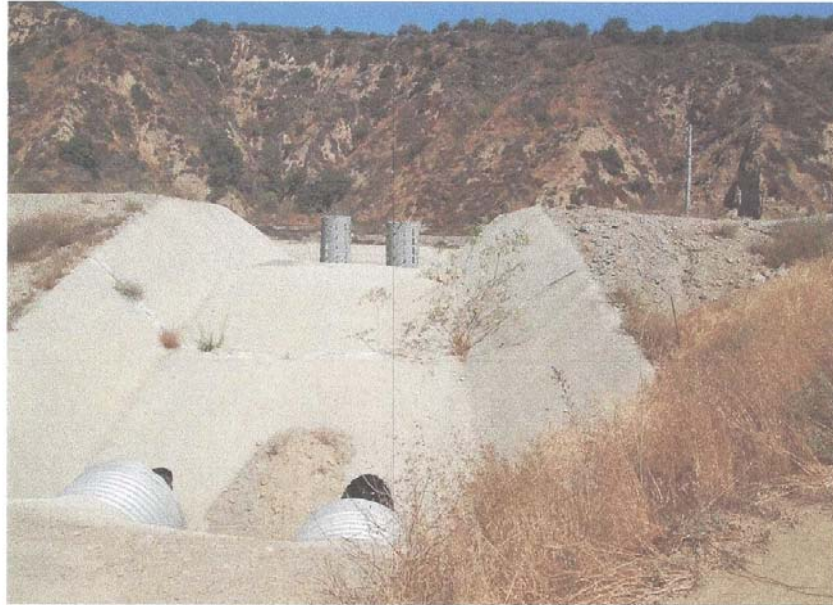
Photo 9: Cracked concrete spillway between two parts of Basin D and vegetation in crack

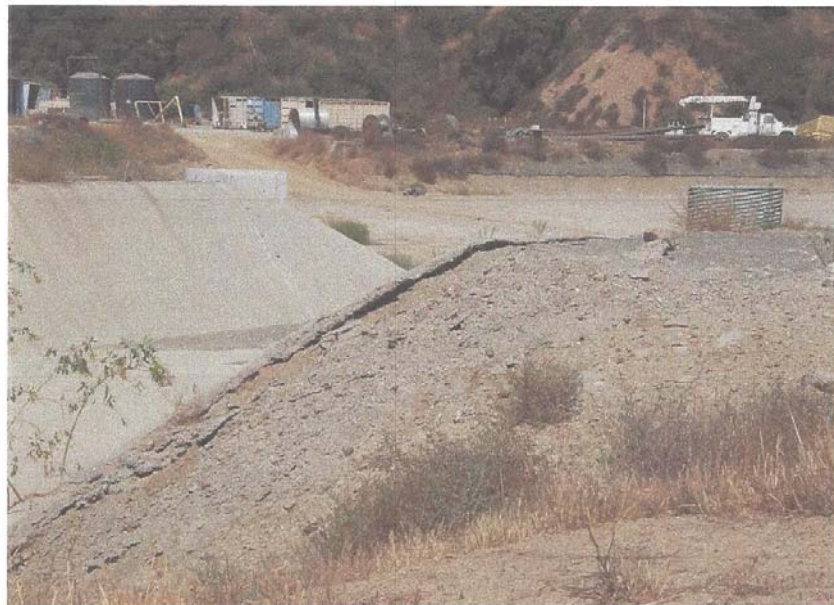
Photo 10: Separation between shotcrete and soil at Basin D

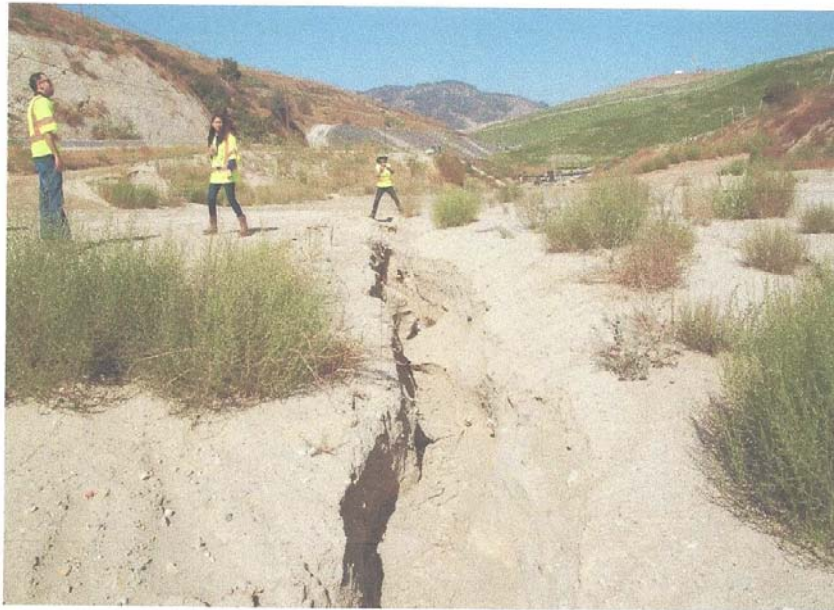
Photo 11: Gully in Cell CC3 basin

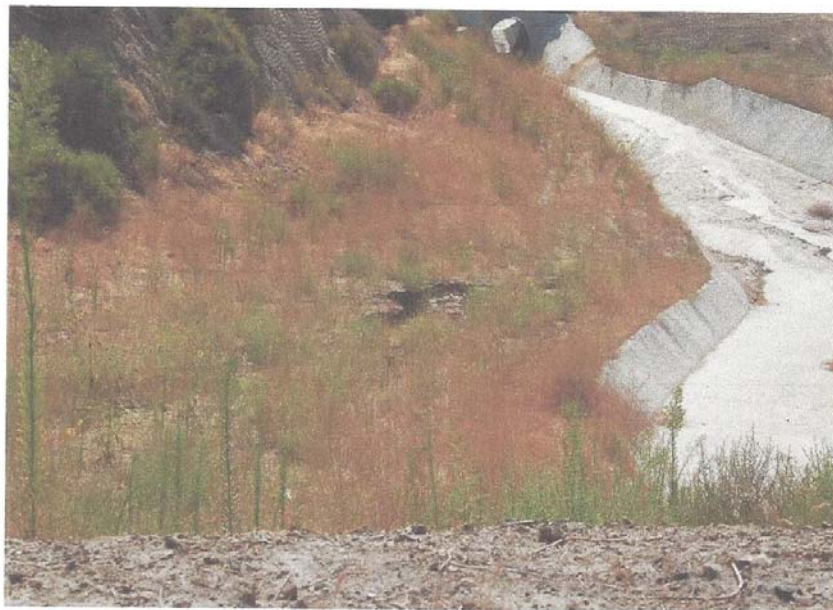
Photo 12: Erosion gully on downstream side of embankment of cell CC3 basin

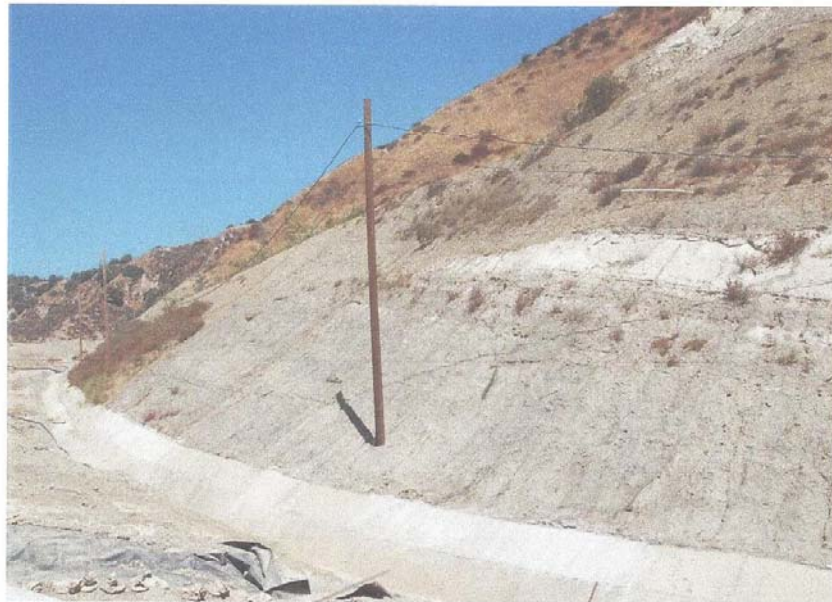
Photo 14: Repaired shotcrete sidewall of eastern drainage channel

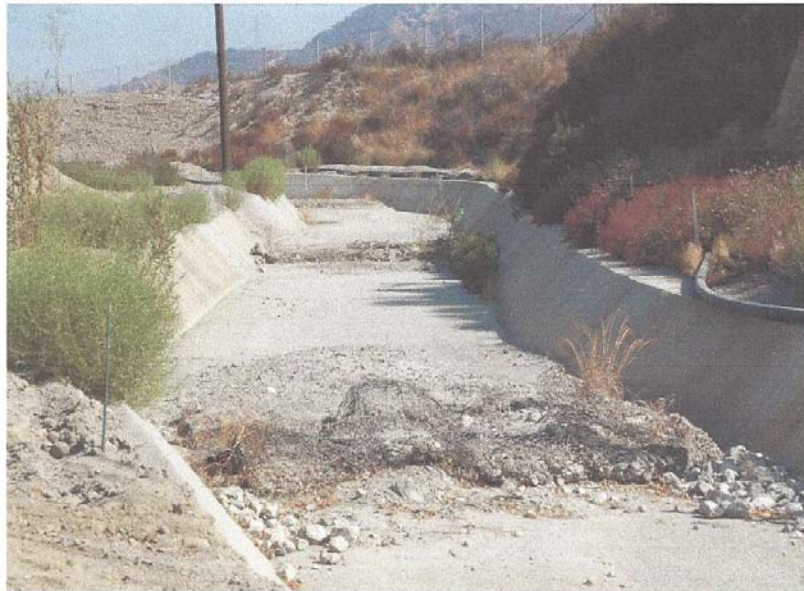
Photo 15: Debris in southern reach of east drainage channel

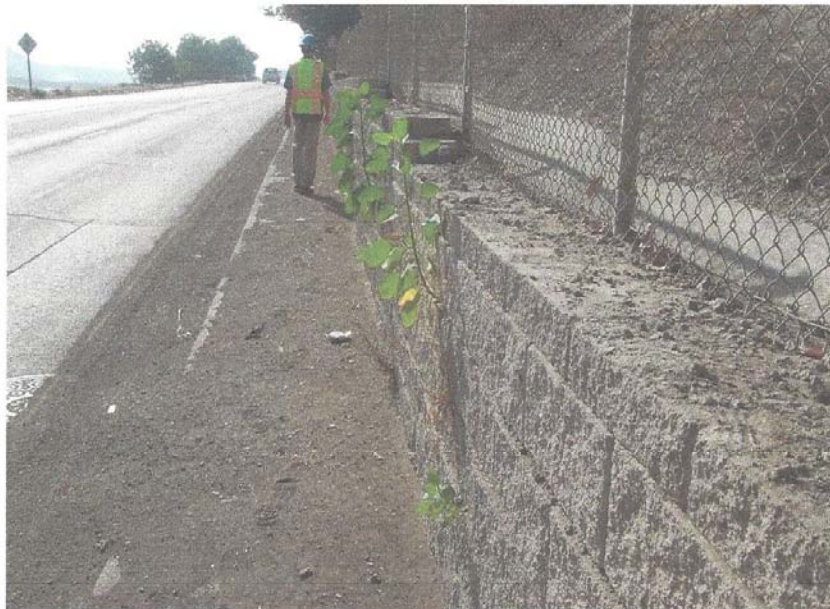
Photo 16: Retaining wall along San Fernando Road: Vegetation growing through precast elements of and sediments against curb blocking drains from swale
