**Sunshine Canyon Landfill
Independent Monitor
Quarterly Site Monitoring Status Report
January 1, 2016 – March 31, 2016**

City of Los Angeles Department of City Planning

County of Los Angeles Department of Regional Planning

May 16, 2016

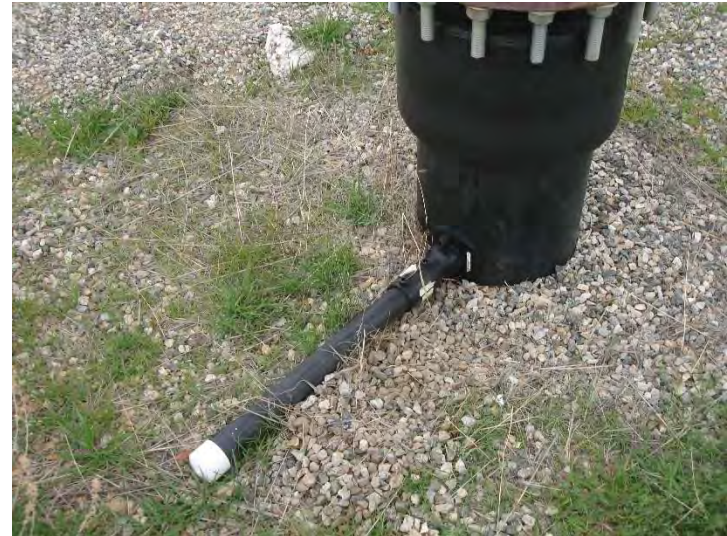
Photo 157: Flare 8 Vacuum Leak: January 27, 2016

Photo 158: Flare 8 Vacuum Leak: January 27, 2016

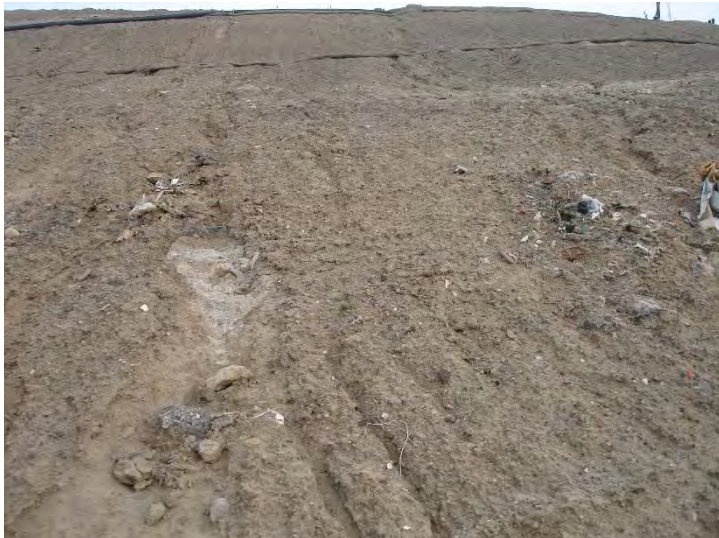
Photo 330: County South Slope Drainage Failure: January 27, 2016

Photo 331: County South Slope Inert Waste Exposed: January 27, 2016

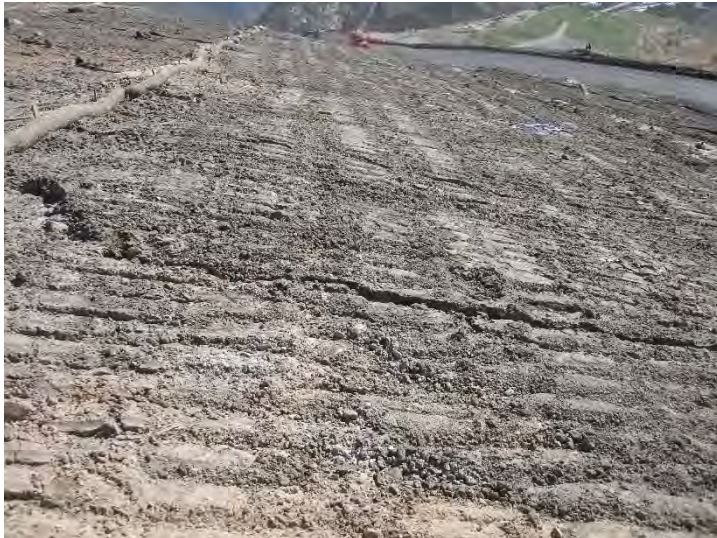
Photo 358: City Slope Erosion, Inert Waste Exposed: February 24, 2016

Photo 359: City Slope Erosion Repair, Inert Waste Exposed: February 24, 2016

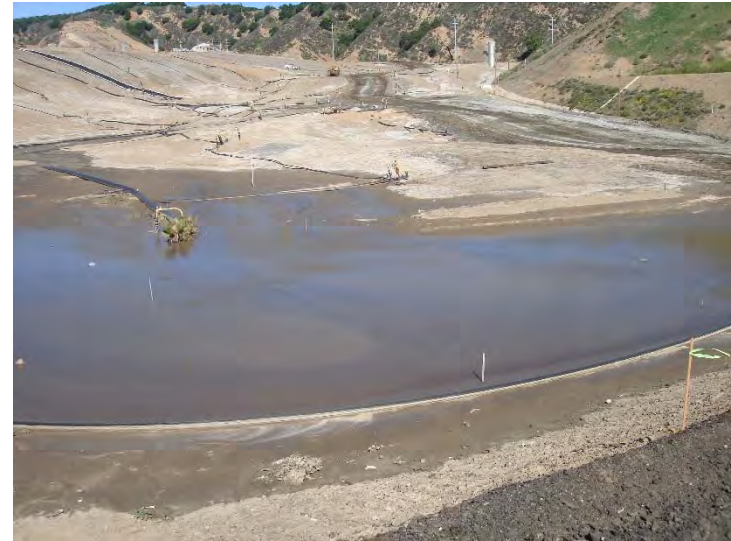
Photo 365: Ponding on City Top Deck: March 9, 2016

Photo 366: Ponding on City Top Deck: March 9, 2016

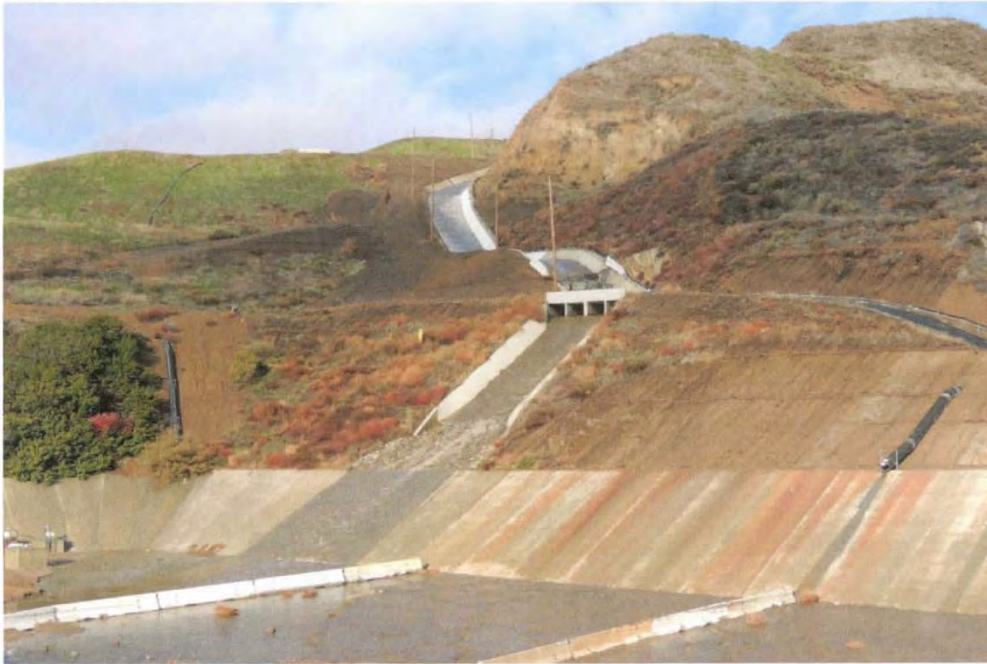
Photo 1: Water flowing along western channel

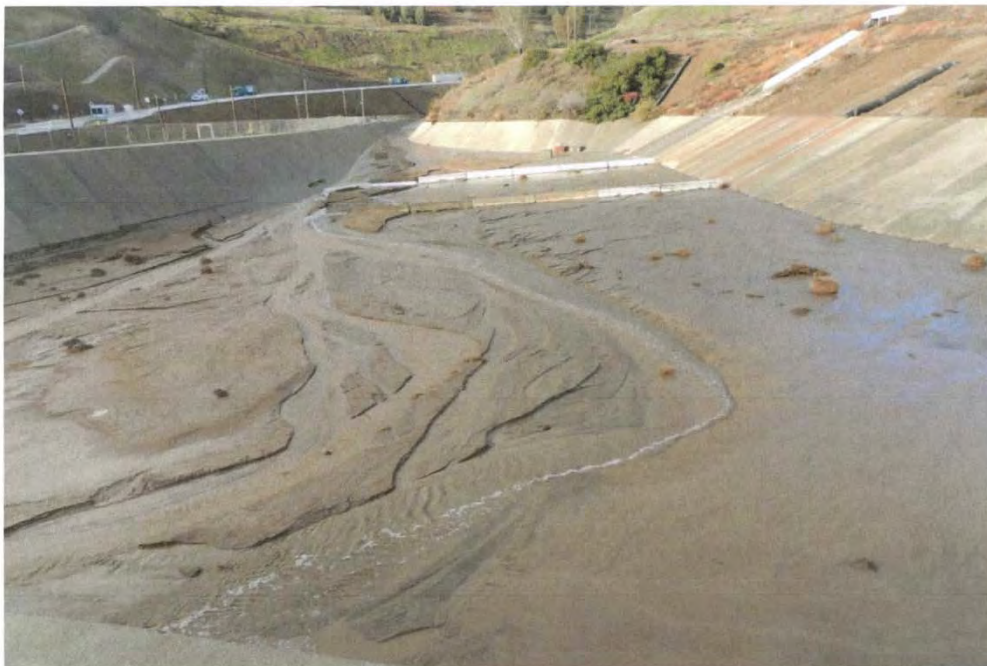
Photo 2: Sediments accumulation in terminal basin

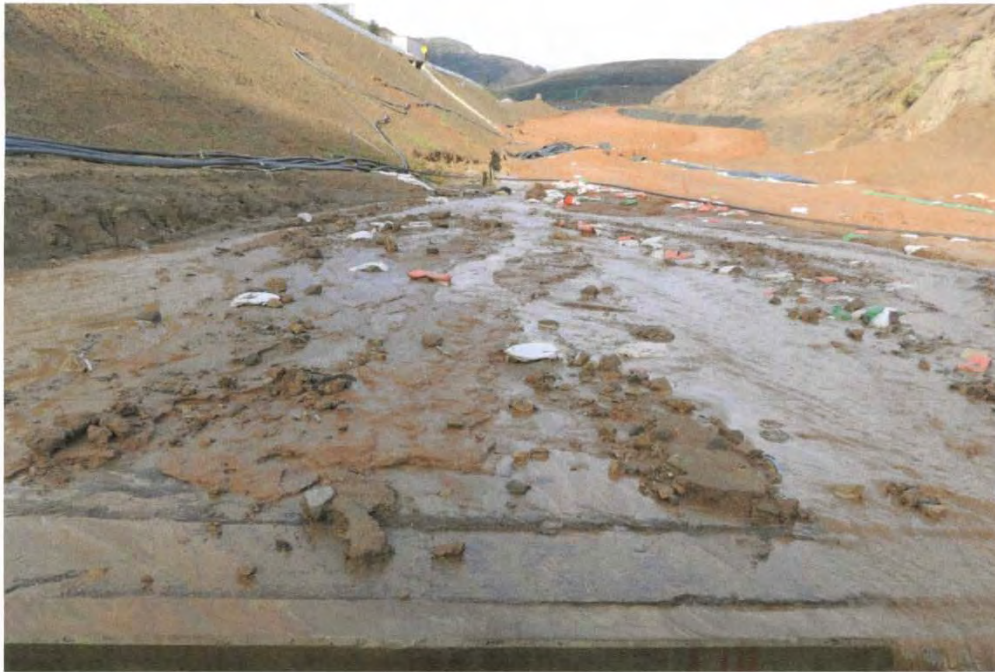
Photo 3: Runoff from cell CC3B

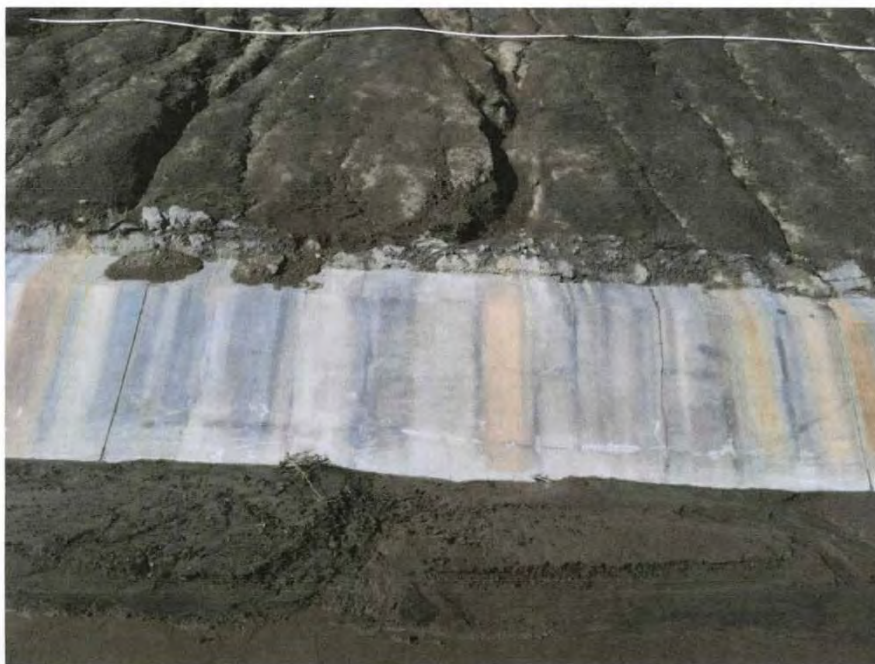
Photo 7: Sediment into channel between Basin A and Basin D

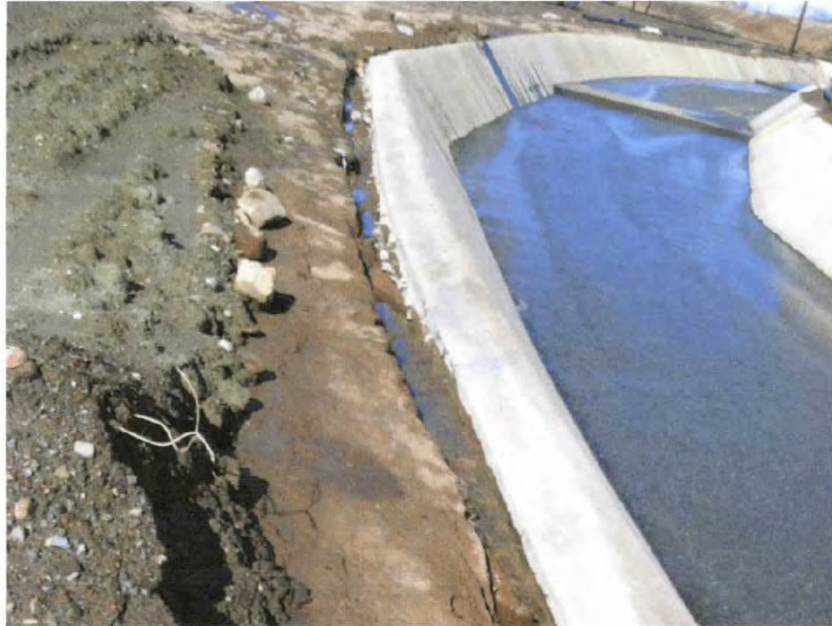
Photo 13: Erosion along edge of west side drainage channel

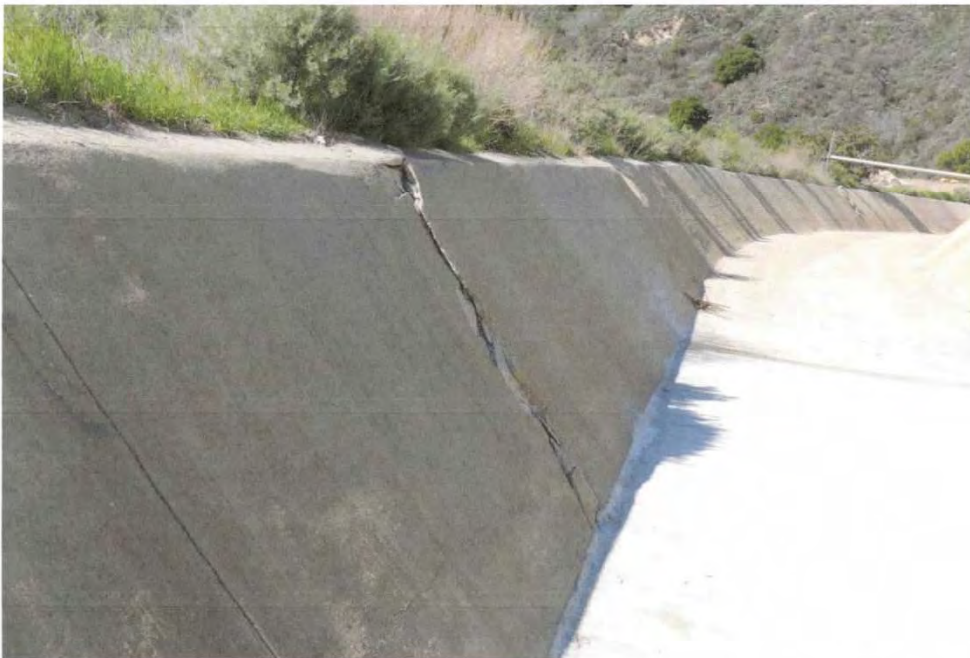
Photo 2: Crack on side wall channel between Basin A and Basin D

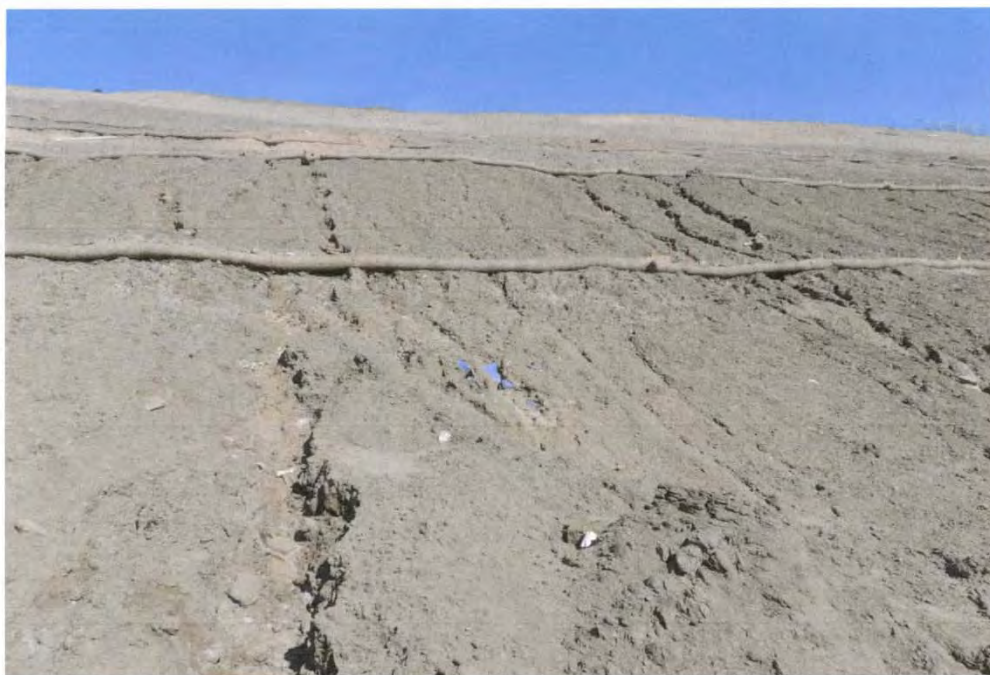
Figure 4: Erosion gullies on side slope at Cell II

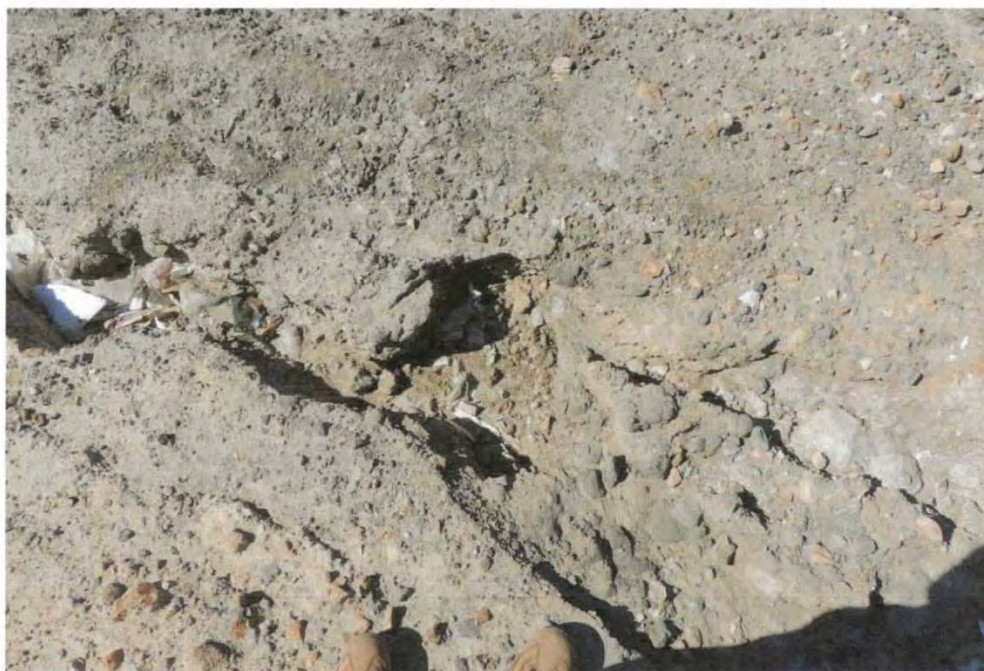
Photo 5: Deep gully on on side slope at Cell II showing refuse

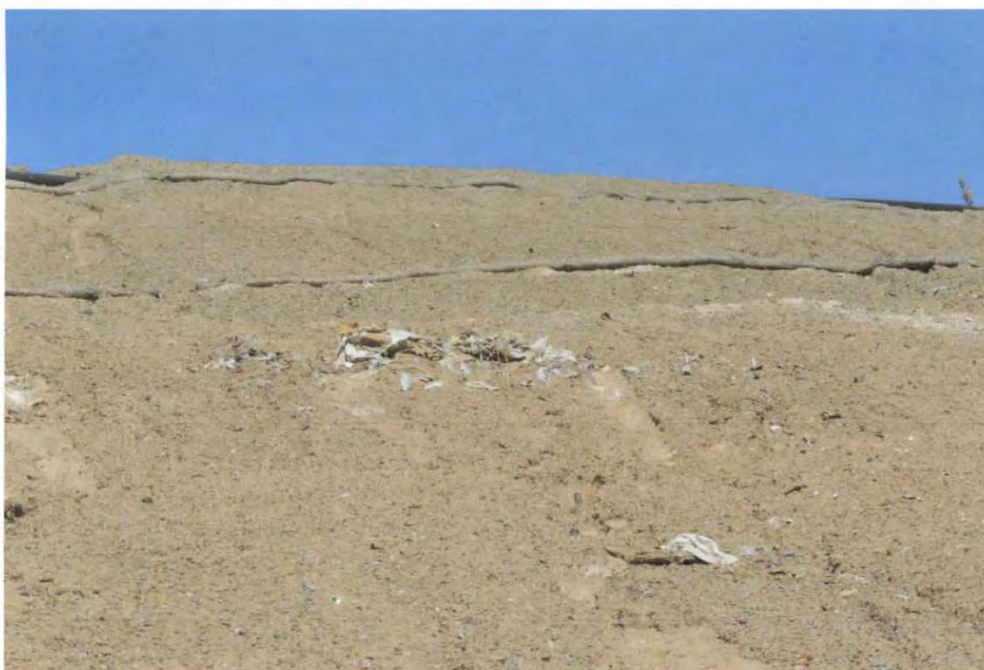
Photo 6: Inert waste showing on southeast facing slope of old county landfill

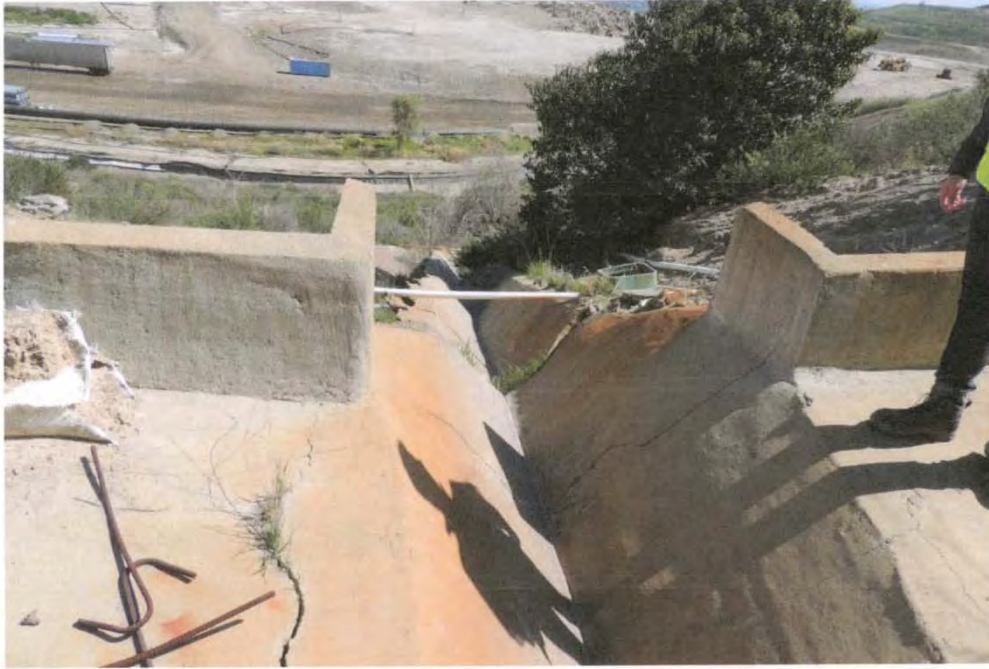
Photo 9: Crack in downchute at coastal sage mitigation area

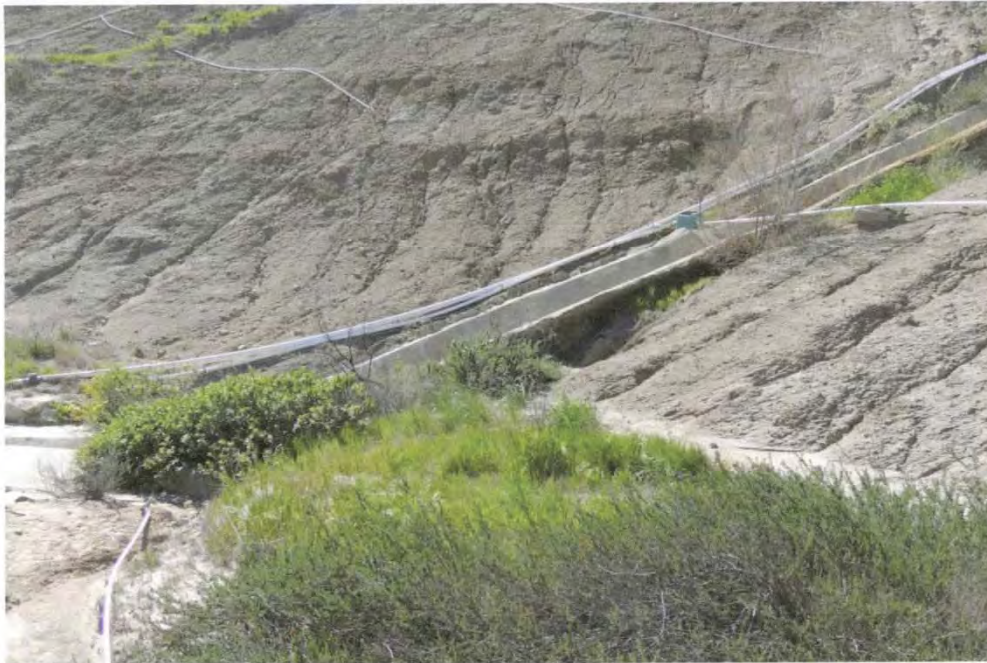
Photo 10: Erosion along edge of downchute at coastal sage mitigation area

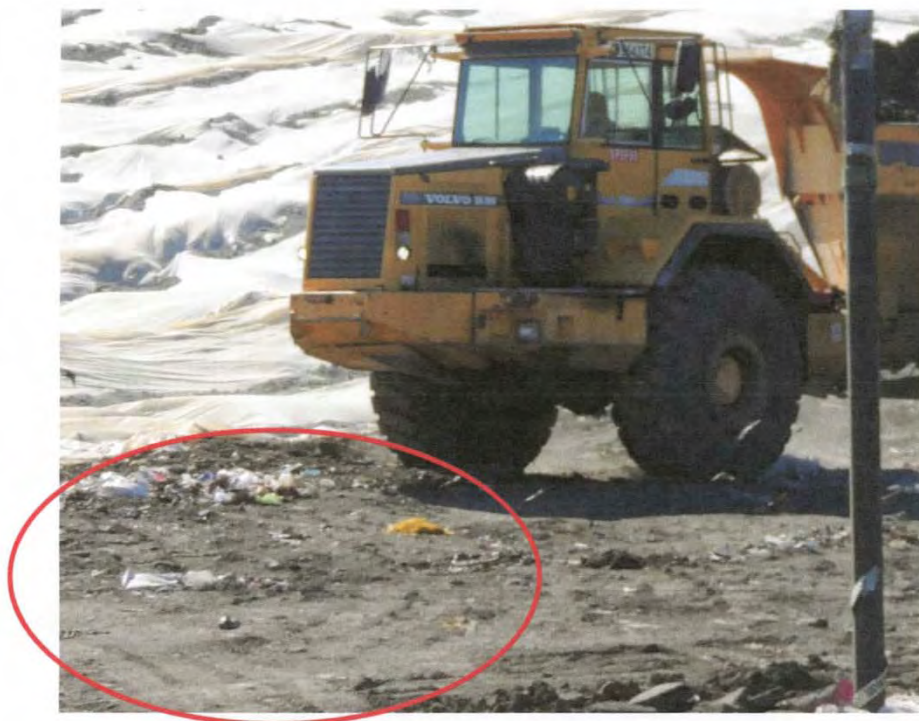
Photo 11: Waste not covered by ADC along the edges

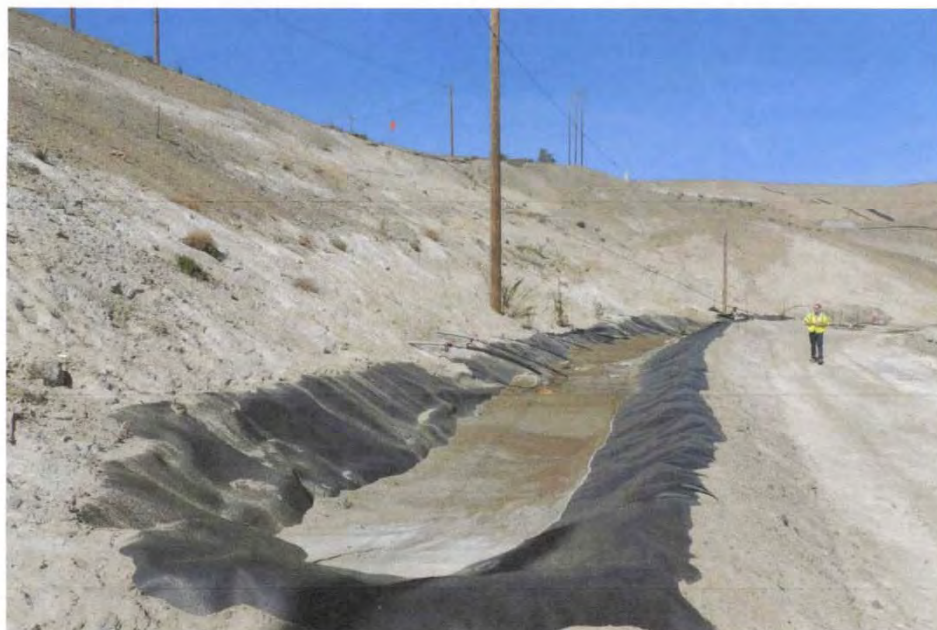
Seep collections
<ul style="list-style-type: none">• Flows from the seeps at the excavated face of future cell CCII are collected and properly managed (Photo 12).
Retaining wall along San Fernando Road
<ul style="list-style-type: none">• sloughed soil is piling up against the wire fence above the wall and filled up the concrete drainage ditch built on top of wall (Photo 13)• a tree at top of slope is leaning dangerously with partially exposed root bulb –its stability should be evaluated as it fell it would take down the pore lien and lead to road blockage (Photo 14)
FURTHER REVIEW NEEDED
COMMENTS
Signed:

Photo 12: Seep collection at toe of future Cell CCII

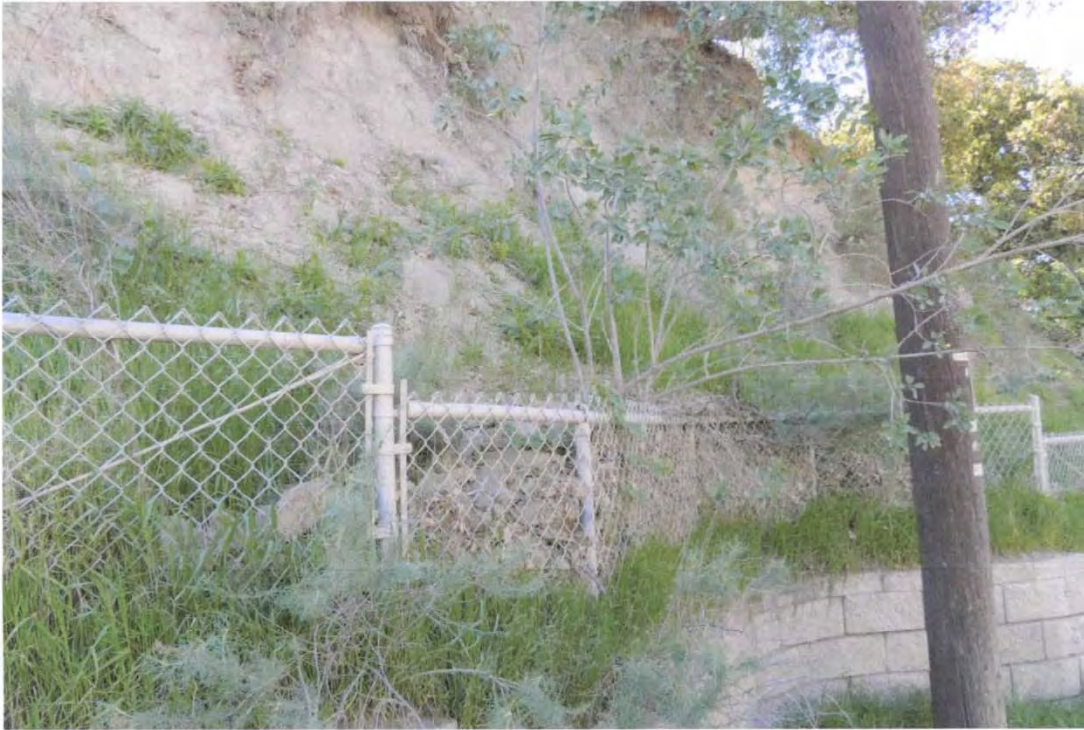
Photo 13: Soil accumulated against the wire fence at wall along San Fernando Road

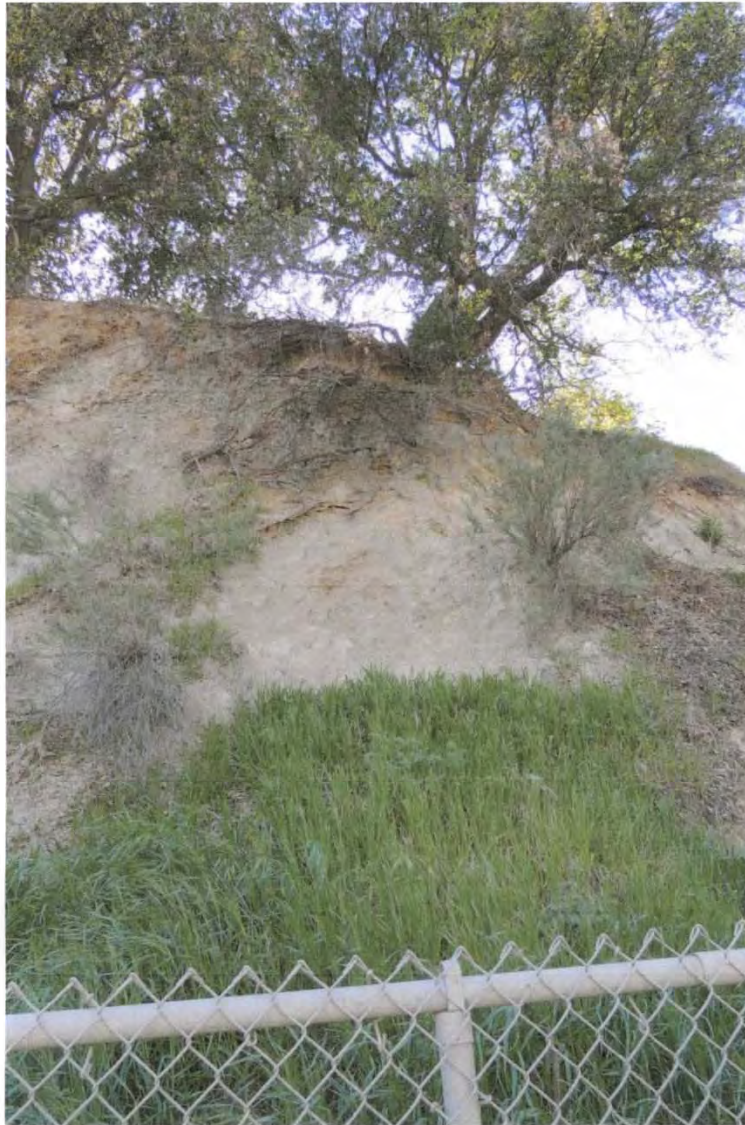
Photo 14: At risk tree above slope at wall along San Fernando Road
