# Sunshine Canyon Landfill Independent Monitor Quarterly Site Monitoring Status Report July 1, 2020 – September 30, 2020

### **City of Los Angeles Department of City Planning**

### **County of Los Angeles Department of Regional Planning**

January 6, 2021

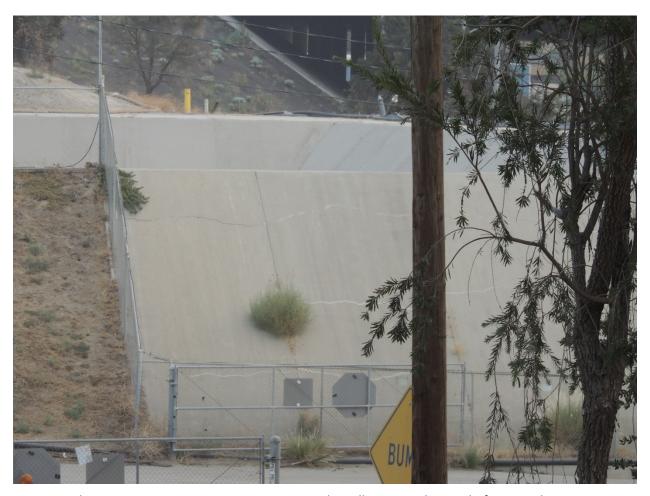
In the 3rd Quarter, it was observed that vegetation was growing out of numerous cracks in the water retention basins and drainage conveyance channels' concrete. The terminal basin had vegetation growing out of cracks in the interior and exterior concrete side walls and top access walkway. Basins B and D concrete outlets had vegetation growing in cracks. The eastside drainage channel had vegetation growing in and adjacent to the concrete channel. Areas of the channels and basins need repair of the concrete and sealing of cracks when vegetation is removed.

Photo THH-1: Vegetation growing in outside wall Water at low end of Terminal Basin

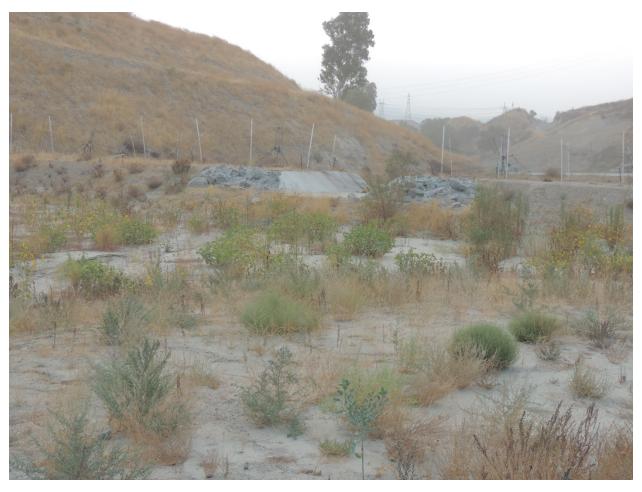
Photo THH-2: Vegetation in Cell CC3 Basin

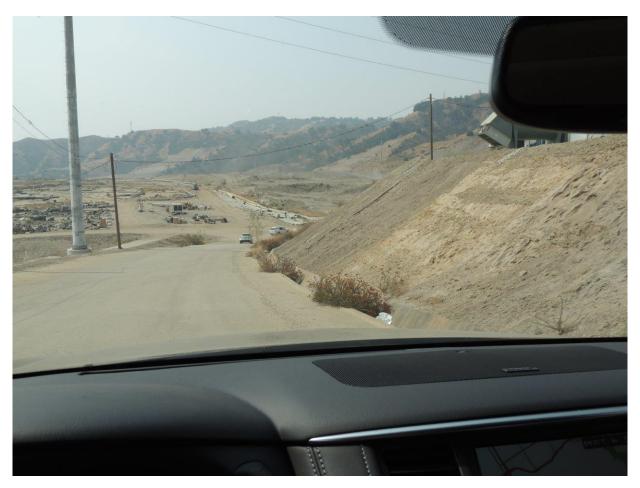
Photo THH-3: Ditches along access road to Flares 9-11
