**Sunshine Canyon Landfill
Independent Monitor
Quarterly Site Monitoring Status Report
October 1, 2016 – December 31, 2016**

UltraSystems
environmental | management | planning

April 19, 2017

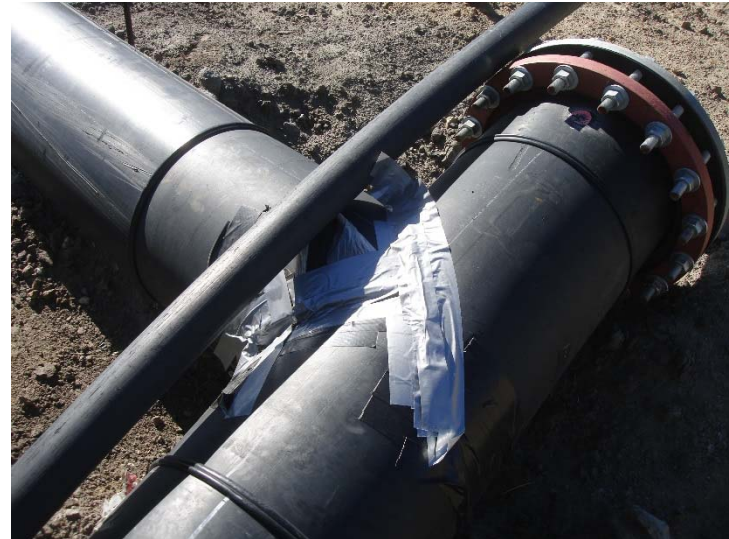
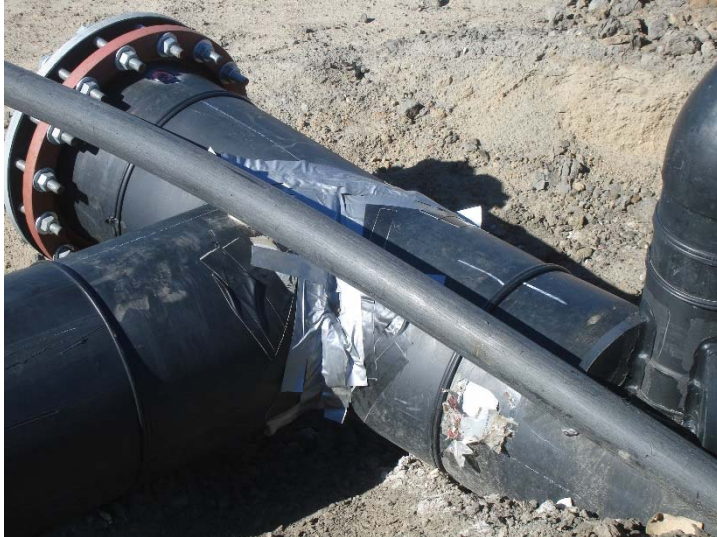
In late November, there was a slight trash odor at Timber Ridge Drive at 7:15 a.m. which was not detected 30 minutes later. There were no other adjacent neighborhood locations where odor was detected. The sewer deep well pump vault area was odorous and the odors could be detected on San Fernando Road. Trucks entering the landfill were observed dripping liquids on the main access road near the oil field road turn-off. There was a localized odor detected near CS-30. A 12" HDPE gas header on a Cell CC-3A slope was leaking gas, with duct tape being used to stop the leak.

Photo 98: Broken Gas Collection Pipe at CC4 Slope: November 29, 2016

Photo 99: Broken Gas Collection Pipe at CC4 Slope: November 29, 2016

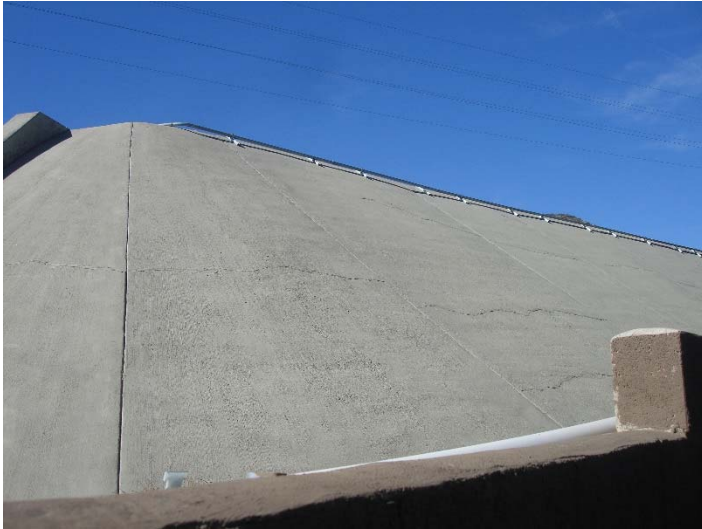
In late November, vegetation was removed from the terminal basin concrete walls and top. Cracks were filled with epoxy. The retaining wall south of the landfill entrance had more soils slide down against the wall fence and on top of the wall drainage. This additional load could pose a problem.

Photo 240: Terminal Basin Front Wall Cleaned: November 29, 2016

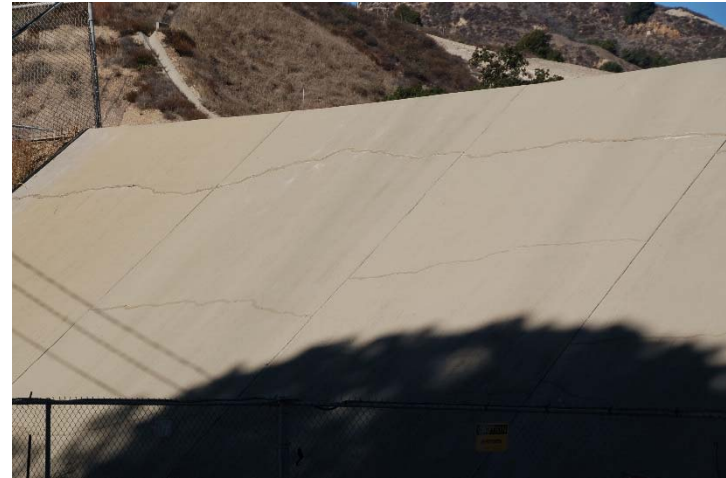
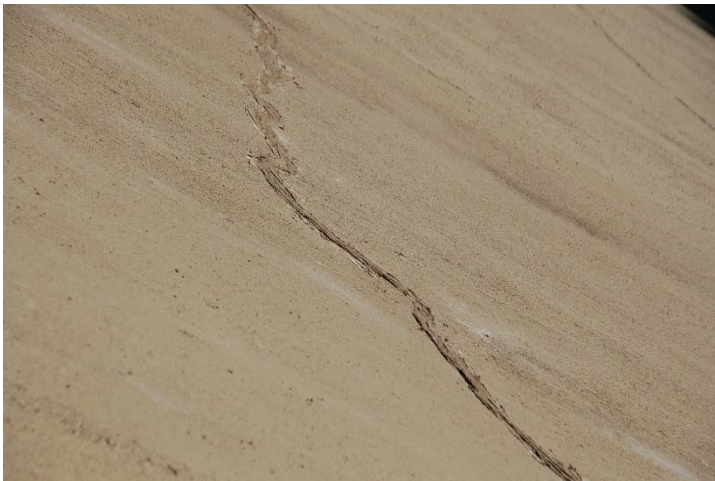
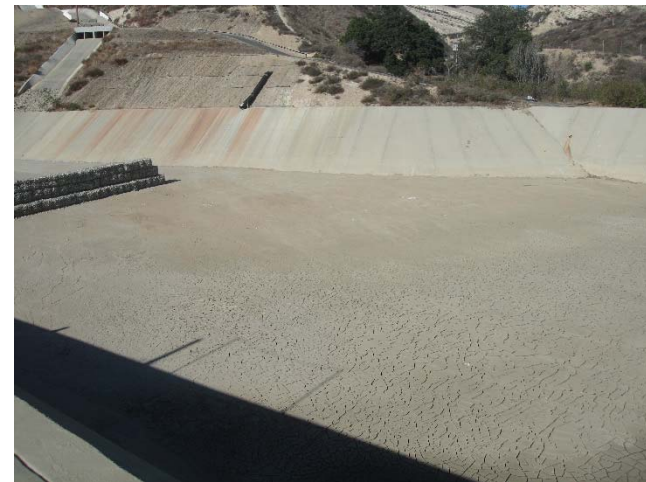
Photo 241: Terminal Basin Exterior Wall Repaired: November 29, 2016

Photo 242: Terminal Basin Exterior Wall Repaired: November 29, 2016

Photo 243: Terminal Basin Exterior Wall Repaired: November 29, 2016

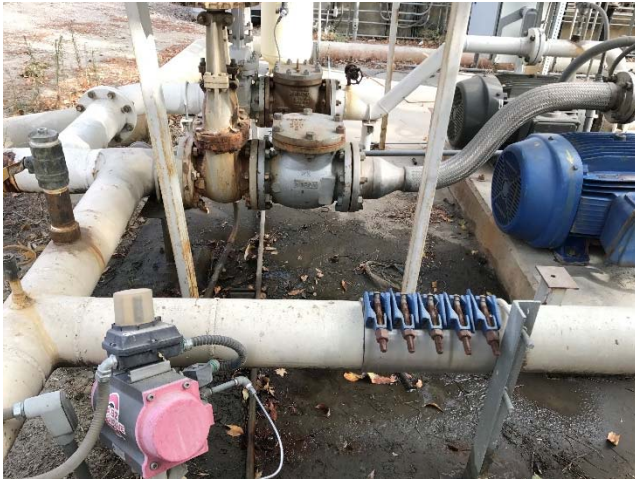
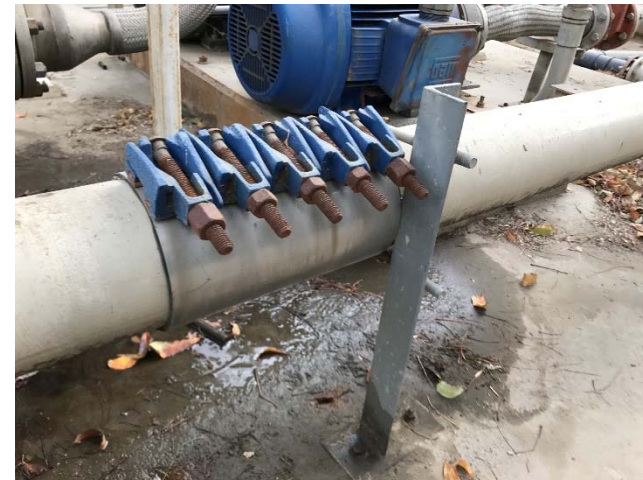
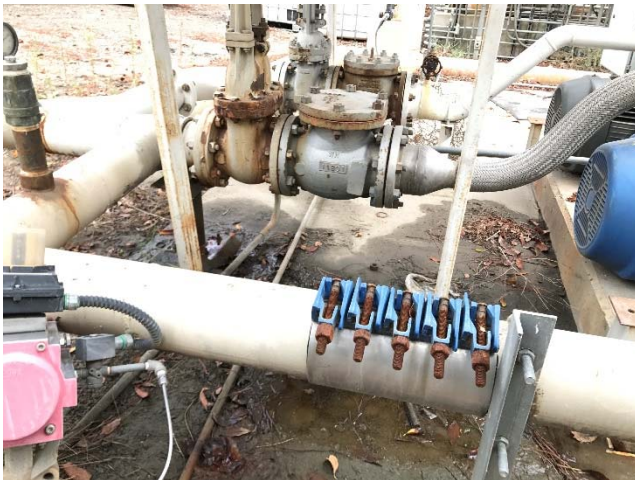
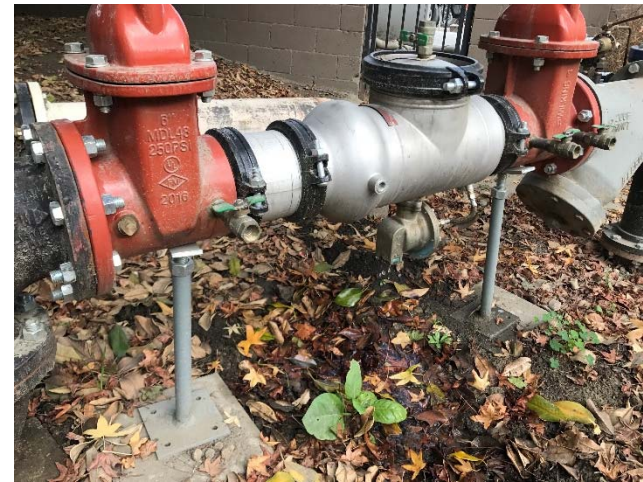
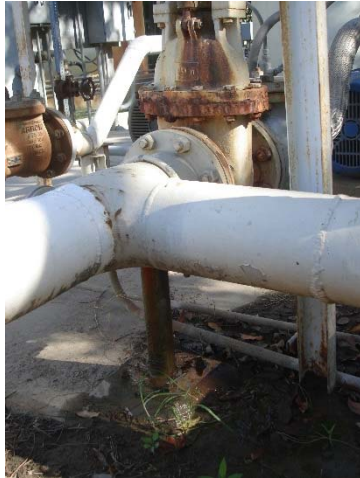
**Photo 248: Potable Water Leak in Graywater Handling area:
October 11, 2016**

**Photo 249: Potable Water Leak in Graywater Handling area:
October 11, 2016**

**Photo 250: Potable Water Leak in Graywater Handling area:
October 11, 2016**

**Photo 251: Potable Water Leak in Graywater Handling area:
October 11, 2016**

**Photo 252: Potable Water Leak in Graywater Handling area:
October 11, 2016**

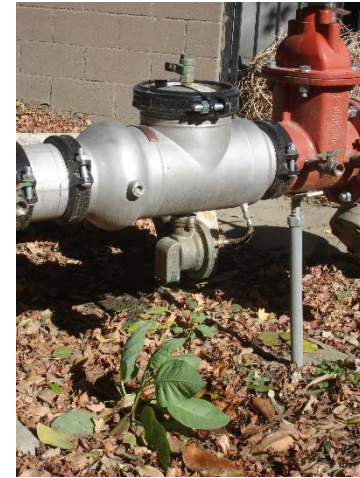
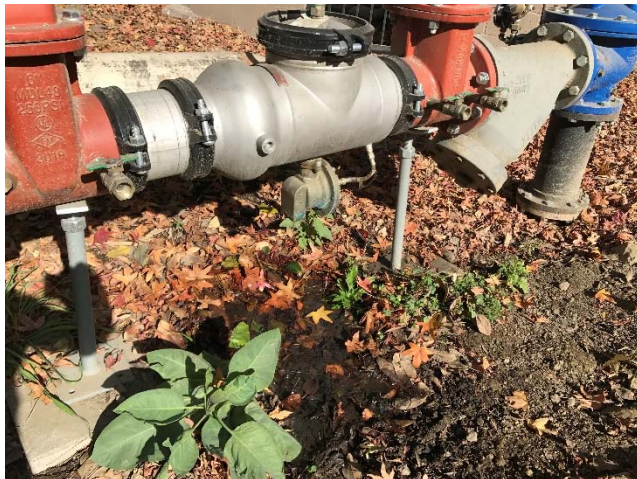
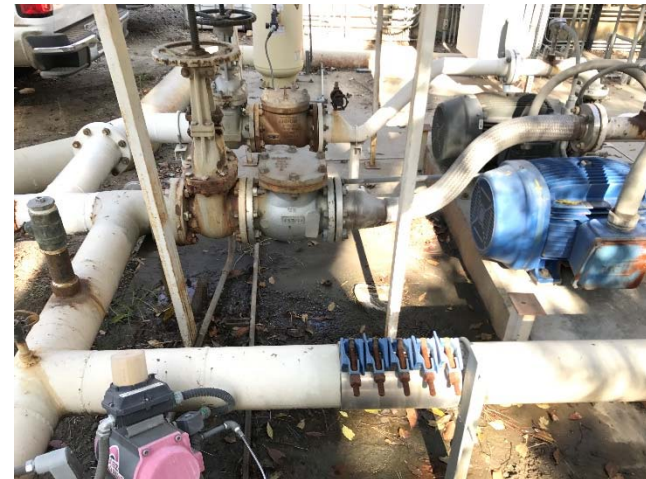
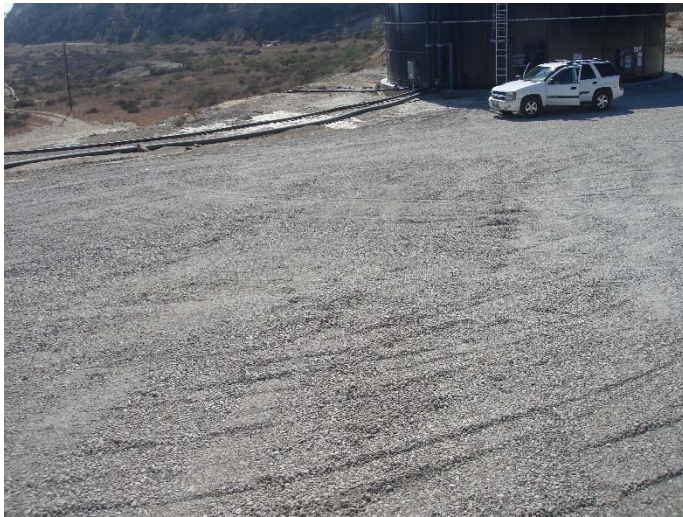
Photo 253: Potable Water Supply Piping Leak: November 29, 2016

Photo 254: Potable Water Supply Piping Leak: November 29, 2016

Photo 255: Potable Water Supply Piping Leak: November 29, 2016

Photo 256: Potable Water Supply Piping Leak: November 29, 2016

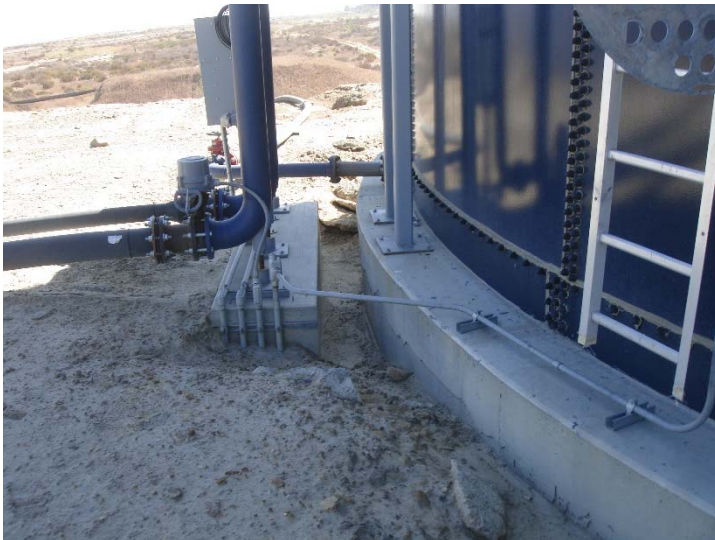
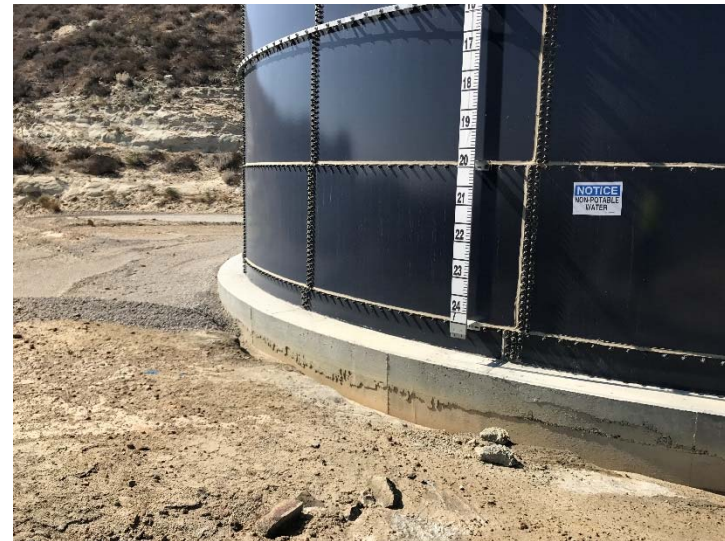
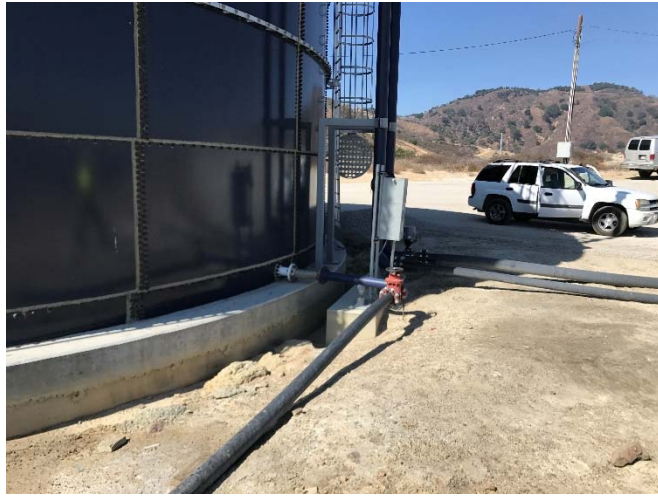
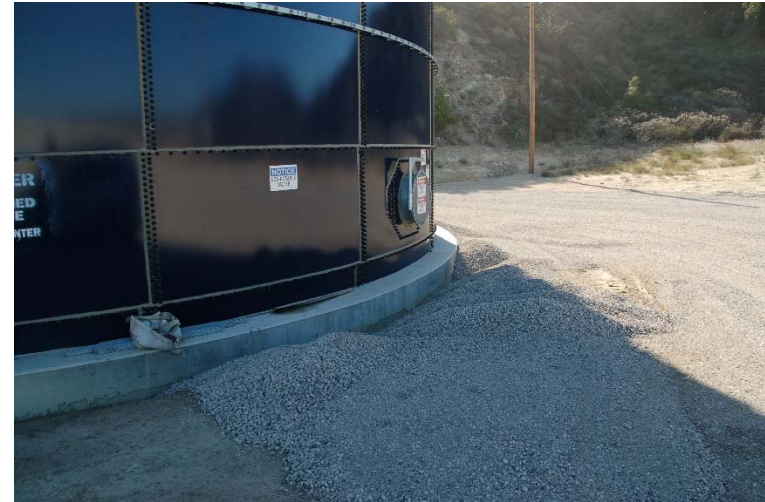
**Photo 258: Deck A Water Tank Foundation Not Backfilled:
October 11, 2016**

**Photo 259: Deck A Water Tank Foundation Not Backfilled:
October 11, 2016**

**Photo 260: Deck A Water Tank Foundation Not Backfilled:
October 11, 2016**

Photo 261: Deck A Water Tank Foundation Not Backfilled: October 11, 2016

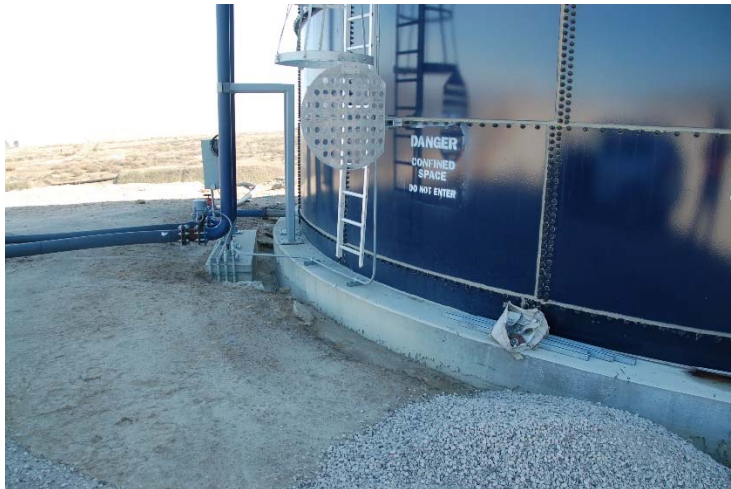
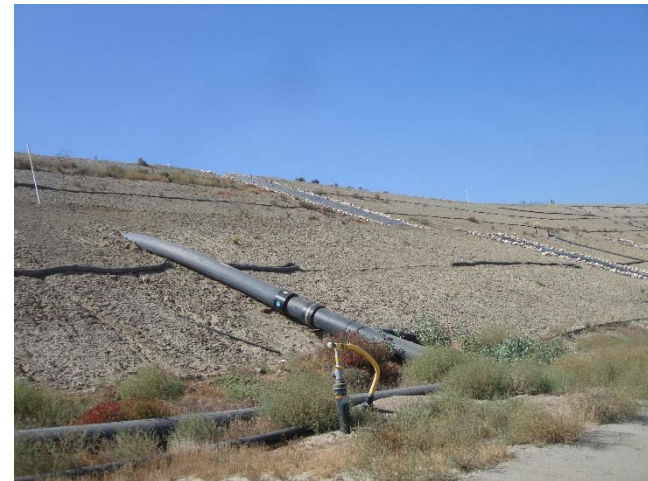
Photo 262: Deck A Water Tank Foundation Not Backfilled: December 14, 2016

Photo 263: Deck A Water Tank Foundation Not Backfilled: December 14, 2016

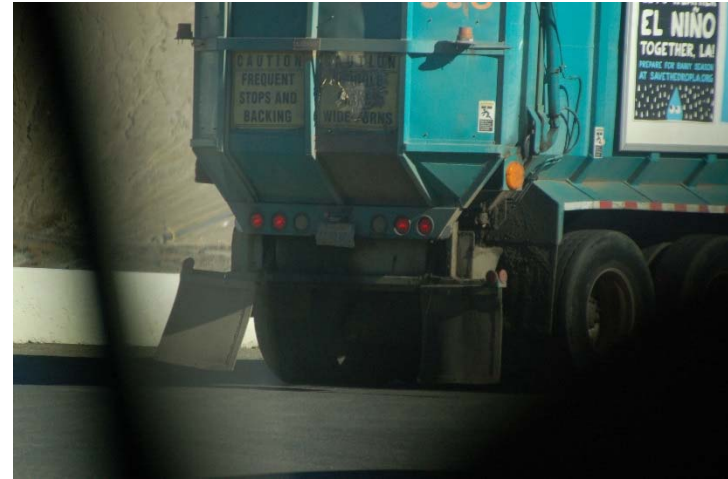
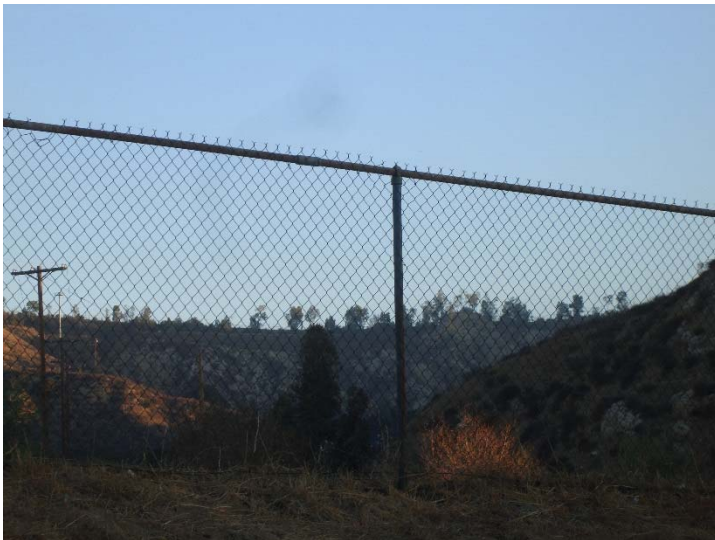
Photo 477: Truck Leaking Liquids near Scales: November 29, 2016

Photo 478: Truck Leaking Liquids near Scales: November 29, 2016

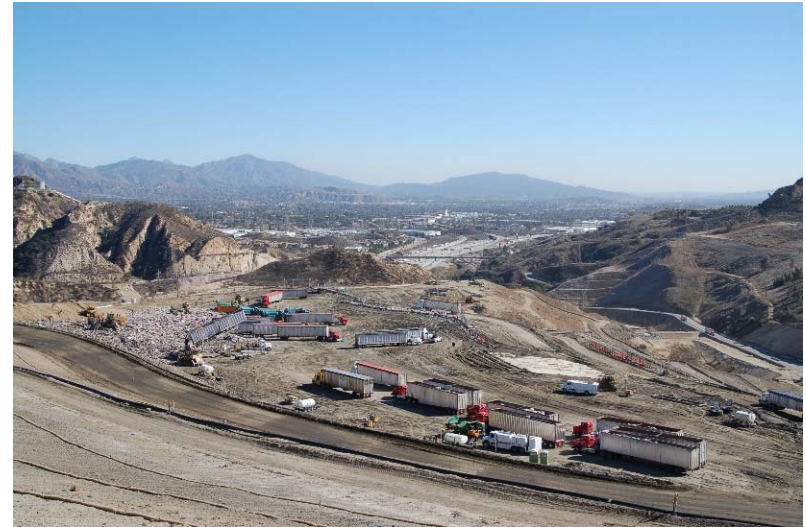
Photo 527: Site - Truck Liquid on Access Road 100pm: November 29, 2016

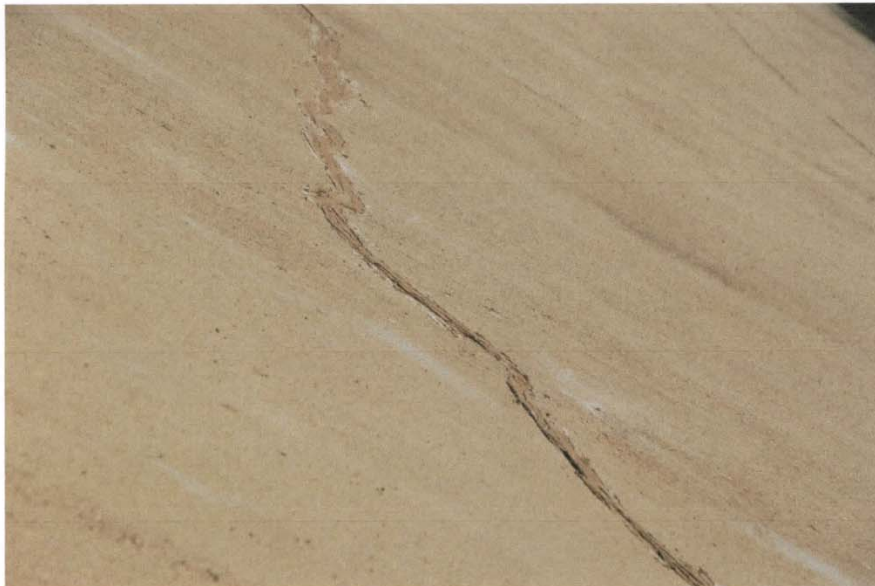
Photo 8: Cracks repaired on wall of terminal basin

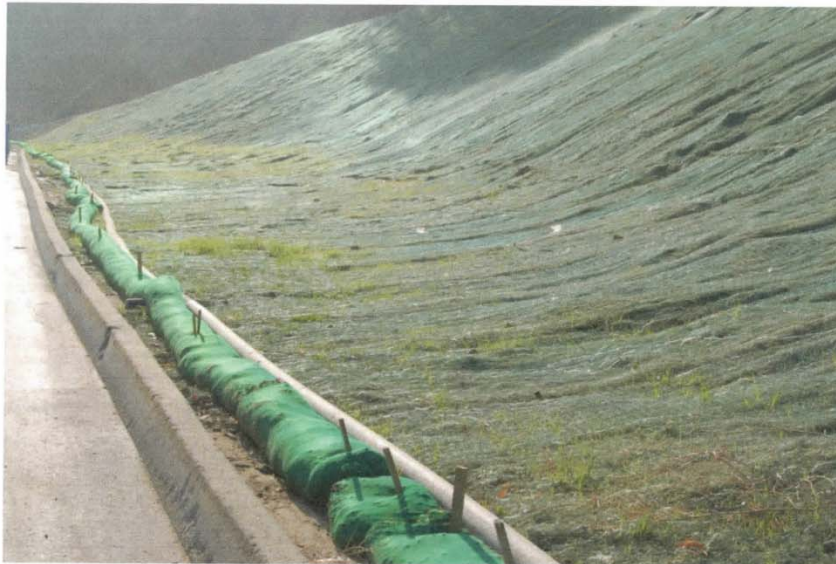
Photo 8: Grass growing through erosion protection system

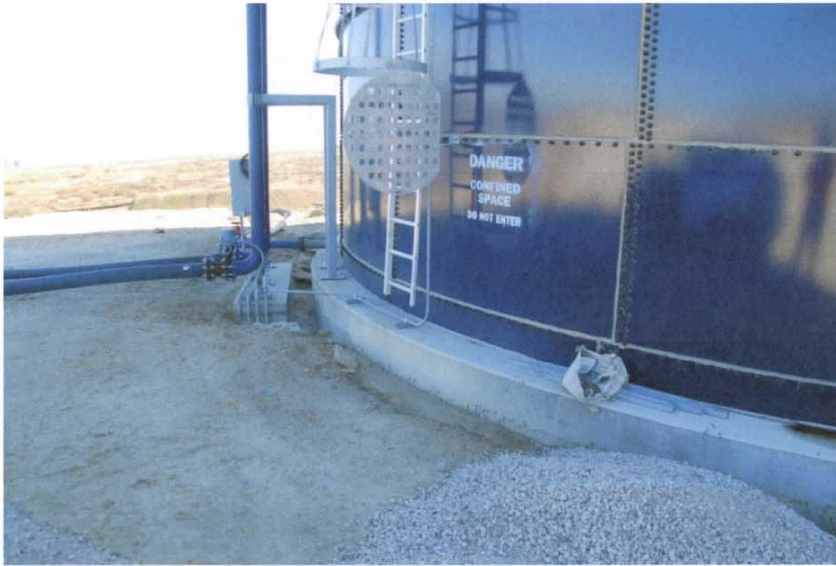
Photo 11: Trench around ring foundation of water tank
