**Sunshine Canyon Landfill
Independent Monitor
Quarterly Site Monitoring Status Report
April 1, 2022 – June 30, 2022**

August 5, 2022

CERTIFICATION STATEMENT

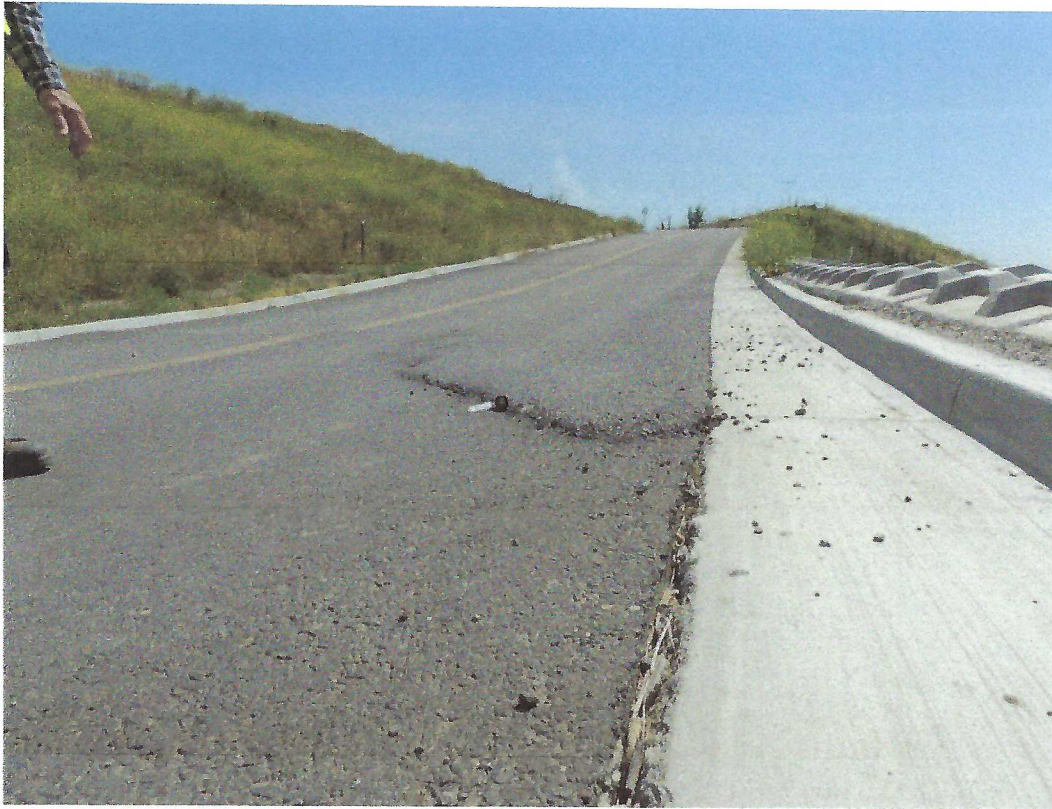
Figure 1 : First crack on access road to the administration pad

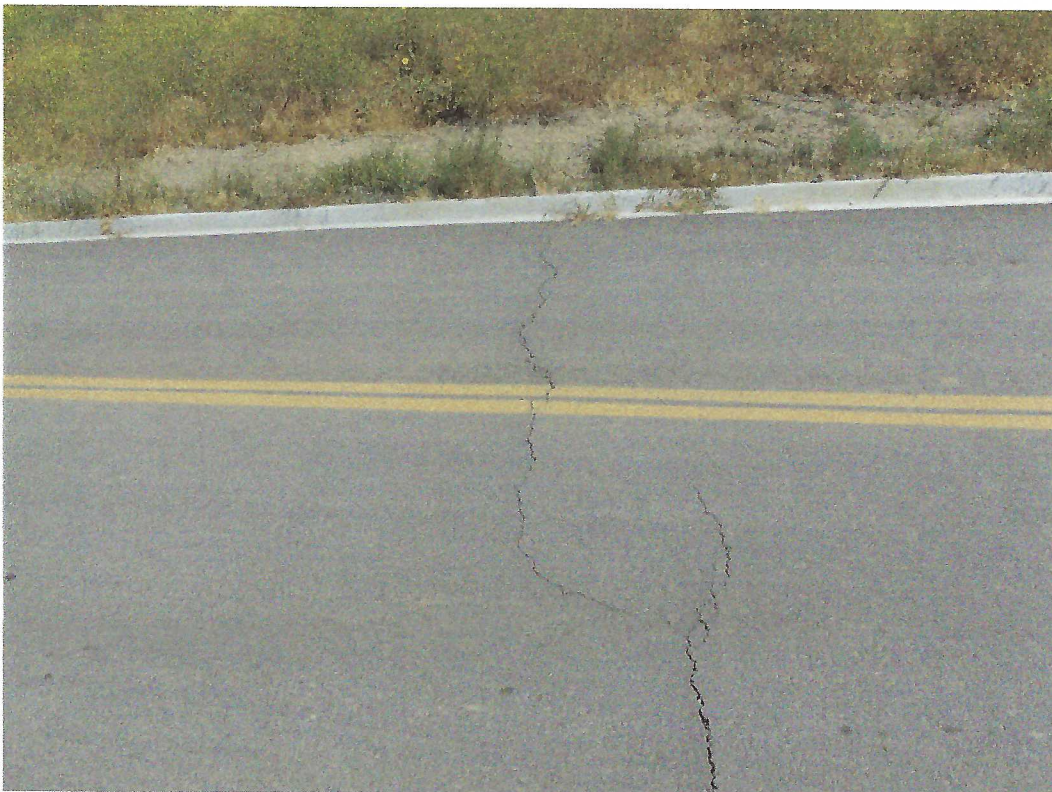
Figure 2 :Second crack on access road to the administration pad

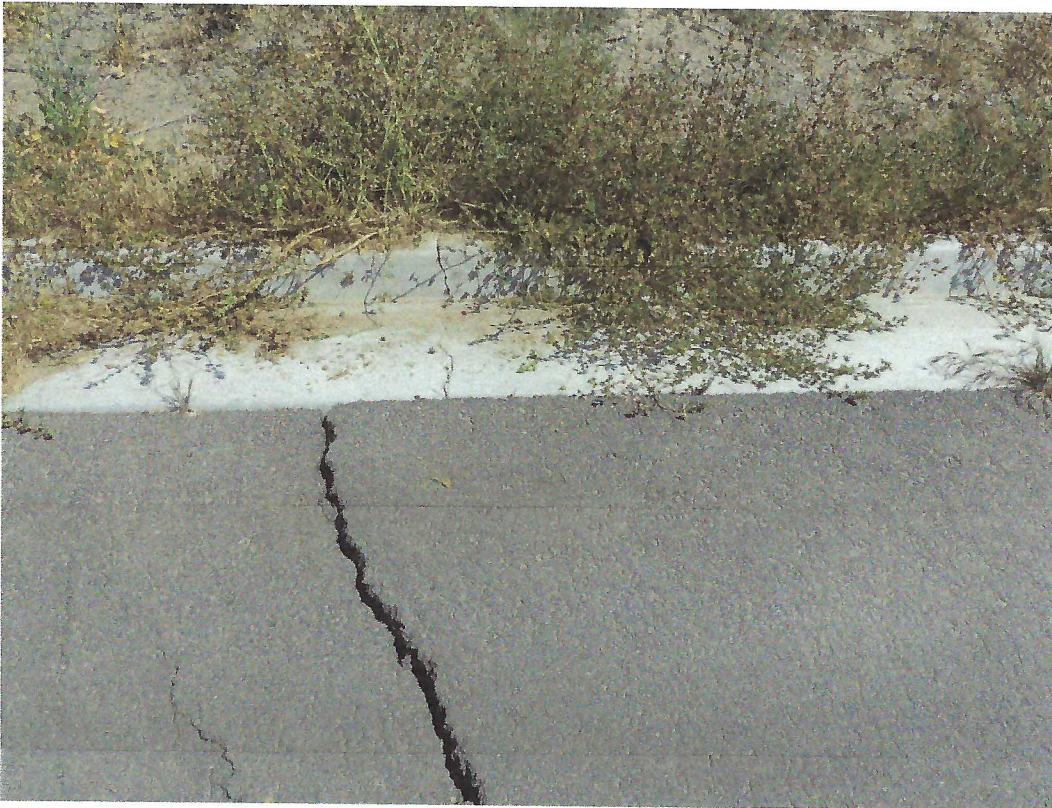
Figure 3 : Second crack on access road to the administration pad, extending through curb

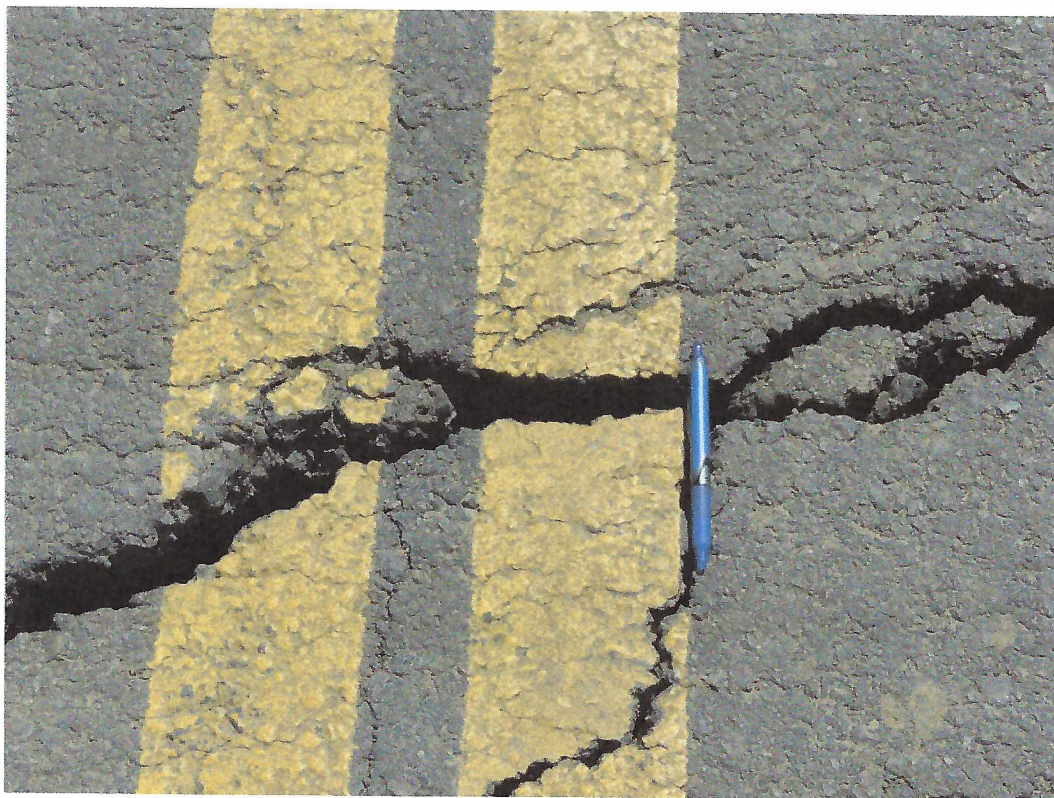
Figure 4: second crack on access road to administration pad: Horizontal offset

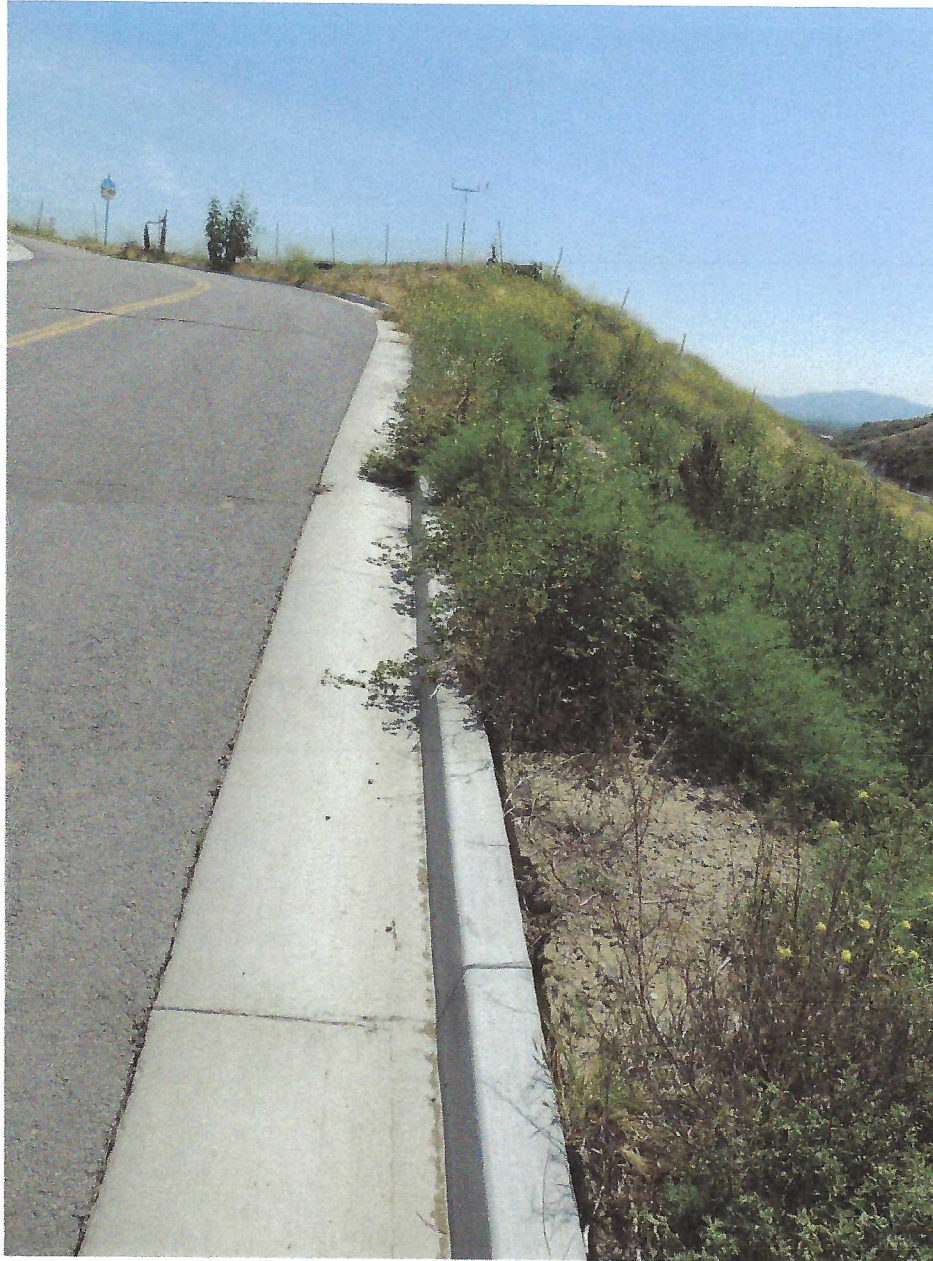
Figure 5: Access road to administration pad: soil separating form curb

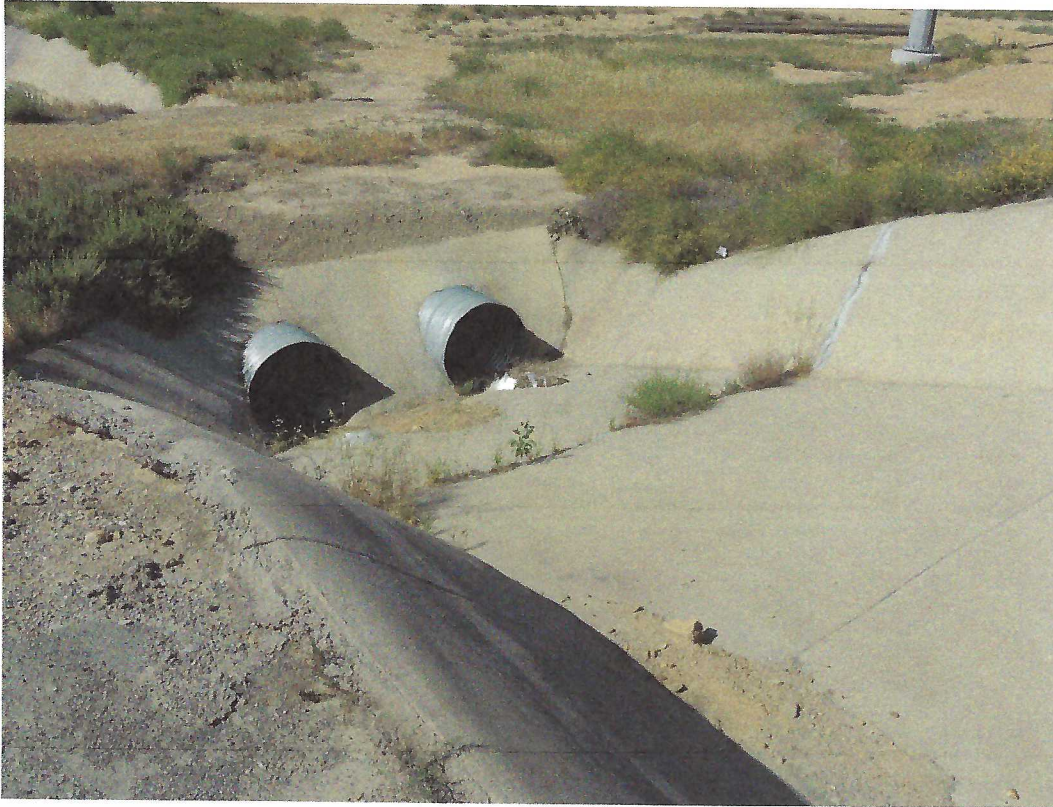
In the 2nd Quarter, it was observed that vegetation was growing out of numerous cracks in the water retention basins and drainage conveyance channels' concrete. There were areas of the channels and basins that needed the growing vegetation to be removed, and repair of the concrete and sealing of cracks. These clean-up and maintenance tasks are put on the monthly preventative maintenance program work list. There were two areas of the eastside channel that were blocked with mud and rock, debris and brush. One was fully blocked and the other one with minimal flow capacity.

Figure 6: Vegetation in cracks at Basin D spillway
