**Sunshine Canyon Landfill
Independent Monitor
Quarterly Site Monitoring Status Report
January 1, 2024 – March 31, 2024**

May 31, 2024

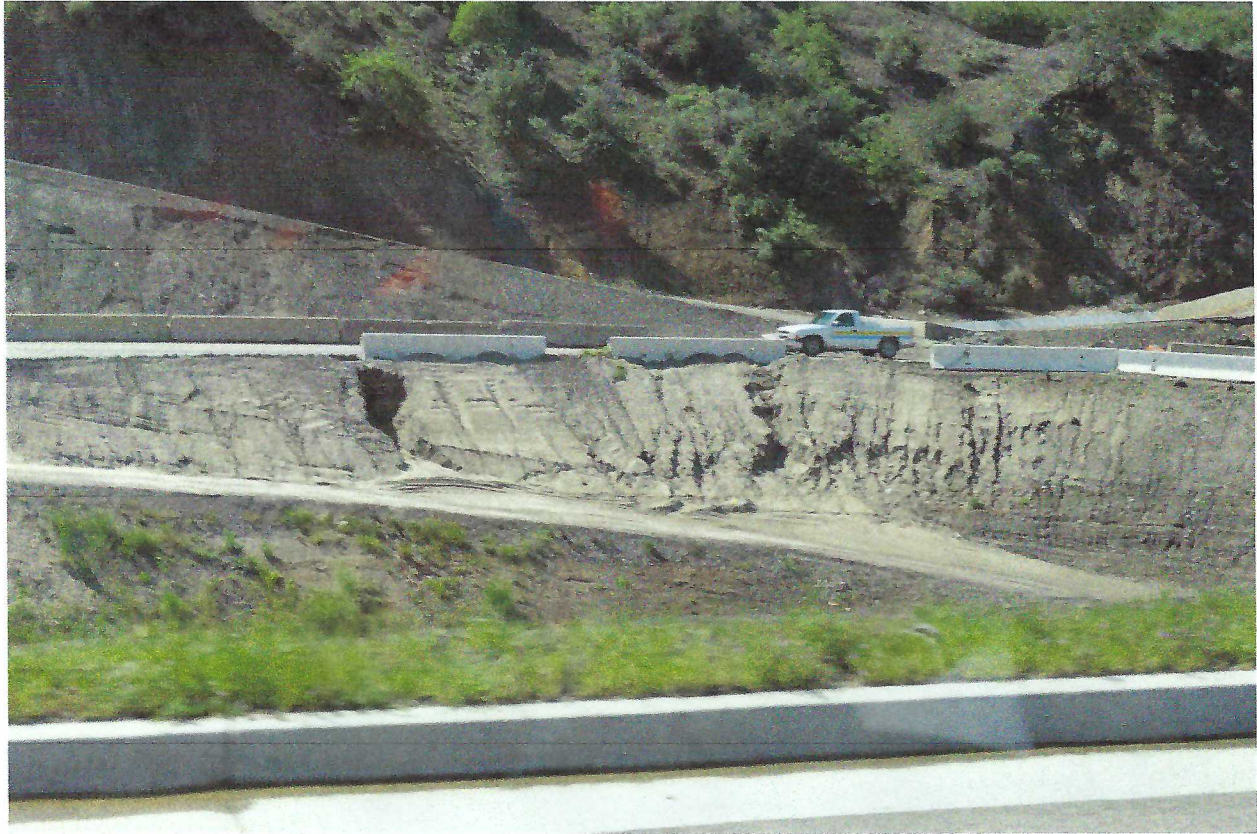
Figure 1: Erosion gullies and soil loss on access road embankment

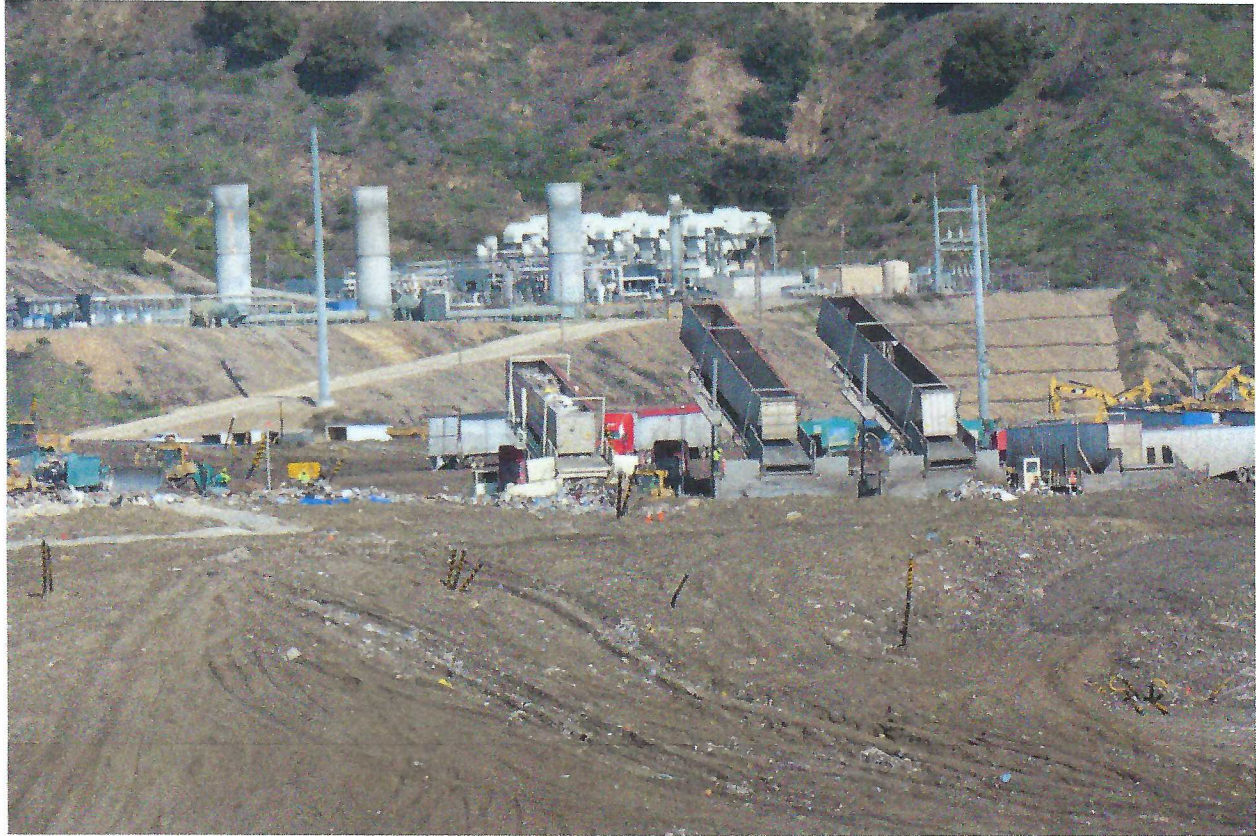
Figure 2: Filters at the waste face
