**Sunshine Canyon Landfill
Independent Monitor
Quarterly Site Monitoring Status Report
January 1, 2019 – March 31, 2019**

April 29, 2019

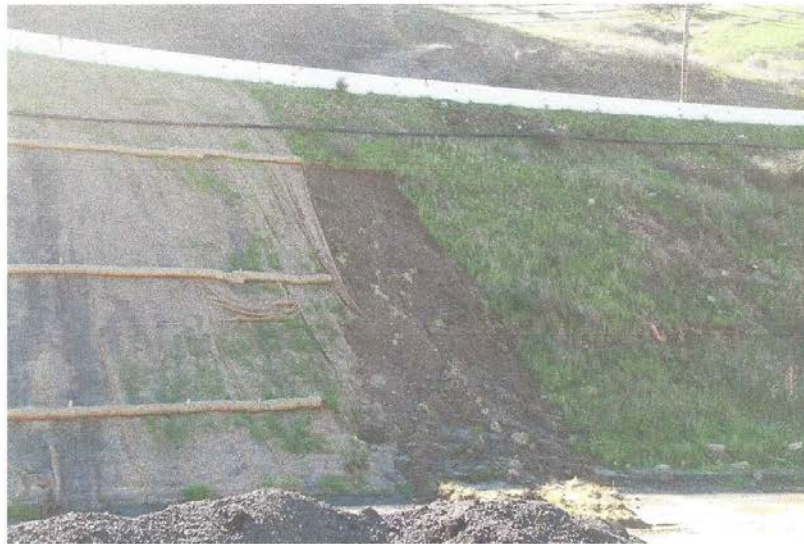
Photo 1: Soil sloughing on slope of embankment of main access road

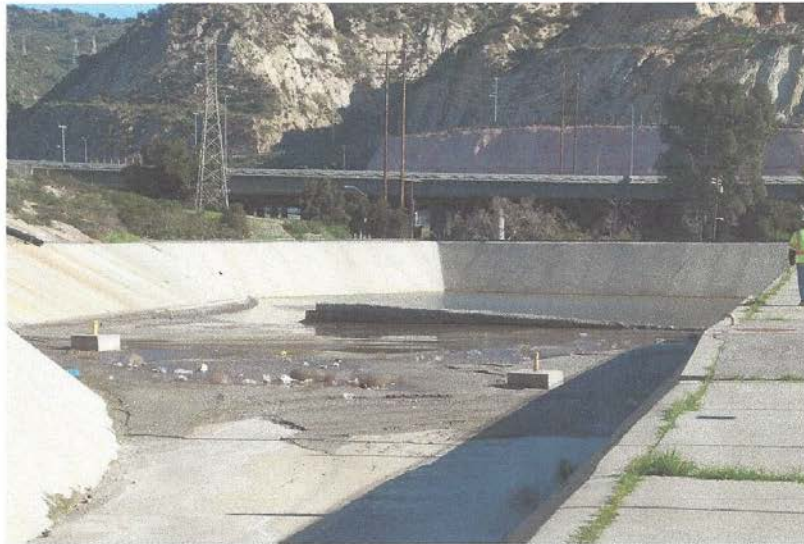
Photo 3: Sediment in Terminal Basin

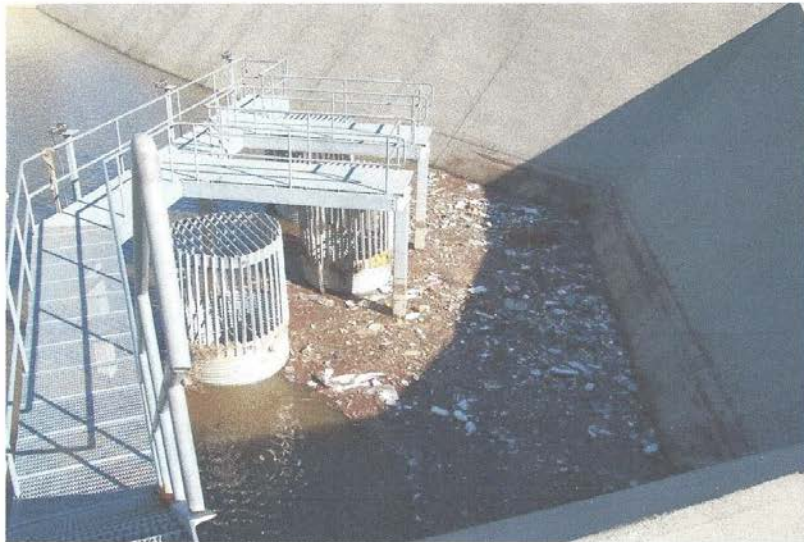
Photo 5: Waste collected behind decant towers at Terminal basin

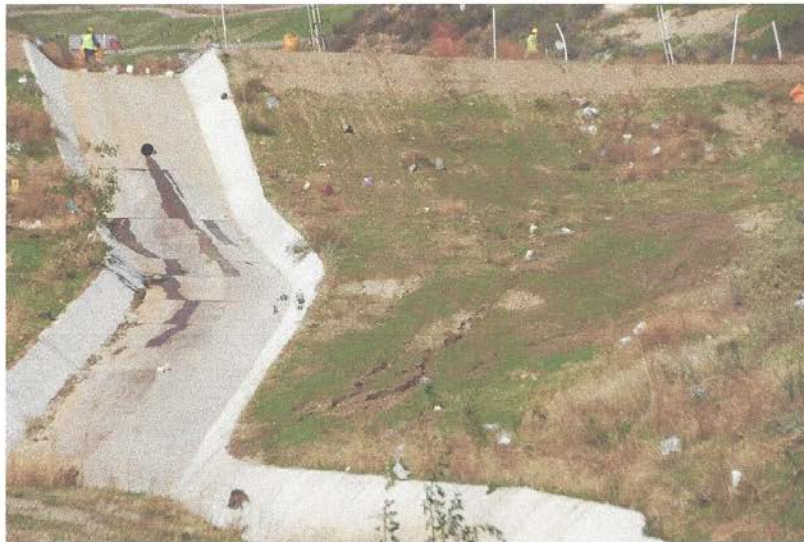
Photo 7: Erosion on slope of embankment for basin CC3

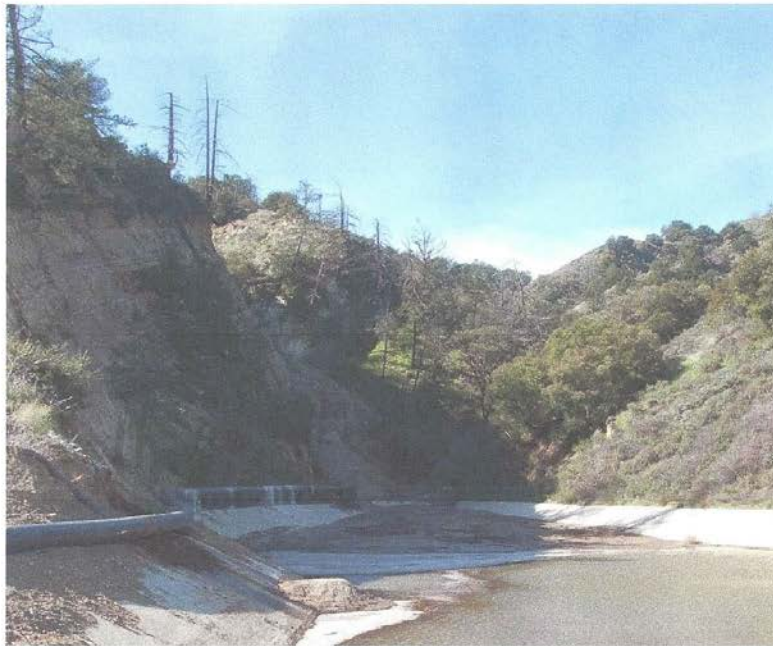
Photo 9: Sediments at back of Basin A

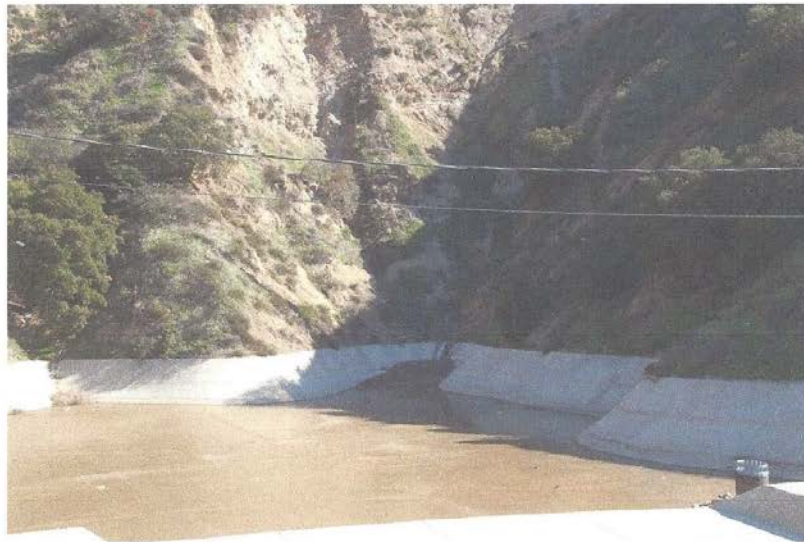
Photo 11: Sediments at back of Basin B

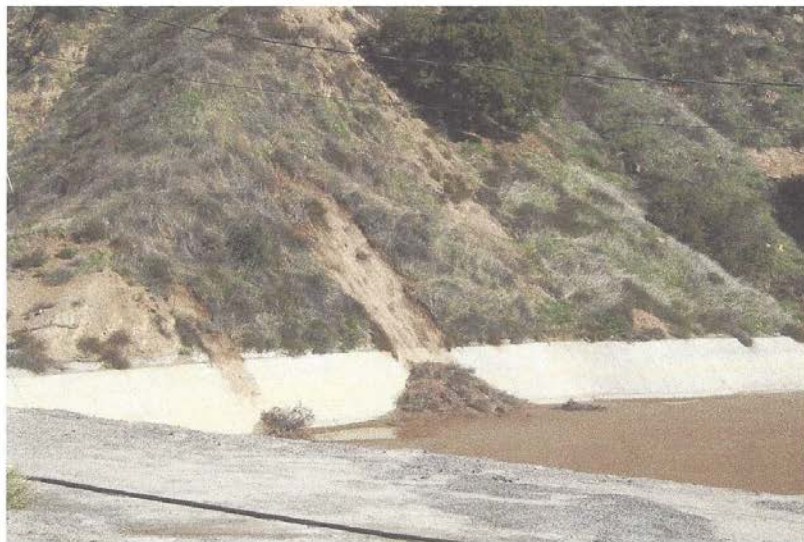
Photo 12: Sloughing on side of Basin B with sediments

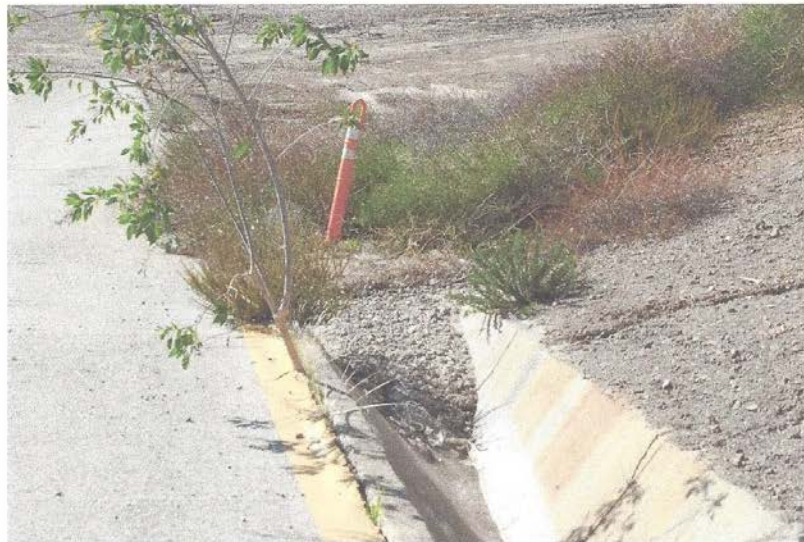
Photo 13: Sediments plugging drain at end of ditch along access road to Flares 9-11

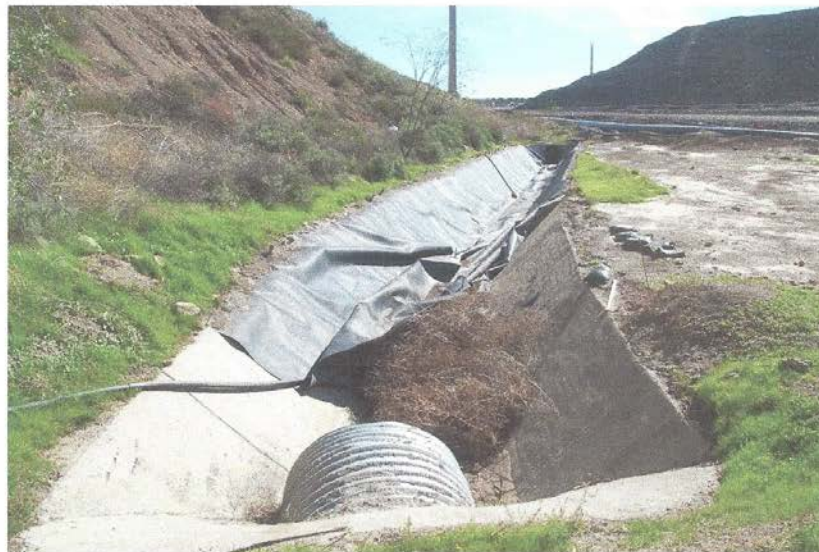
Photo 14: Damage to membrane on first segment of channel west of the access road to Flares 9-11

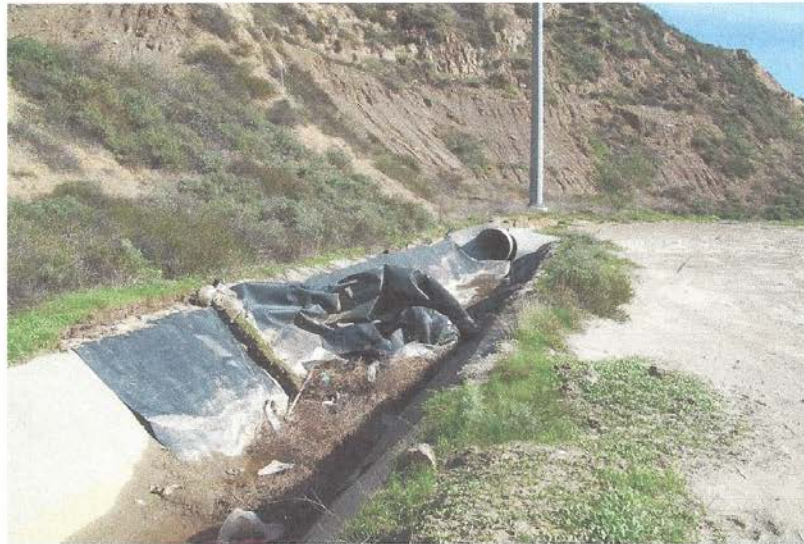
Photo 15: Damage to membrane and culvert on second segment of channel west of the access road to Flares 9-11

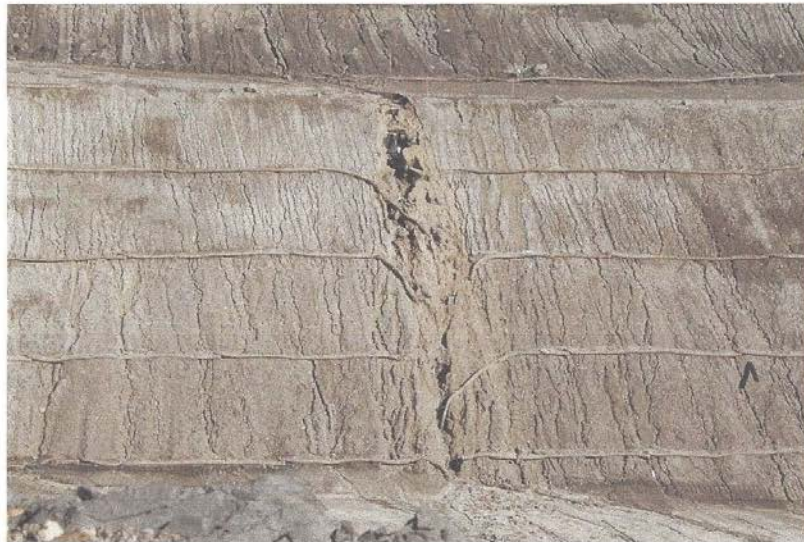
Figure 19: Deep erosion gully exposing refuse on slope of Cell CC3 Phase 3

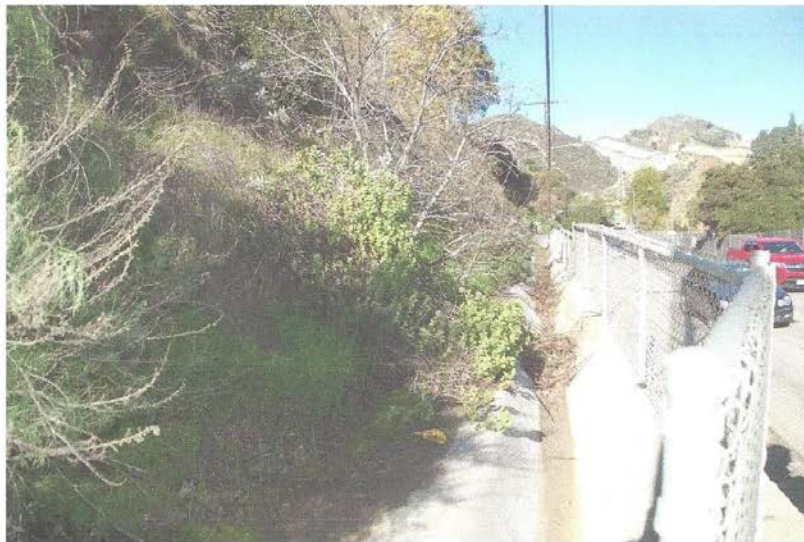
Figure 20: Sediments in drainage swale at wall along San Fernando road

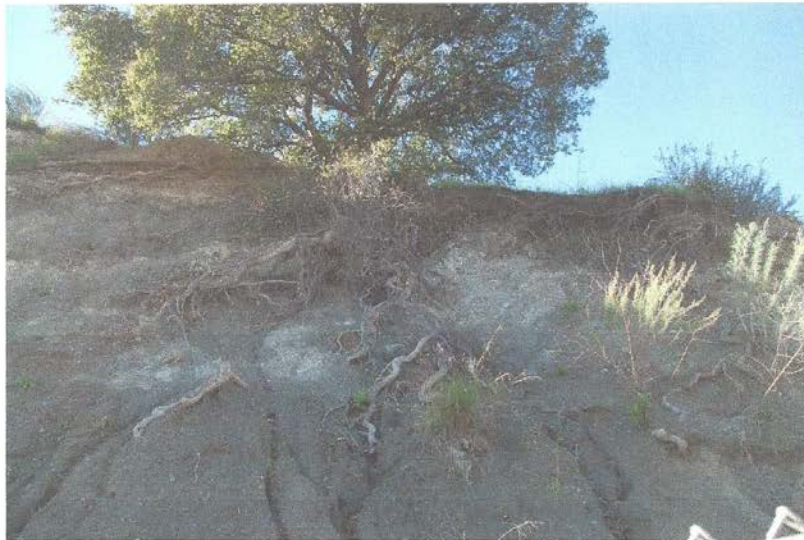
Figure 21: Exposed roots of tree above wall along San Fernando road

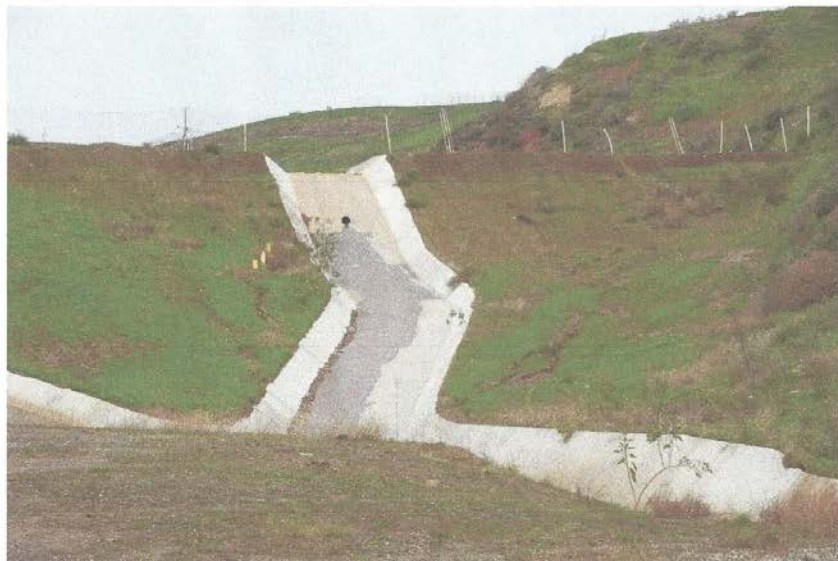
Photo 8: Erosion on slope of embankment for earthen basin CC3

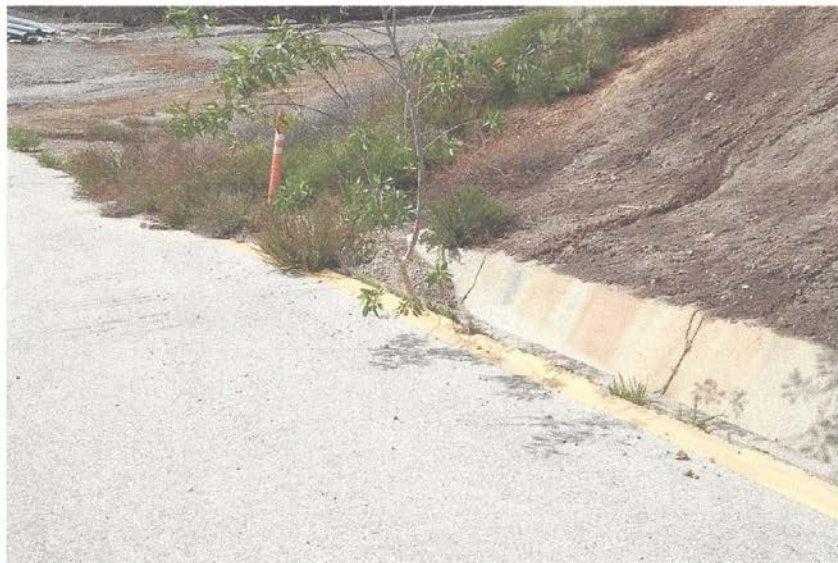
Photo 10: Sediments plugging drain at end of ditch along access road to Flares 9-11

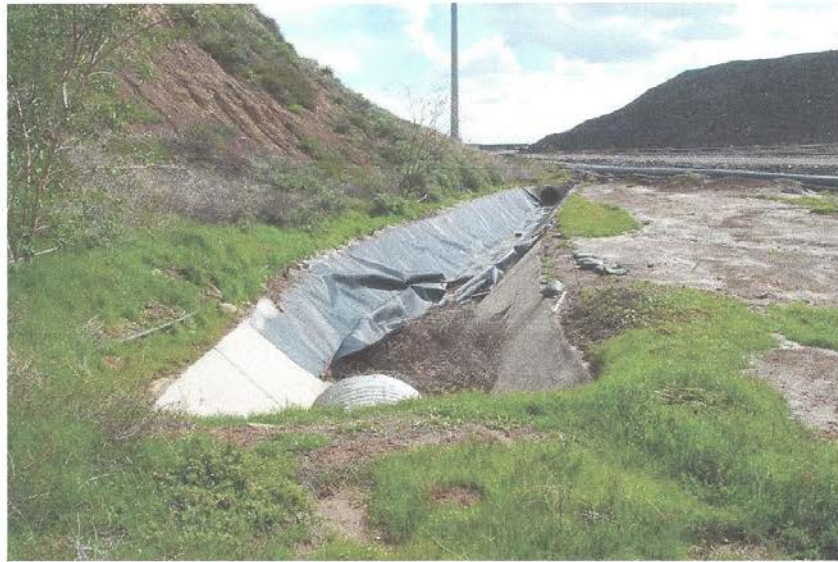
Photo 11: Damage to membrane on first segment of channel west of the access road to Flares 9-11

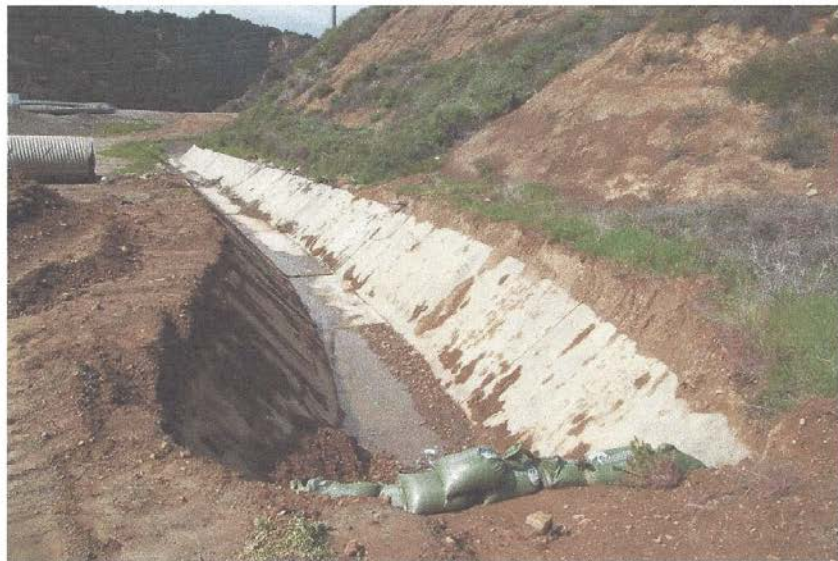
Photo 12: Culvert removed on second segment of channel west of the access road to Flares 9-11

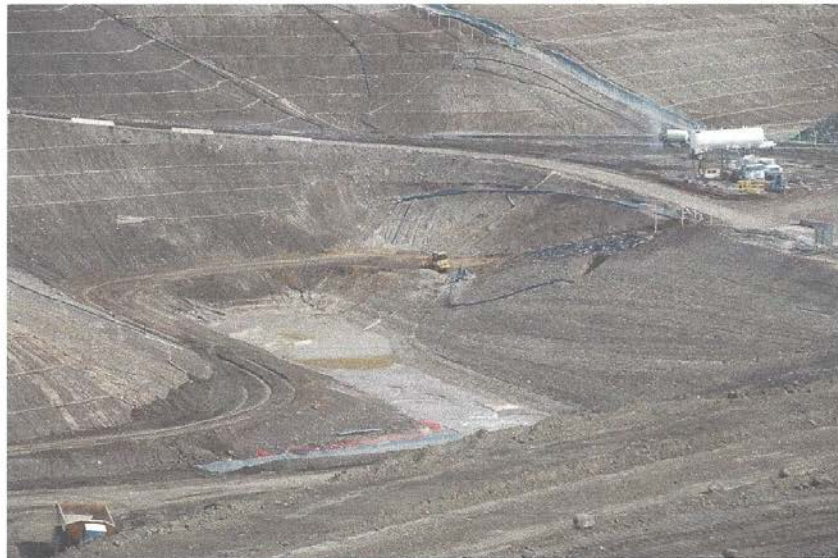
Photo 14: Sediment accumulation in moat around Cell CC4 Phase 3

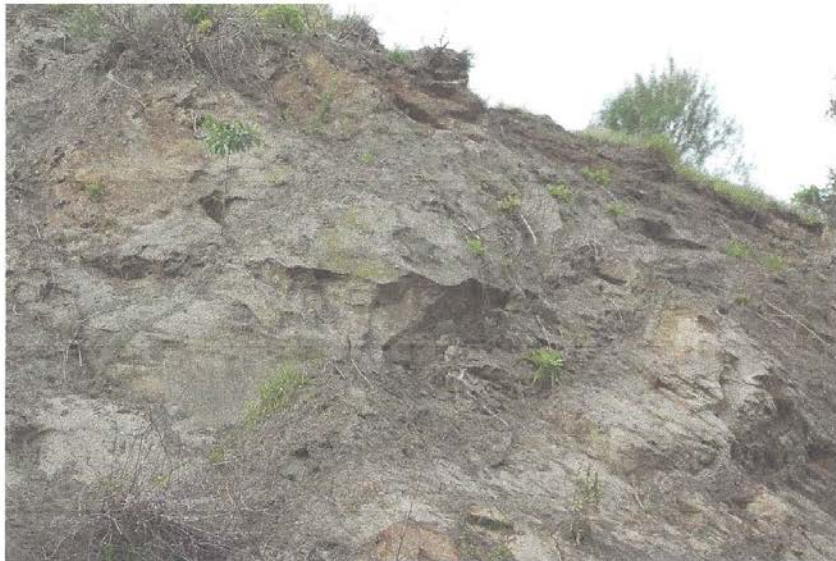
Figure 16: Overhang above wall along San Fernando road

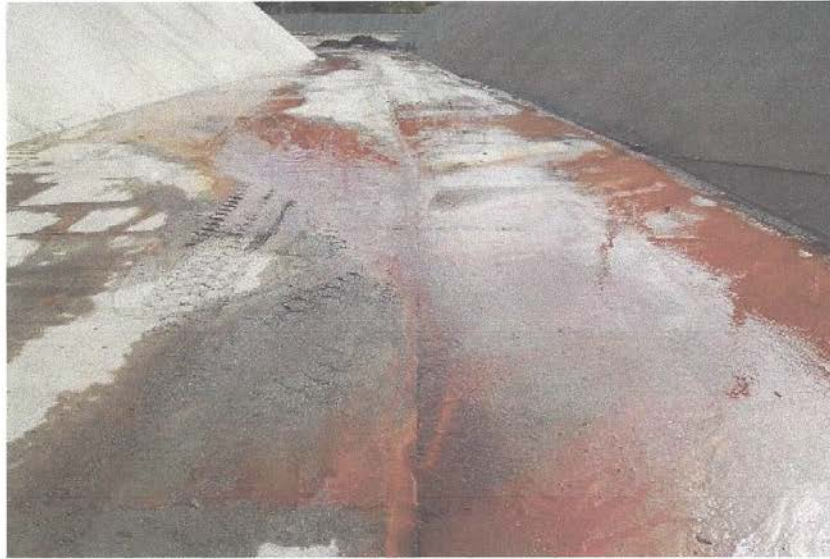
Photo 5: Water flowing out between floor slab joints at Terminal basin

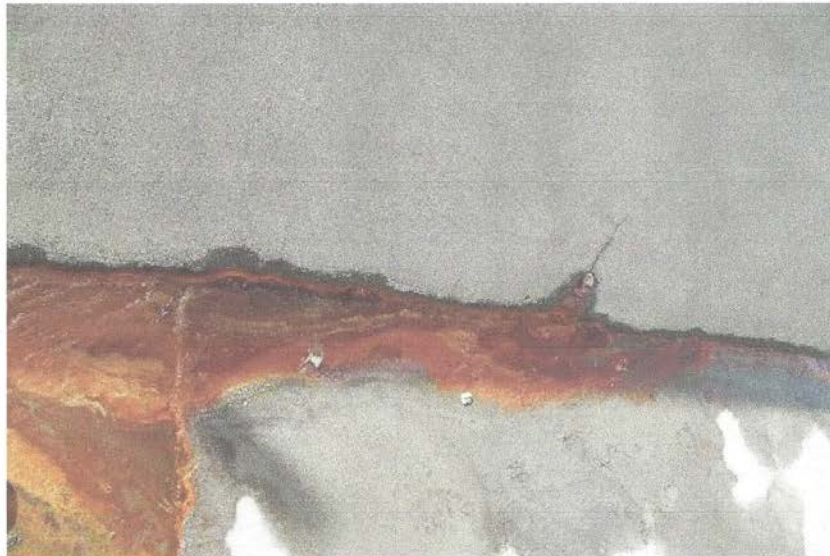
Photo 6: Reddish deposit from water seeping through weep holes at the bottom of the wall

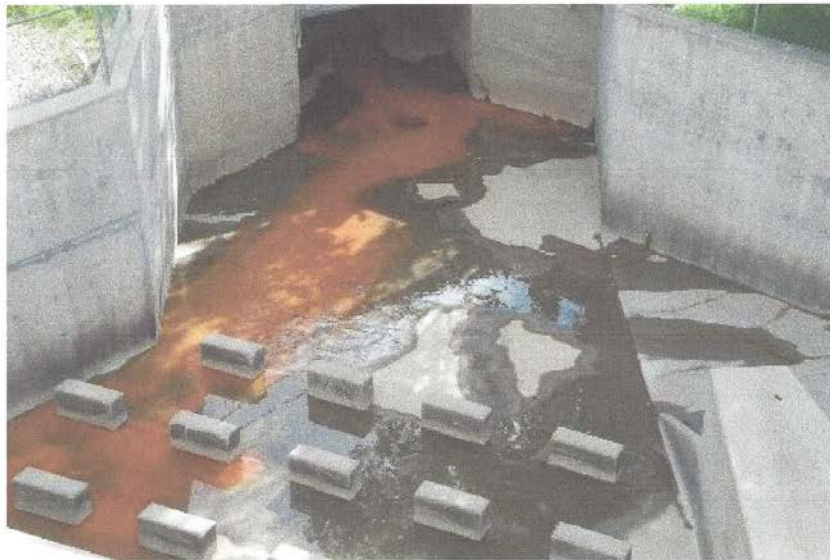
Photo 7: Reddish water exiting Terminal basin

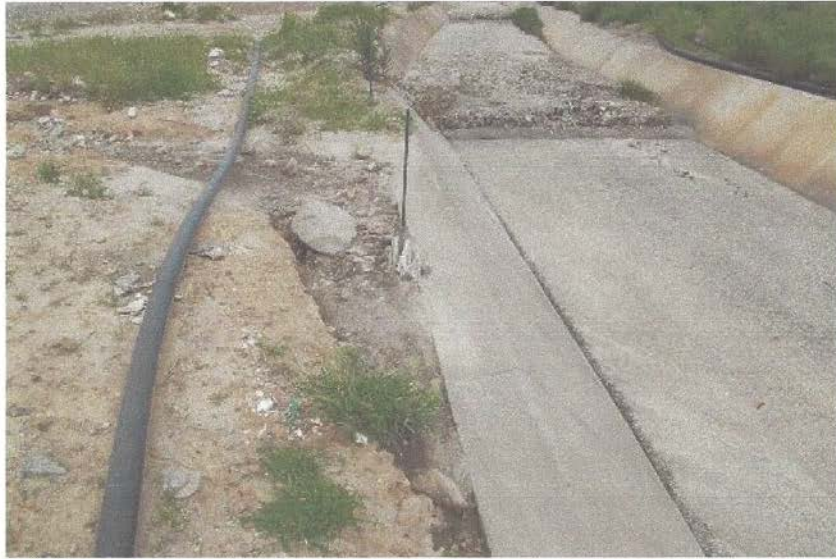
Photo 9: Erosion along edge of channels between Basin B and Terminal Basin and sediments trapped on gabion

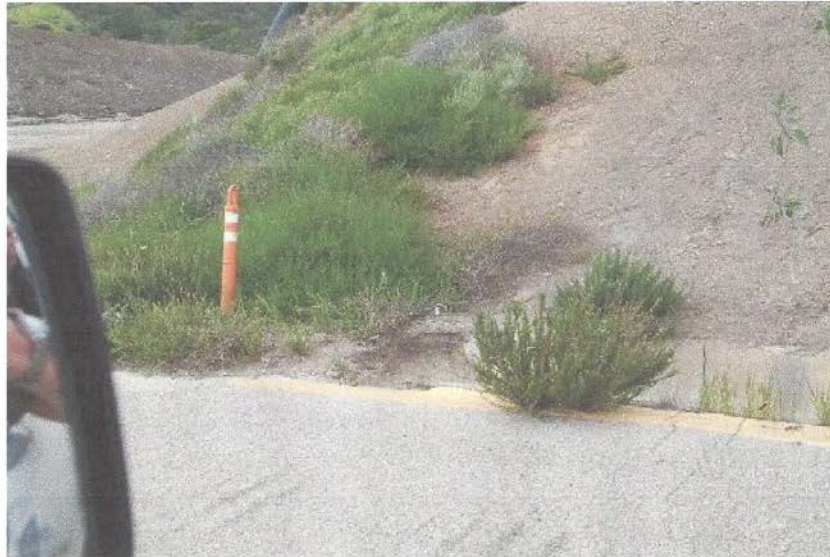
Photo 11: Sediments plugging drain at end of ditch along access road to Flares 9-11

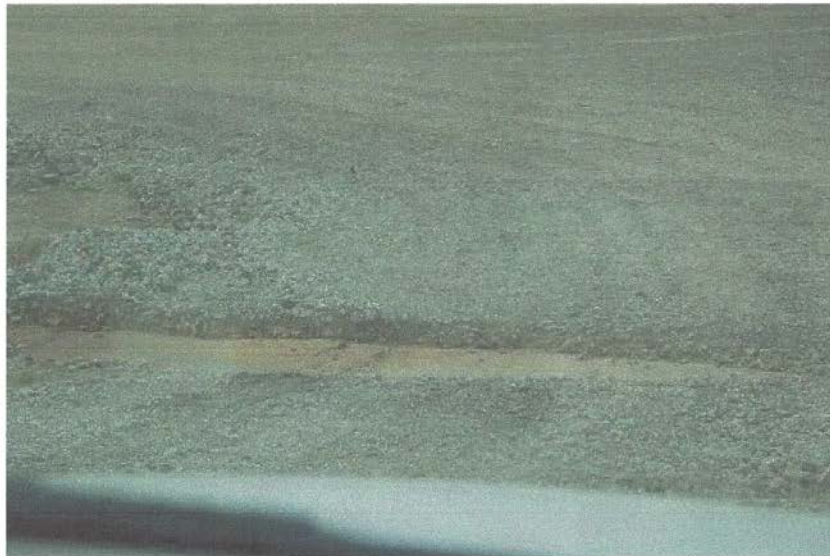
Photo 12: Erosion gully at edge of access road to Flares 9-11

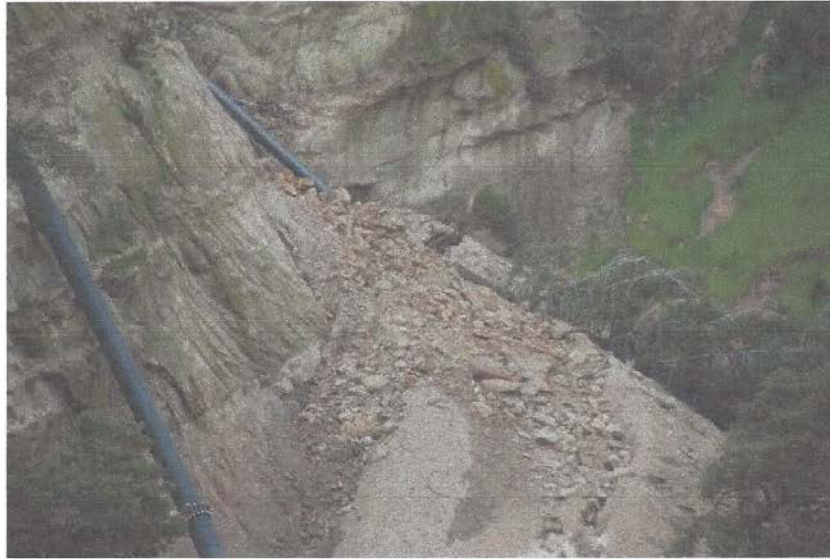
Photo 17: soil and rock slide at back of Basin A

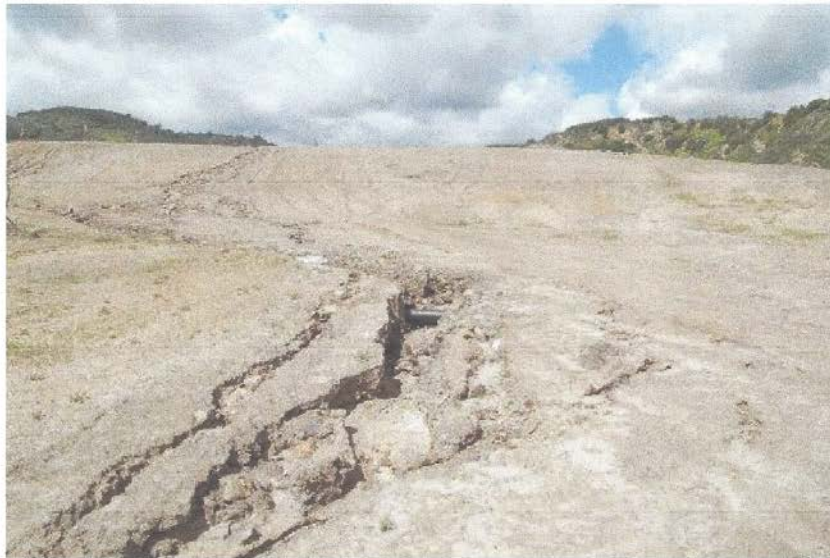
Figure 20: Deep erosion gullies on interim cover – County landfill deck
