**Sunshine Canyon Landfill
Independent Monitor
Quarterly Site Monitoring Status Report
October 1, 2019 – December 31, 2019**

City of Los Angeles Department of City Planning

County of Los Angeles Department of Regional Planning

April 3, 2020

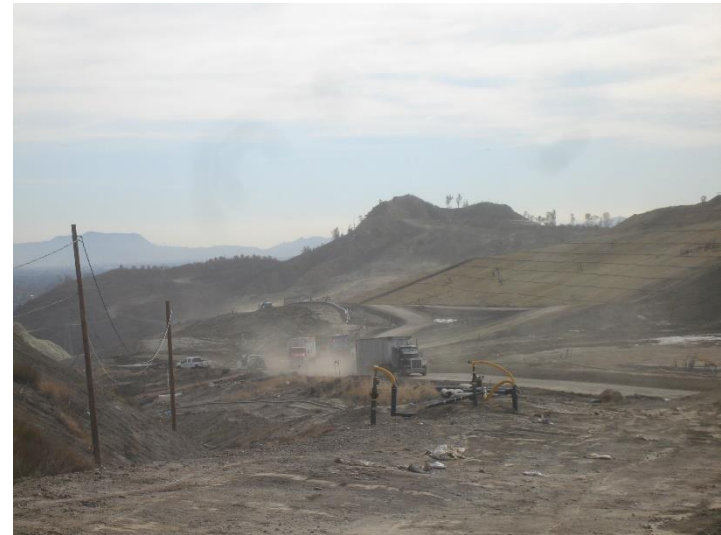
Current Status/Comments – In December, mid-day disposal trucks that were using dirt roads near the County Bowl area created dust clouds. The frequency of the roads being watered was not adequate. The dirt entrance road to CC-4 Part 3 was not being adequately watered and dust clouds were observed. This road could not yet be constructed with rock because of its proximity to the liner.

Photo 122: Site Working Area CC4 Part 1&2 Haul Road Dust: December 11, 2019

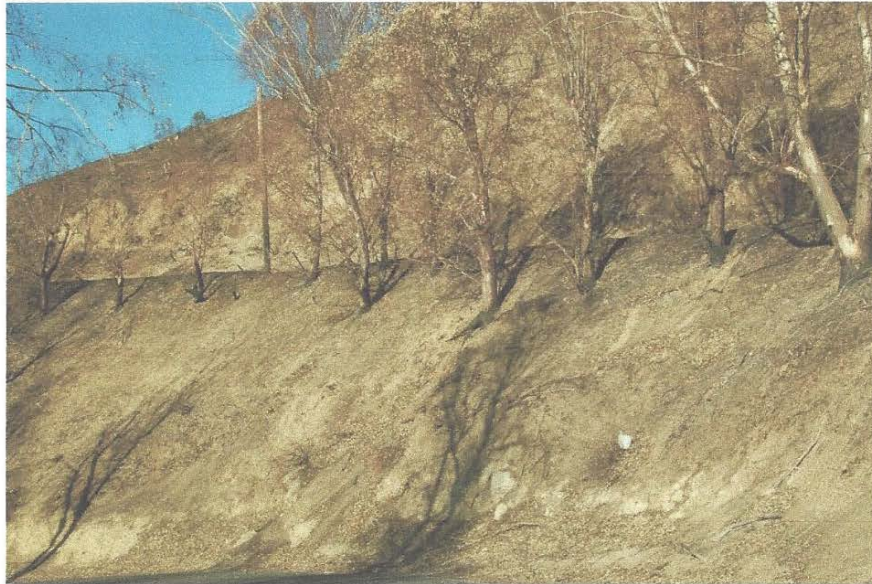
Photo 1: Fire damage on the slopes along oilfield road

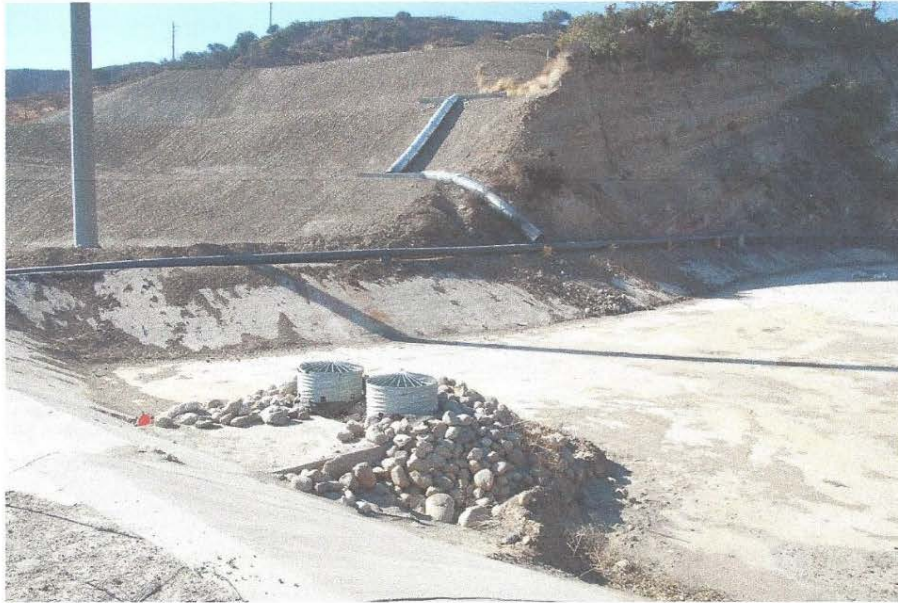
Photo 7: Sediments against rock around the decant towers at Basin A

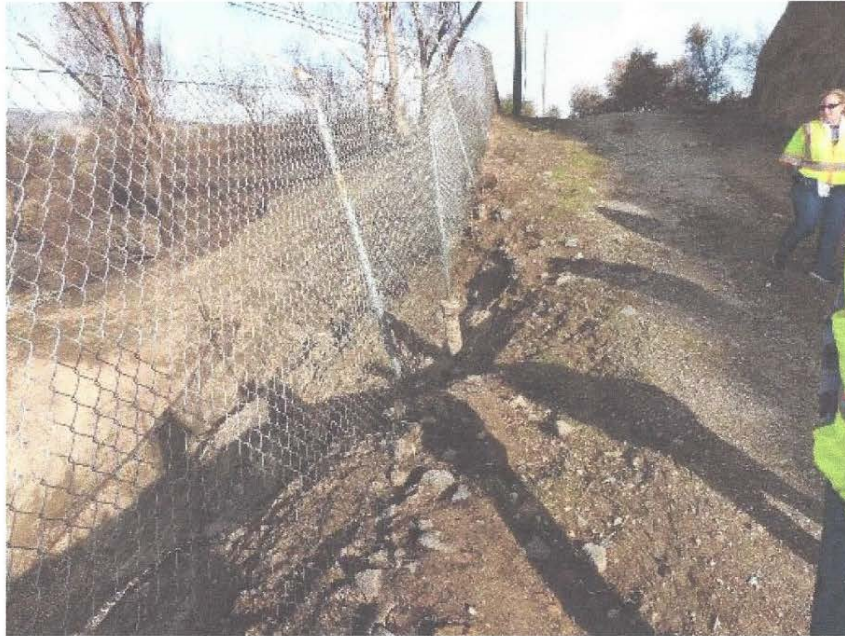
Photo 1: Damage to emergency exit road

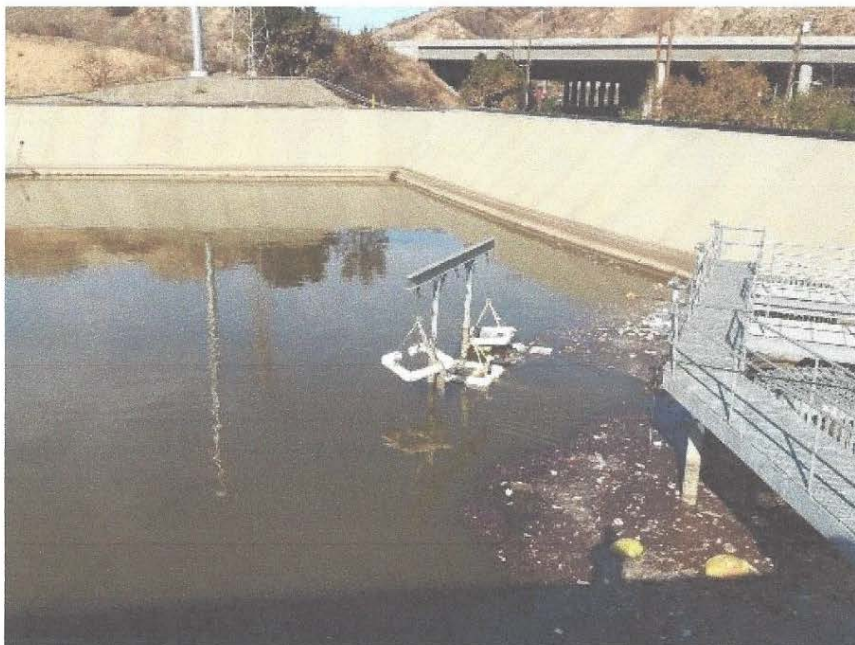
Photo 4: Skimmer at Terminal basin – one skimmer was on

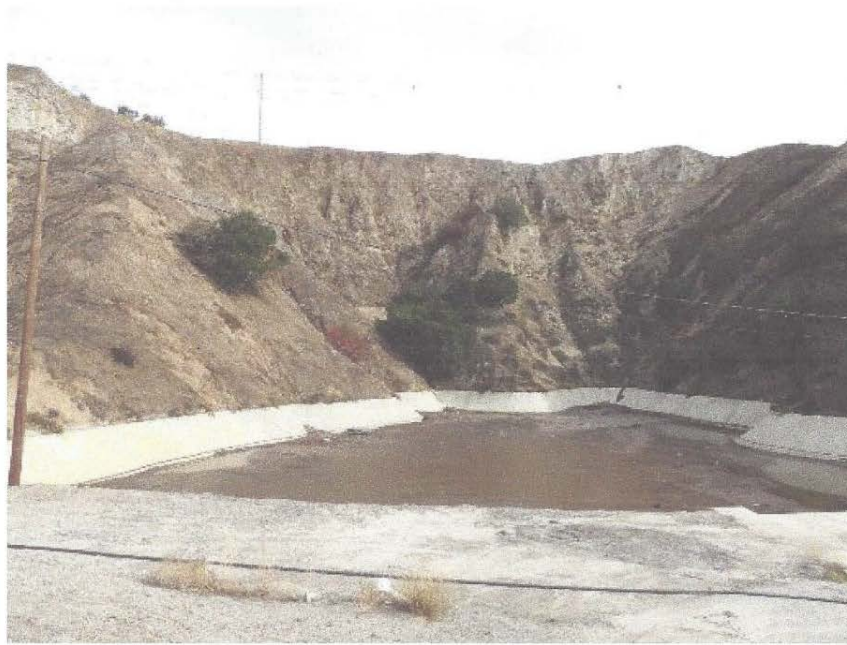
Photo 7: Sediments in Basin B

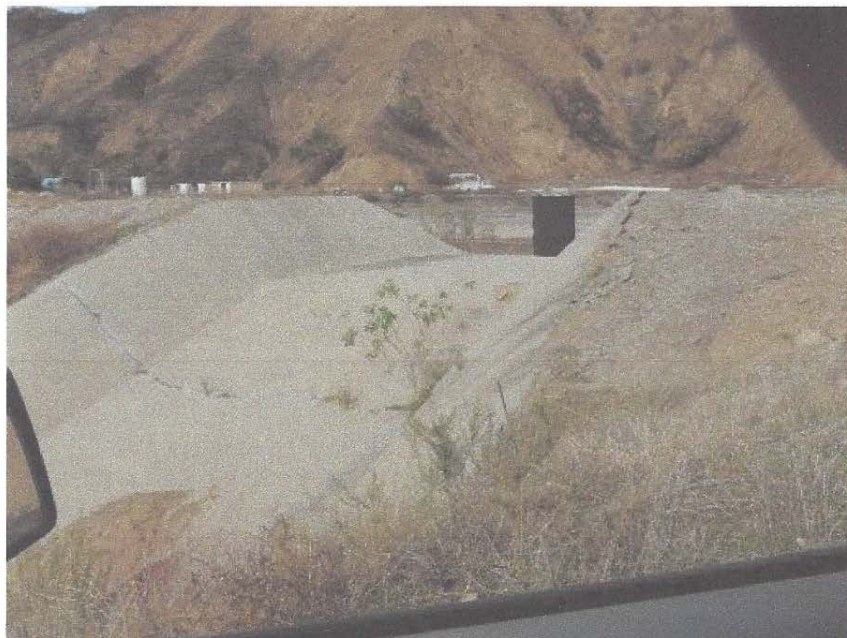
Photo 8: Vegetation and concrete crack in spillway of Basin D

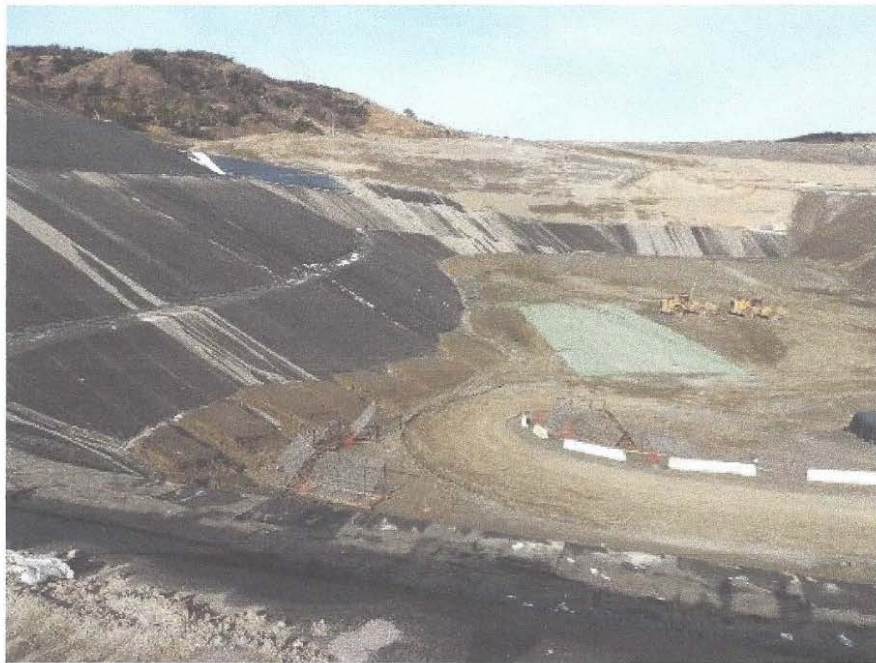
Photo 13: Damage to operation layers on slope of Cell 4 Phase 3

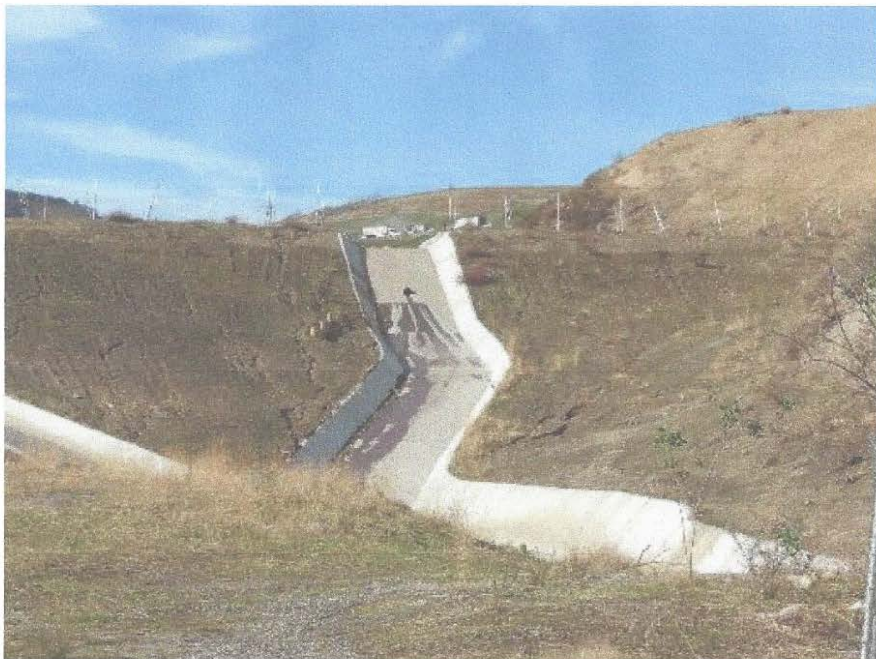
Current Status/Comments – The erosion control measures were in place by October 15, 2019. After the December rain events, some gullies and ruts were observed on the slopes above the CC-4 Part 3 basin. The slopes in the County sage mitigation area had a minor increase in erosion rills. Other areas of the landfill erosion control systems performed well, with minor erosion occurring.

Photo 14: erosion gullies on downstream slope of Cell CC3 earthen basin
