Los Angeles Department of City Planning

RECOMMENDATION REPORT

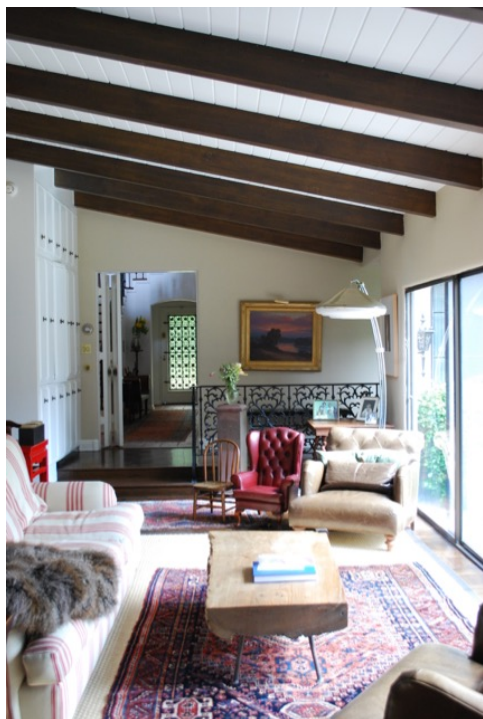
Since purchasing the home, the present owner has worked painstakingly to reverse alterations that covered up and obscured original character-defining features of the home. The additions made in the 1960s have not been reversed, but finishes have been rehabilitated and stylistic changes have been made to lessen the distraction from the original construction style, while still recognizing and telling the story of the later modifications. For example – the family room has a different type of flooring, but it has been stained a similar color, so that the spaces are distinct from each other while also being compatible.

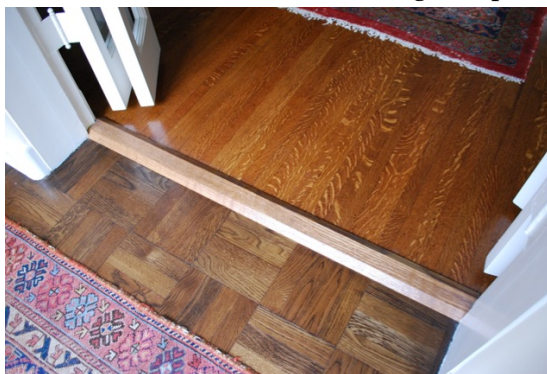
When the current owners purchased the property it had undergone numerous alterations and was also suffering from deferred maintenance. Documented alterations include a “4-by-16 foot passageway” that was built and an existing patio porch was converted into a family room in 1968. The 1968 permit shows the location of the additions.

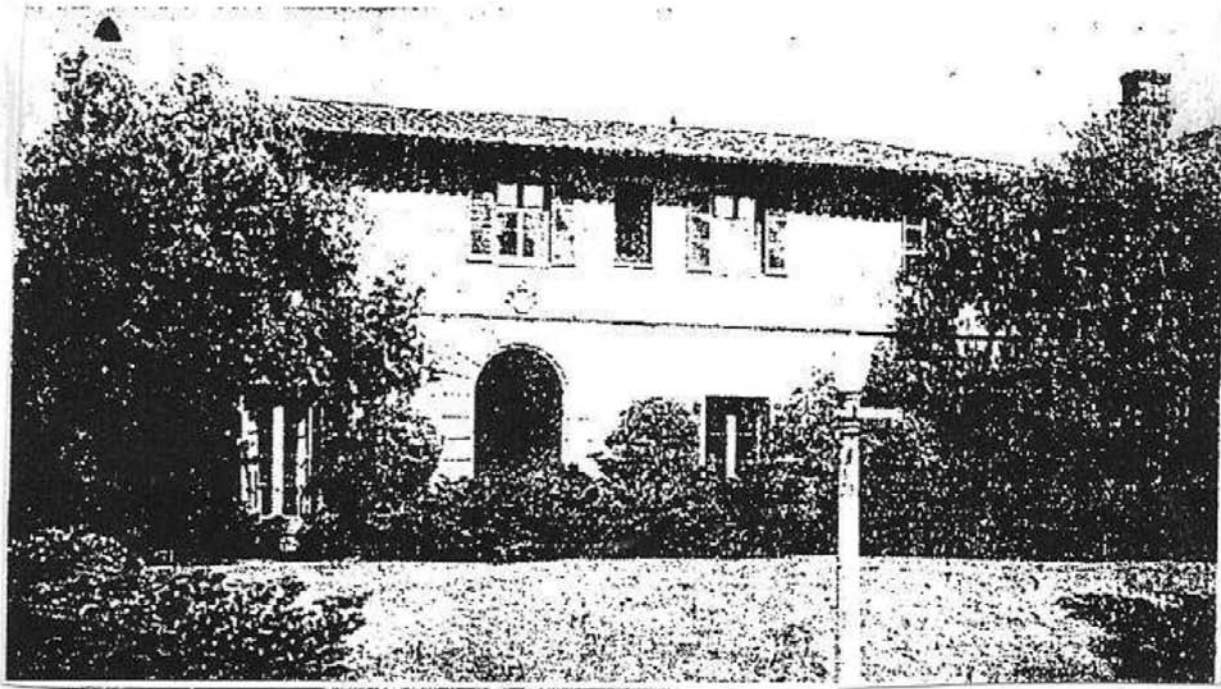
The immediately above view is of the Mediterranean-type residence, at 404 North June street, adjoining the Wilshire Country Club, in the Hancock Park area, just bought by E. J. Soule of New York, from Mrs. Marvel Rusk for approximately \$30,000, it was announced. The transaction was handled by George Schnelders of Kells and Grant.

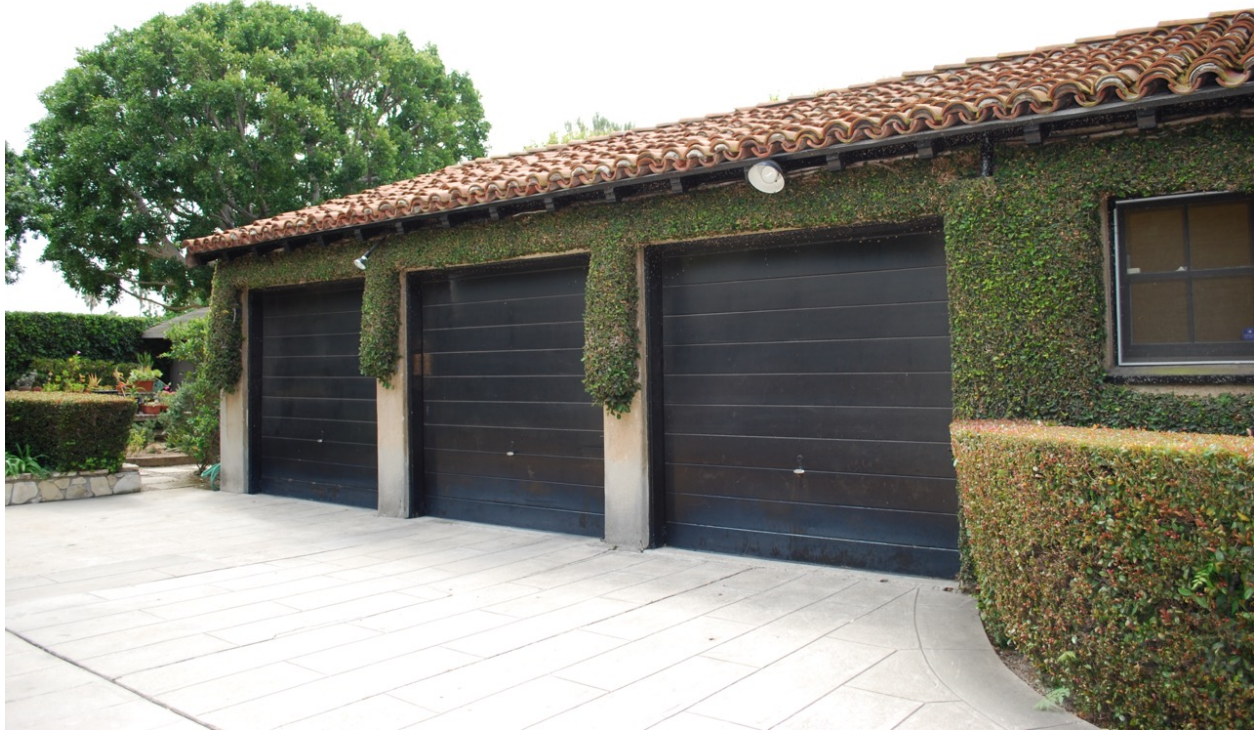
Garage: A garage is located at the rear of the property. The garage is attached to the house along the long L of the plan. It is accessed from a driveway that runs along the north side of the house. The garage has three bays, each with a wood planked door. There are vines growing on a significant portion of the garage.

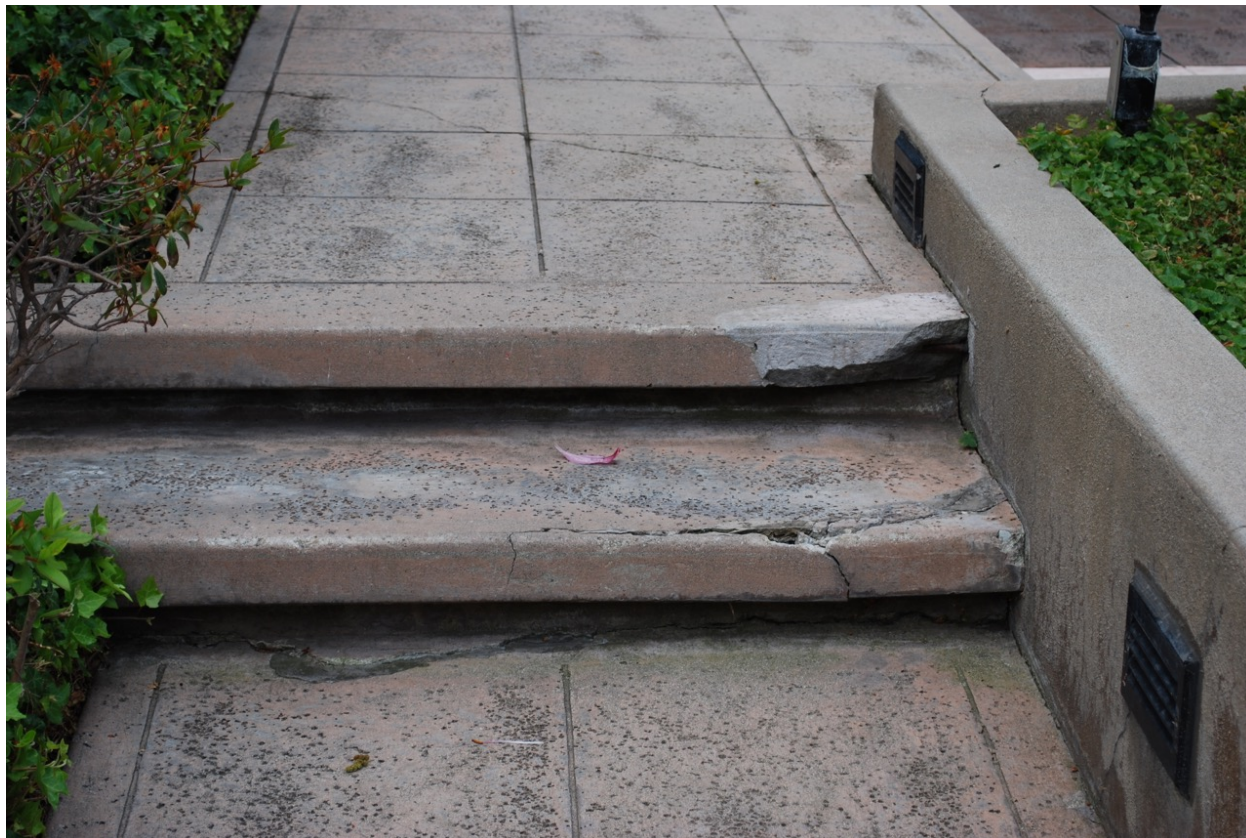
Exterior – Materials and Finishes

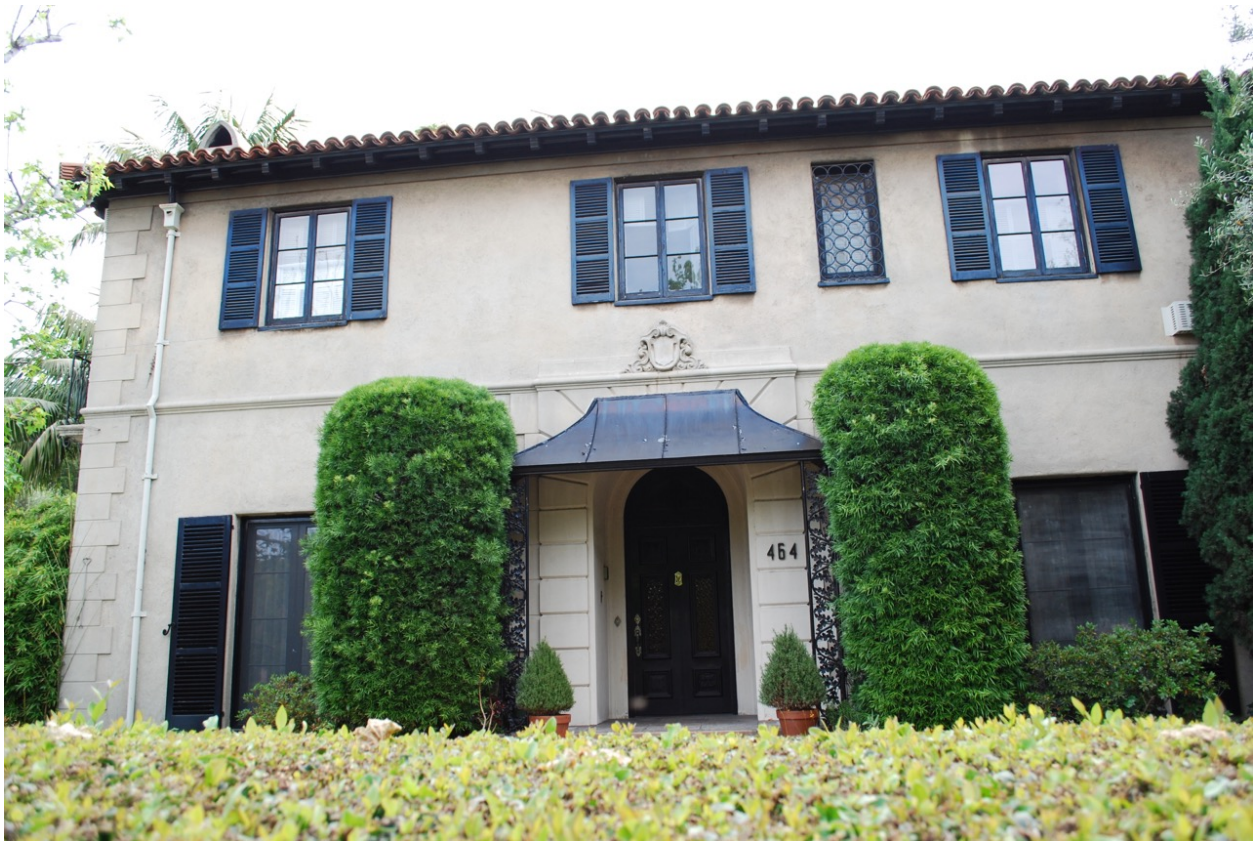
West (Rear) Elevation:

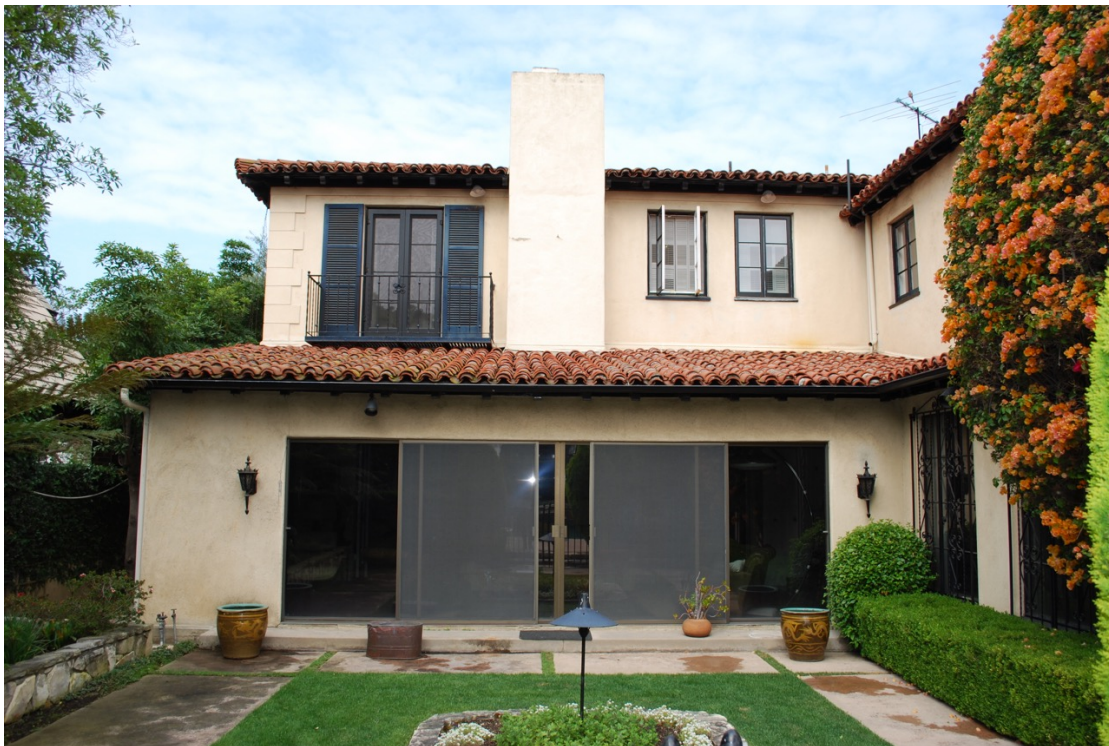
North Side: The North side of the residence accommodates the driveway. This elevation shows some damaged stucco and cracks in the driveway, damage to ironwork and a balcony, but otherwise appears to be in good condition.

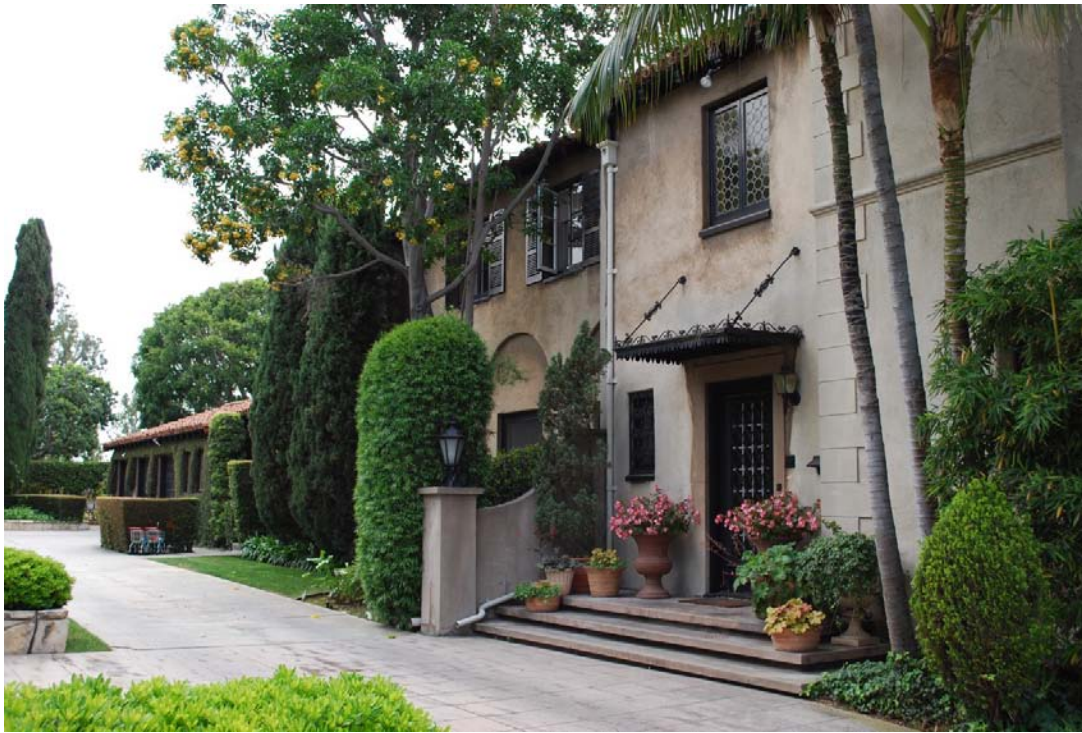
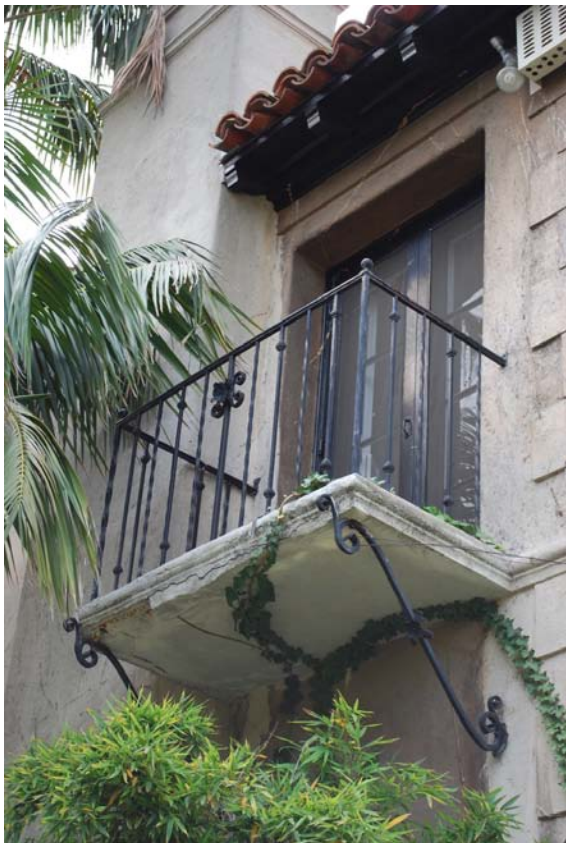
South Elevation: The South Elevation exhibits similar materials to the other elevations of the house and appears to be in fair/good condition. Proximity of trees/planters should be further investigated.

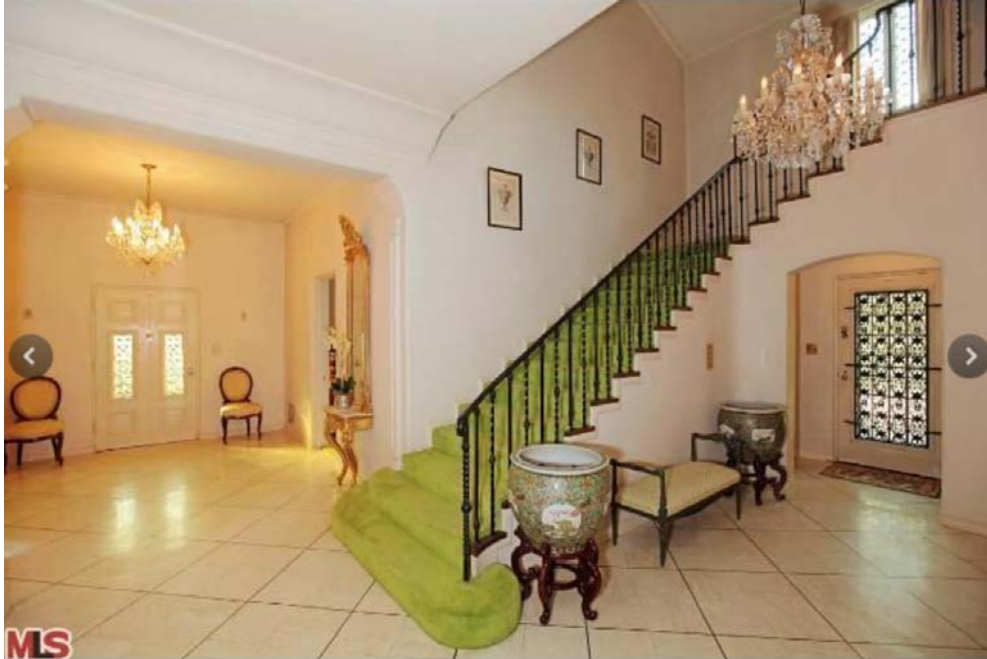
Front Stair Hall before removal of floor tile and carpet

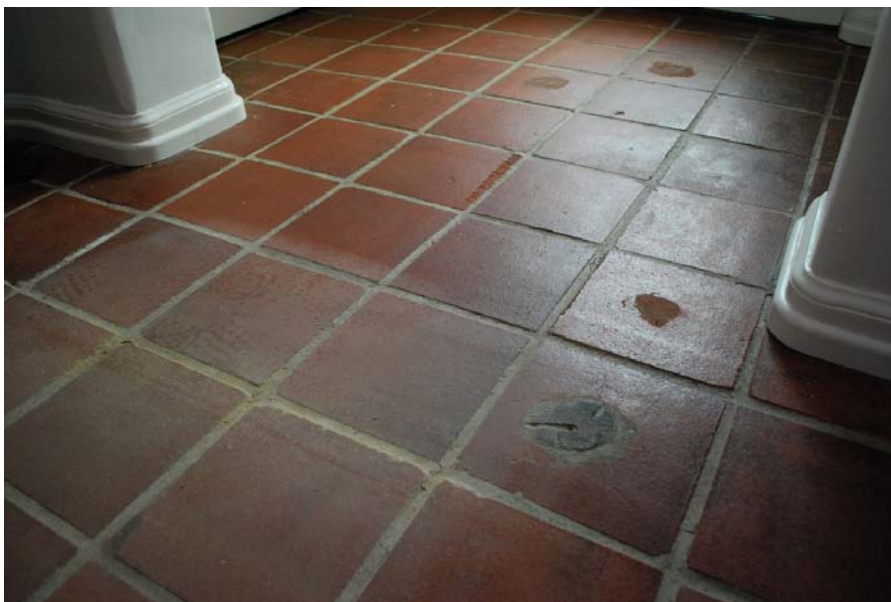
The Stair Hall features an iron balustrade stair, low arched openings, and terracotta floors. Many of the home's primary rooms are accessed from the Hall including the study (just to the left as you enter the front door). The Stair Hall is in good condition. The main concern in the stair hall is the terracotta floors, which are in poor condition and require restoration.

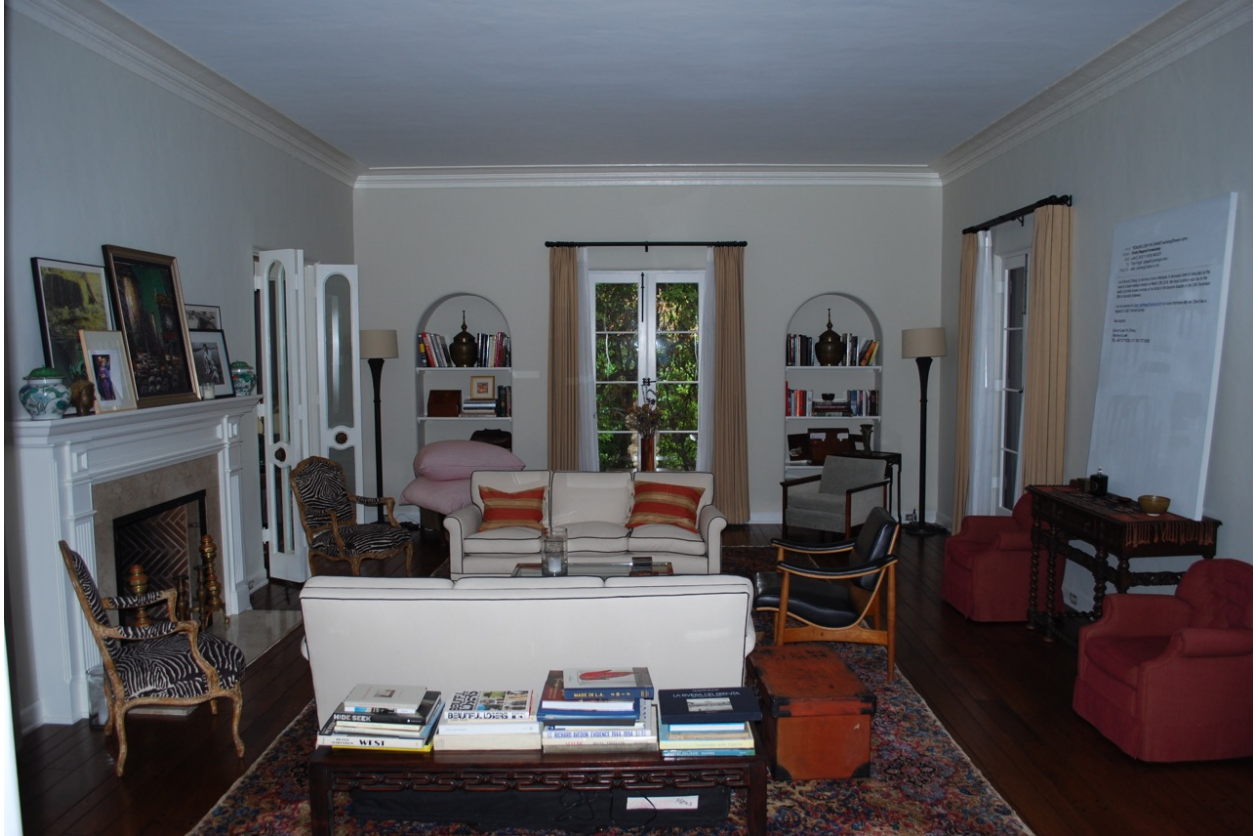
Living Room in its current condition

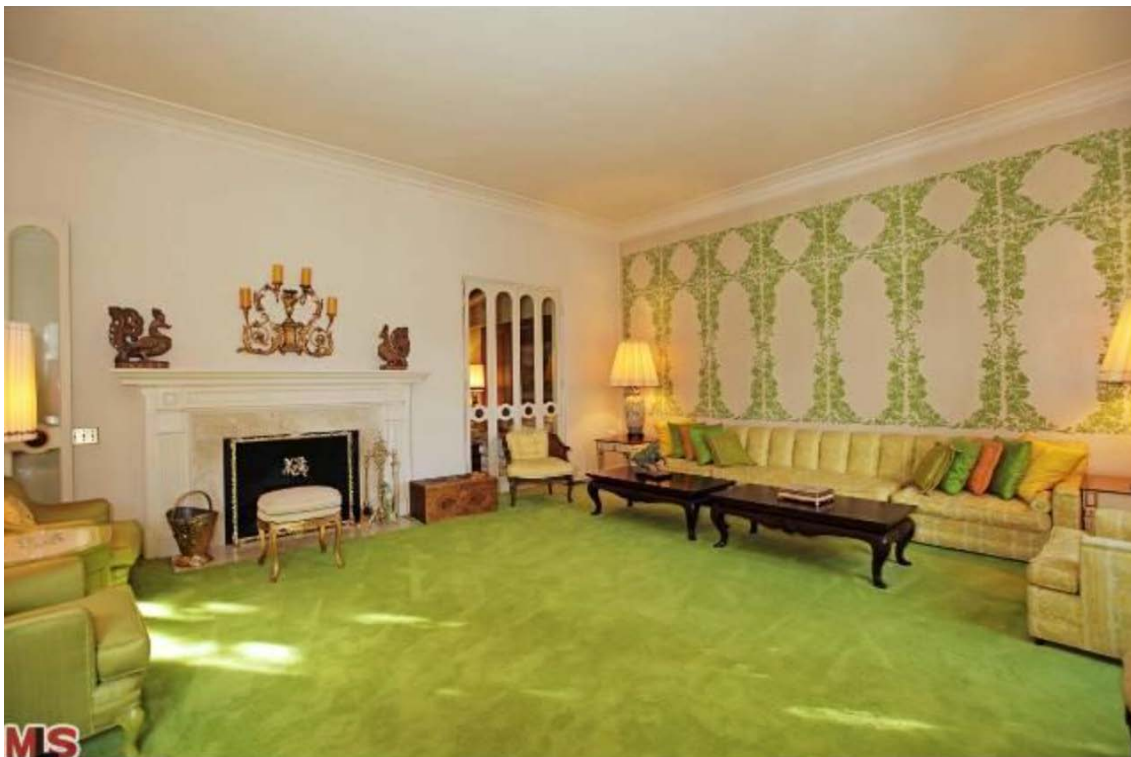
Living Room before rehabilitation and restoration of French doors

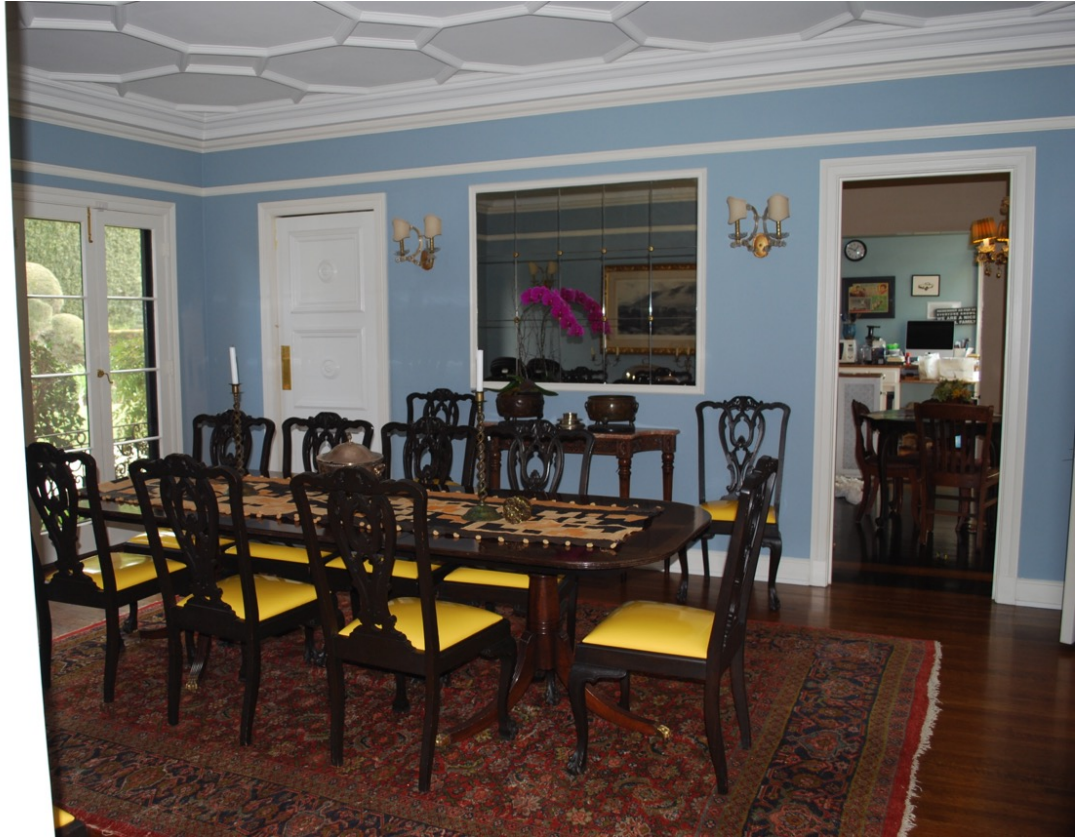
The Dining Room contains many original architectural features, including a paneled ceiling. It appears to be in good condition.

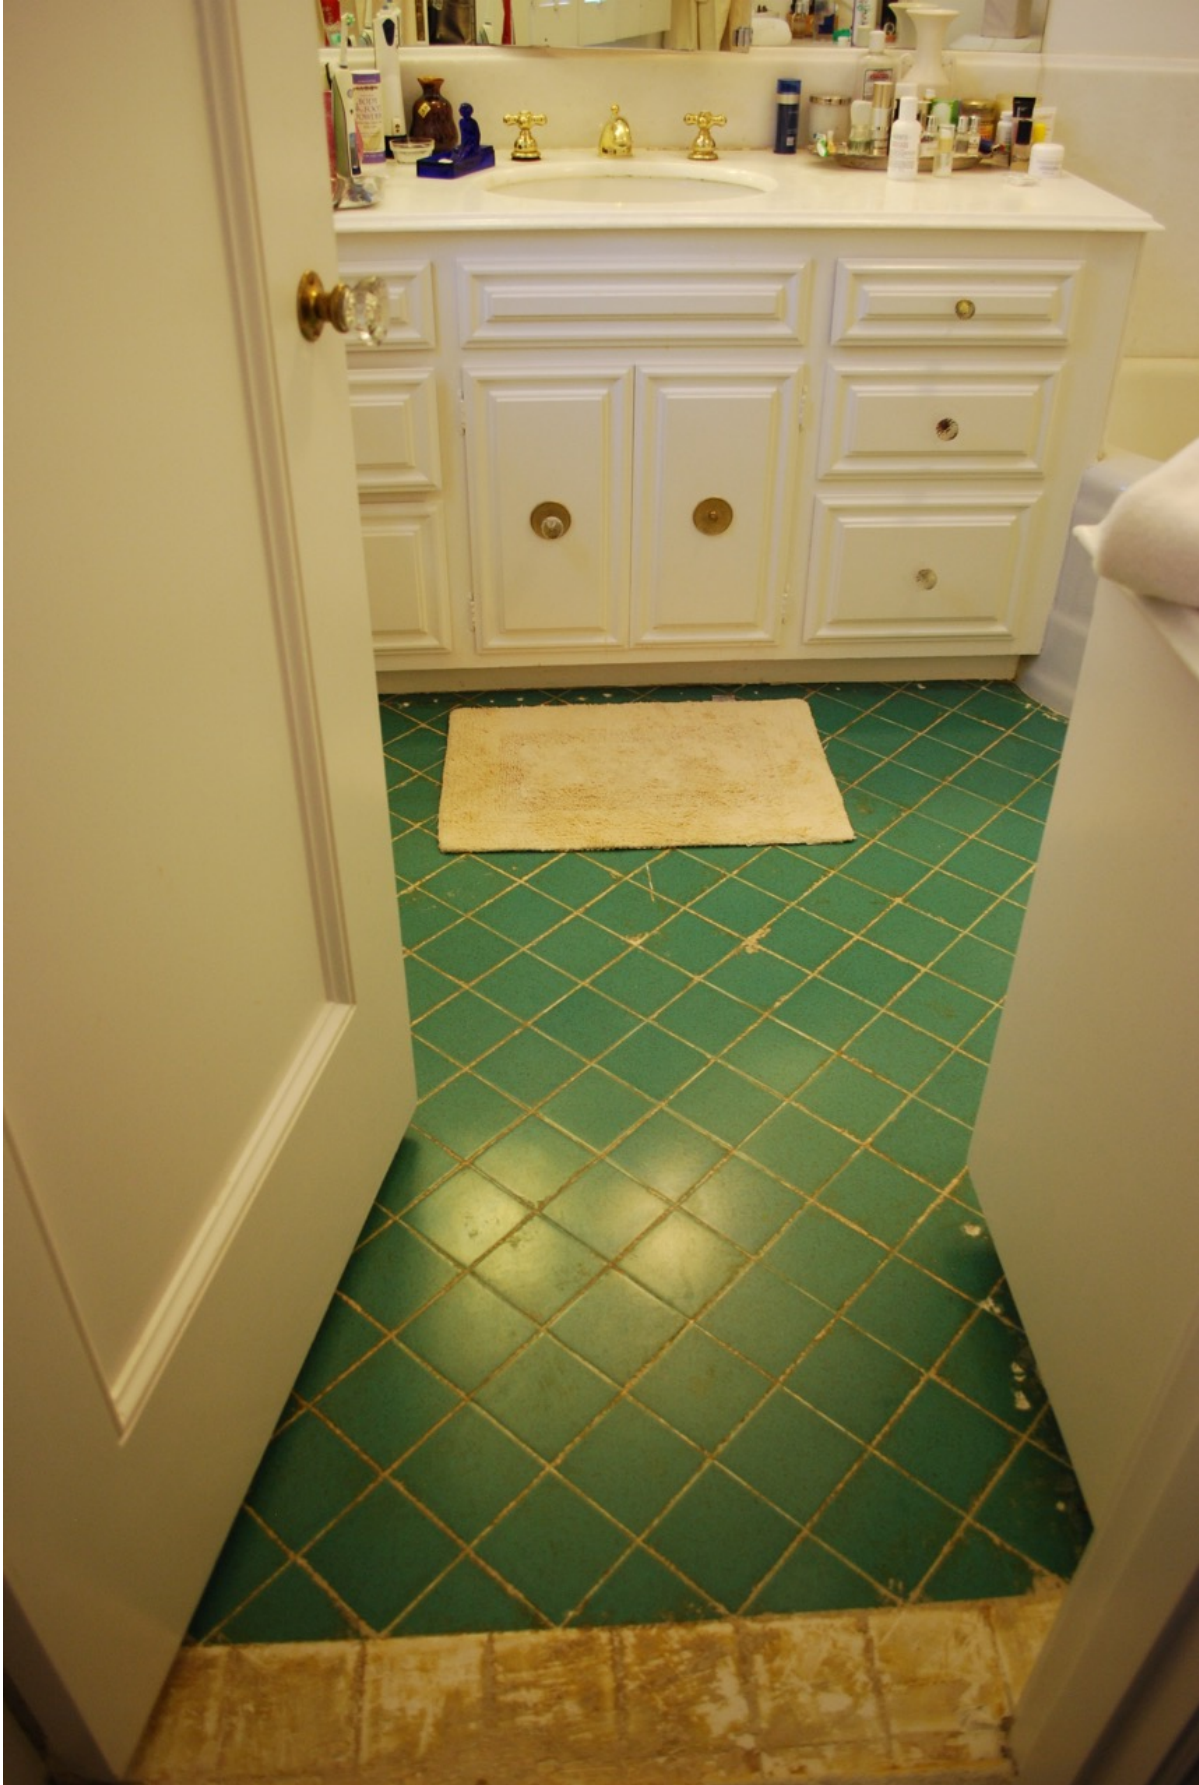
Interior – Systems (Plumbing and Electrical)

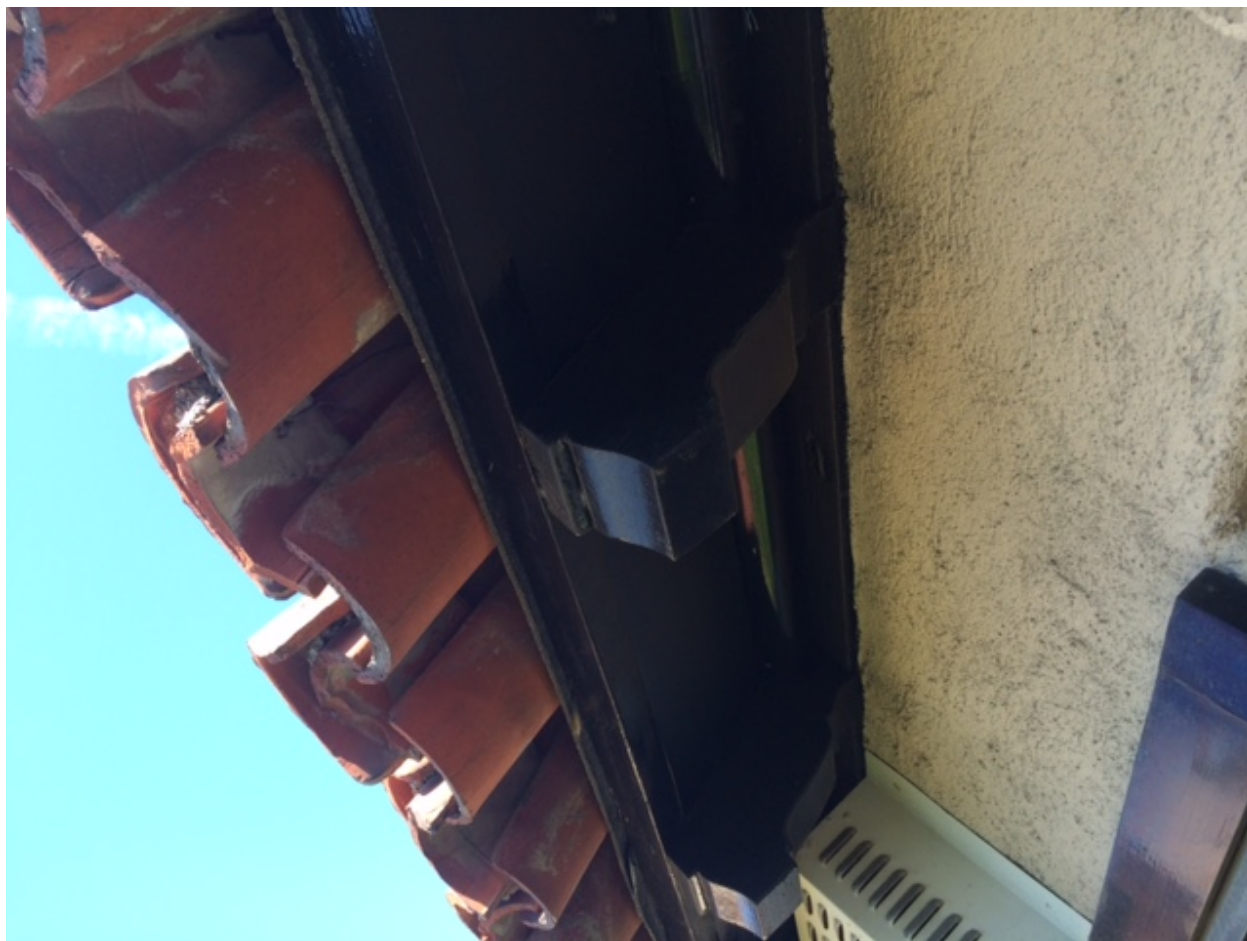
The roof of The Chessman Residence is an important character-defining feature of the building. It is a clay tile that is installed using mortar. These particular tiles are especially prone to breakage when undergoing intervention. Vincent H. Hobson's book Historic and Obsolete Roofing Tile offers a catalog of photographic samples to help identify the particular manufacturer of the tile that exists on the building. Taking a sample from the building and determining type and manufacturer can assist in locating a source for new replica tiles (should the need arise). It is always preferable to re-use as much of the original tile as possible whenever undertaking a roof intervention with this type of roof system. It is recommended that the roof be carefully monitored for leaks and that only skilled roofers with experience with historic buildings work on the roof.

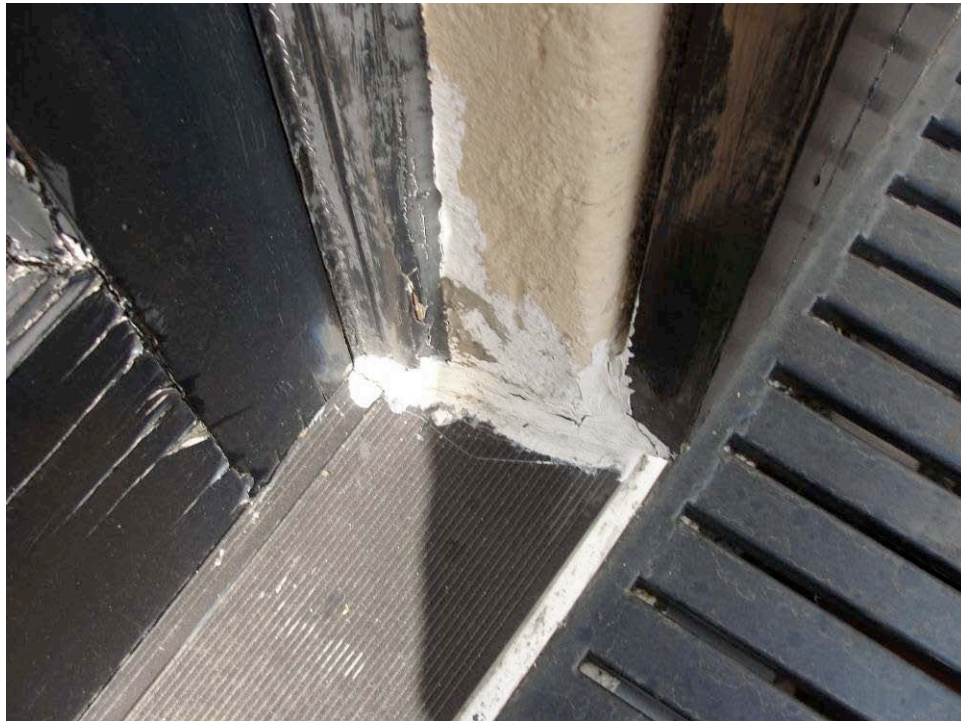
PHOTO: The joints at the threshold of the doors at the master bedroom have been caulked.

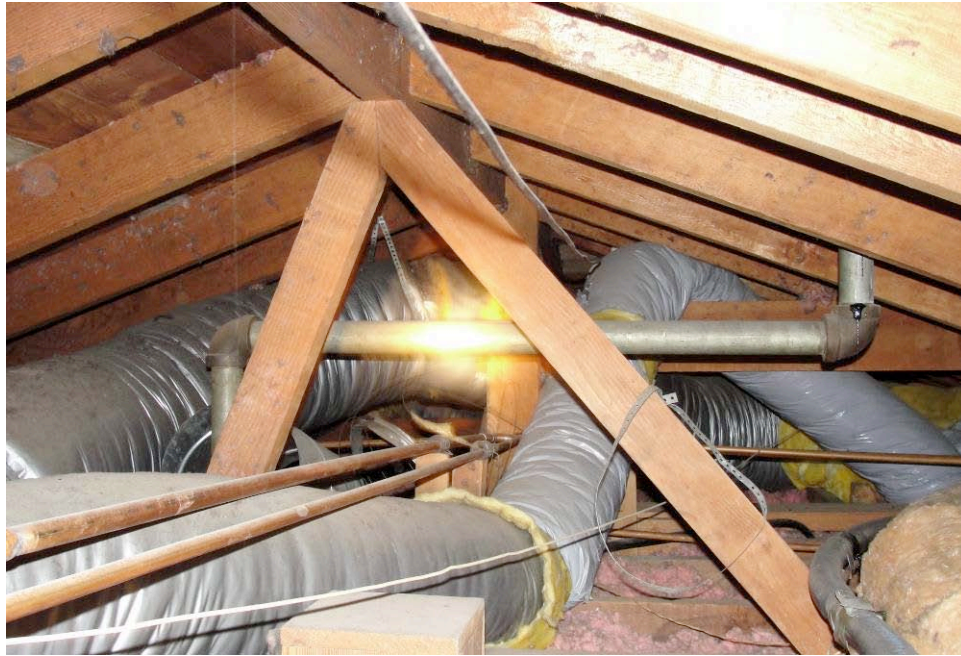
PHOTO: A view of the upper attic, looking north from the hall access hatch.

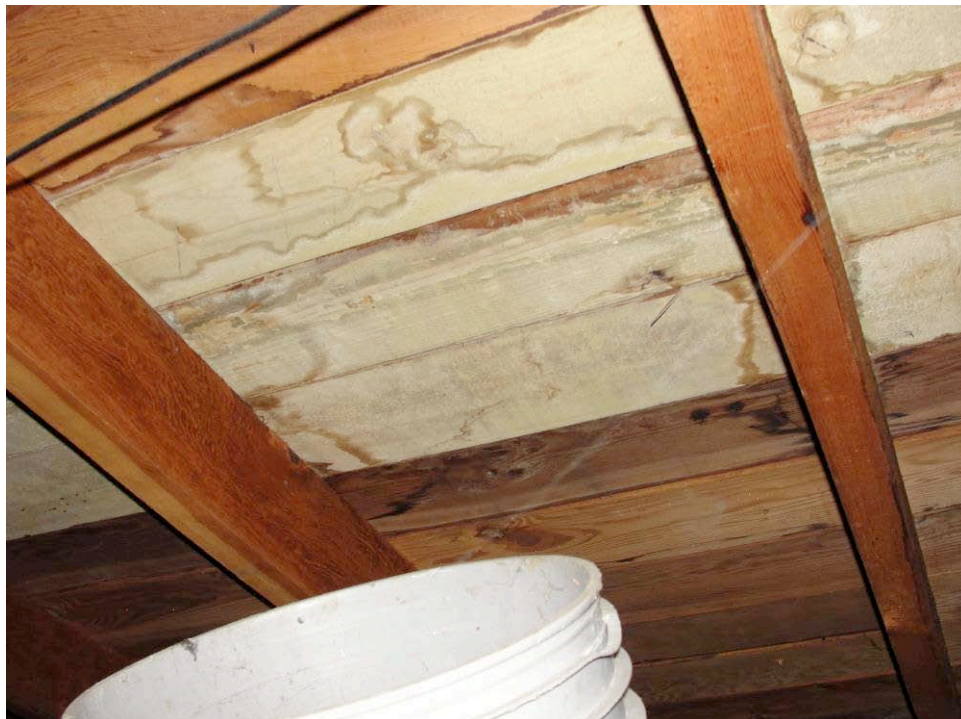
PHOTO: This water stain and the bucket below it were found in the lower attic, above the laundry.

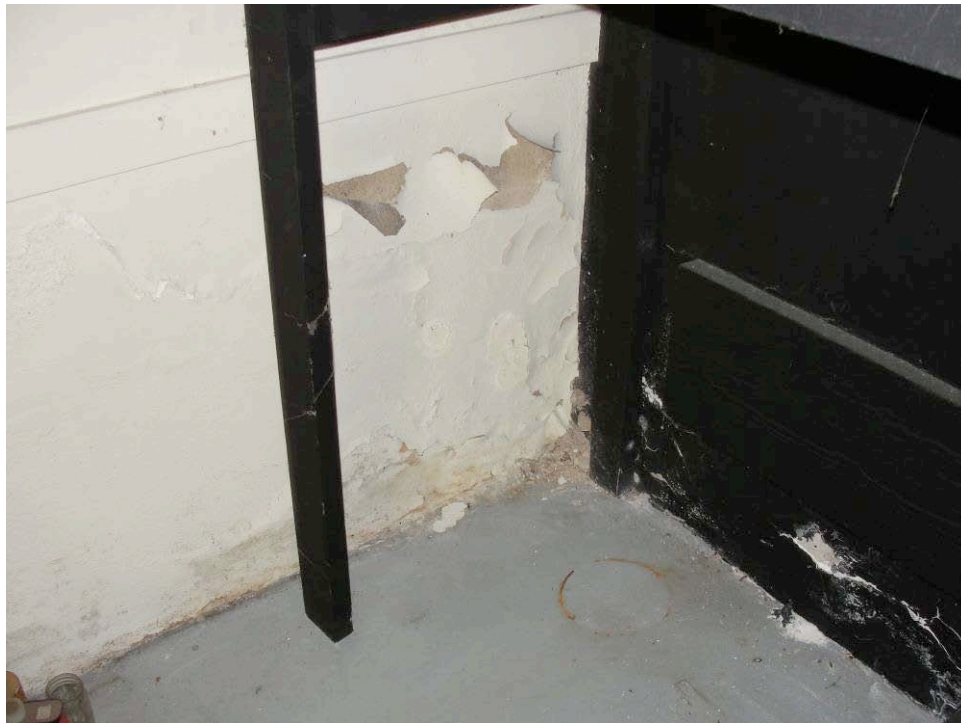
PHOTO: The south east corner of the garage is water damaged.

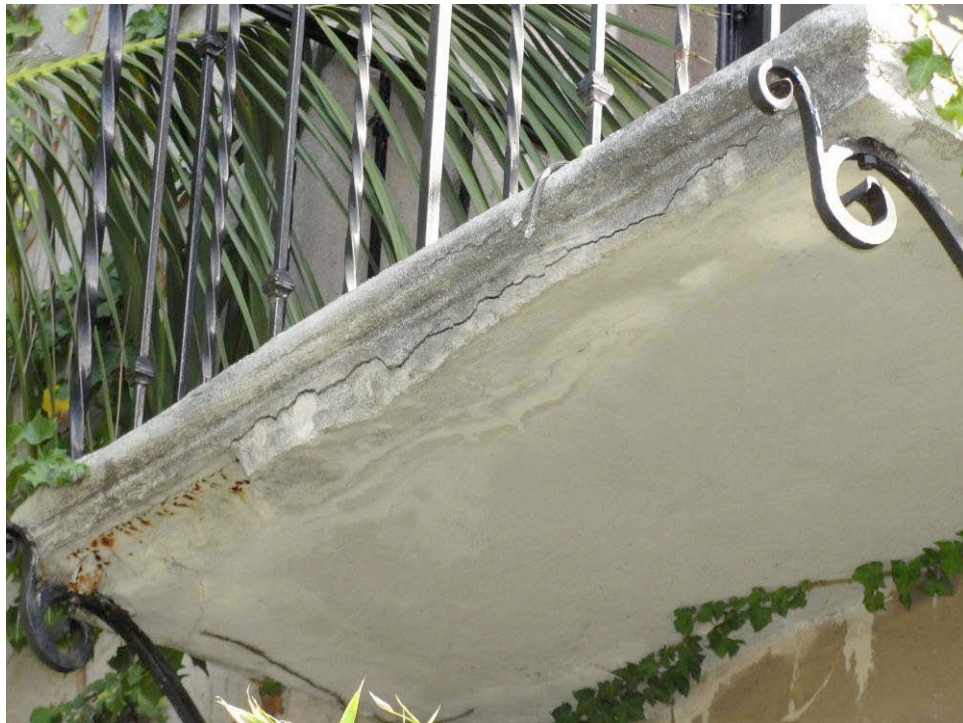
PHOTO: The concrete balcony at the north west bedroom is damaged.

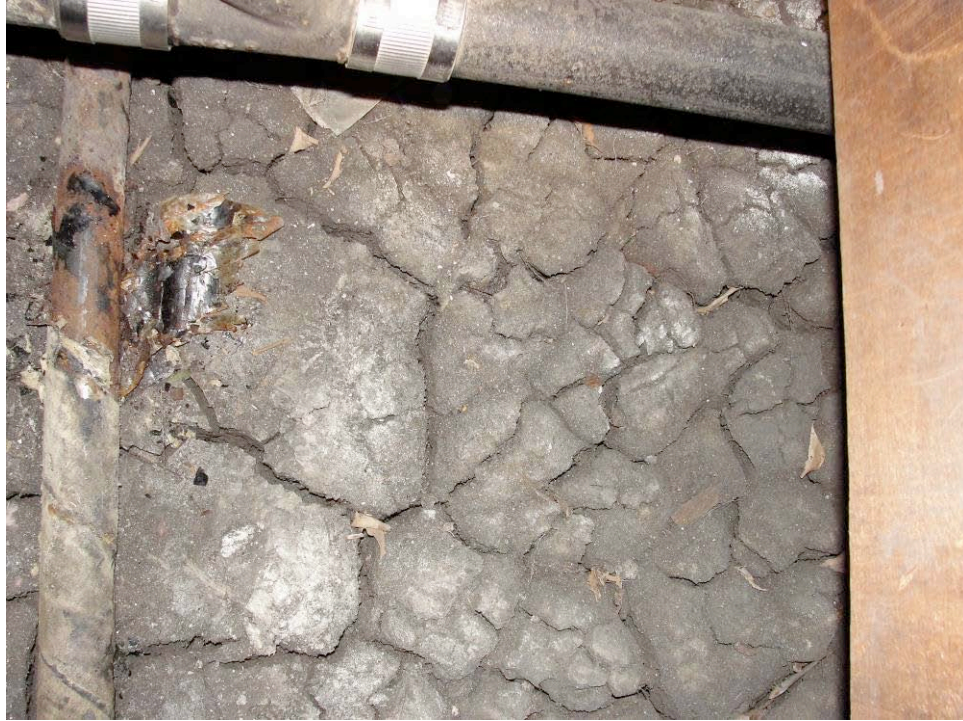
PHOTO: The cracked earth is an indication of expansive soils and past excessive moisture. Also note the damaged “field wrap” on the gas line in the left of the photo. See PLUMBING SYSTEMS notes below.

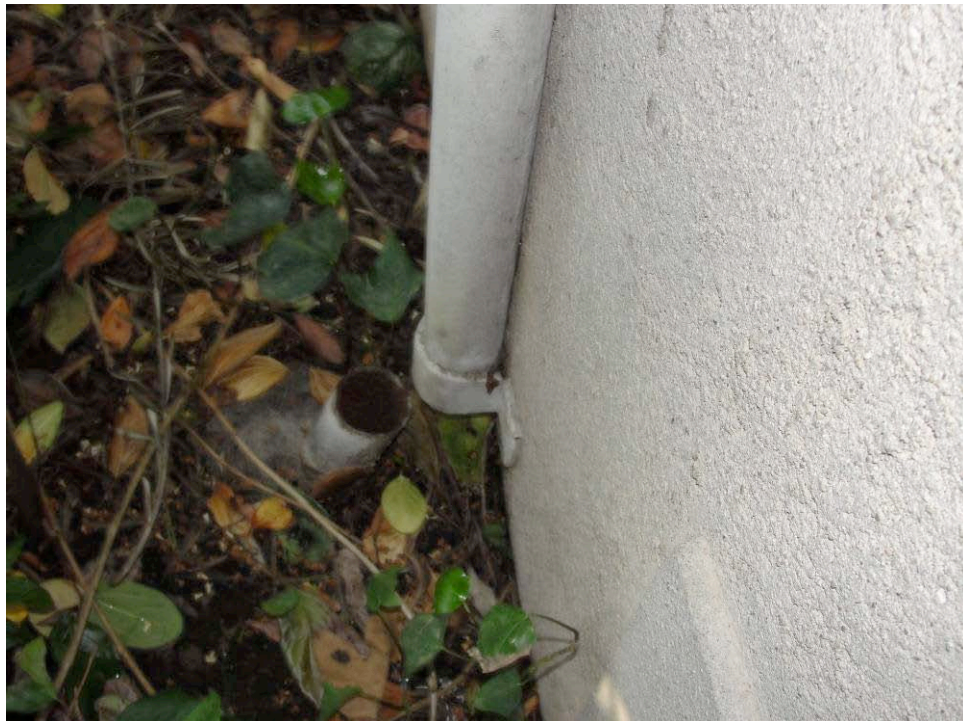
PHOTO: This separated drain will contribute to the adverse site drainage conditions.

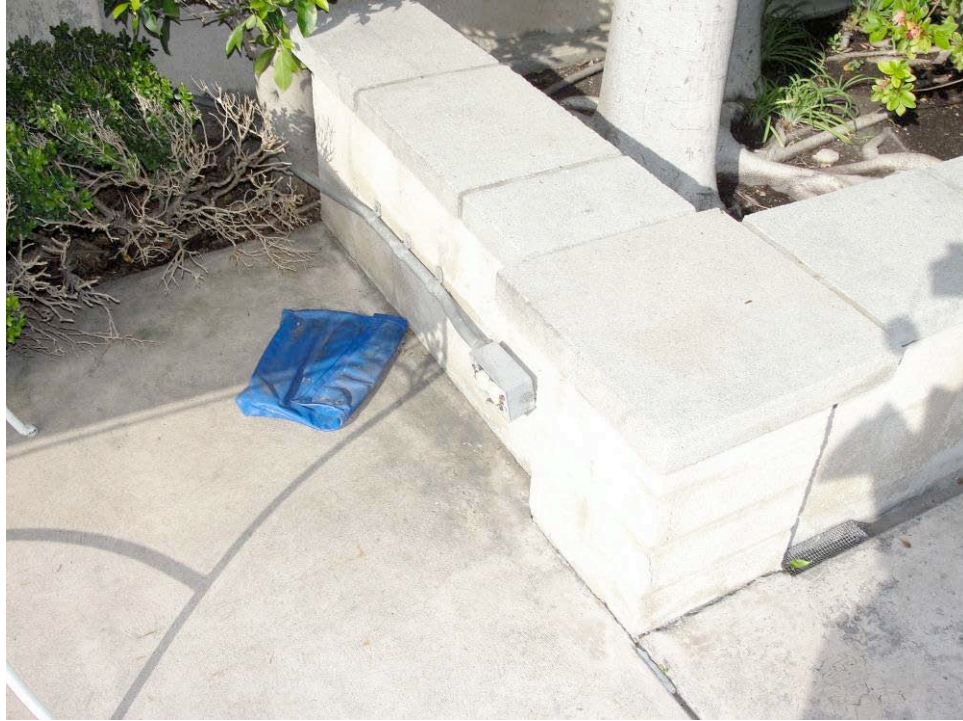
PHOTO: This receptacle has no cover and is not the GFCI type. It is a hazard at this location.

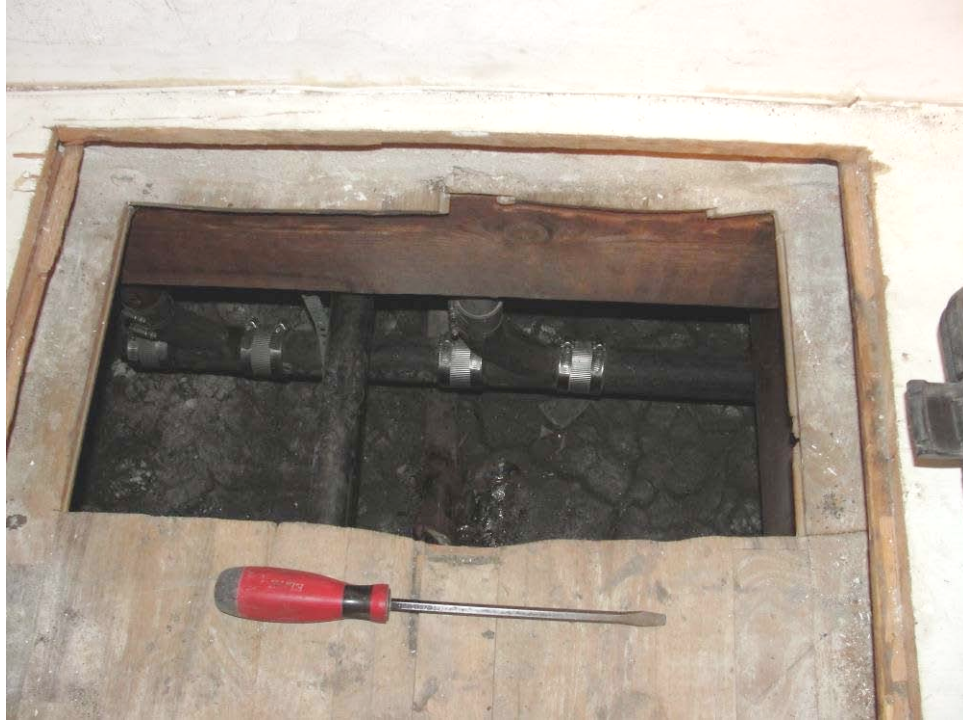
PHOTO: This is the hatch in the east maid's room. The screwdriver was placed to provide scale.

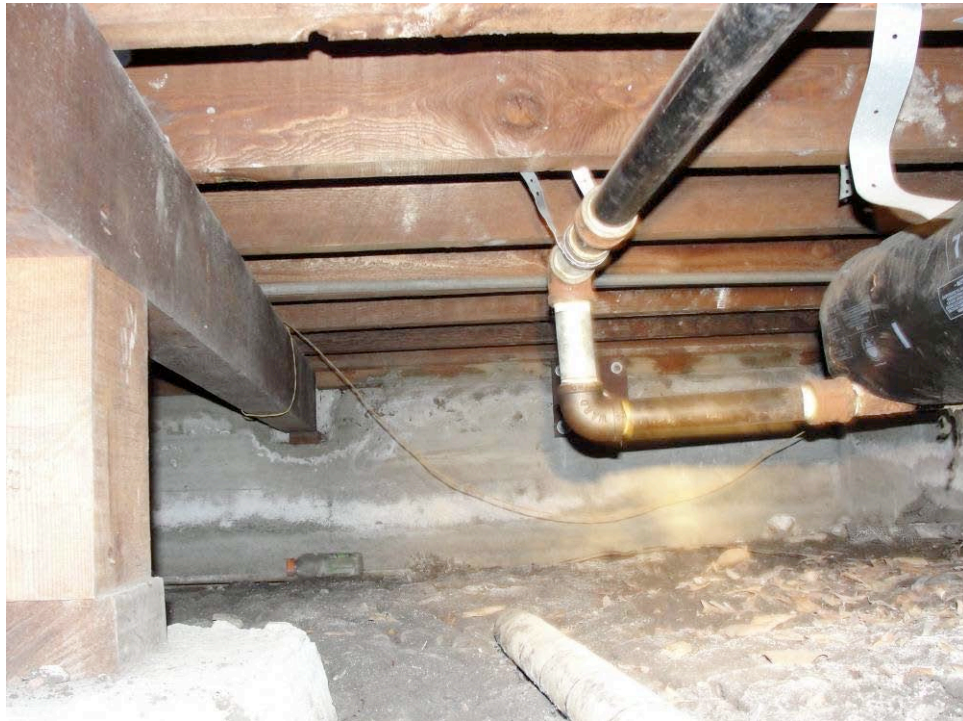
PHOTO: This photo was taken "blind" from the hatch in the bedroom. It is looking east. Note the good condition of the concrete foundation wall. Also note the presence of the foundation anchor (directly behind the gas line in the center of the photo.)

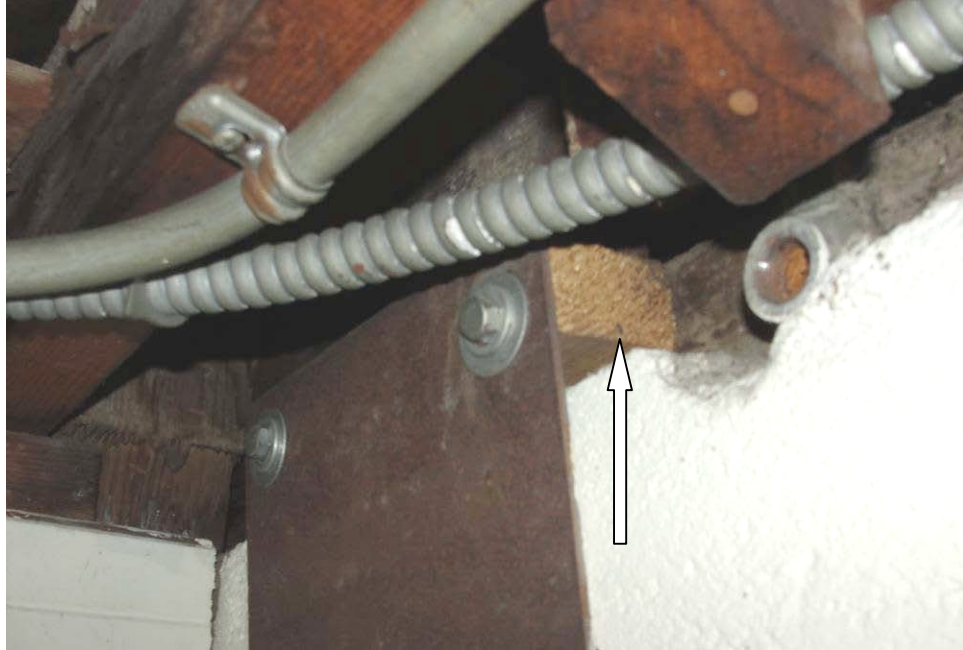
PHOTO: The foundation anchors are secured with wood blocks between the anchor and the mudsill.
