Los Angeles Department of City Planning

RECOMMENDATION REPORT

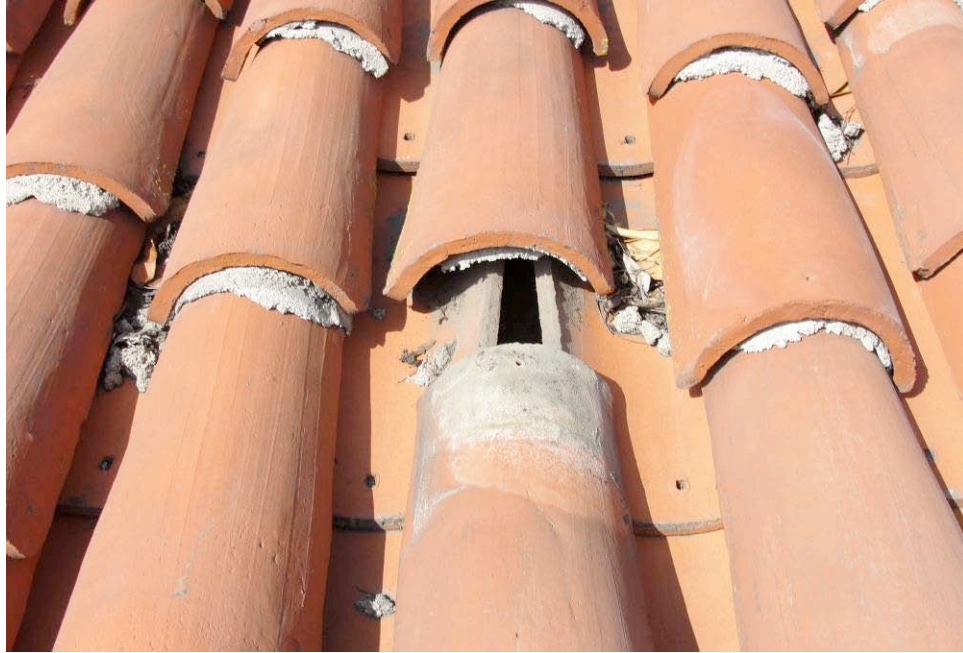
PHOTO: The tiles are not attached to the roof sheathing. This tile was moved to illustrate the condition and then carefully replaced.

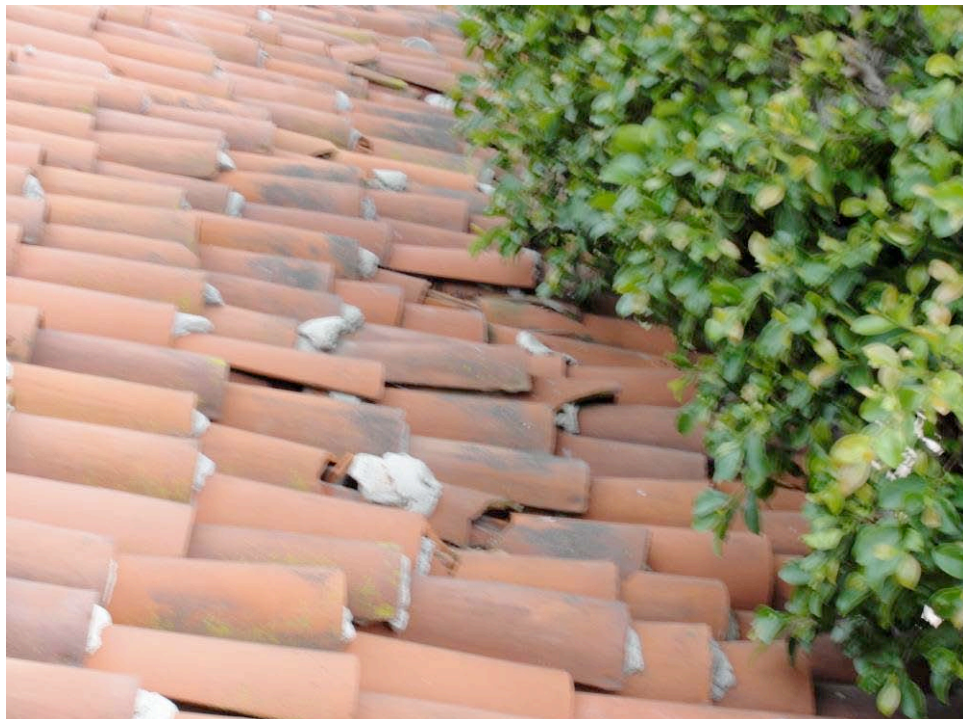
PHOTO: This is the area on the east side of the lower roof. Note the many damaged tiles.

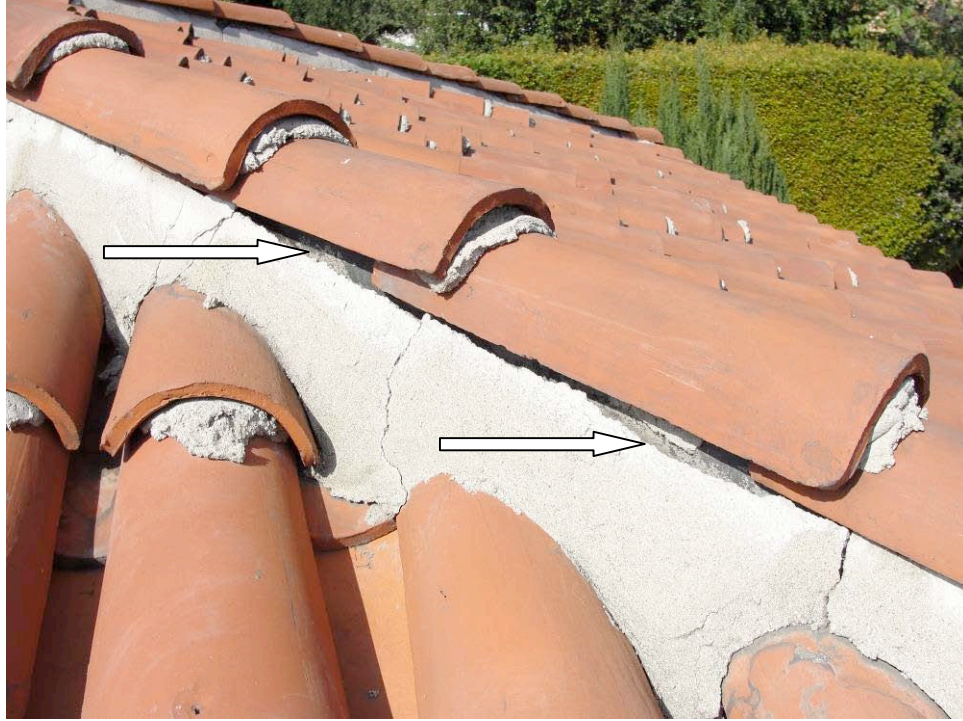
PHOTO: The mortar is thin at the hips and ridges. It appears susceptible to water penetration to the underlayment.

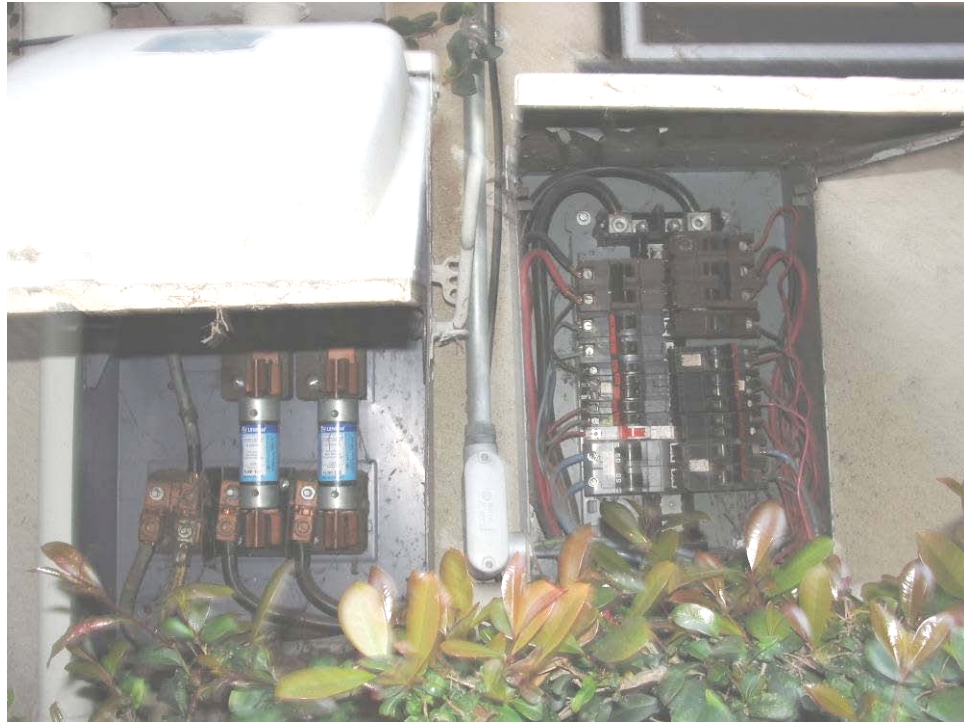
PHOTO: A view of the open main panel and the adjacent sub panel.

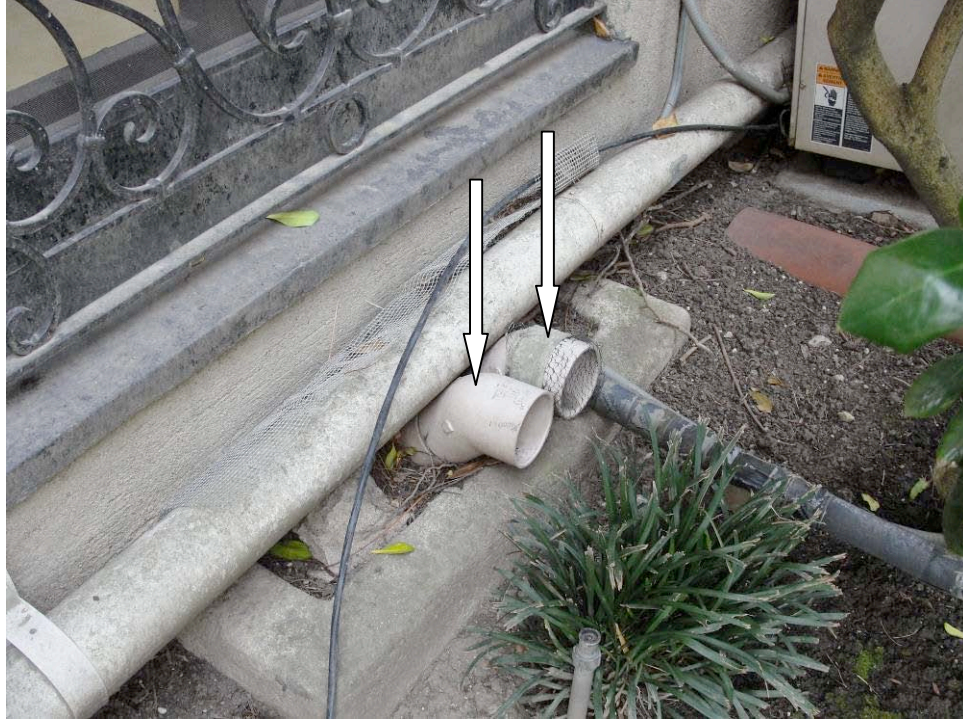
PHOTO: The exhaust and intake of the downstairs furnace are close.
