GPA Consulting (GPA) was retained to prepare this report to help guide the rehabilitation of the Tokio Florist/Sakai-Kozawa Residence in compliance with the Standards. It includes a summary of the property's significance and history as well as an illustrated inventory of character-defining features and recommendations for treatment. The Tokio Florist/Sakai-Kozawa Residence was exclusively a residential property from 1929 to 1960 and a mixed-use, residential and commercial property from 1960 to 2006. A proposed project involves adaptively reusing the property for commercial office use.

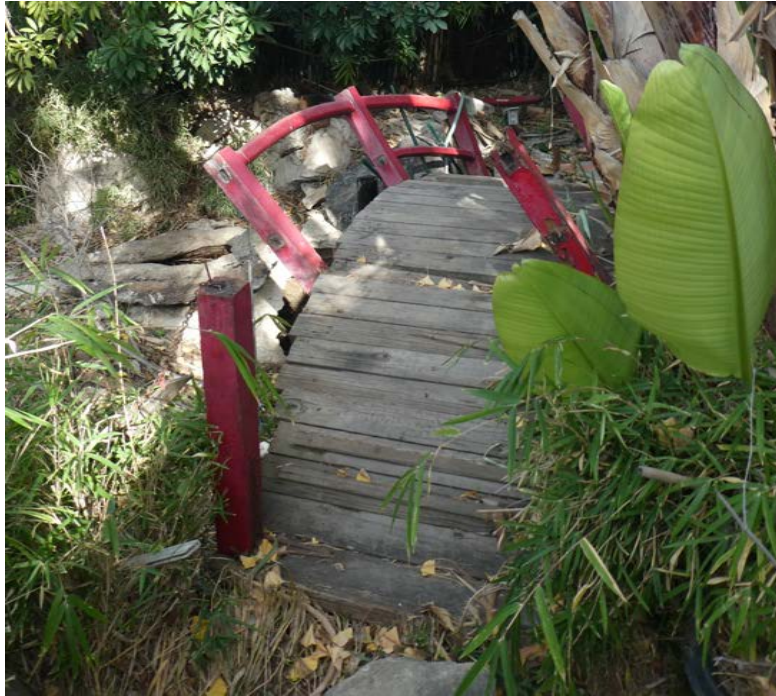
Figure 6: Foot bridges in the Japanese garden are in poor condition (GPA, 2019)

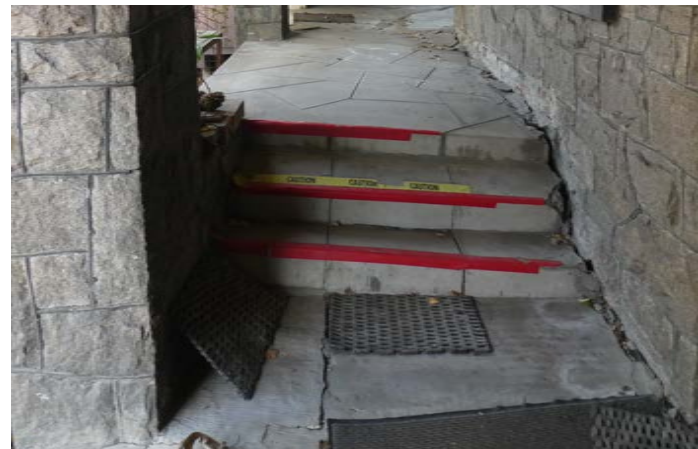
Figure 7: Differential settlement at porch on west elevation (GPA, 2019)

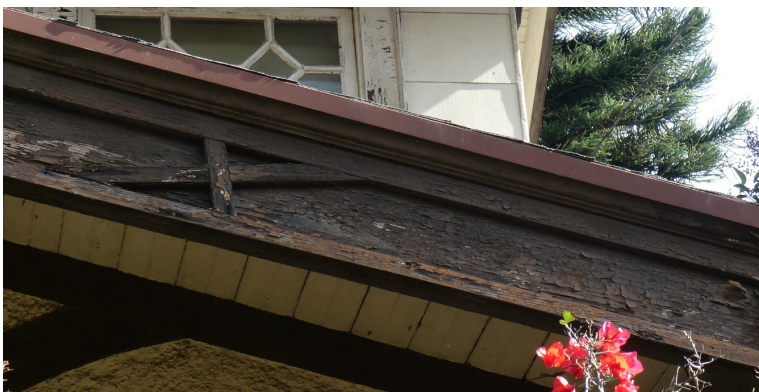
Figure 8: Porte-cochere on west elevation, wood deterioration at ornamental rake (GPA, 2019)

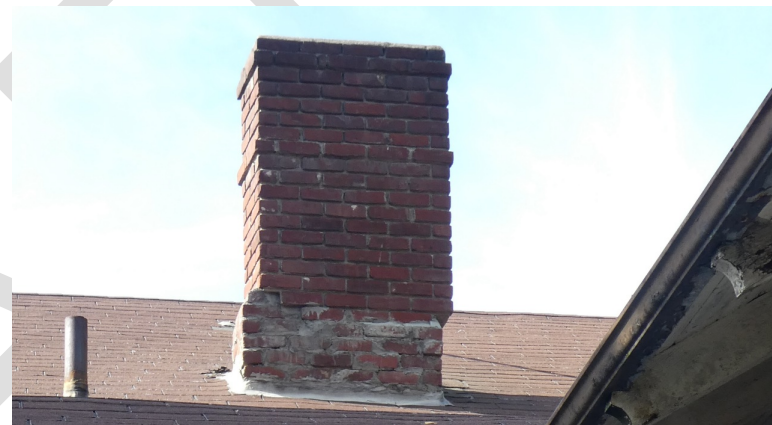
*Figure 9: Tilting brick chimney on east side of roof (GPA, 2019)*

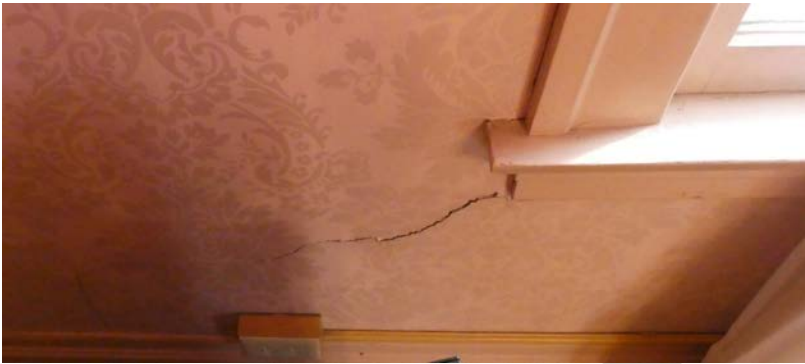
*Figure 10: Southeast bedroom on the second floor, stress crack in the plaster on the east wall (GPA, 2019)*
