Subject: Supplemental Geologic Lot Evaluation 1765 N. Vista Del Mar Avenue Hollywood, California

370 Amapola Avenue, Suite 212, Torrance, CA 90501 TEL: (310) 320-5100 Anaheim – Irvine – Ontario – Oakland – San Diego – Torrance – Victorville www.GroupDelta.com GDC Project No. LA-1183 A Supplemental Fault Report 1765 Vista Del Mar Avenue

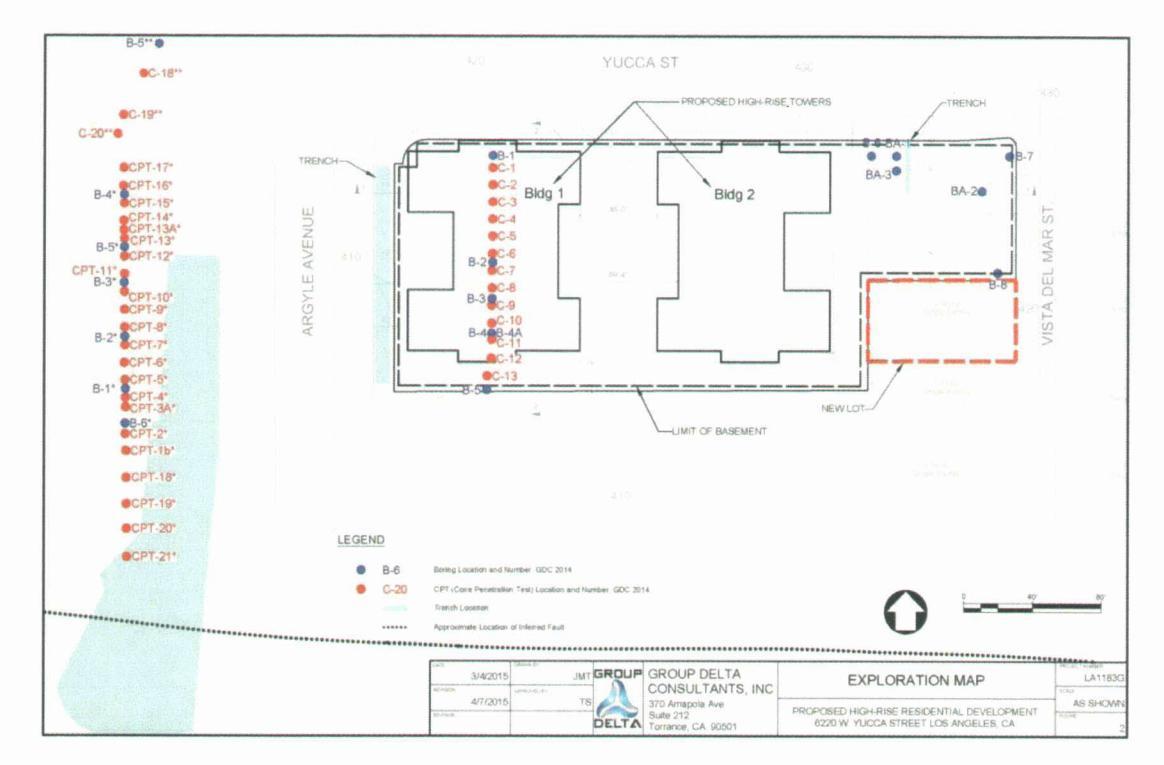
Figure 1: Location of New Lot with Respect to the Proposed Development.
